MSC-PA-R-69-1

APOLLO 8 MISSION REPORT

MANNED SPACECRAFT CENTER

FEBRUARY 1969

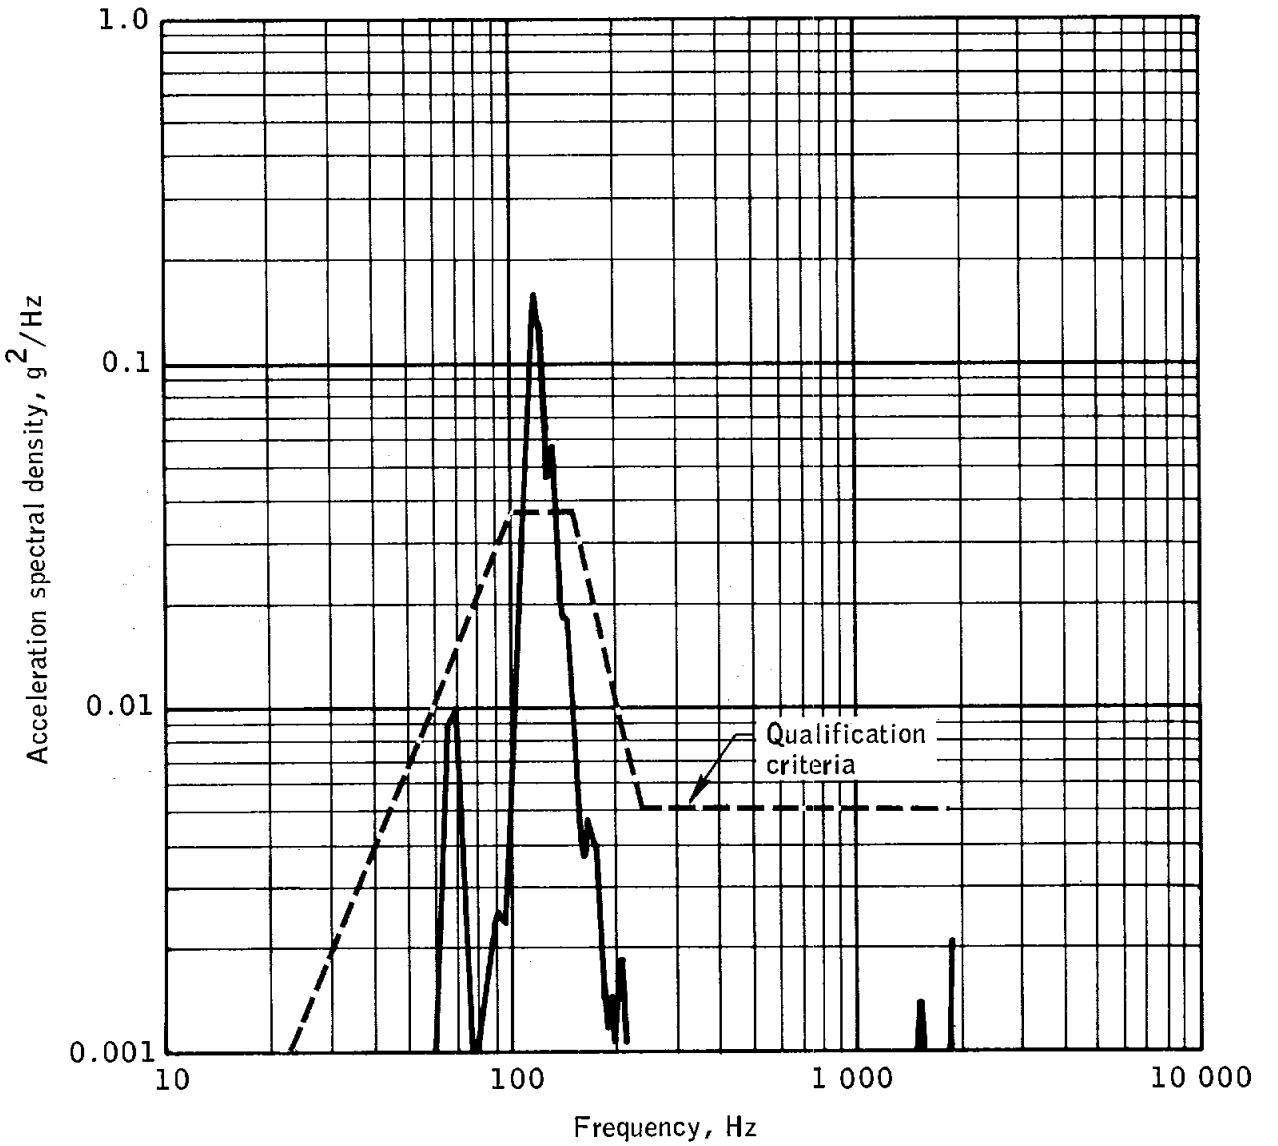
Sensitive axis	Frequency, Hz	Above criteria, dB		
		Lift-off	Transonic (Mach 1)	Maximum q
X-axis	70	3.2	--	--
	120	6.2	--	--
	1500	--	8.5	8.8
	1860	--	--	4.0
Tangential	1200	--	--	4.0

Figure 6.1-1.- Comparison of high-gain antenna vibration at lift-off with criteria.

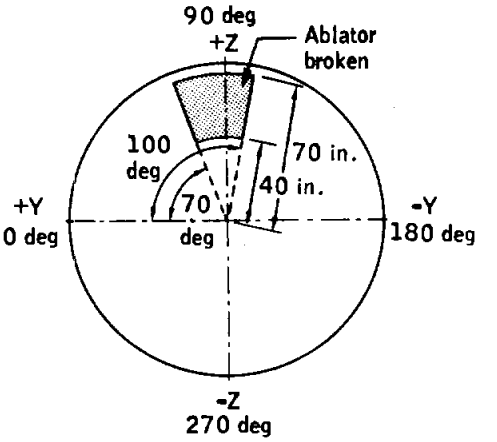
Pieces of charred ablator were broken from a large area in the general stagnation region (fig. 6.4-1). Examination of the damaged area and char thickness measurements at adjacent locations definitely indicate that the char was intact during entry. Similar damage was noted on Apollo 4 and 6 heat shields but over a much smaller area. The damage most likely resulted from landing shock, and, therefore, does not relate to ablator performance.

Figure 6.4-1.- Location of damaged ablator.

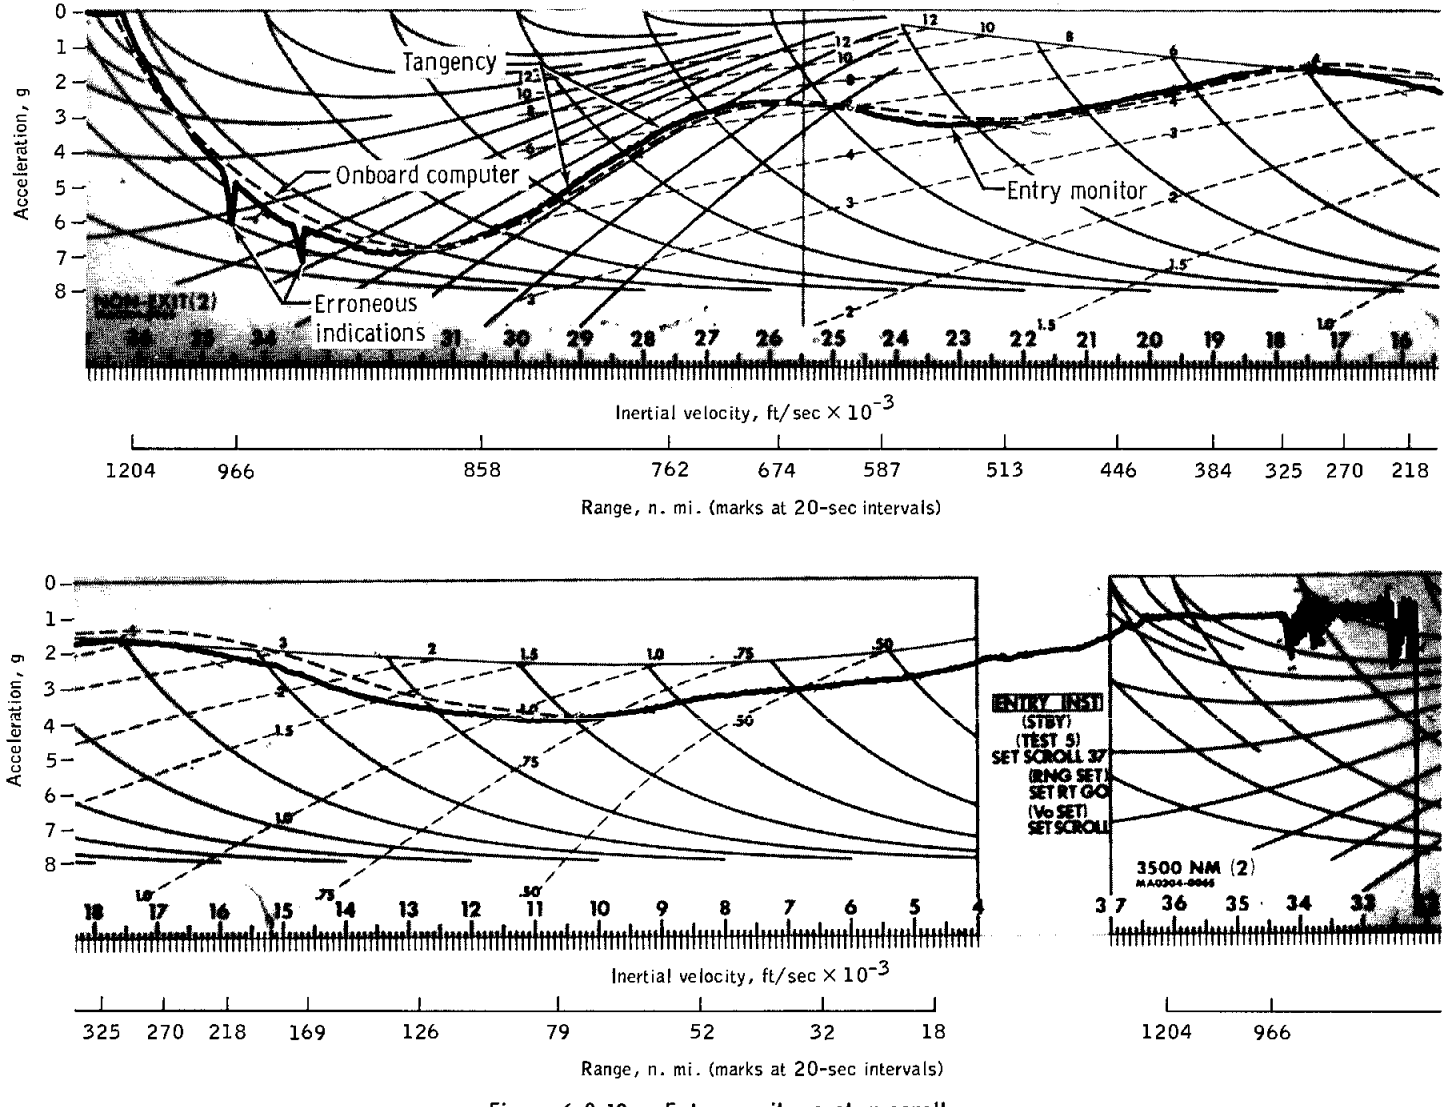
Figure 6.9-12.- Entry monitor system scroll.

The only abnormality during the entry phase involved the entry monitor system. Figure 6.9-12 shows the entry velocity/load-factor scroll from the entry monitor system. Plotted on the scroll is the actual velocity/g trace and one reconstructed from guidance system data. As this figure shows, the g trace contained several jumps during entry. (See section 12 for further discussion.) The apparent violation of the exit guidance is not a true violation, since during the period of tangency, the guidance system was commanding the proper roll attitude (180 degrees, lift down).

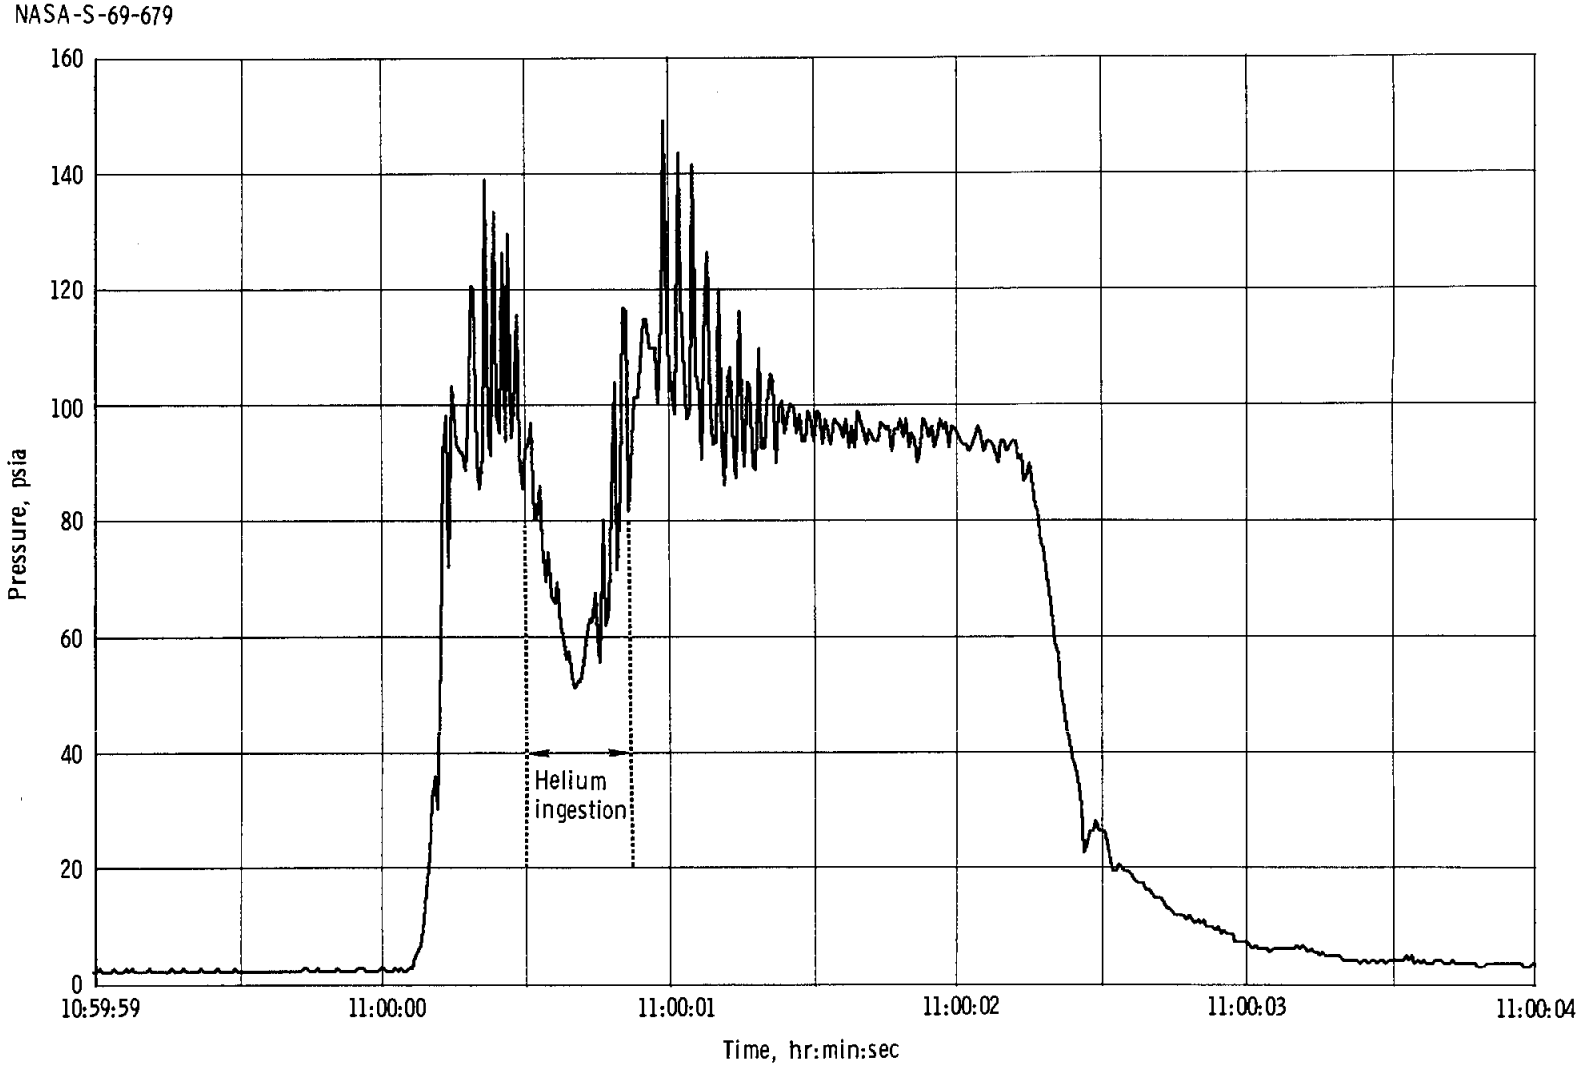
Figure 6.11-1. - Chamber pressure during first service propulsion maneuver.

A momentary drop in chamber pressure (fig. 6.11-1) was observed at the start of the first maneuver; this drop is attributed to the presence of a helium bubble in the oxidizer feed line. The trapped helium resulted from an inadequate engine-oxidizer bleed during preflight servicing. Comparable chamber pressure traces were obtained during a spacecraft ground test when the bleed procedure was also improperly conducted and during the AS-202 mission, during which the second service propulsion maneuver also exhibited helium ingestion. Chamber pressure characteristics were normal for the remaining three maneuvers. Bleed procedures have been changed in future spacecraft to preclude recurrence of trapped helium in the lines.

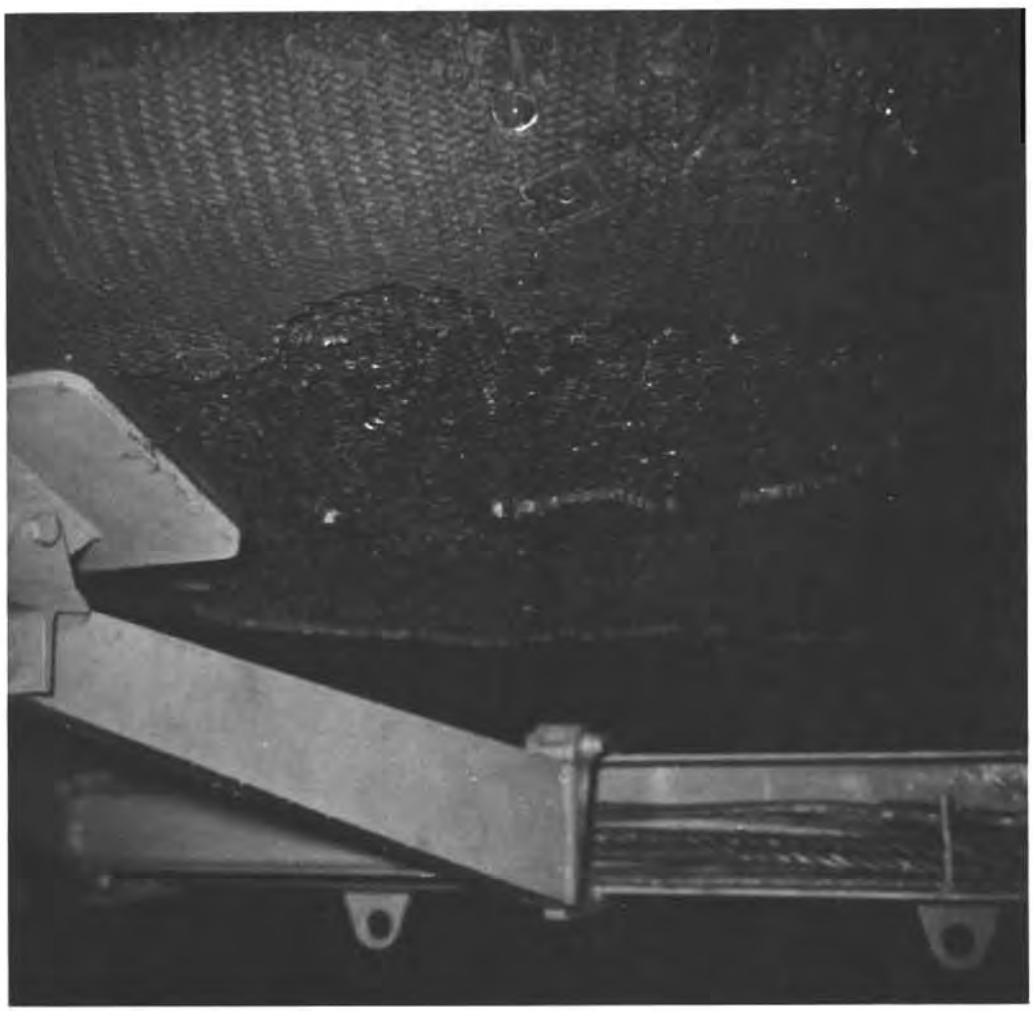
Figure 9.3-5.- Broken ablator on aft heat shield.

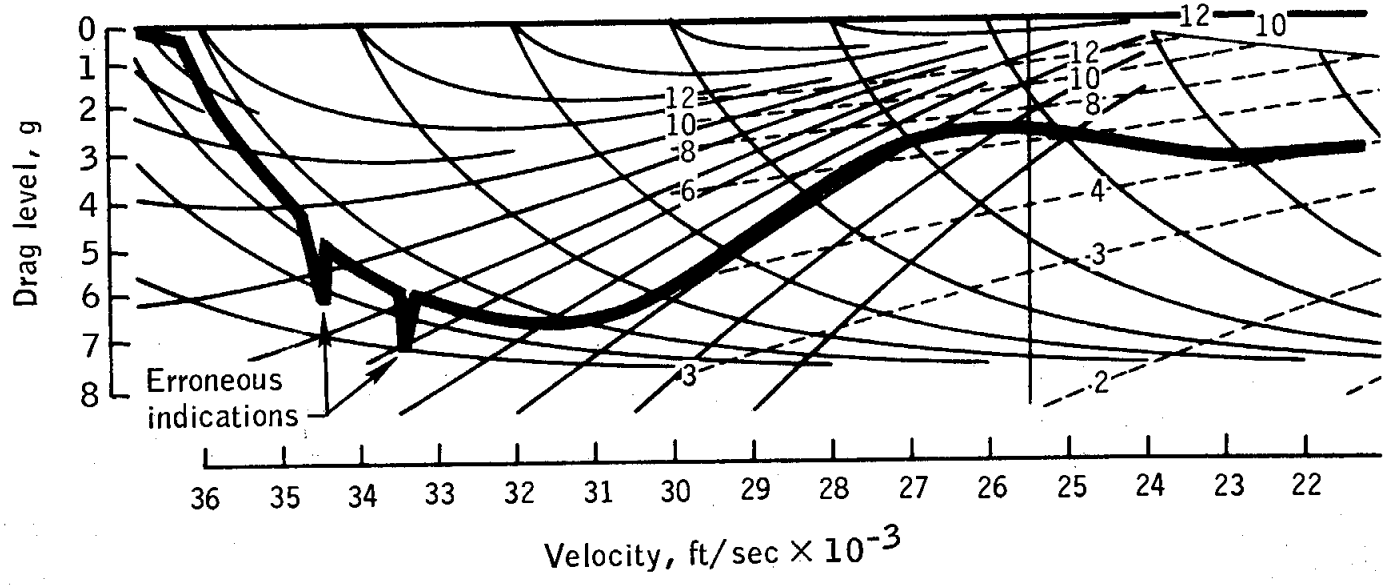
Figure 12-1.- Entry monitor system scroll.

4. For the initial entry phase, the g/velocity trace on the entry scroll showed two short, incorrect g transients (fig. 12-1). Operation of the scroll assembly was normal in all other respects.

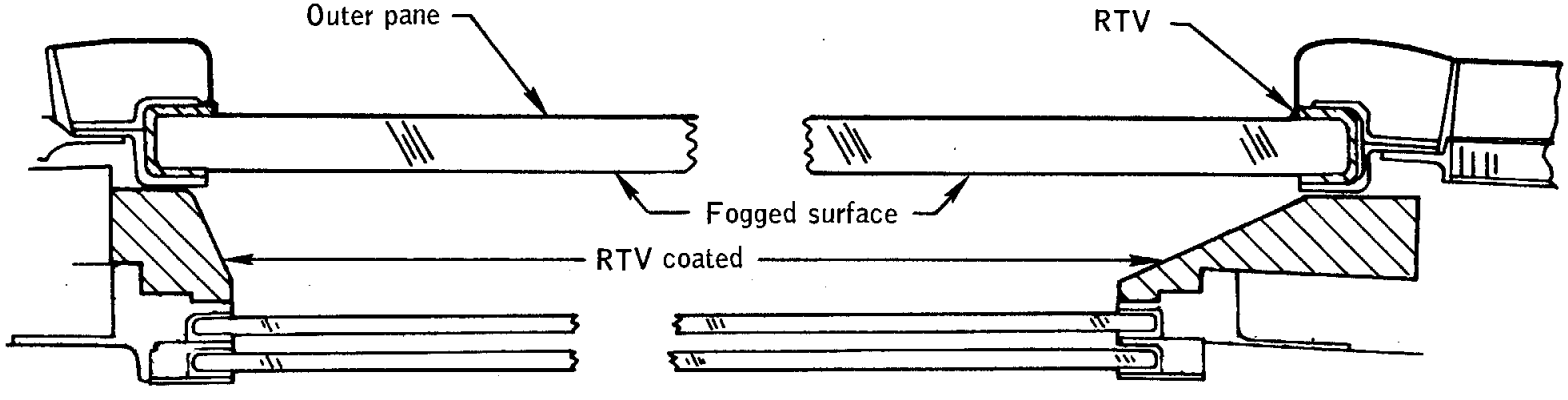
Figure 12-2.-Side window cross section (also typical for hatch window).

As experienced on Apollo 7, windows 1, 3, and 5 became contaminated early in the flight. The center (hatch) window began to fog during earth parking orbit, and by 6 hours this window was unusable. Modifications for subsequent spacecraft should eliminate this condition; further discussion is contained in section 12.

Figure 12-2 shows a cross section of the side windows, including the typical installation of the three windows and the location of the modification. The modification consists of a new RTV curing process to greatly reduce the residual oils.

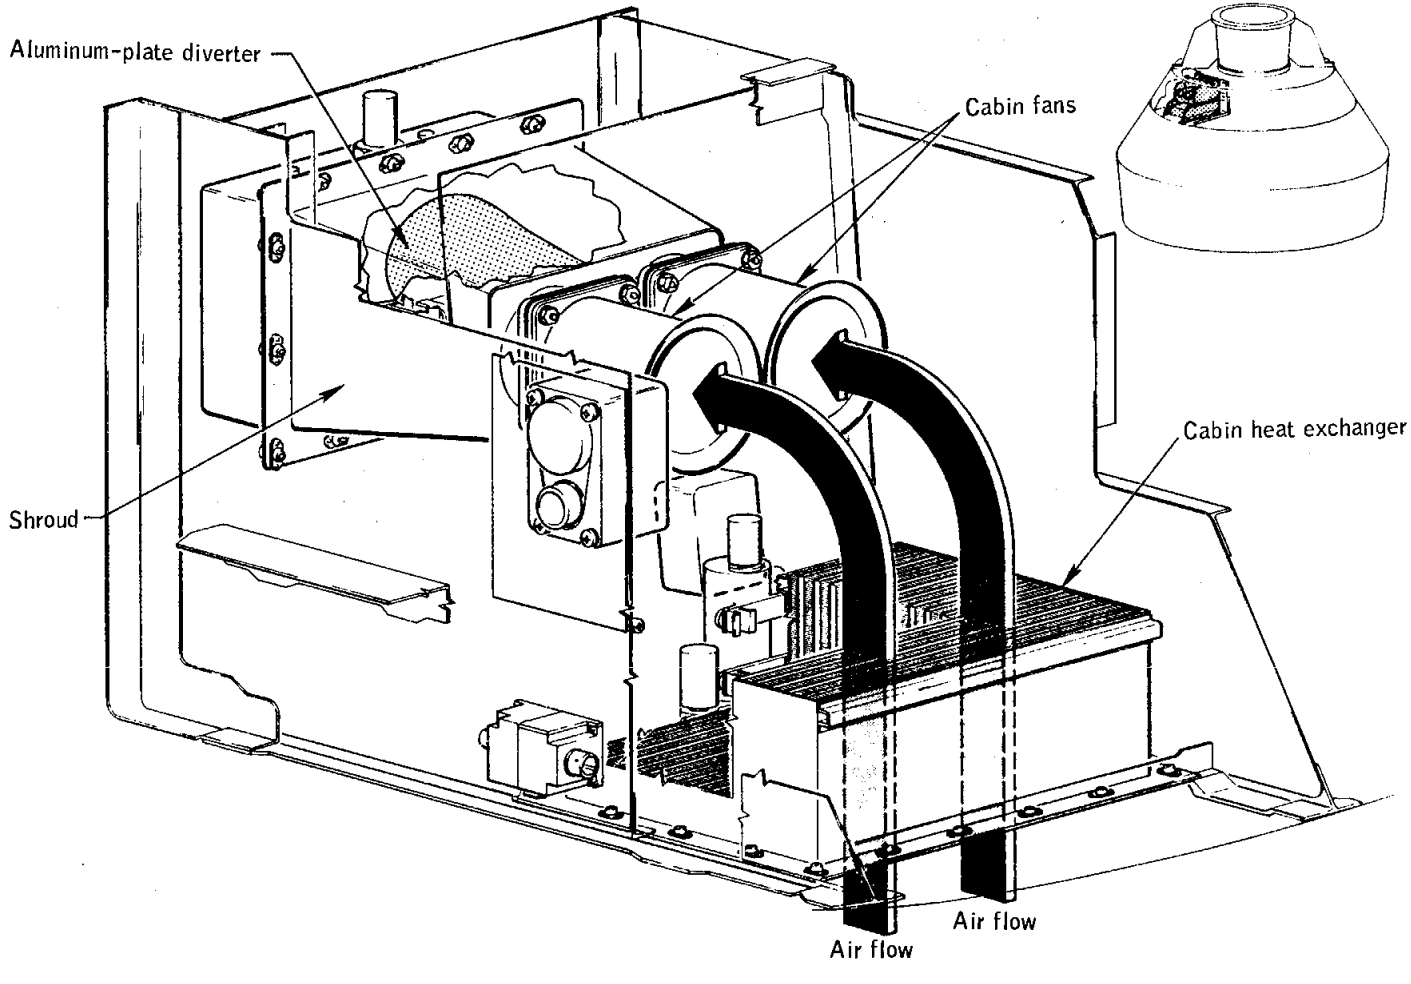
Figure 12-3.- Cabin fan installation.

During the sixth day of the mission, the cabin fans (fig. 12-3) were momentarily turned on, and the crew reported that both were noisy.

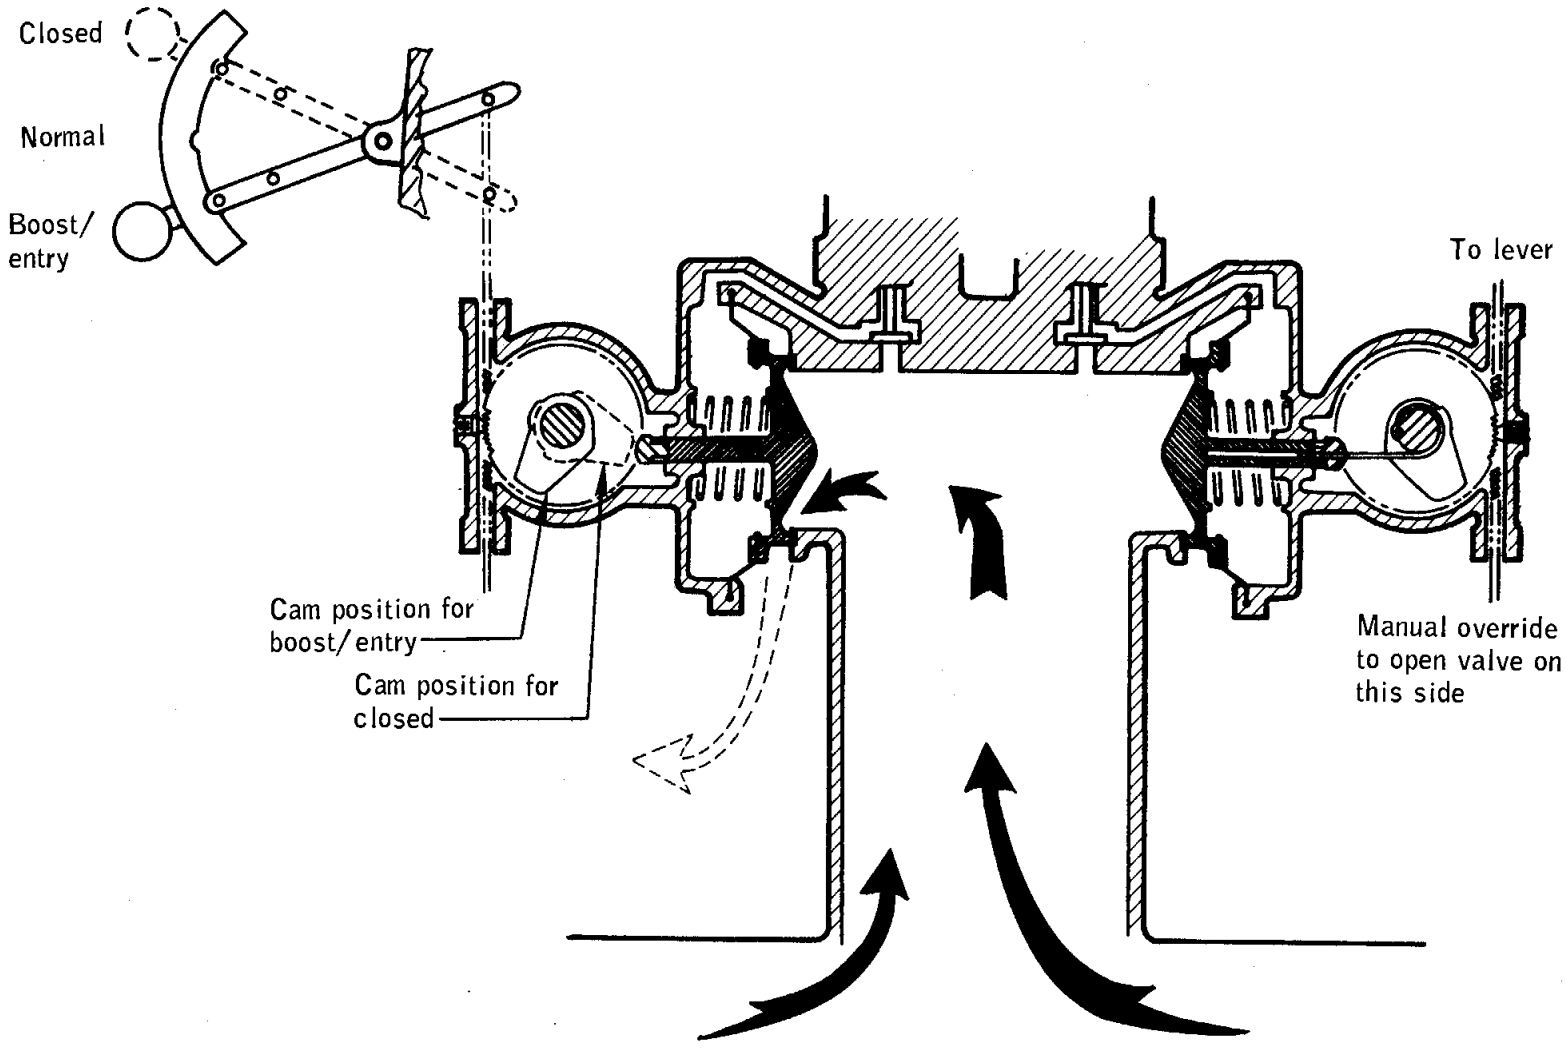
Figure 12-4.- Cabin pressure relief valve.

The Commander reported that his left shoulder was showered with water at landing, implying that sea water entered through the cabin pressure relief valve (fig. 12-4); the crew reported that both sides of the valve had been positioned to the closed position, as specified by the crew checklist.

A manual lever is connected to each side of the redundant cabin pressure relief valve. With the two levers in the closed position (dashed lines in fig. 12-4), a cam prevents the valve from opening. Any other position of the lever and cam allows the valve to open at ambient-to-cabin differential pressure of 0.3 psi. Postflight, the valves were tested to 13 psi in the closed position, and the leakage was within specification. Increasing the pressure to 25 psig caused a fine spray around the valves. However, the valves did not yield permanently. Only a negligible amount of sea water could enter by ram effect against the relief

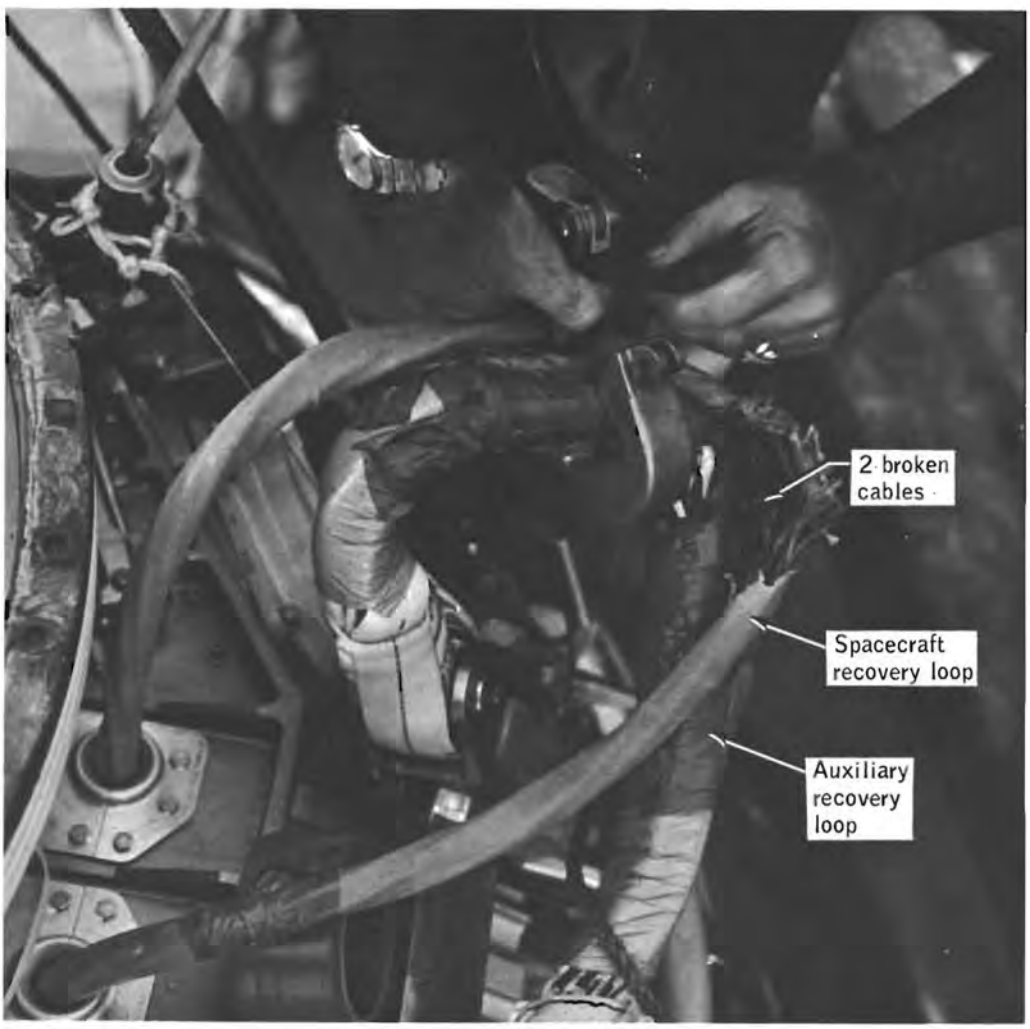
Figure 12-5.- Broken cables in spacecraft recovery loop.

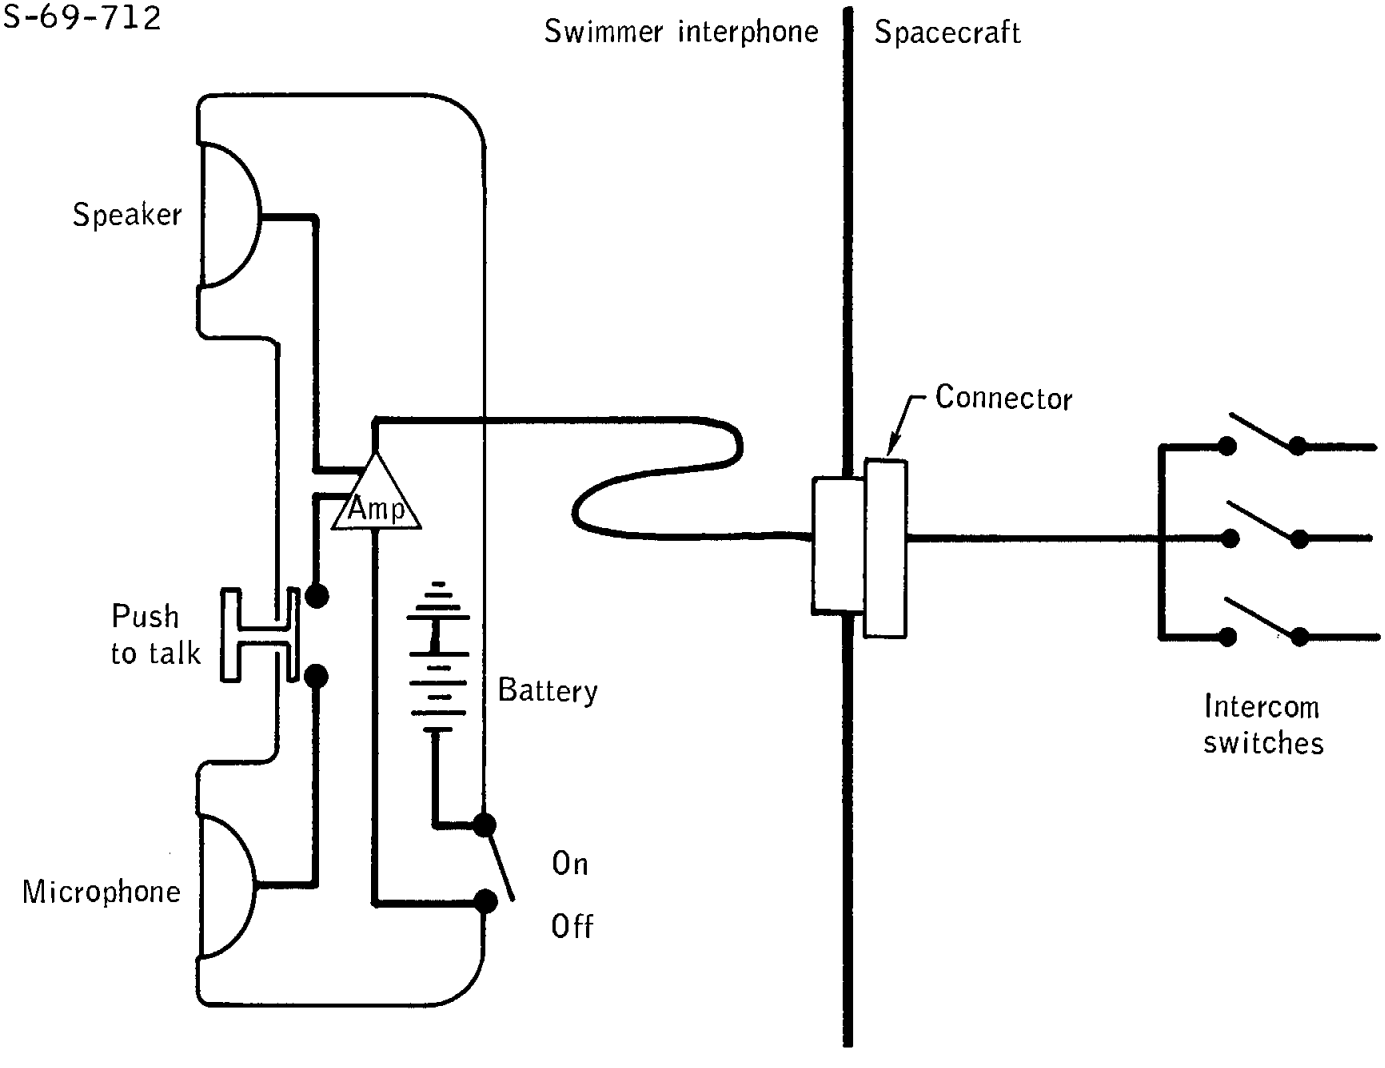
Figure 12-6.- Swimmer interphone.

During recovery operations, the swimmers were unable to communicate with the crew via the intercommunications system. The crew reported that the spacecraft intercom switches were in the proper position. As shown in figure 12-6, the swimmer interphone, which plugs into the spacecraft, has a push-to-talk switch and an ON-OFF switch.

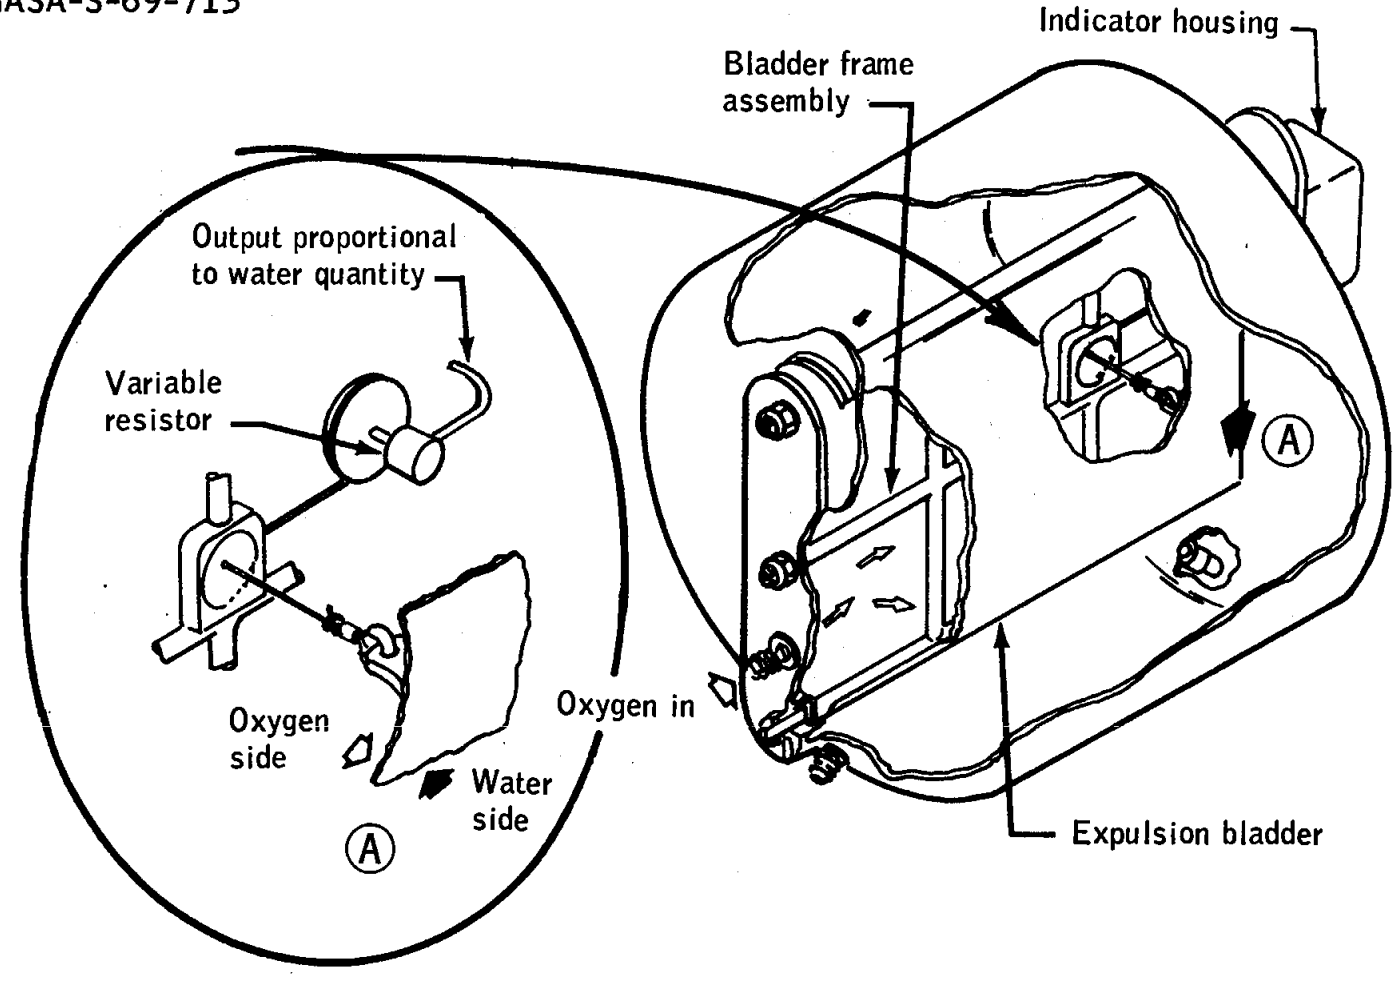
Figure 12-7.- Potable water tank.

Examination of the disassembled unit (fig. 12-7) revealed corrosion in the indicator housing, on the variable resistor, and on the actuator pulley, indicating moisture had been present in the oxygen side of the tank pressurization system. The actuator line was broken, probably as a result of postflight calibration with the pulley shaft frozen from corrosion. Analysis of the residue in the area indicated that the contaminant was urine and possibly water from the waste water tank. The contamination could have come through the oxygen bleed filter and orifice (fig. 12-8) into the indicator housing and bladder.

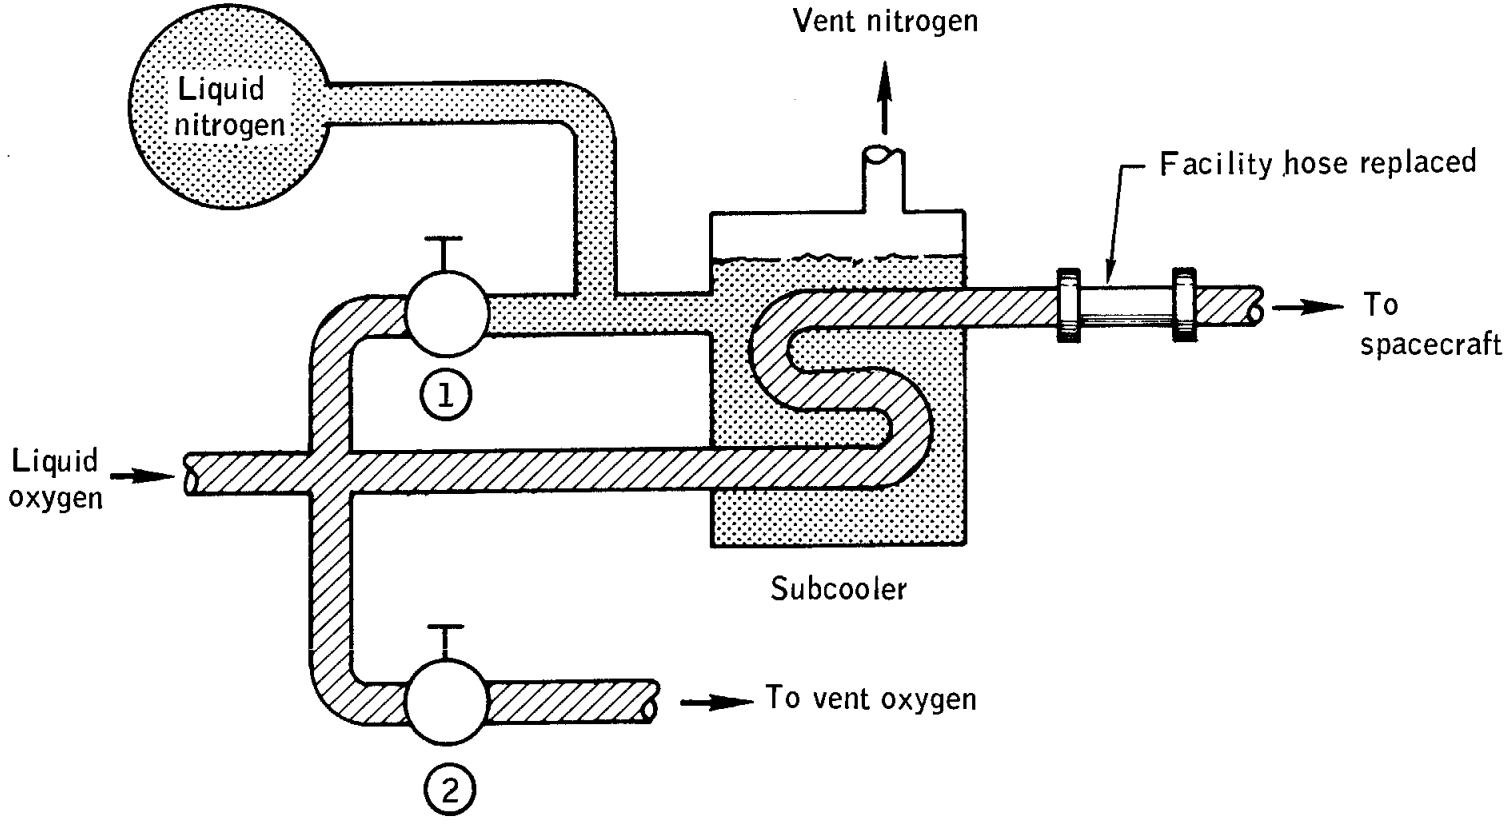
Figure 12-9.- Simplified schematic of cryogenic oxygen servicing unit.

Figure 12-9 shows only the basic system elements associated with the problem.

While servicing liquid oxygen, a leak developed in a facility liquid oxygen line, causing a safety shutdown. To preclude overpressurization because of stagnant liquid oxygen, the system was vented using the normal shutdown procedure. This procedure was incorrect in one area, which called for opening valve 1 instead of valve 2. This error allowed liquid nitrogen to flow through valve 1 into the liquid oxygen supply line. Procedures have been corrected and verified by test. This anomaly is closed.
