FINAL REPORT

INVESTIGATION INTO THE MECHANISM OF DEGRADATION OF SOLAR CELLS

WITH SILVER-TITANIUM CONTACTS

July 1, 1970

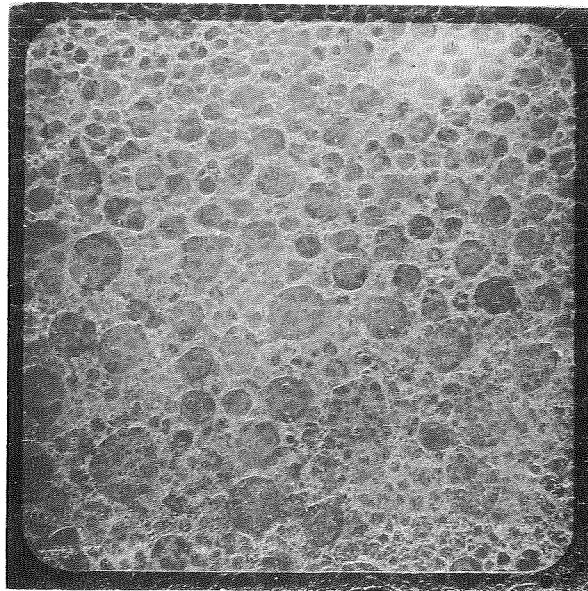
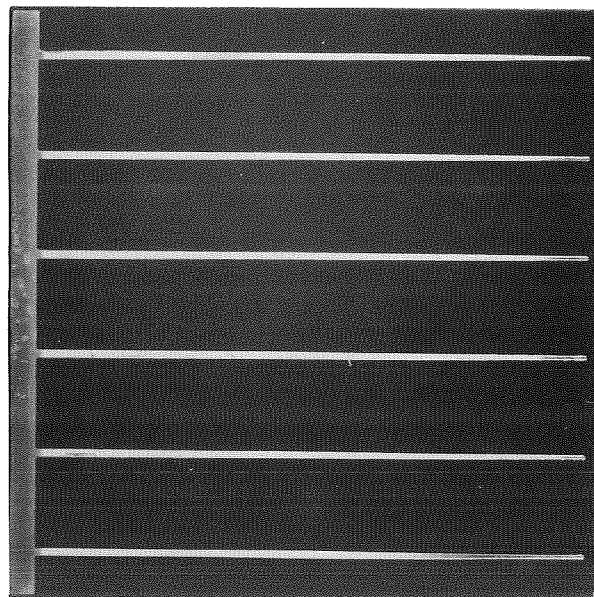
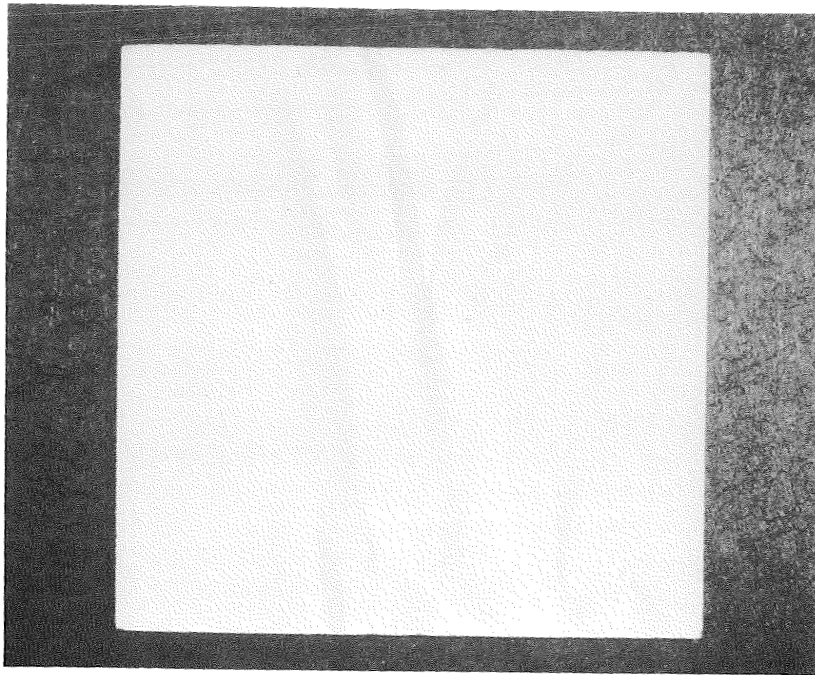
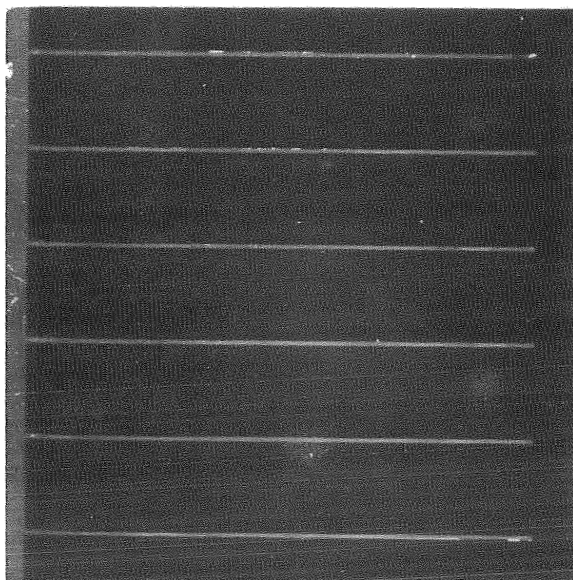
Figure 5 :   HELIOTEK SOLAR CELL (LASA)

Optical micrographs of the sun-facing and back surfaces, taken with a 5 MM metallograph having a 400-watt Xenon light source, are shown in Figures 5, 6, and 7 for LASA, present Centralab, present Heliotek solar cells. Sun-facing areas of all three cell types appear similar except for small differences in grid length and bar contact width. Views of the back contact (Figures 5 and 7) show a mottled surface with "grain-like" characteristics in Heliotek's LASA and present day 1970 cells. The notch in Figure 7 was for identification.

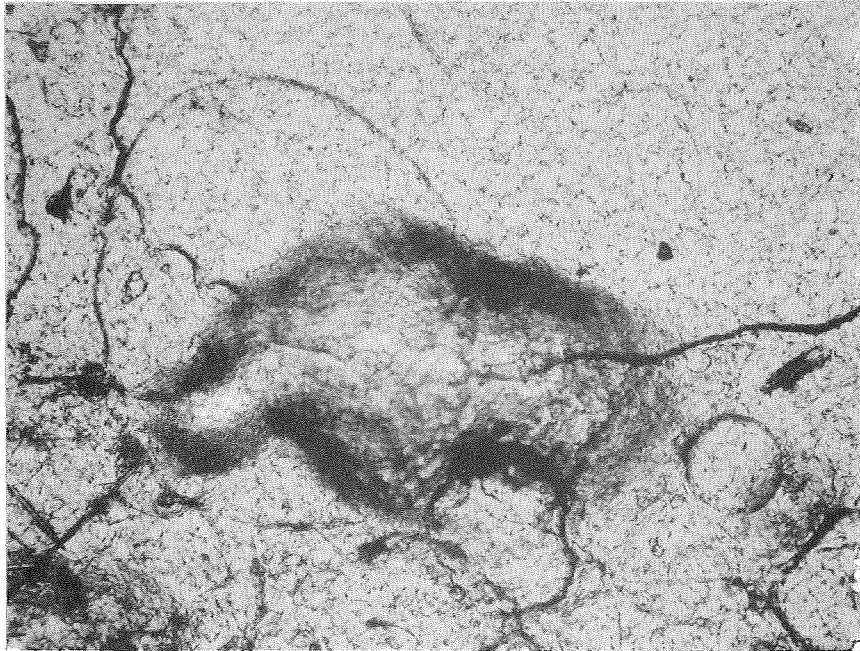
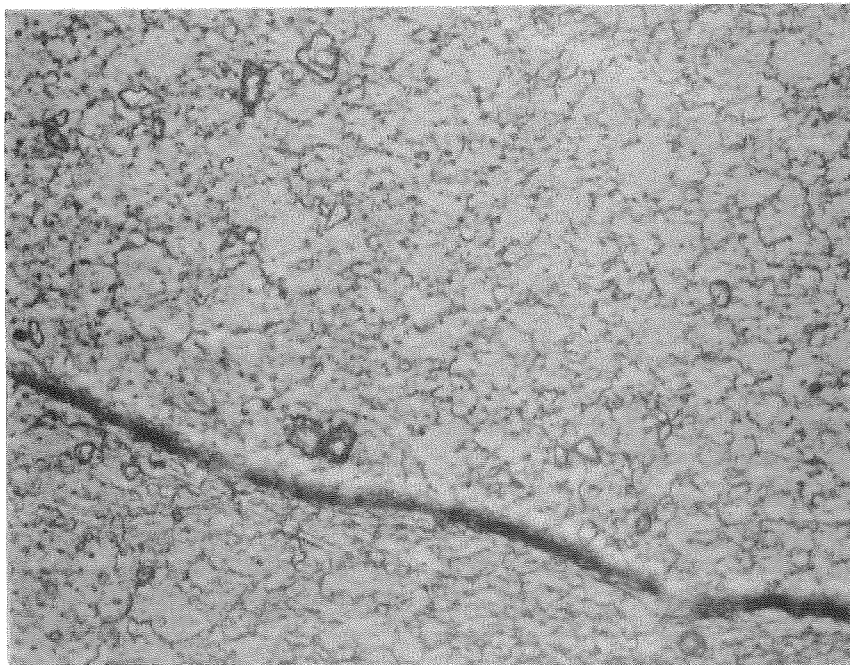
Figure 8: BLISTERED AREA(200X)

Examination of the mottled surface at a higher magnification shows a series of plateaus with no grain boundary (Figures 8 and 9). In particular, Figure 9 shows a continuous surface pattern through a ridge that has a grain boundary appearance at low magnification. The blisters were observed to be located at these plateau boundaries. A metallographic cross section of a solar cell shows rather sharp steps in the silicon substrate, supporting the contention that the apparent grains are substrate plateaus (Figure 10).

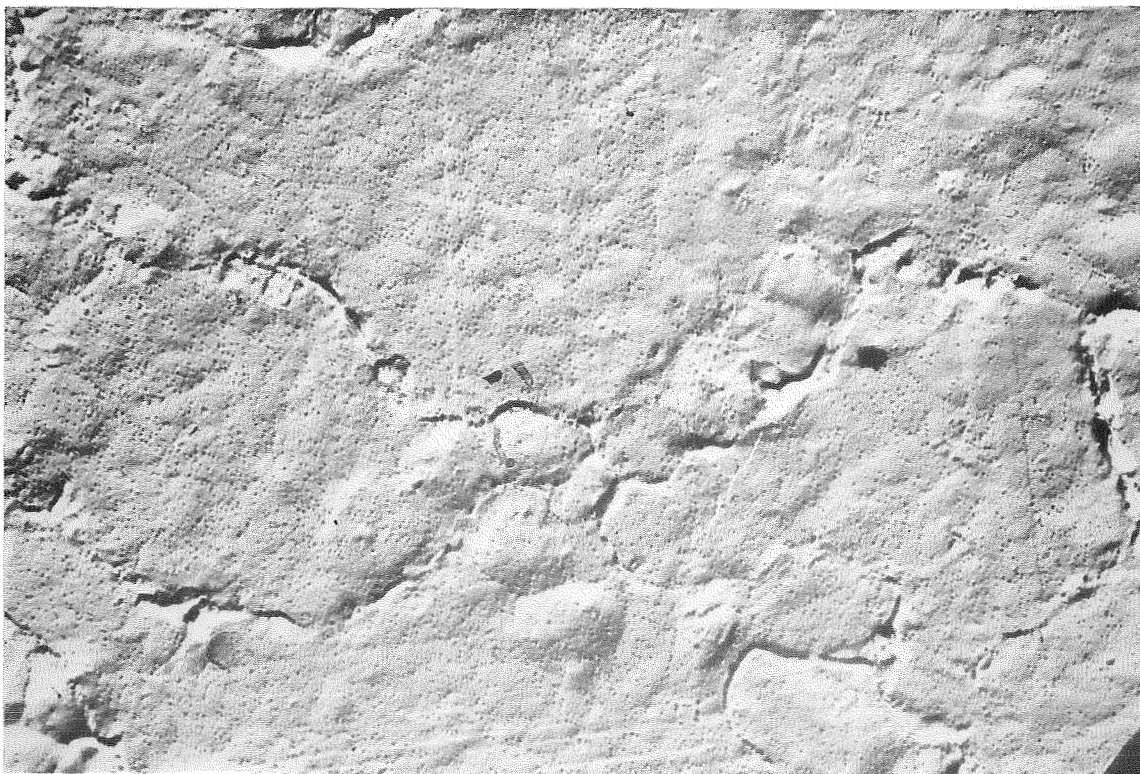
Figure 11: ELECTRON MICROGRAPH (8000X)
OF CONTACT SURFACE

The fine grain structure observed optically is well delineated by electron microscopy, using a JEM 7 (JEOLCO) microscope at 80KV. The replicas were prepared by a two stage technique using acetate tape for replicating, and germanium and carbon for shadowing. The boundaries appear to contain a precipitate, and small pores are prevalent within the grain (Figures 11, 12, 13). We believe that the pores are thermal etch pits generated during sintering.

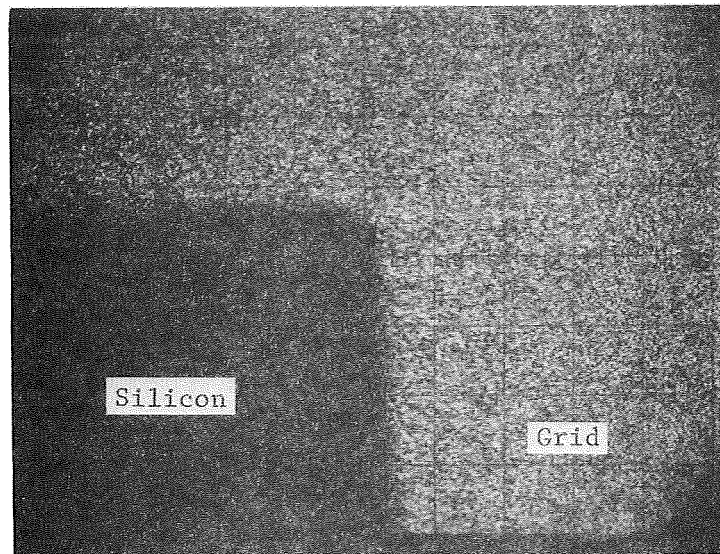
Figure 20: MICROPROBE PHOTOGRAPH OF CELL
            SURFACE WITHOUT SILVER CONTACT

We were able to locate the place where the contact separated with an electron microprobe. We peeled off the silver layer of a badly degraded solar cell and bombarded its back side with 30 KV electrons from an Applied Research Laboratory microprobe. The stripped solar cell itself was also analyzed. The characteristic X-ray from titanium was detected with a X-ray detector, the output of which was displayed on an oscilloscope. Photographs of the scanned samples are shown in Figures 20 and 21. White areas indicated the presence of titanium on the solar cell. The silver contact, on the other hand, had only a small patch of titanium present. Similar studies at 3M also indicated that peeled contacts contained only traces of titanium compared to the amount left on the cell. We thus conclude that the contact failure occurs at the silver-titanium interface.

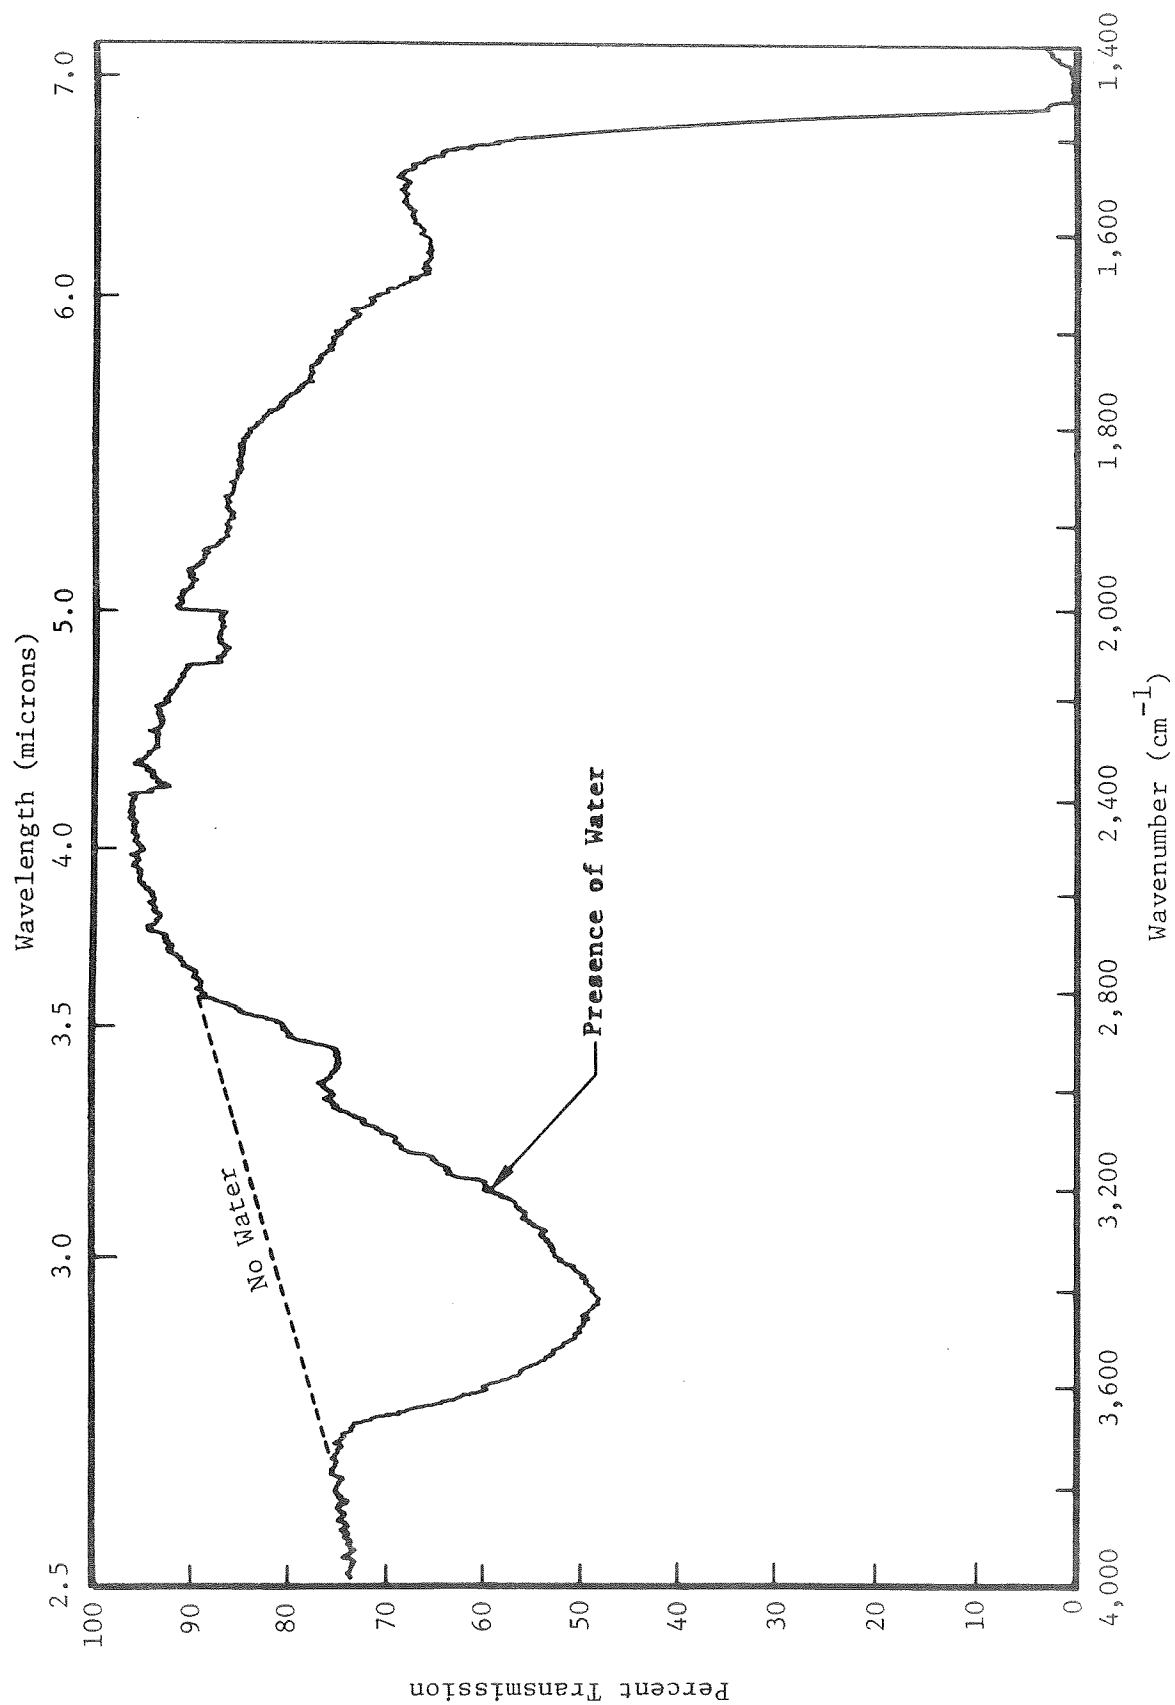
Figure 23: IR TRANSMISSION SPECTRUM

The initial tests were made with the Boeing-prepared wedge. A spectrum taken after 48 hours in a 96% RH showed the presence of water (Figure 23), proving that the silver layer is porous to water. Others (Ref. 9, 11) had assumed that the silver layer on solar cells was porous but this is the first actual measurement of the porosity.

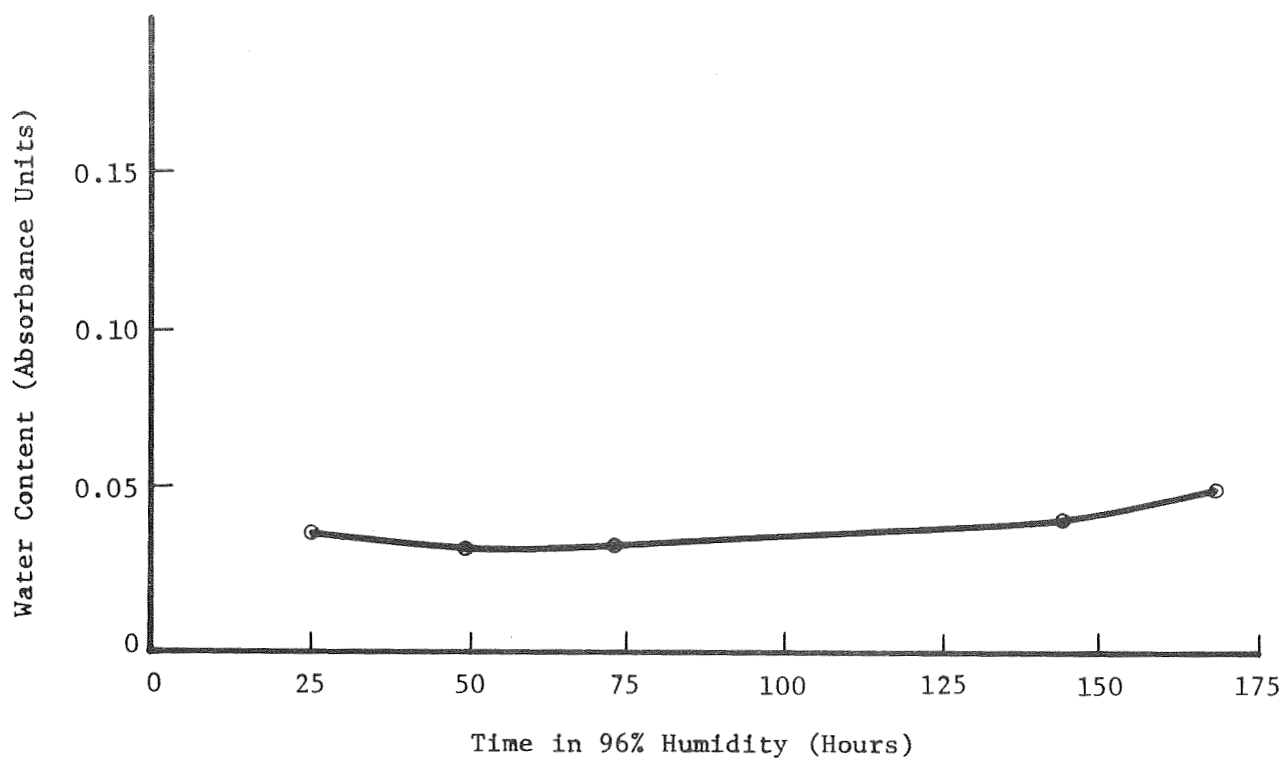
Figure 26: WATER BUILD-UP VERSUS TIME AT CONSTANT HUMIDITY

The silicon wedge with Heliotek-made contacts was placed in 32% RH atmosphere for 168 hours, 52% RH for 168 hours, and 75% RH for 192 hours. No water absorption appeared in the IR spectrum. This sample was then placed in a 96% RH atmosphere, and water absorption appeared within 24 hours. The amount of water at the interface can be estimated quantitatively by subtracting the peak absorbance at 3400 cm^{-1} from an assumed linear background. Errors associated with absorbance readings are in the order of ± 0.005 units. The water content within the sample was seen to increase very slowly with time (Figure 26), indicating that the presence of water does not rapidly catalyze further condensation.

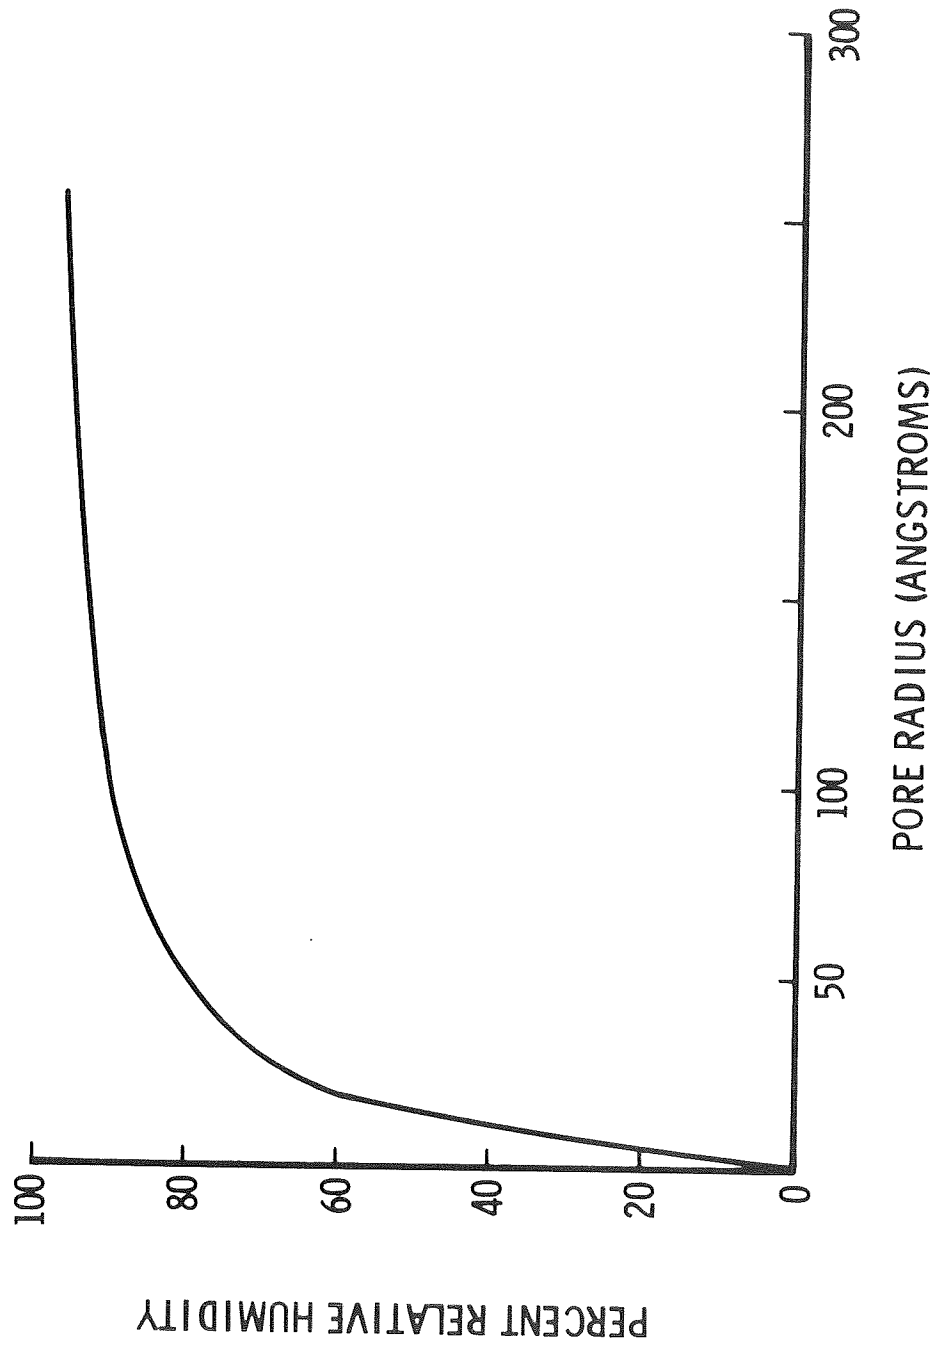
Figure 28: PORE SIZE REQUIRED FOR CAPILLARY CONDENSATION

The capillary sizes needed to condense water at various relative humidities are shown in Figure 28. Condensation occurring at 81% RH implies a minimum pore size of about 50 Å for the Heliotek sample. As the humidity is increased the water content at the interface increases more rapidly than an increase expected from a time factor (Figure 27) and implies a pore size distribution, the upper limit of which cannot be predicted by this method. Because the silver is typically 30,000 Å thick it is very unlikely that the porosity in silver is caused by individual capillaries which extend all the way through the sample. A more reasonable model is a "sponge" type structure which presents an average pore radius of 50 Å to the humid air.

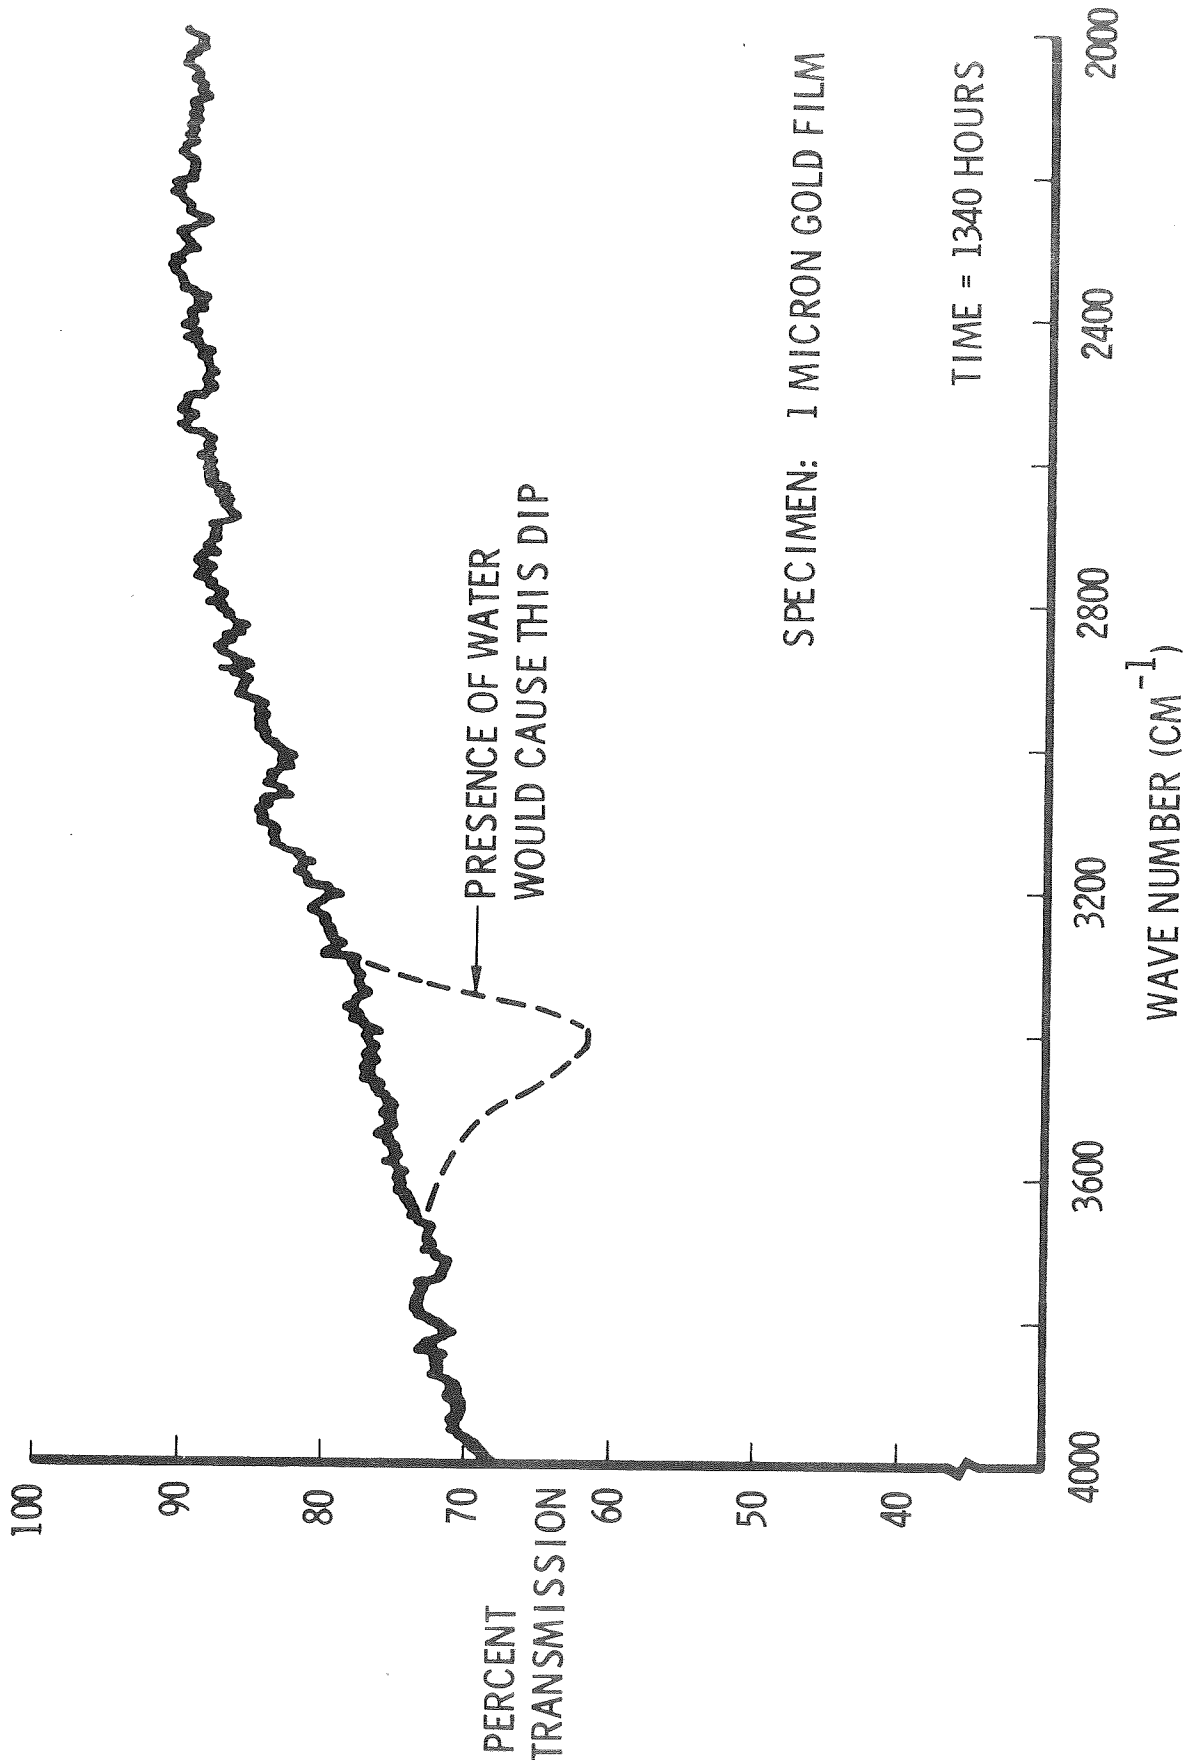
Figure 29 : IR ABSORPTION SPECTRUM---GOLD COATED SAMPLE

Protection of the chemically reactive titanium with a non-porous layer would be one solution to the contact degradation problem. The use of gold instead of silver is a good prospect. A one-micron layer of gold was vacuum evaporated onto a silicon wedge used for internal reflection spectroscopy and placed in a 96% RH atmosphere at room temperature. After 1340 hours no evidence of water was seen (Figure 29) indicating that even one micron of gold is not porous to water.

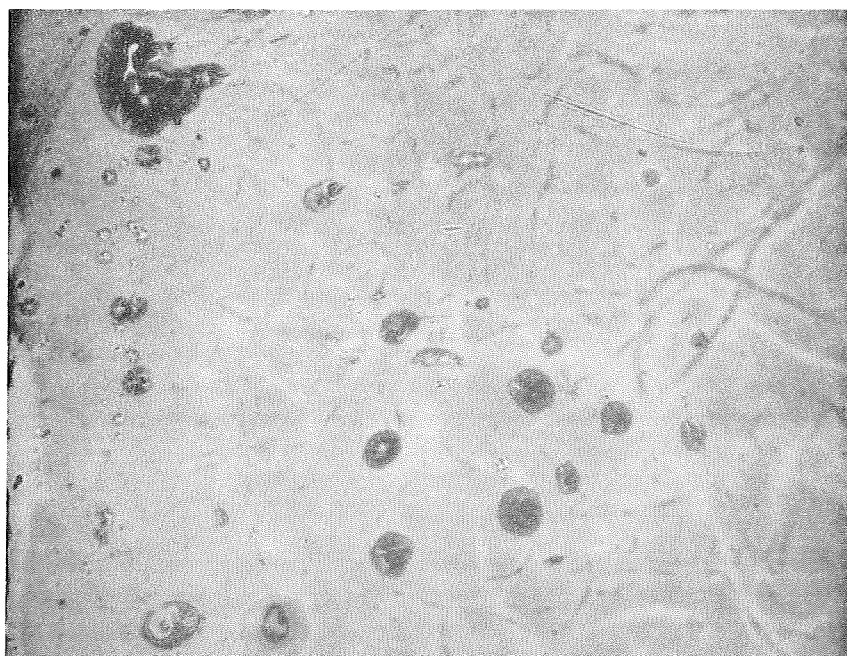
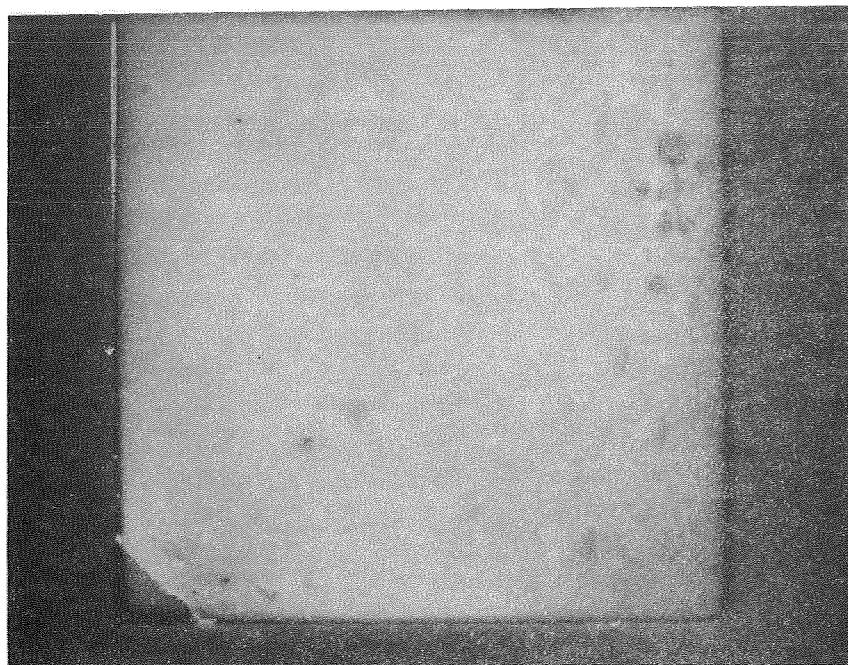
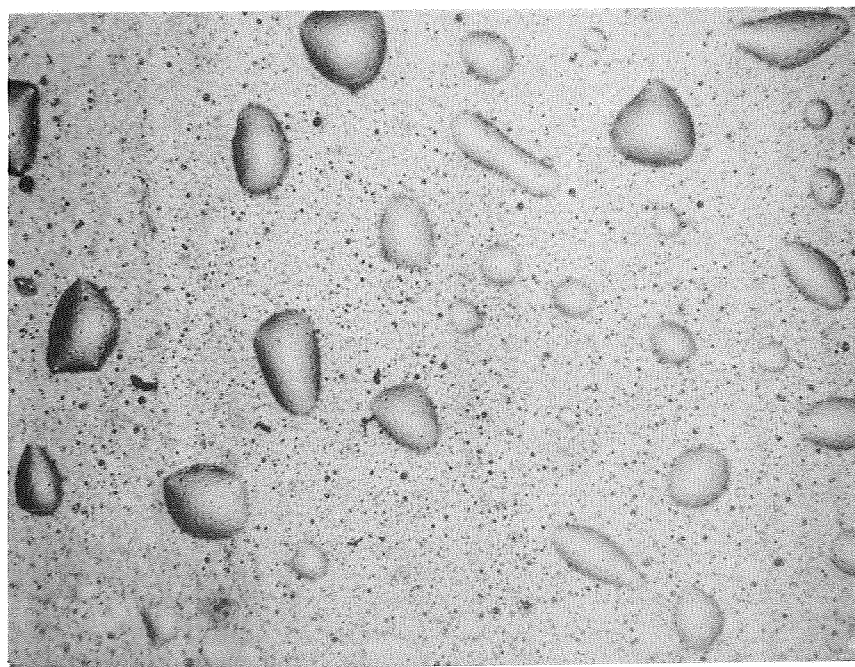
Figure 31 : BLISTERS ON CENTRALAB
SILVER-ON-SILICON SAMPLE (25X)

Figure 30 : BLISTERS ON HELIOTEK

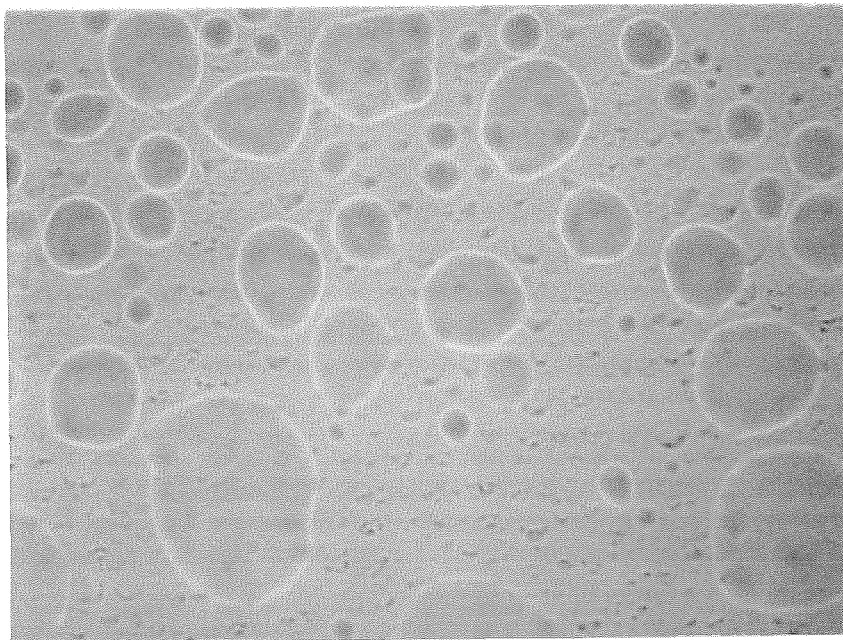
Figure 46: SILVER-TITANIUM-GLASS SAMPLE #1 (25X)

Blisters tend to form along the edges of the contact first. Even the silver-titanium-glass samples initially formed blisters along the edges. Further degradation is accompanied by blister formation in the cell interior. The cell contact layers have no overlap at edges, thus exposing titanium to the atmosphere and providing a surface where corrosion can start. Blisters are less likely to form on the sun-facing contact. This may be due to the narrow width of the grid fingers, allowing the gas to escape before a blister can be formed. As a result grids very often separate without the appearance of blisters.

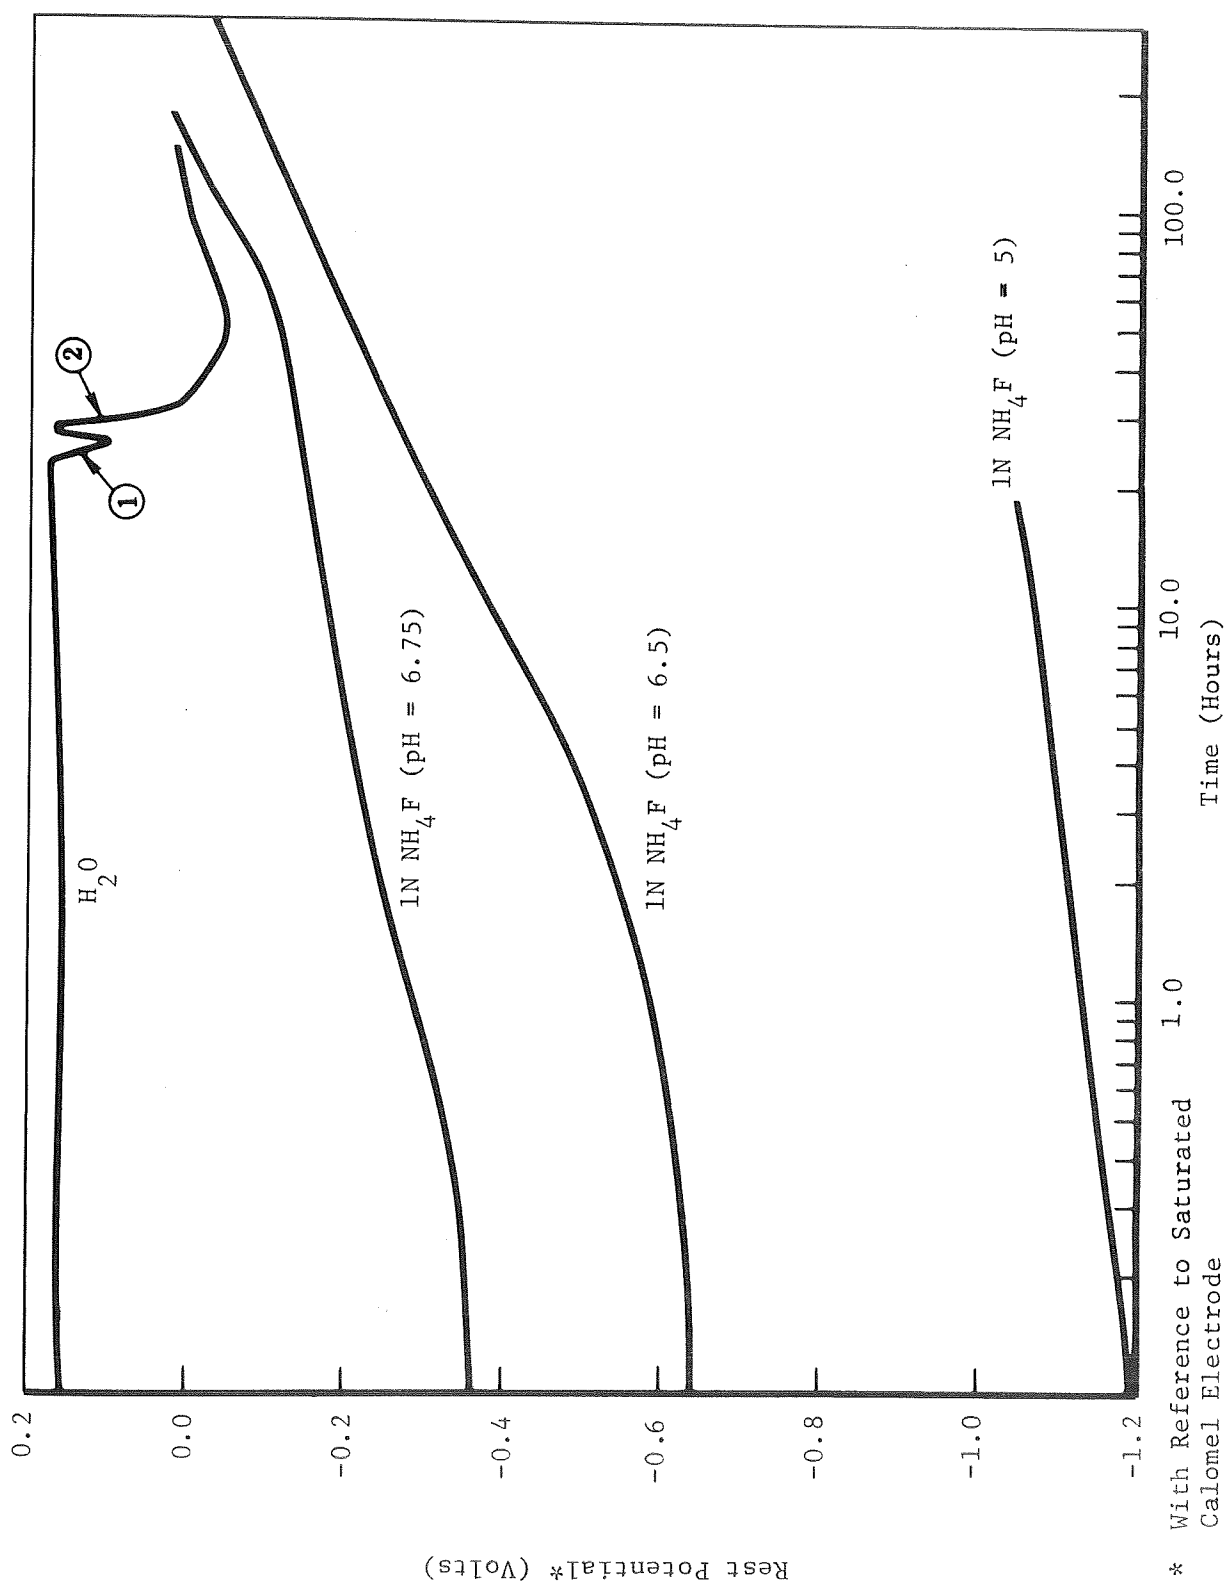
Figure 49 : REST POTENTIAL OF TITANIUM

Pieces of 1-mil-thick titanium were abraded with emery cloth, cleaned with alcohol, and placed in solutions of water, 1 normal NH_4F, and 1 normal NH_4F adjusted to a pH=5. The resulting rest potentials are plotted as a function of time in Figure 49. Points 1 and 2 on the water curve represent the addition of approximately 10^{-3} moles of fluoride ions to the solution, and the adjustment of the solution pH to 5, respectively. The changes seen in the rest potentials reflect these perturbations.

The titanium in the 1 normal NH_4F (pH = 5) solution immediately began turning black with the evolution of a gas, presumably hydrogen. After 17.5 hours, the solution contained a solid residue and exhibited a pale violet color, characteristic of Ti^{+3}. At the air-titanium-solution interface, the titanium was corroded almost all the way through. In a subsequent test where the titanium was not abraded it behaved similarly. Within a few minutes, gas was evolved and the rest potential measured -1.2 volts against a saturated calomel electrode, indicating that the protective oxide of the titanium had been attacked and the titanium was corroding.

The titanium placed in the other solutions, however, showed no visible evidence of corroding. This result is in apparent disagreement with the results previously discussed (Section 3.2.3.2) where a pH of 6.5 in 1N NH_4F and 1N NaCl solutions accelerated degradation of solar cells. However, part of the previous tests were at 90°C. Since reaction rates depend quite strongly on temperature, another test was performed where one-mil titanium foil was inserted into a 1N NH_4F (pH = 6.5) solution which had been heated to 90°C. Bubbles appeared and a potential of -1.18V was recorded. Obviously the room temperature corrosion rate was too small to be observed. This is a good example of the effect of temperature on corrosion rates.

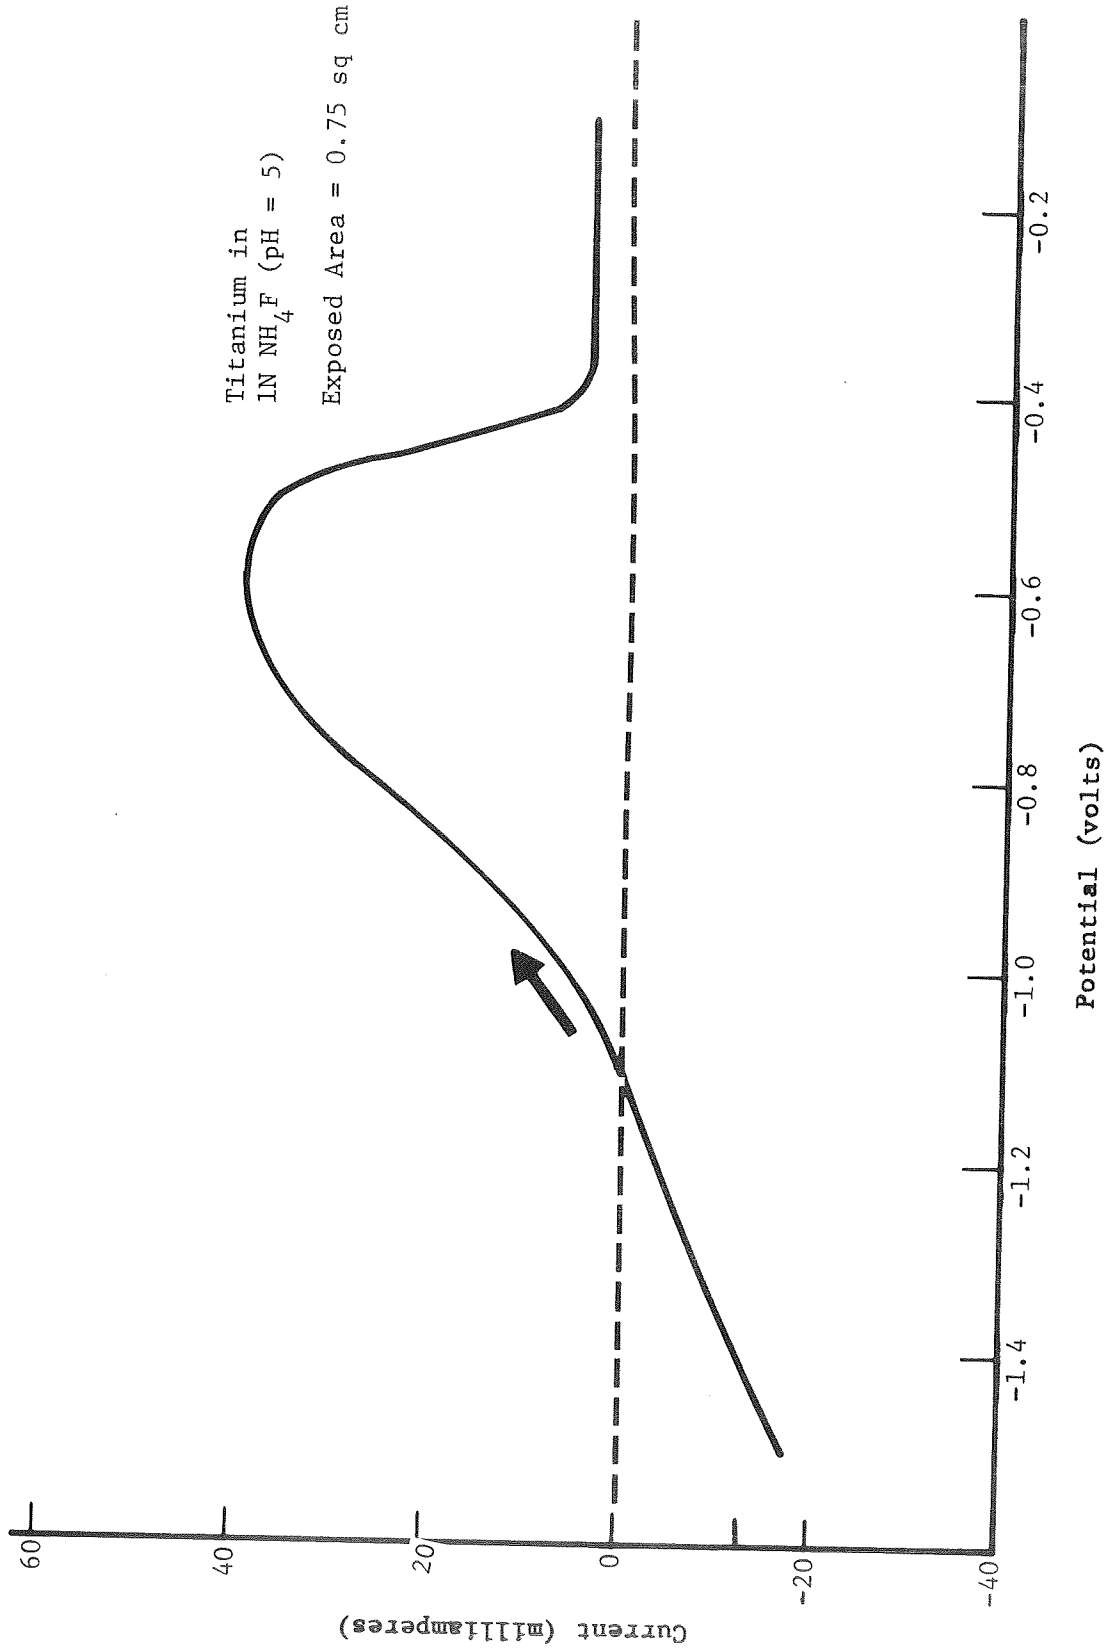
Figure 50 : POLARIZATION CURVE (1 Normal NH_4F, pH = 5)

A typical polarization curve (Figure 50) for 1 normal NH_4F(pH=5) shows the presence of a positive current in the region of -800 mv, indicating corrosion. Assuming that the unstirred solution is diffusion-limited by fluoride ions, the limiting corrosion current can be defined (Ref. 27) as:

Using these values, the limiting current i_1 can be estimated to be approximately 58 mA/cm^2, which agrees well with the experimentally observed value of 53.5 mA/cm^2 for the 1 normal NH_4F(pH=5) solution.

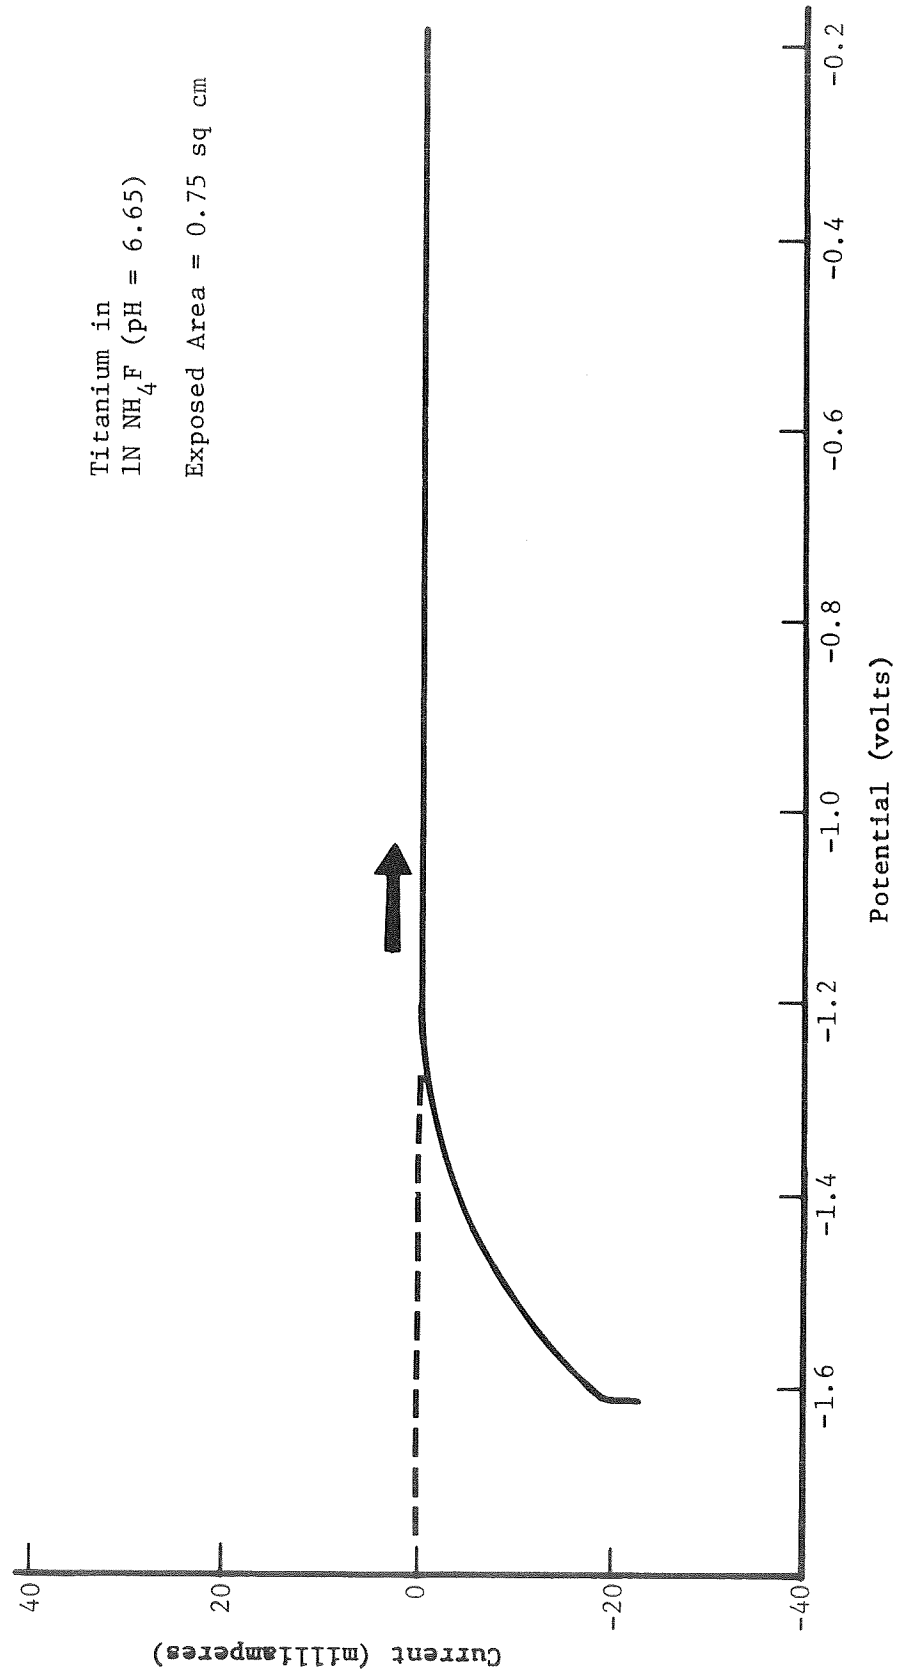
Figure 51: POLARIZATION CURVE (1 Normal NH$_4$F, pH = 6.65)

Corrosion was found to occur for only some combinations of halide ion concentrations and pH. For example, titanium in 1 normal NH_4F(pH=6.65) exhibits no visible corrosion current (Figure 51).
