FINAL REPORT

INVESTIGATION INTO THE MECHANISM OF DEGRADATION OF SOLAR CELLS

WITH SILVER-TITANIUM CONTACTS

July 1, 1970

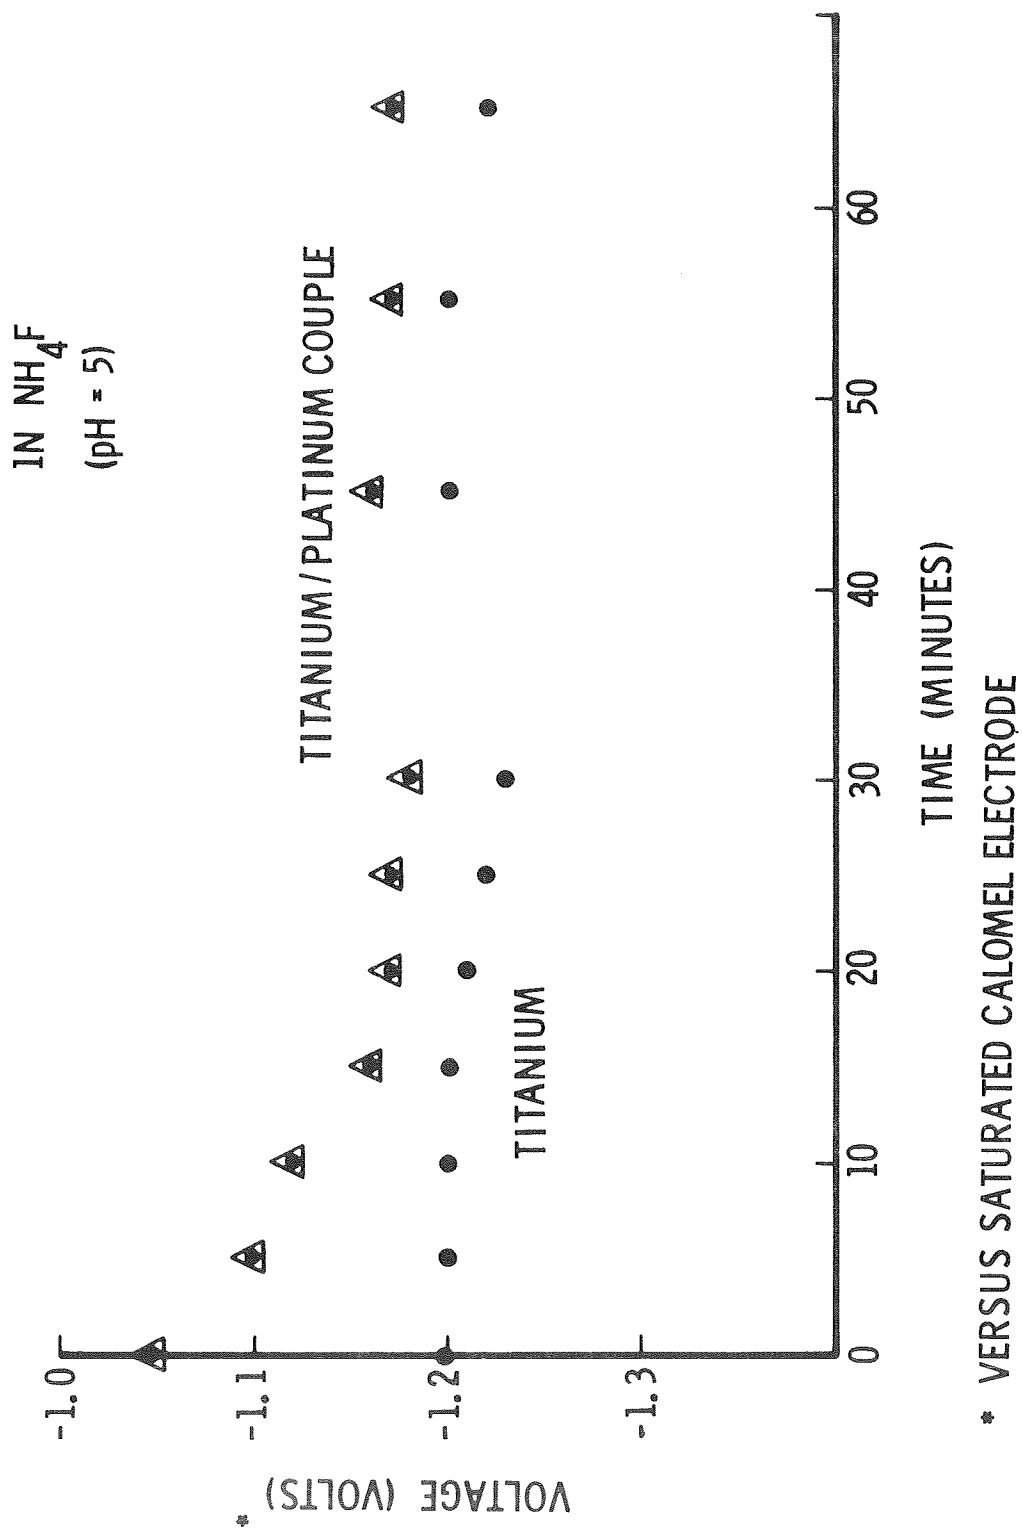
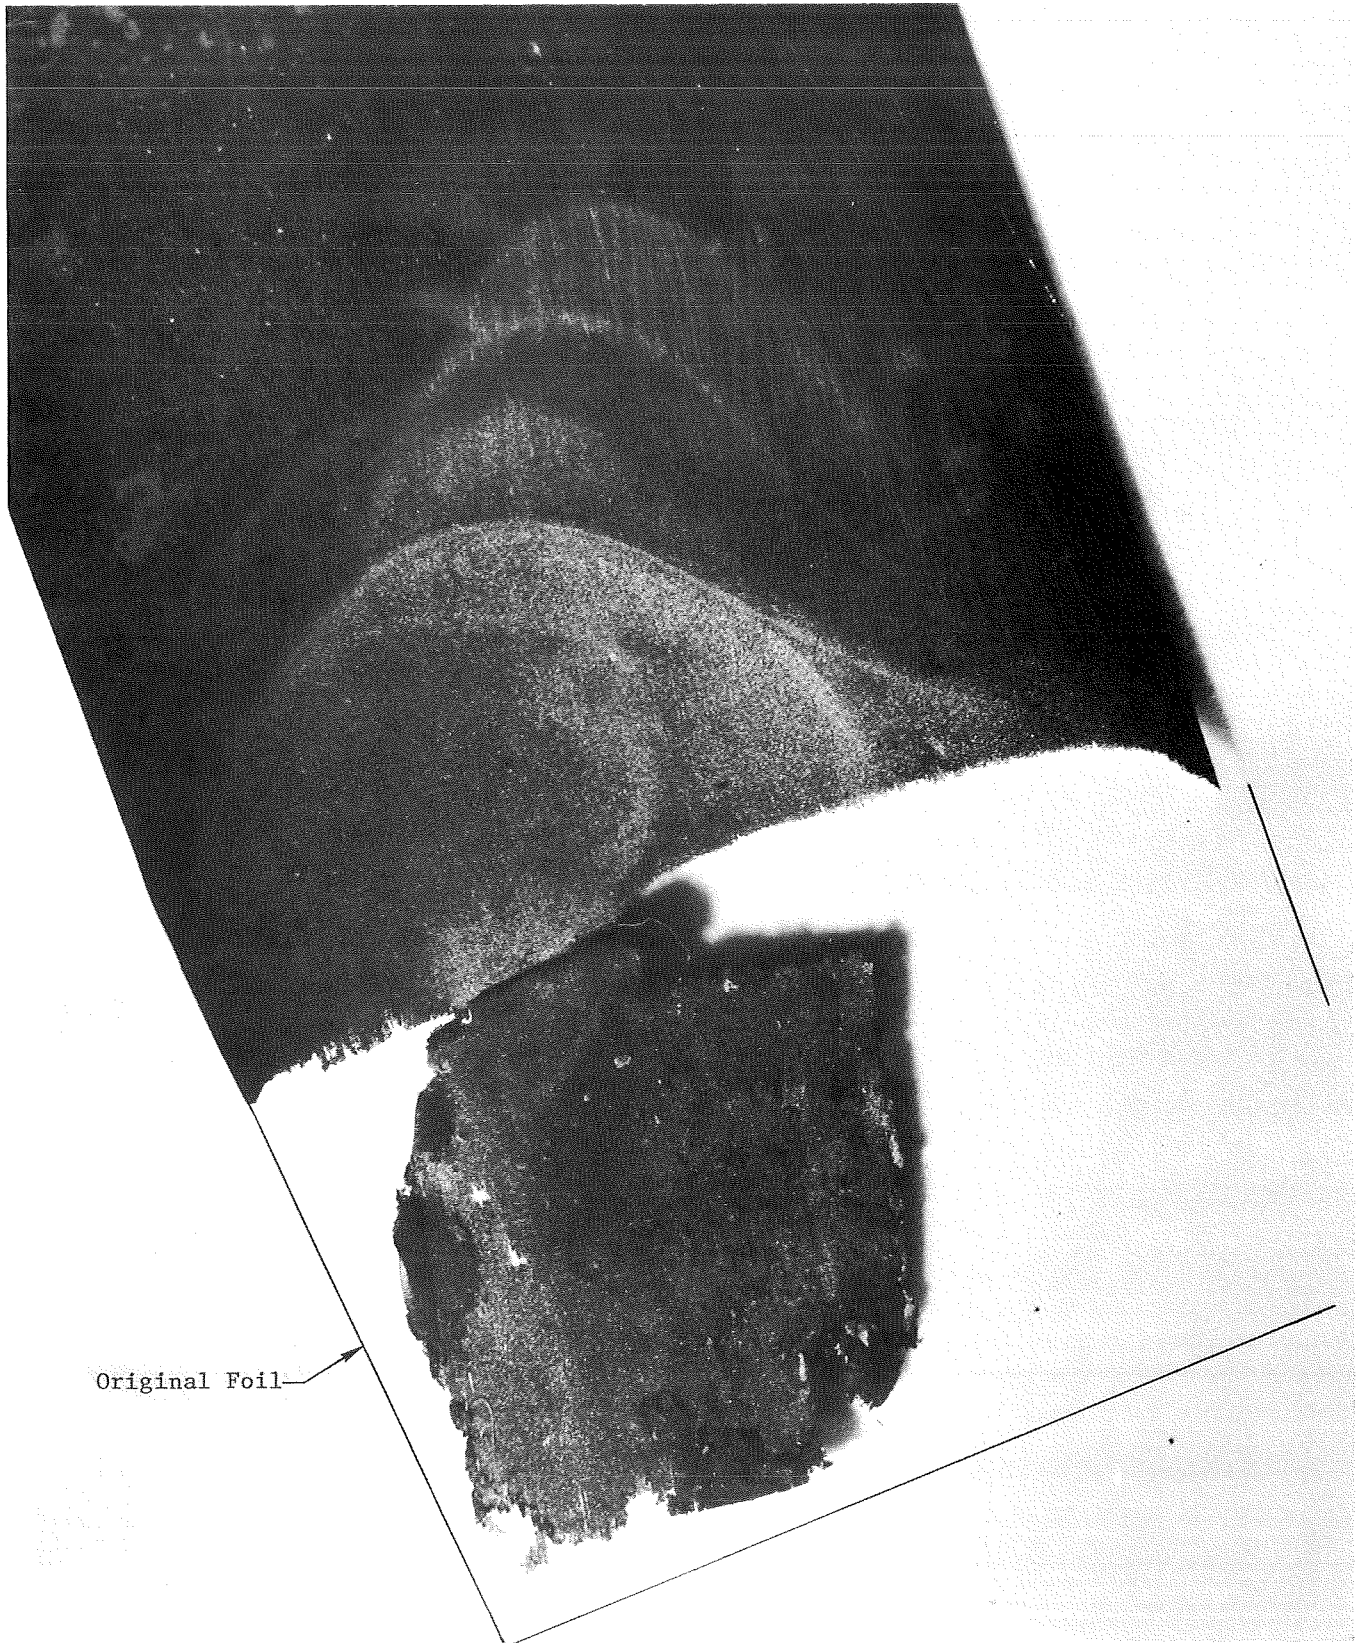
Figure 52 : REST POTENTIAL OF TITANIUM---PLATINUM COUPLE

It is known that titanium alloyed with a noble metal reduces the corrosion rate of the titanium (Ref. 31). It should be noted, however, that the corrosion is not completely halted. To explore the behavior of titanium-noble metal systems in the presence of fluoride ion we coupled titanium to platinum in a one-normal NH_4F(pH = 5) solution and recorded the rest potential as a function of time (Figure 52). When coupled to the platinum, fewer bubbles were emitted from the titanium surface, suggesting that the corrosion slowed, but did not stop. After one hour, the one-mil thick piece of titanium had almost corroded through (Figure 53). Buck et. al. (Ref. 13) also noted that the presence of fluoride increased the corrosion rate of titanium-platinum alloy appreciably.

● Coupling of titanium with platinum reduces the corrosion rate of titanium in the presence of fluoride ion, but does not halt it.
