INVESTIGATION OF ADVANCED REGENERATIVE
THRUST CHAMBER DESIGNS

AEROJET LIQUID ROCKET COMPANY

FINAL REPORT

November 15, 1970

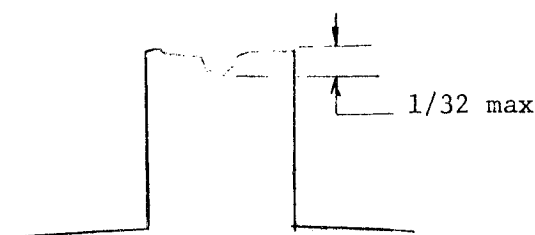
The maximum depth of cavity in the rib was approximately 1/32 in. Because the cavity was discolored and thus might contain impurities, it was agreed that the surface would be removed by hand grinding. Camin Laboratories indicated that, with additional chemical cleaning, the outer shell nickel would bond and fill the cavities.

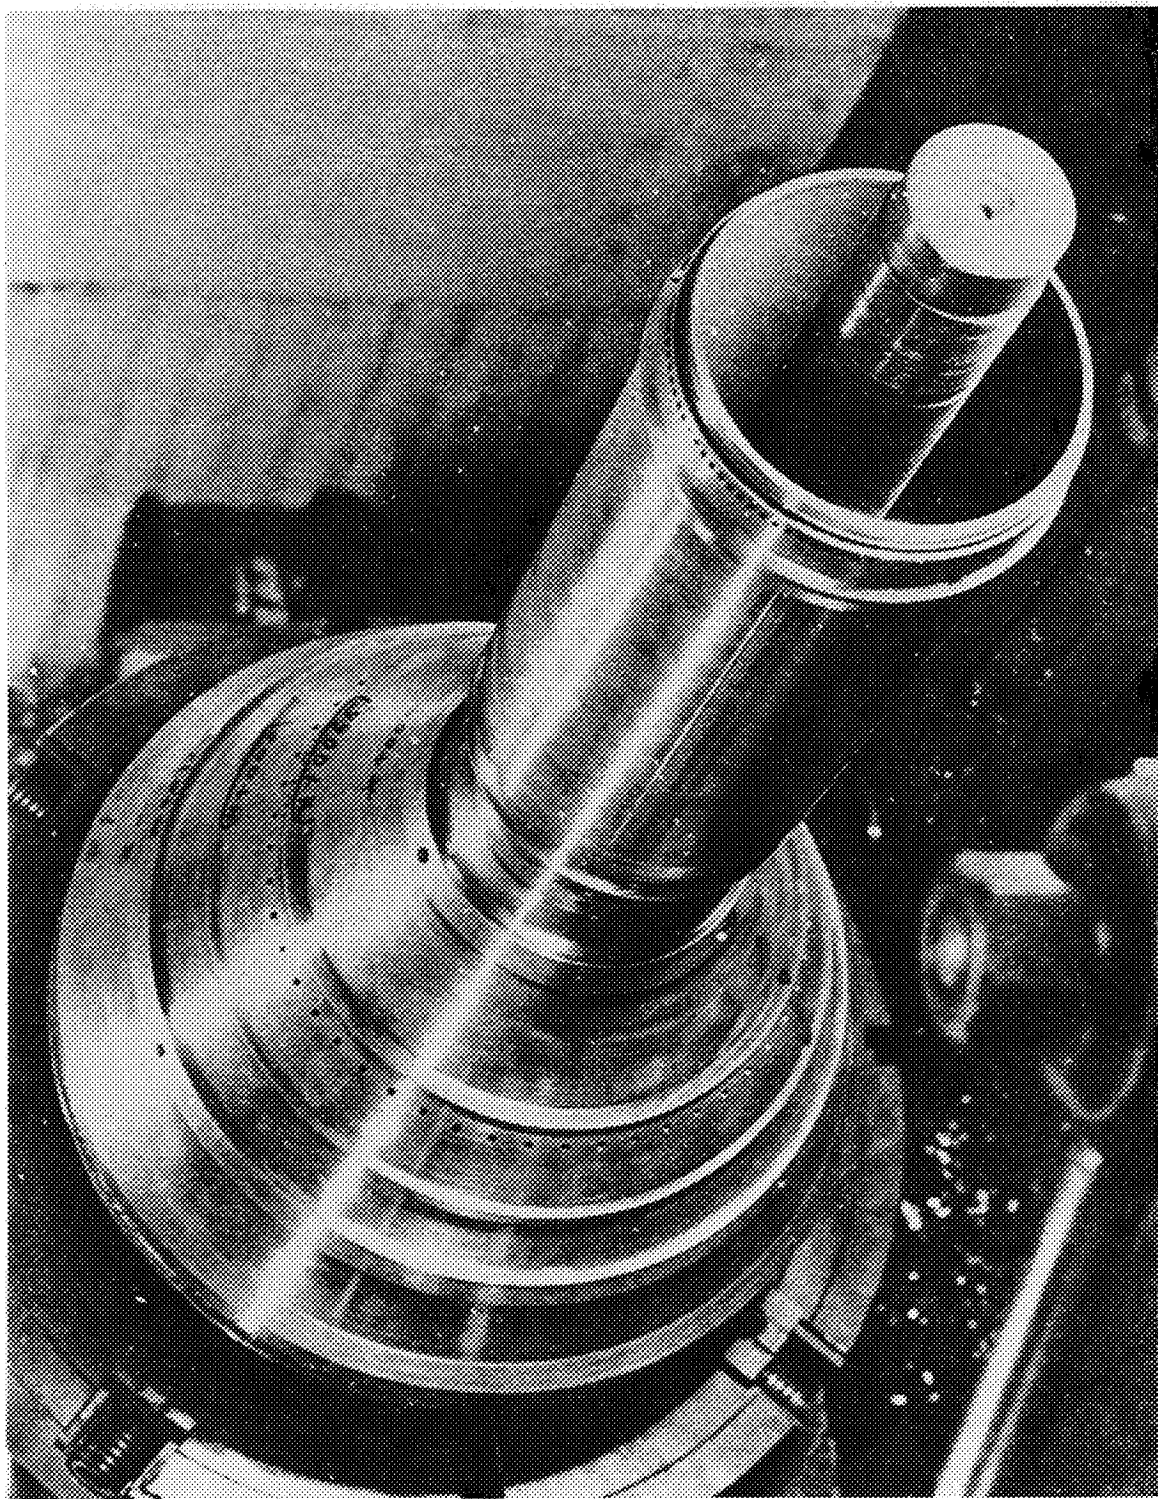
Figure 16. Dimensional Inspection

Figure 16 shows the chamber in a lathe in process of inspection. A maximum diametral eccentricity of 0.0125 in. was found in the exit area. This was presumed to be due to relieving of plating and other stresses on removal of the graphite mandrel. Sufficient stock had been left on the manifold attachment areas of the components to permit match machining to obtain a maximum clearance of 0.004 in. for electron beam welding.

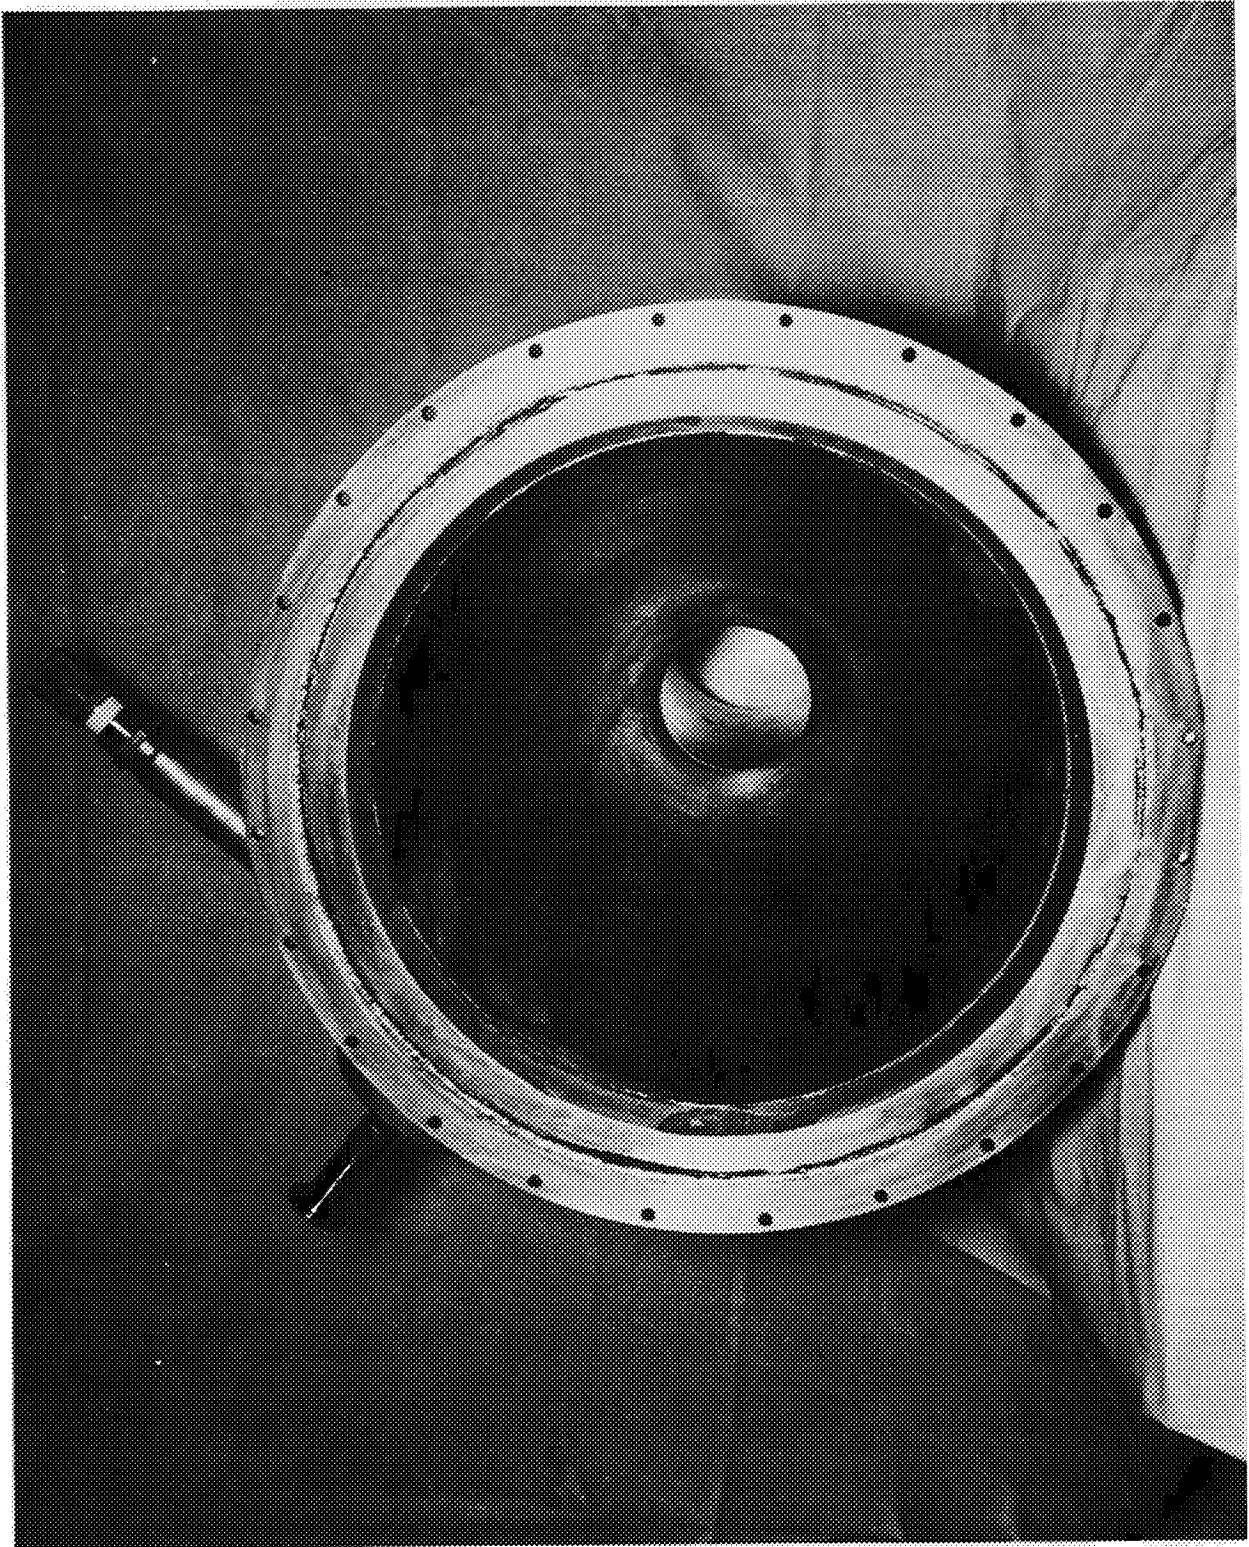
Figure 21. First Electroform Repair

The repair was completed by making a light machine cut over the repaired area and by grinding the aft end of the thermal barrier liner to eliminate the discontinuity. Figure 21 is a photograph taken from the aft end showing the first electroform repair. Figures 22 and 23 are photomicrographs of the holes found in leak testing. Figure 22 shows a single hole having the appearance of the metal bridging over a void. The leak path of the hole, as evidenced by the emitted stream of water, was nearly parallel to the surface. The leak in the area shown in Figure 23 was from the small crack in the center of a small dimple. A considerable amount of scattered porosity can be seen in the area.

A machining error during final machining of the aft flange resulted in excessive metal being removed from the coolant channel aft closure wall. A spacer ring was machined and welded in place to replace the material removed in error. Some weld cracking was noted at the edge of the weld on the inner wall. Electroforming was investigated as a possible repair procedure and appeared to have an excellent chance for success. The NASA/ LeRC project manager approved this approach. The thrust chamber was sent to Electroforms, Inc., Gardena, California, where electroformed nickel was built up over the discrepant area and approximately 1.0 in. of the chamber inner surface. Figure 21 shows the repaired area after machining.

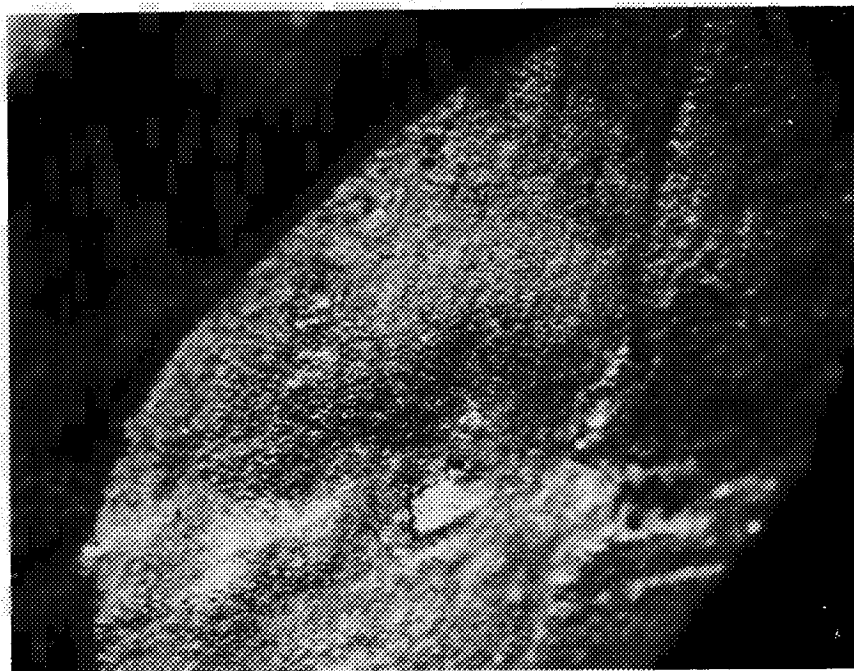
Figure 23. Leak in Chamber Wall - Scattered Porosity

On the basis of fact number (1), it is possible to make the following supposition: a local protrusion resulted in a thin area of the nickel inner shell that failed under the 1100 psig proof load. The appearance of the hole in Figure 23 tends to support this theory.

Based on fact number (2), it can be postulated that the nickel substrate was not continuous, or contained a nonmetallic inclusion, which resulted in the electroformed nickel bridging over the nonconductive area, leaving a void. This void or nonconductive area could have developed during the coating process, however, it is more likely that the detonation gun nickel coating was damaged in handling or transit in a manner that left a small nonconductive area, resulting in bridging, as noted above, and void areas within the nickel.

Although the leak cause cannot be verified, the following recommendations are made to preclude leakage from the possible causes described. First, the substrate contour should be ground to an axi-symmetric configuration to remove all small protrusions left by previous processes. Secondly, the conductive coating applied over the nonconductive substrate should be inspected both visually and by an electric probe arrangement to ensure that the coating is continuous. This inspection should be made immediately prior to electroforming.

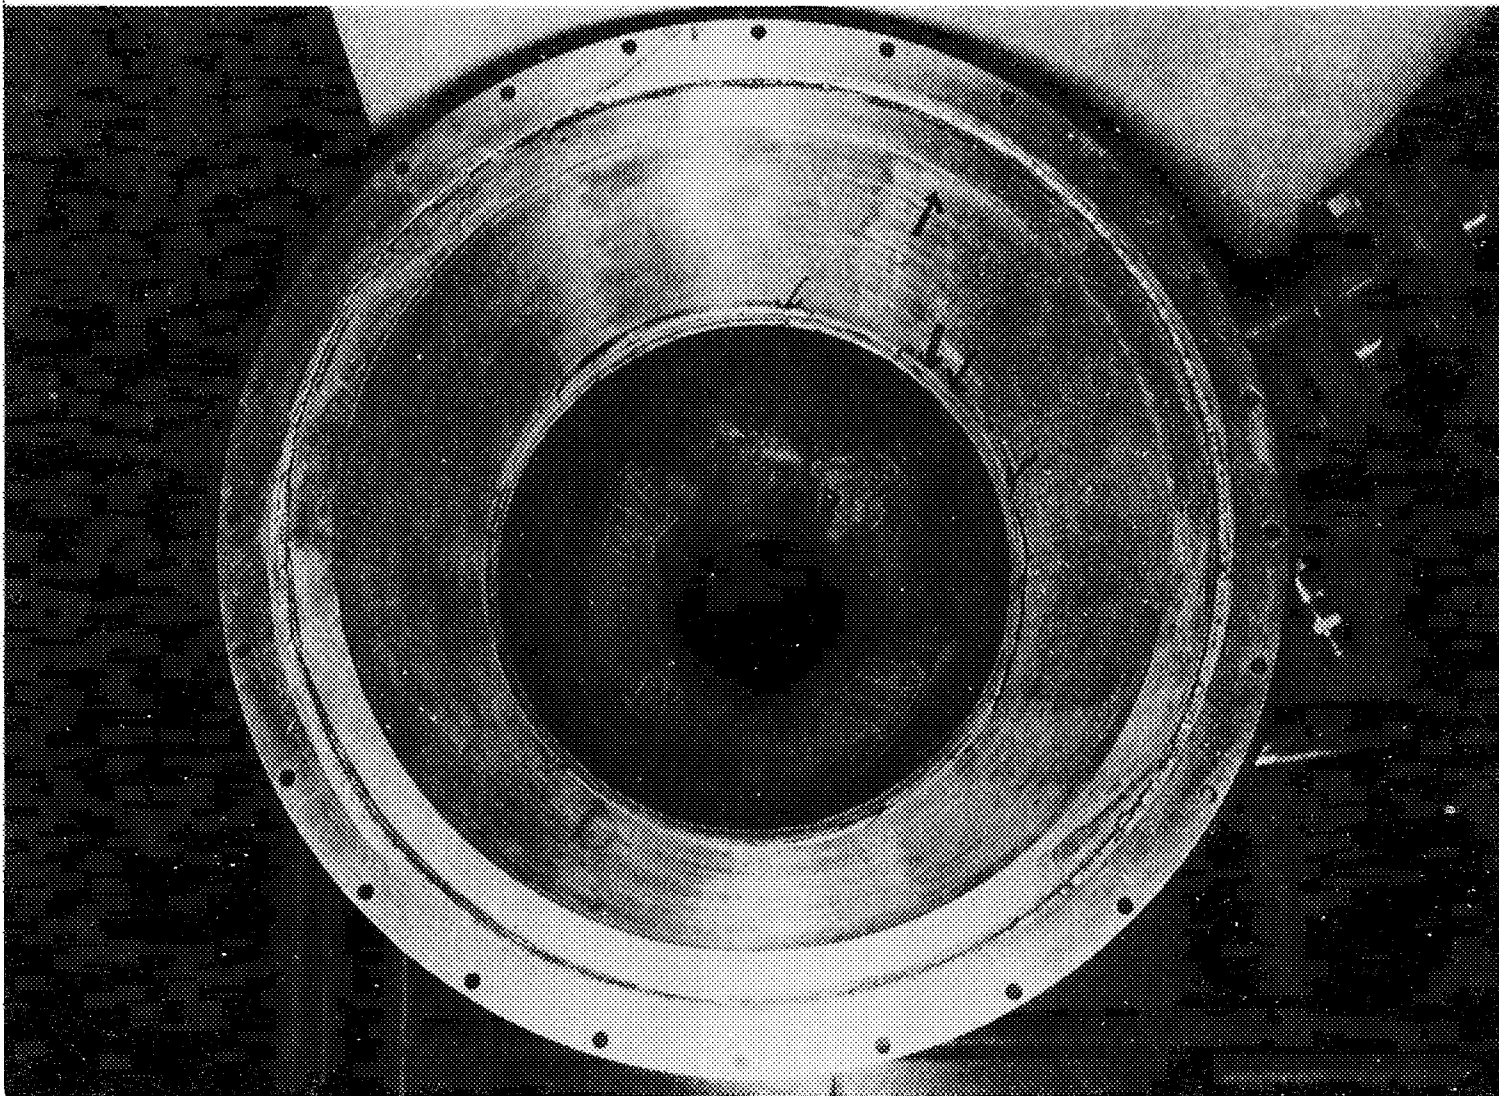
Figure 24.   Final Electroform Repair, Aft End, Showing Areas of Leakage

Subsequent flow testing indicated a reduction in pressure drop of 9.6 psi. During the test, it was noted that the leak rate previously estimated at 20 drops/min at 760 psi had increased considerably. A static pressure test was made and water leakage recorded at 23 cc per min. The photograph (Figure 24), taken after the final repair and leak check, shows the areas of leakage. The flow testing sequence and results are shown in Table II.

After discussion with the NASA/LeRC project manager, no further efforts were made to determine the cause of the excessive pressure drop. A photographic record was made of the leak locations (Figure 24) and the thrust chamber was crated and shipped to NASA/LeRC, Cleveland, Ohio.
