NASA TECHNICAL MEMORANDUM

REPORT ON THE FLIGHT PERFORMANCE OF THE Z-93 WHITE PAINT USED IN THE SERT II THERMAL CONTROL SYSTEM

by N. John Stevens and George R. Smolak
Lewis Research Center
Cleveland, Ohio

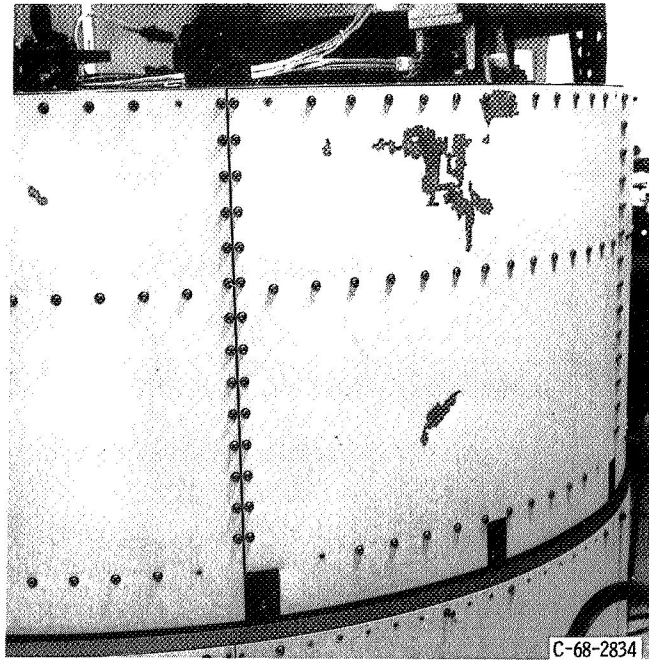
Figure 5. – Self lifting of Z-93 paint from magnesium.

The paint's reputation for being difficult to apply became apparent in the early prototype phase of the program. The paint applied to the magnesium panels began to flake off under ambient conditions about one week after application (see fig. 5). The panel substrate was changed to aluminum and a program undertaken to relearn the secret of successful application of Z-93 paint. The first lesson learned was that the cleanliness of the substrate is a major contributor to good paint adhesion. This alone did not solve the application problems for the paint texture would vary between rough, sandy coatings and smooth, glossy finishes. The glossy coating looked well but did not exhibit the adhesion of the sandy coating in the bend adhesion test (see fig. 6). The difference was finally found to be in the drying of the paint: in periods of high humidity the water did not evaporate and the paint dried to a smooth, glossy texture. The addition of a bake out immediately after application resulted in a panel that was uniformly coated with a rough, sandy textured coat of Z-93 paint that had excellent adhesion. The details of the successful application of Z-93 paint can be found in Ref. 8.

It has been postulated that the paint may have cracked and peeled off in a manner similar to that experienced by the prototype panels. Experience with the application of Z-93 paint has shown that cracking and peeling of the paint is a phenomena that takes place within a week or two of application. No such cracking or peeling of any of the flight panels was noted from the time of application in September, 1969, throught the testing and packaging, up to the final installation in February, 1970. Once the paint has survived the initial few weeks of drying without cracking, it usually remains firmly attached to the substrate. In addition it
