NASA CR-1815

THREE-STAGE POTASSIUM VAPOR TURBINE TEST

by B. L. Moor and E. Schnetzer

Prepared by
GENERAL ELECTRIC COMPANY
Cincinnati, Ohio 45215
for Lewis Research Center

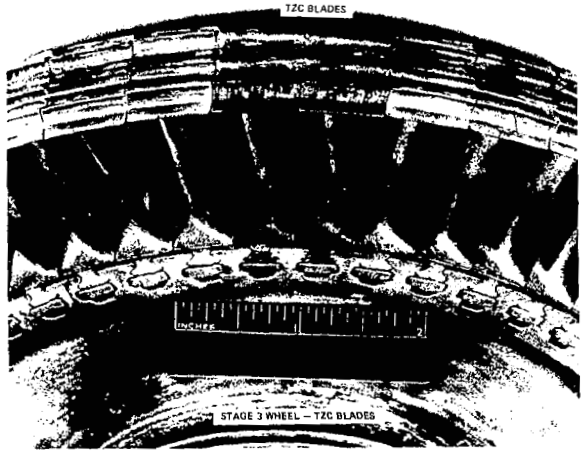
A 1400-hour test, carried out in 1968, ended with inconclusive results. The turbine was shut down as a result of excessive and inexplicable output torque reduction. Upon opening the turbine, it was discovered that the four Mo-TZM third-stage blades had lost substantial portions of their tip shrouds. In addition, many of the blade retainer clips of all stages had strain age hardened and fractured at the non-annealed aft assembly bend. Mechanical damage due to the retainer clip fragments was noted generally on rotor and stator blades. The damage to the leading edges of the third-stage rotor blades was such as to preclude separation of mechanical and erosive effects, Figure 2. The tip shroud fragments could have contributed to this leading edge damage.

Figure 2. Third Stage Turbine Wheel Showing Combined Mechanical and Erosion Damage After 1400 Test Hours in 1968. (P68-9-8J)

To eliminate the previous source of mechanical damage, new spring type bucket retainers, Figure 7, were developed and incorporated in the turbine. The tip shrouds of the third-stage rotor blades were removed to eliminate another potential for damage, Figure 8. This permitted direct visual blade tip inspection.

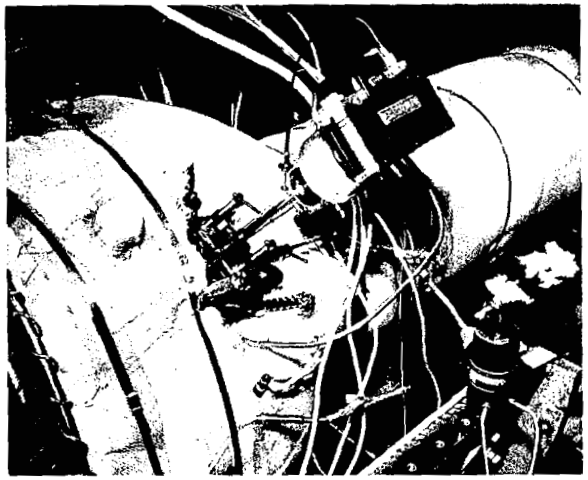
Figure 4. Blade Inspection Port Equipped With Borescope and Camera. (P69-8-1D)

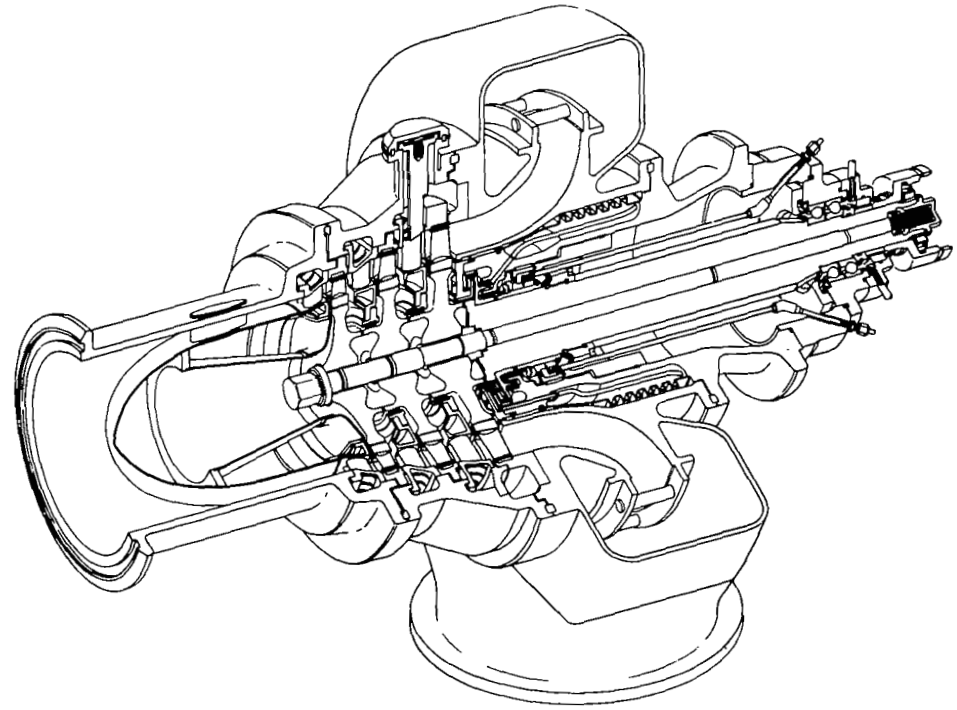
Figure 3. Three-Stage Potassium Test Turbine With Blade Inspection Port. (AS-857)

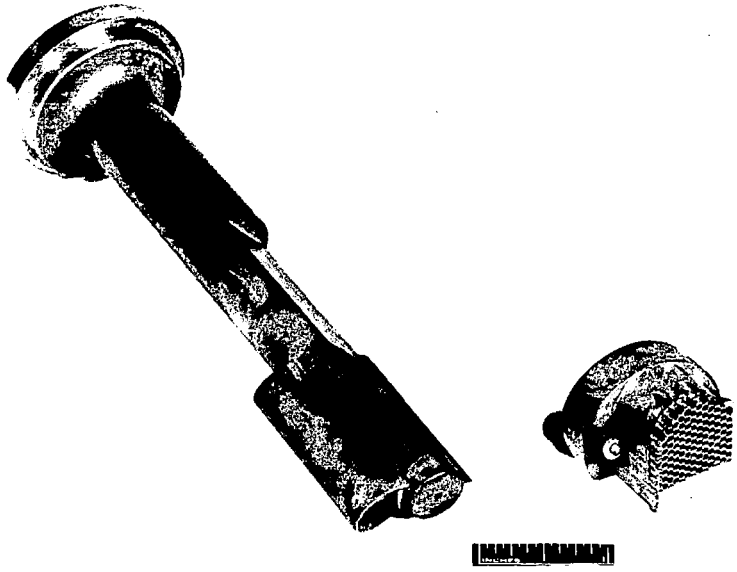
Figure 5. Stage 3 Removable Nozzle Vane and Tip Seal Insert After 405 Hr of Testing. (P69-9-25A)

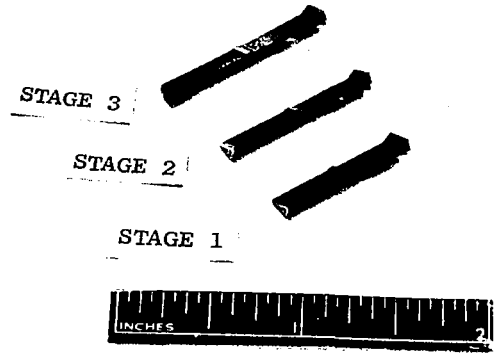
Figure 7. Three-Stage Turbine Blade Retainers - Material, Rene' 41. (P69-5-38Q)

extent by the new retainer design, which permitted axial shifting of buckets more than desired. The centrifugal forces due to unbalance unloaded the two 27^{o} angular contact ball bearings at the rear of the turbine. Axial preload was provided to maintain continuous contact of the balls and races.

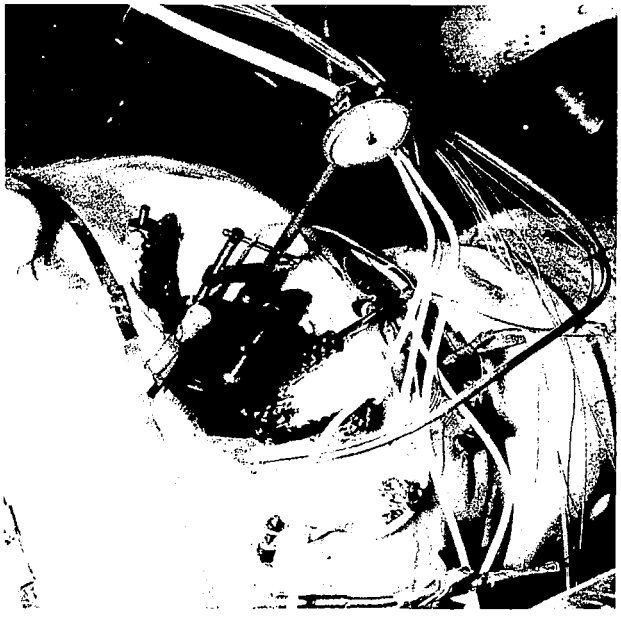
In addition, a dial indicator method of measuring the leading edge contours of the rotor blades was established. The front face of each blade dovetail tang is the reference for the blade contour. Repeatable measurements of the blade contour were obtained, Figure 6.

Figure 6. Dial Indicator Used to Measure Blade Leading Edges. (P69-8-1E)

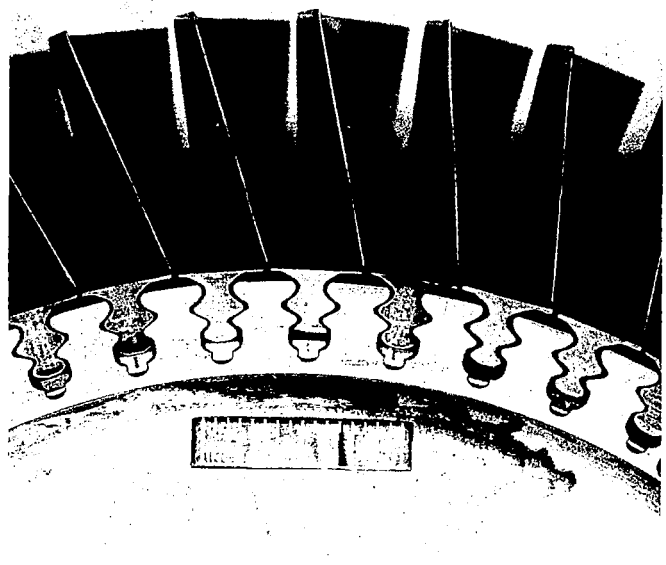
Figure 8. Third-Stage Rotor Blades With Tip Shrouds Removed and New Blade Retainers. (P69-5-38AG)

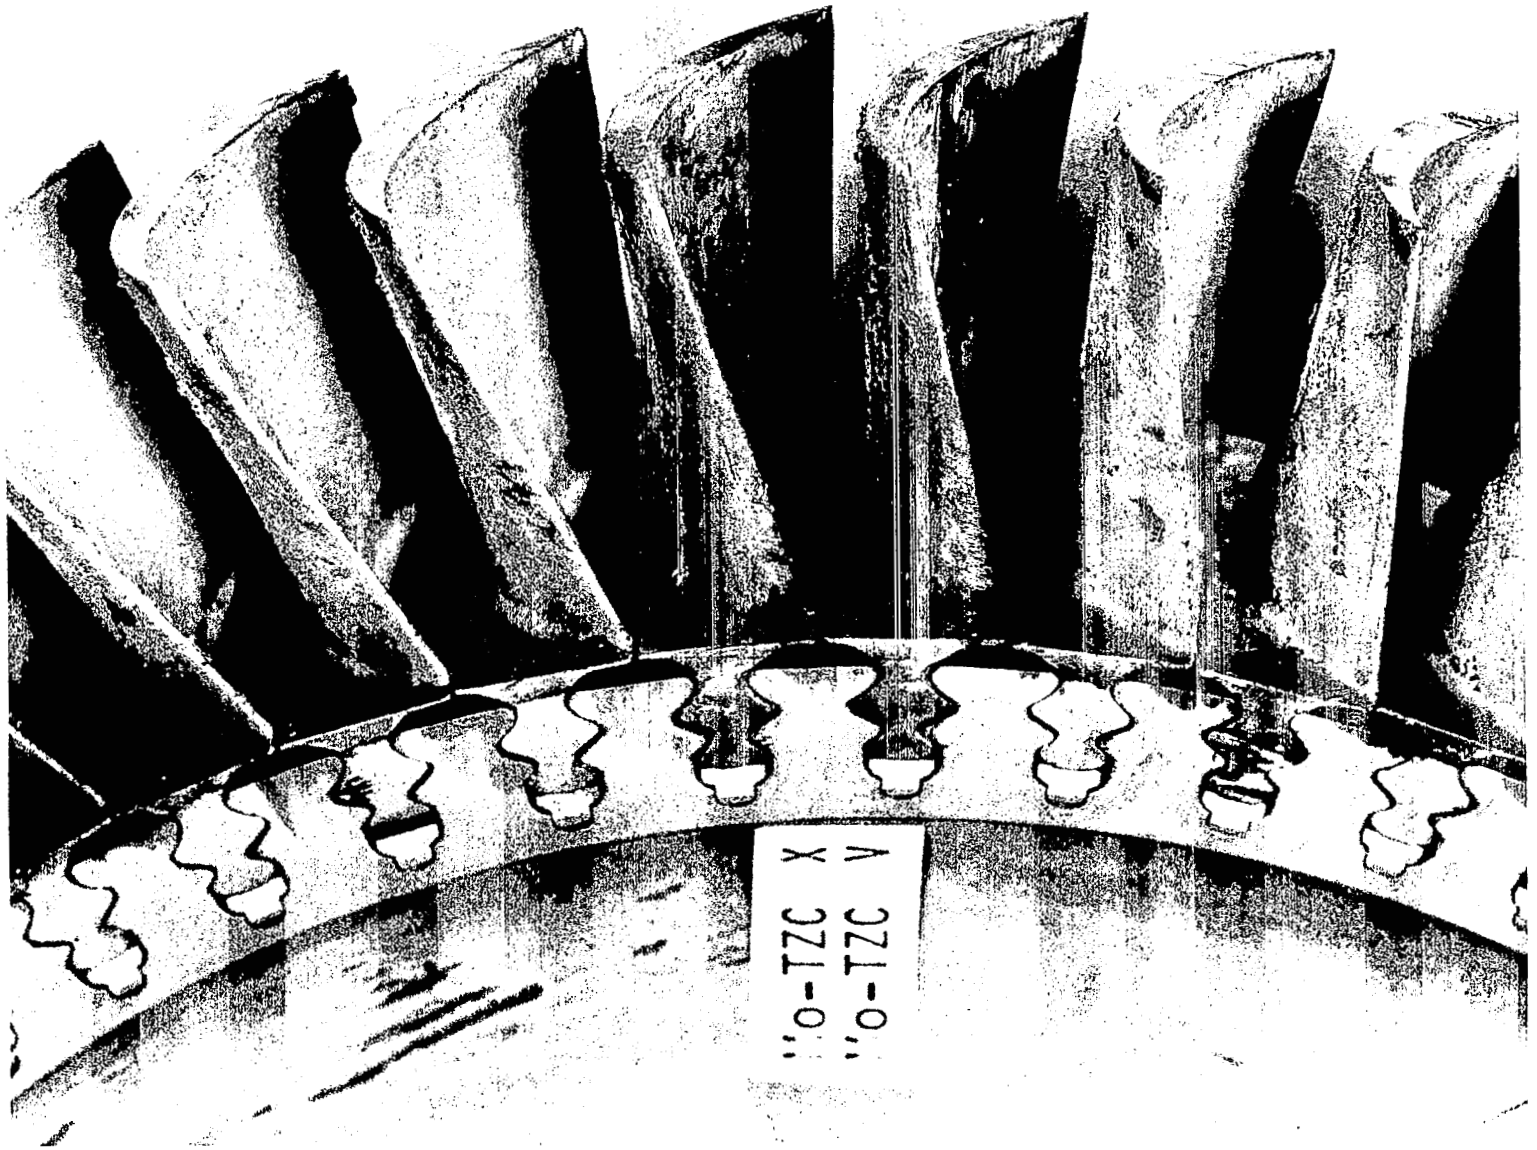
3778 Hr.	Corrosion apparently continued in previous patterns.	More Rene' 77 blades lost tip leading edge materials. The bordering surface had a spongy pitted appearance.	Buckets coated with silvery potassium film and gray powder, globules and whiskers.	Axial position measurements showed ±10 mil (0.25 mm) variations in location over the full blade complement.
5000 Hr.	Corrosion continued. Mo buckets had very sharp leading edges and were axially grooved severely in the lower halves of airfoil leading edges and tops of platforms. Airfoil roots and trailing edges were grooved radially. Concave surfaces and aft half of convex surfaces were virtually like new. Rene' 77 blades had radial grooves on both sides of the trailing edges and concave side of the leading edges. Convex tips were slightly rounded, with minor grooving.	Rene' 77 blades had convex tip leading edge pitting and tip corner erosion. Mo blade pits were microscopic in size. The damage to either type of blade was mechanically insignificant. The maximum triangular wear pattern was about 150 mil (3.66 mm) axial x 75 mil (1.83 mm) radial. For example, see tip of bucket on right side of Figure 11.	All rotating and static components were covered with Fe/Ni film about one mil thick. All had potassium dizirconate deposits which were thin on rotating components but closed some stator vane exit passages.	See Figures 10-13.

Figure 11. Forward Surface of Stage 3 Rotor Bucket and Wheel After 5000 Hour Test. Mo-TZC Buckets X and V in Center. (P70-6-19AE)

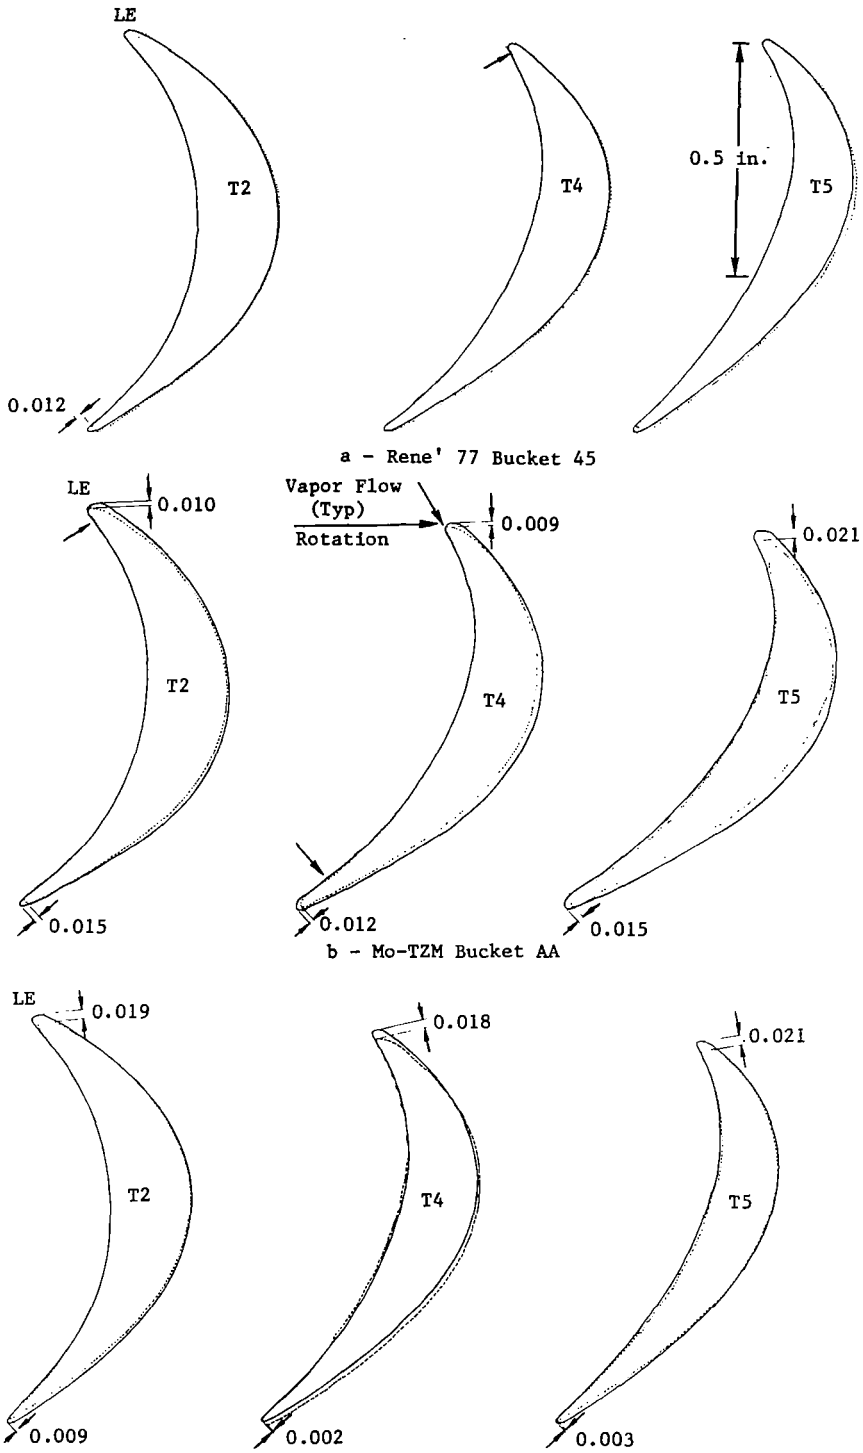
Rene' 77 bucket 45, Figure 12a, showed no loss of leading edge material except for a 5 mil deep x 10 mil wide corrosion groove on the T4 concave surface (see arrow). The 0-12 mil deposits not penetrated by the stylus were primarily potassium dizirconate. The trailing edge lost 12 mils at section T4, which is the approximate location where the concave and convex surface radial corrosion grooves intersect.

Mo-TZM bucket AA, Figure 12b, showed substantial leading edge and trailing edge material losses. The T2 and T4 concave surfaces were unchanged except for 0-5 mil deep radial grooves near the leading edge and trailing edge. The T5 concave surface lost material generally, up to 10 mils depth. All convex surfaces lost material generally, up to 20 mils depth, an indication of washing corrosion.

Mo-TZC bucket W, Figure 12c, showed wear patterns similar to those of Mo-TZM bucket AA. Both Mo-TZC and Mo-TZM are similarly susceptible to corrosion by potassium which contains oxygen. The difference in material loss at comparable positions is a function of the ability of the stylus to penetrate the deposits on the buckets and of the observer to accurately match the pretest and post-test airfoil contours.

Figure 12. Pantascribe Measurements of Three Stage 3 Rotor Buckets Before and After 5000 Hour Test With Potassium Dizirconate Deposits Present.

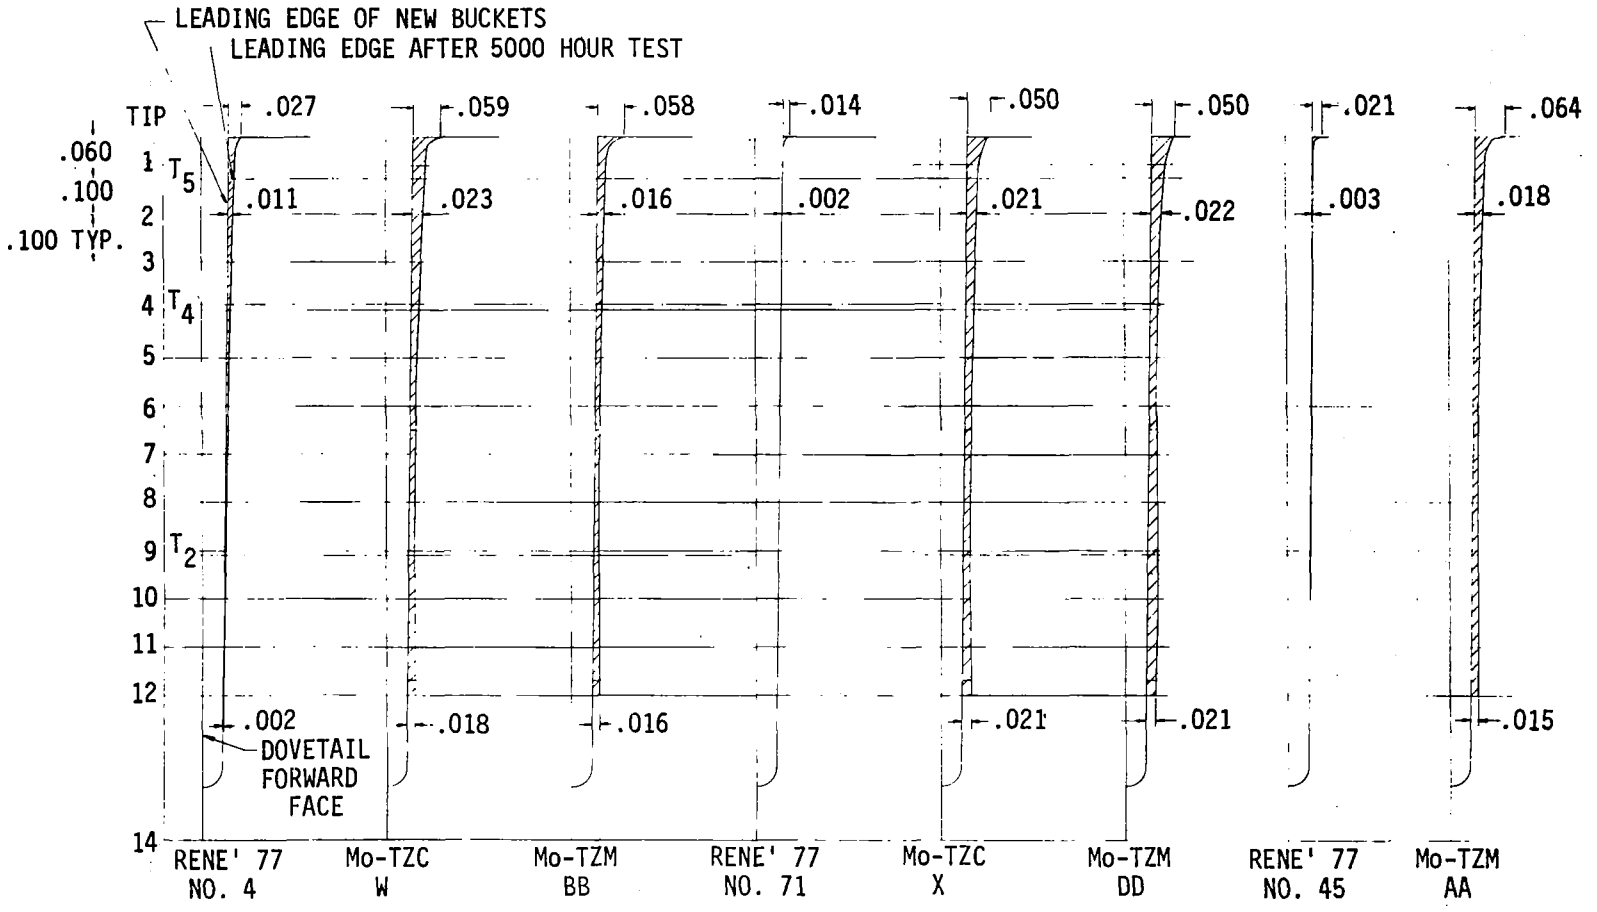
Figure 13. Surface Plate Measurements of Stage 3 Bucket Leading Edges.
(All dimensions in inches)

at 0.1 inch increments. The dovetail forward faces were used as a reference since shallow pretest identification marks and machining grooves could be seen when not covered by the metallic film. The differences between pretest and post-test configurations correlate well with the Pantascribe measurements of Figure 12.

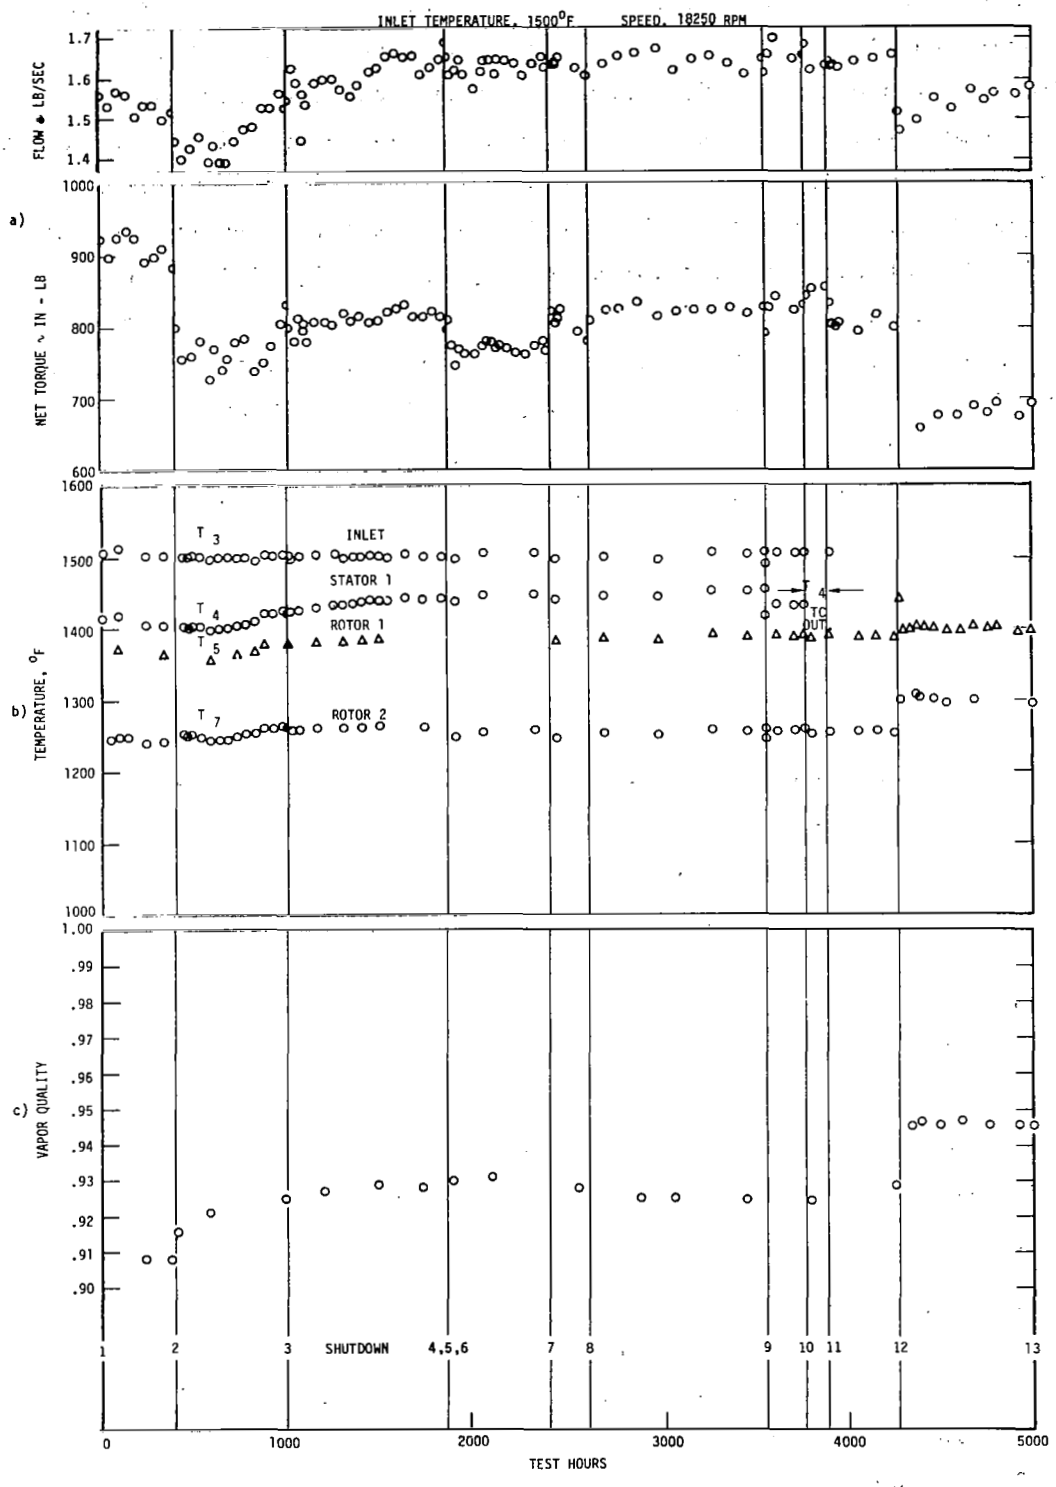
Shown in Figure 14 are the important performance parameters plotted as a function of time. It can be seen that the flow rate and net torque decreased significantly after the first shutdown. Subsequently the flow rate increased to a value greater than the initial value while the torque increased only slightly. It appears likely that the initial decrease in flow and torque was caused by potassium dizirconate or iron-nickel deposits on the turbine blades, and the subsequent increase in flow rate was due to the hole in the bulletnose which eventually permitted about one-third of the flow to bypass the first stage nozzle. This rationale is supported by the temperature plot which shows an increase in the first stage nozzle exit temperature, T_4, in the 700- to 1500-hour time period when the flow rate was increasing. Thus the hole in the bulletnose seems to have occurred after 700 hours. The decreases in torque at 1856 and 4268 hours are attributed to potassium dizirconate deposits found on the turbine blades. The decrease in flow after 4200 hours is attributed to heavy potassium dizirconate deposits on the third stage nozzle vanes. This conjecture is supported by the significant increase in the temperature after the second stage rotor, T_7, which could result, for instance, from the partial blockage of the third stage nozzle.

Figure 14. Flow Rate, Net Torque, Temperature, and Stage 3 Inlet Vapor Quality Performance During 5000 Hour Test.

agreement with the 1968 performance test results[4] which determined a benchmark turbine efficiency. For subsequent test points the turbine efficiency was estimated from measured values of flow rate, speed, and net torque. The turbine efficiency, exit pressure, and inlet conditions locate the condition line of the turbine on the potassium Mollier diagram. The quality at the inlet to the third stage was estimated from the measured value of the second rotor exit temperature, T_7, (Figure 14) and its location on the turbine condition line on a Mollier diagram. The third stage inlet quality varied from 0.91 at the beginning of the test to 0.93 after the bulletnose was fully opened, continuing at 0.93 until 4268 hours. After the next shutdown the quality rose to about 0.95 when the performance decreased due to heavy deposits on the third stage nozzle vanes.

1. The bulletnose failure was probably initiated after 700 hours and was probably completed at about 1700 hours.
2. For most of the test (4268 hours) the third stage inlet quality was no more than 0.93.
3. The decrease in flow and torque after the next-to-last shutdown was caused by heavy deposits, primarily in the third stage nozzle.

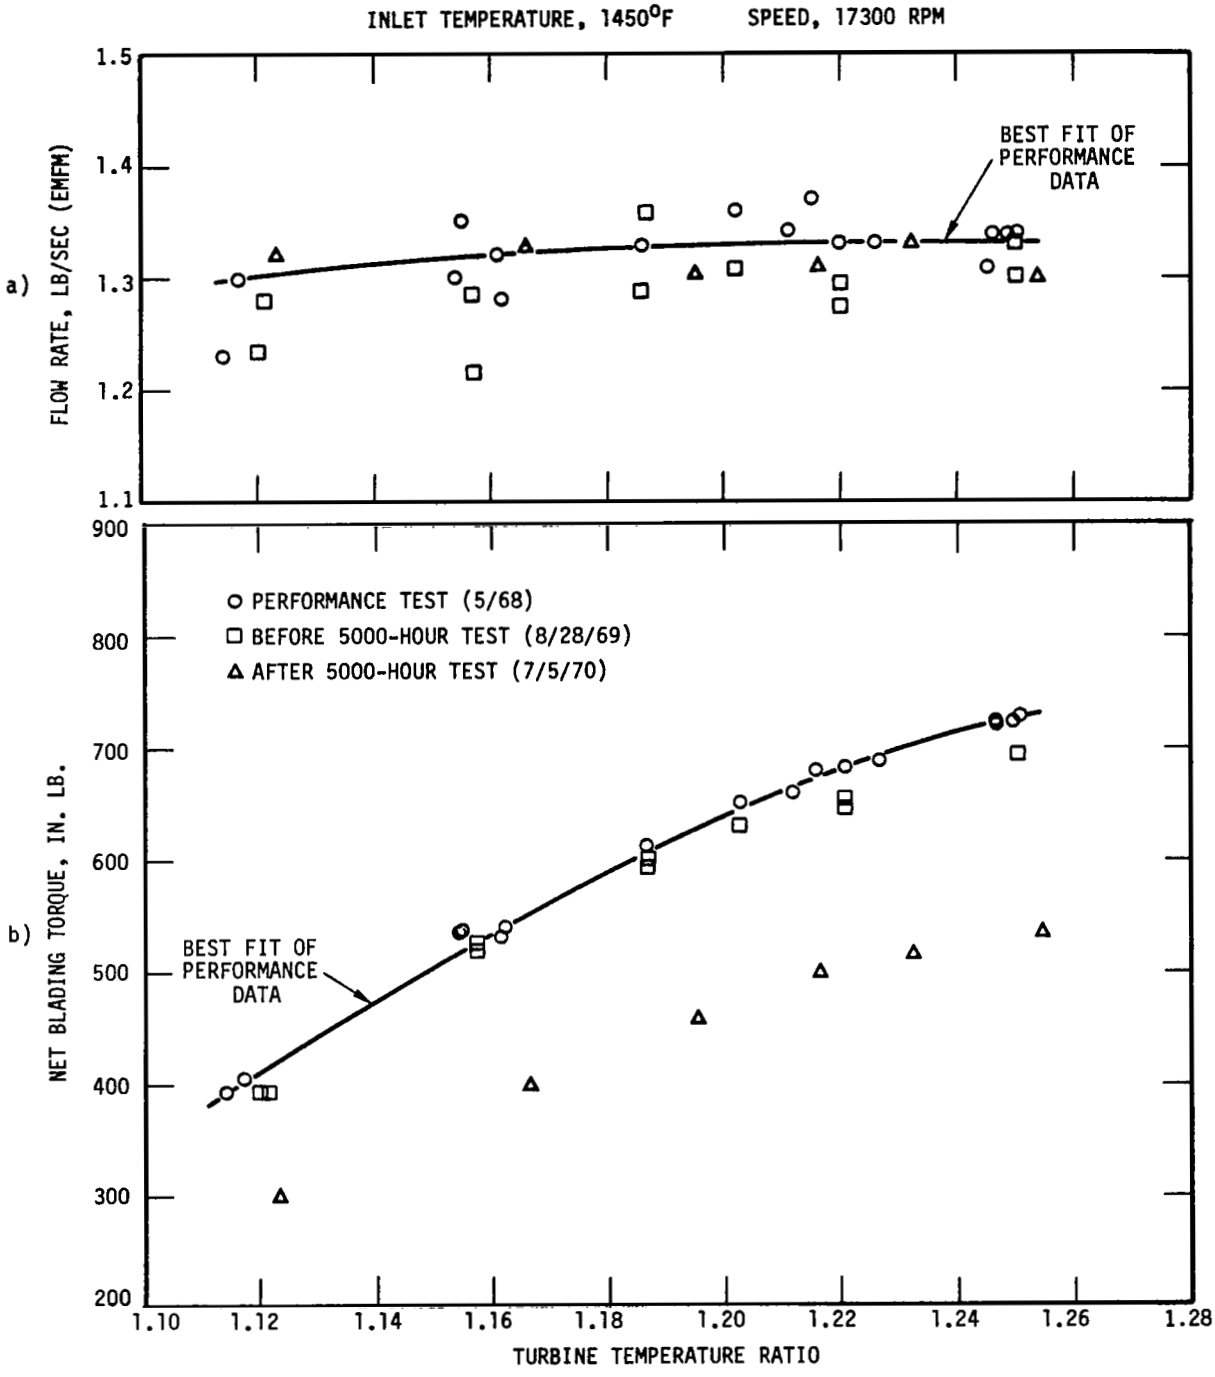
Shown in Figure 15 is a comparison of performance test results obtained from the 1968 performance test, before the 5,000 hour endurance test, and after the endurance test. The flow rate is about the same for all three tests, but the torque after 5,000 hours is about 25% lower than the original values. This is about the same decrease shown on Figure 14 for the 5,000 hour endurance test.

Figure 15. Net Blading Torque and Flow Rate Performance in 1968 and Before and After 5000 Hour Test.

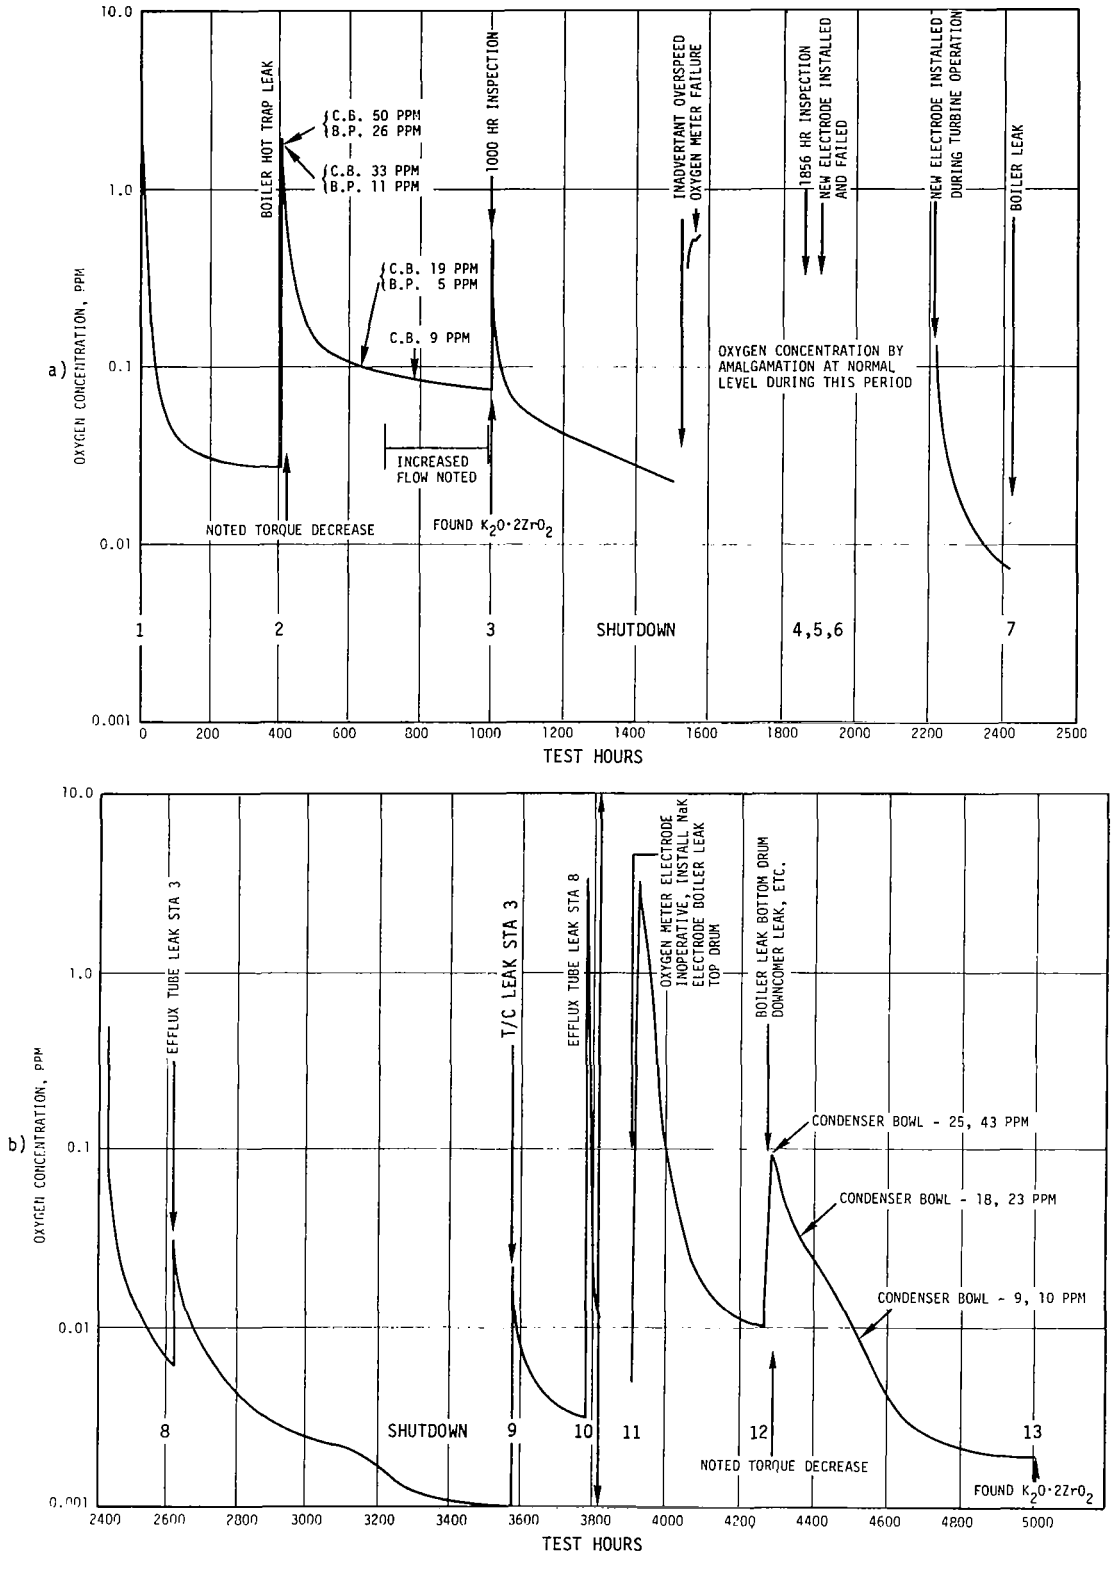
Figure 16a shows the oxygen meter data for the first 2425 hours of endurance testing. During the initial operation the indicated oxygen concentration dropped rapidly. After the boiler hot trap leak the rate of decrease was much less. During this same period the condenser bowl and bypass samples also showed higher than normal values (5 to 10 ppm) with the bypass values being lower, as expected. The oxygen meter values were, of course, still lower because of the blank in the amalgamation data. The data indicated that the loop was contaminated to a considerable extent. A torque decrease was noted at the 405-hour startup and potassium dizirconate ($K_2O \cdot 2ZrO_2$) was noted on the stator vanes at the 1000-hour inspection. The ensuing data indicated that subsequent problems did not result in serious contamination, as indicated by the very rapid drop in oxide concentration during startups and the continually decreasing values during normal operation. Analysis of condenser bowl samples, during the period when no oxygen meter was operating, indicated the usual values between five and ten ppm. At about 2200 hours a new electrode was installed during operation and the noted spike was due to cleanup of the oxygen meter loop.

Figure 16b shows that the boiler leak which occurred after 2425 hours of operation did not result in serious contamination nor did subsequent mishaps until the leak in the top boiler drum at about 3900 hours. Another electrode was installed at this point. It had been used previously in a NaK system and had to be cleaned up by an alcohol washing before installation in the turbine facility. It is not possible to say whether the apparent slow cleanup of the loop after this mishap was due to contamination or to conditioning of the elctrode. However, the condenser bowl

Figure 16. Three Stage Turbine Oxygen Meter Data During 5000 Hour Test.

sample indicated seven ppm oxygen at the startup and supports the contention that contamination was not excessive. In contrast, the boiler leak at 4268 hours definitely resulted in contamination, as indicated by the relatively slow decrease in oxygen meter concentration and by the high values obtained from the condenser bowl samples. A decrease in torque was again seen and at the final inspection potassium dizirconate was again found to be deposited on the stator vanes. After the 5000-hour test, visual inspection of the condenser zirconium hot trap showed it to be cracking, but essentially intact. X-ray diffraction indicated that the black powder found on the surfaces consisted of Zr_4Fe and a trace of potassium dizirconate. In contrast, inspection at the boiler bypass zirconium hot trap showed that it was disintegrating and contained a considerable quantity of potassium dizirconate. Therefore, it was the principal source of the turbine deposits.

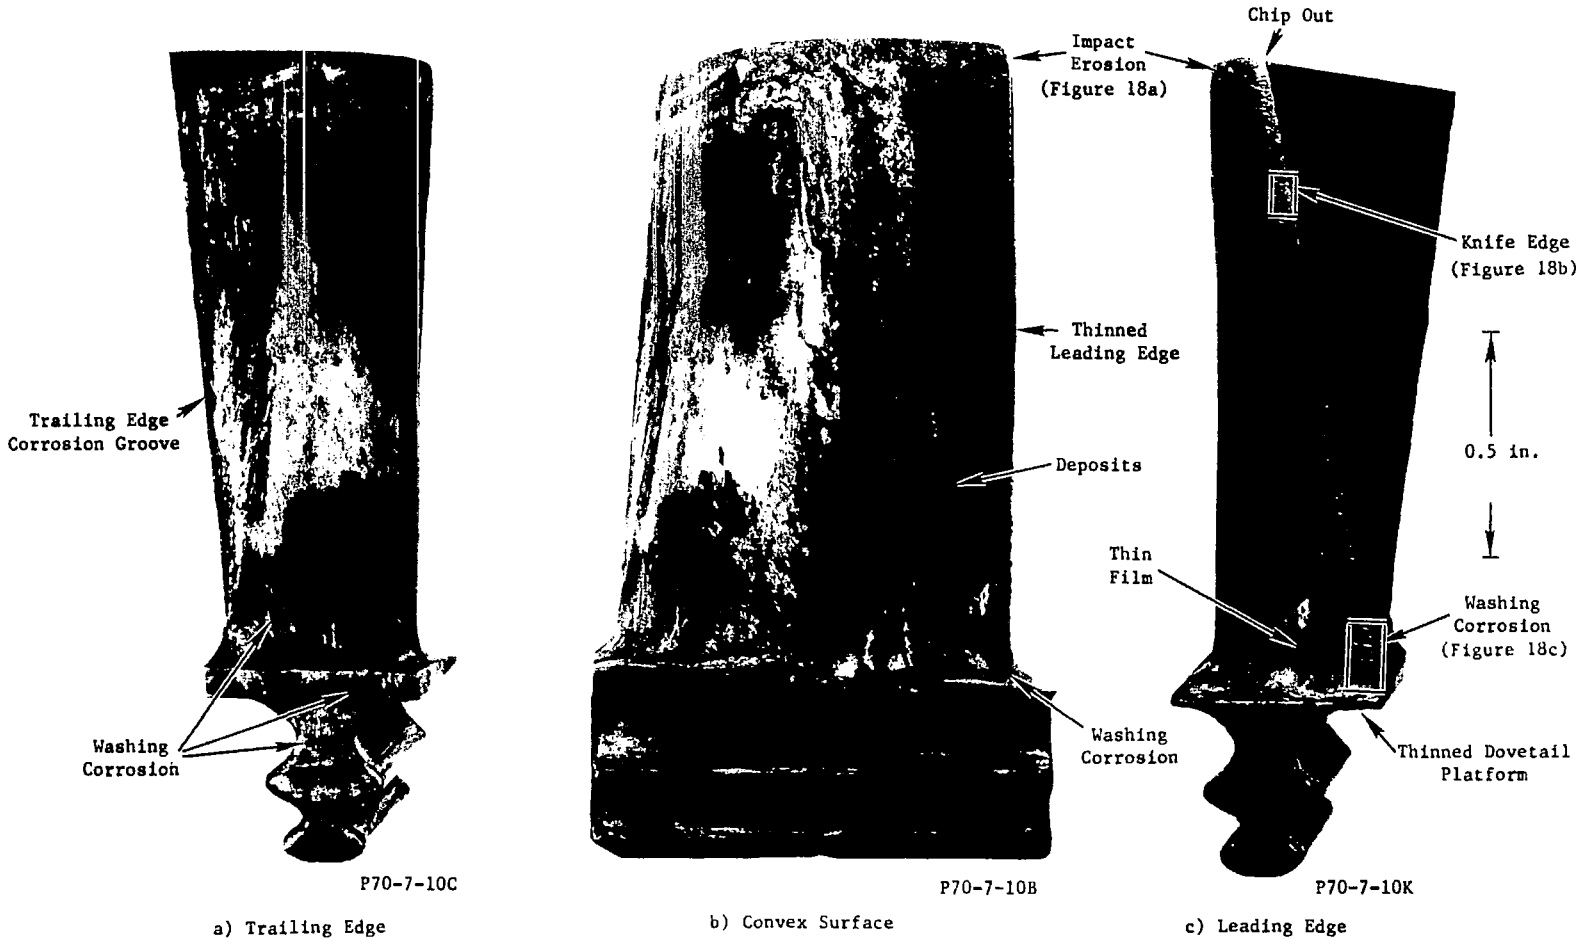
To characterize the third stage buckets and the thin films found on them, metallographic and chemical analysis techniques were employed. Figure 17c shows the leading edge of a Stage 3 Mo-TZM bucket. The heaviest washing corrosion occurred at the root of the blade. On top of the dovetail platform, where undercutting can be noted, the upper portion of the airfoil has been worn to a knife edge. A small amount of

Figure 17. Mo-TZM CC Third Stage Rotor Bucket Following 5000 Hours Exposure to Potassium - Inlet Vapor Temperature 1250°F, Vapor Quality 90-93%, Tip Speed 845 ft/sec.

impact erosion damage is evident at the tip of the blade despite the washing corrosion which also occurred at the tip.

Figure 17b shows a deep corrosion groove that starts on the pressure surface and extends radially upward on the suction surface. These observations are typical for both Mo-TZM and Mo-TZC buckets.

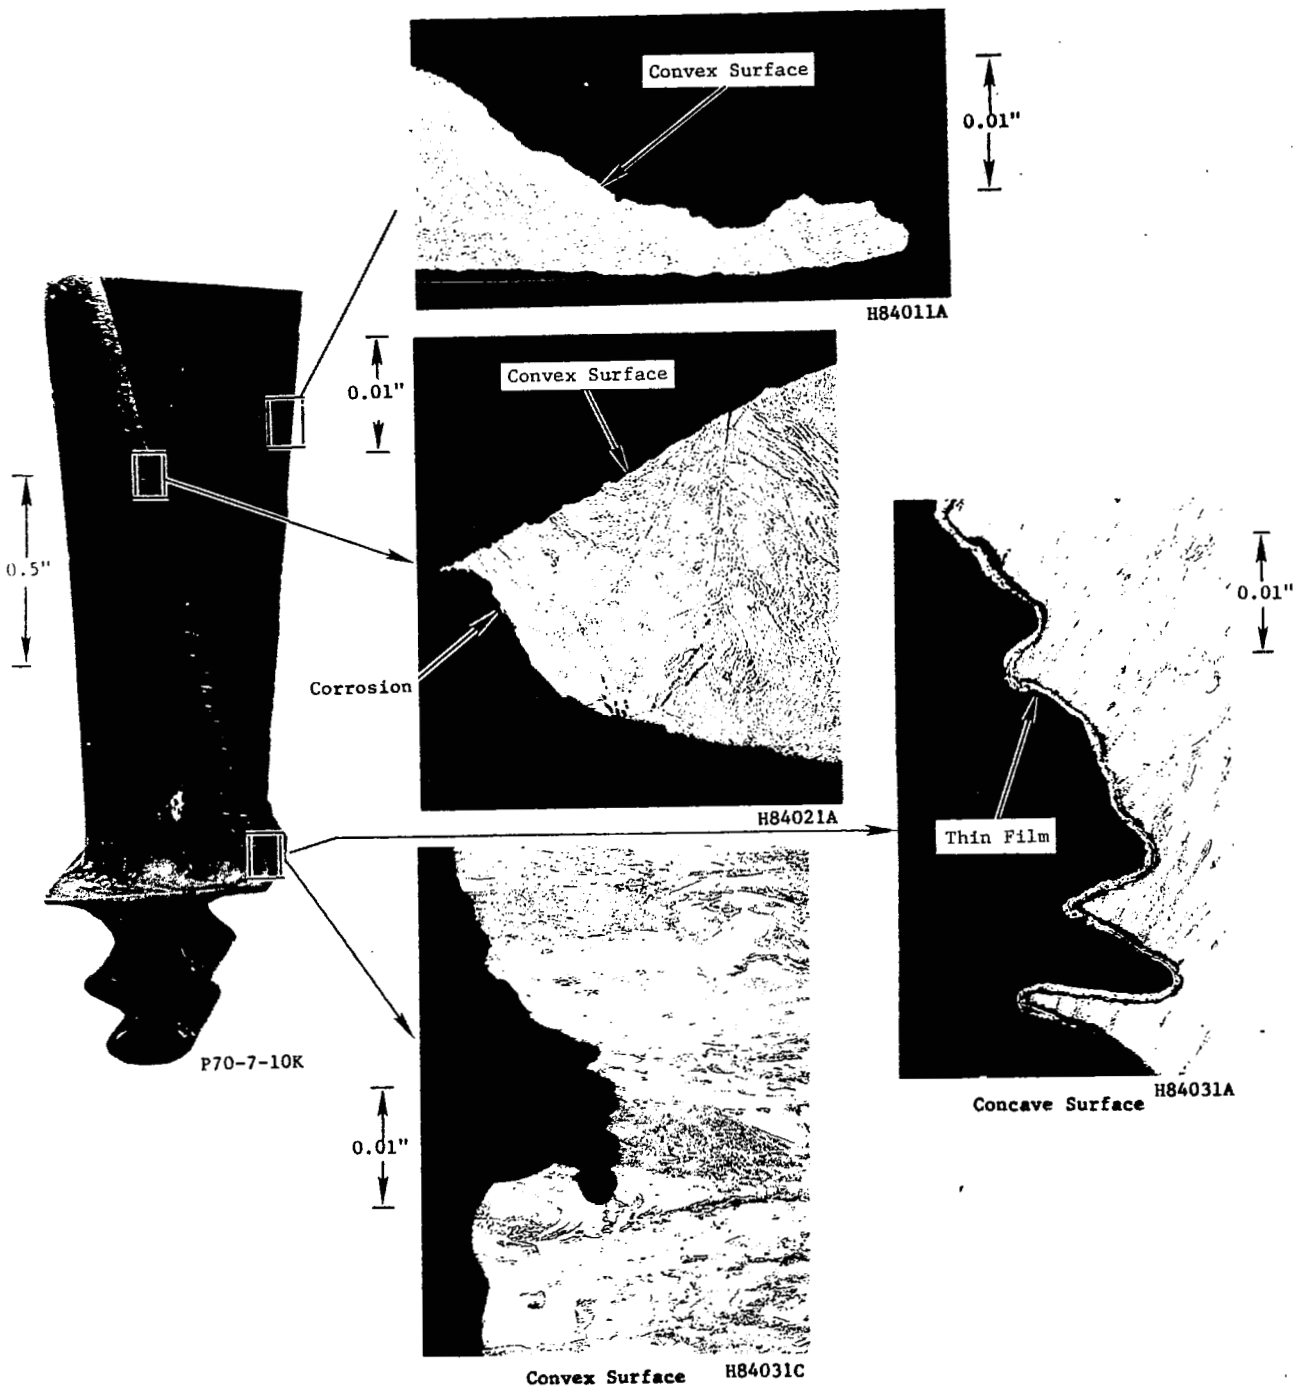
Figure 19 shows the microstructure of a third-stage Mo-TZC bucket. Washing corrosion has occurred on both the concave and convex surfaces at the base of the airfoil leading edge. Some of the material removal occurred on the concave surface of the thinned leading edge. Also, signs of corrosion are seen at the trailing edge convex surface where a groove runs almost the entire length of the convex surface of the airfoil. The groove is 0.030 inch wide and has a maximum depth of 0.005 inch.

Figure 19. Microstructure of Mo-TZC #U Third Stage Rotor Bucket.

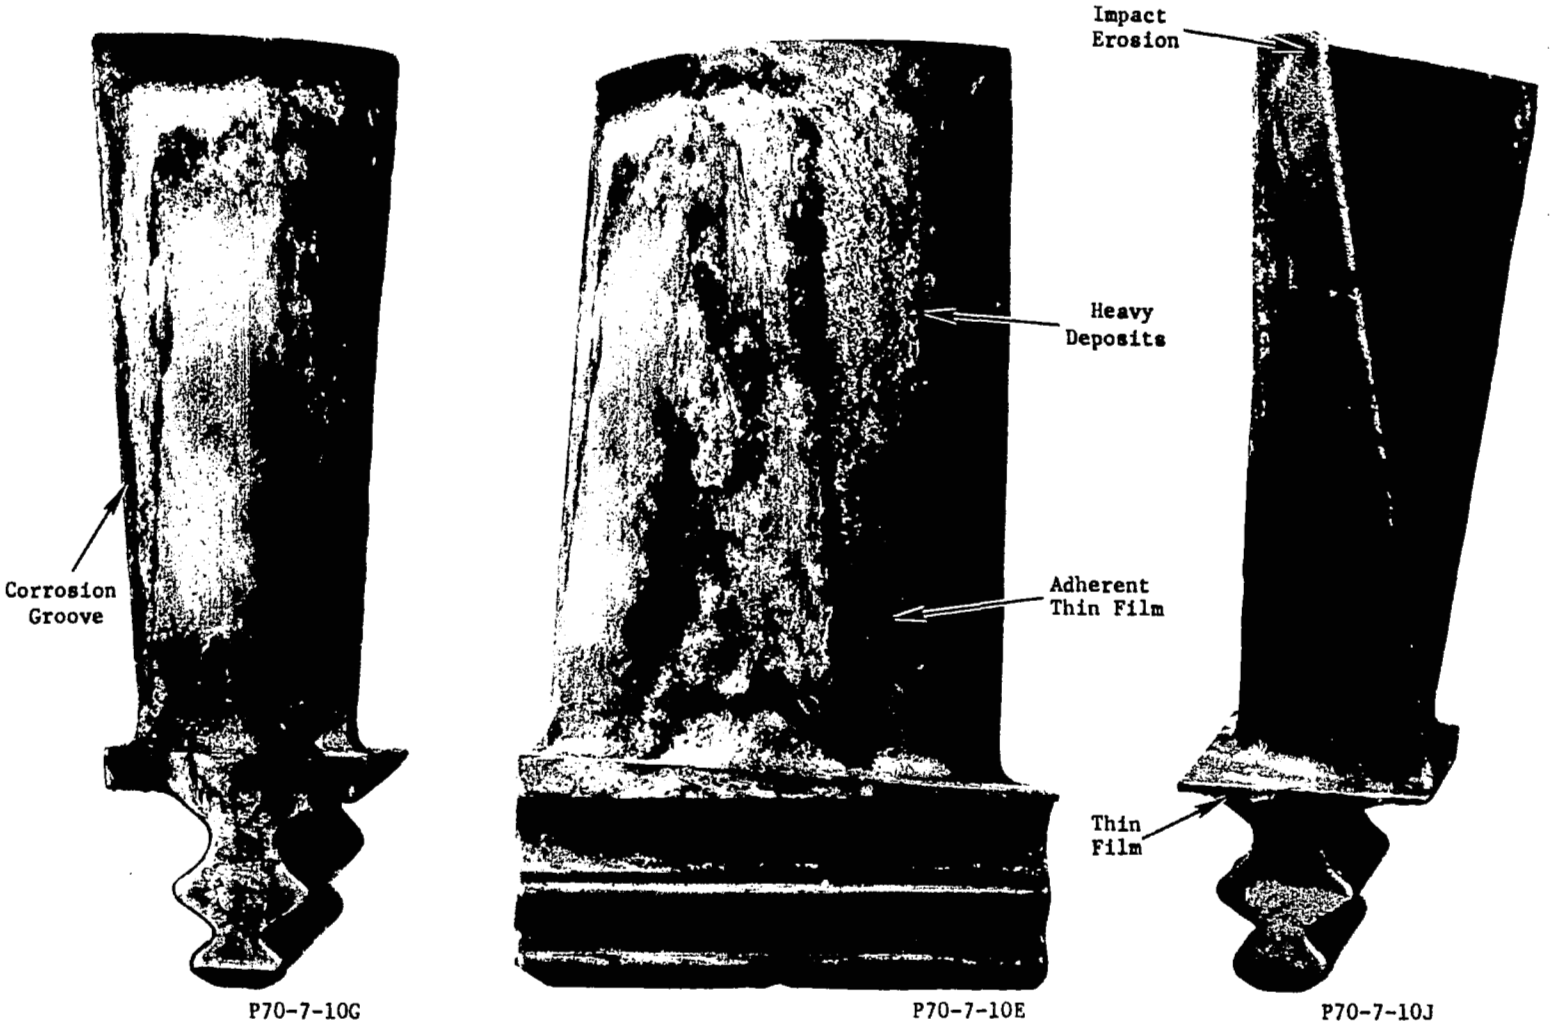
Apparently the differences in appearance between the molybdenum alloy and nickel alloy buckets can be attributed to oxygen effects.

Figure 20. Rene' 77 No. 19 Third Stage Rotor Bucket Following 5000 Hours Exposure to Potassium-Vapor Temperature 1250°F, Vapor Quality 90-93%, Tip Speed 845 ft/sec.
