NASA CR-1815

THREE-STAGE POTASSIUM VAPOR TURBINE TEST

by B. L. Moor and E. Schnetzer

Prepared by
GENERAL ELECTRIC COMPANY
Cincinnati, Ohio 45215
for Lewis Research Center

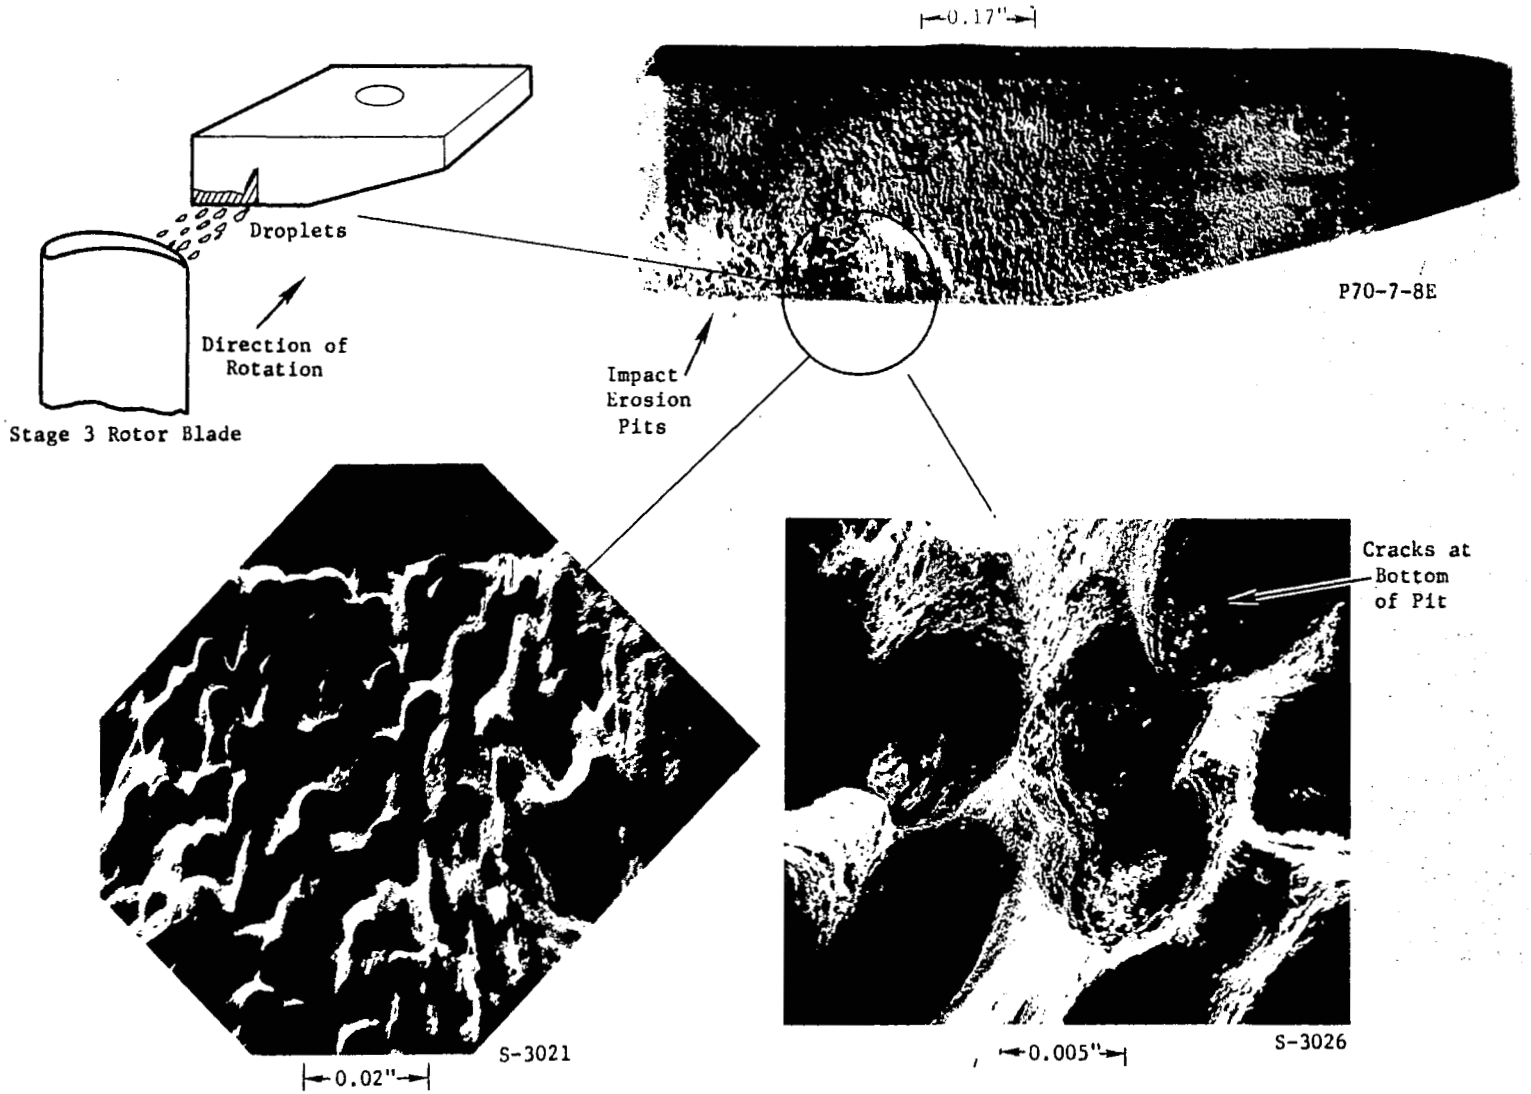
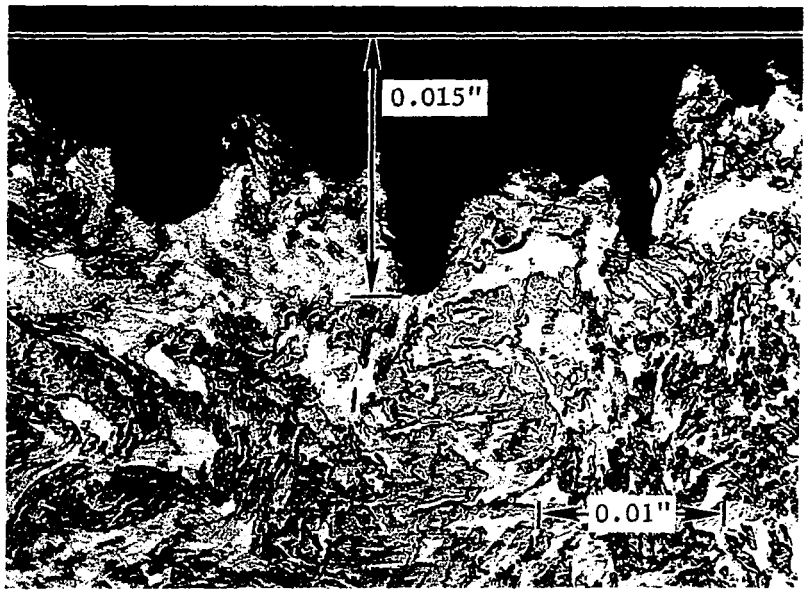
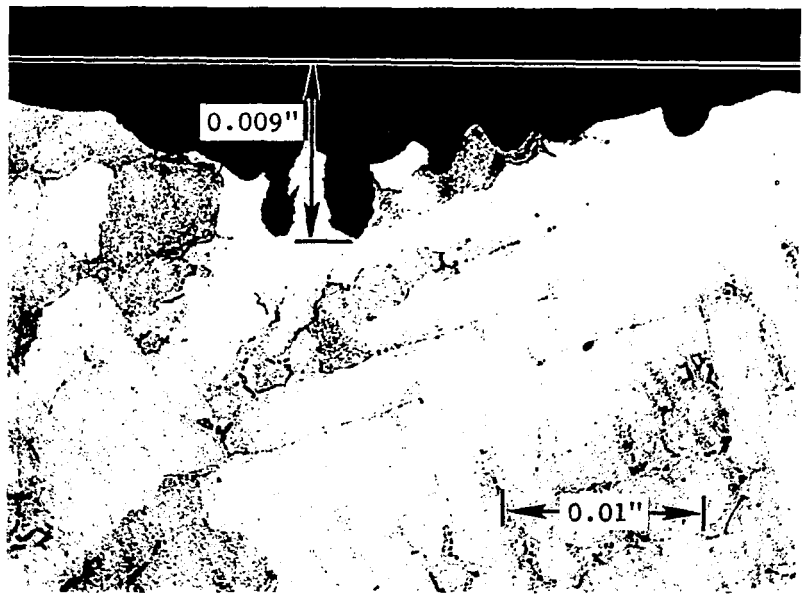
Table V contains the summary of erosion insert volume loss which indicates that the molybdenum alloys lost about 0.1 cubic centimeter, sixteen times that of Rene' 77 and eight times that of the U-700. However, the material loss of the molybdenum inserts by washing corrosion is part of the total volume loss.

Figure 21. Impact Surface of Mo-TZM No. 1 Erosion Insert and Magnifications of Damage After 5000 Hours of Test.

a) Mo-TZC - Maximum Pit Diameter = 0.0090 In.
