CR 134739
LYC 74-55

DEVELOPMENT OF SELF-ACTING SEALS FOR HELICOPTER ENGINES

Peter Lynwander

AVCO LYCOMING DIVISION
550 South Main Street
Stratford, Connecticut 06497

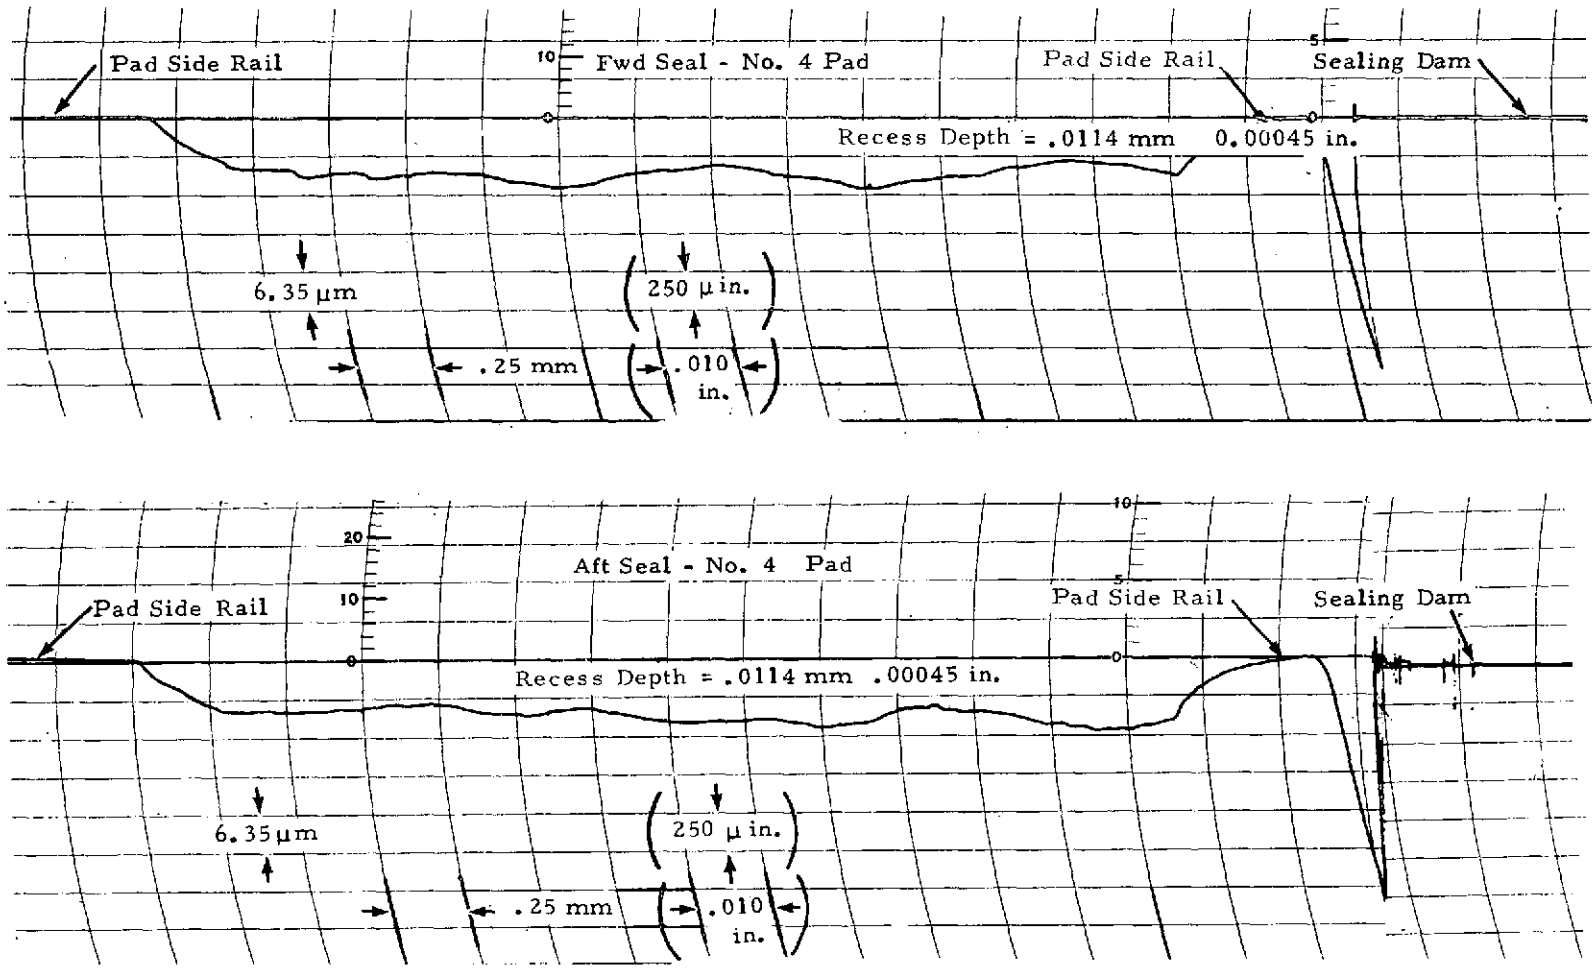
Following each phase of testing, a visual and analytical inspection was performed on the primary carbon ring and the seat. The depth of the lift pads on the primary carbon ring was measured by taking a proficorder trace radially across the face. The average total wear of the carbon faces for the 500-hour test was 0.0051 mm (0.0002 in). Traces of the primary ring sealing faces of the forward and aft seals prior to testing are shown in Figure 7. Only one pad is depicted. Traces of four of twelve pads were taken after each test. Table III lists the pad recess depths at each phase of testing. Traces of the lift pads after the 500-hour test are shown in Figure 8.

Figure 8. Trace of Forward and Aft Seal Carbon Ring Sealing Faces After 500-Hour Endurance Test - Trace Taken Radially Across a Self-Acting Lift Pad.

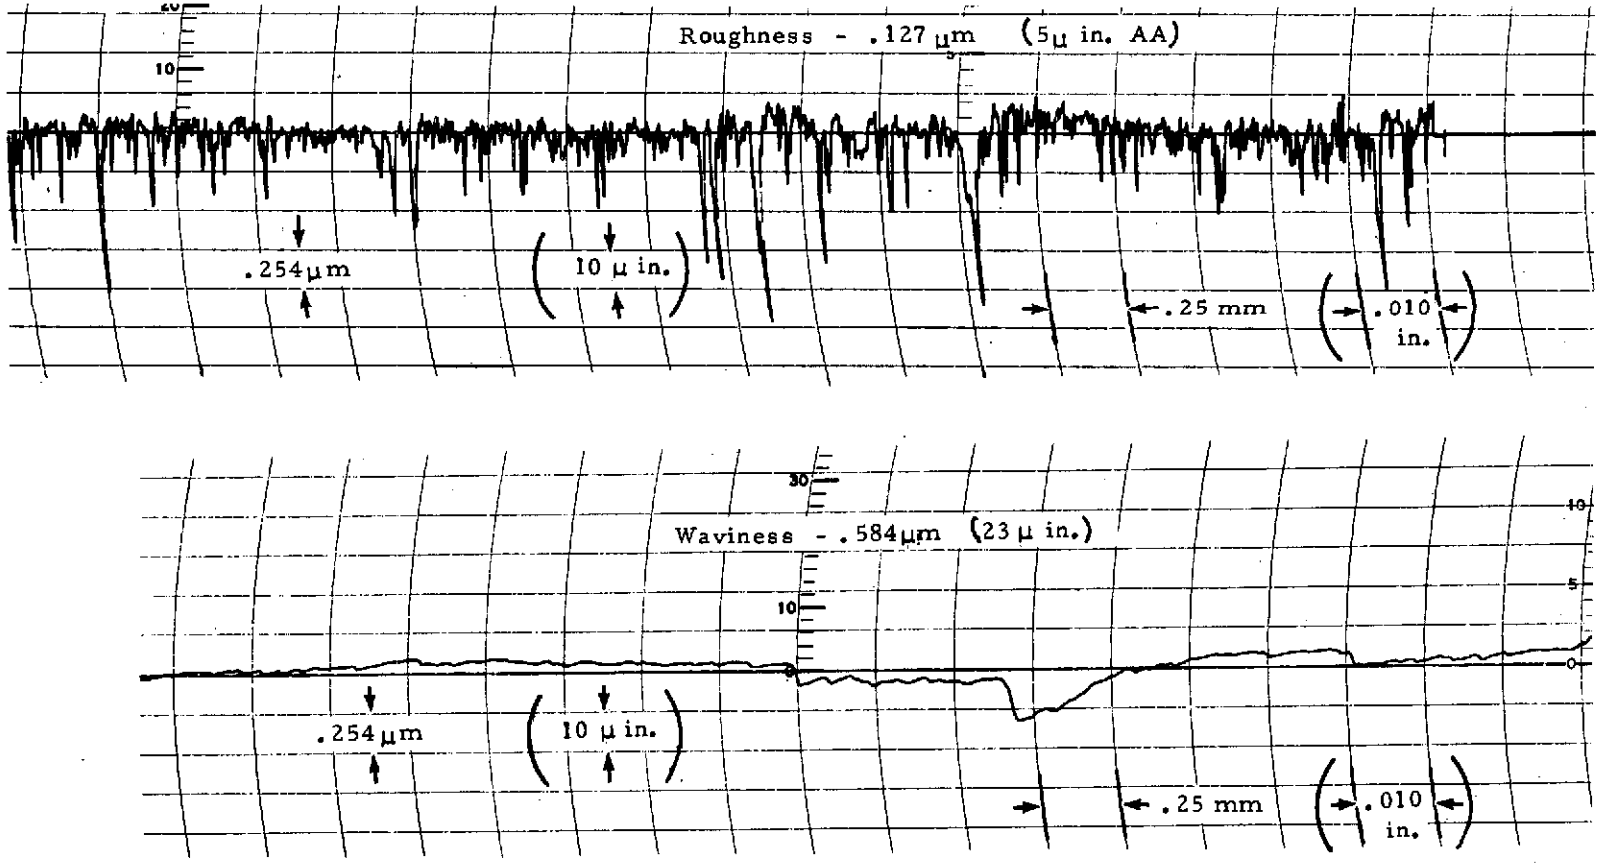
Figure 9. Forward Self-Acting Face Seal Seat Trace of Roughness and Waviness After Second 100-Hour Endurance Test - Trace Taken in a Radial Direction on the Seat Face Across the Running Track.

Seal seats were traces for roughness, waviness, and flatness in the unassembled state. Table IV lists these values prior to and after testing. Flatness of the assembled seats clamped in place on the shaft did not exceed 0.0015 mm (0.00007 in). Measurement charts showing seat surface texture before and after the endurance test are presented in Figures 9 through 12.

These traces were taken in a radial direction through the running track. Although some deterioration was measured, the seal seats were in acceptable condition for further operation after the 500-hour test.

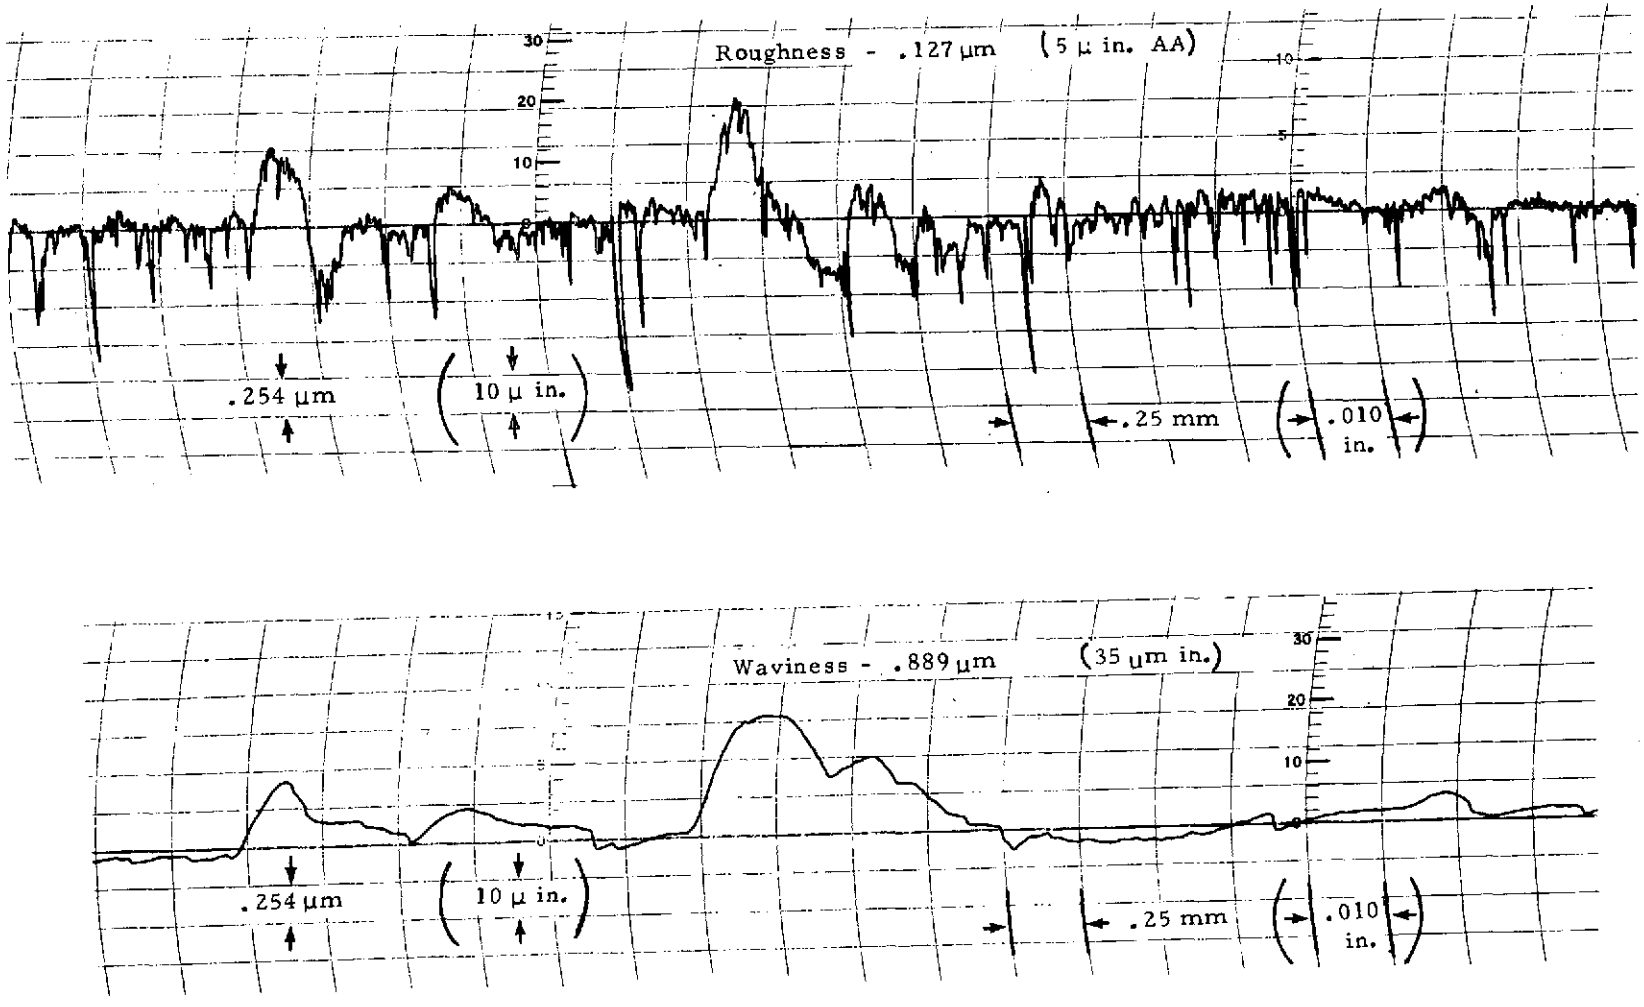
Figure 11. Forward Self-Acting Face Seal Seat Trace of Roughness and Waviness After 500-Hour Endurance Test - Trace Taken in a Radial Direction on the Seat Face Across the Running Track.

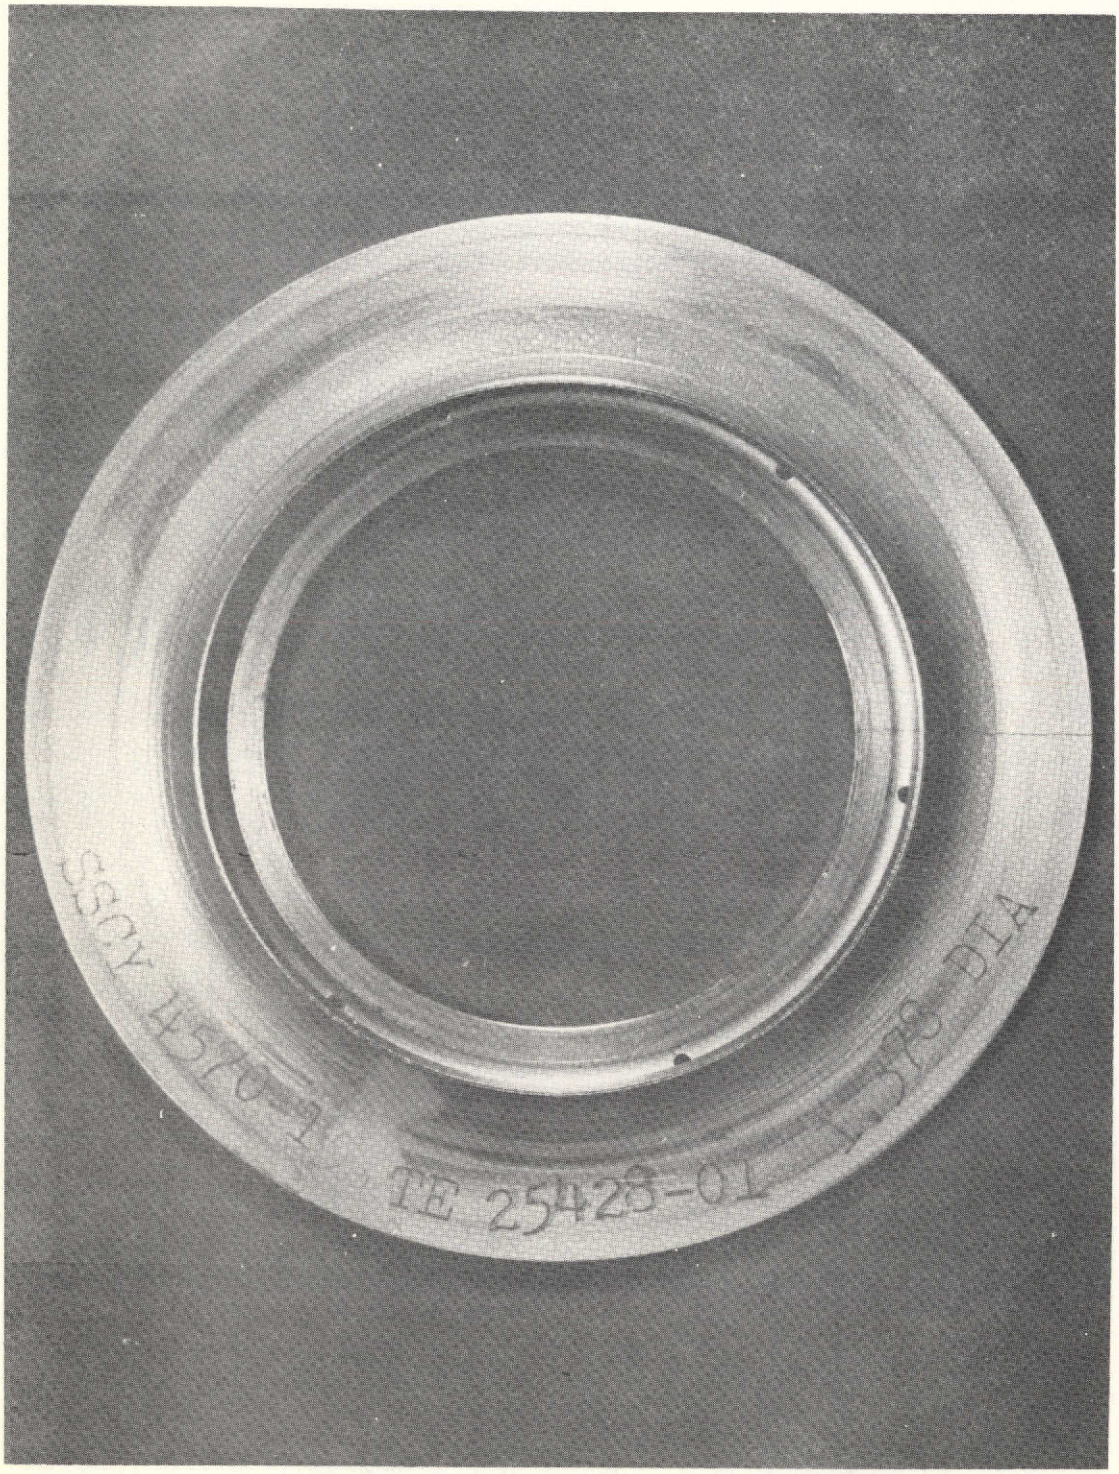
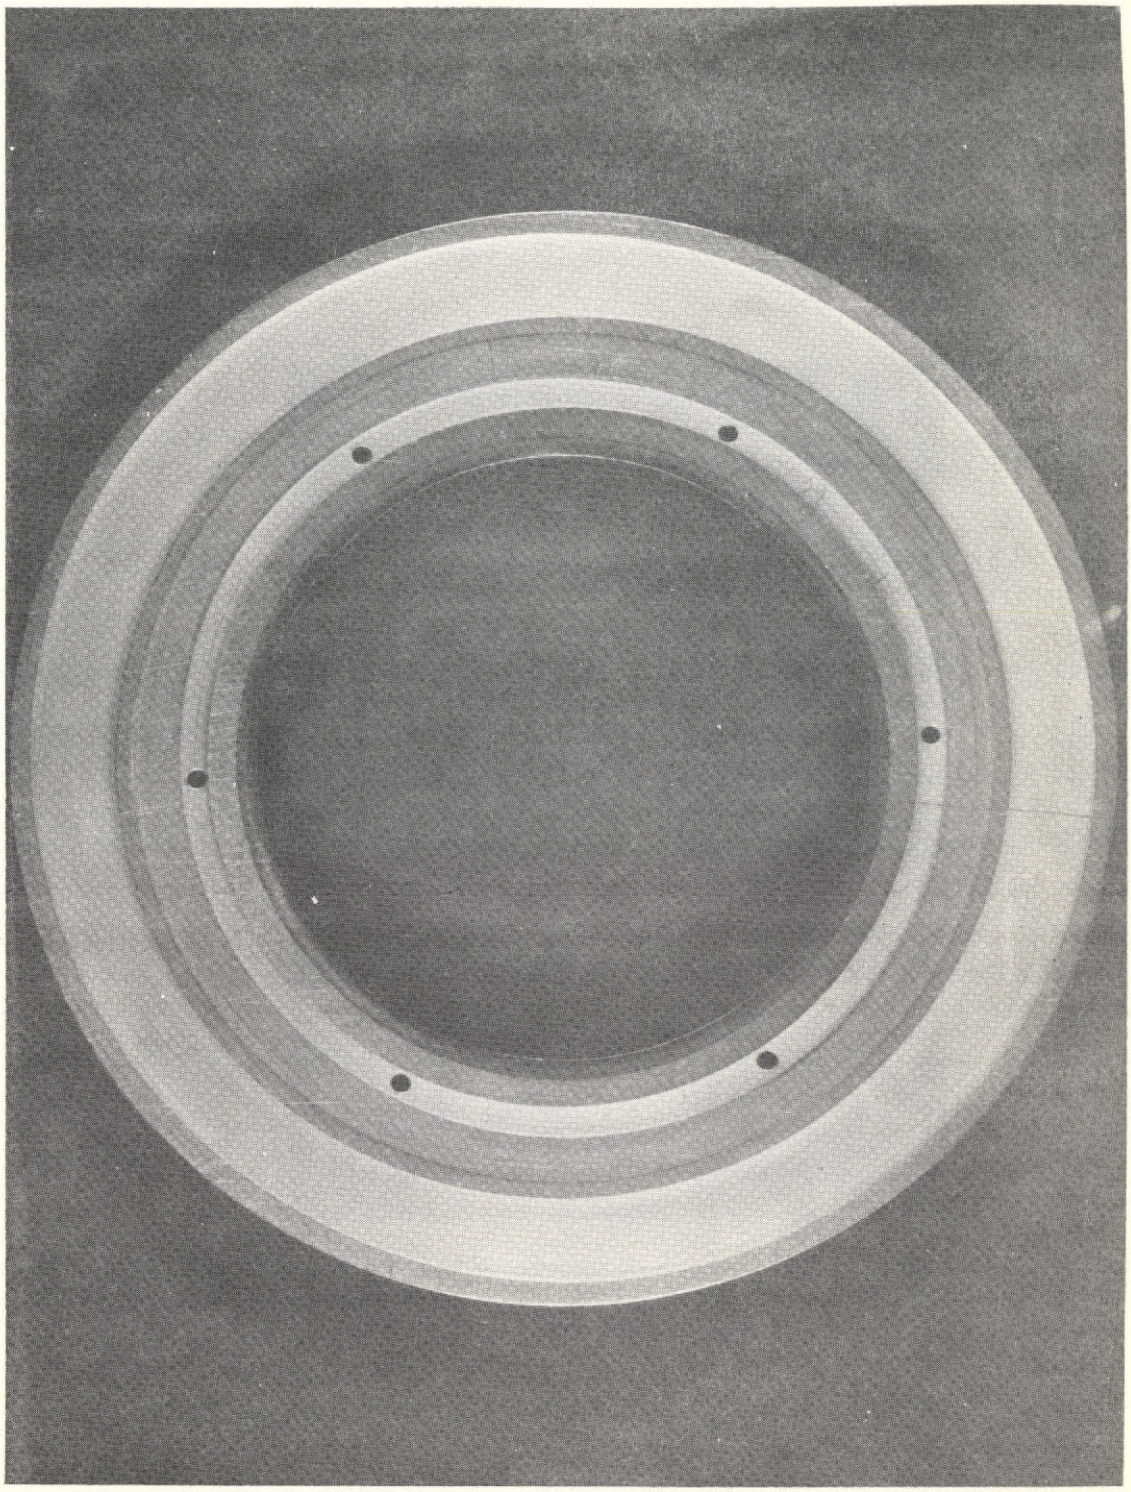
Inspection following the 500-hour test revealed a problem in the forward seal. The carbon sealing face was found to be distorted, and there was a radial crack in the oil dam and heat shield.

Figures 13 and 14 show both sides of the oil dam illustrating the crack. Figure 15 is the crack surface. Metallurgical examination showed the crack to be a fibrous fracture with no trace of fatigue.

Figure 13. Cracked Oil Dam and Heat Shield, Oil Side.

Figure 14. Cracked Oil Dam and Heat Shield, Seat Side.

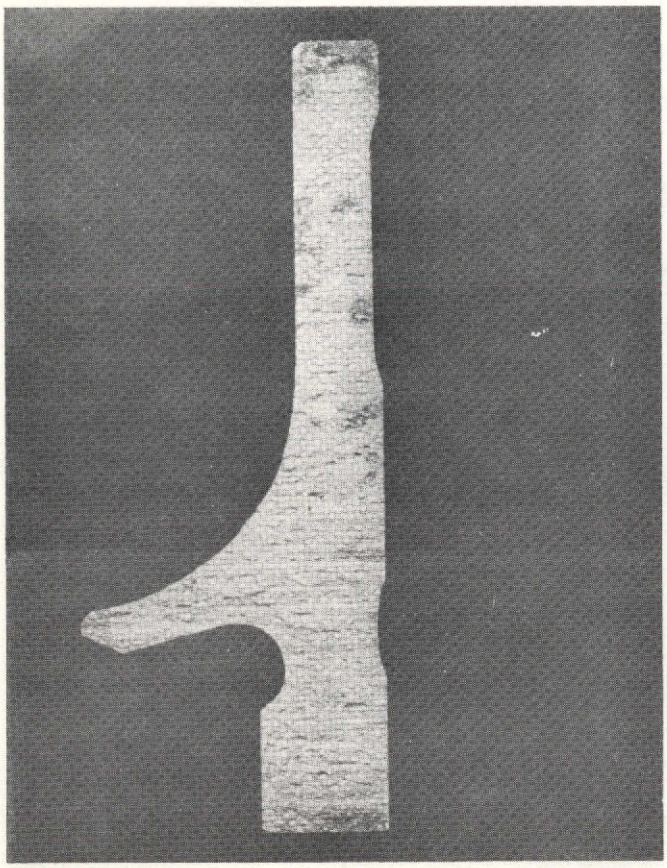
Figure 15. Oil Dam and Heat Shield, Crack Surface.

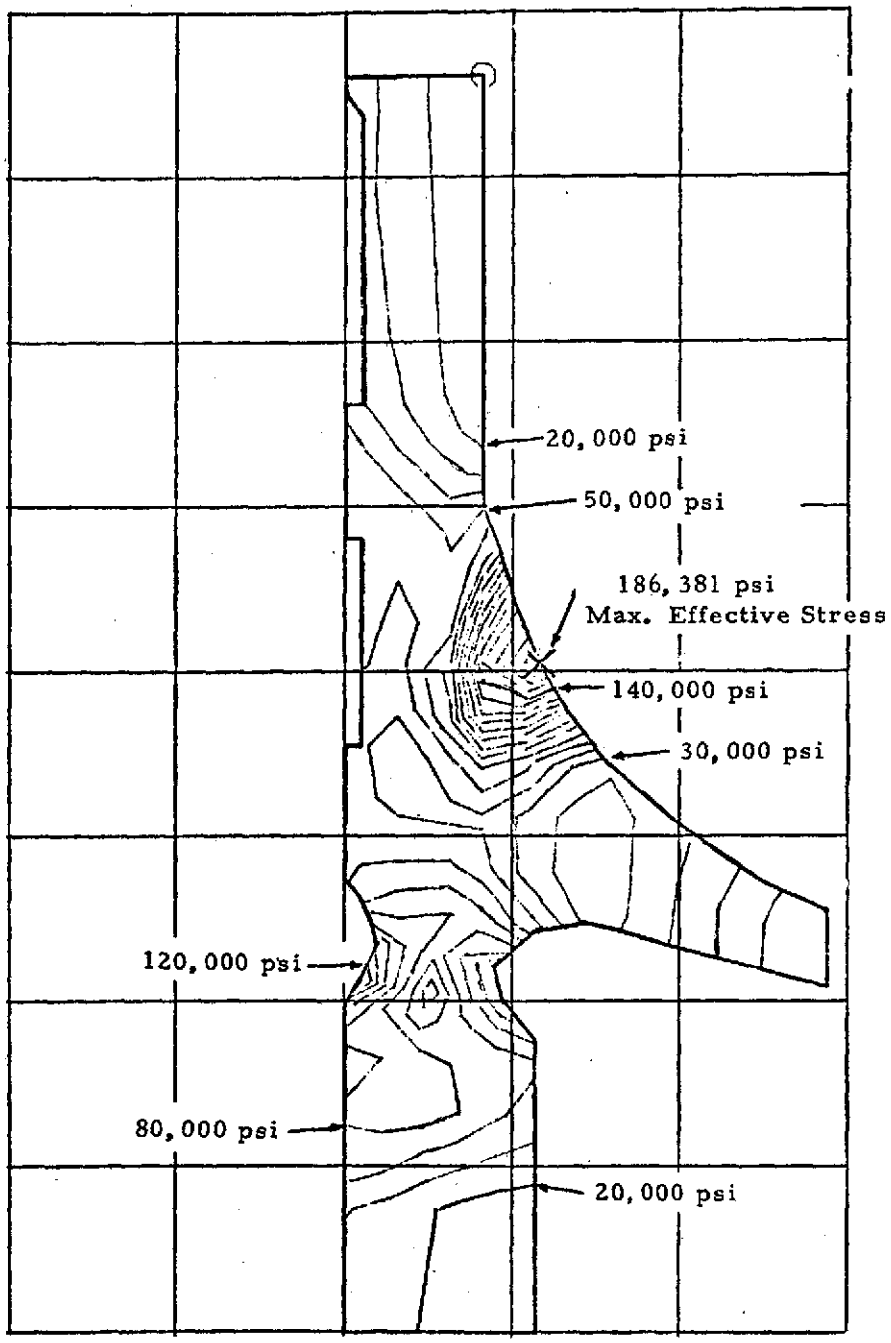
A finite element stress analysis of the oil dam at the seal operating conditions was conducted. Figure 16 presents the results of the analysis showing lines of constant stress and the point of maximum stress. The dam material is AMS 5630 heat treated to R_c 54-60 with a yield stress of 190,000 N/cm^2 (275,000 psi). The maximum dam stress of 128 N/cm^2 (186,381 psi) is well below this value. To date no explanation has been found for the crack.

Figure 16. Stress Analysis of the Oil Dam.

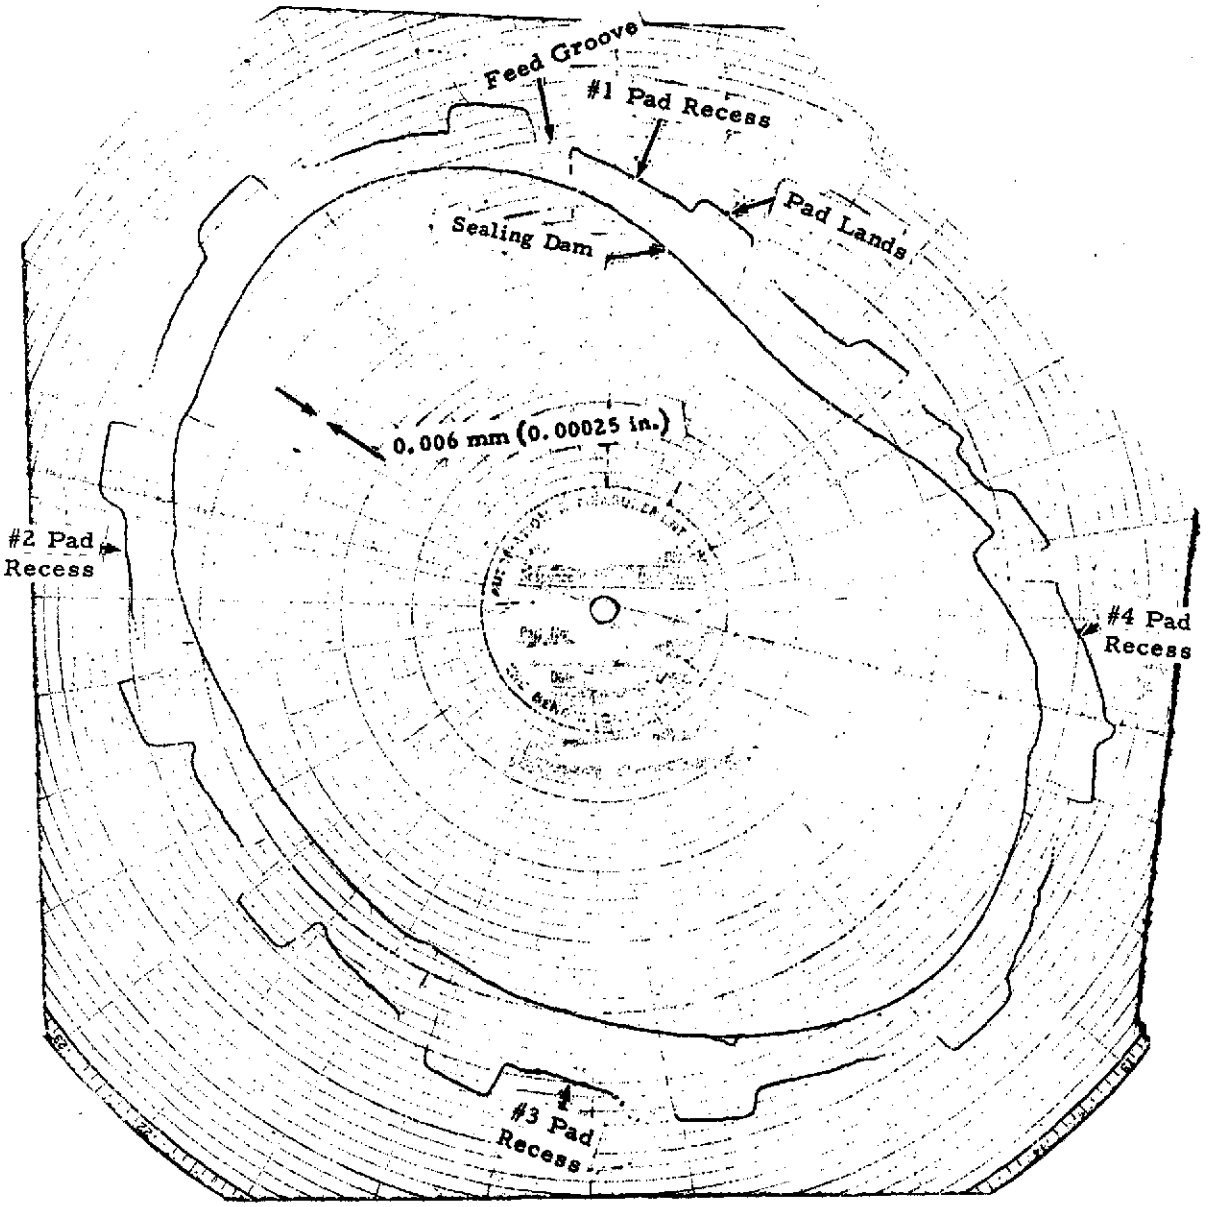
Figure 17 presents an Indiron trace of the forward carbon sealing face showing it to be .089 mm (0.0035 in.) out of flat. In comparison Figure 18 shows the aft carbon sealing face after testing.

Figure 17. Trace of Forward Carbon Flatness After 500-Hour Endurance Test.

The forward carbon shifted within its retaining ring probably due to motions of the seal seat caused by the cracked oil dam and heat shield. It is theorized that this happened at the very end of the test since the components could not have operated for any length of time in this condition.

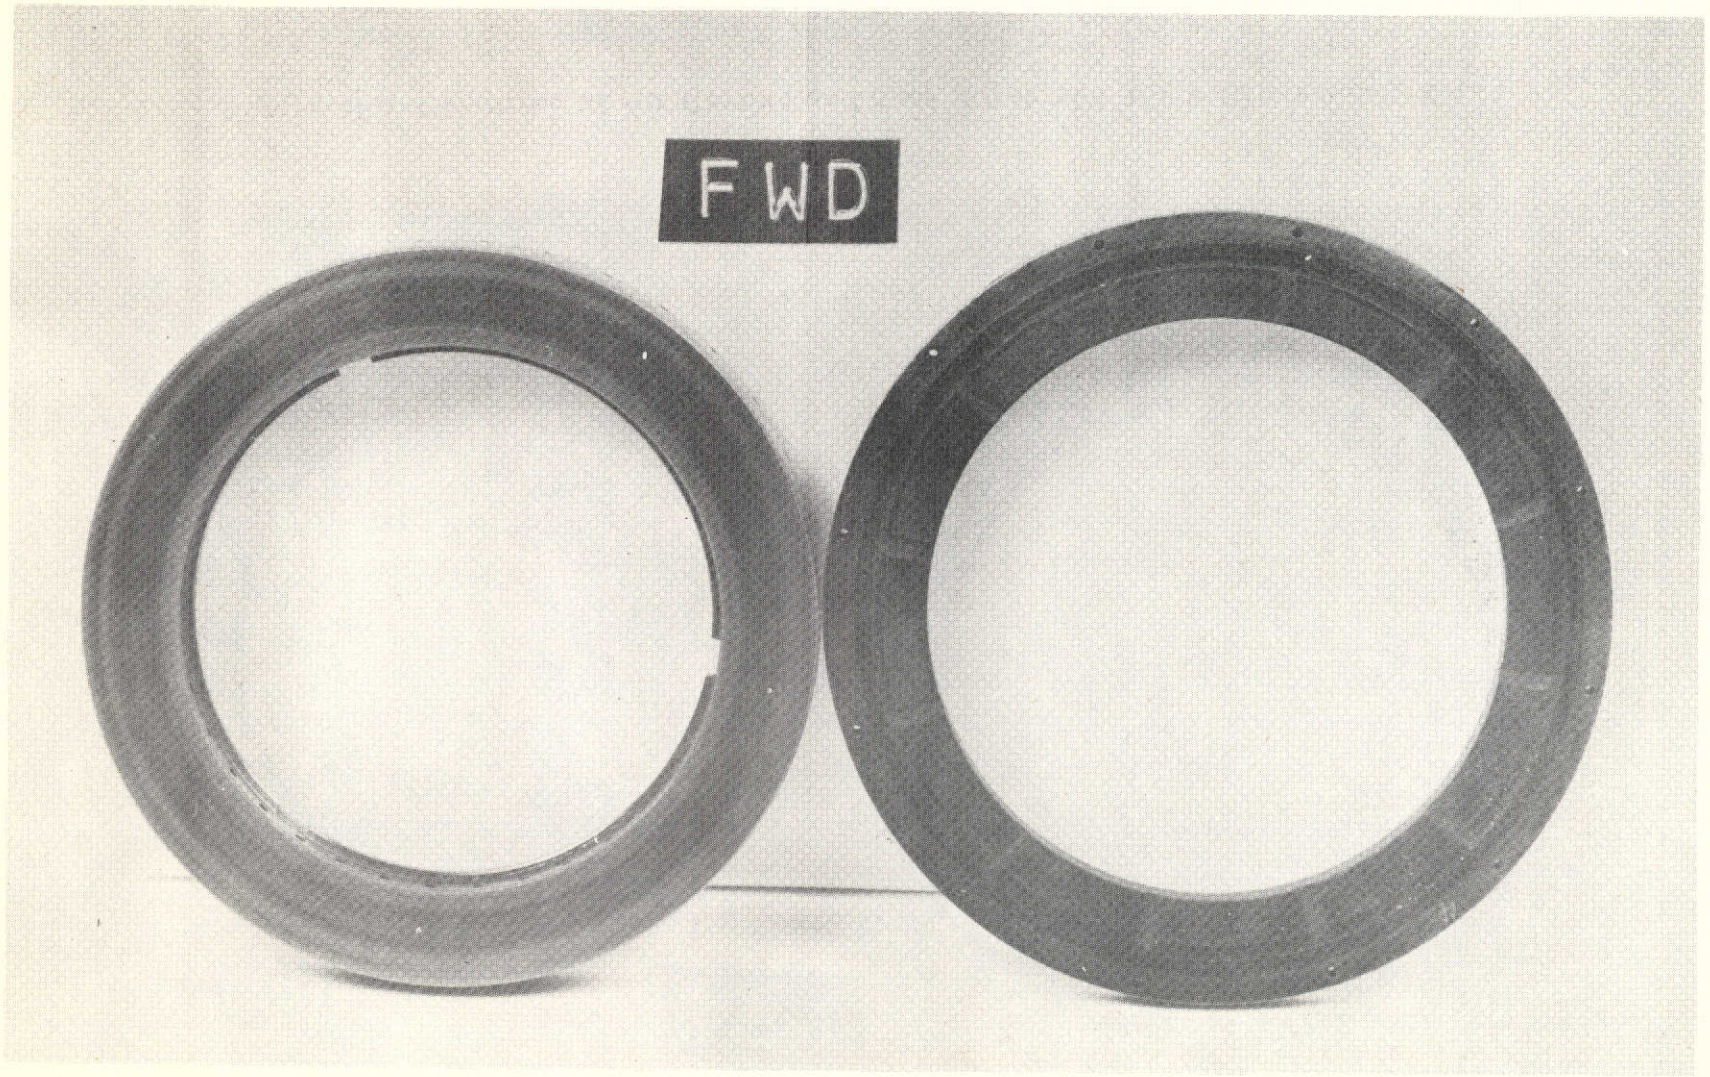
Figures 19 and 20 illustrate seal carbon and seat condition following the 500-hour endurance run. All parts were acceptable for further operation.

Figure 19. Condition of Forward Carbon and Seat After 500-Hour Endurance Test.

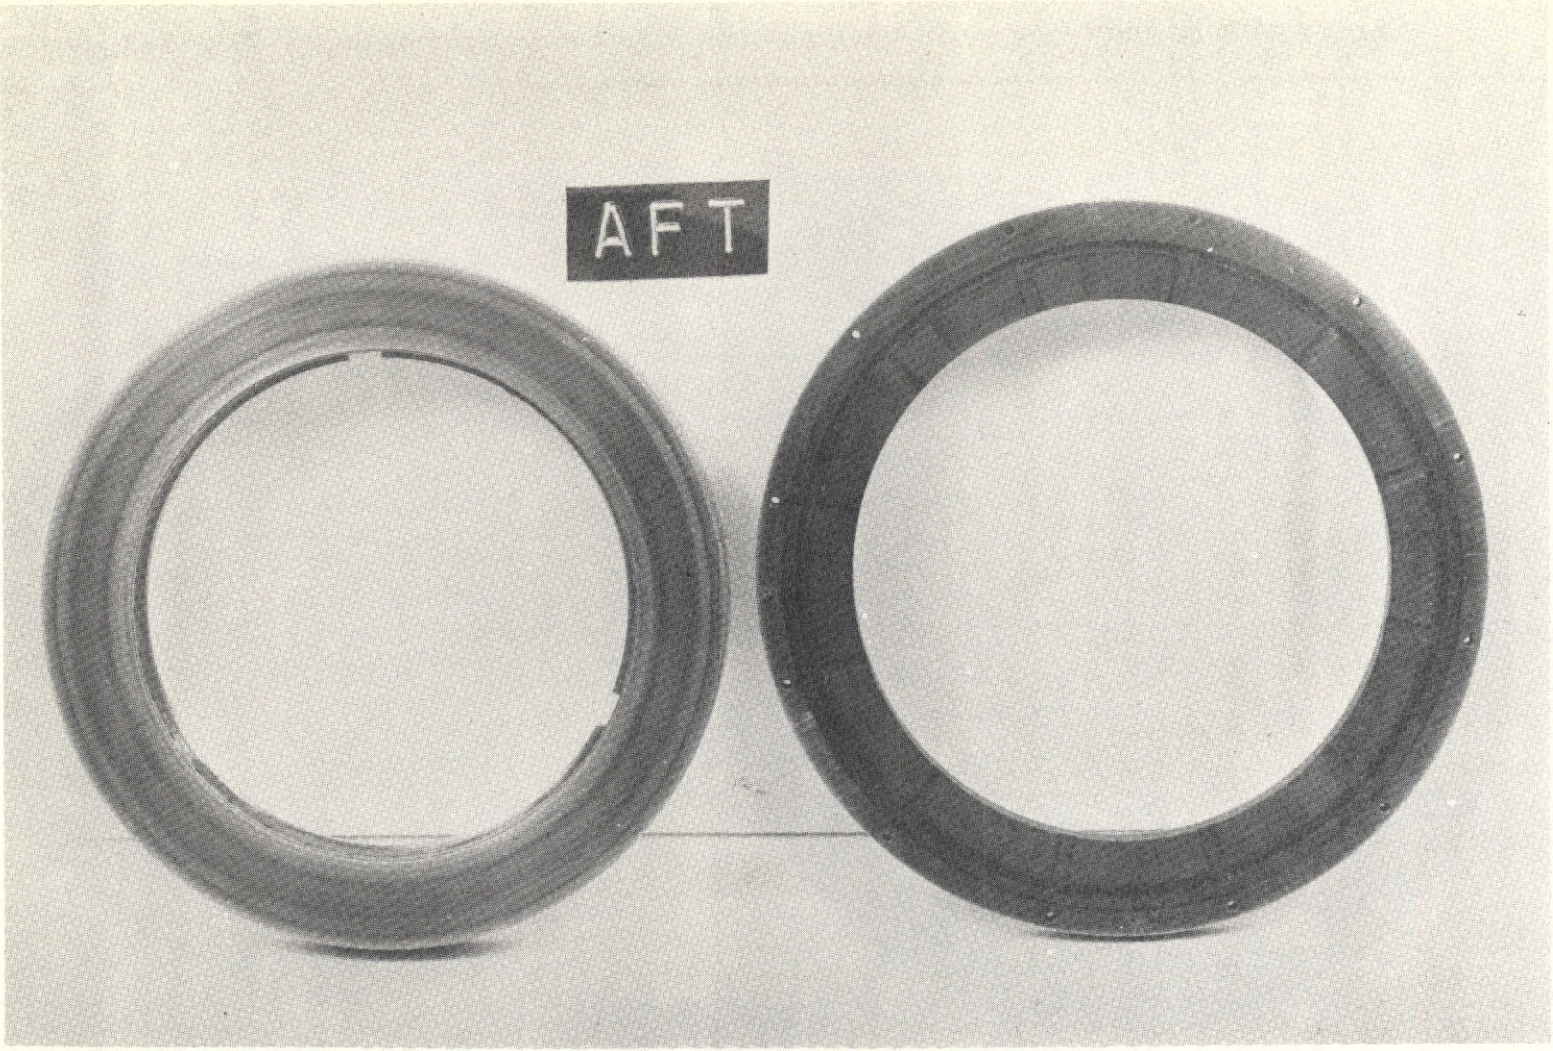
Figure 20. Condition of Aft Carbon and Seat After 500-Hour Endurance Test.

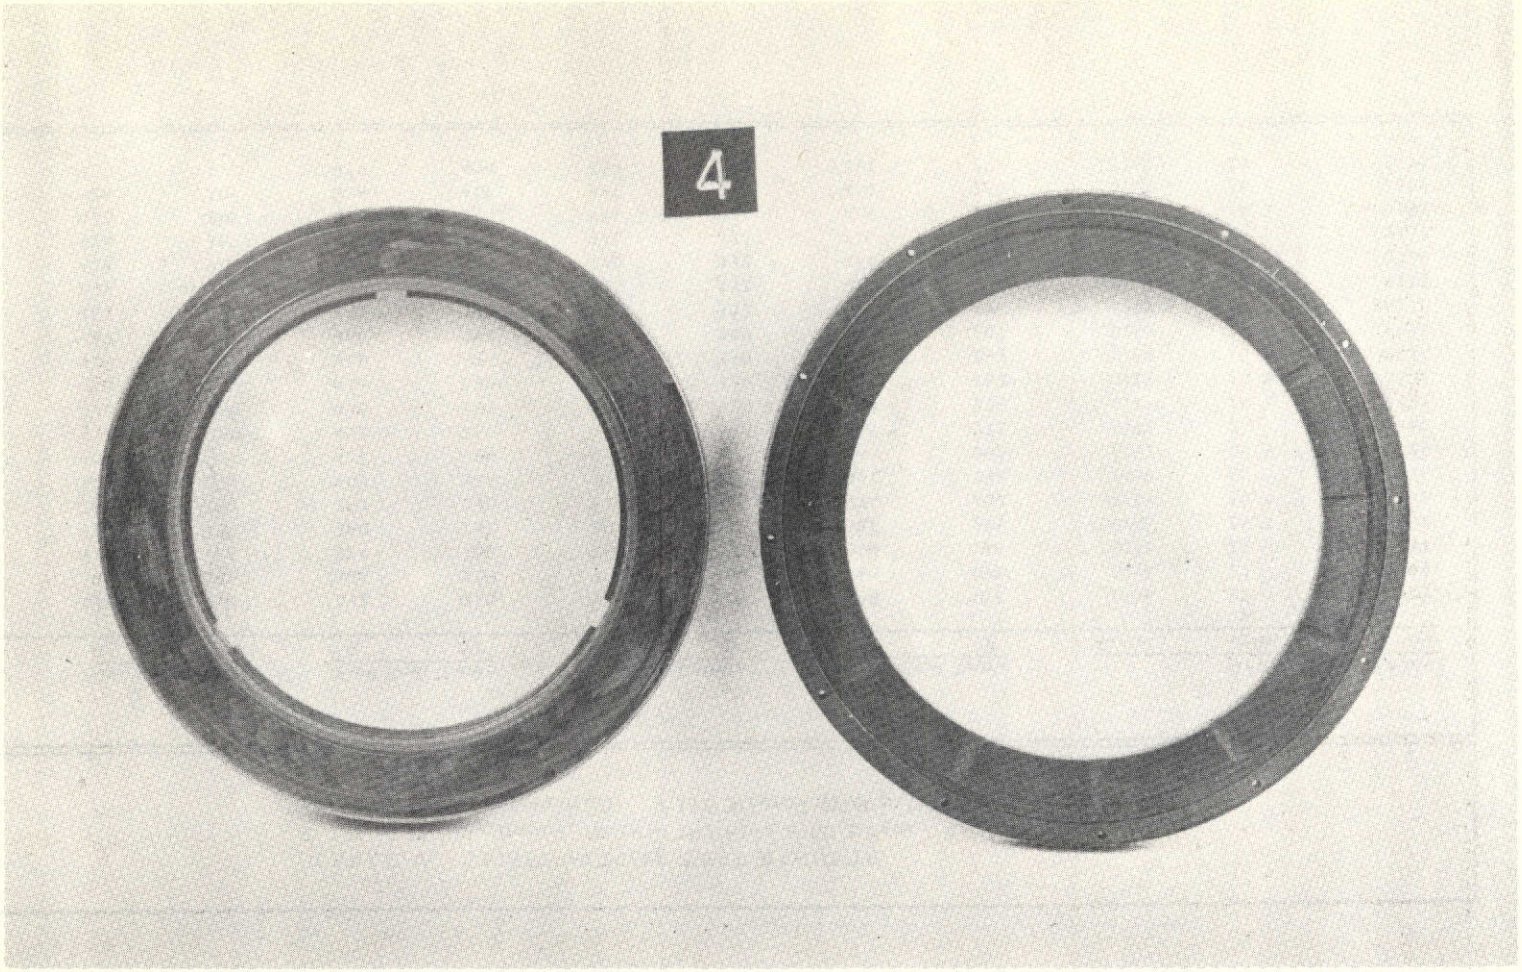
During runs 18 and 19, forward seal temperature and airflow started to fluctuate. The rig was shutdown, and inspection revealed that the forward seal carbon was worn out and the seat burned. Figure 21 illustrates the seal condition.

Airflow was excessive during the run; 0.015 kg/sec (26 scfm, .033 lb/sec). It was determined that significant air leakage was occurring at the bellows seat sealing interface. The bellows lip had worn and was not forming a perfect seal. This leakage is harmful in two ways; hot air is introduced in the bearing cavity, and the high pressure air enters under the seal and impedes the flow of the cooling oil. The seal failure, therefore, was attributed to thermal distortion of the seat caused by the air leakage past the bellows-seat interface.

Figure 21. Condition of Forward Carbon Ring and Seat After the Temperature Test.

The face of the seat closest to the hot ambient air tends to expand faster than the face exposed to the oil side. Interruption of the cooling oil flow increases the differential expansion which rotates the outside diameter of the seat away from the carbon sealing nose, resulting in contact at the inside diameter of the sealing interface. This seat-carbon contact generates additional heat, which causes increasing distortion and increasing severe rubbing contact, with seal failure as the final result.

A redesign of the self-acting face seal is required to overcome difficulties related to thermal distortion of the face plate leading to contact of the sealing surfaces during operation, excessive heat generation, and wear.

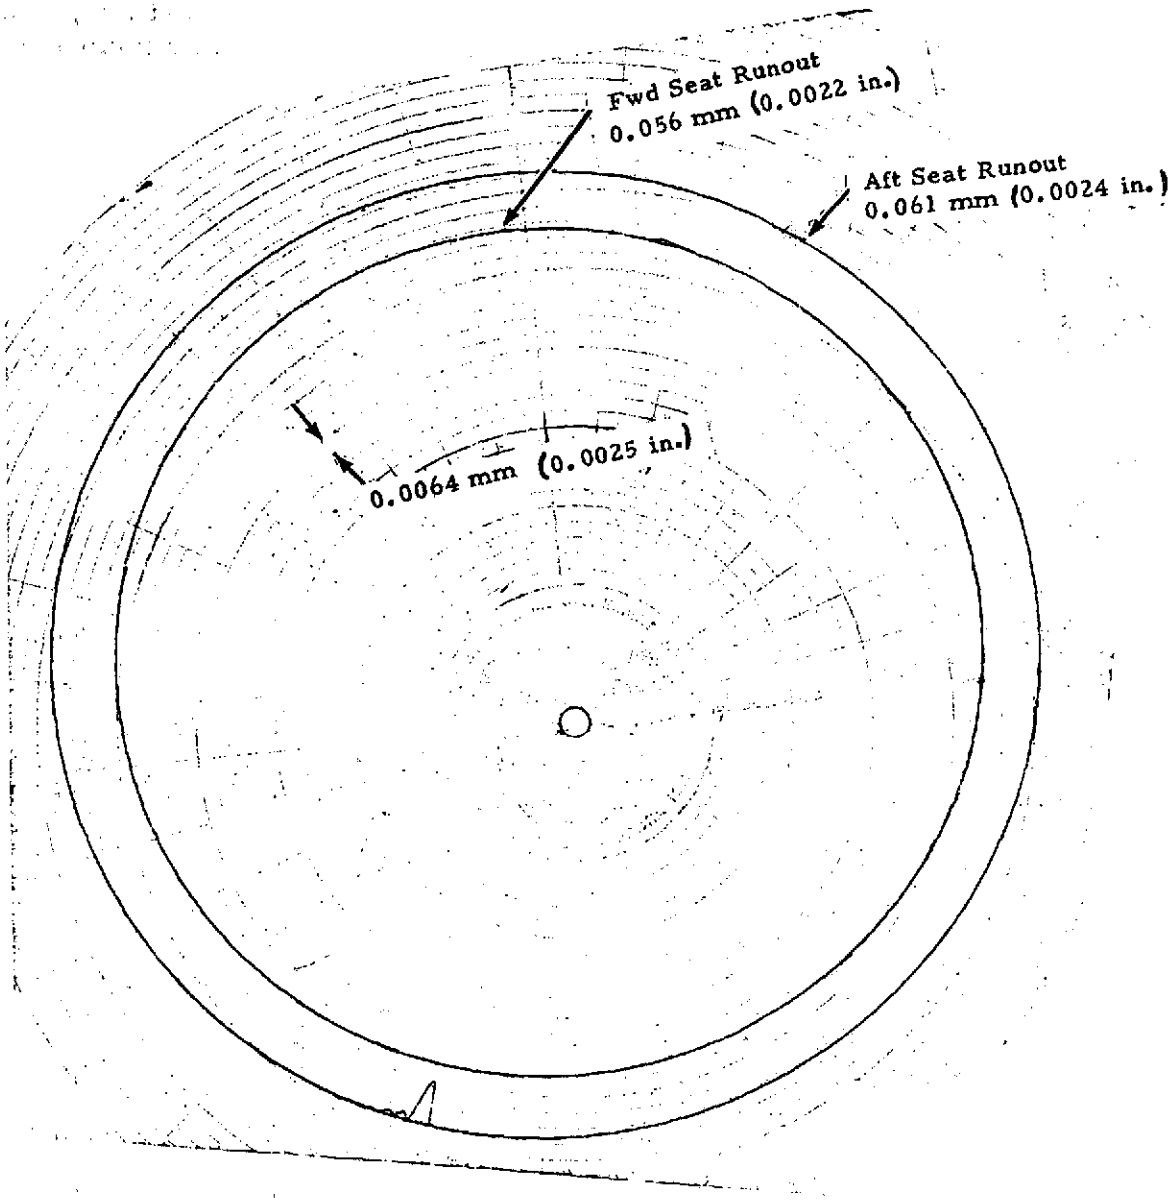
Figure 22. Seat Face Axial Runout in the Free State.

Testing continued with the 0.051 mm (0.002 in.) axial runout seats. When measured in the free state, the runout was 0.051 mm (0.002 in.) on both the forward and aft seat. Figure 22 is an Indiron chart of seat runout in the free state. In the assembled condition, with the seats clamped to the shaft, the axial runout was reduced to 0.033 mm (0.0013 in.) on the forward seat and 0.048 mm (0.0019 in.) on the aft seat.

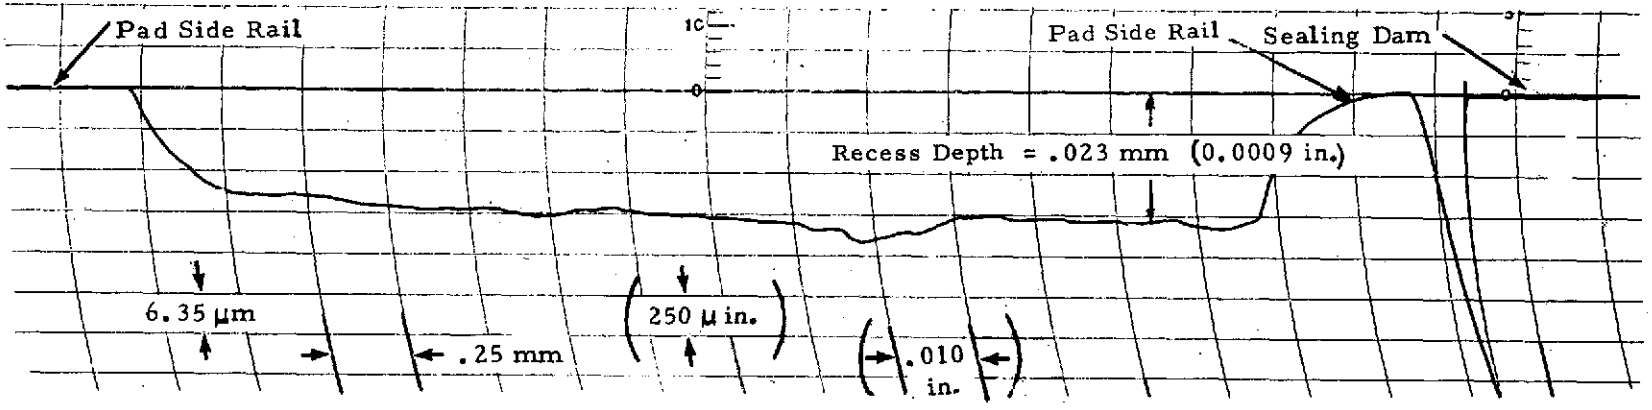
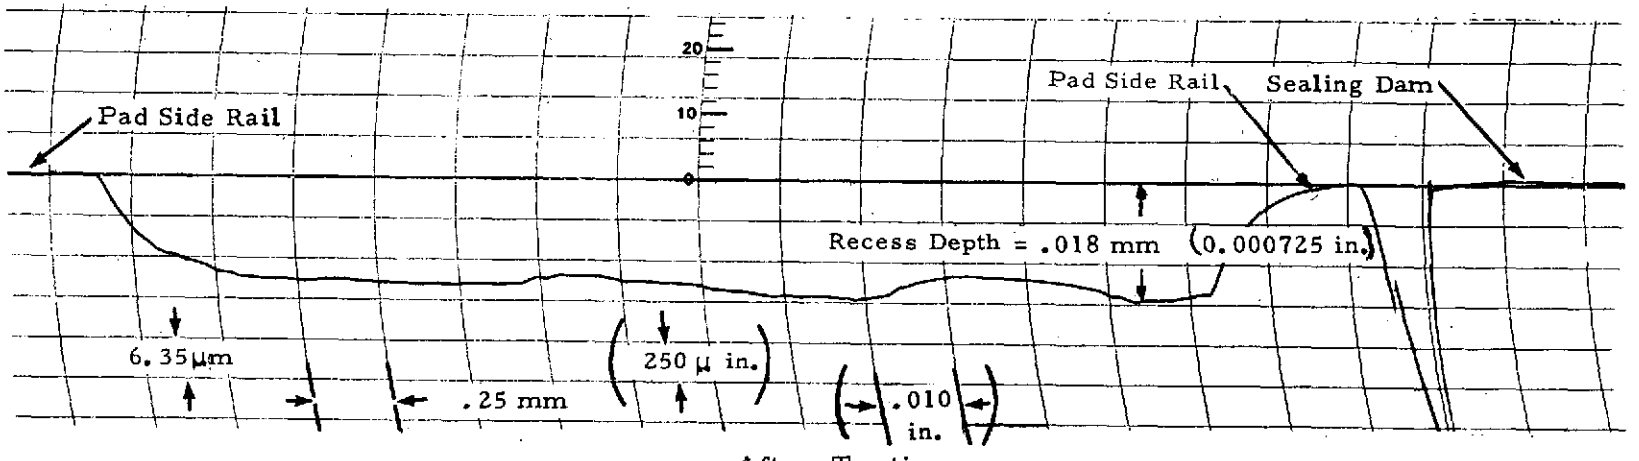
Inspection revealed carbon wear on the order of 0.0025 mm (0.0001 in.) uniformly across the lands and dam. Figure 26 shows a typical trace across a lift pad before and after testing. Figure 27 shows the seal seat scratches after testing. The scratches were extremely shallow. Figures 28 and 29 are traces of the aft seal seat taken through the contact area in a radial direction.

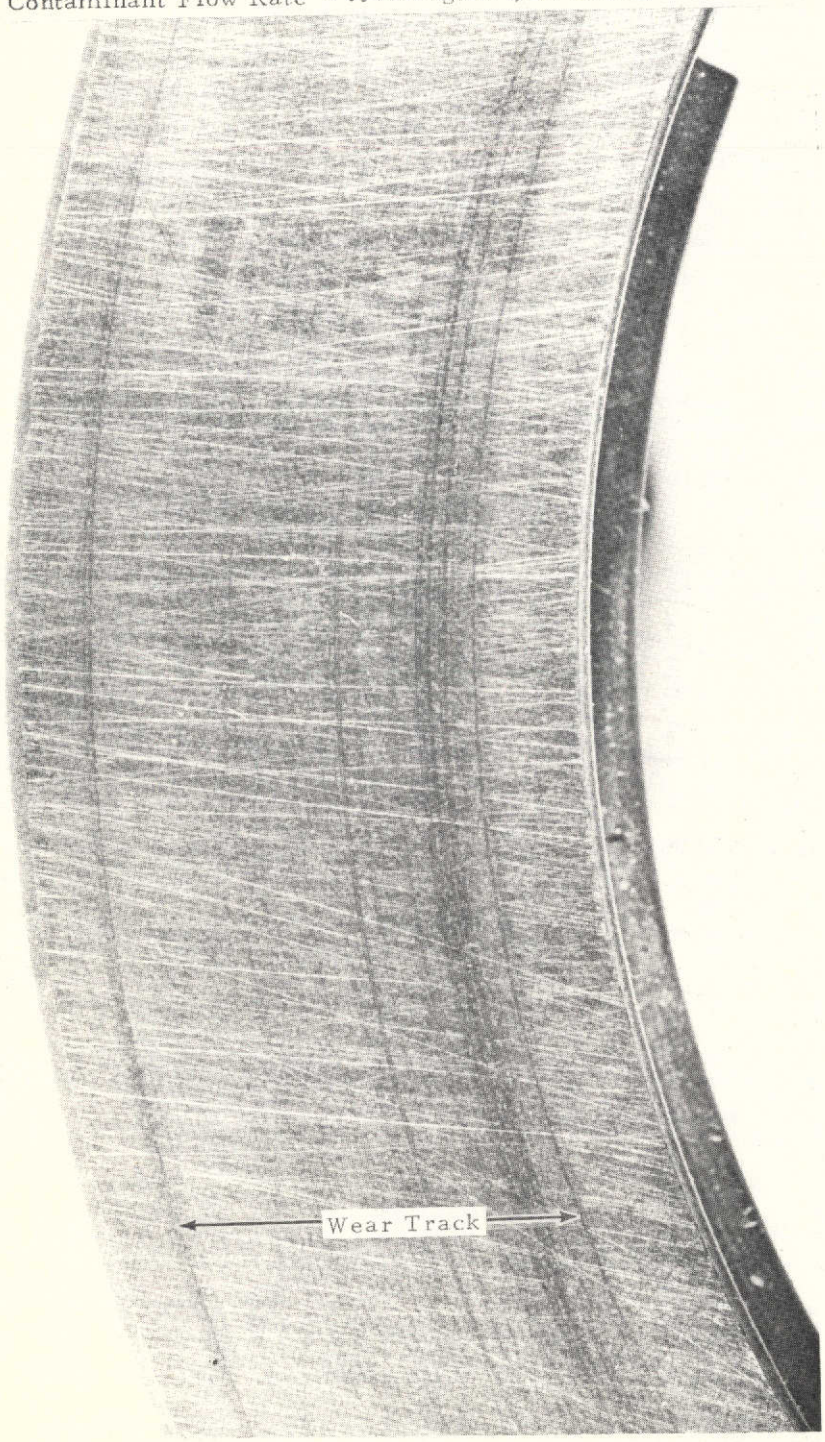
Figure 27. Aft Seal Seat After Sand and Dust Test I.
