CR 134739
LYC 74-55

DEVELOPMENT OF SELF-ACTING SEALS FOR HELICOPTER ENGINES

Peter Lynwander

AVCO LYCOMING DIVISION
550 South Main Street
Stratford, Connecticut 06497

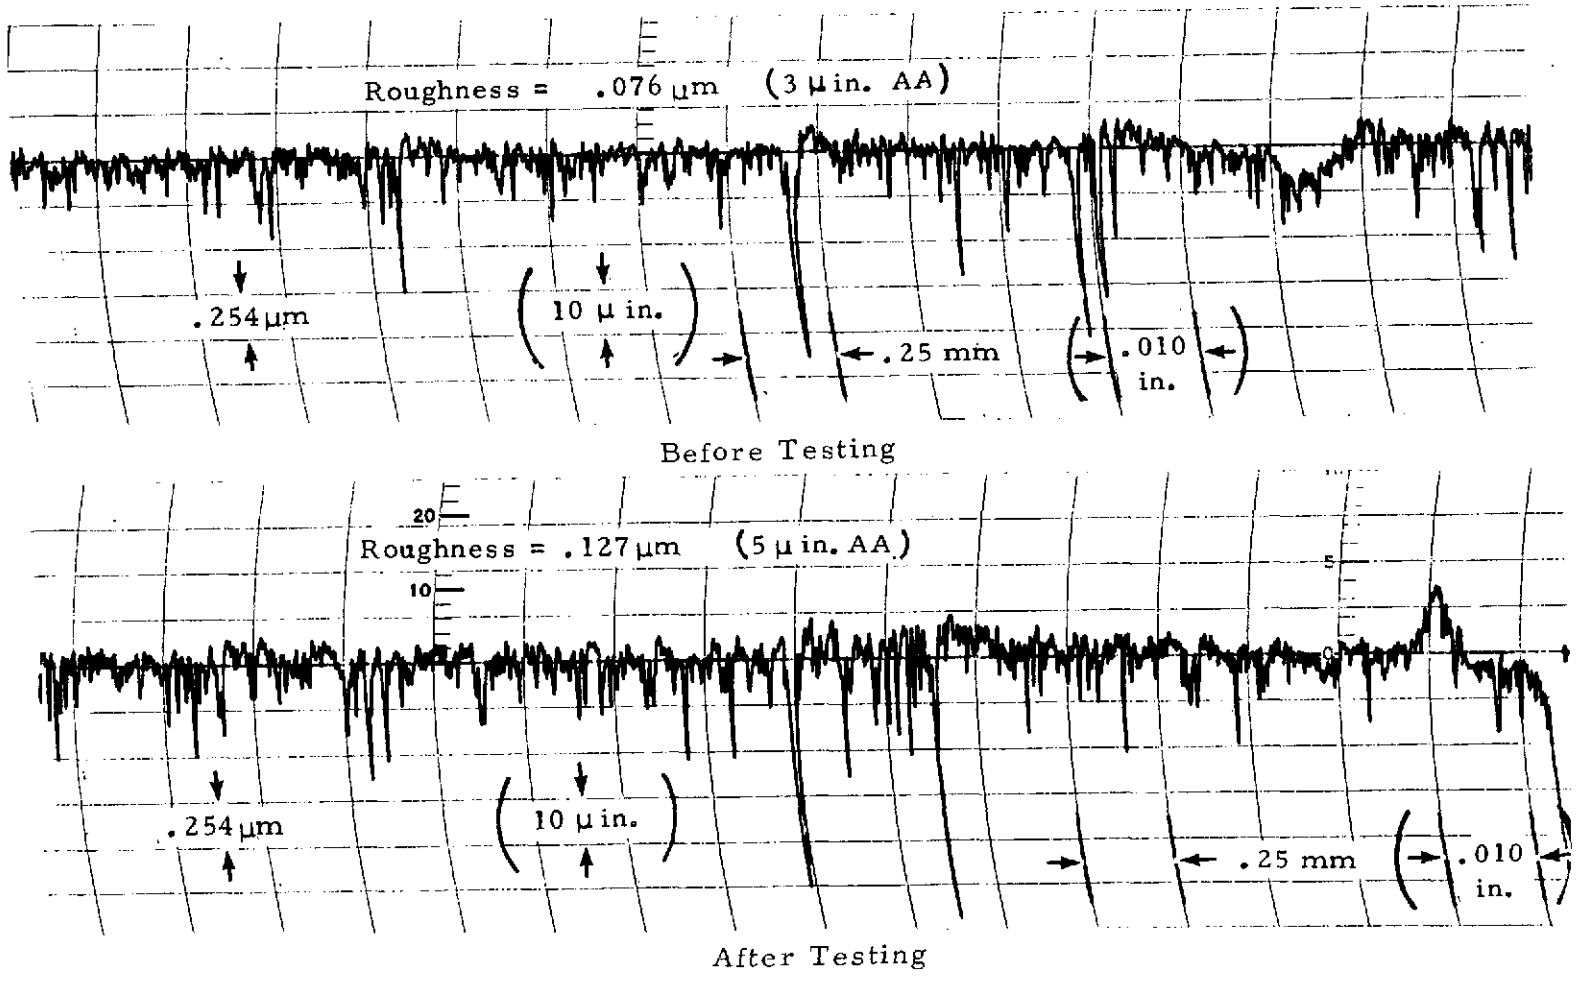
Figure 28. Trace of Aft Seal Seat Roughness Before and After Sand and Dust Test I - Trace Taken in a Radial Direction on the Seat Face Across the Running Track.

Inspection revealed carbon wear on the order of 0.0025 mm (0.0001 in.) uniformly across the lands and dam. Figure 26 shows a typical trace across a lift pad before and after testing. Figure 27 shows the seal seat scratches after testing. The scratches were extremely shallow. Figures 28 and 29 are traces of the aft seal seat taken through the contact area in a radial direction.

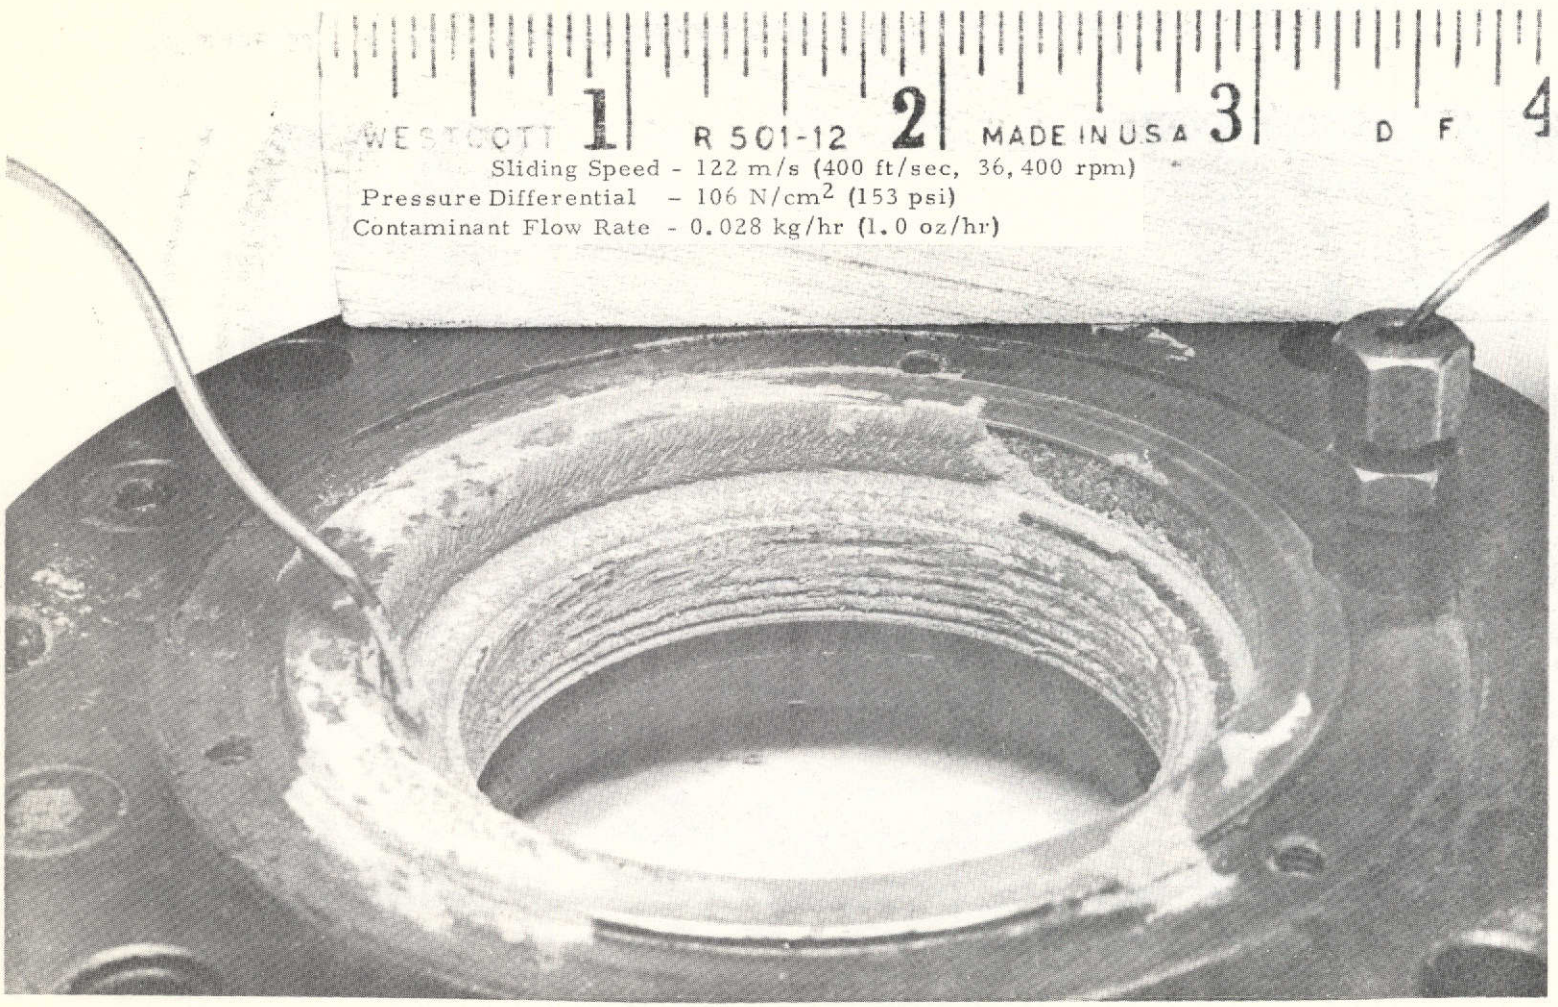
Seal components were in good condition following the test. Average wear on the forward seal carbon was 0.002 mm (0.00009 in.) and 0.001 mm (0.00005 in.) on the aft seal carbon.

Figure 30. Aft Seal After Sand and Dust Test IV Viewed From the Air Side.

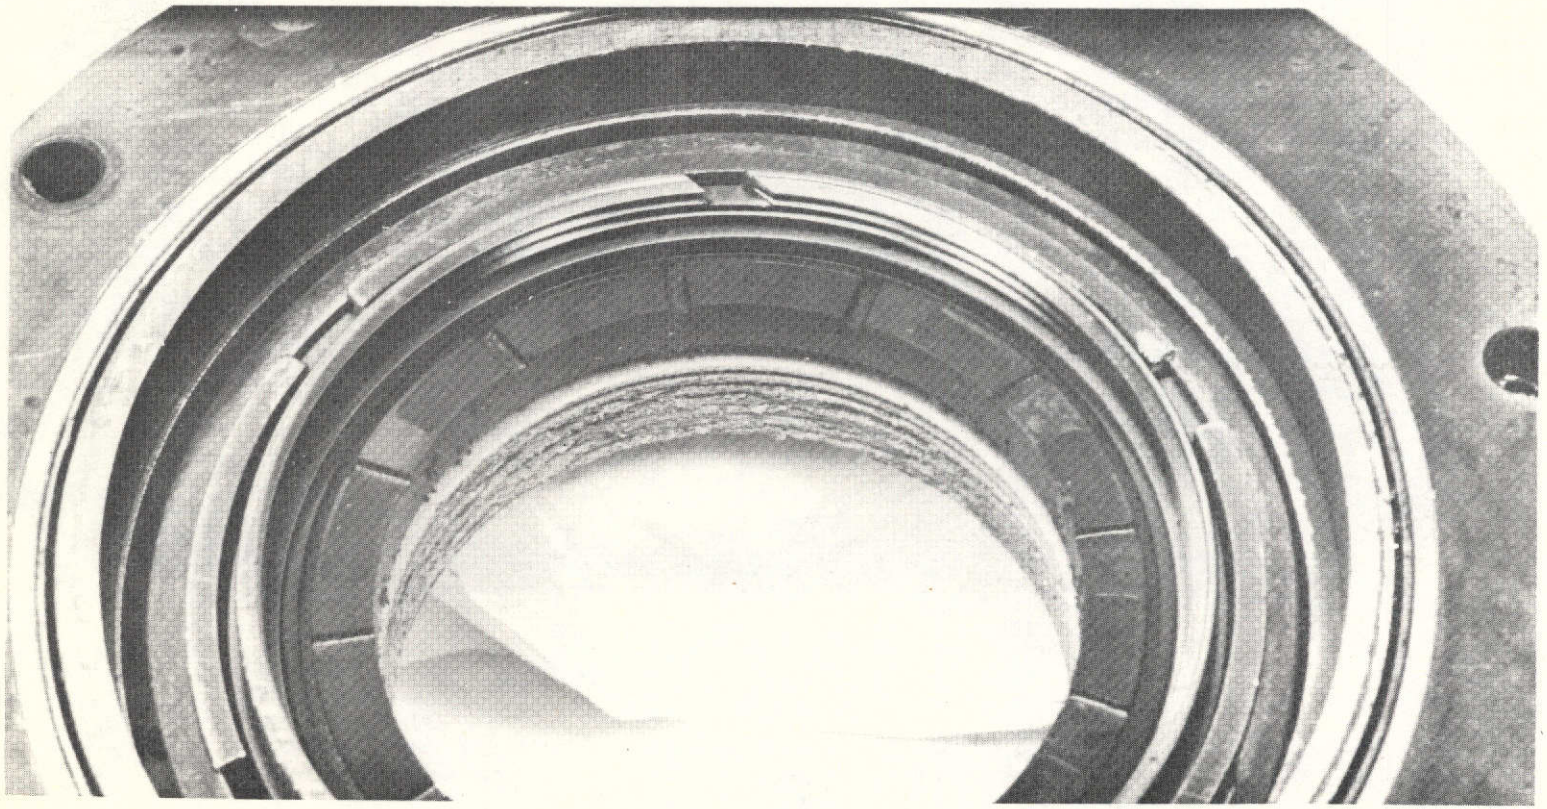
Figure 31. Aft Seal After Sand and Dust Test IV Viewed From the Oil Side.

Figures 30 and 31 show the aft seal and its housing after testing. Figure 32 shows the forward seal and its housing after testing. Figure 33 shows the seal seats and the aft rotating windback after testing.

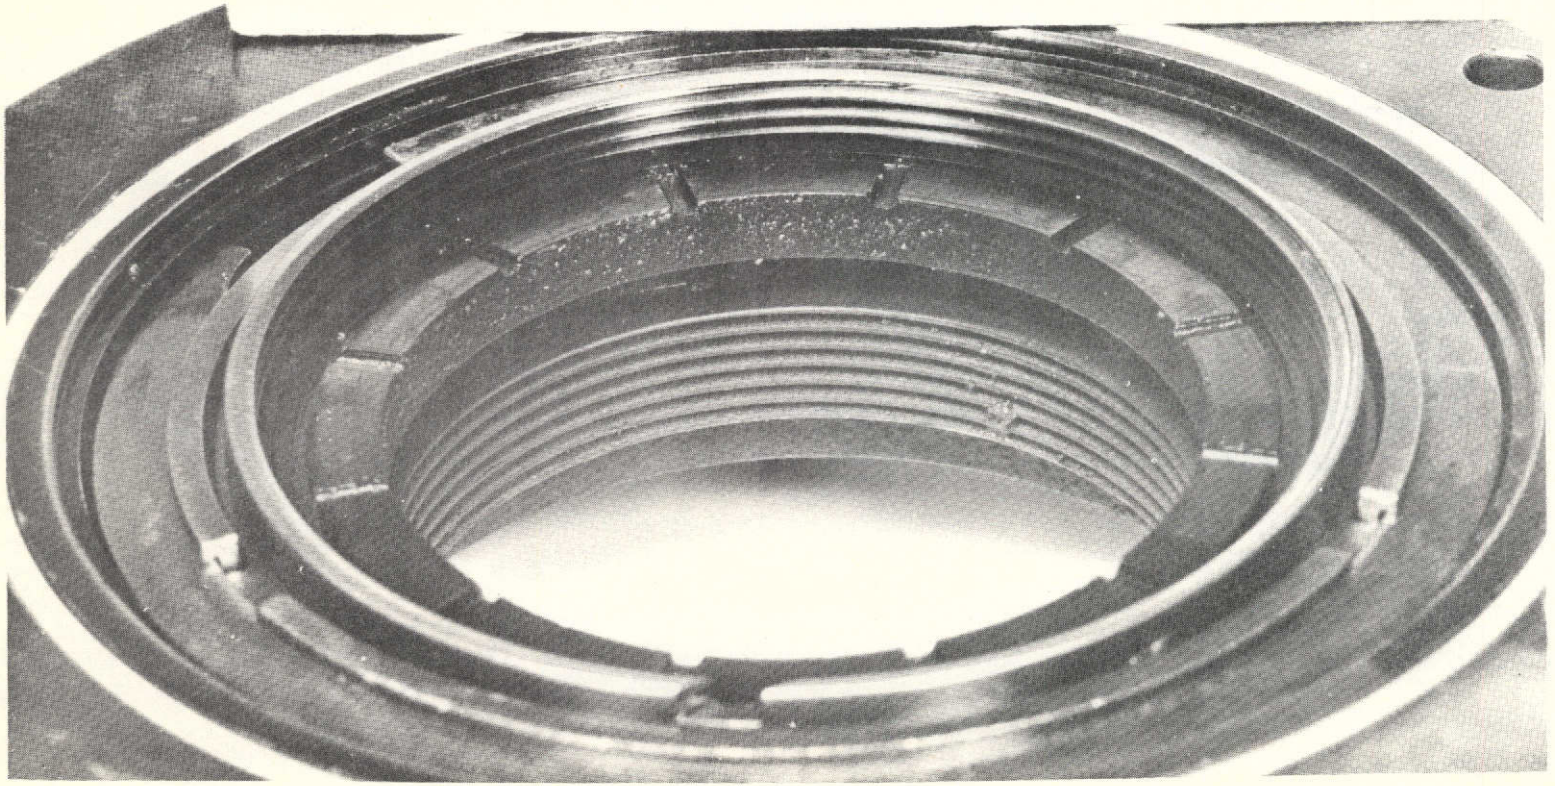
Figure 32. Forward Seal After Sand and Dust Test IV.

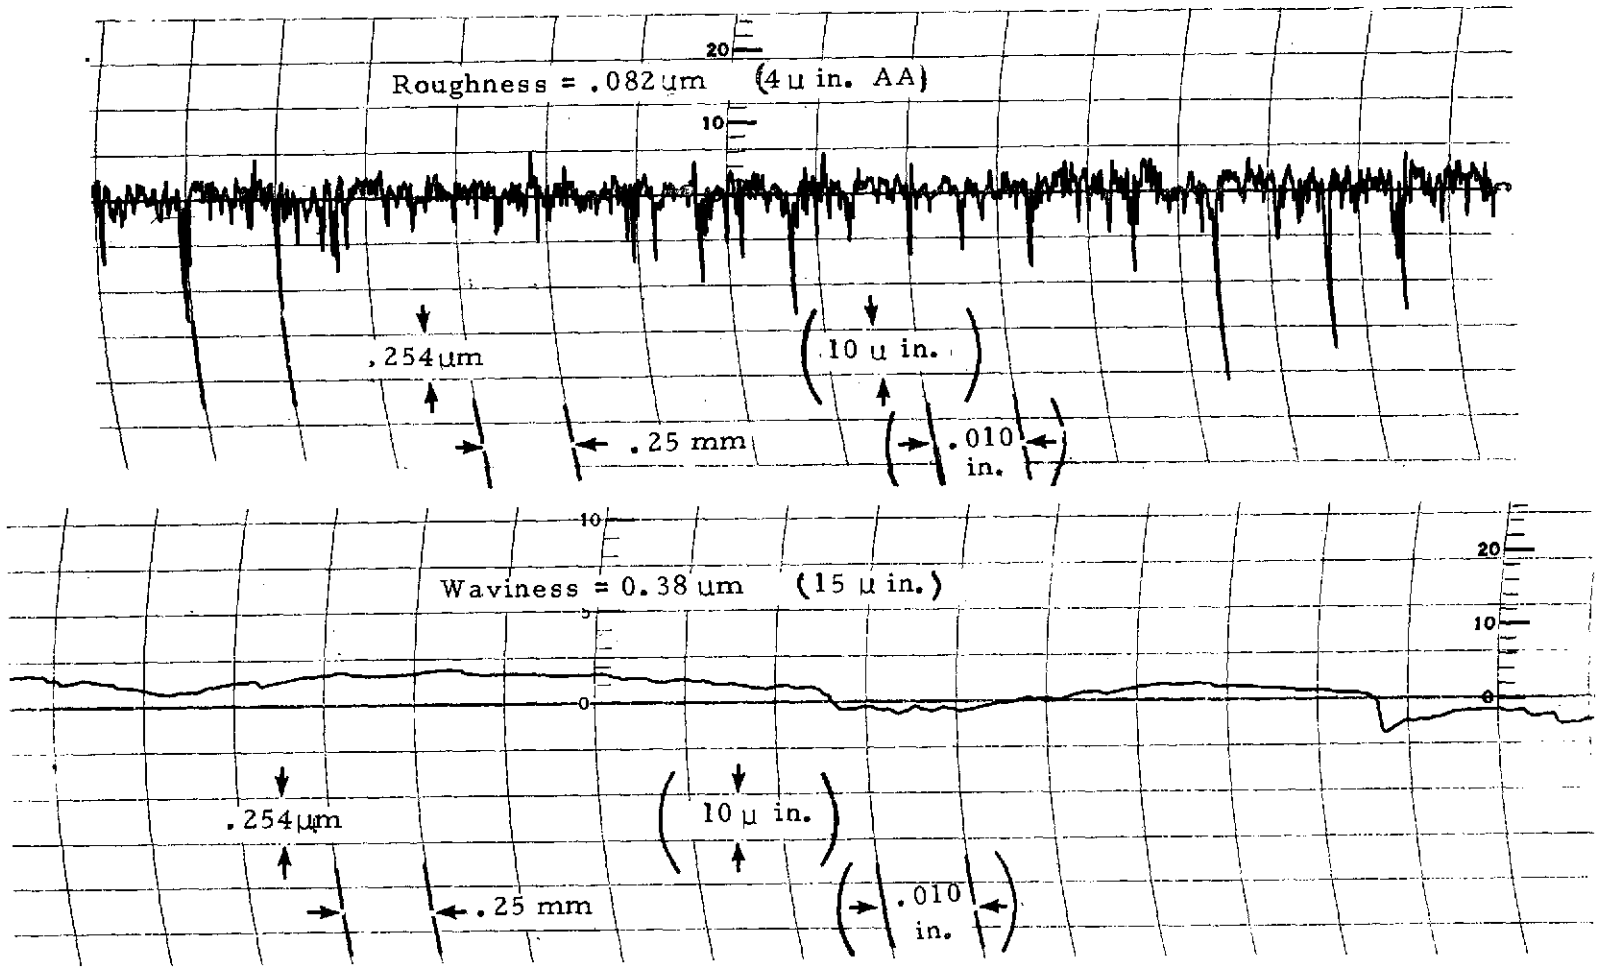
Figure 34. Forward Seal Seat Surface Texture After Sand and Dust Test IV - Taken in a Radial Direction on the Seat Face Across the Running Track.

Figures 34 through 36 show component surface texture following testing.
