NASA TECHNICAL MEMORANDUM

NASA TM X-71675

SOLUTIONS FOR DISCHARGE CHAMBER SPUTTER-
ING AND ANODE DEPOSIT SPALLING IN
SMALL MERCURY ION THRUSTERS

by John L. Power and Donna J. Hiznay
Lewis Research Center
Cleveland, Ohio 44135

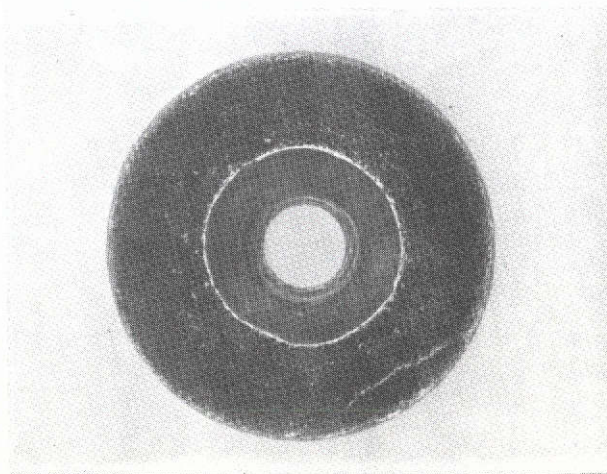
Figure 9. - Downstream surface of baffle, after test. Central area covered by baffle screw head. (Test conducted for 200 hr at $\Delta V_I = 64.6$ V.)

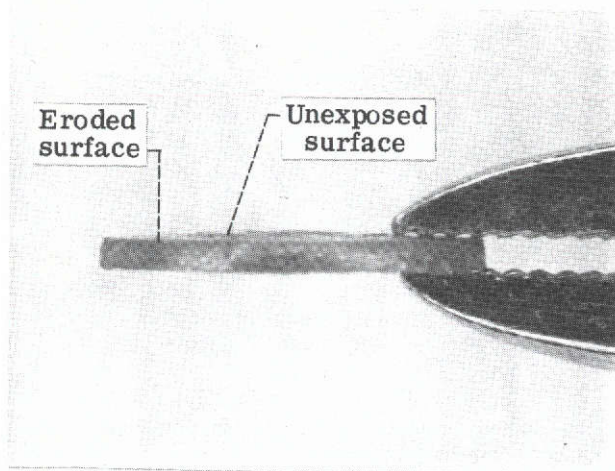
Figure 10. - Edge view of baffle, after test. Downstream surface up.

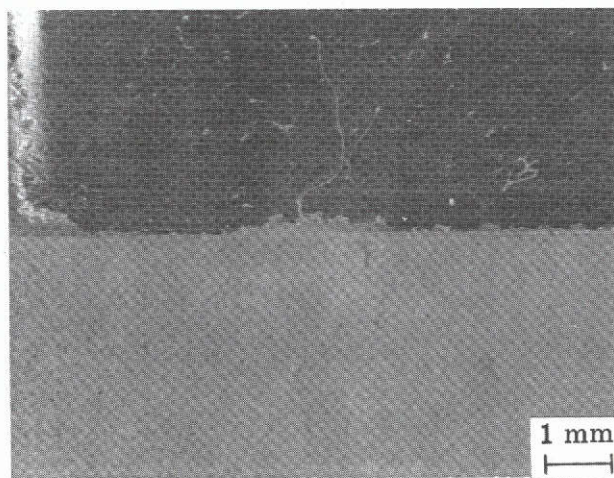
flaws, or spalling, to both of the grit-blasted anode surfaces. The typical appearance of the coating on these surfaces is seen in the lower portion of figure 11, which shows the coated, grit-blasted tantalum surface following the test. Even severely stressing the coated, grit-blasted surfaces by shearing pieces from them caused no cracking or spalling of the coating to occur.

The dominant effect that grit-blasting the substrate surface has on the adhesion of the sputtered anode coating is well illustrated in figure 11. This photograph of the tantalum foil insert following the test shows that the boundary between the completely spalled region of the coating (upper portion of figure) and the completely adhered region (lower portion of figure) almost exactly coincides with the boundary between the smooth and the grit-blasted areas of the insert.

Figure 11. - Portion of tantalum foil anode insert, after test, showing coated grit-blasted surface, at bottom, and smooth surface with coating spalled off, at top.

The accelerated life test demonstrated that the sputtered coating adhesion to the anode could be dramatically improved by grit-blasting the substrate surface. It also showed that a wire cloth anode surface could limit the size of any spalled coating flakes to the cloth mesh dimensions. For these reasons a systematic study was undertaken to optimize the grit-blasting procedure for both solid and wire cloth surfaces. It was expected that the grit-blasted wire cloth surfaces should combine the assets of good sputtered coating adhesion and of mesh dimension-limiting of the size of any spalled coating flakes.

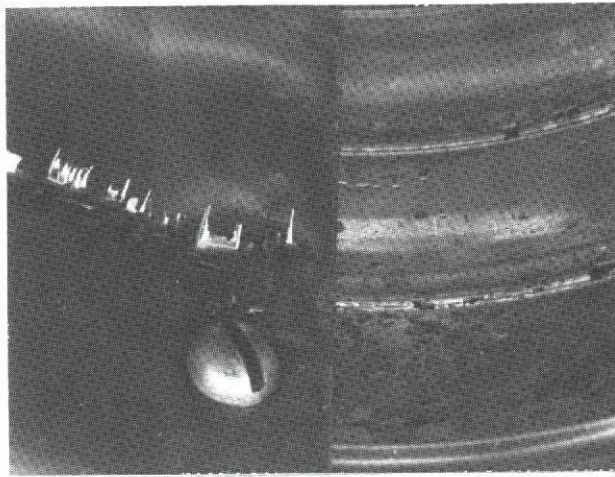
Both the smooth stainless steel and the smooth tantalum anode surfaces, on the other hand, showed extensive spalling of their sputtered coatings following the test. Figure 12 shows portions of both of these surfaces; the spalling and flaking of their coatings is evident. In fact, the sputtered coating on well over half the area of both of these surfaces had spalled off completely when examined after the test, and upon stressing the smooth surface of the tantalum insert by cutting out samples from it, much of the remaining coating separated in large flakes.

Figure 12. - Interior view of anode surface after test. Smooth tantalum foil insert surface at left; smooth stainless steel shell surface at right.

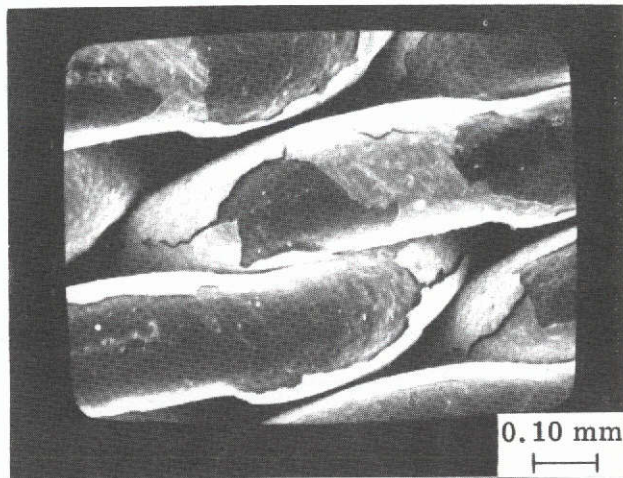
The sputtered coating on the coarse stainless steel wire cloth anode insert initially showed fairly good adhesion following the accelerated life test. However, on microscopic examination many cracks in the coating could be seen along the exposed wire crests. With time and extended exposure to air much of the sputtered coating on the exposed wire surfaces spalled off, leaving coating fragments on the individual wires of the insert which appeared as seen in figure 13 when viewed with a scanning electron microscope. On extensive examination of the spalled coating areas of the wire cloth insert, no evidence could be found of spalled flakes larger than a fraction of the surface mesh opening dimensions ($\sim 0.40 \times 0.50$ mm, measured between adjacent wire center lines). In fact, no cases could be found in which a

continuous coating extended from one wire of the cloth to an adjacent or crossing wire. The results of the accelerated life test indicate that the size of spalled anode coating flakes can be limited (provided the coating is thin compared to the limiting mesh dimensions) by employing a tightly woven wire cloth anode surface of appropriately small mesh size.

Figure 13. - Spalled coating on stainless steel wire cloth anode insert, after test.

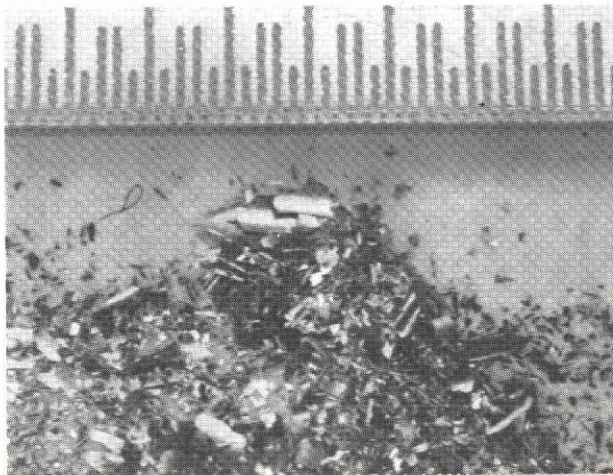
The thruster was horizontally oriented during the accelerated life test, and when it was disassembled afterwards a copious amount of loose coating flakes was found in it, particularly on the anode. A portion of these loose flakes is shown in figure 14. At least most of the flakes clearly were sections of the sputtered coating which had spalled off of the smooth anode surfaces. Though the flakes were of all sizes, many of the larger were over 1.0 mm long, much longer than necessary to short out the grid system or cause other serious problems. Generally smaller loose coating flakes were also found on the interior surface of the anode pole piece insert, as seen in figure 15. These and all the flakes collected were nonmagnetic.

Figure 14. - Portion of loose flakes and material collected from thruster discharge chamber after test. Smallest intervals on ruler each 0.254 mm (0.01 in.).

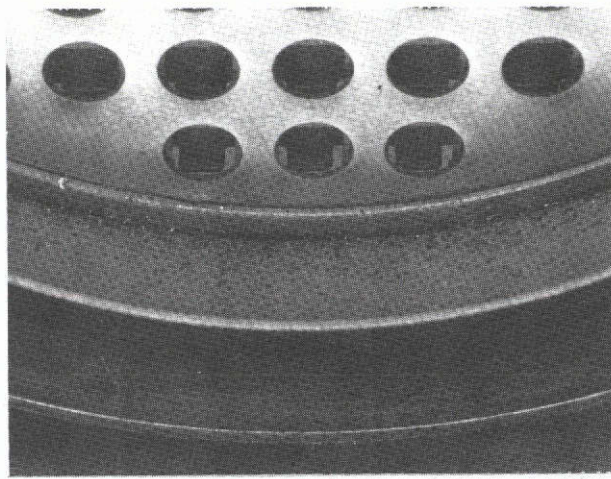
Figure 15. – Loose flakes on interior surface of anode pole piece insert, after test.

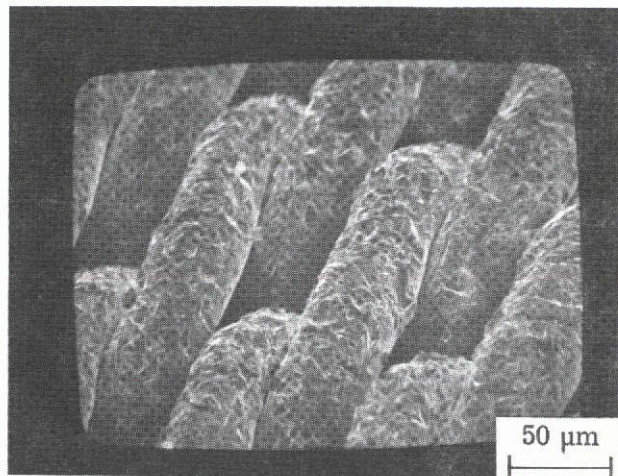
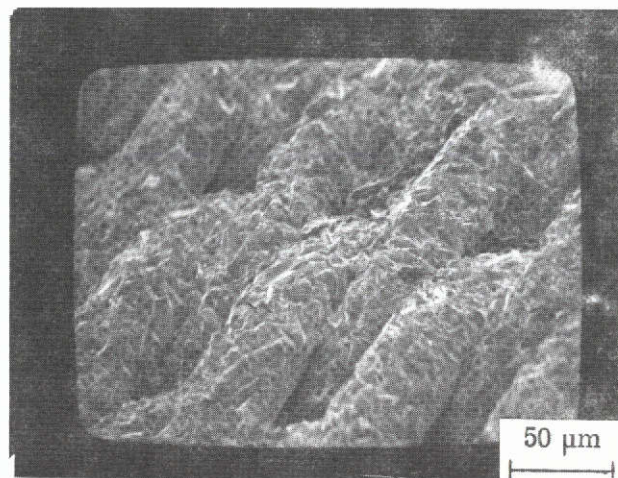
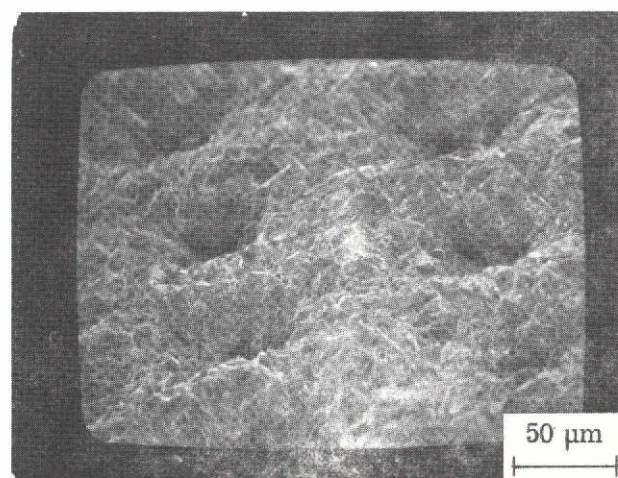
This effect may be seen in figures 23(a), (b), and (c). These are SEM images at ×700 magnification of the fine mesh stainless steel wire cloth grit-blasted at the optimized conditions of table III except that pressures of 14, 28, and 41 N cm^{-2}, respectively, were employed for the three samples. Surface feature saturation on the exposed portions of the wires was evidently just achieved in the low pressure case (fig. 23(a)). The specimen prepared at the intermediate 28 N cm^{-2} pressure (fig. 23(b)) shows surface erosion mildly in excess of a saturated surface feature condition. The specimen shown in figure 23(c),

Several other grit-blasting variables listed in table III had effects comparable to that of the pressure in causing excessive erosion of the fine mesh stainless steel wire cloth. Increasing the grit-blasting time, decreasing the nozzle to specimen distance, decreasing the nozzle orifice size, and increasing the feed rate all led to the same overeroded condition depicted in figure 23(c).

Figure 23. - Fine mesh stainless steel wire cloth, comparatively grit-blasted at different pressures under otherwise optimized conditions. SEM conditions: 700 X, 60° tilt.

Some small degree of grit-blasting of the wire cloth surface beyond surface feature saturation, as in figure 23(b), appears to be advisable to insure that the partially concealed wire surfaces inside the mesh openings are roughened at least to a moderate extent. For the fine mesh wire cloth tested, the wire edge to wire edge spacing of ~45 μm across the surface mesh openings suggests that the ~50 μm diameter abrasive particles can barely, if at all, enter the mesh openings to impinge on the partially concealed wire surfaces. Hence the observed difficulty in roughening these surfaces with the 50 μm abrasive powder is understandable. The other effects associated with excessive grit-blasting of the fine mesh wire cloth surfaces all appear to be undesirable for improving the adhesion of sputtered coatings. These considerations therefore indicate that the optimum grit-blasting

conditions for preparing fine mesh wire cloth surfaces should produce a minimally overeroded surface.

Hence the optimal grit-blasting conditions recommended and specified in table III were chosen to achieve surface feature saturation on the exposed substrate surfaces, produce moderate roughening of the partially concealed wire surfaces of the wire cloths evaluated, and yet avoid more than moderate overerosion of the highly exposed wire surfaces of these wire cloths. The prescription should be applicable to all solid metal surfaces behaving like stainless steel upon grit-blasting and to all stainless steel wire cloths of mesh size greater than or equal to that of the fine mesh cloth tested in this work.

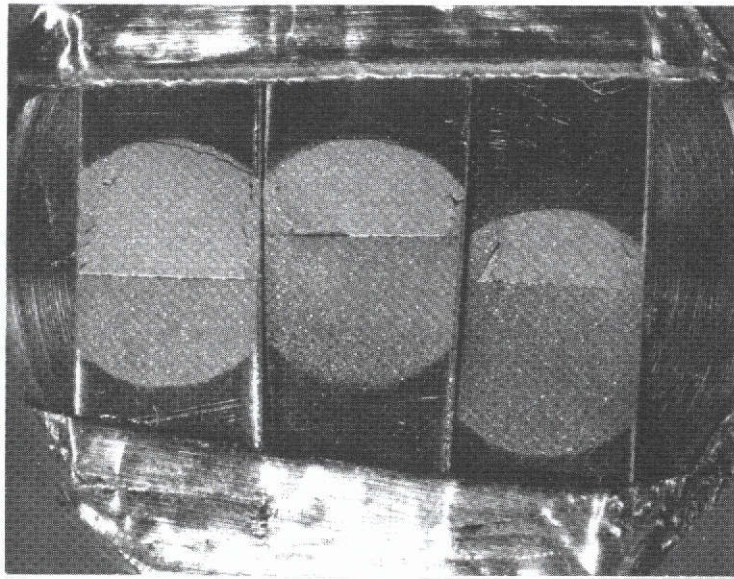
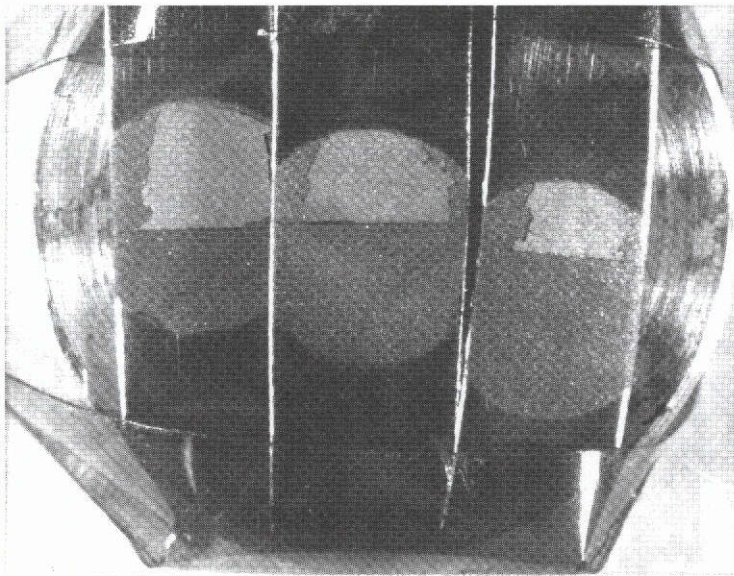
Figure 25. - Solid stainless steel specimens after thick tantalum sputter deposition test. (Equivalent to $\sim 10^5$ hr small thruster operation.) Areas grit-blasted at 14 (left), 28 (center), and 55 (right) $N\ cm^{-2}$ pressure.

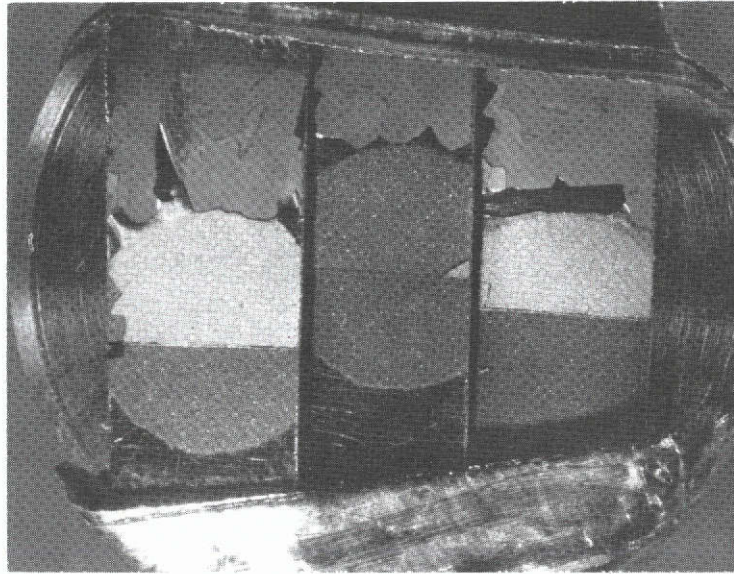
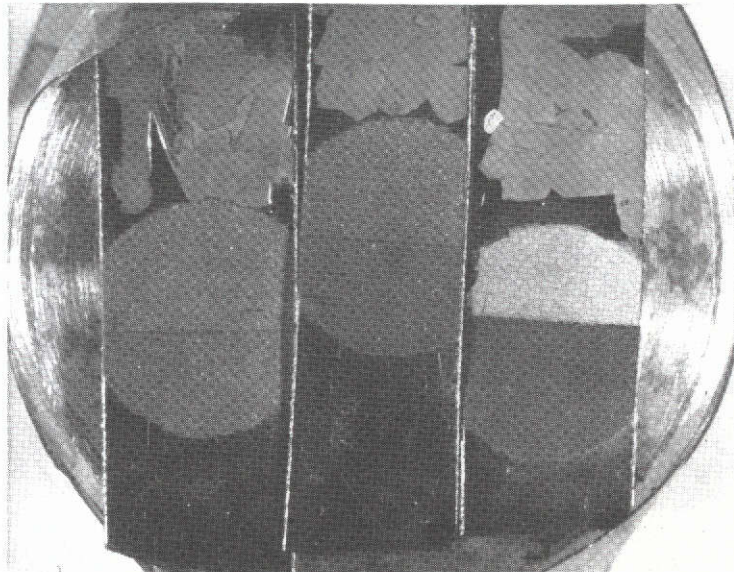
Figure 26. - Solid tantalum specimens after thick tantal-
um sputter deposition test. Areas grit-blasted at 14
(left), 28 (center), and 55 (right) N cm^{-2} pressure.

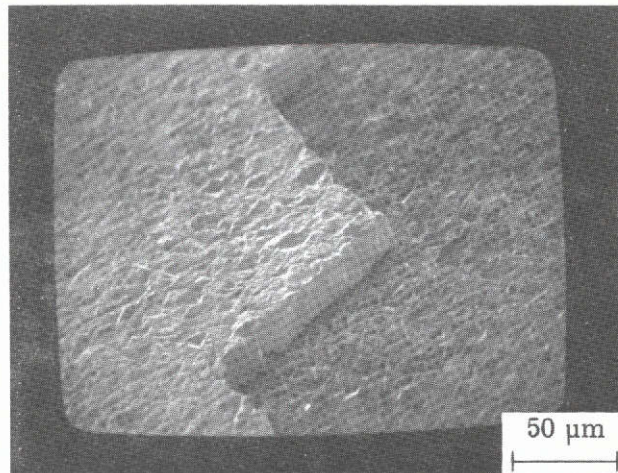
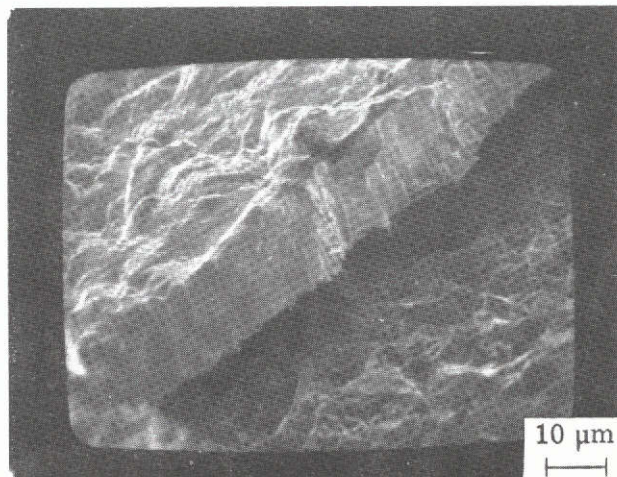
Figure 27. - Broken edges of thick sputtered
tantalum coating on grit-blasted solid stain-
less steel specimens, showing replication of
grit-blasting features in coating surface.

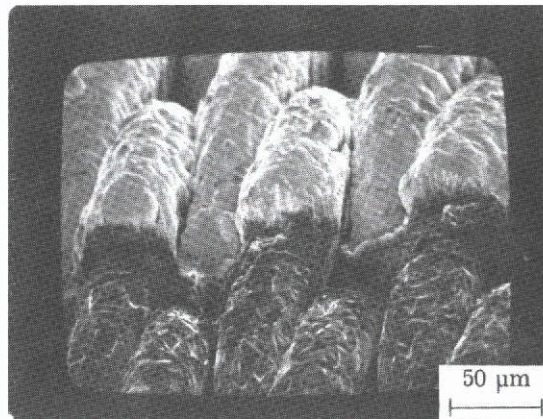
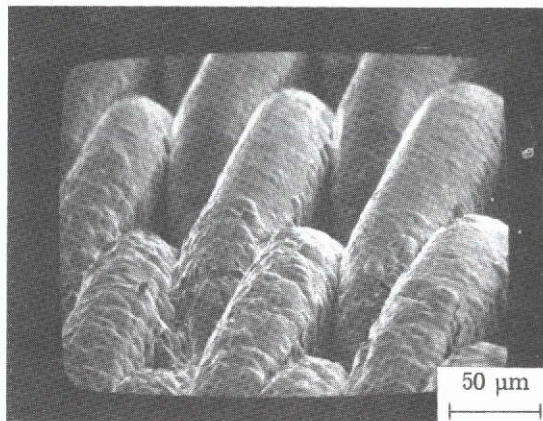
Several types of nonuniform deposits were noted with the SEM
on coated sections of the test samples from the sputter deposition
test. Among these, nodular deposits found on the nongrit-blasted
areas of the fine mesh wire cloth samples were concentrated on the
steeply inclined, partially shielded sides of the wires deep within the
mesh openings. These deposits somewhat resembled the similarly
located deposits seen in figures 28(b) and 30(b).

Figure 28. - Thick sputtered tantalum coating on fine mesh stainless steel wire cloth grit-blasted at 14 N cm^{-2}, showing replication of grit-blasting features in coating surface. SEM conditions: 700 X, 60° tilt.

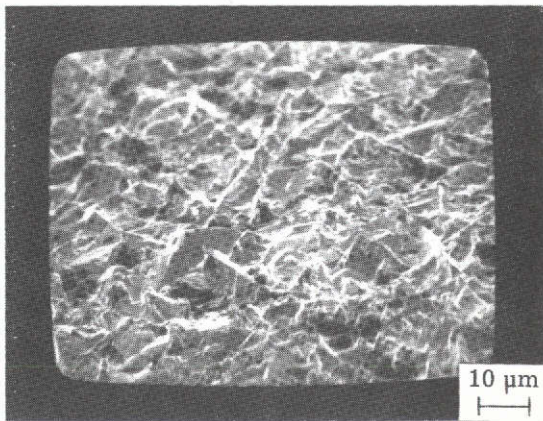
Figure 29. - Under surface of thick sputtered tantalum coating flake spalled from solid tantalum specimen grit-blasted at 14 N cm^{-2}. SEM conditions: 2000 X, 60° tilt.

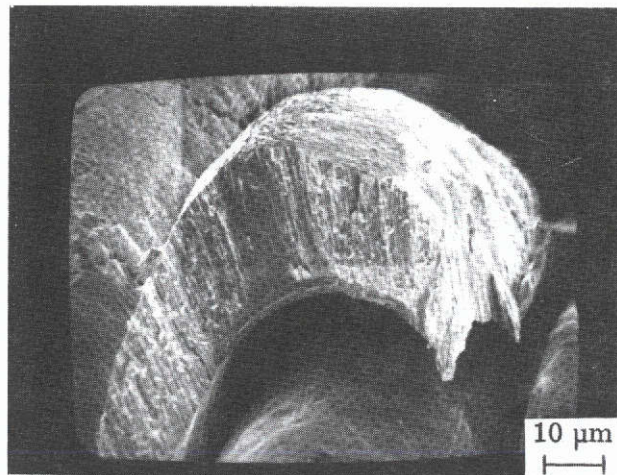
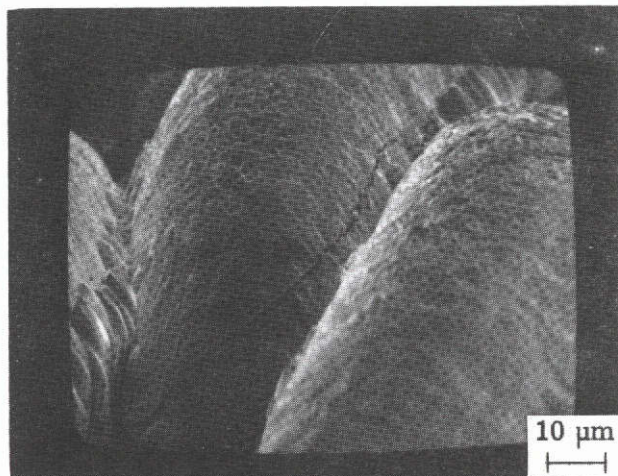
Figure 30. - Thick sputtered tantalum coating
on non-grit-blasted areas of fine mesh stain-
less steel wire cloth. SEM conditions:
2000 X, 60° tilt.

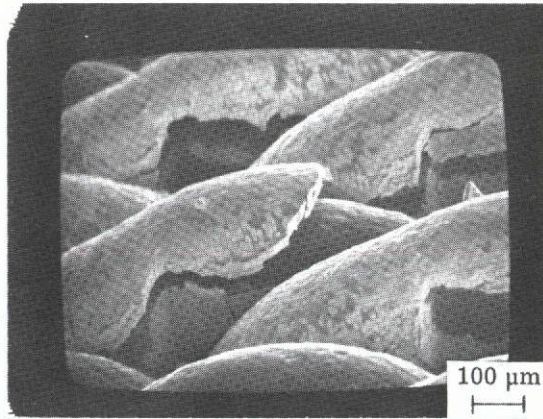
Figure 31. - Thick sputtered tantalum coat-
ing spalled from non-grit-blasted area of
coarse mesh stainless steel wire cloth.
SEM conditions: 200 X, 60° tilt.

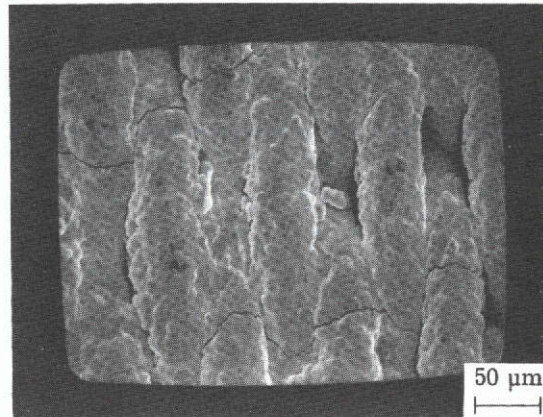
Figure 32. - Cracks in thick sputtered tan-
talum coating on fine mesh stainless
steel wire cloth grit-blasted at 28 N cm^{-2},
after mechanical stressing. SEM condi-
tions: 500 X, 0° tilt.

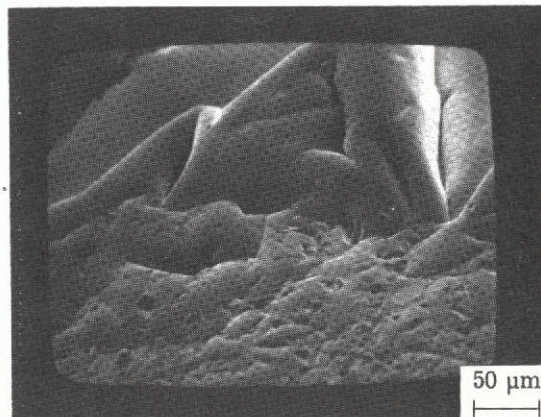
Figure 33. - Thin sputtered tantalum coat-
ing (equivalent to coating from ~10^4 hr
small thruster operation) on solid tan-
talum specimen grit-blasted at 28 N
cm^{-2}, showing coated area across bound-
ary between grit-blasted region (fore-
ground) and non-grit-blasted region
(background). Note spalling of coating
to boundary. SEM conditions: 500 X,
60° tilt.

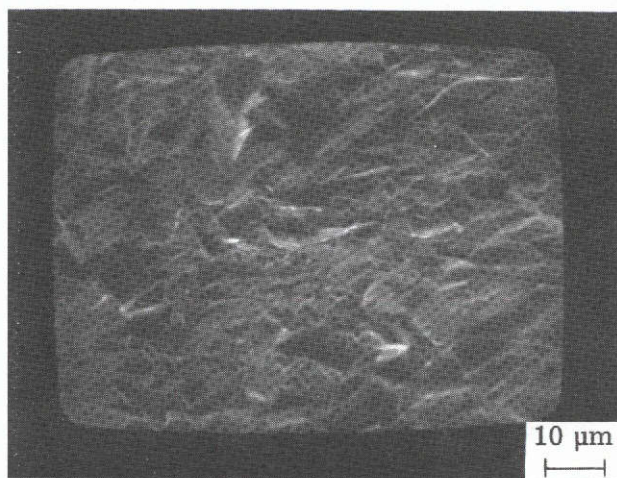
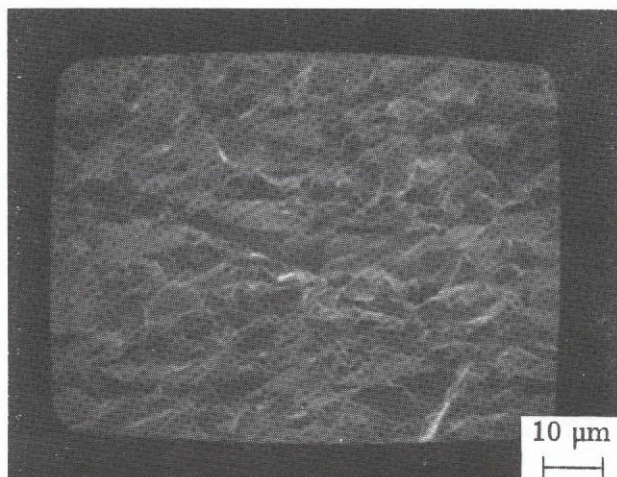
Figure 34. - Solid stainless steel specimen
grit-blasted at 28 N cm^{-2} for thin tantalum
sputter deposition test. SEM conditions:
2000 X, 60° tilt.

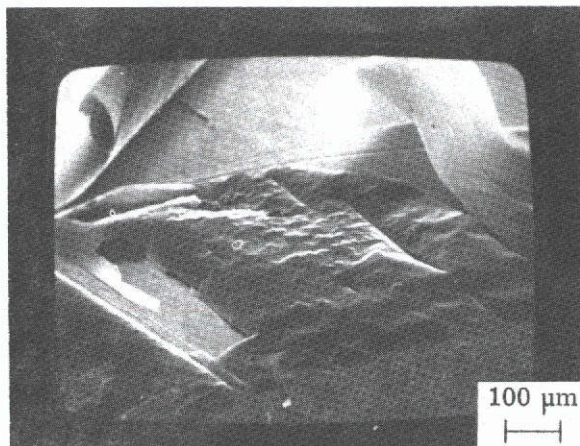
Figure 36. - Sputtered graphite coating on
solid stainless steel specimen grit-
blasted at 14 N cm^{-2}. (Equivalent to
coating from ~10^4 hr small thruster op-
eration.) Note spalling from non-grit-
blasted region to boundary of grit-
blasted region (lower right). SEM con-
ditions: 200 X, 60^0 tilt.

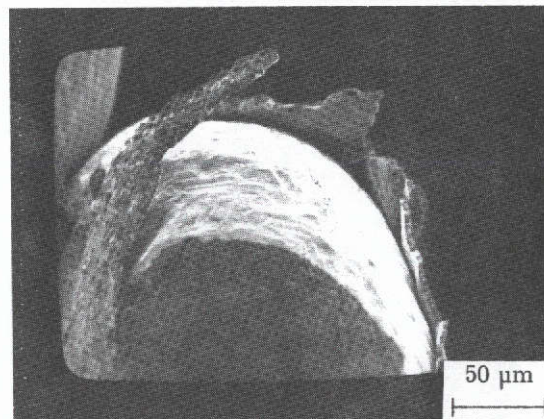
Figure 39. – Sputtered composite coating spalling from non-grit-blasted region of coarse stainless steel wire cloth specimen. (Equivalent to coating from ∼10^4 hr small thruster operation.) SEM conditions: 700 X, 60° tilt.

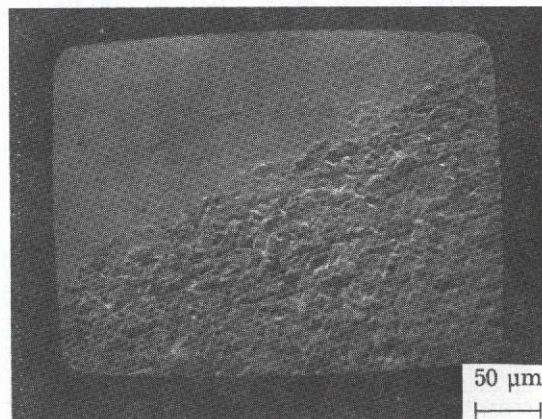
Under SEM examination, the top surface of the sputtered coatings
on the grit-blasted test sample surfaces showed good replication and
propagation of the original substrate surface features and appearance.
Typical is the SEM view in figure 40, showing at ×500 magnification
a coated boundary region between the grit-blasted and the nongrit-
blasted regions on the solid stainless steel specimen grit-blasted at
28 N cm^{-2}. On close examination under the SEM, the coating sur-
face on the grit-blasted regions generally showed evidence of slight
rounding and filling in of the original surface features and contours.
This effect, however, did not threaten to erase the original roughness
of the grit-blasted surface until a deposited coating at least several
times as thick as that actually observed in the test was built up.

Figure 40. – Sputtered composite coating on solid stainless steel specimen grit-blasted at 28 N cm^{-2}, showing coated area across boundary between grit-blasted region (foreground) and non-grit-blasted region (background). SEM conditions: 500 X, 60° tilt.

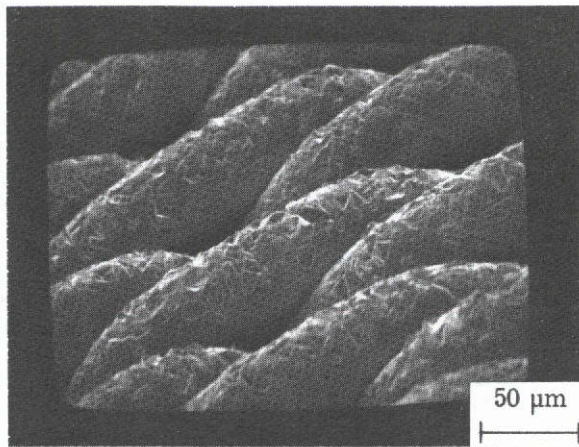
Figure 41. - Anomalous sputtered material deposits on fine mesh stainless steel wire cloth grit-blasted at 14 N cm^{-2} in composite target sputter deposition test. SEM conditions: 700 X, 60° tilt.

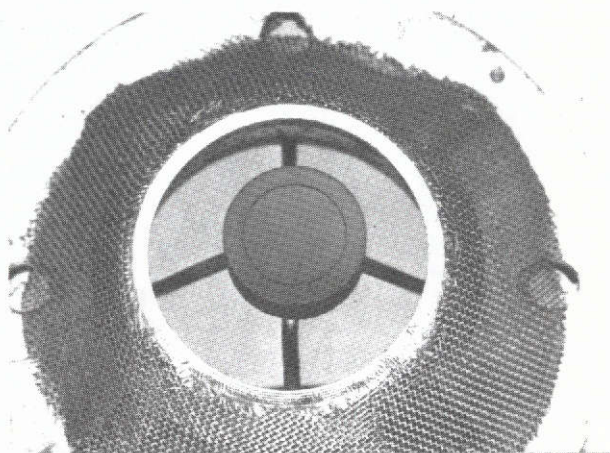
The baffle assembly used in the 400 hour test is shown before the test in figure 42, as mounted on the cathode pole piece. It consisted of a base piece and a mating, flush, top surface insert. Both parts were machined from anisotropic pyrolytic graphite oriented with the graphite atomic planes parallel to the flat surfaces of the structure. The baffle assembly was designed so that no material other than

which was employed in the 400 hour SIT-5 thruster test described in the previous section. After 1156 hours of thruster operation in the cycling life test the baffle assembly delaminated and split into two pieces, apparently for the reasons suggested earlier. It was therefore replaced with a thin baffle, identical to that shown in figure 43, made of isotropic, high purity (nonpyrolytic) graphite. The thin baffle, 6.35 mm in diameter by 0.63 mm thick, was mounted with a thin head tantalum screw in a manner similar to that shown in the figure.

Figure 42. - Thick (2.8 mm) pyrolytic graphite baffle assembly mounted on cathode pole piece, before 400 hr test.

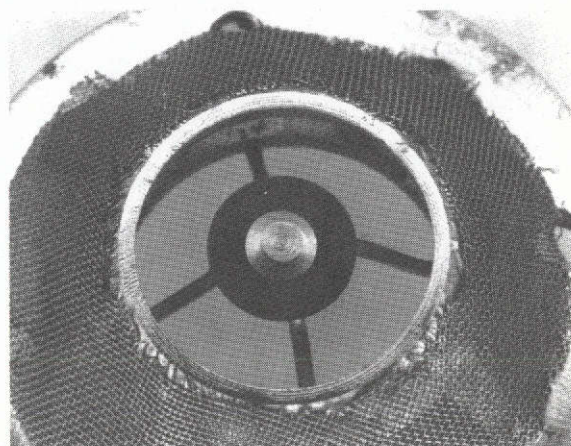
decided that a thin baffle employing an isotropic form of graphite was preferable. Such a revised baffle is shown in figure 43, as mounted on the SIT-5 cathode pole piece with a thin head tantalum screw. The dimensions of this baffle (6.35 mm diam by 0.63 mm thick), as well as the details of its mounting to the cathode pole piece, are essentially identical to those of the tantalum baffle employed in the accelerated life test (see fig. 1). The baffle was fabricated of a high purity isotropic grade of graphite having an apparent density of ~ 1.75 g cm^{-3}. (For comparison, the density of pyrolytic graphite approaches the 2.20 g cm^{-3} theoretical limit of graphite.) Five and 8 cm thrusters incorporating the thin design, isotropic graphite baffle, mounted as indicated in figure 1, have demonstrated satisfactory performance with no known baffle structural problems.

Figure 43. - Thin (0.63 mm) isotropic graphite baffle mounted on cathode pole piece with tantalum mounting screw. Similar to configuration used in cycling life test.
