FINAL REPORT

EFFECT OF POLYMER PROPERTIES AND ADHEREND SURFACES ON ADHESION

National Aeronautics
and
Space Administration
December, 1975
NASA GRANT NSG-1124

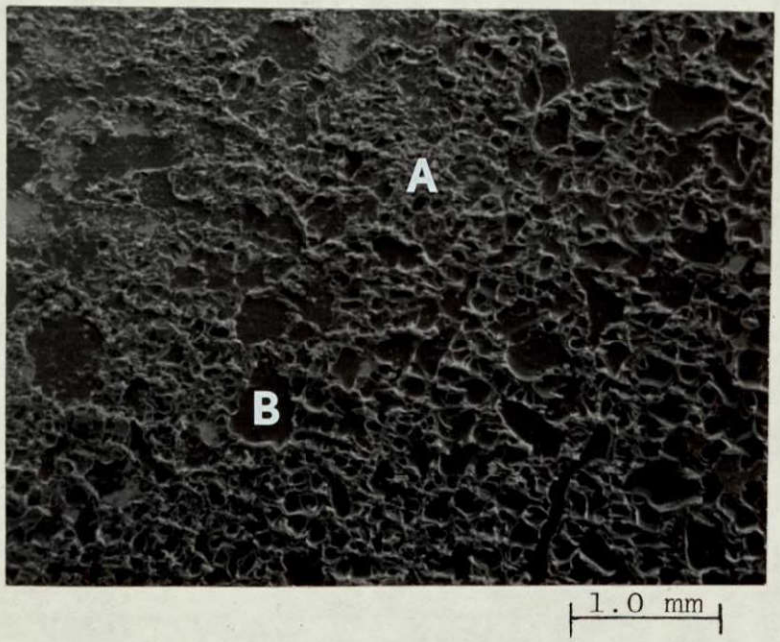
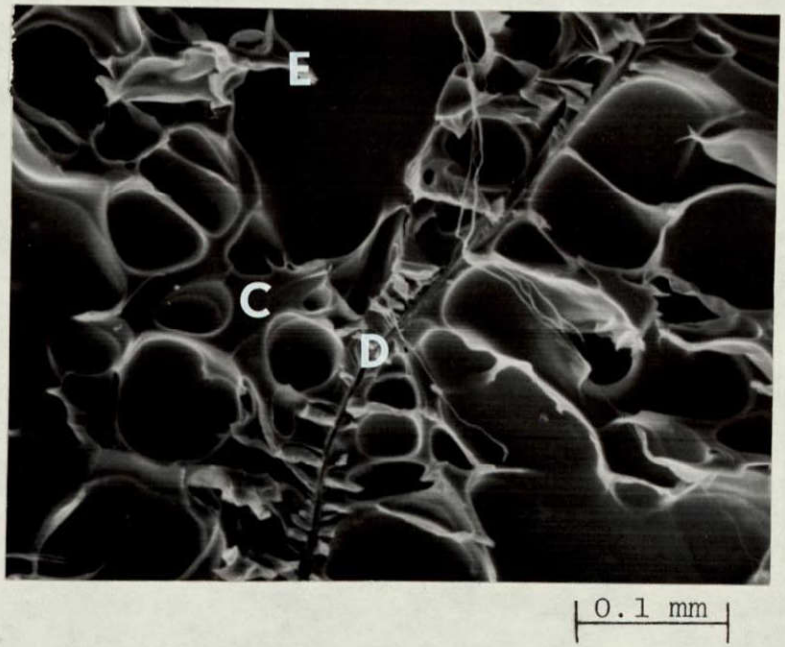
The same general features characterize the fracture surface of the sample tested at room temperature (Figure 5) as have been seen in previous (unaged) high strength samples (1-3). At lower magnification there is a fairly uniform distribution of raised material that forms a filigree pattern (A) superimposed upon lower, smooth, oblong areas (B) that have dimensions ranging from 0.02 to 0.5 mm, approximately. The low areas are the bottoms of voids that were probably created during the formation of the joint and expanded during fracture. The filigree is composed of the void-cell walls that have undergone plastic deformation and finally fractured, primarily by a brittle cleavage-crack propagation mechanism. Some of these cracks are smooth and quite parallel to the substrate such as in area C on the higher magnification photomicrograph, but also fine louvers, tilted at an angle to the adherend, appear along the curved line that comes down the center (D). No doubt the fracture process is practically adiabatic, creating locallized "hot spots" that could promote ductility indicated at E. Note that only a very small amount of interfacial failure appears and many very thin walls result from plastic deformation.

FIGURE 5. Two magnifications of sample #731D1 that gave 3570 psi shear strength at room temperature after aging 30 days at 295°C. Features similar to previous (1-3) high-strength samples.

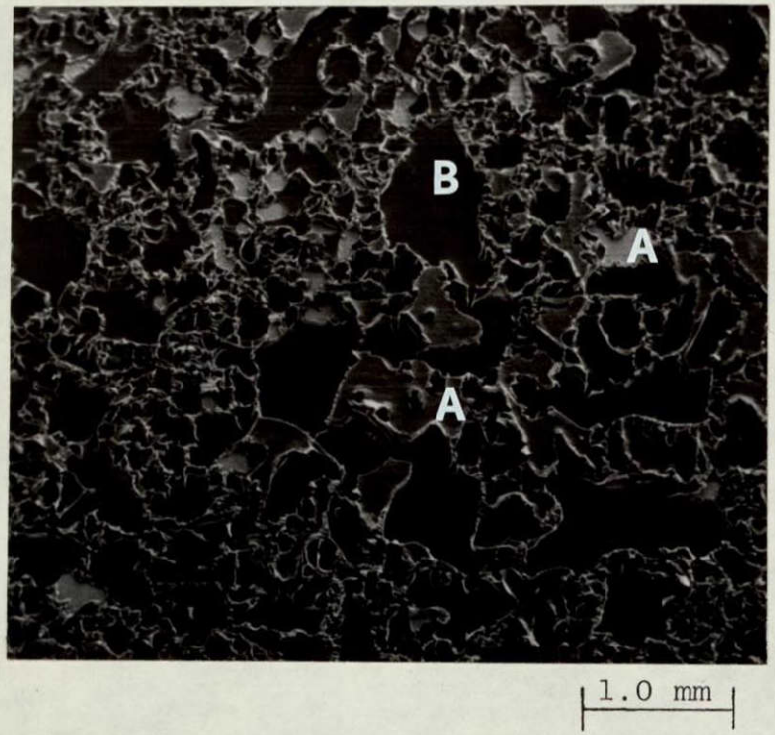
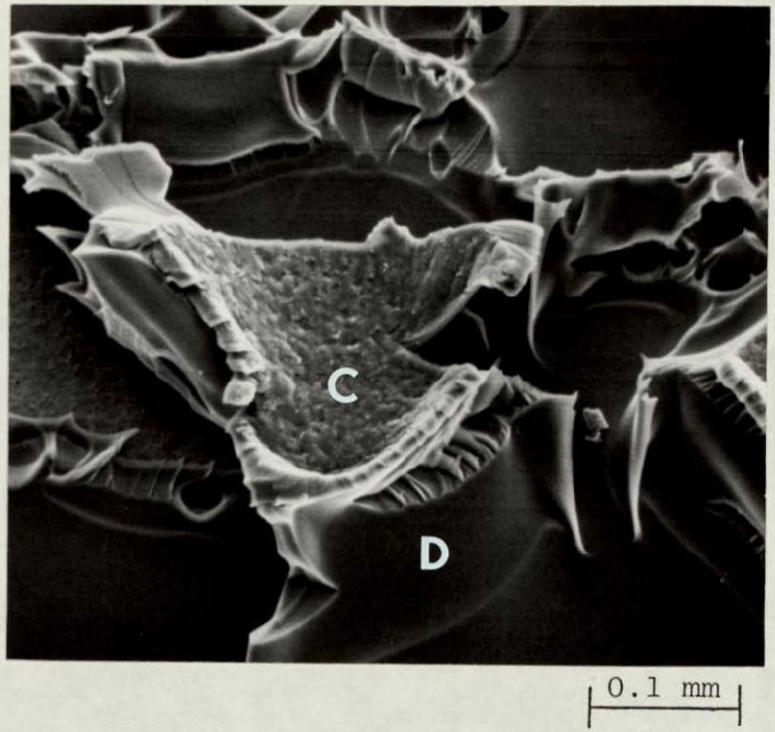
Generally similar features are seen in the first high temperature sample (Figure 6), but the proportion of interfacial failure (A) and void area (B) has increased. Areas of adhesive that have detached from the opposite adherend show that original interfacial contact was good, because the polymer faithfully replicates the detailed surface features of the titanium in area C. Comparing Figures 5 and 6, it is tempting to say that the voids have coalesced in the latter, sometimes reaching dimensions over 1 mm. Correspondingly, void-cell walls are thicker; area D (higher magnification) provides a striking example of a plastically drawn void-cell wall circumscribed by brittle cleavage cracks.

FIGURE 6. Two magnifications of sample #721D1 that gave 2065 psi shear strength at 225°C after aging for 30 days at 295°C. More interfacial failure and void area, and plastic deformations have thicker walls.

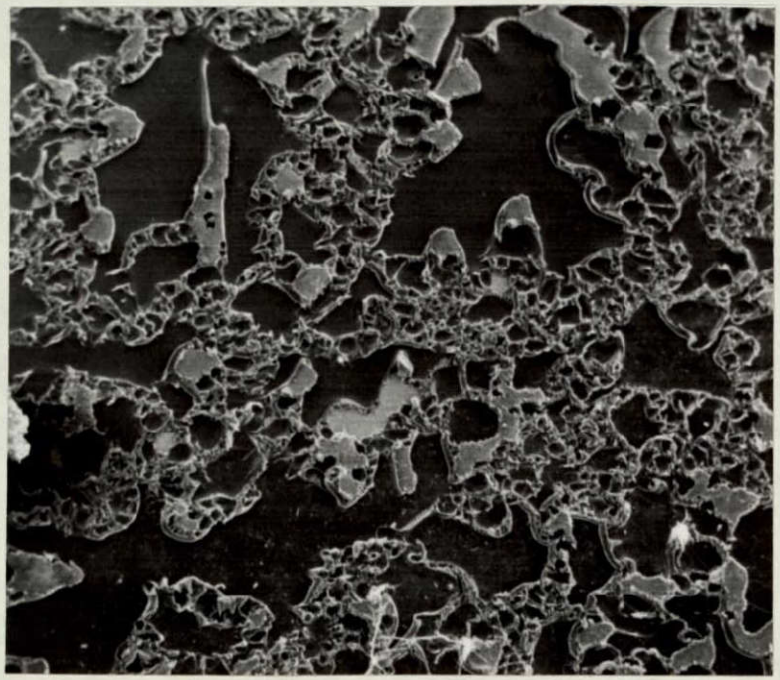
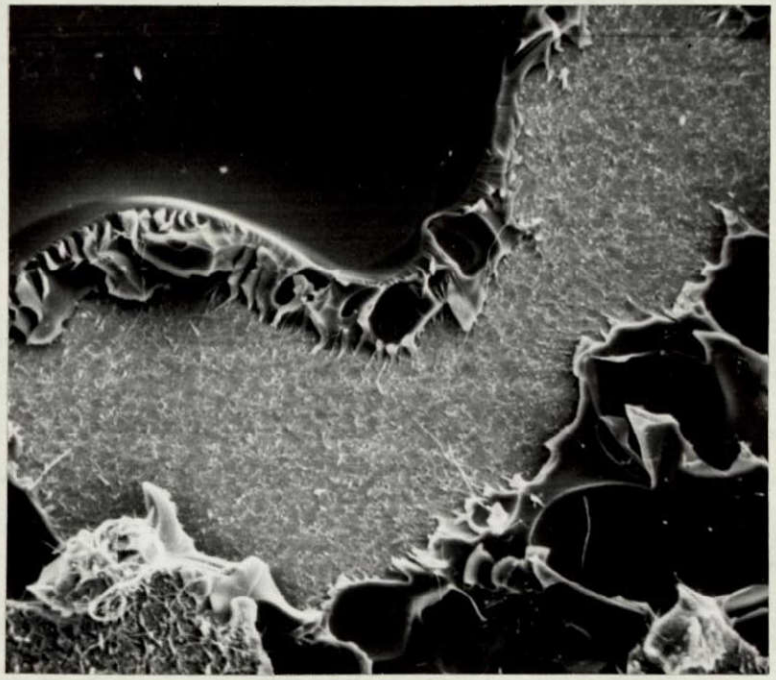
Figure 7 shows that the fraction of interfacial failure and void area continues to advance with temperature. Large void spaces are almost completely interconnected across the sample. At higher magnification, some strength across the interface is indicated at the place where the louvers between brittle cleavage cracks meet the exposed substrate.

FIGURE 7. Two magnifications of sample #721D2 that gave 1465 psi shear strength at 250°C after aging for 30 days at 295°C. Even more interfacial failure and void area.

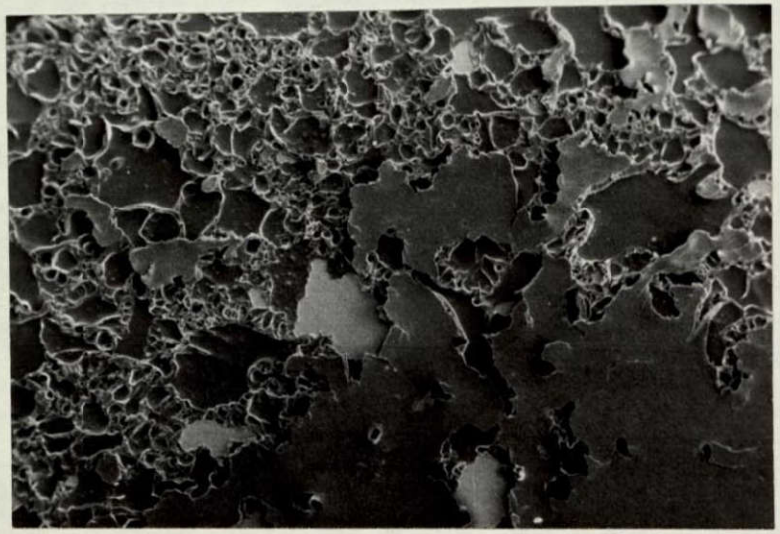
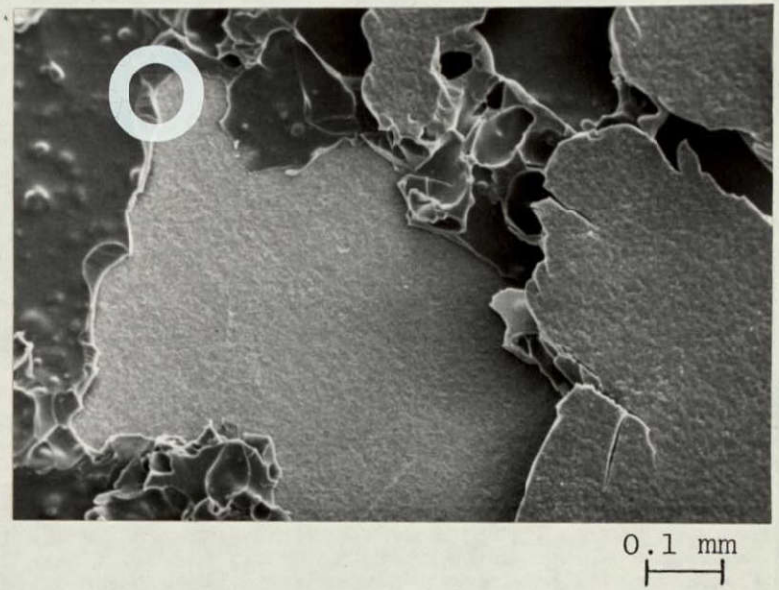
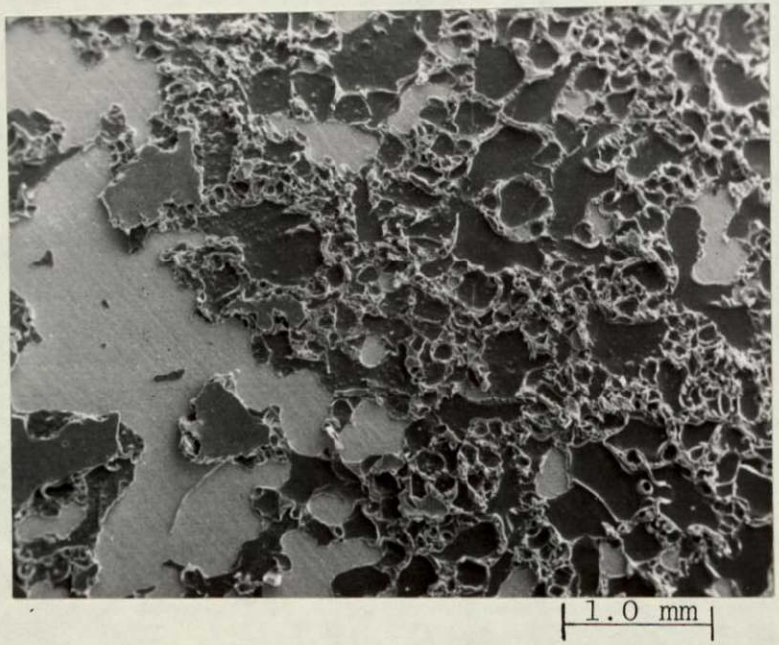
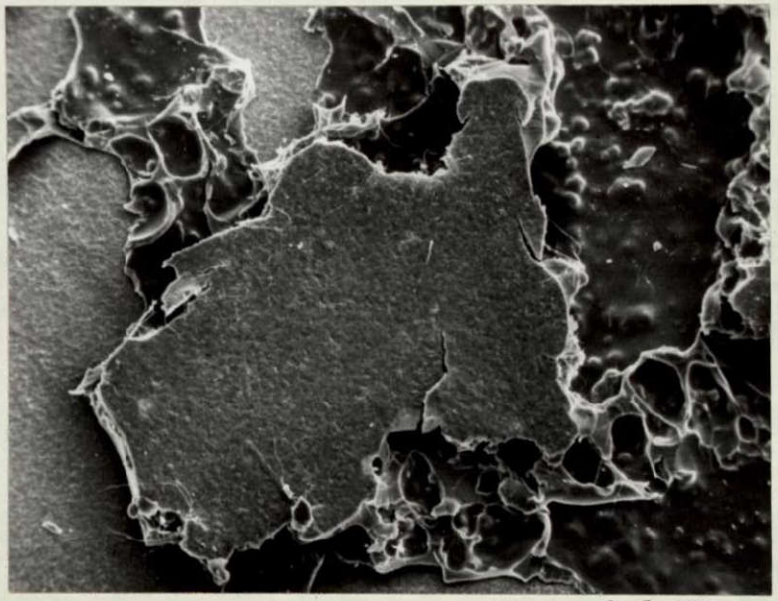
Interfacial failure predominates at the highest test temperature. The opposite sides of mating fracture surfaces are shown in Figure 8; it is quite simple and instructive to locate the matching features. There is very little plastic deformation, hence little strength.

Brittle cleavage cracks without much louvering account for the failure that is not interfacial. The circled area of Side 1 is shown at higher magnification in Figure 9, illustrating a few brittle cleavage crack louvers and also low forces across the polymer/metal interface.

FIGURE 8. Two magnifications of the opposite mating fracture surfaces of sample #721D4 that gave 760 psi shear strength at 270°C after aging for 30 days at 295°C. Extensive interfacial failure, and small amount of plastic deformation and cleavage cracks.

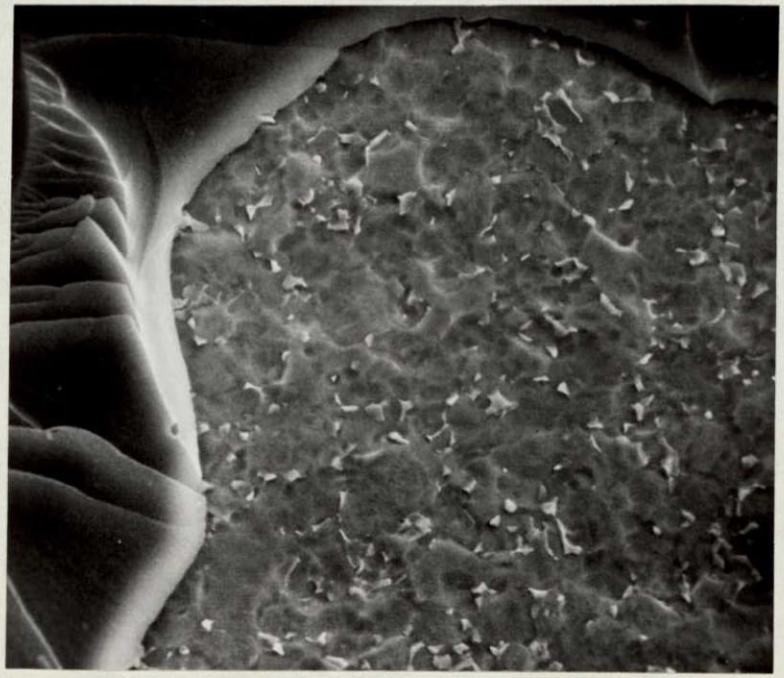
FIGURE 9. High magnification view of area circled on Side 1, Figure 8. No bonding apparent at junction of polyimide and titanium. Good illustration of brittle cleavage cracks at left.

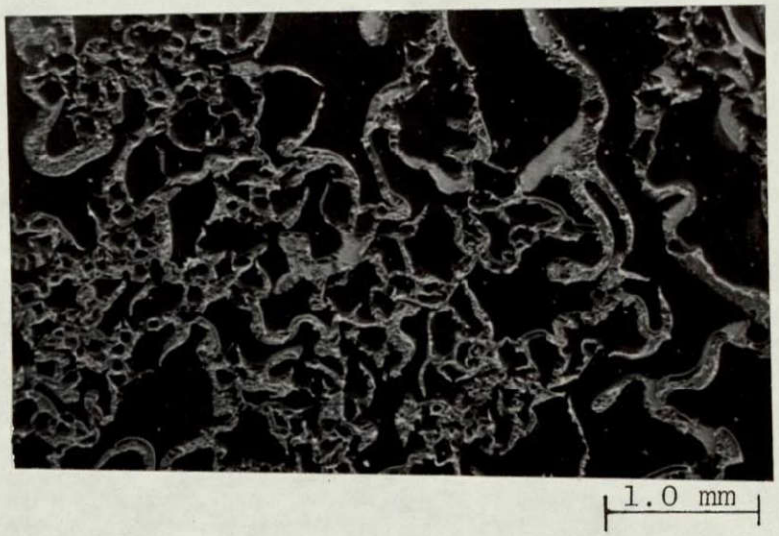
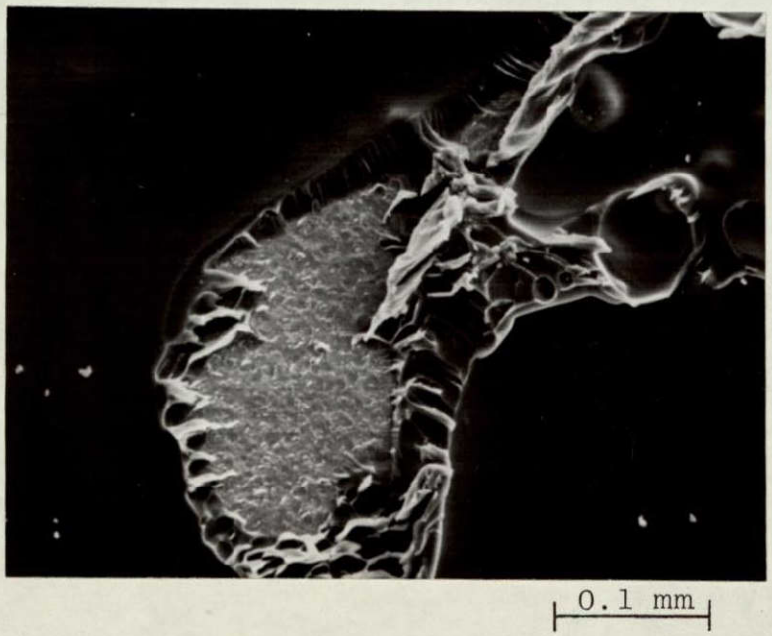
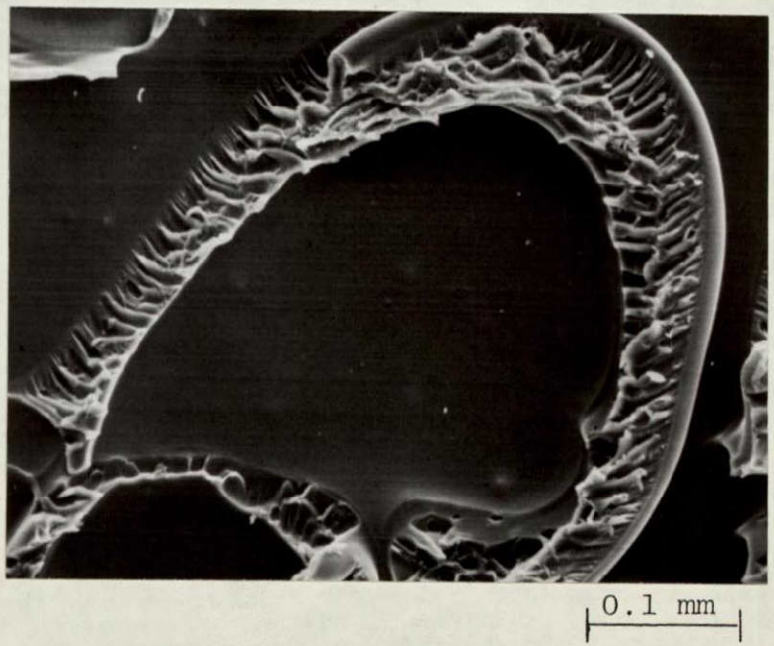
The use of dimethylformamide (DMF) as solvent for standard polyimide gives little interfacial failure, but a large proportion of connected void area compared to fracture area, shown in Figure 10. Apparently the 3700 psi strength is developed by the initiation and annihilation of a large number of brittle cleavage cracks illustrated by all the louvers in the higher magnification photomicrographs.

FIGURE 10. Sample #848D2: Standard BTDA/mm'-DABP polyimide in DMF solvent; shear strength 3700 psi.

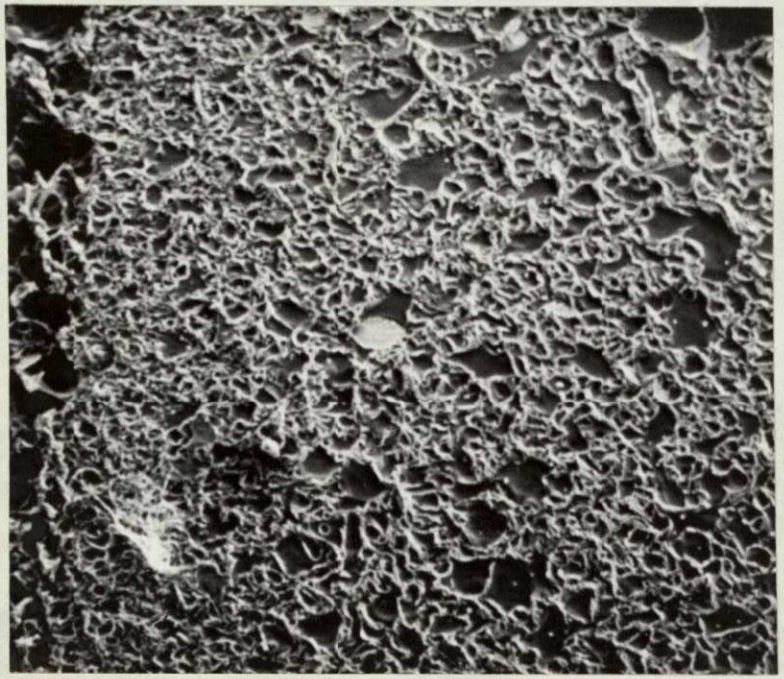
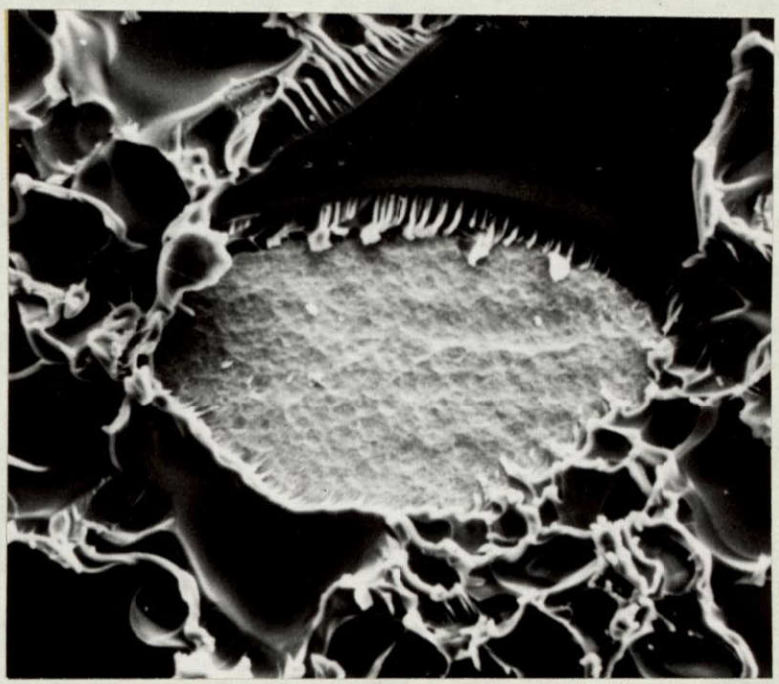
Figure 11 shows a large proportion of drawn and fractured polymer in a high-strength sample prepared with anhydride comonomer, ODPA. At higher magnification, a balance between moderate plastic deformation and brittle fracture is apparent.

FIGURE 11. Sample #878D3: OPDA/mm'-DABP/DG; shear strength 4500 psi.

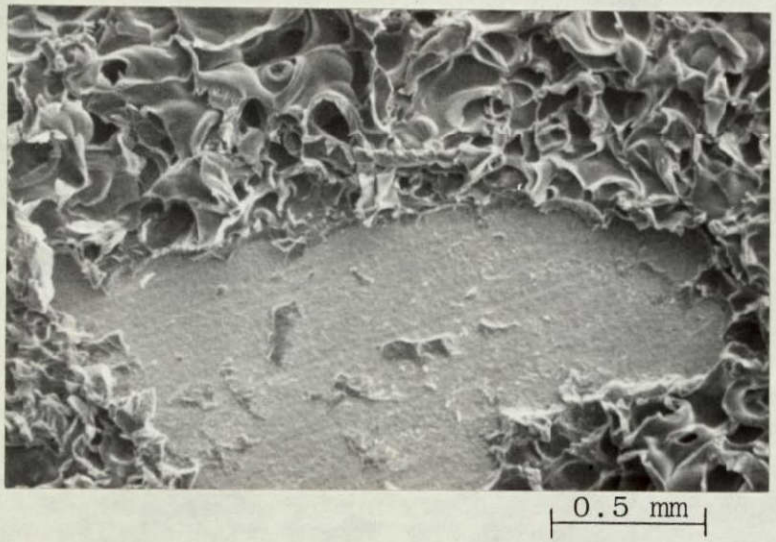
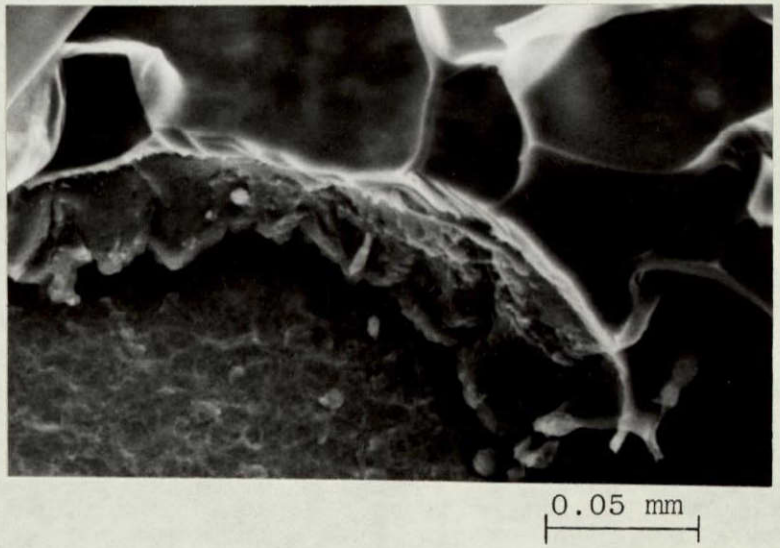
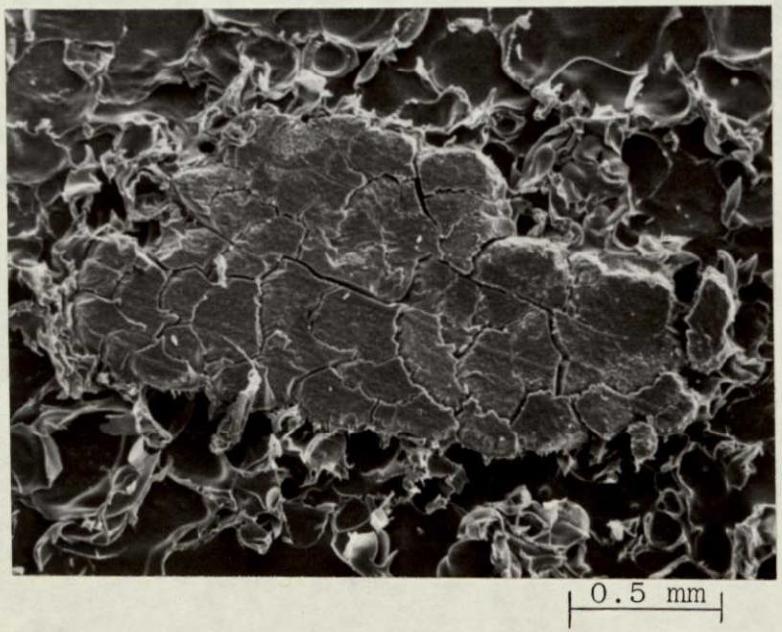
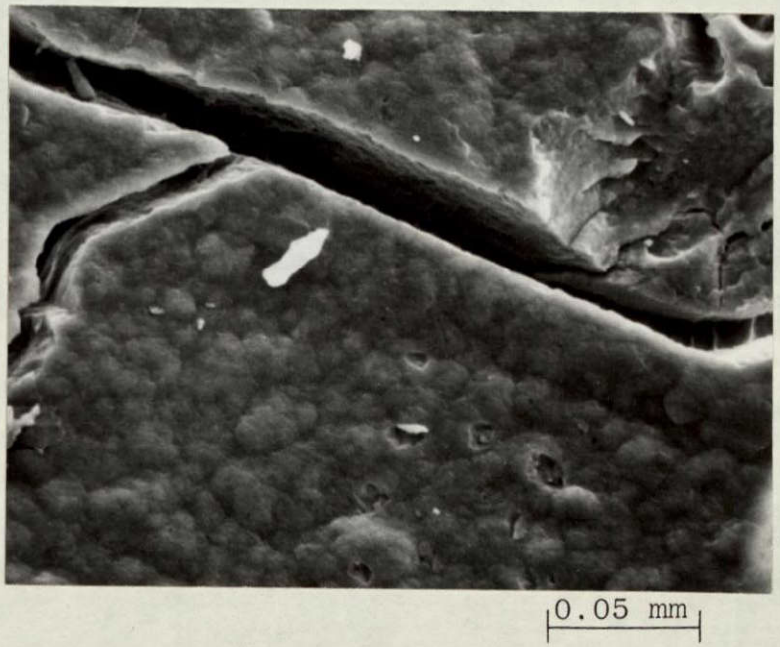
Mating sections from both sides of the 1400 psi joint are shown in Figure 12. It is difficult to compare this sample with

FIGURE 12. Sample #880D2: BTDA/pp'-DABP/DG; shear strength 1400 psi.

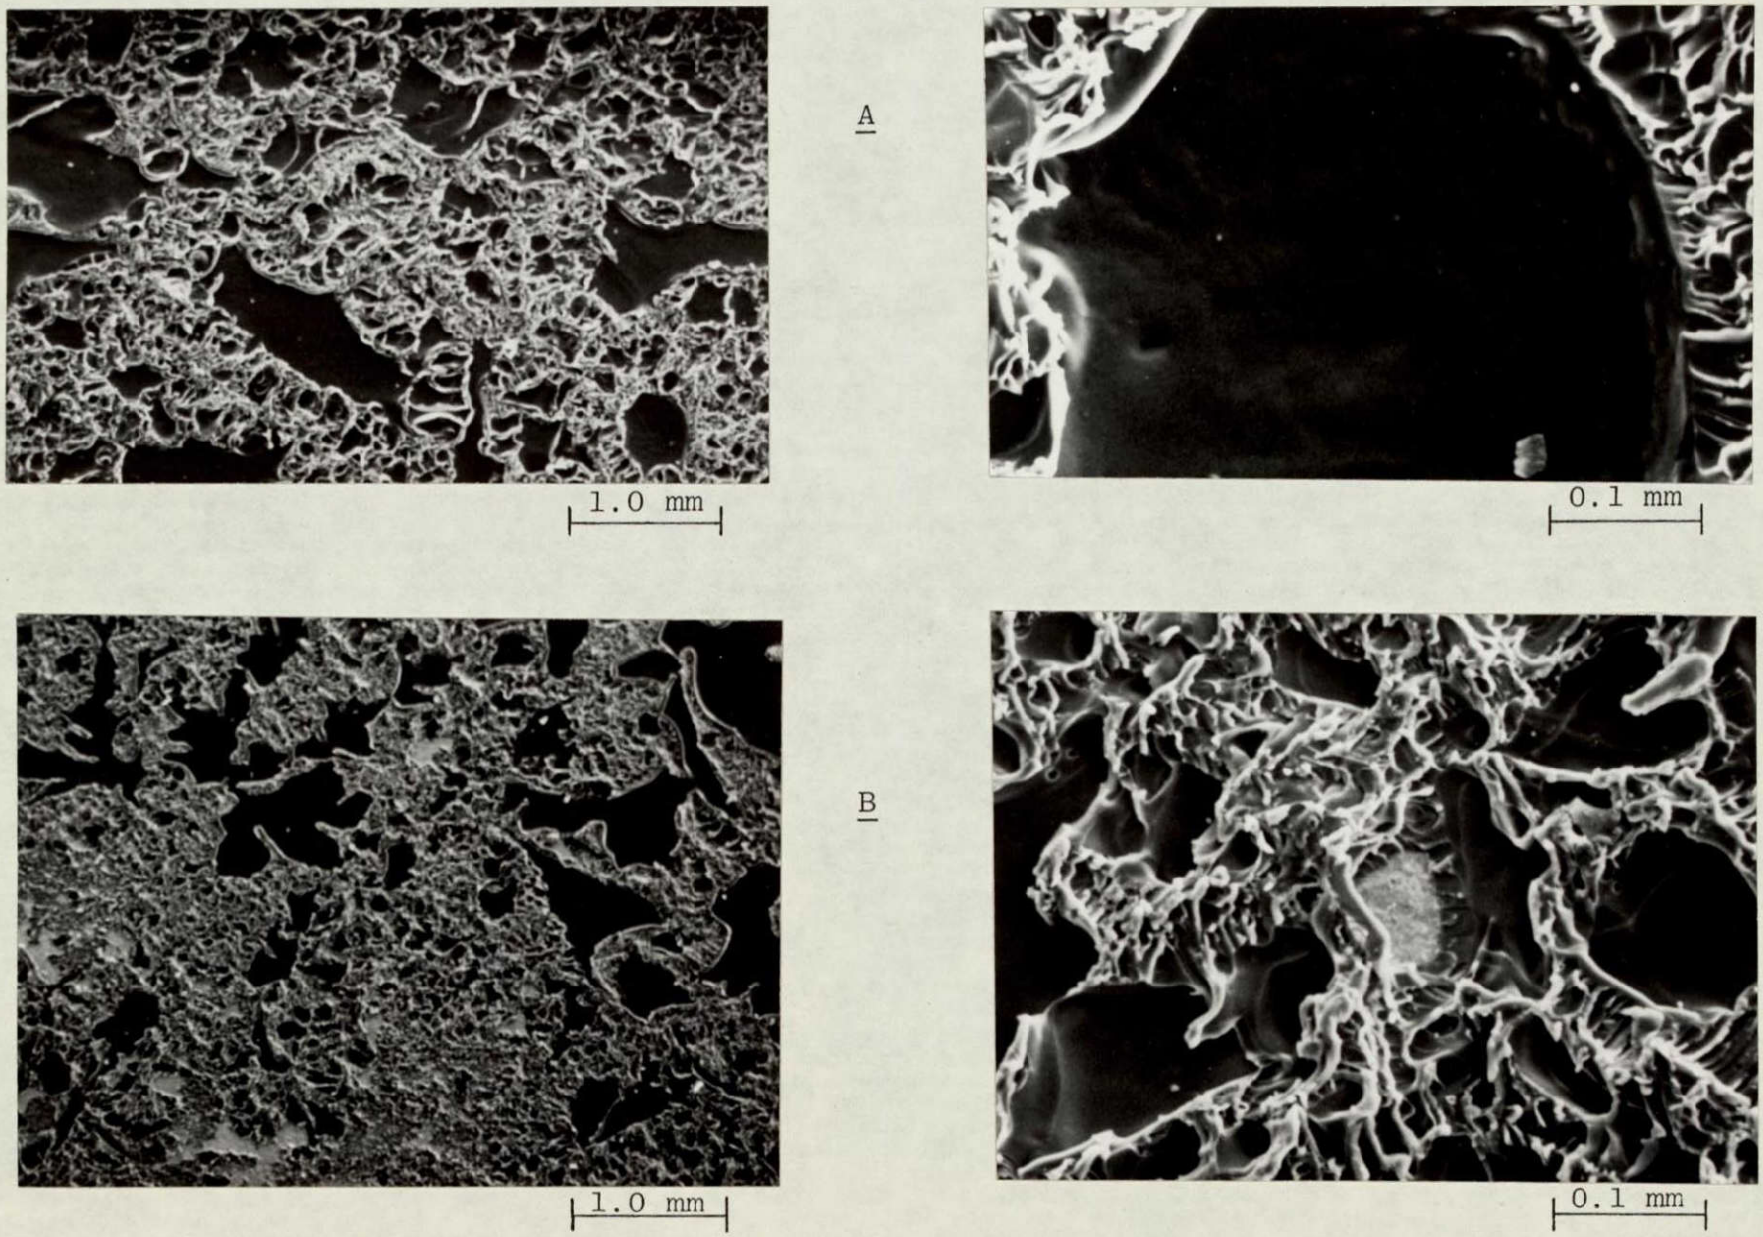
FIGURE 13. 2BTDA+1 PMDA/mm'-DABP/DG, A. Sample #881D1: shear strength 2640 psi; B. Sample #881D4: shear strength 5140 psi. Note correlation between amount of filigree and bond strength.

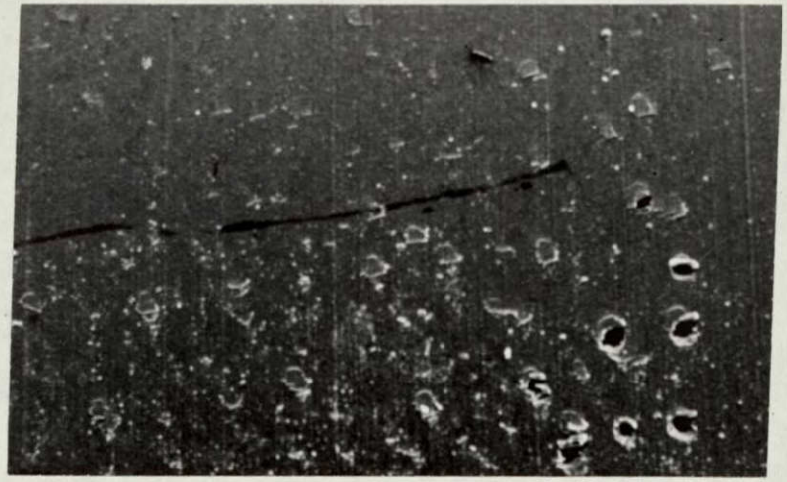
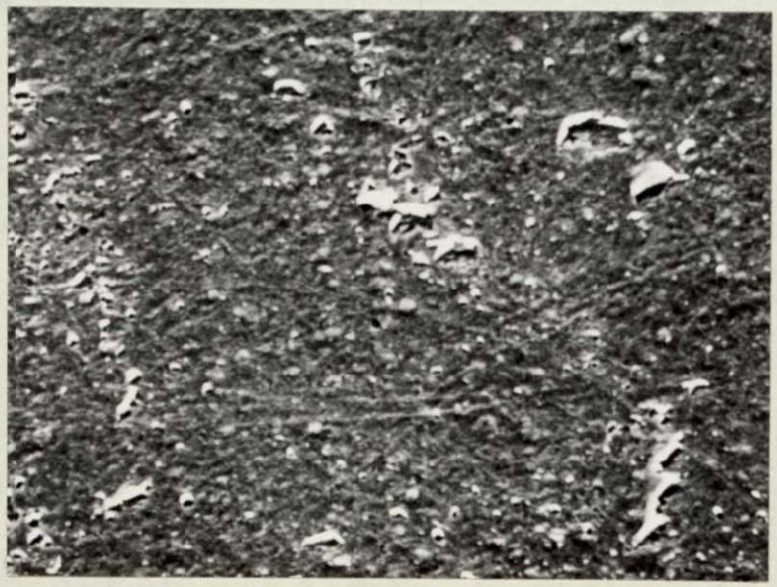
The most facinating result was obtained using a totally imidized, film adhesive. EAH-13 comonomer was used to provide enough flow at high temperature so that good interfacial contact occurs during pressing at 200 psi and 300^{o}C for an hour. The photomicrographs in Figure 14 show that the polymer has formed a detailed replica of the titanium surface. Failure is totally interfacial on one side of the joint. It is amazing that 3500 psi shear strength can be obtained without contributions from plastic and brittle mechanisms. Perhaps elastic deformation occurred. Otherwise, the

FIGURE 14. Sample #891D1:BTDA/EAA-13/DMAc; shear strength 3500 psi. Note that virtually no void present; completely different appearance when no water of imidization released in the joint.

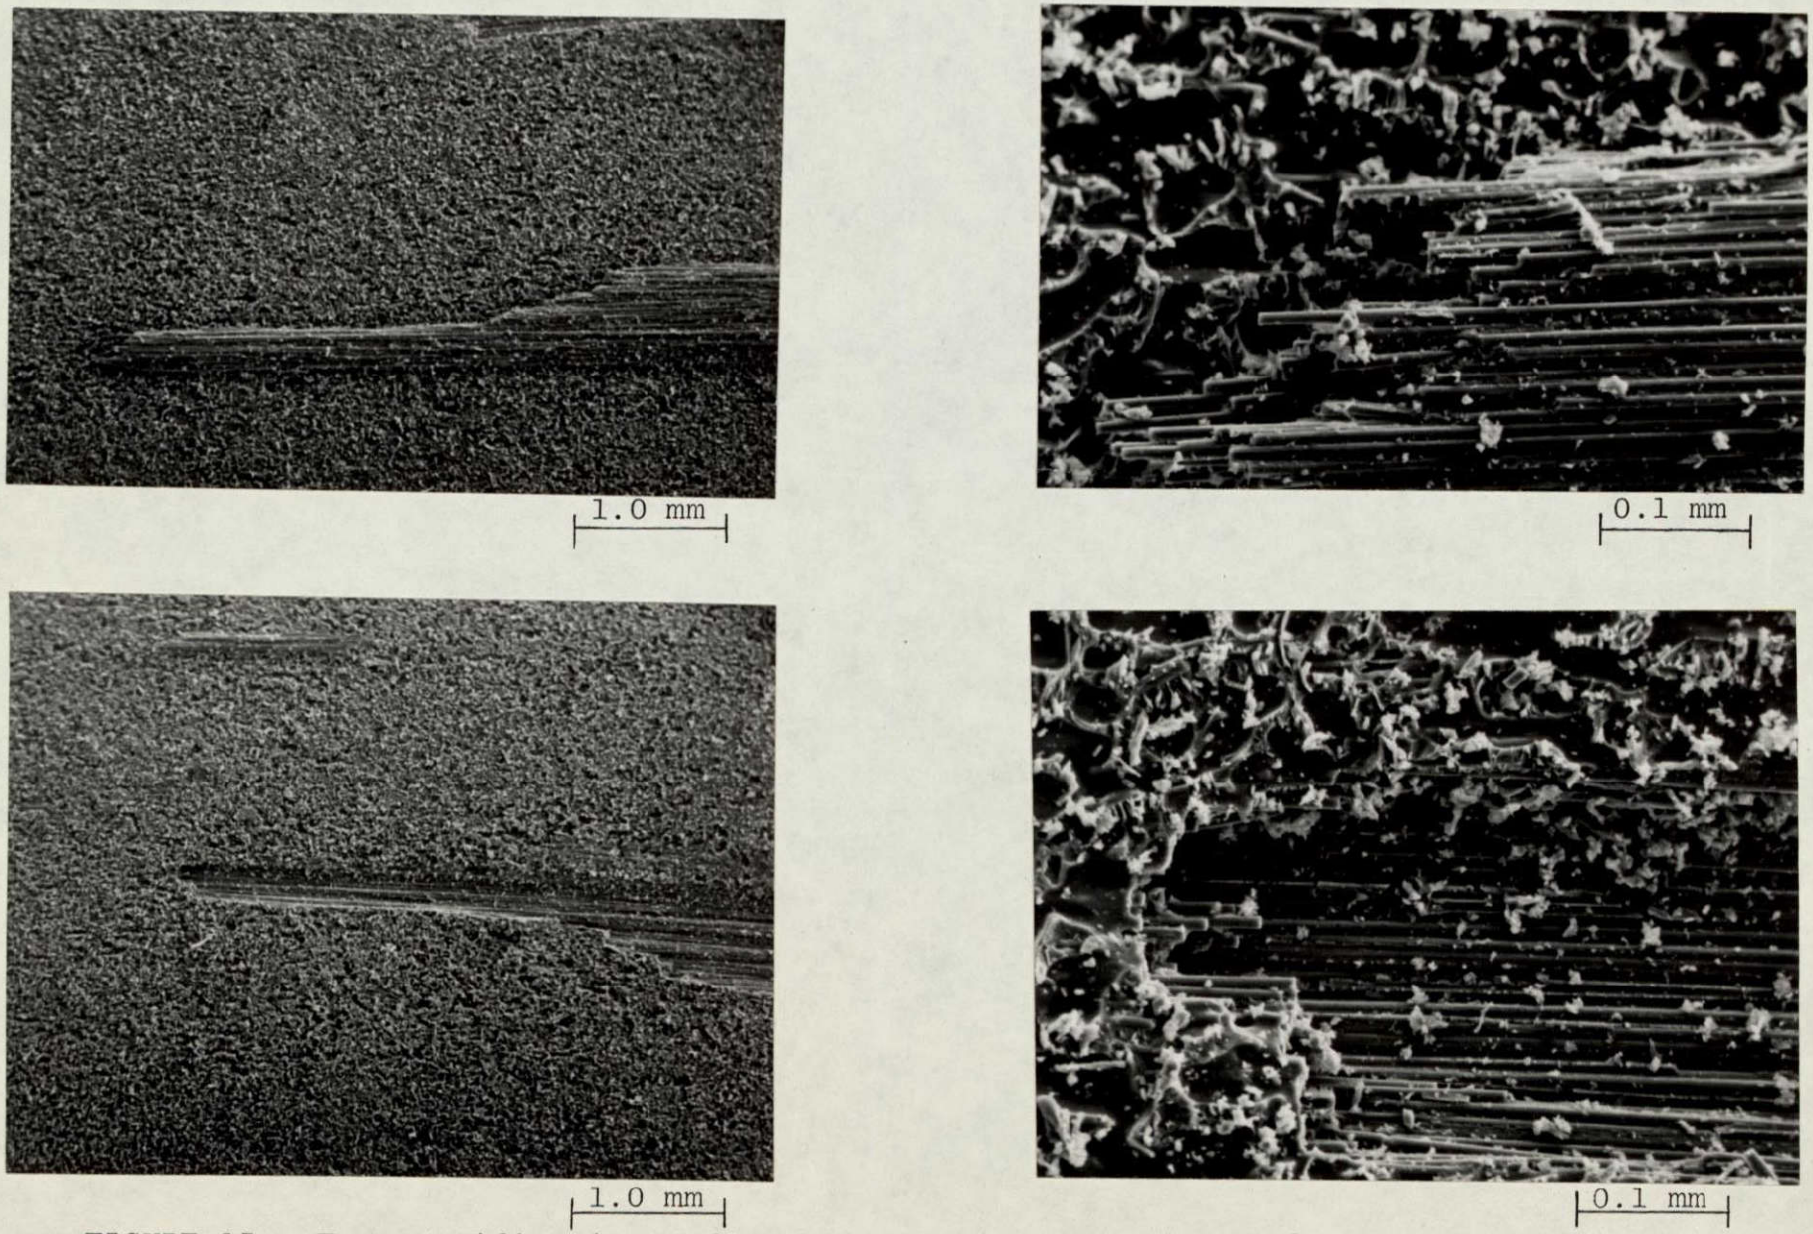
FIGURE 15. Two magnifications of opposite mating fracture surfaces from Sample #946D1; both adherends were HT-S/P13N composites molded at 400 psi. Shear strength was 3360 psi, and failure was mostly in the void-filled adhesive layer.

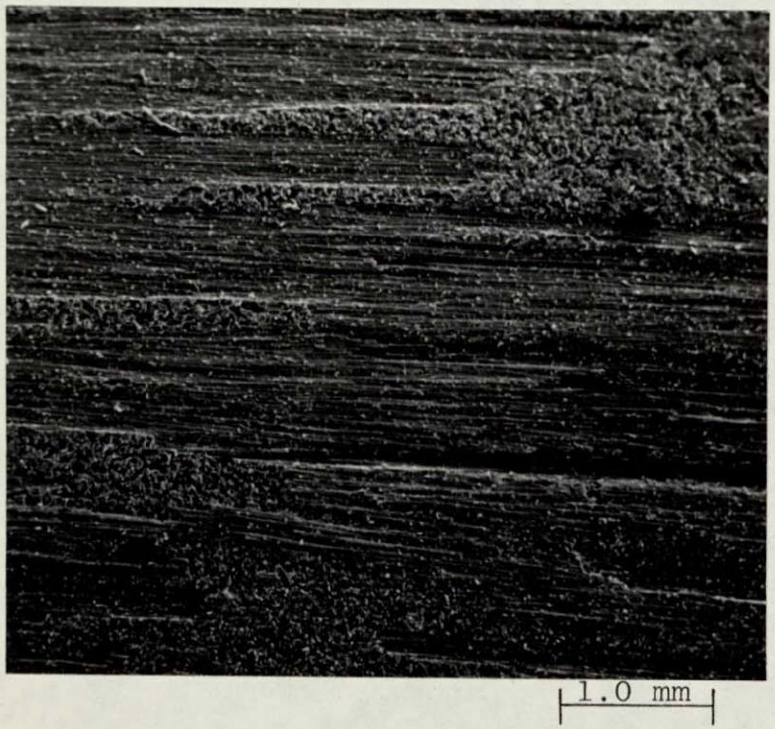
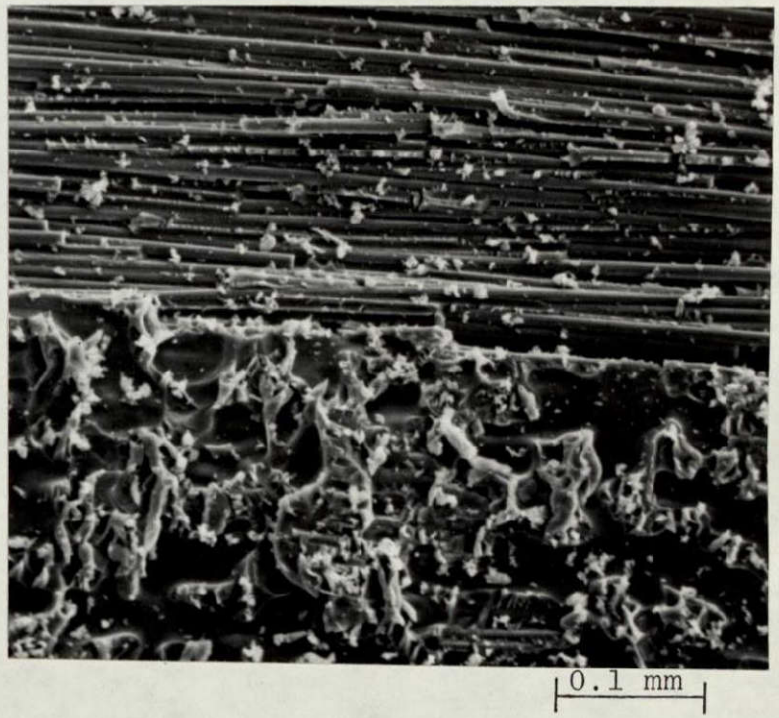
FIGURE 16. Two magnifications of Sample #947D1; adherends were HT-S/P13N composites molded at 1000 psi. Shear strength was 3690 psi and failure was about 2/3 in the composite.

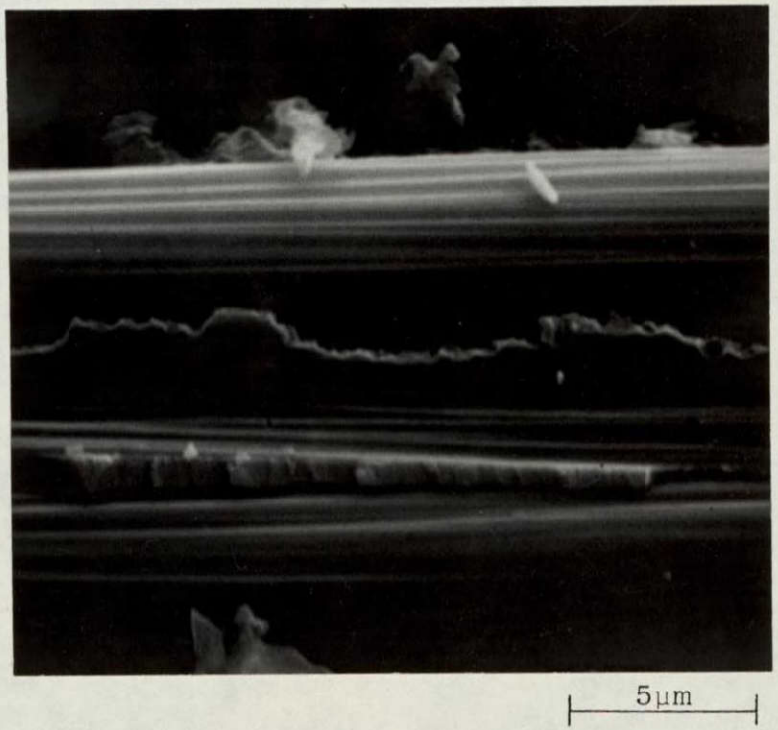
FIGURE 17. High magnification view of composite failure in Sample #947D1. Polymer/fiber interfacial failure is obvious. There is no plastic deformation and brittle fracture surface area is small.

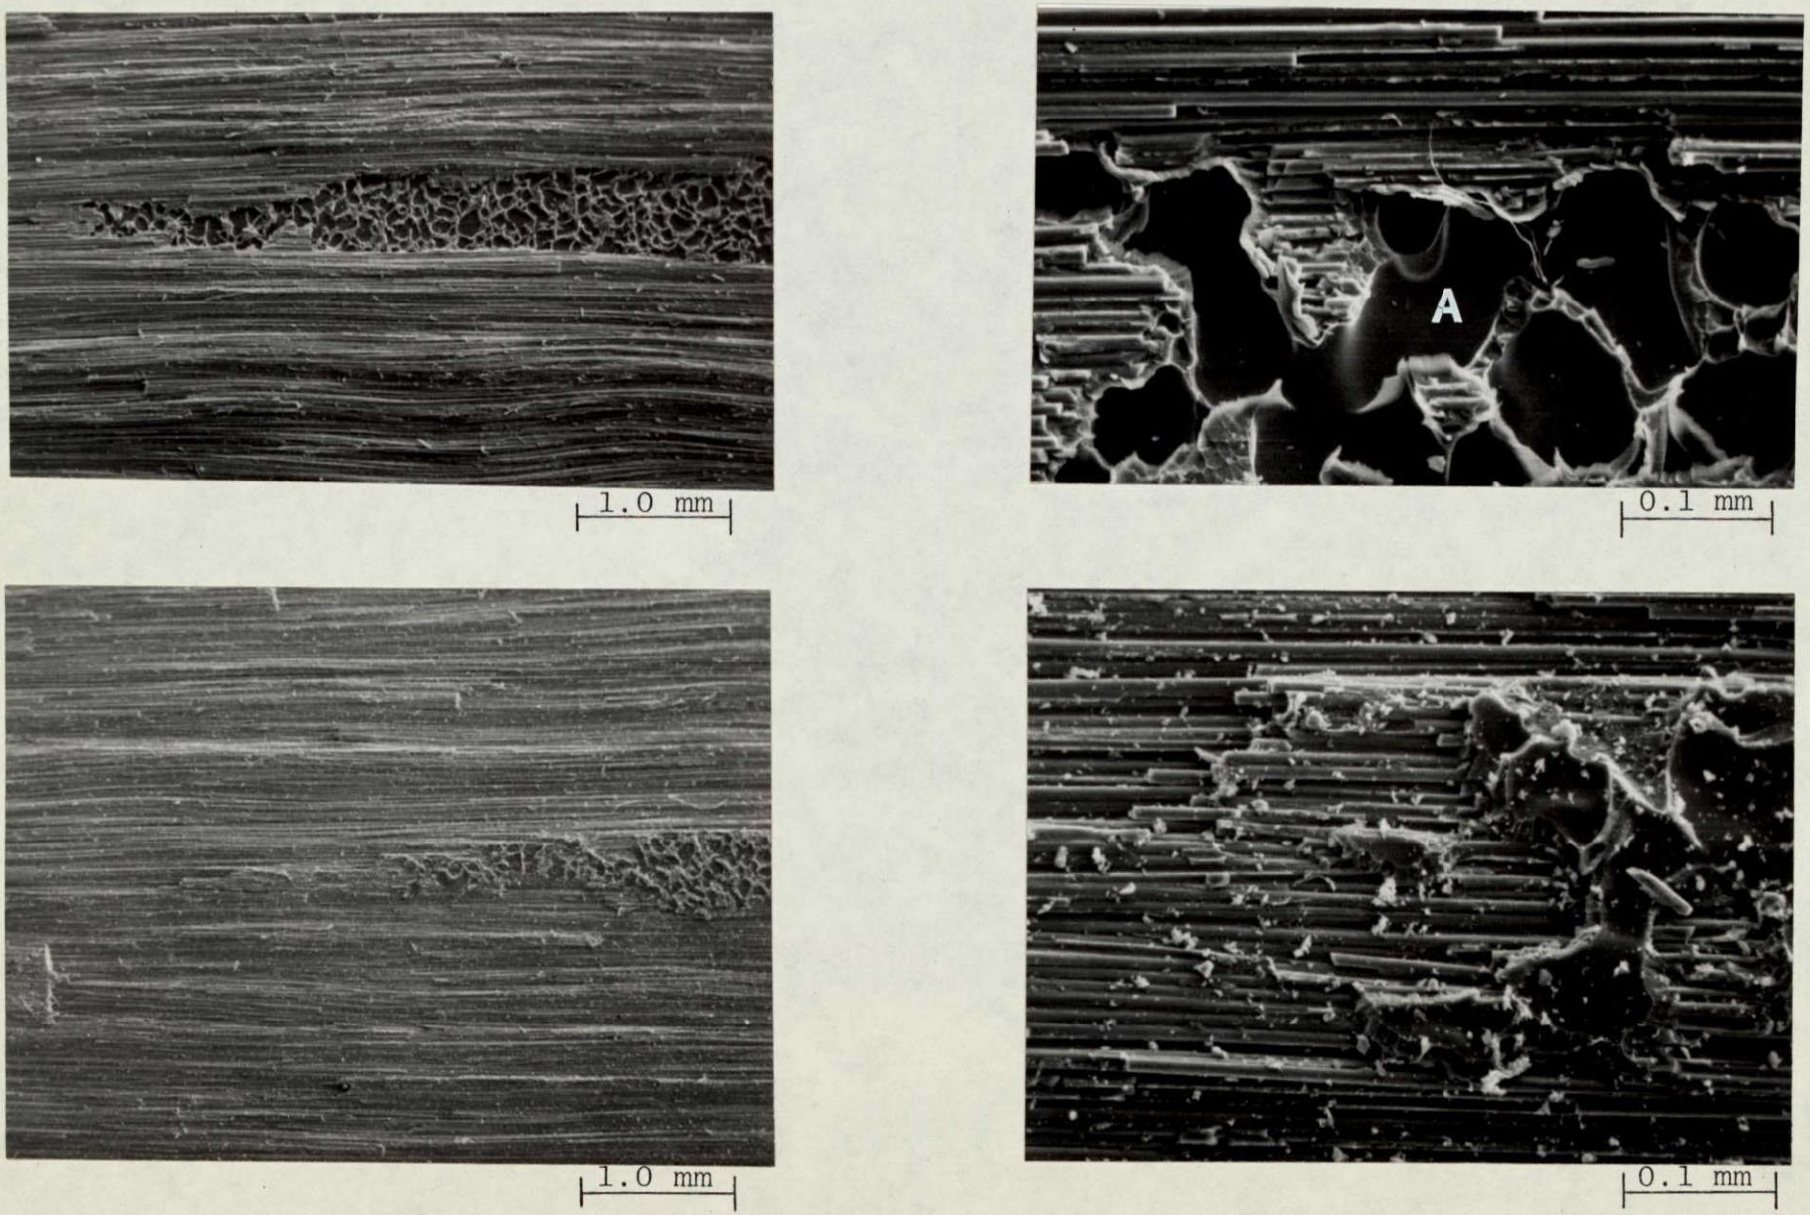
FIGURE 18. Two magnifications of opposite mating fracture surfaces from Sample #948D1; one adherend was titanium and the other was HT-S /P13N composite molded at 400 psi. Shear strength was 3750 psi and failure was mostly in the composite.

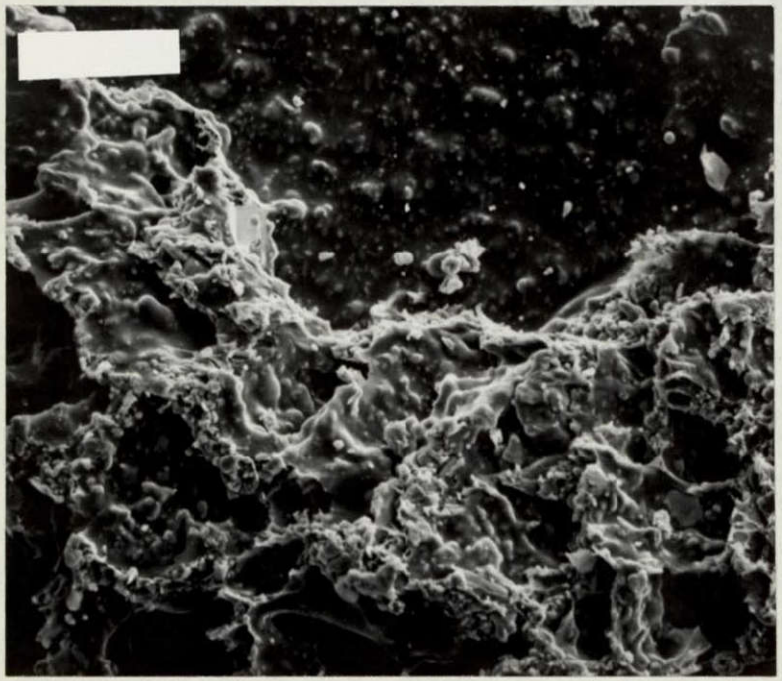
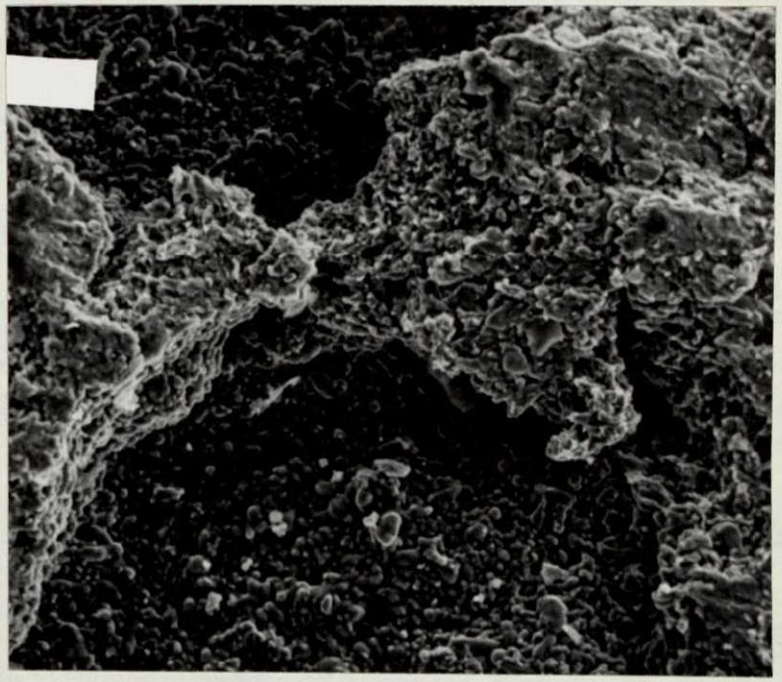
FIGURE 19. High magnification view of Sample #546D4 and #547D3, showing the effect of increasing filler content.
