FINAL REPORT

EFFECT OF POLYMER PROPERTIES AND ADHEREND SURFACES ON ADHESION

National Aeronautics
and
Space Administration
December, 1975
NASA GRANT NSG-1124

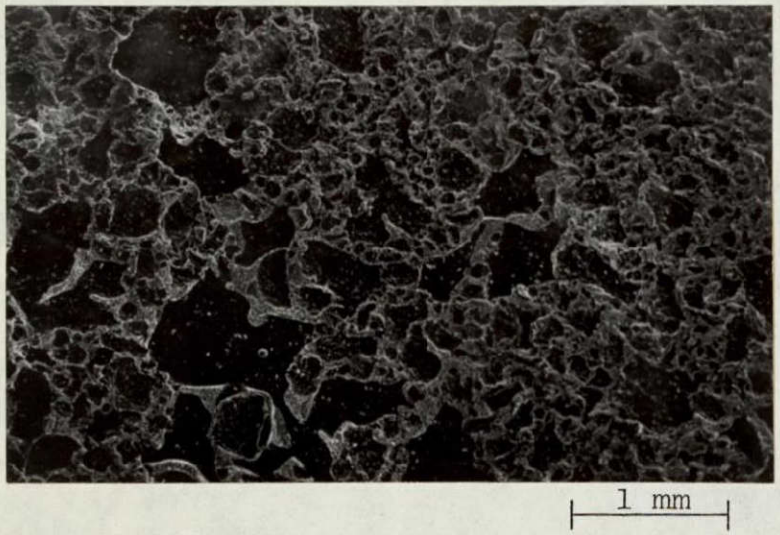
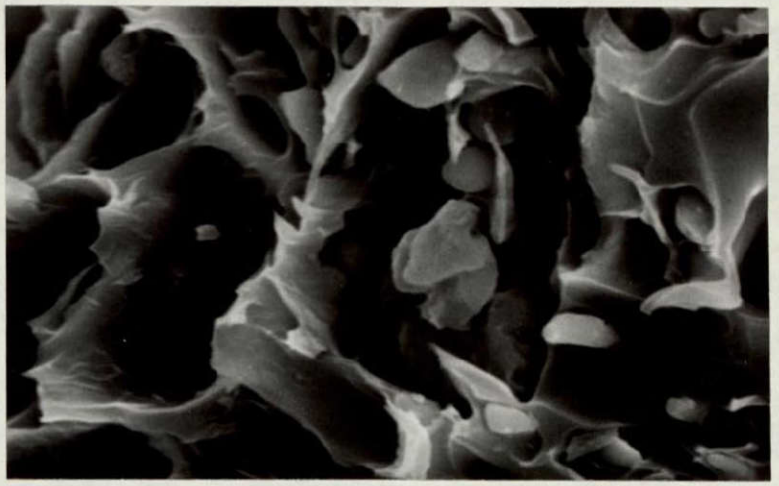
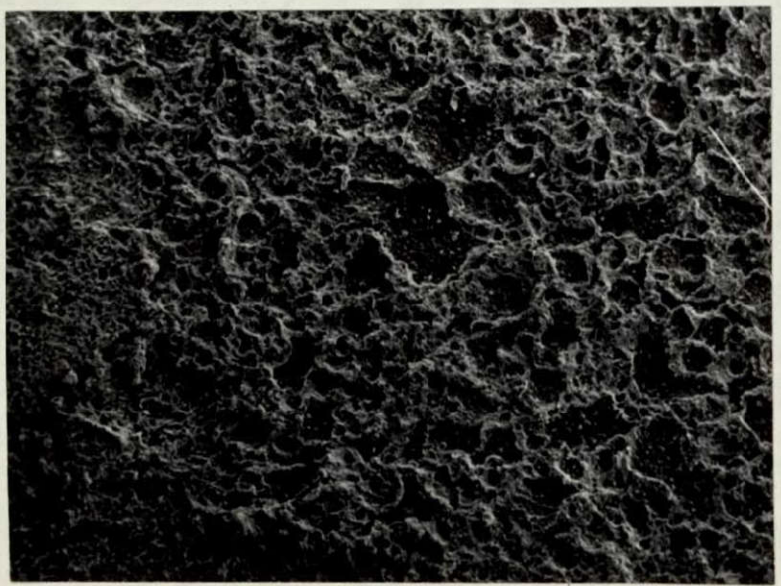
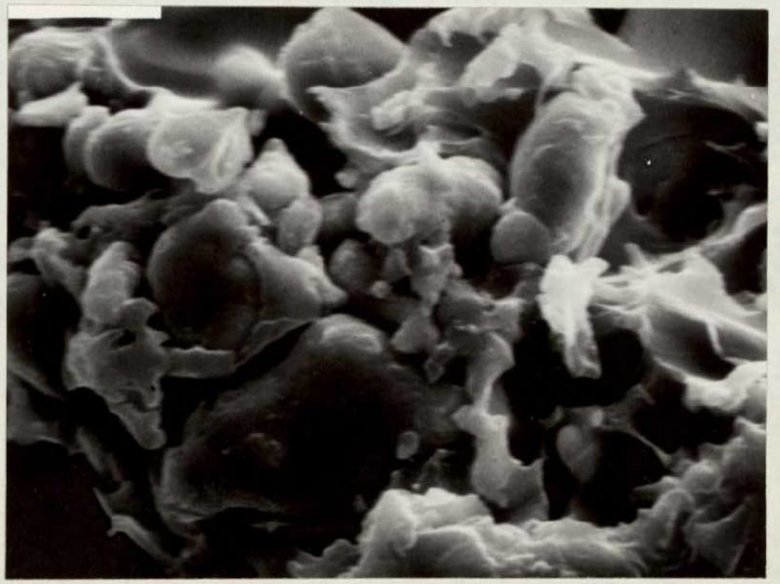
Figure 20 shows a survey (20X) and fine detail (2000X) of the sample with 50% Al, bonded at 40 psi. At low magnification the balance of void and filigree areas is similar to many of the previous samples. The room temperature sample (#546D3) has good strength, and at high magnification the fracture surface is composed of very thin, plastically deformed microvoid-cell walls. This feature is unique to the filled adhesive. By contrast, the high temperature sample (#546D4, 1210 psi) appears melted and has no thin, drawn films. It looks as though the high temperature and stress softened the polymer and reduced its strength. No interfacial failure occurred, in contrast to the results at 250°C with

FIGURE 20. Two magnifications of sample #546D3 and #546D4, both with 50% Al, tested at 25° and 250°C, respectively. Shear strength dropped from 3775 psi to 1210 psi. "Melting" caused by high temperature and stress is visible in the lower right.

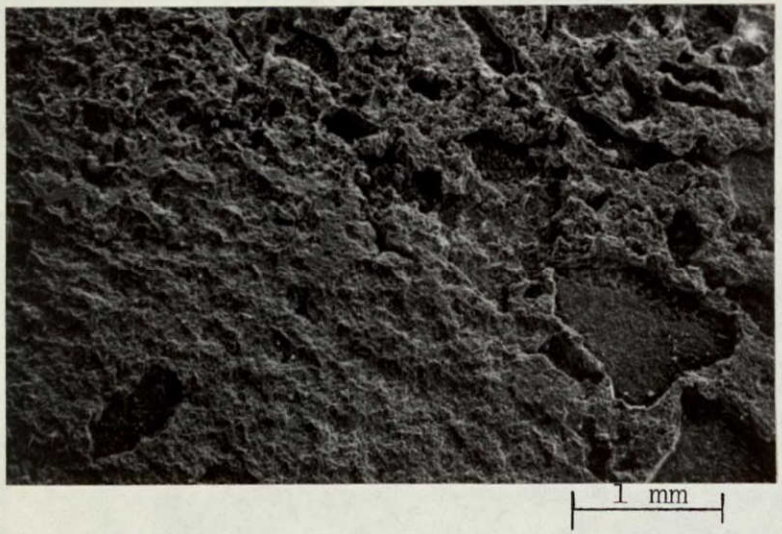
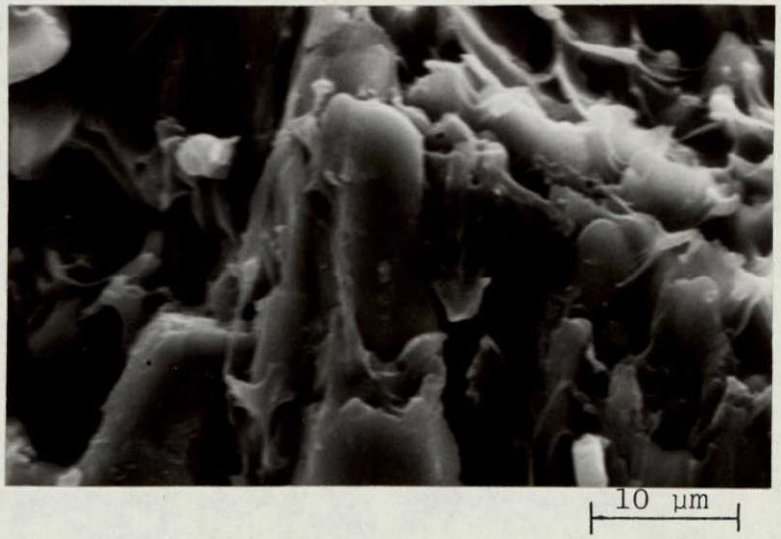
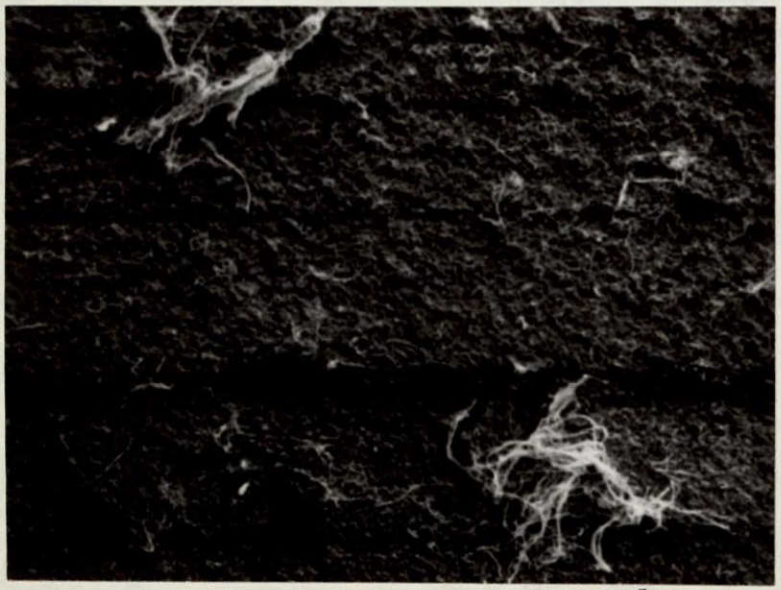
FIGURE 21. Two magnifications of Sample #554D3 and #554D4, both with 70% Al, tested at 25° and 250°C, respectively. Shear strength dropped from 3715 psi to 2335 psi. Higher filler content increases the fracture-surface area and prevents the "melting" at high temperature. Fibers are artifacts.

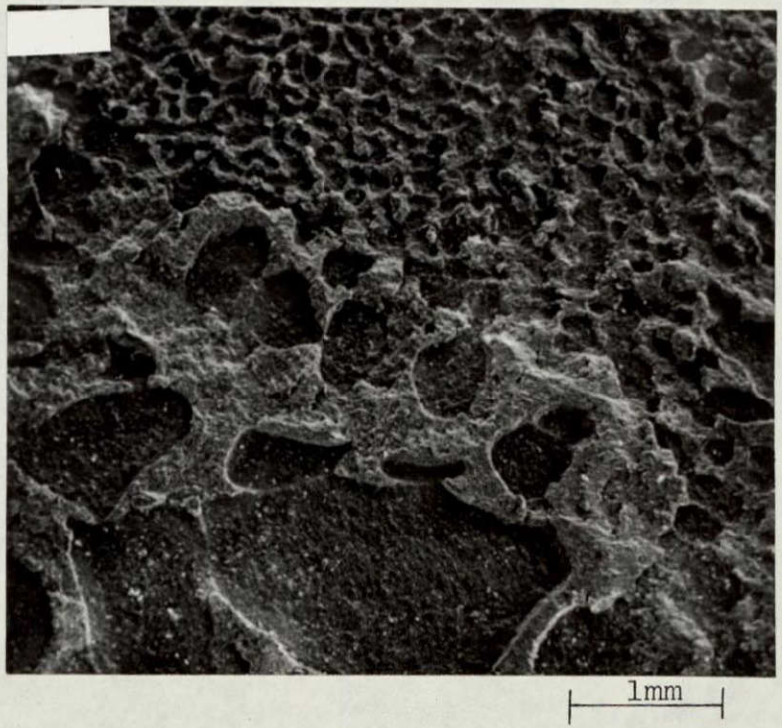
FIGURE 22. Sample #547D3, showing a relatively high ratio of void to fracture-surface area probably responsible for the relatively low 3000 psi shear strength.

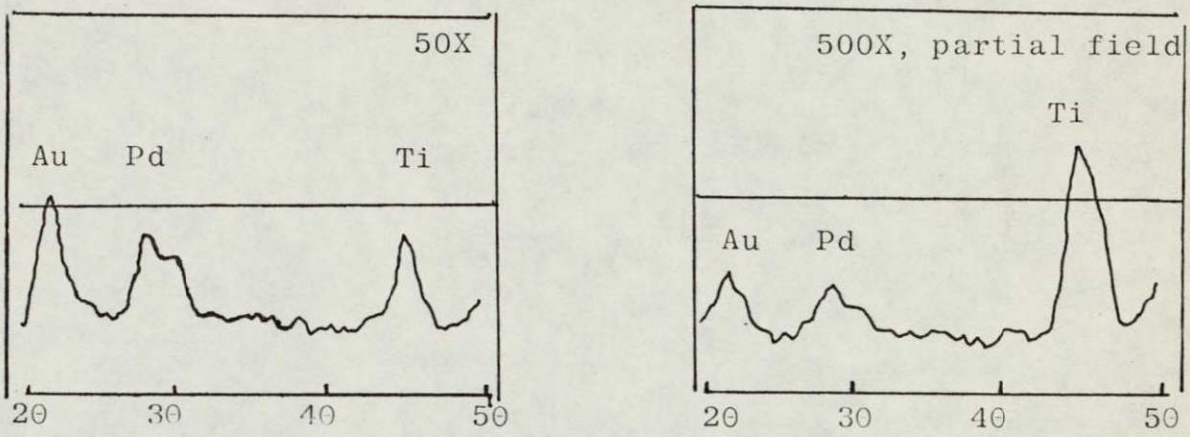
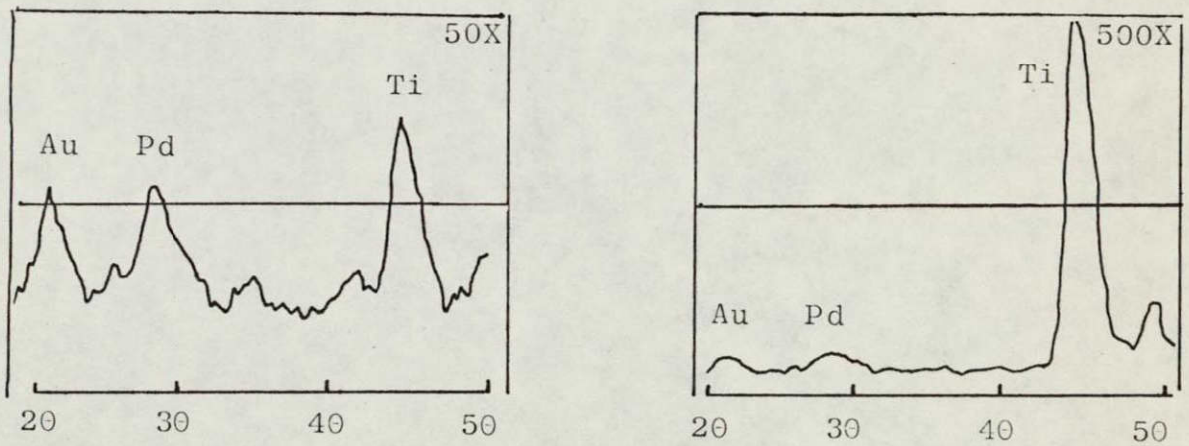
FIGURE 23

A. EDAX at two magnifications on sample #546D3. Some adherend shows through on the 50X "survey" on the left, and even more when the beam was focussed into the hole shown in Figure 24.

B. EDAX at two magnifications on sample #554D3. More adherend shows through at 50X, and dominates the spectrum when the beam was focussed into the bottom of the void shown in Figure 24.

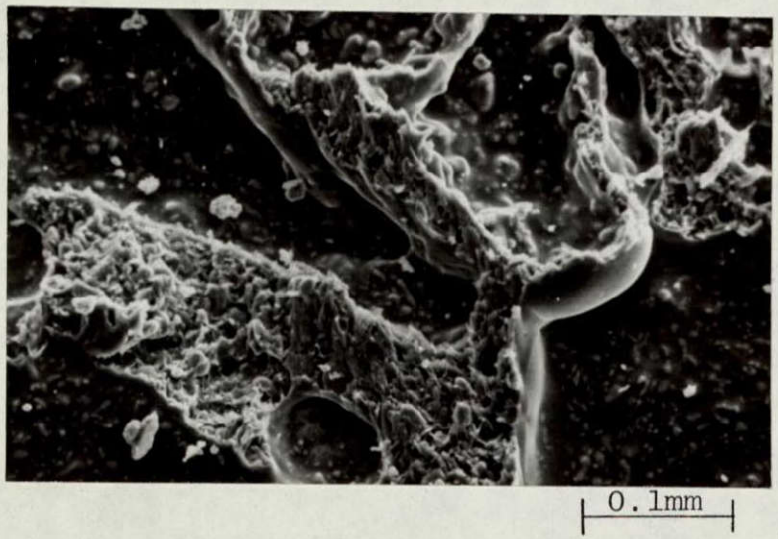
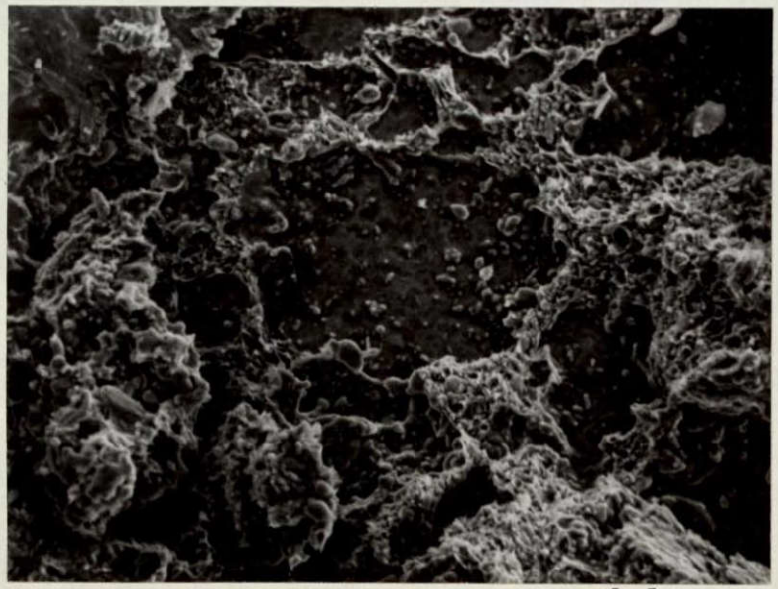
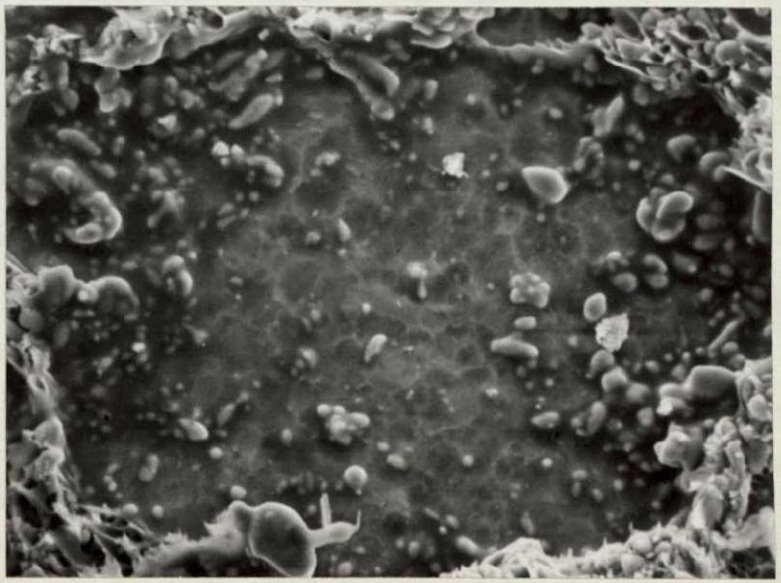
FIGURE 24. Two magnifications of sample #546D3 and #554D3, showing the areas from which the EDAX spectra of Figure 23 were collected.

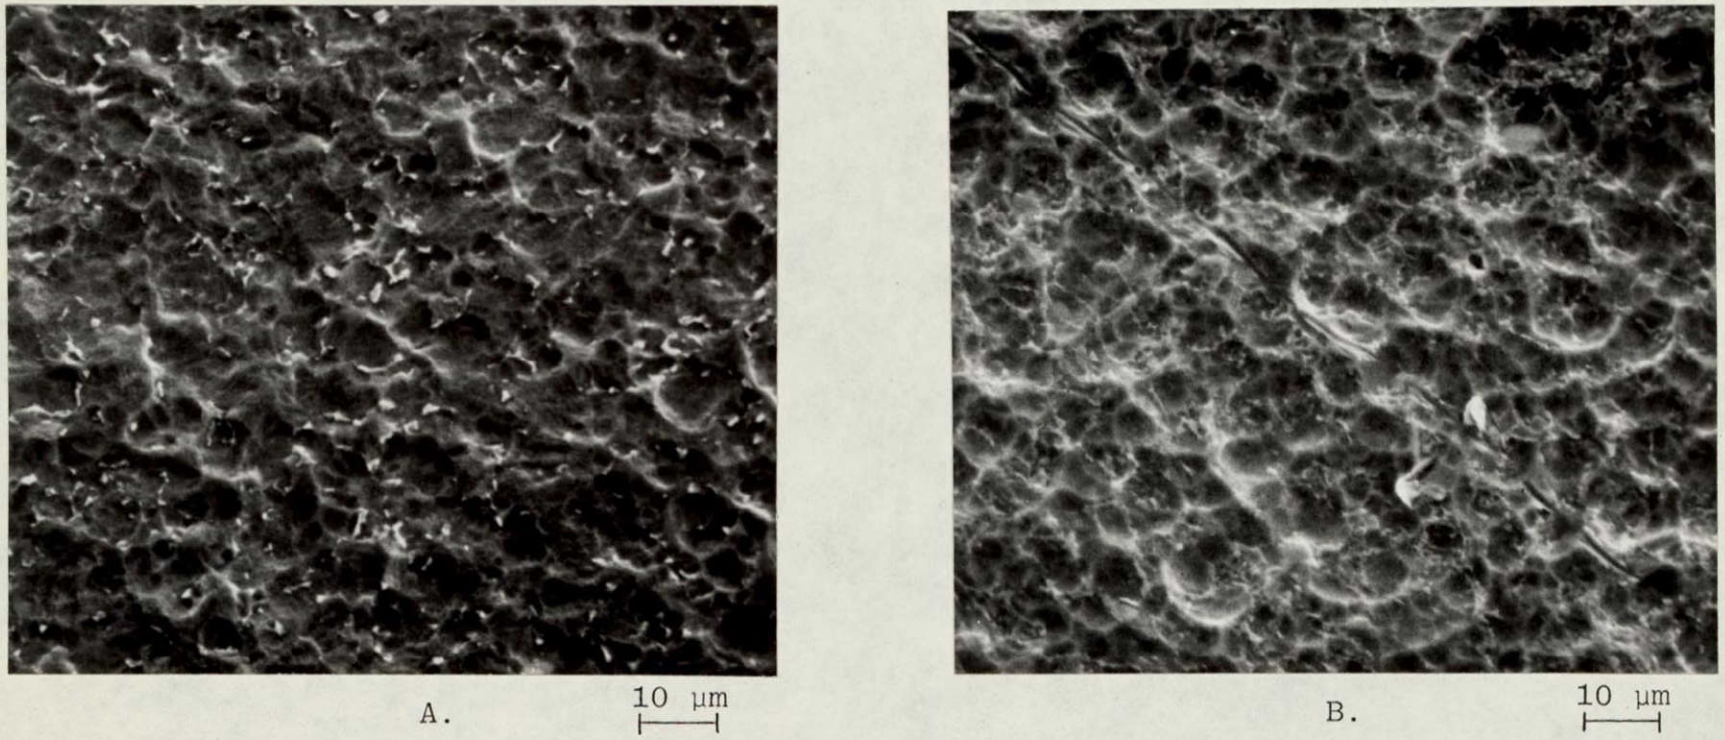
Figure 25 shows a high magnification view of the Ti 6-4 surface after the phosphate-fluoride and Turco cleaning processes. The phosphate-fluoride etch gives a similar SEM photomicrograph as reported for the Pasa-Jell process (3). However, the white β-phase particles are not as apparent in the panel cleaned by the Turco process.

An aluminum panel was cleaned in a sequence of steps: Alkaline rinse, wipe, acid rinse. High magnification photomicrographs after each step are shown in Figure 26. After the alkaline step, the surface appears like a structureless gel containing small white particles. Presumably these are various amorphous and crystalline forms of hydrous aluminum oxide-hydroxide gel. The wiping step removes the surface layer, leaving a solid surface covered with

FIGURE 25. Titanium panels after two different cleaning processes: A. phosphate-fluoride. B. Turco.

FIGURE 26. Aluminum panels after fine sanding and sequential cleaning steps: A. alkaline clean. B. wipe. C. acid clean.

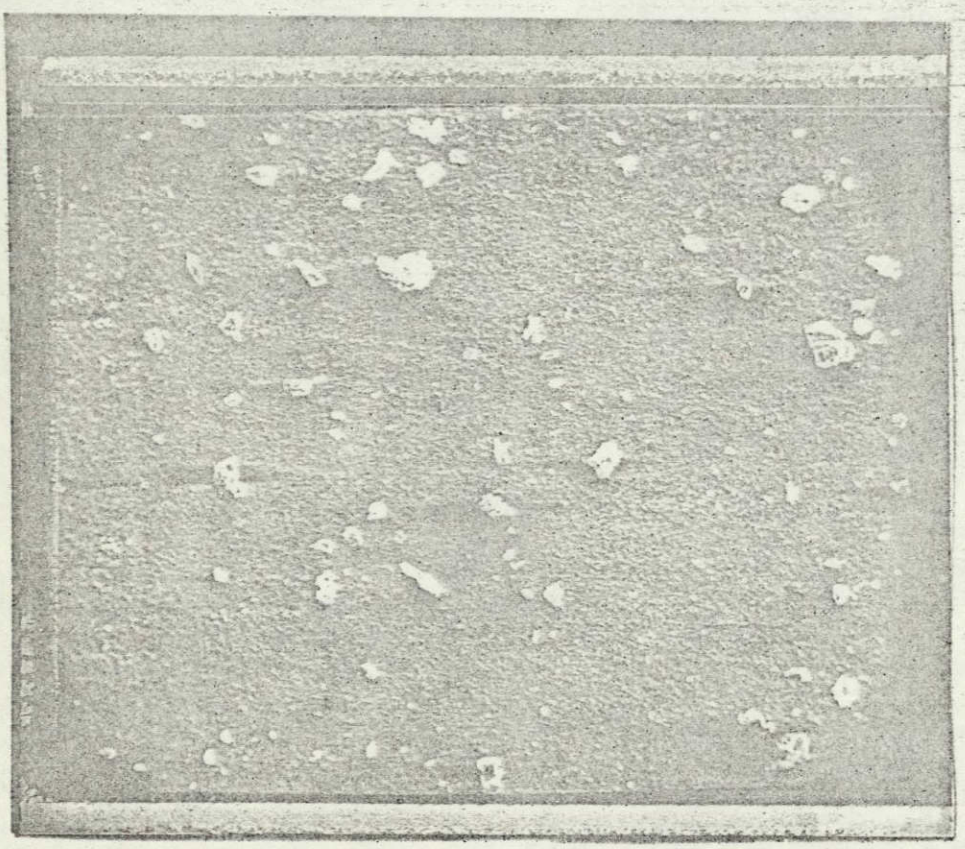
1. Adherend Surfaces. The most striking feature in the scanning electron photomicrographs of the untreated metal surface is the amount of debris (large white particles) typically observed as shown in Figure 1. At 100 x the surface is noticeably fine

Fig. 1. Photomicrograph of Untreated Ti-6-4 Sample (100 X)

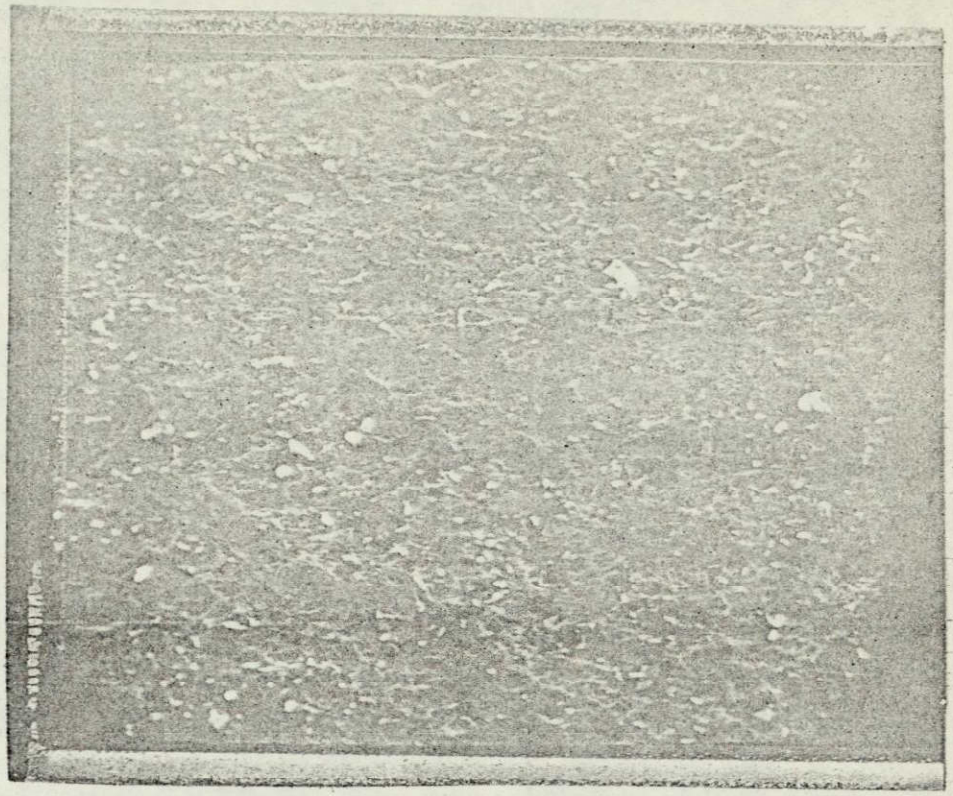
grained, whereas at the higher magnification (x1000) shown in Figure 2 the microscopic roughness readily becomes apparent. In addition, many smaller white presumably crystalline particles are contained in and projecting from a matrix of greyish material.

Fig. 2. Photomicrograph of Untreated Ti-6-4 Sample (1000 X)

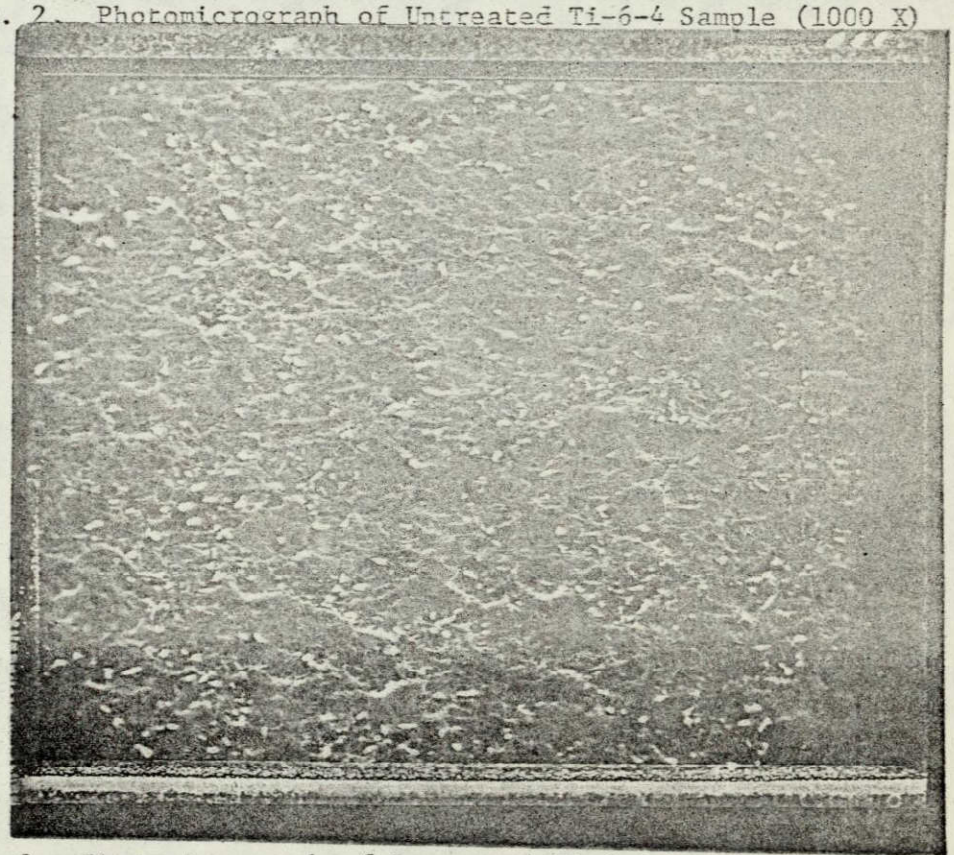
A photomicrograph (X1000) of the degreased sample in Figure 3 has the same surface features as the untreated sample except that the amount of debris is significantly reduced. The photomicrograph (X1000) in Figure 4 shows that the alkaline step of the cleaning

Fig. 3. Photomicrograph of Degreased Ti-6-4 Sample (1000 X)

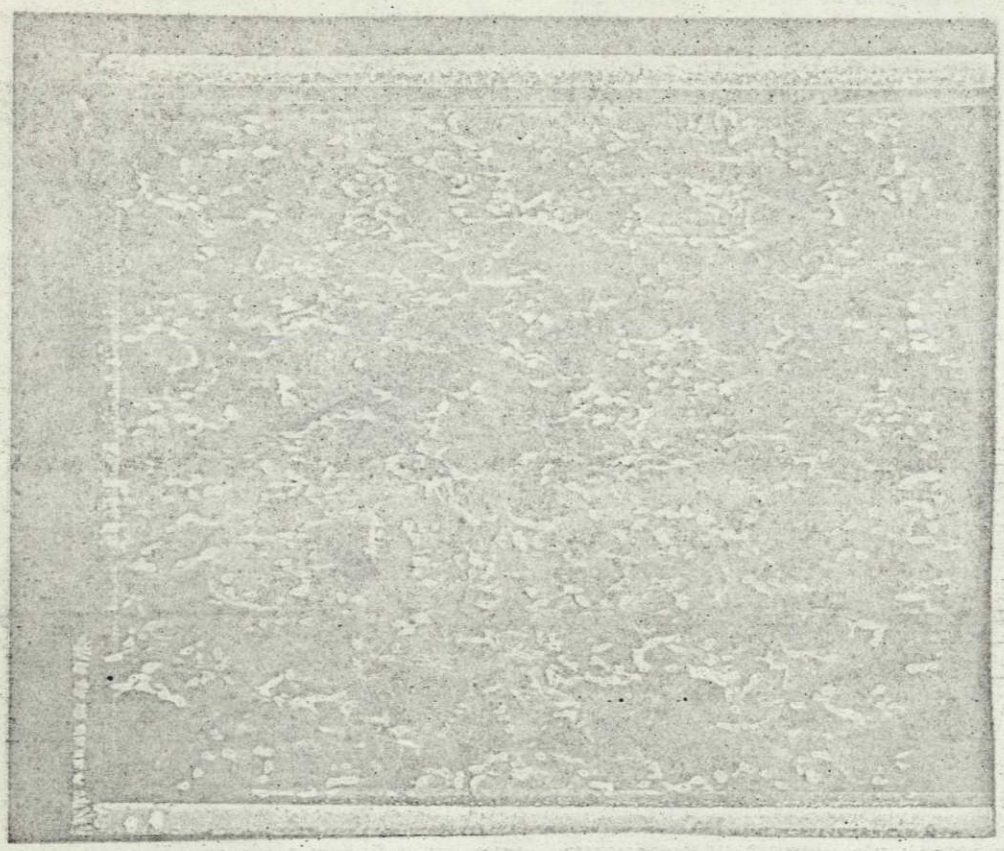
Fig. 4. Photomicrograph of Alkaline Cleaned Ti-6-4 Sample (1000 X)

process selectively etches the grey material, thus exposing more of the small white particles. Acid cleaning continues the selective etching of the grey material as indicated by the photomicrograph (X1000) in Figure 5. No discernibly different features were noted in the photomicrographs after the Pasa-Jell treatment. Thus, each step of the cleaning process produces distinct changes in surface features except the final Pasa-Jell treatment.

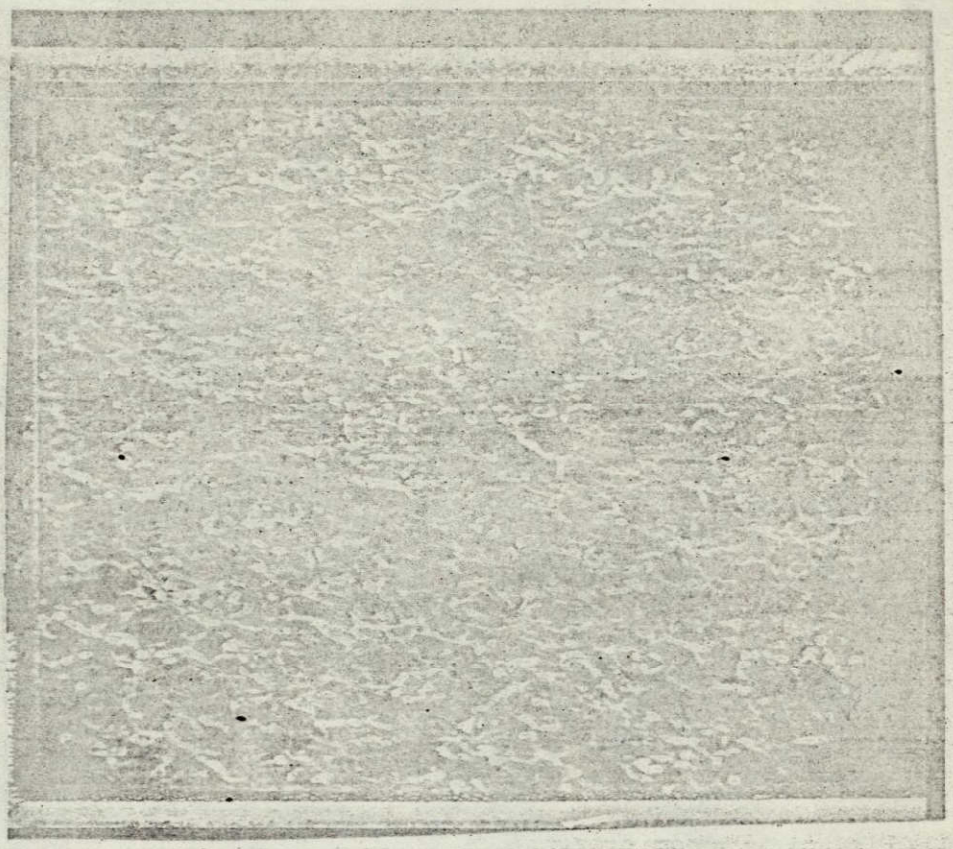
Fig. 5. Photomicrograph of Acid Cleaned Ti-6-4 (1000X)

material spread on the surface. Steps and ridges of the alpha phase become important features as etching takes place. Etching along planes of the crystal faces oriented oblique to the surface produces the steps and ridges as seen in Figure 5. Similar SEM results for Ti-6-4 have been reported by Hamilton (8).

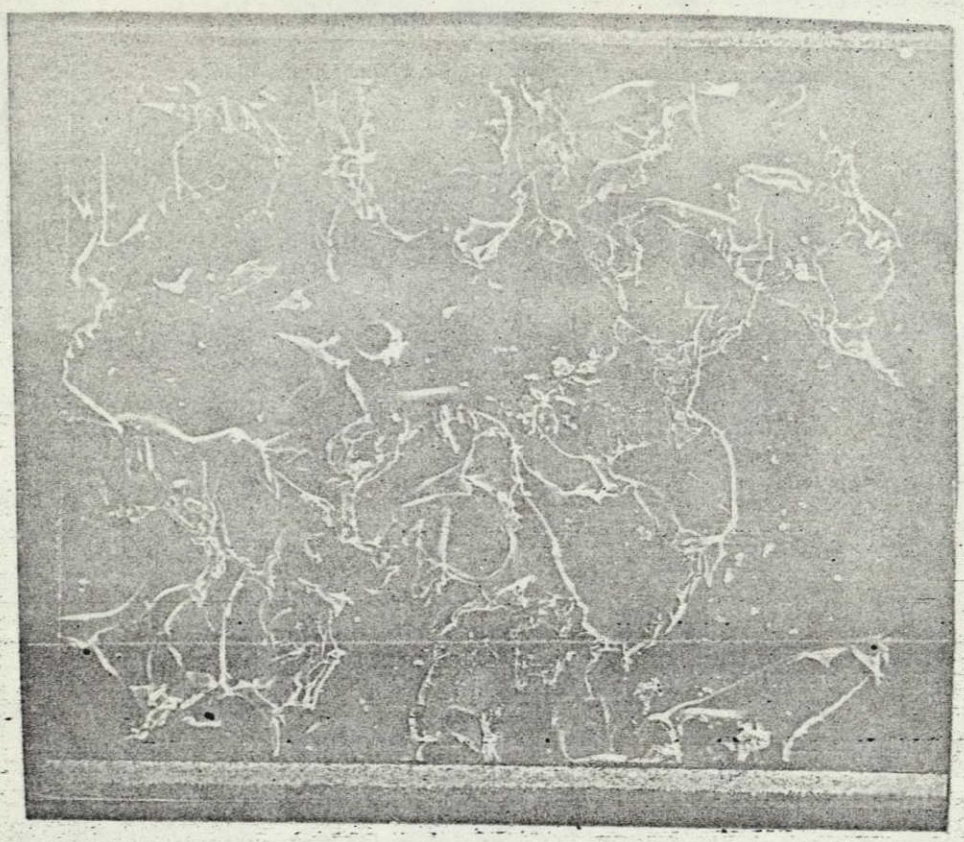
2. Fracture Surfaces - Set I. Photomicrographs of the fractured samples from Sets I and II are shown in Figures 6 to 16. Diglyme was used as a solvent in Sample 219D2 whereas DMAC was used as a solvent in Sample 220D3 in Set I. The photomicrographs of Sample 219D2 in Figure 6 and of Sample 220D3 in Figure 7 indicate dramatically the difference in the extent of surface coverage of the adhesive in these two systems. Sample 219D2 (diglyme) exhibits an almost complete coverage of the metal surface by the adhesive with only small patches of metal exposed indicative of cohesive failure. On the other hand, the surface of sample 220D3 (DMAC) has large areas of metal exposed as seen in Figure 7 indica-

Fig. 6. Photomicrograph of Fracture Sample 219D2 (100 X)

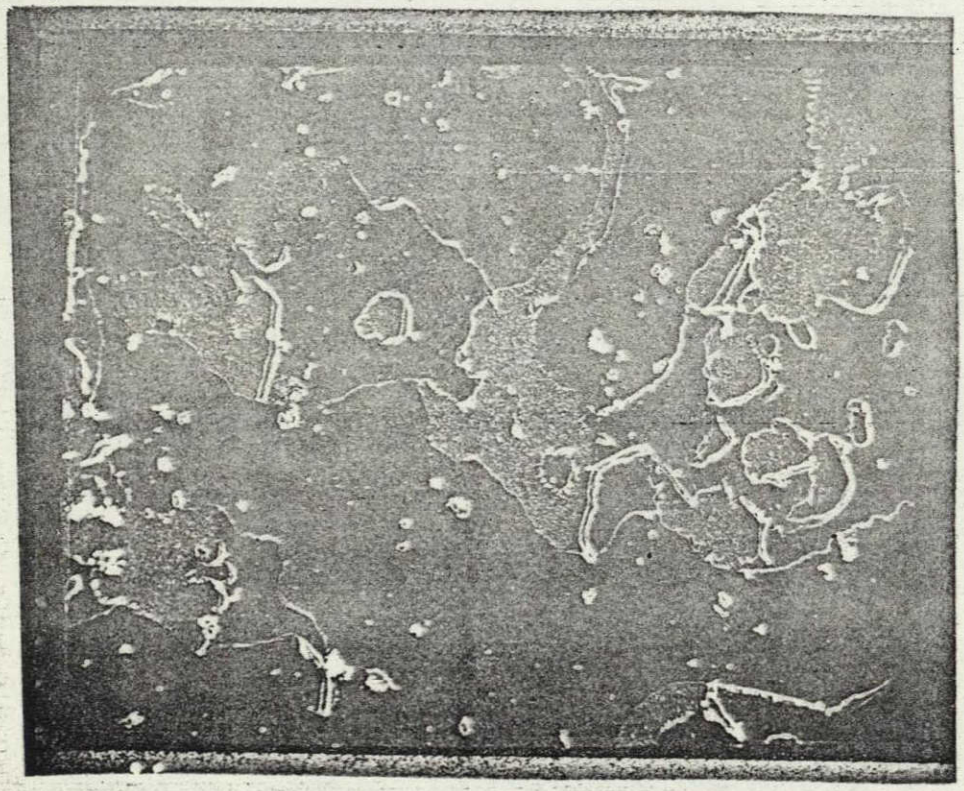
Fig. 7. Photomicrograph of Fracture Sample 220D3 (100 X)

tive of adhesive failure. The adhesive apparently did not wet the substrate in this system. Additional evidence for non-wetting of the substrate by the adhesive in the DMAC system compared to the diglyme system is seen on comparison of the photomicrographs in Figures 8 and 9. The adhesive/substrate interface in Figure 8 is

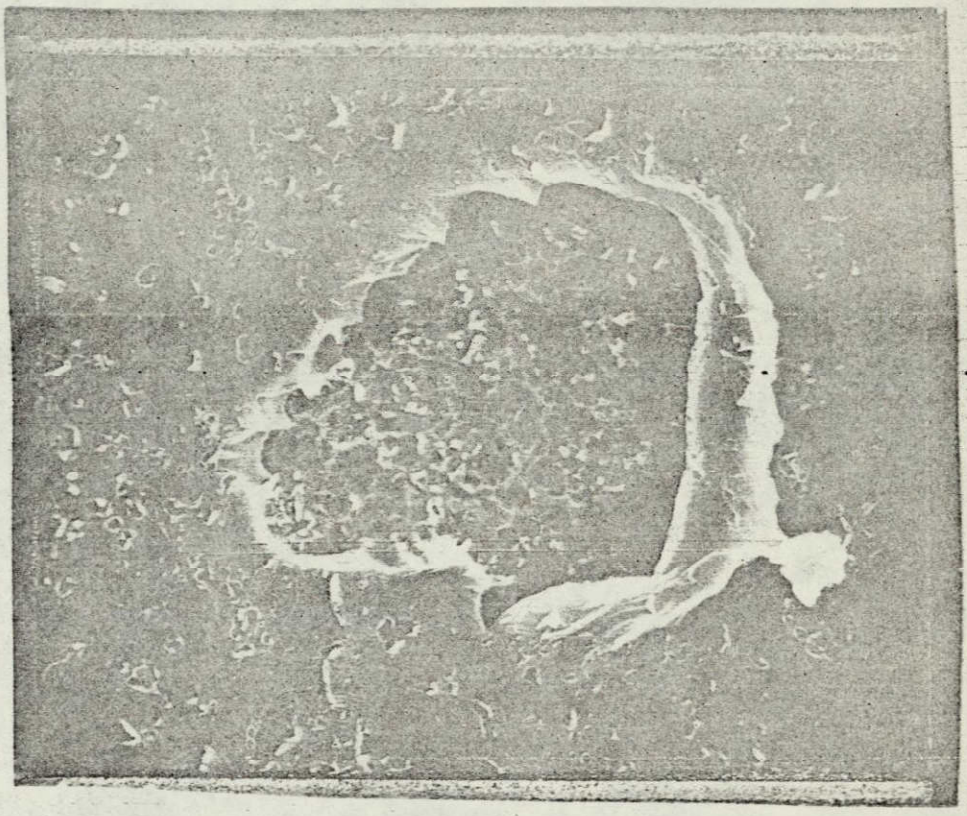
Fig. 8. Photomicrograph of Fracture Sample 220D3 (1000 X)

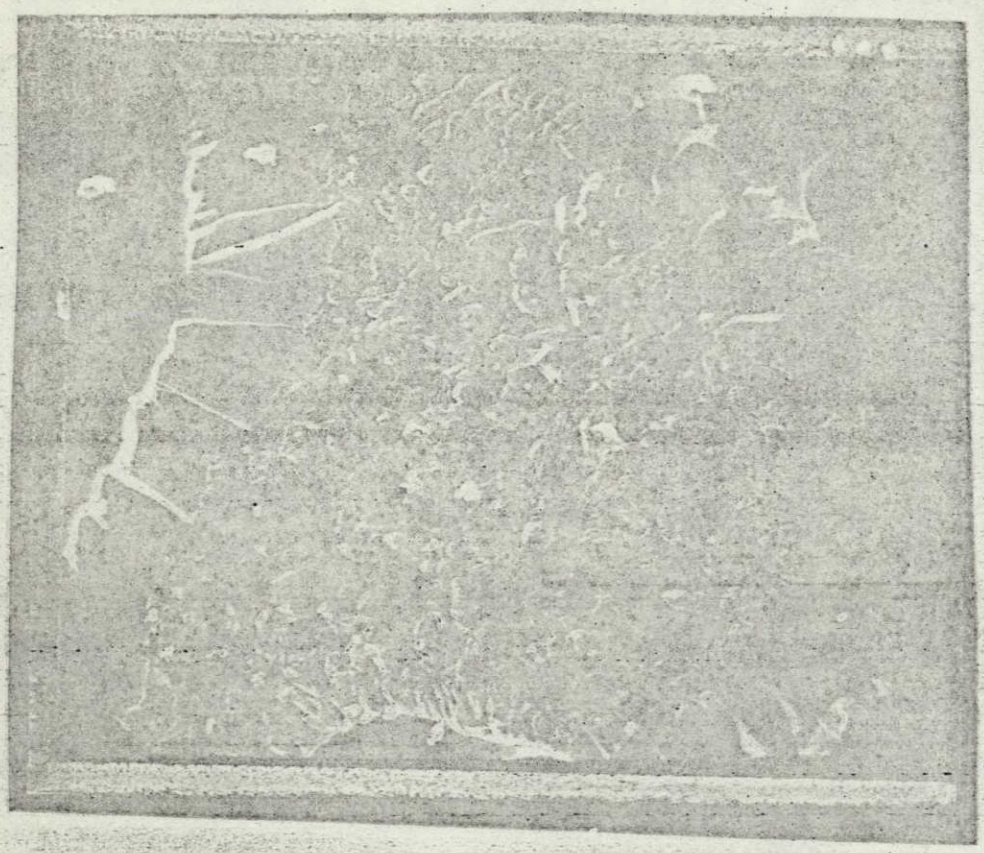
Fig. 9. Photomicrograph of Fracture Sample 219D2 (1000 X)

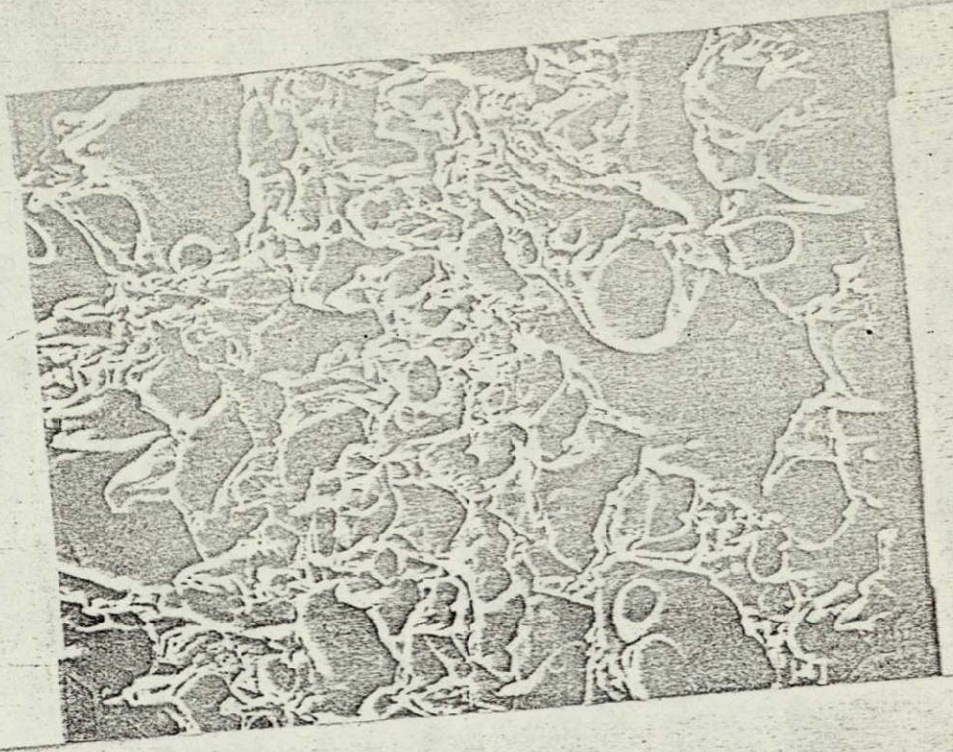
Fig. 10. Photomicrograph of Fracture Sample 1m2-517D1 (100 X)

3. Fracture Surfaces - Set II. The samples in Set II were prepared twelve months after the samples in Set I. As noted in Table I, the average lap-shear strength of the samples in the 1m2-517 series (Set II) was 3860 psi. This series has the greatest lap-shear strength of the different series in Set II. The 1m2-517 series is the same adhesive-solvent system as the sample 219D2 in Set I. The difference in the absolute value of the lap-shear strength is not considered significant. In Figure 10 is seen a 100X photomicrograph of the sample 1m2-517D1. The features of this sample were representative of the other samples of this series. The significance of this photomicrograph was the apparent absence of the metal substrate structure. The excellent reproducibility of the SEM analysis of the fracture surface is demonstrated by the similarity of the features in Figure 10 and Figure 6 for Set I for the same BTDA + m,m'DABP/diglyme system. A closer examination of this sample at 500X can be seen in Figure 11. The smoothness of the pockets relative to the jagged areas is apparent. The jagged regions are believed to result from the fracture of contact areas between the two adhesive-coated panels when the samples were lap-shear tested. Adhesive strength might be substantially increased if more contact with the resin were possible. The pockets in Figure 11 represent non-bonding areas.

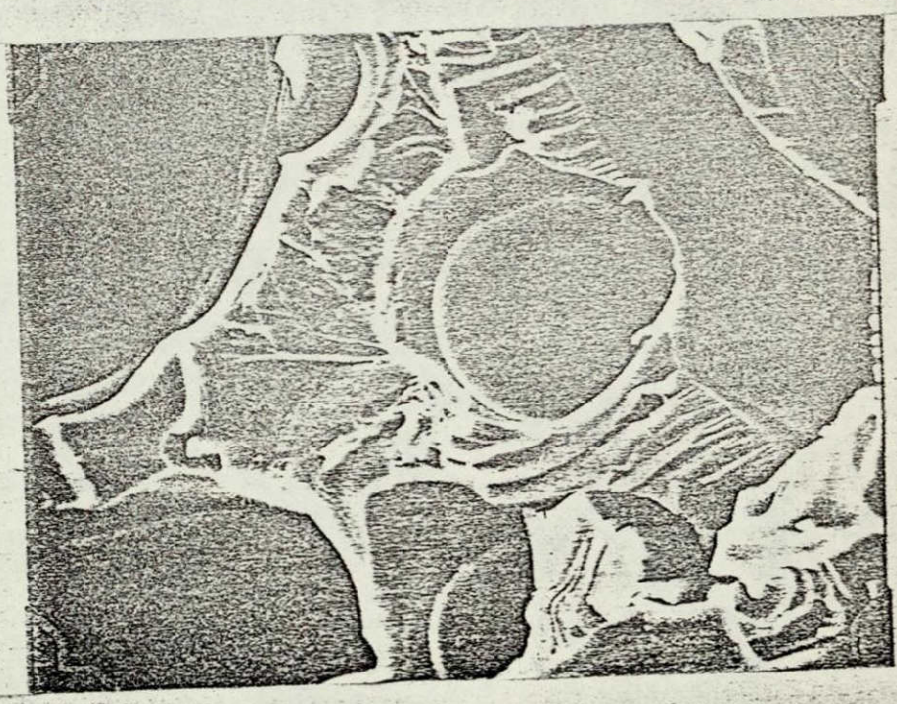
Fig. 11. Photomicrograph of Fracture Sample 1m2-517D1 (500 X)

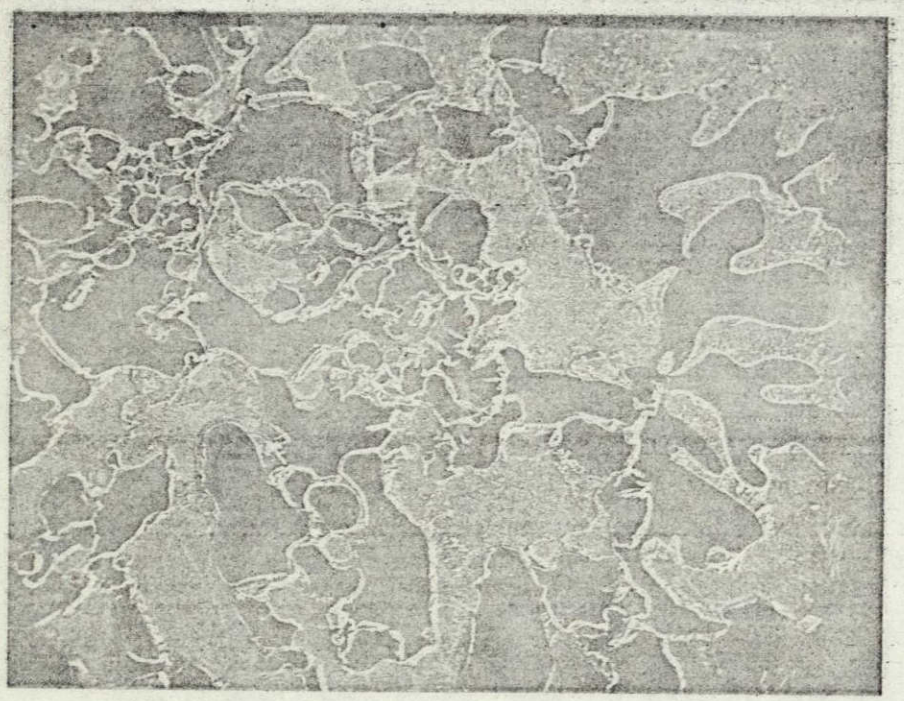
Fig. 12. Photomicrograph of Fracture Sample 1mp2-516D1 (20 X)

The samples in the 1mp2-516 series had an intermediate average lap-shear strength of 2073 psi (Table I). A 20X photomicrograph, Figure 12, of the sample 1mp2-516D1 illustrates a structure very different from that observed for the 1m2-517 series of fracture samples. The dissimilarity of the 1m2-517 and the 1mp2-516 samples is more apparent in Figure 13 (500X) which is a photomicrograph of one of the lighter regions seen in Figure 12. Whereas in the 1m2-517 sample the adhesive appeared smooth, the adhesive in this photomicrograph appears porous and brittle-like. A closer examination of a darker region noted in Figure 12 is seen in Figure 14 (1000X). This region appears smooth with no evidence of metal substrate. The important feature to note in Figures 12-14 is again the lack of the metal substrate structure.

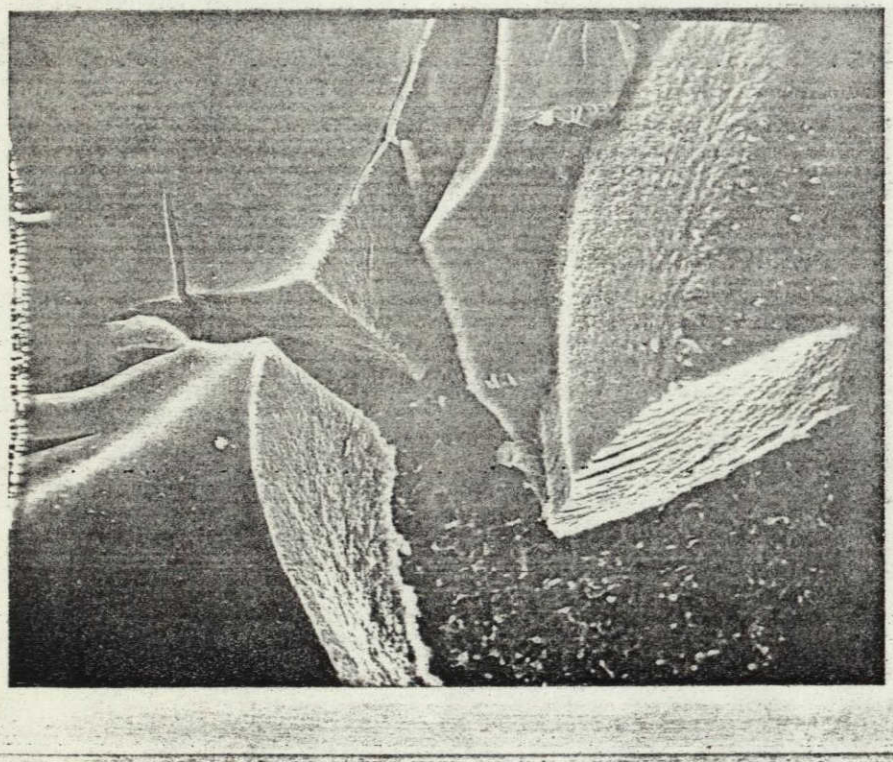
Fig. 16. Photomicrograph of Fracture Sample 2m2-515D1 (500 X)

A 20X photomicrograph of sample 2m2-515D1, which is representative of the samples of zero strength, is seen in Figure 15. This sample has a jig-saw puzzle appearance in that the adhesive is cracked and broken. This feature is more clearly seen in Figure 16 (500X). The metal substrate structure is apparent and there appears to be little wetting between the adhesive and the

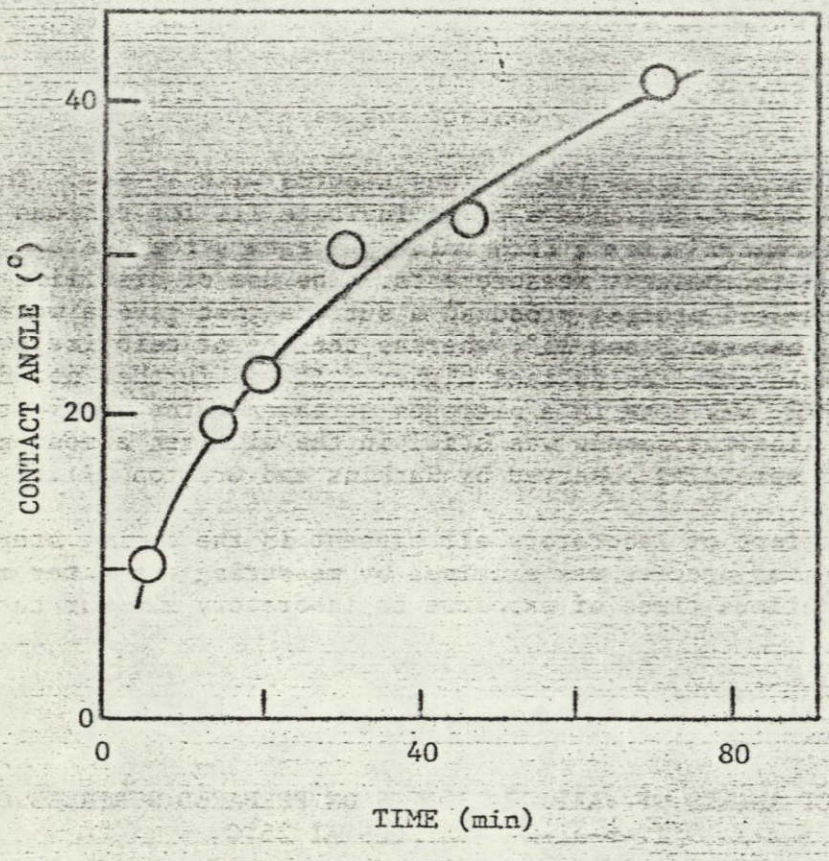
Fig. 17. Water Contact Angle Versus Lab Air Exposure Time for Cleaned Ti-6-4 Samples at 25°

after some four days of exposure to lab air was 60°. Koranyi and Acs (10) also reported an increase in the contact angle of water on glass from 4° to 23° within 4 hours after heating. The noted increase in contact angle (Figure 17) is taken to be indicative of contamination by adsorption of contaminants from laboratory air. This interpretation is in general agreement with the work of Bartell and Smith (11) for water contact angles on gold surfaces. They reported the following values for the conditions indicated: water vapor + pure air : 6°, water vapor + benzene vapor : 84°, and water vapor + lab air : 65°.

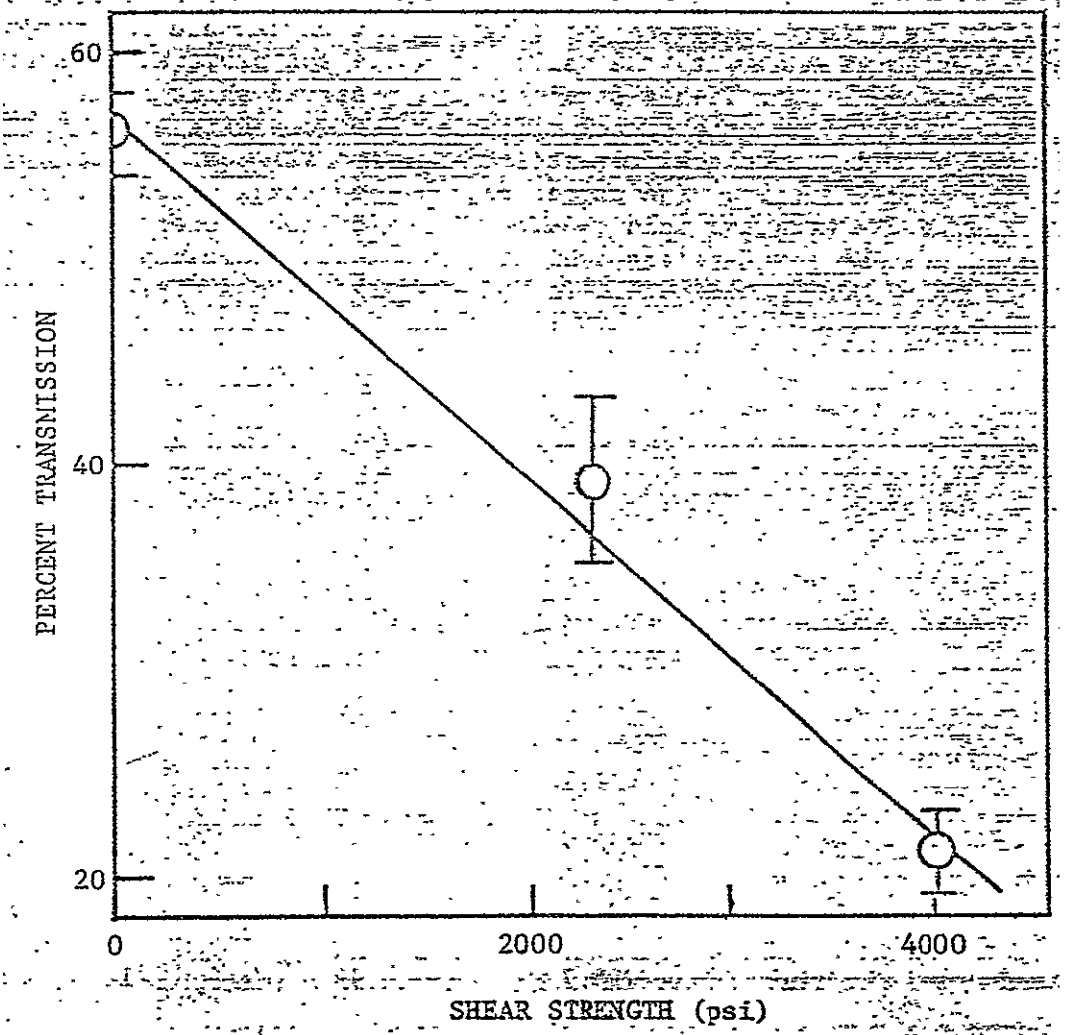
The percent transmission value obtained in the single beam mode for the fracture surfaces of Set II are plotted against the respective lap-shear strength in Figure 18. There appears to be a somewhat linear relationship between the percent transmission and the shear strength of the samples. This may be of no more than

Fig. 18. Percent Transmission vs. Shear Strength for Set II Sample

qualitative significance but it is interesting to note that the samples of zero shear strength (series 2-2-315) in which bare metal was seen in the SEM micrographs have the highest reflectivity.
