FINAL REPORT

EFFECT OF POLYMER PROPERTIES AND ADHEREND SURFACES ON ADHESION

National Aeronautics
and
Space Administration
December, 1975
NASA GRANT NSG-1124

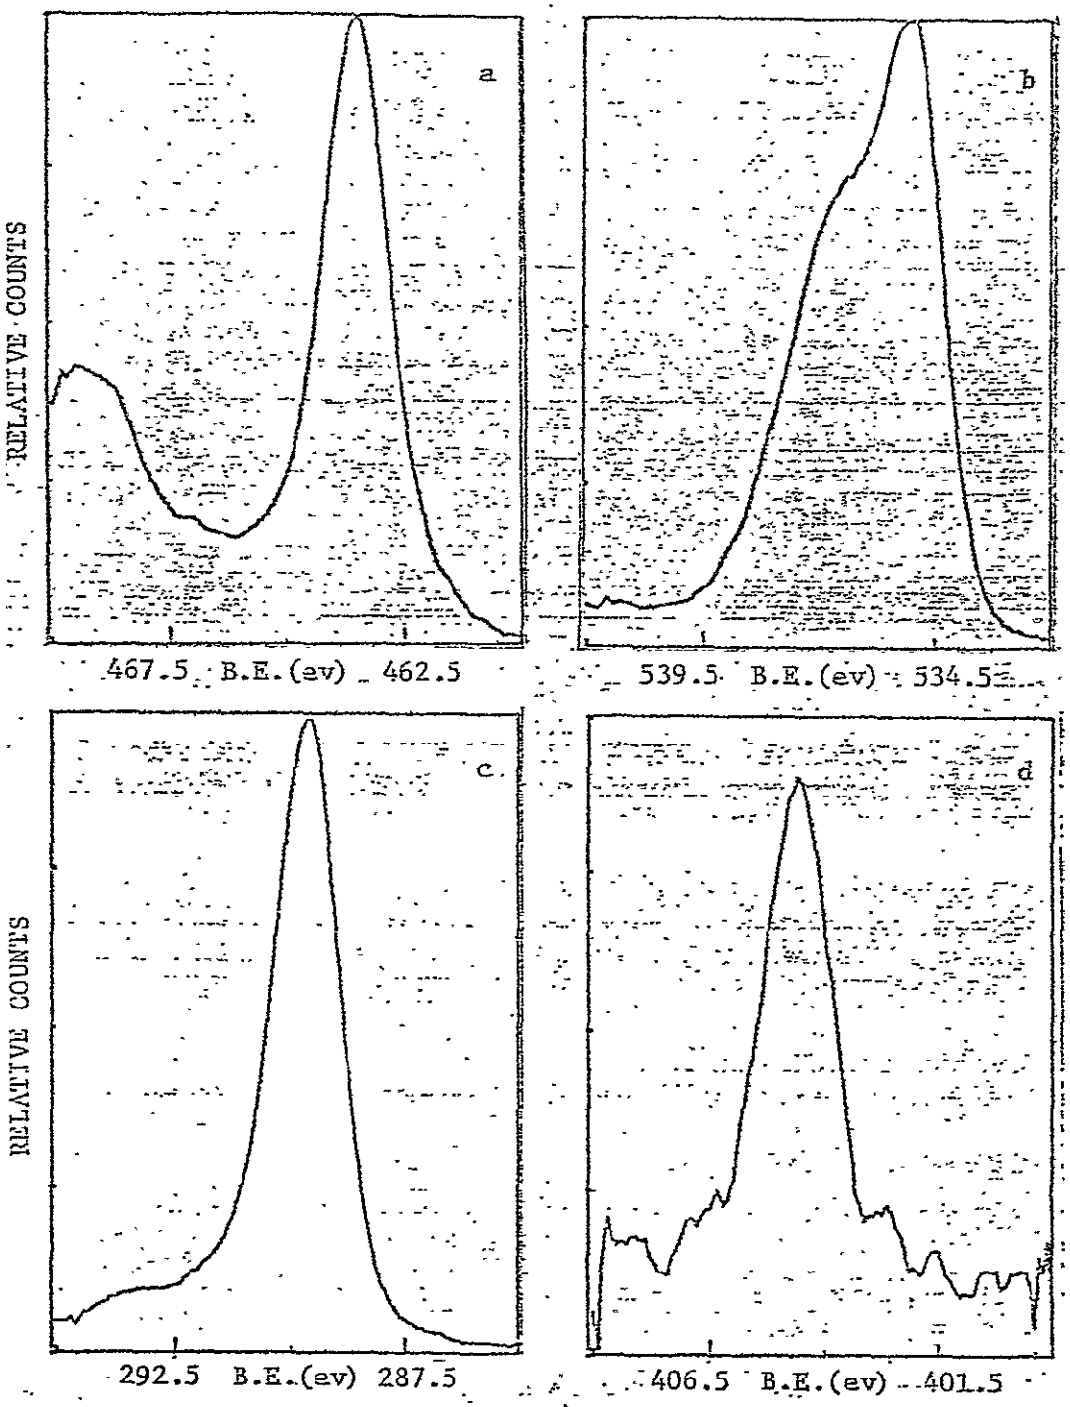
Figure 19 shows typical ESCA spectra for the titanium alloy selected from 23 separate ESCA runs on samples that were either in the as-received state or cleaned. Table V is a listing of the binding energies for titanium, oxygen, nitrogen, and carbon corrected for the work function of the spectrometer. The uncertainty in assignment of the cited binding energies is ± 0.3 ev at a 95% confidence level determined for five independent sample runs. The literature values and assignments in Table V are from Siegbahn (16). The binding energies for titanium and oxygen are in excellent agreement with the values of 457.9 and 529.6 ev reported by Hamilton (8) for Ti-6-4 samples. The observed shift in the binding energies of the titanium doublet from the literature values is taken to indicate the presence of an oxide film on the surface of the Ti-6-4 sample. The oxygen peak was typically broad as shown in Figure 19b with the main shoulder being of lower energy. The carbon peak in some spectra exhibited shoulders indicating different types of carbon contamination in contrast to the sharp peak exhibited in Figure 19c.

Fig. 19. a. Typical ESCA Spectrum of Titanium $2p_{1/2}$ and $2p_{3/2}$ Electron
b. Typical ESCA Spectrum of Oxygen $1s_{1/2}$ Electron
c. Typical ESCA Spectrum of Carbon $1s_{1/2}$ Electron
d. Typical ESCA Spectrum of Nitrogen $1s_{1/2}$ Electron

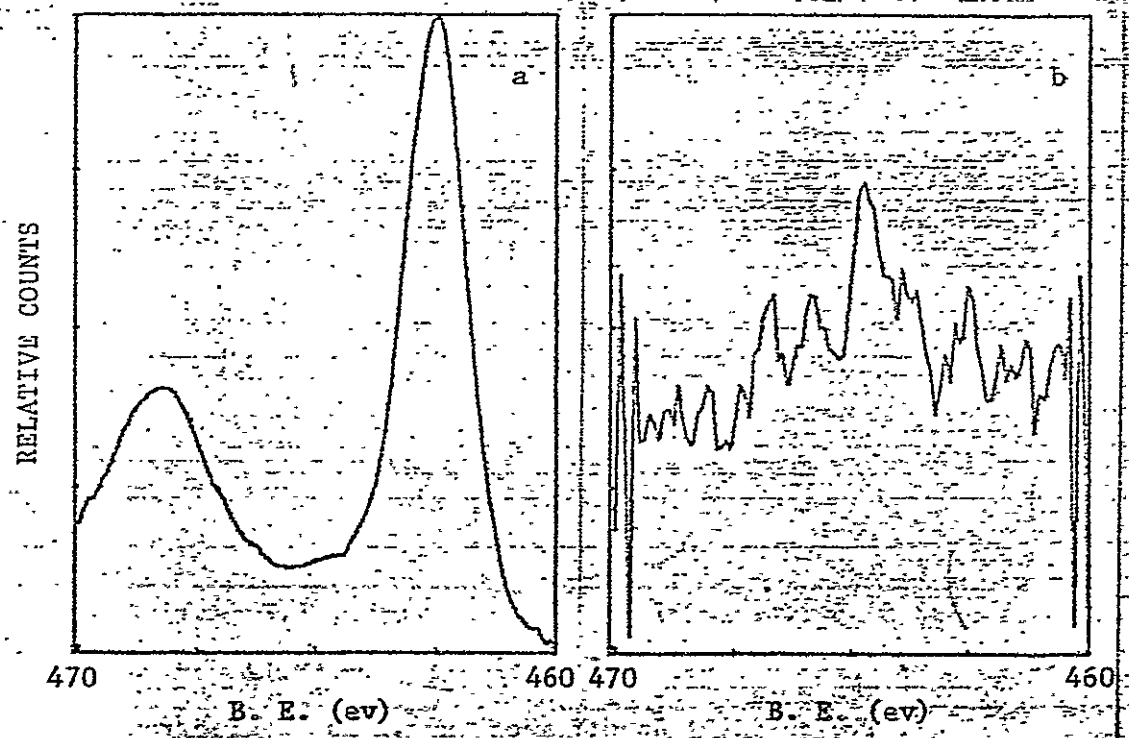
Fig. 20. a. ESCA Spectrum of Ti in Fracture Sample 2m2-515D4 Scanning: 100 channels, 3 sec/channel, 18 scans.
b. ESCA Spectrum of Ti in Fracture Sample 1m2-517D3 Scanning: 100 channels, 3 sec/channel, 18 scans.

The most significant feature to note is that for the fracture samples (Table VI) no Ti signal was found for samples 1m2-517D3 or 1mp2-516D4 indicating the presence of a film at least as thick as 50-100 Å on the panels. This film is seen for the 1m2-517 and 1mp2-516 series in the SEM photomicrographs of Figures 10 and 12. The SEM results showed that bare metal was present on the 2m2-515 samples and the strong ESCA Ti signal for sample 2m2-515D4 clearly supports this finding. The ESCA results demonstrate the utility of the ESCA technique in establishing unambiguously adhesive or cohesive failure at the molecular level of 50-100 Å.
