NASA TM-78892

INVESTIGATION OF THE EFFECT OF CERAMIC
COATINGS ON ROCKET THRUST CHAMBER LIFE

by R. J. Quentmeyer, H. J. Kasper, and J. M. Kazaroff
Lewis Research Center
Cleveland, Ohio 44135

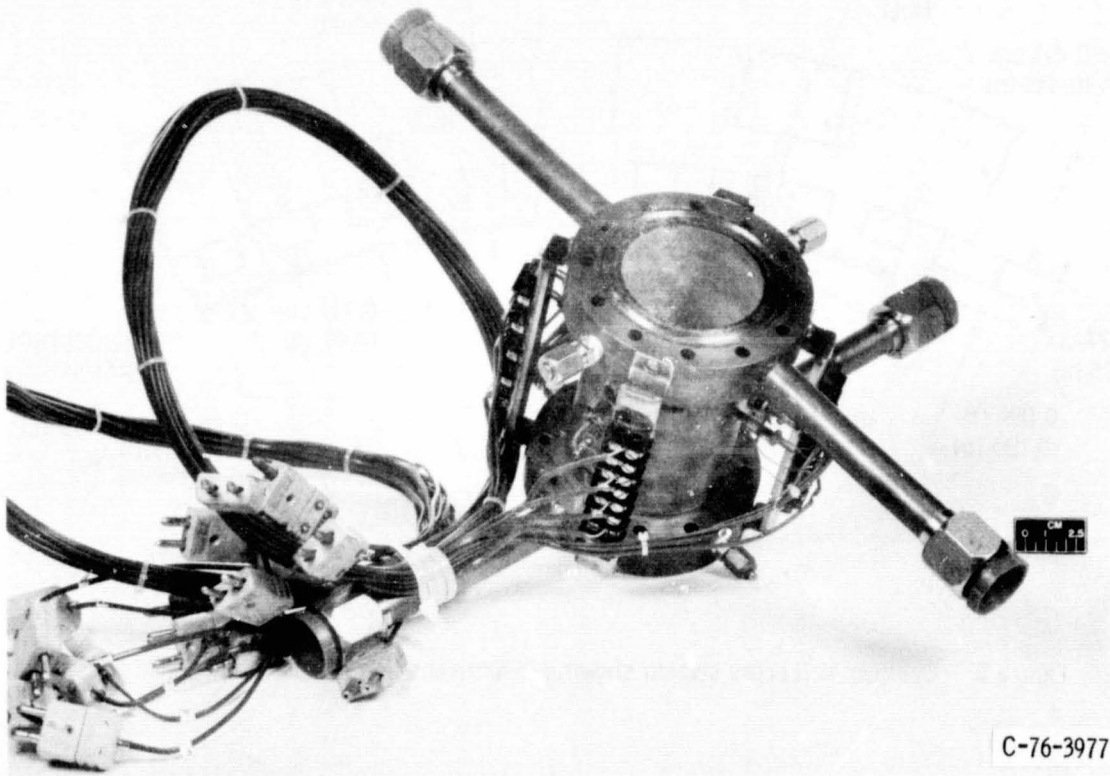
Figure 4. - Coated cylinder S/N 37 with instrumentation installed.

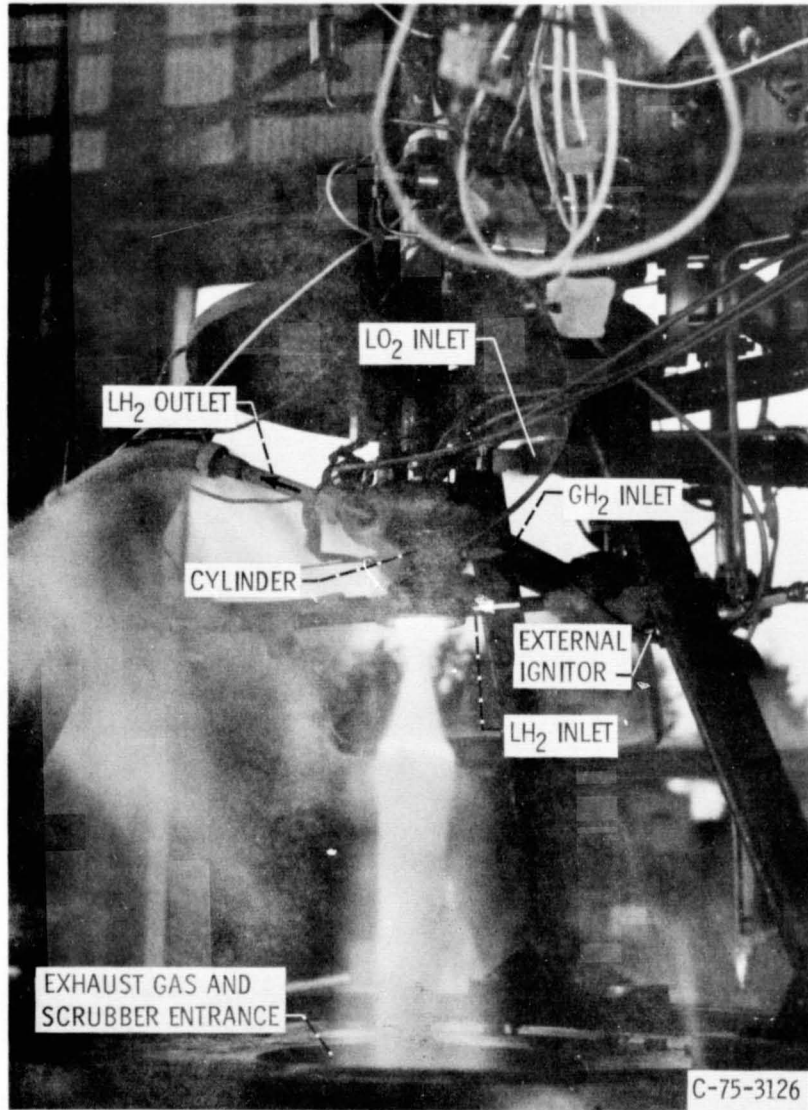
Figure 9. - Cylindrical thrust chamber during cyclic test.

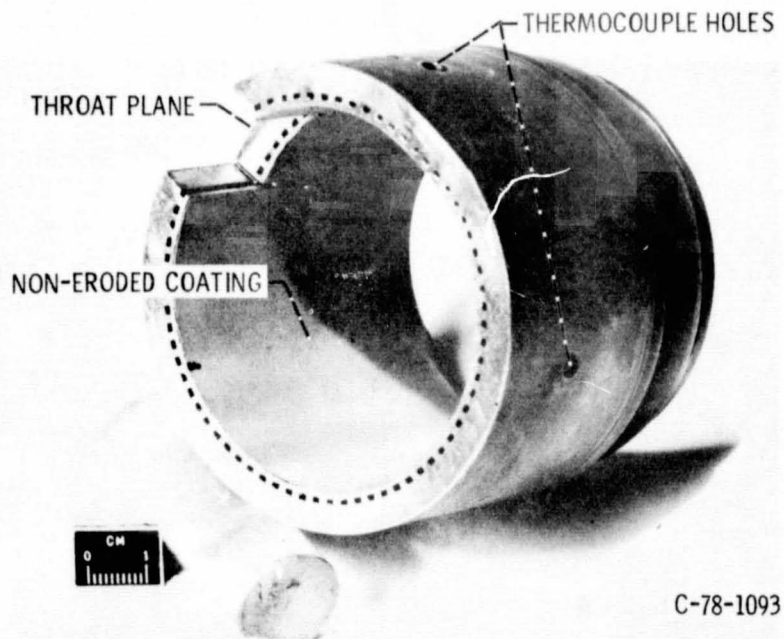
Both coated cylinders showed an erosion of the coating surface, but not uniformly over the entire surface. Figure 10 shows the region of cylinder S/N 36 where the coating remained completely intact. Figure 11 shows another view of cylinder S/N 36 showing the eroded areas of the coating. The throat plane in this figure is the cross section plane that contains the thermocouple hole centerlines. Approximately 55 percent of the coating remained completely intact in the throat region.

Figure 10. - Non-eroded coating in the throat region of cylinder S/N 36.

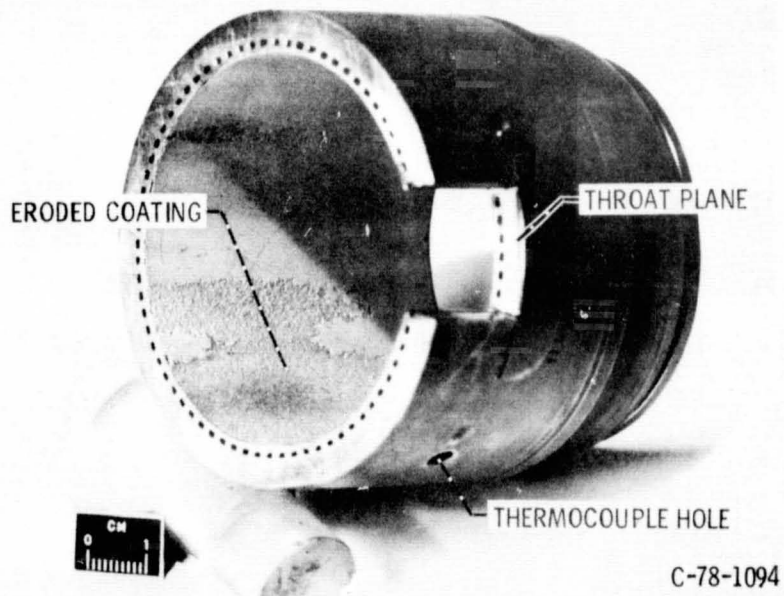
Figure 11. - Eroded coating in the throat region of cylinder S/N 36.

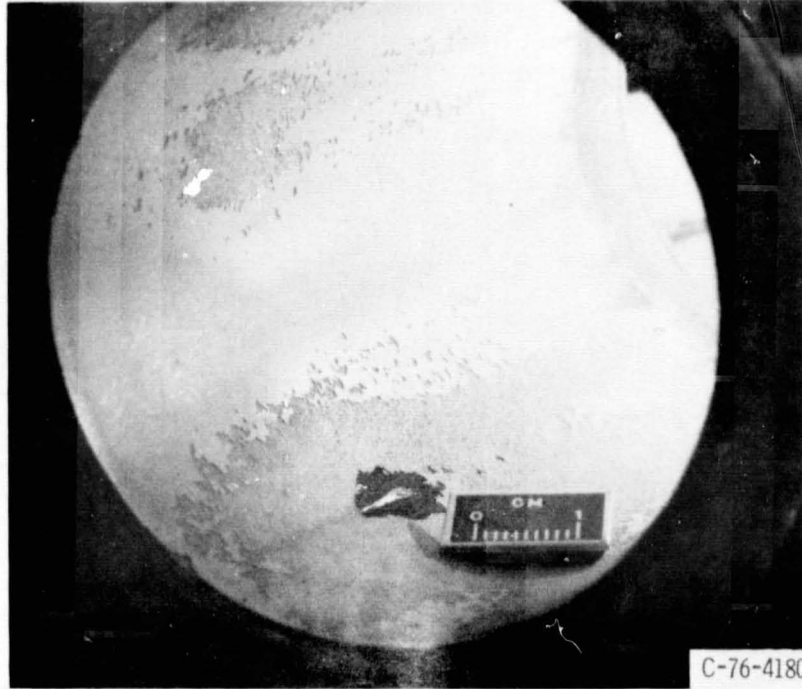
Figure 12 shows the burnout area in the throat region of cylinder S/N 37. During the destructive analysis, the cylinder was cut so that a cross section of the cooling passage in which the burnout occurred could be examined. It was found that the cooling passage was completely blocked with plater's wax at two locations. Consequently, the only cooling provided to this passage was due to the heat conduction through the copper liner to the adjacent cooling passages. Figure 13 shows the plater's wax in the cooling passage. It was concluded that the hot spot caused the cooling passage wall to locally and progressively deform during the cyclic testing until the coating could no longer adhere to the copper wall. Once this local area was exposed to the hot gas, a burnout occurred on the 659th cycle.

Figure 12. - Burned out cooling passage in throat region of cylinder S/N 37.

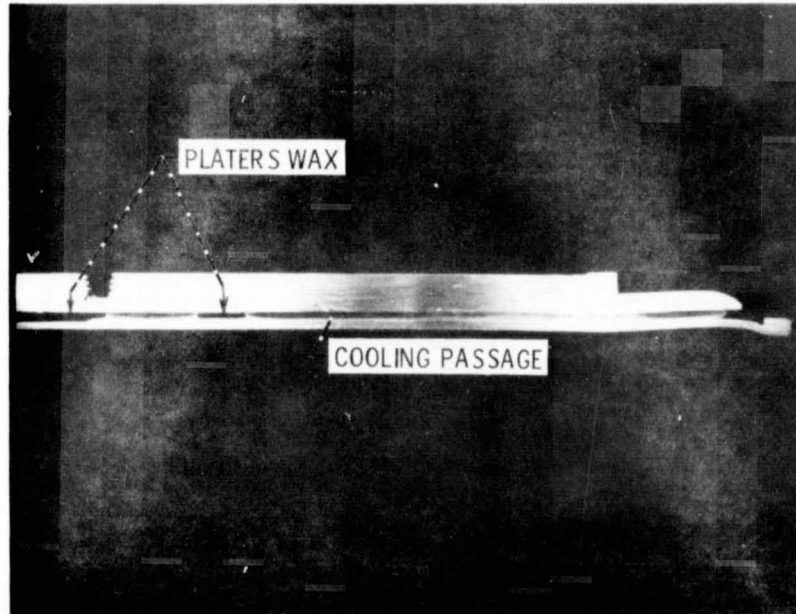
Figure 13. - Blocked cooling passage of cylinder S/N 37.

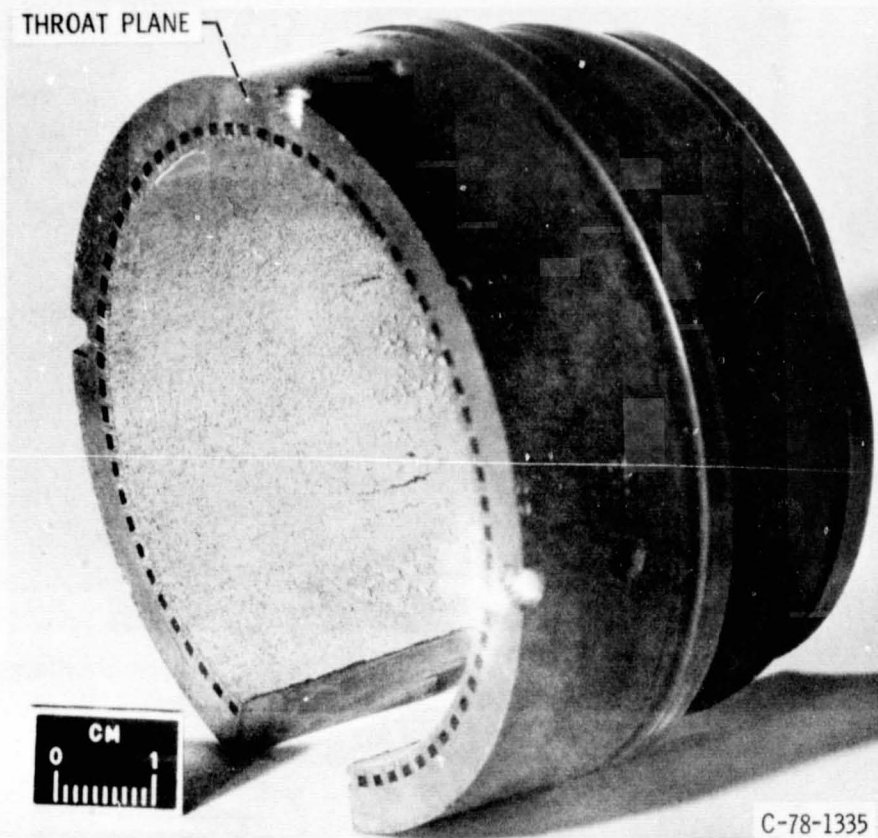
Cylinder S/N 37 showed erosion in the throat region similar to cylinder S/N 36. However, due to the greater number of cycles experienced by cylinder S/N 37, only about 30 percent of the original coating surface remained intact as compared to 55 percent for cylinder S/N 36. Figure 14 shows the uniformly eroded coating surface in the throat region of cylinder S/N 37. Excluding the burned out area of cylinder S/N 37, there was no other area on either cylinder where bare copper was exposed due to failure of the coating to adhere.

Figure 14. - Uniformly eroded coating surface of cylinder S/N 37.

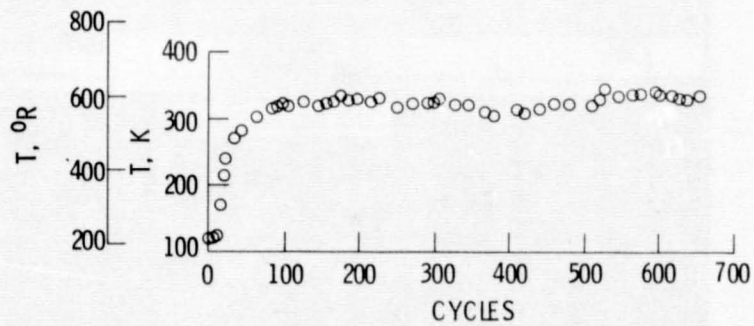
The measured rib temperatures showed that most of the erosion in both cylinders occurred during the initial 80 cycles of testing. This was evidenced by the observed rib temperatures in the areas where erosion occurred. Temperature data from a throat thermocouple in cylinder S/N 37 showed a continuous increase in steady-state temperature to about 80 cycles indicating the coating erosion was taking place. Beyond this, however, the steady-state temperature stabilized indicating that erosion was no longer occurring in that region as shown in figure 15. Although cylinder S/N 36 was tested for only 80 cycles the same characteristic of initial erosion was observed.

Figure 15. - Steady-state temperature of a rib thermo-
couple in an eroded region of coated cylinder S/N 37.

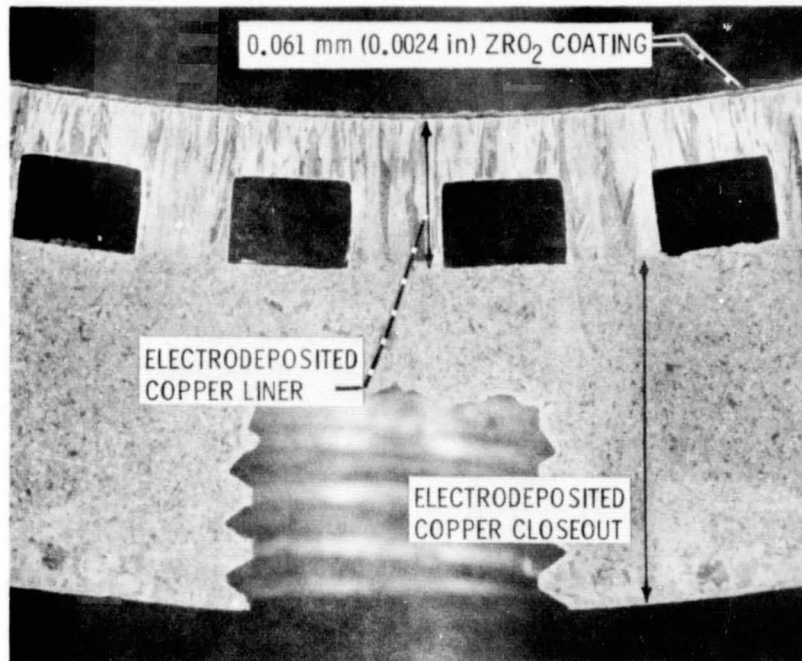
Figure 16 shows a cross section of cylinder S/N 37 at the throat plane at a circumferential location away from the burnout region. The coating at this location has eroded to the 0.061 mm (0.0024 in.) thickness. The uniformity of the coating can be seen in this figure. Note that there is virtually no deformation of the cooling passages, even after 659 thermal cycles. Compare this figure with the cross section of uncoated cylinder S/N 34 shown in figure 17, which developed a crack in the cooling passage wall at 210 cycles. The severely deformed cooling passages are typical of the failure mechanism reported in reference 1, that is, thinning of the cooling passage wall at the centerline until a rupture occurs. It was mentioned previously that cylinder S/N 37 failed prematurely due to a blocked cooling passage. However, if there had been no blocked cooling passage, one could conclude from figure 16 that the cylinder would have endured several hundred more cycles. The effectiveness of the coating in prolonging thrust chamber life can readily be seen from these two figures.

Figure 16. - Cooling passages at throat plane of cylinder S/N 37 after 659 cycles.

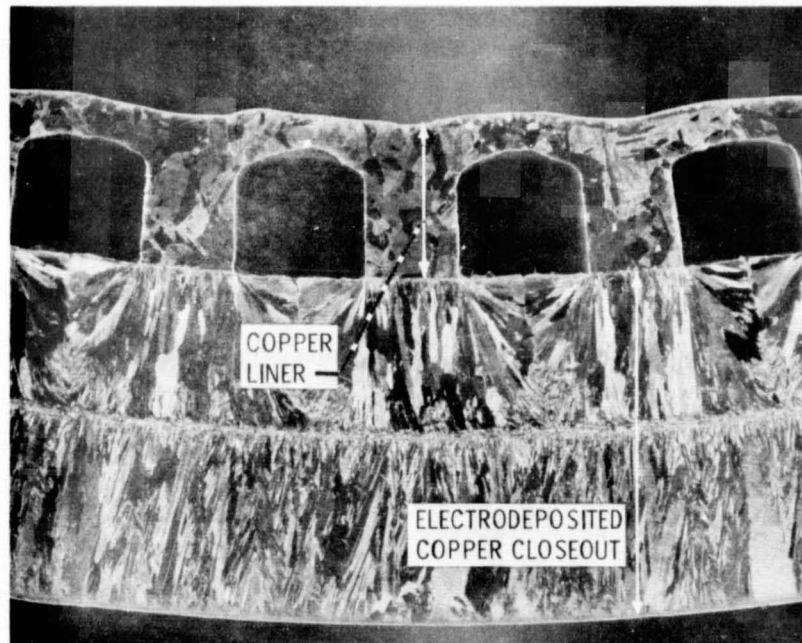
Figure 17. - Deformed cooling passages at throat plane of cylinder S/N 34 after 210 cycles.

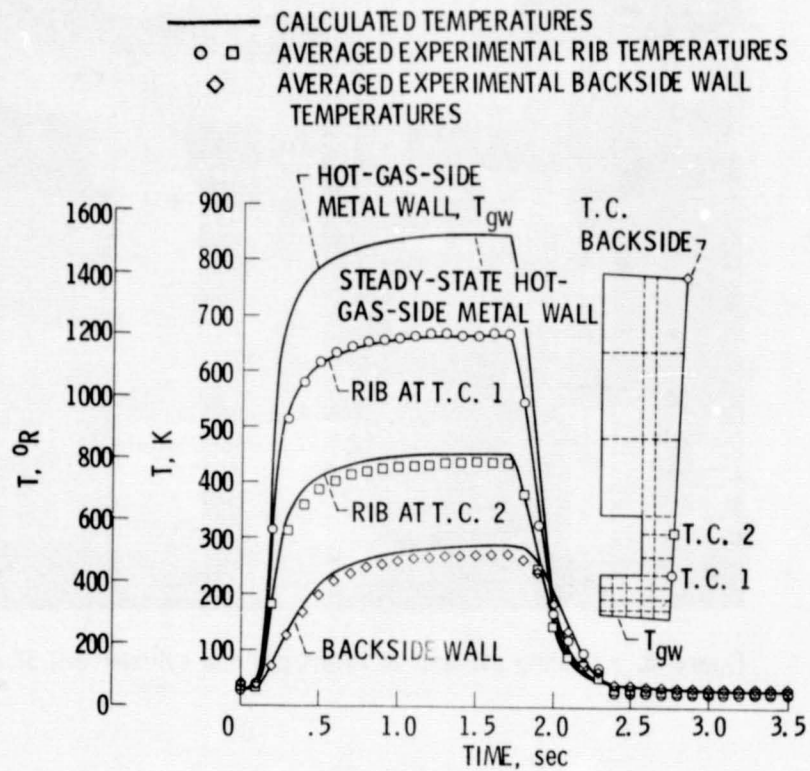
Figure 18. – Matching of thermal analysis with experimental

temperature measurements of uncoated cylinder S/N 34.

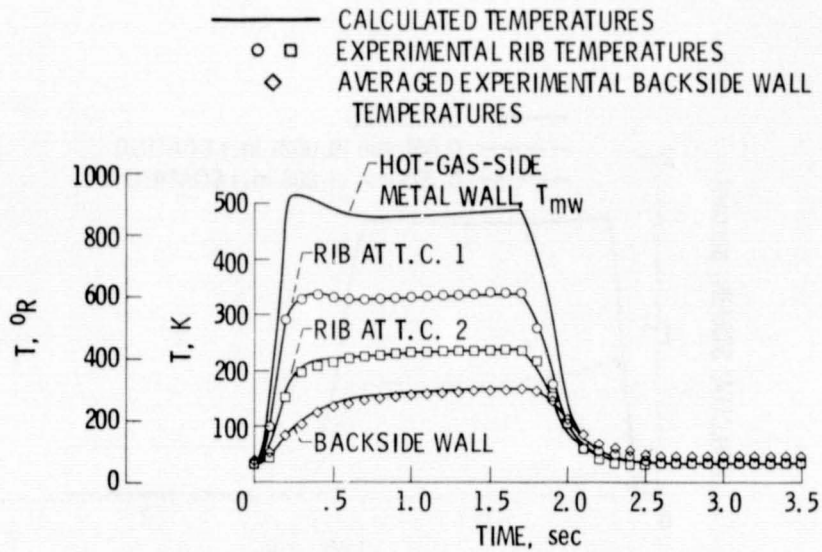
Figure 19. – Matching of thermal analysis with experimental
temperature measurements of coated cylinder S/N 37.

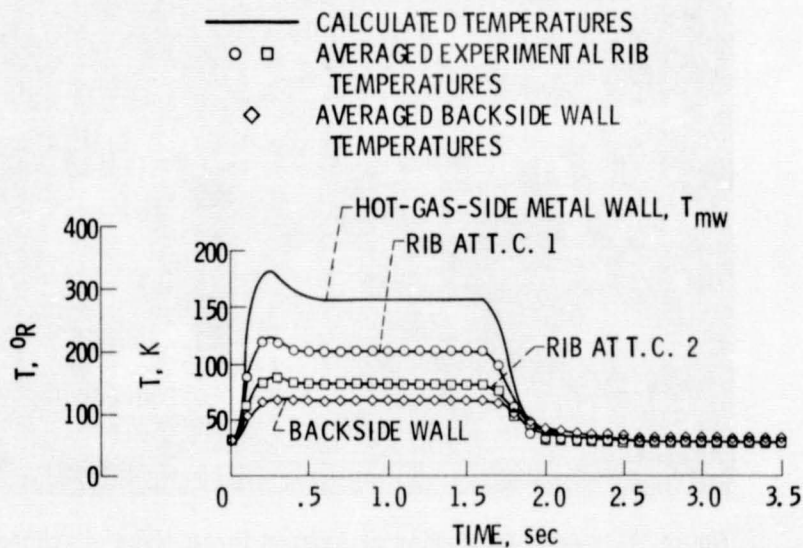
Figure 20. - Matching of thermal analysis with experimental temperature measurements for the eroded coating area of cylinder S/N 37.
