ACCELERATED LIFE TESTING EFFECTS ON CMOS MICROCIRCUIT CHARACTERISTICS

Final Report
May 1976 to December 1979

Contract NAS8-31905

Prepared By
RCA, SOLID STATE DIVISION
Somerville, New Jersey

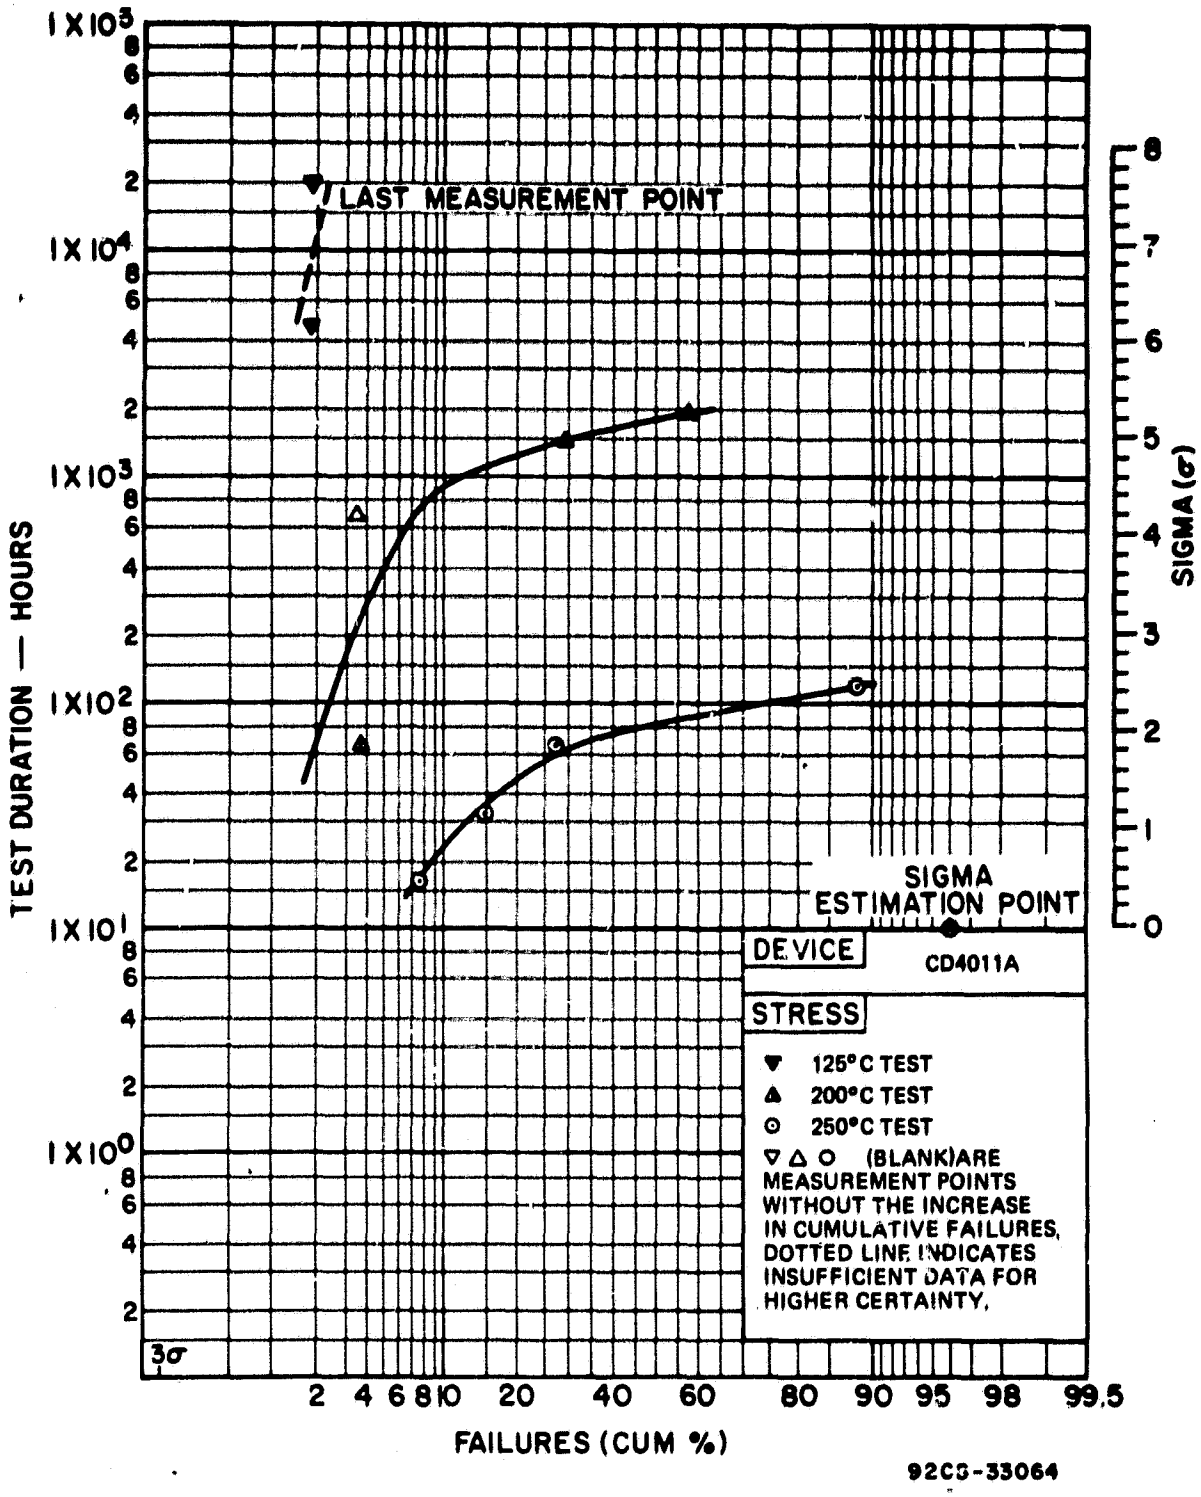
Fig. 10 - Distribution of test failures for CD4011A.

The lower tail regions which represent the early failures (infant mortality) distributions are largely taken out by the standard 125°C burn-ins to which all test devices had been subjected prior to the accelerated life tests. The useful life regions are the regions with constant or decreasing failure rates. These regions are clearly evidenced at 200°C and 125°C test temperatures. The third region shown in the S curve is the wear-out region; this region is represented by the main distribution. The presence of this region is apparent in the 250°C and the 200°C test temperature curves. The characteristic feature of this wear-out region is increasing failure rate. The wear-out region has not been reached by the tests conducted at 125°C.

The 250°C test curves, with a possible exception of the CD4011A, exhibit a compression of the useful life region to such an extent that it becomes indistinguishable from the wear-out region for all practical purposes. Moreover, the available data suggest that the onset of wear-out could have occurred quite early in the test, and that it might have been caused by the exceeding of a yet unknown threshold peculiar to that temperature. Because of these factors it is impossible to estimate the effect of the 125°C burn-ins on the results of accelerated testing at 250°C.

The transition from the useful life region to the wear-out region is most clearly defined by the 200°C test curves for the CD4011A and the CD4013A. The onset of the wear-out region is identified by the knee in the curve where the failure rate begins to increase. The location of this knee is at about 1000 hours for the CD4011A, about 400 hours for the CD4013A, and could be estimated to be at about 100 hours for the CD4024A. The repeat tests (Figs. 13 and 14) conducted at two test temperatures, i.e., 250°C and 200°C, with the CD4011A and the CD4013A, have confirmed a) the existence of fairly well defined regions in the life of the tested microcircuits, i.e., the useful life region and the wear-out region, and b) the location of the knee in the "S" curve, the transition from one region into the other, which is characterized by the changing failure rate from constant to increasing.

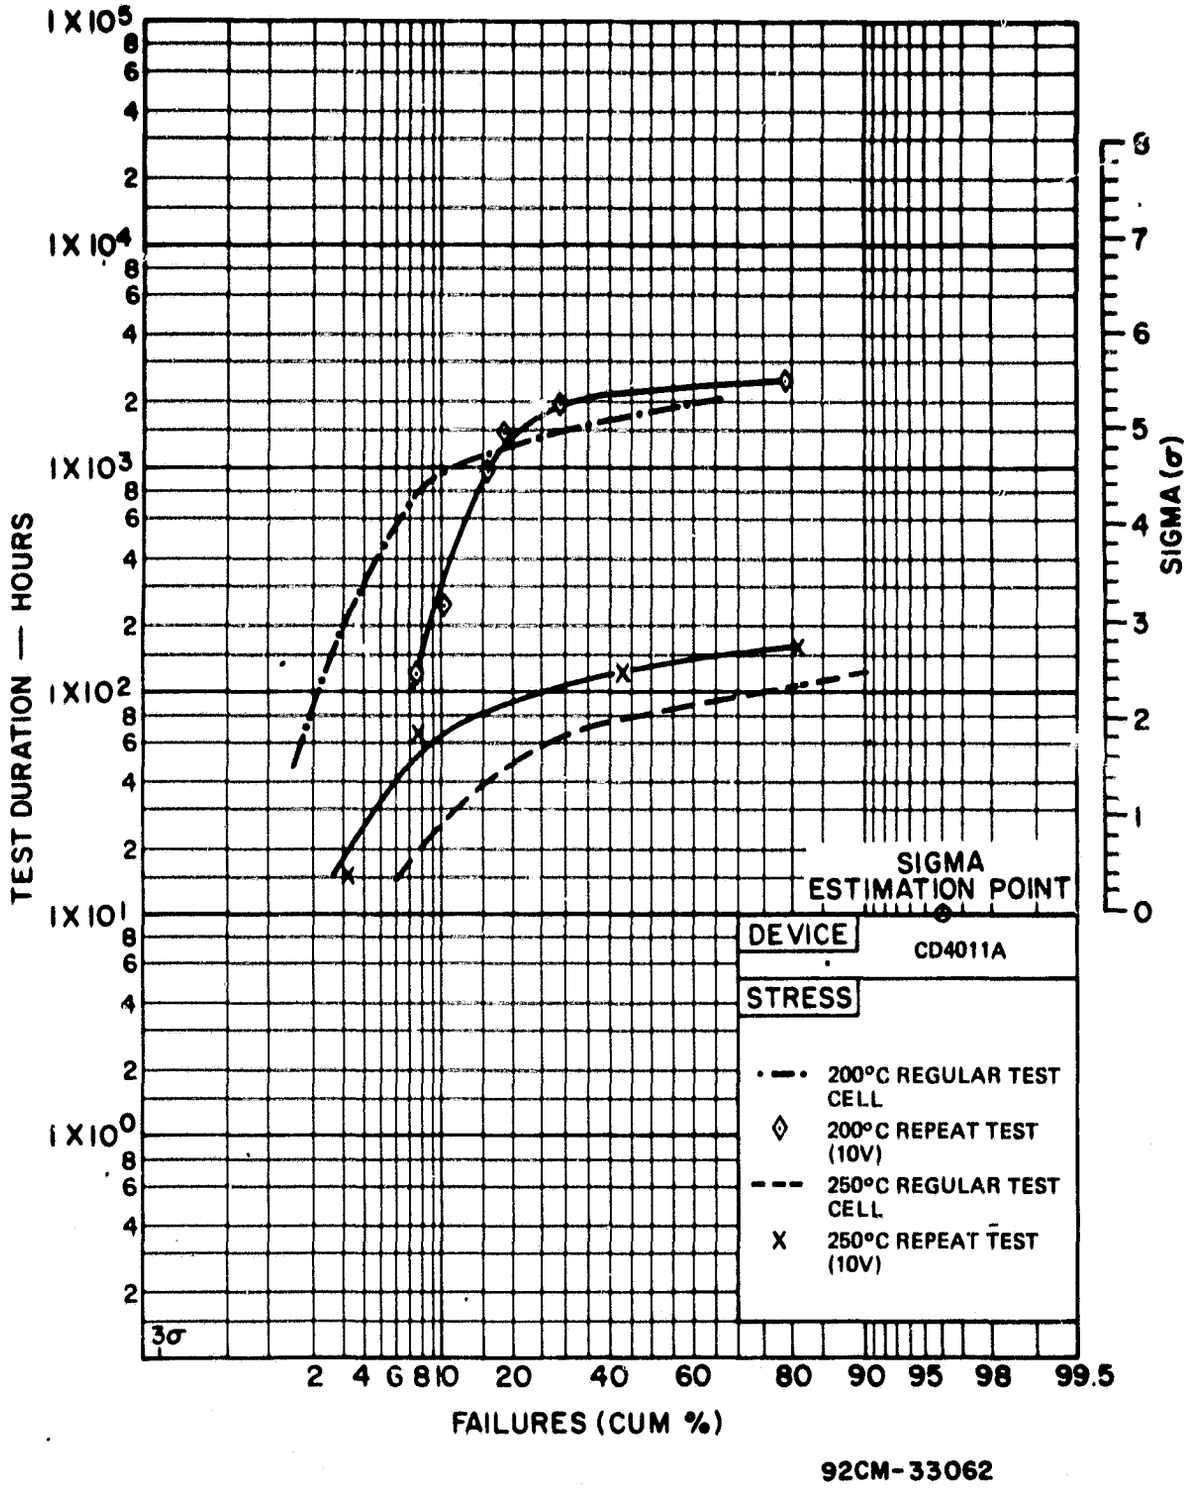
Fig. 13 - Distribution of test failures for CD4011A - Repeat test.

It should be noted that the main distribution at both 250°C repeat tests occurs noticeably later than those of the first test. The reason for this was found to be the life-test voltage: 10 volts during the repeat test instead of 12.5 volts due to an inadvertant error in setting up the test in a different location and by different personnel. This error does not, however, diminish the validity of the confirmation of the existence of the main distributions with increasing failure rate.

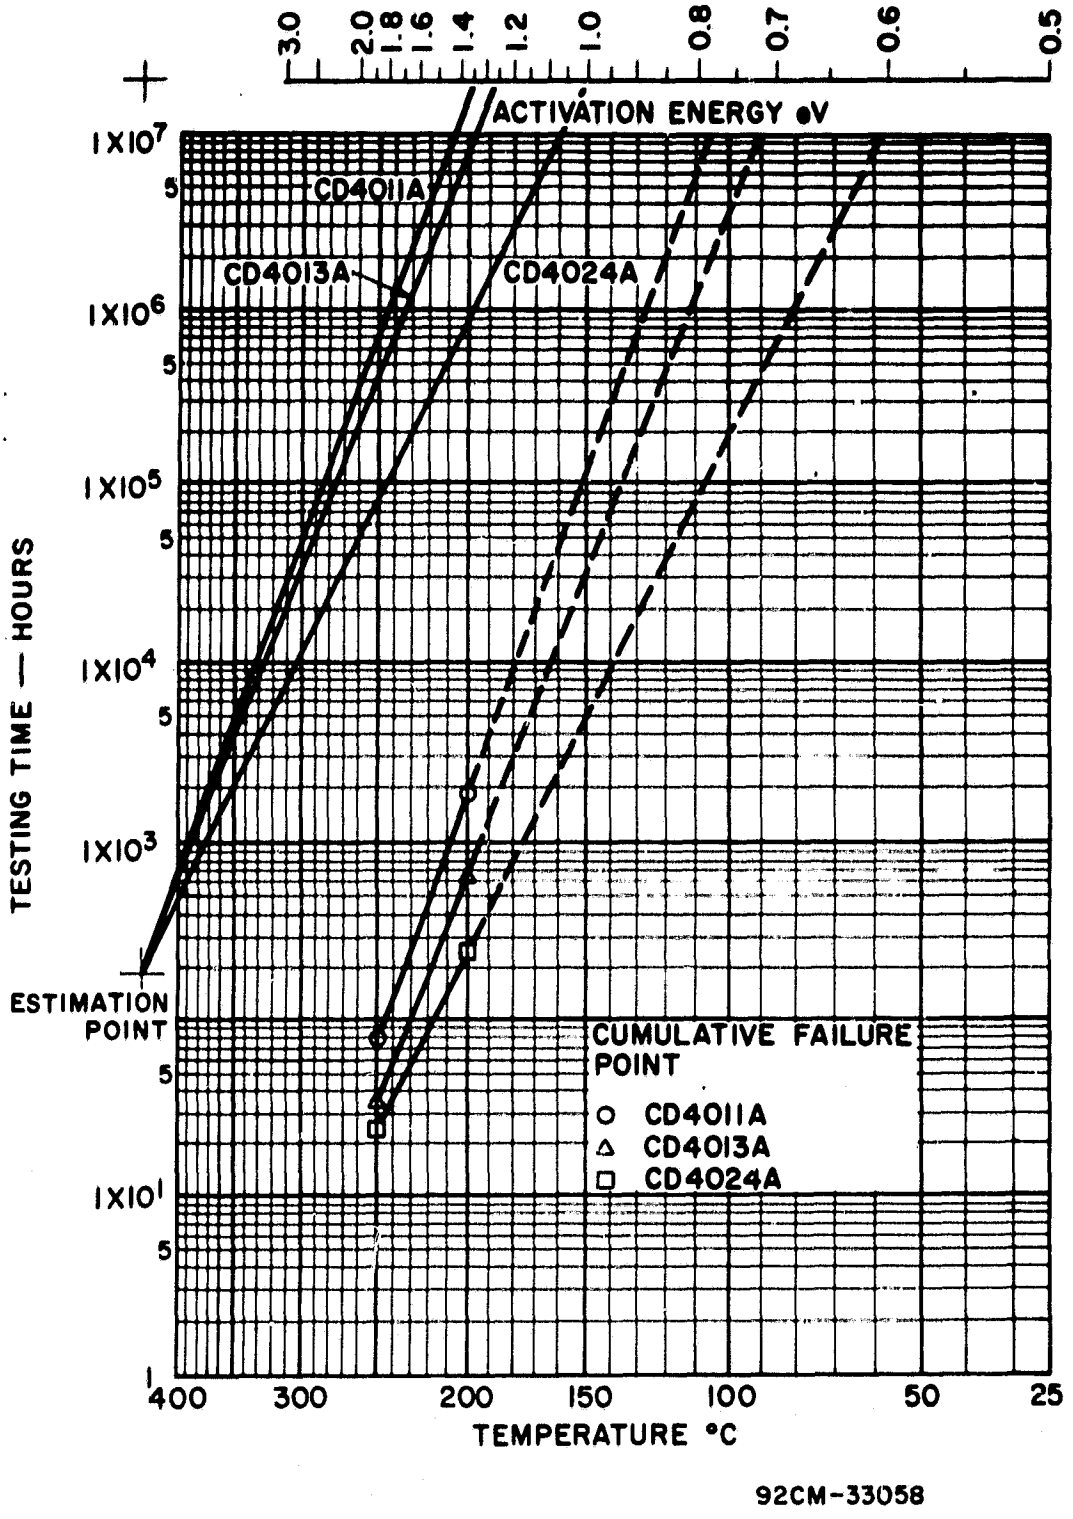
Fig. 15 - Estimation of activation energy.

The activation energy between 200°C and 250°C was estimated on the basis of main distributions (wear-out region); it was found to vary from

type to type: 1.35 eV for CD4011A, 1.25 eV for CD4013A, and 1.0 eV for CD4024A. A more accurate determination of the activation energy and/or verification of the observed type-to-type variations would require a third data point. The wear-out region for the test temperature of 125°C was not reached at 20,000 hours, consequently the third data point was not obtained. The method of graphical estimation of activation energies for each device type is shown in Fig. 15. The times at which 50-percent cumulative failure is reached during tests made on each device type at 200 and 250°C are plotted on the graph of Fig. 15 as a function of temperature, and the resulting points joined by a straight line. Another line with the same slope and passing through the estimation point will intersect the activation energy scale at the value of the activation energy for that device type.

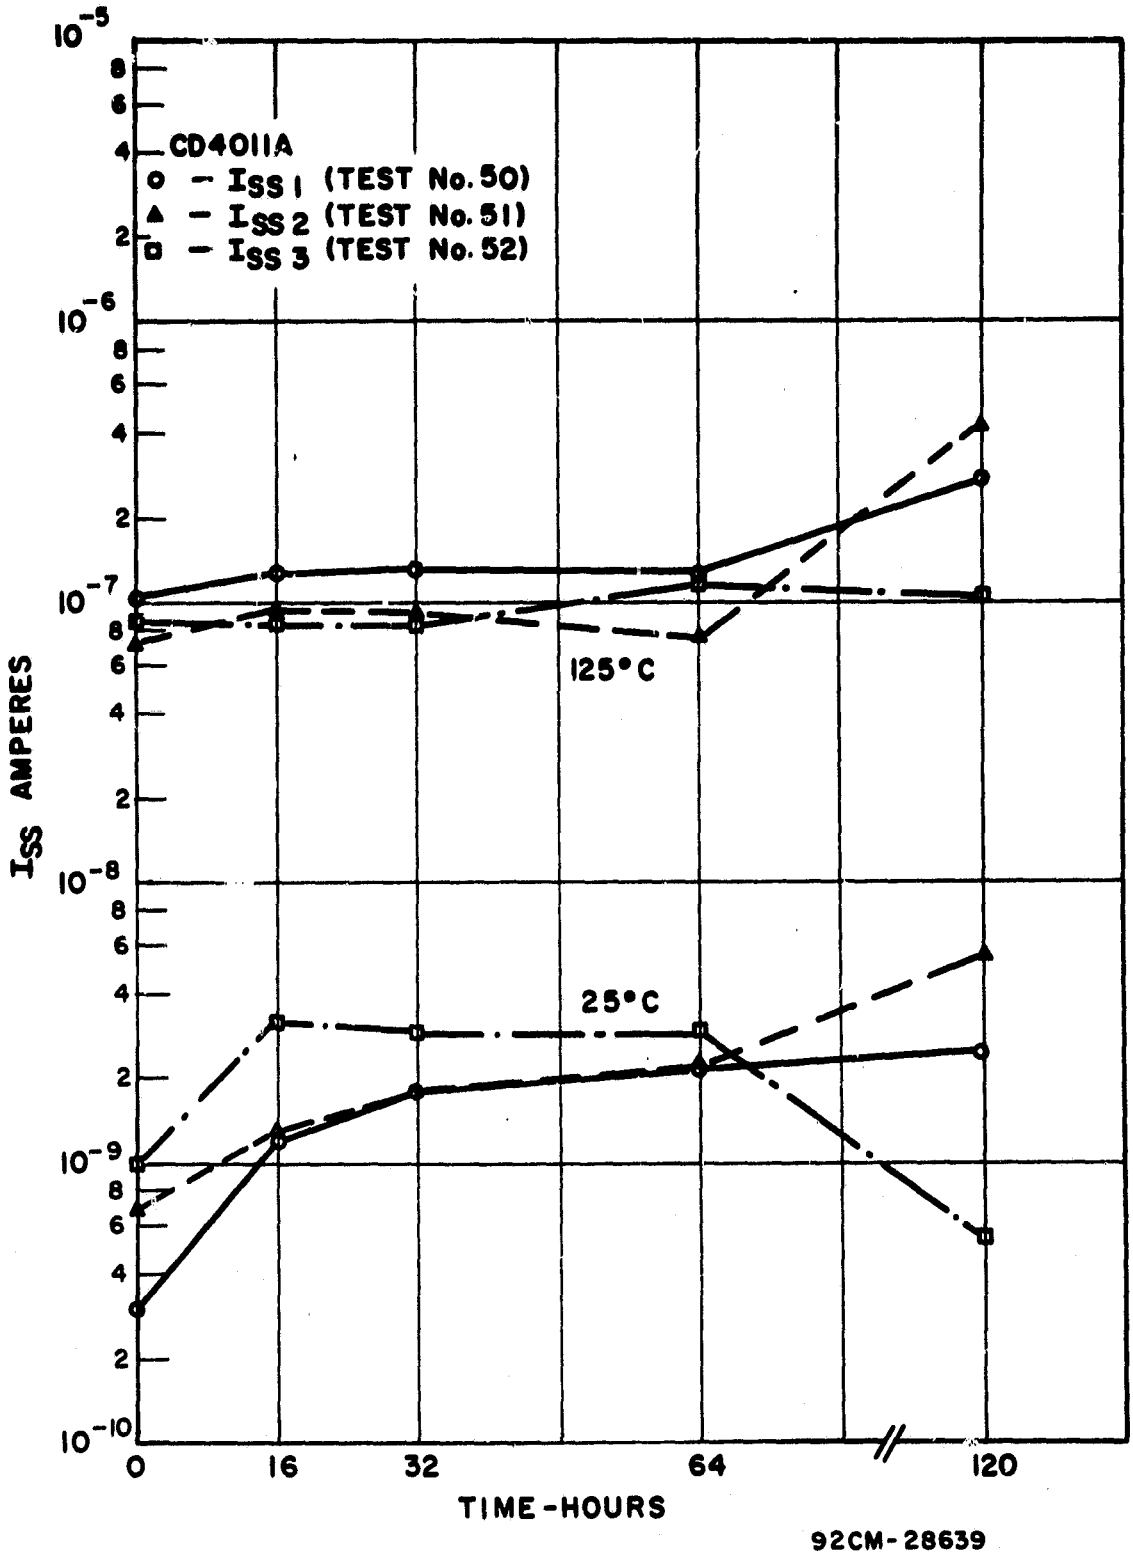
Fig. 16 - CD4011A; I_{SS} vs time; three-lot average of mean.

There are three I_{SS} tests in the M38510/05001 (CD4011A) specifications. The results of all three of these tests were used in the parameter trend tables and graphs. From the M38510/05101 (CD4013A) and M38510/05605 (CD4024A) test results, three I_{SS} tests for each type were selected to avoid presentation of repetitious data. The selected I_{SS} test data indicated the greatest parameter shift. The leakage versus time plot indicates a fair stability for the surviving CD4011A, but shows considerable movement for the CD4013A and CD4024A. The 25°C measurements seems to track the 125°C measurements, indicating that for the purpose of observing leakage shift, both measurement temperatures are equally effective.

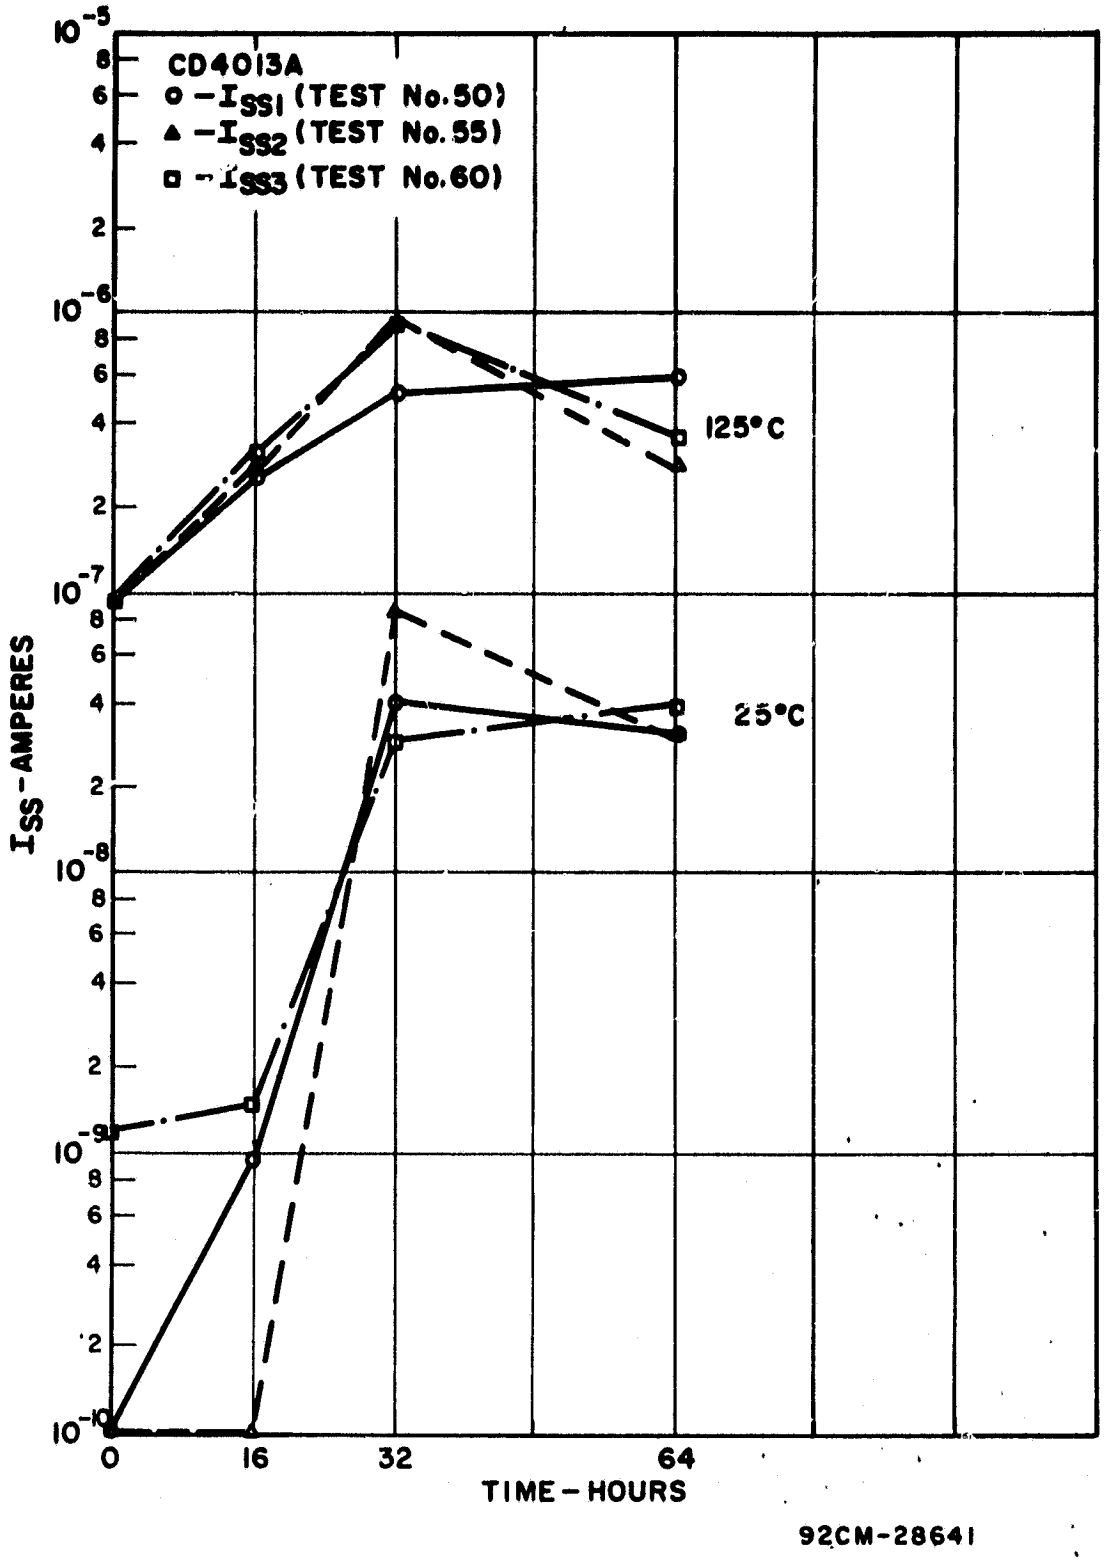
Fig. 17 - CD4013A; I_{SS} vs time; three-lot average of mean. Only one lot was kept on life test to 64 hours. Value of I_{SS} < 0.1 nA are plotted on the base line.

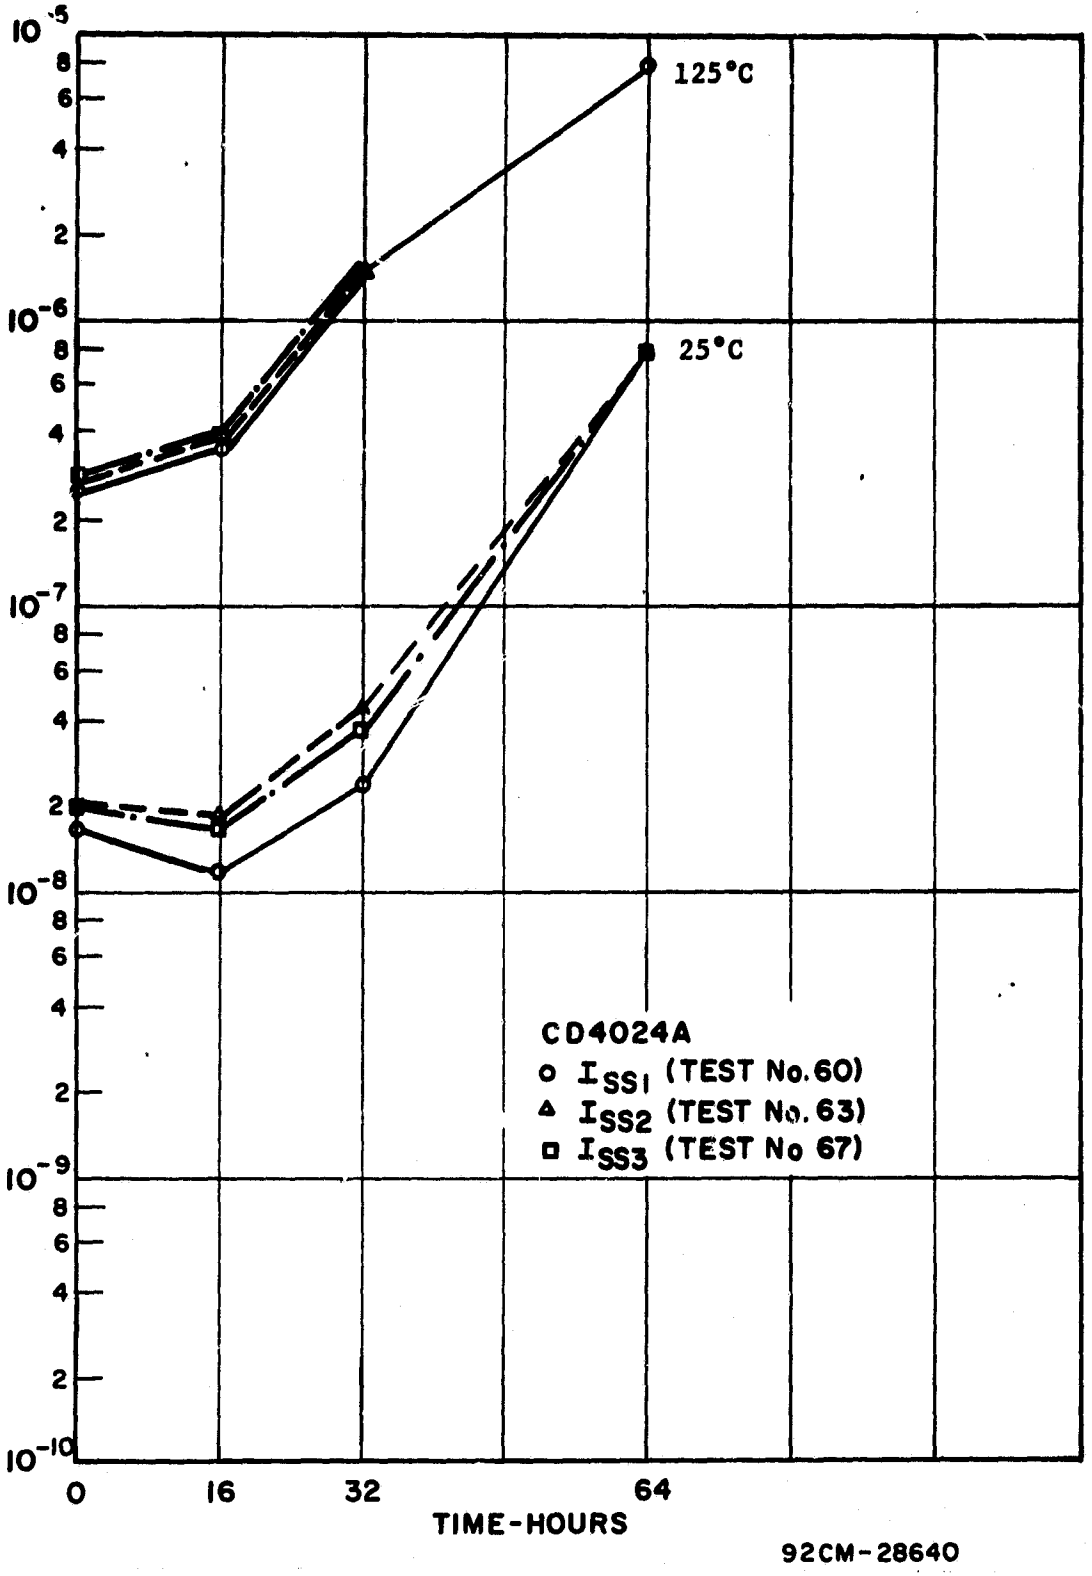
Fig. 18 - CD4024A; I_{SS} vs time; three-lot average of mean. Only one lot was kept on life test to 64 hours.
