NASA CR-165392
RI/RD80-186

HIGH-PRESSURE HOT-GAS SELF-ACTING FLOATING RING SHAFT SEAL FOR LIQUID ROCKET TURBOPUMPS

R. E. Burcham and W. A. Diamond

Rockwell International
Rocketdyne Division

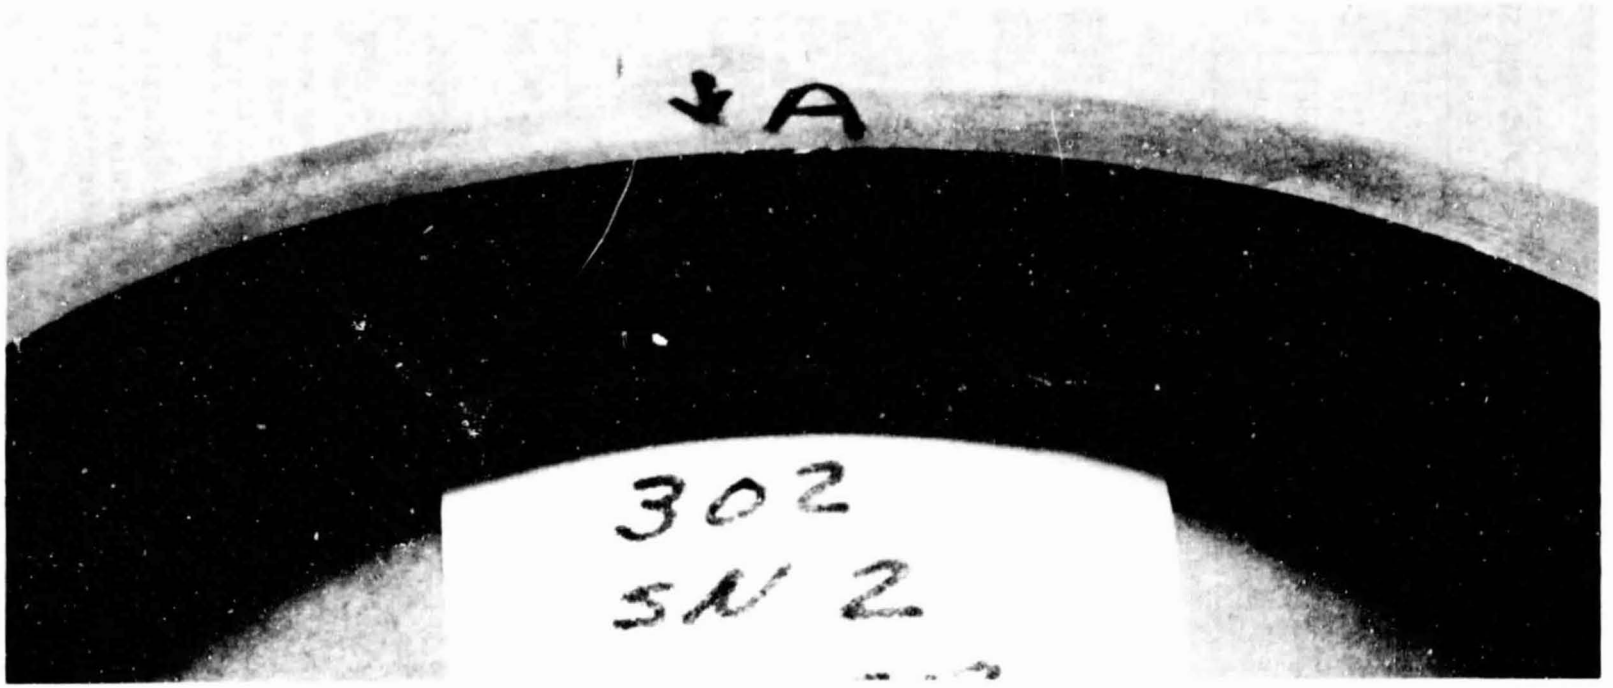
Figure 33. Pump End Primary Seal Ring, P/N 99RS010302, S/N 067602, Build 4, Posttest 12

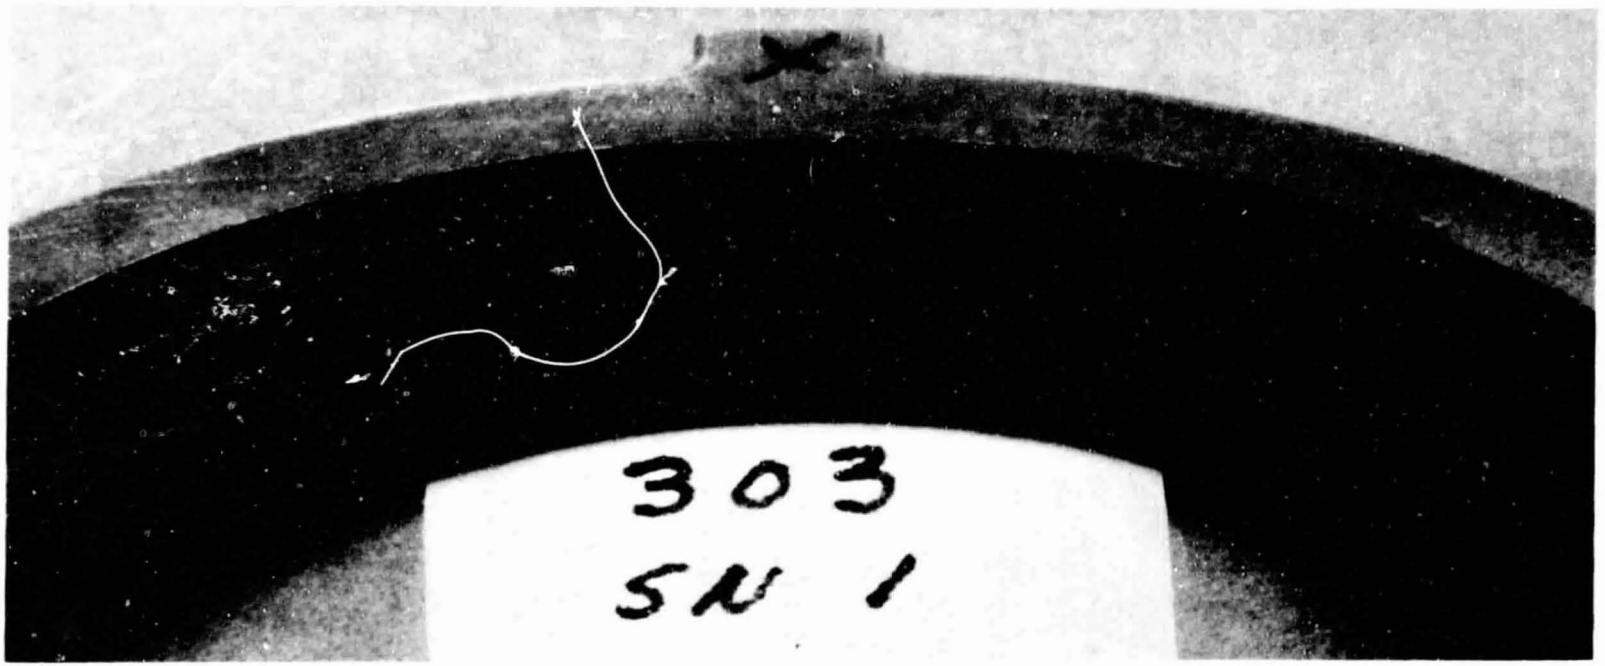
Figure 35. Turbine End Primary Seal Ring, P/N 99RS010303, S/N 067601, Build 4, Posttest 12

There was some erosion of the carbon seals at the leading edge of the sealing dam. The carbon seal diametral wear varied from 0 to .00000508 m (.0002 in.). The lift pads appeared to be completely worn away on all seal rings except for visible traces on the pump end primary seal ring. The mating ring sleeve wear in the pump end area was .00001397 m (.00055 in.). The seal hardware is shown in Fig. 33 through 37. The pump end primary seal surface profile trace is shown in Fig. 38 .

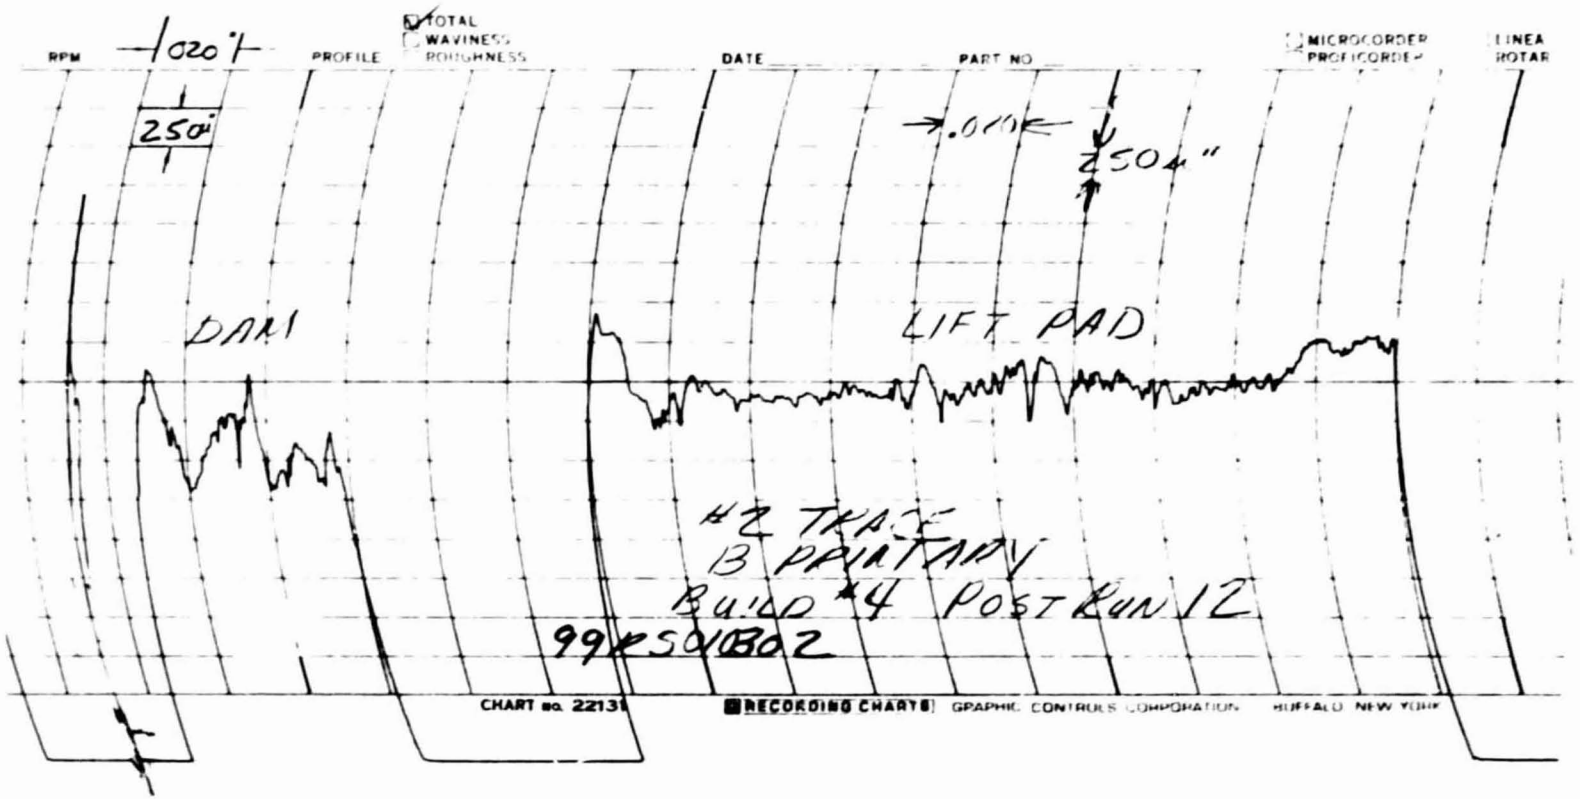
Figure 38. Surface Profile Trace Pump End Primary Seal Lift Pad #2 P/N 99RS010302, S/N 02, Build 4, Posttest 12

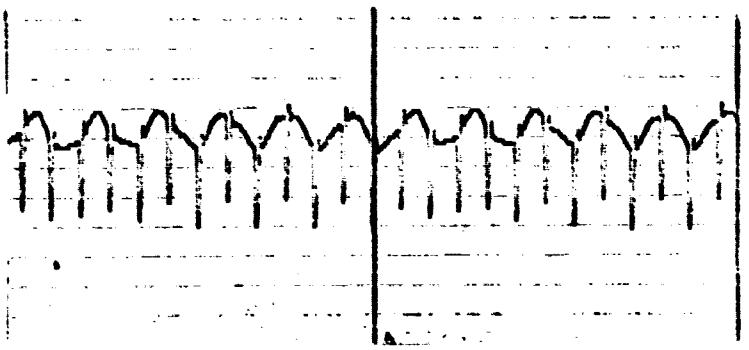
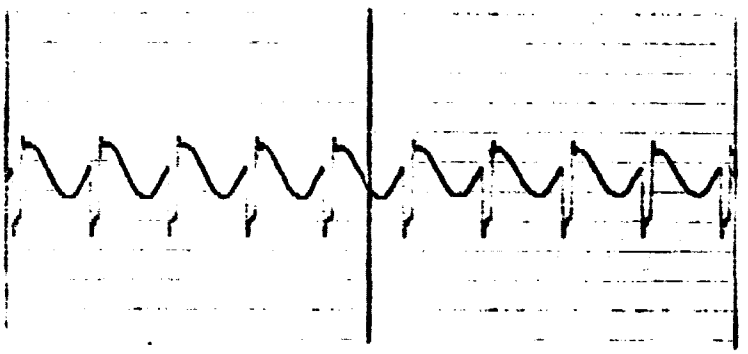
Figure 39. Turbine Wheel Radial Displacement Traces From High Frequency Data on Balance Test 8 (Calibration Notch = 0.0001016 m (0.004 inch)

with indication of subsynchronous whirl. The results are given in Table 15 and shown in Fig. 39 and 40.

(a) Steady at 3193 rad/sec (30,500 rpm)
(Subsynchronous Whirl)

(b) Critical Coasting Down at 1196 rad/sec
(11,428 rpm)

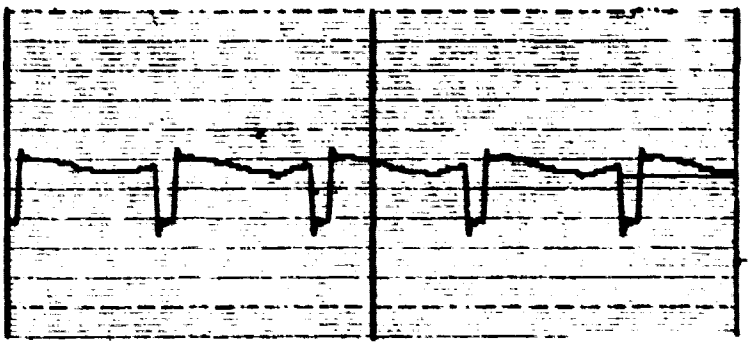
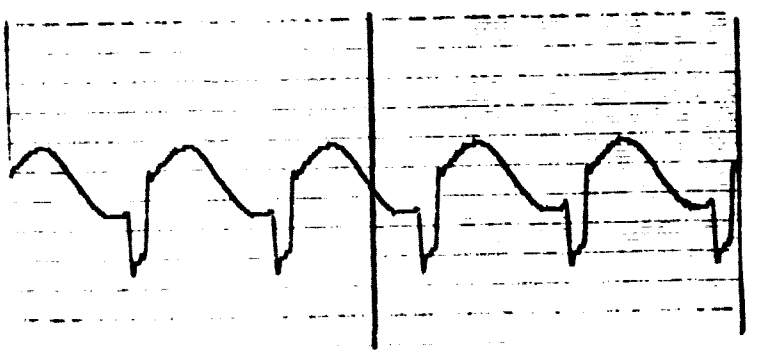
Figure 40. Turbine Wheel Radial Displacement Traces From High Frequency Data on Balance Test 9 (Calibration Notch = 0.0001016 m (0.004 inch)

(a) Critical Accelerating at 1185 rad/sec (11,320 rpm)

(b) Steady at 3141 rad/sec (30,000 rpm) (Subsynchronous Whirl)

(c) Critical Coasting Down at 1185 rad/sec (11,320 rpm)

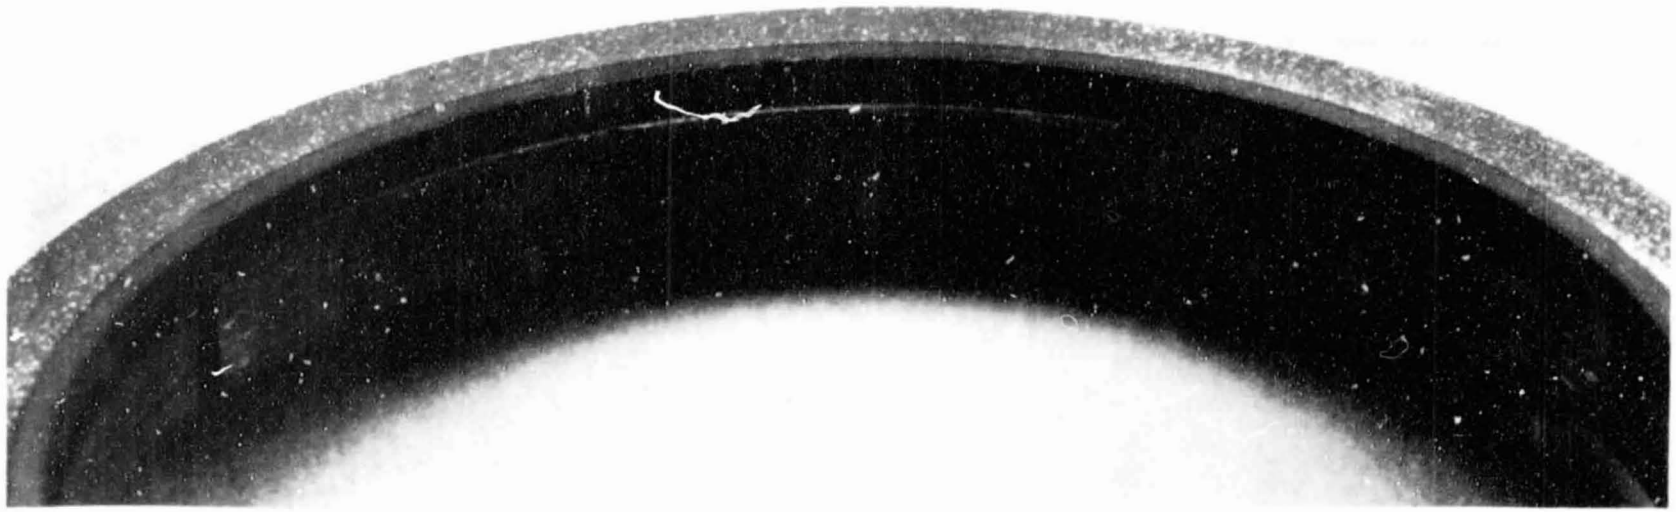
Figure 41. Pump End Primary Seal Ring, P/N 99RS010302, S/N 04, Build 6, Posttest 20

SEAL	TURBINE END		PUMP END	
	PRIMARY	SECONDARY	PRIMARY	SECONDARY
WEAR M (IN.)	.0000!524(.0006)	0	.00001778(.0007)	0

The mating ring sleeve had a rub pattern with a deposit of carbon in the area of the seal rings. The tungsten carbide surface was in good condition with no measureable wear, since Test 016. Inspection revealed that there was no additional rubbing between the mating ring sleeve and the seal housing. The seal hardware and surface profile traces are shown in Fig. 41 through 48.

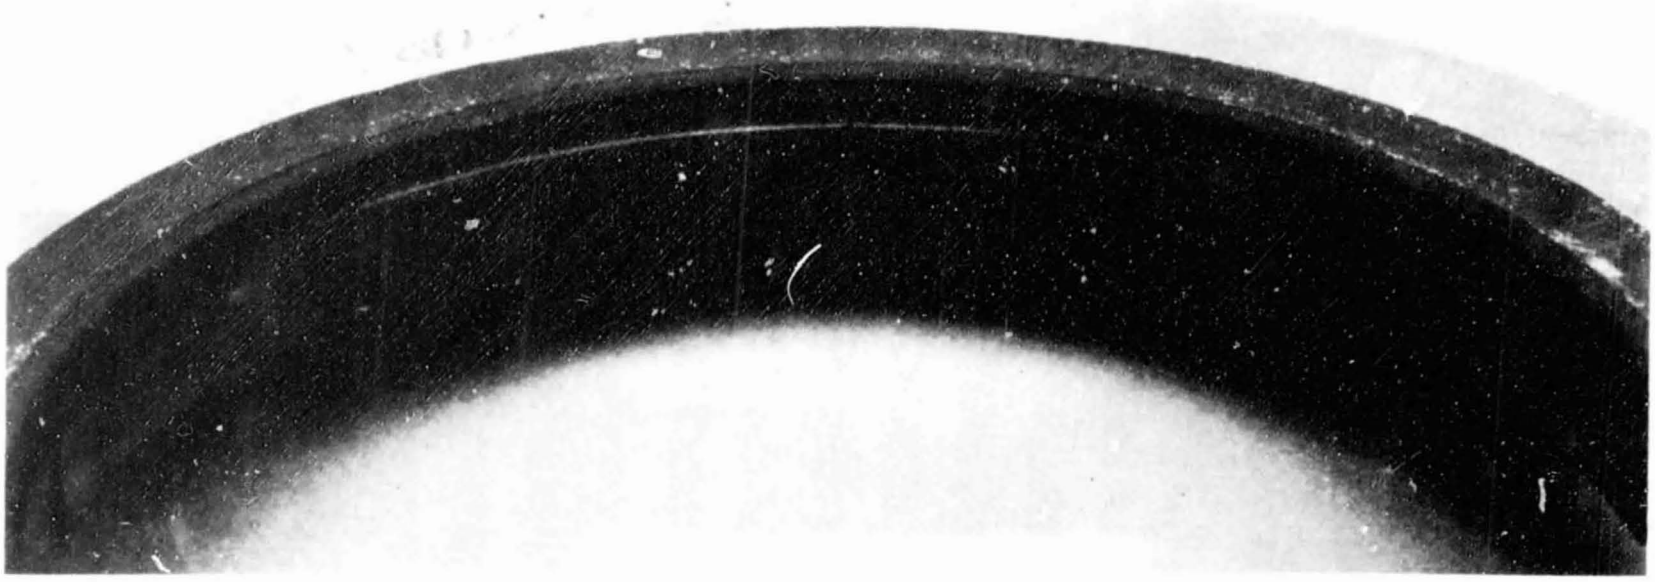
Figure 43. Turbine End Primary Seal Ring, P/N 99RS010303, S/N 06, Build 6, Posttest 20

Visual inspection revealed that the dam area of the turbine end primary seal ring was eroded away axially and chipped on the upstream edge of the carbon ring. The measured amount of axial dam wear on the turbine end primary seal ring is shown below. The axial dam wear on the other seal rings was negligible.

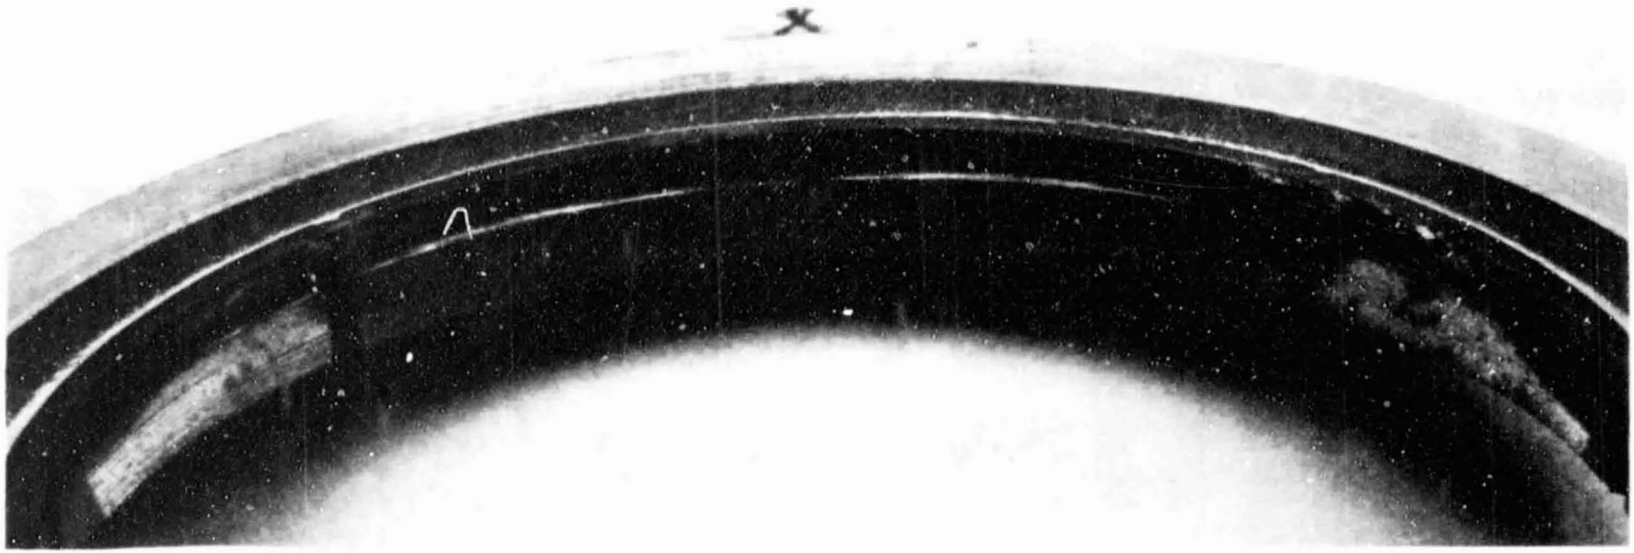
Figure 44. Turbine End Secondary Seal Ring, P/N 99RS010305, S/N 05, Build 6, Posttest 20

The lift pads were worn away on the turbine end secondary seal ring. The wear on the other lift pads varied from zero to .00001524 m (.0006 in.). A summary of the lift pad wear data is shown in Table 8 .

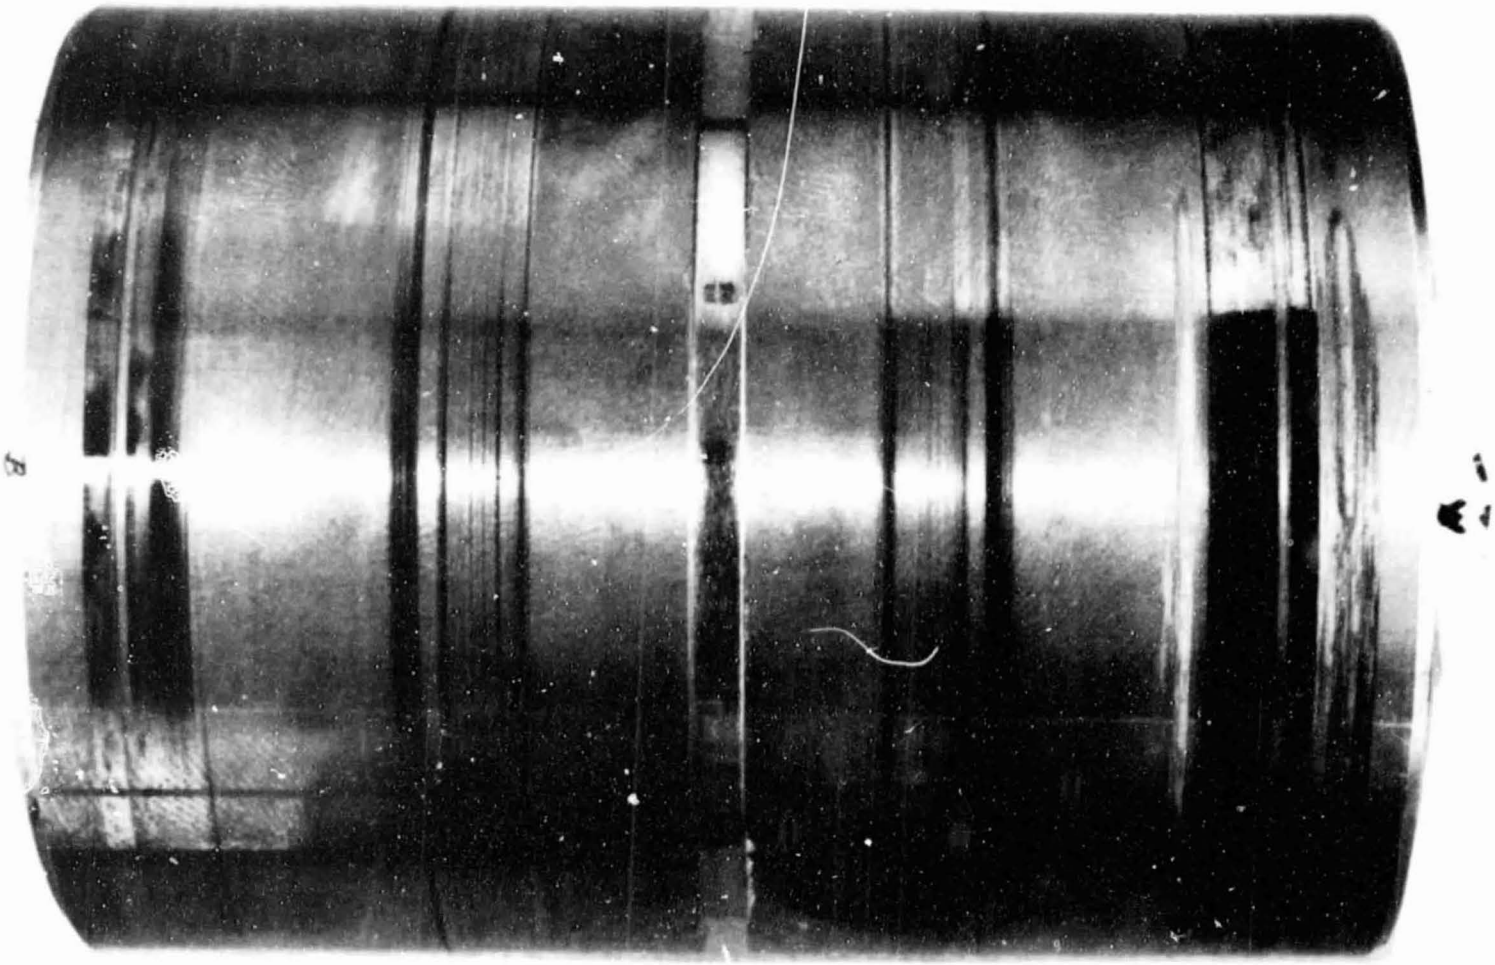
Figure 45. Mating Ring Sleeve, P/N RS005092X-005, S/N 2, Build 6, Posttest 20

The mating ring sleeve had a rub pattern with a deposit of carbon in the area of the seal rings. The tungsten carbide surface was in good condition with no measurable wear, except for .00000254 m (.0001 in.) at the sealing dam location. Inspection revealed the tester shaft sleeve had not rubbed the seal housing. There was no evidence of high vibration or shaft displacements.

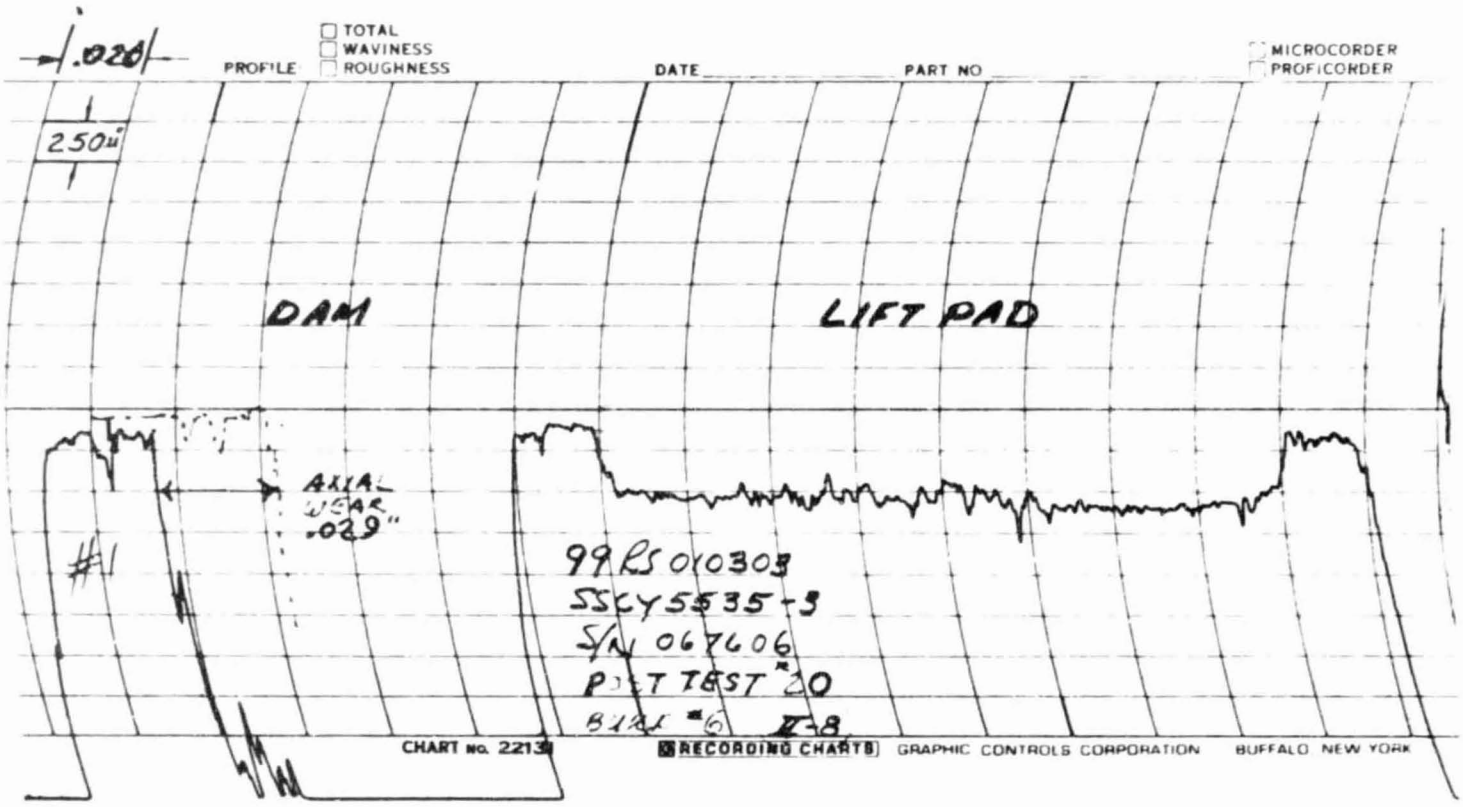
Figure 46. Surface Profile Trace Turbine End Primary Seal Lift Pad 1, P/N 99RS010303, S/N 06, Build 6, Posttest 20

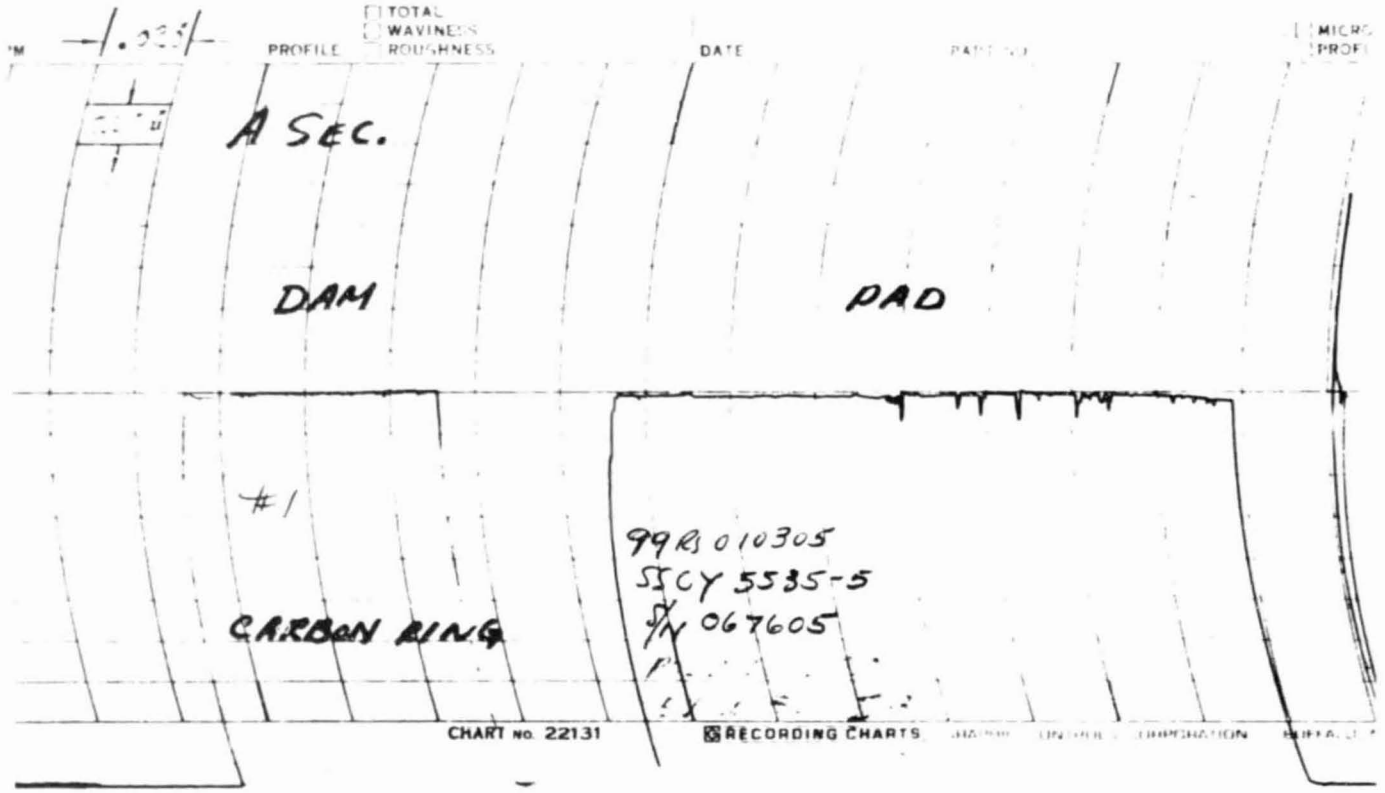
Figure 47. Surface Profile Trace Turbine End Secondary Seal P/N 99RS010305, S/N 05, Build 6, Posttest 20

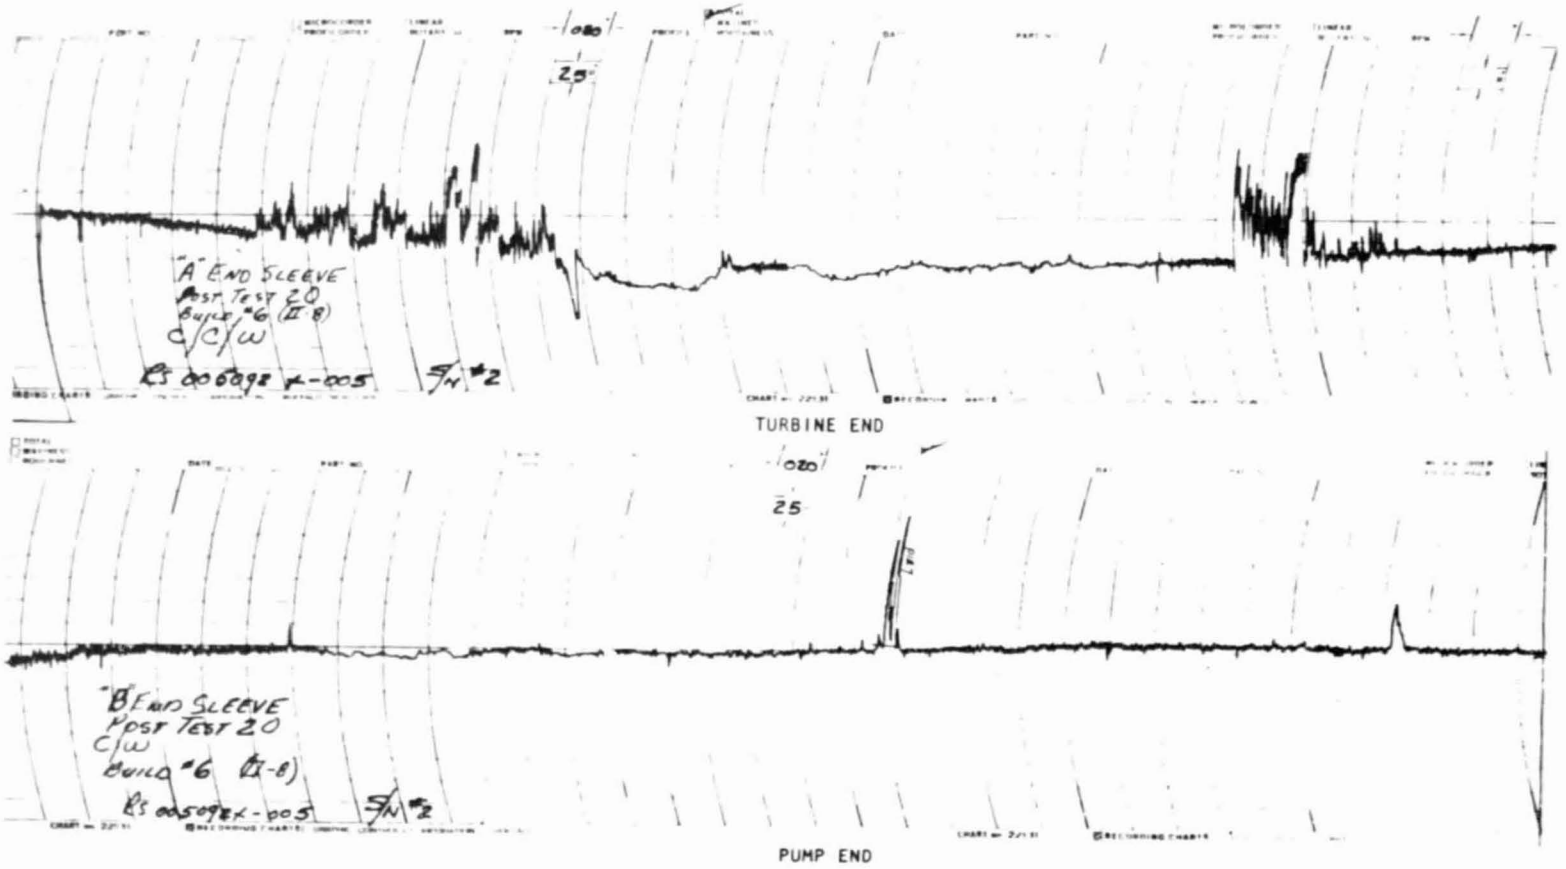
Figure 48. Surface Profile Trace of Tester Mating Ring Sleeve, P/N RS005092X-005, S/N 2, Build 6, Posttest 20

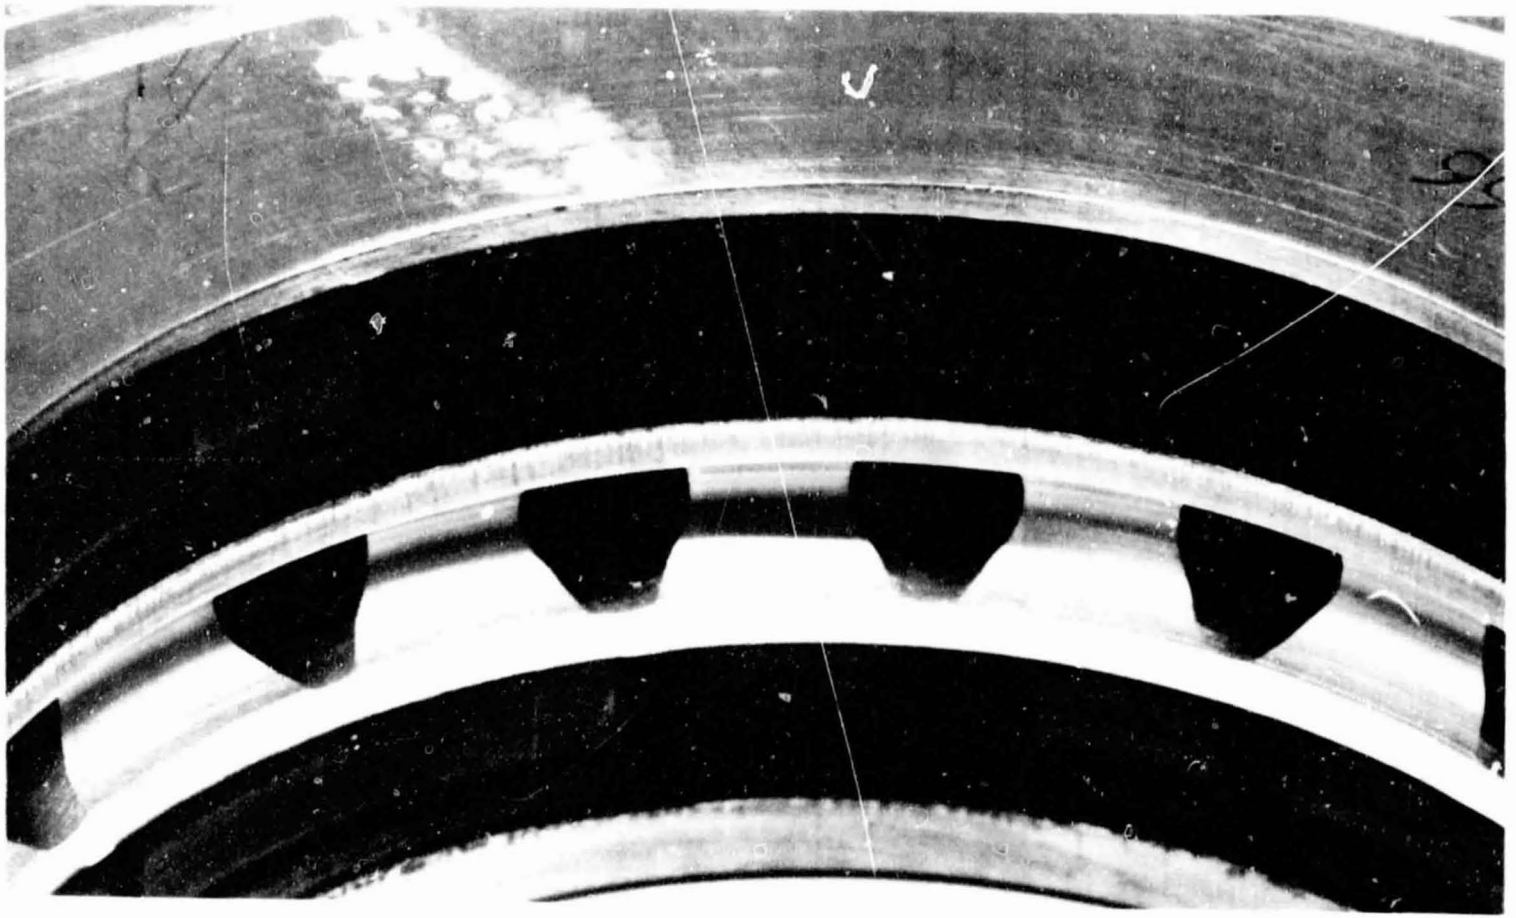
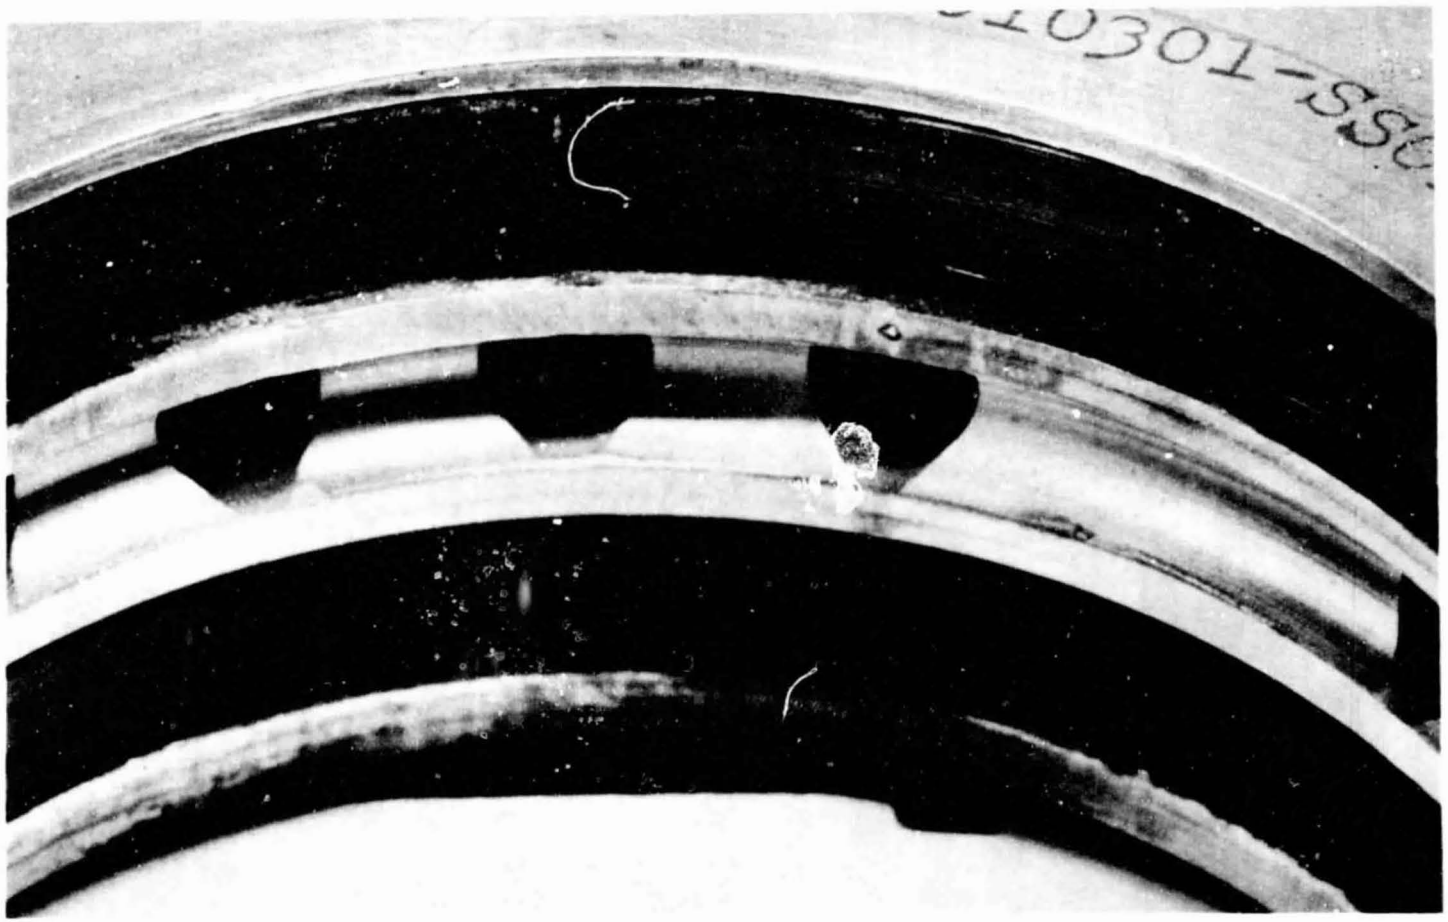
Inspection revealed that the turbine end primary ring sealing dam had fragmented and broken away completely around the circumference. The pump end seal rings appeared to be in satisfactory condition, except for erosion and wear. The seal assemblies prior to disassembly are shown in Fig.48 through 51 . The seal hardware condition is shown in Fig. 52 through 62.

Figure 50. Turbine End Assembly Position 1, P/N 99RS010310, Build 9, Posttest 107

As a result of the failure caused by excessive wear due to shaft rubbing it was decided to change to a hydrostatic tapered bore design. The test program was modified to include testing of the new design.

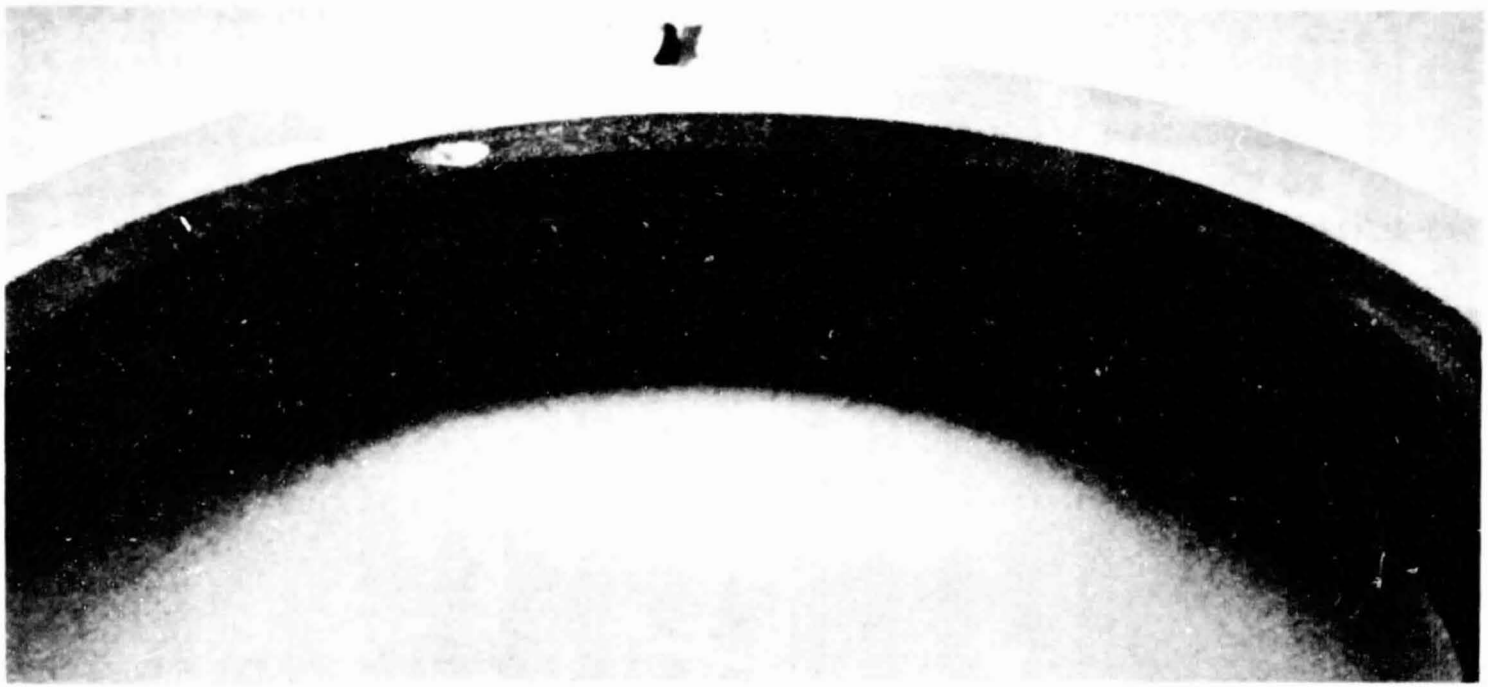
Figure 52. Pump End Primary Seal Ring Position 1, P/N 99RS010302, S/N 067605, Build 9, Posttest 107

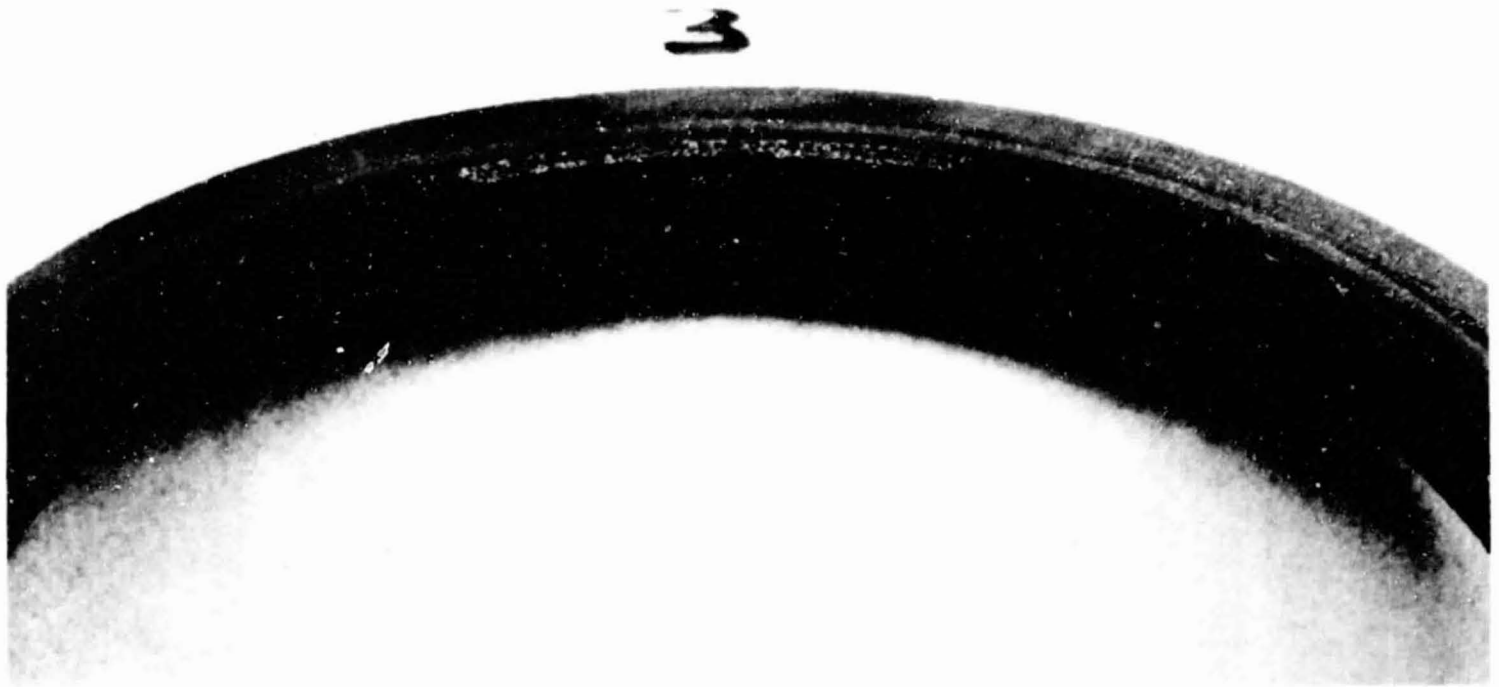
Figure 54. Pump End Secondary Seal Ring, P/N 99RS010304, S/N 067605, Build 9, Posttest 107

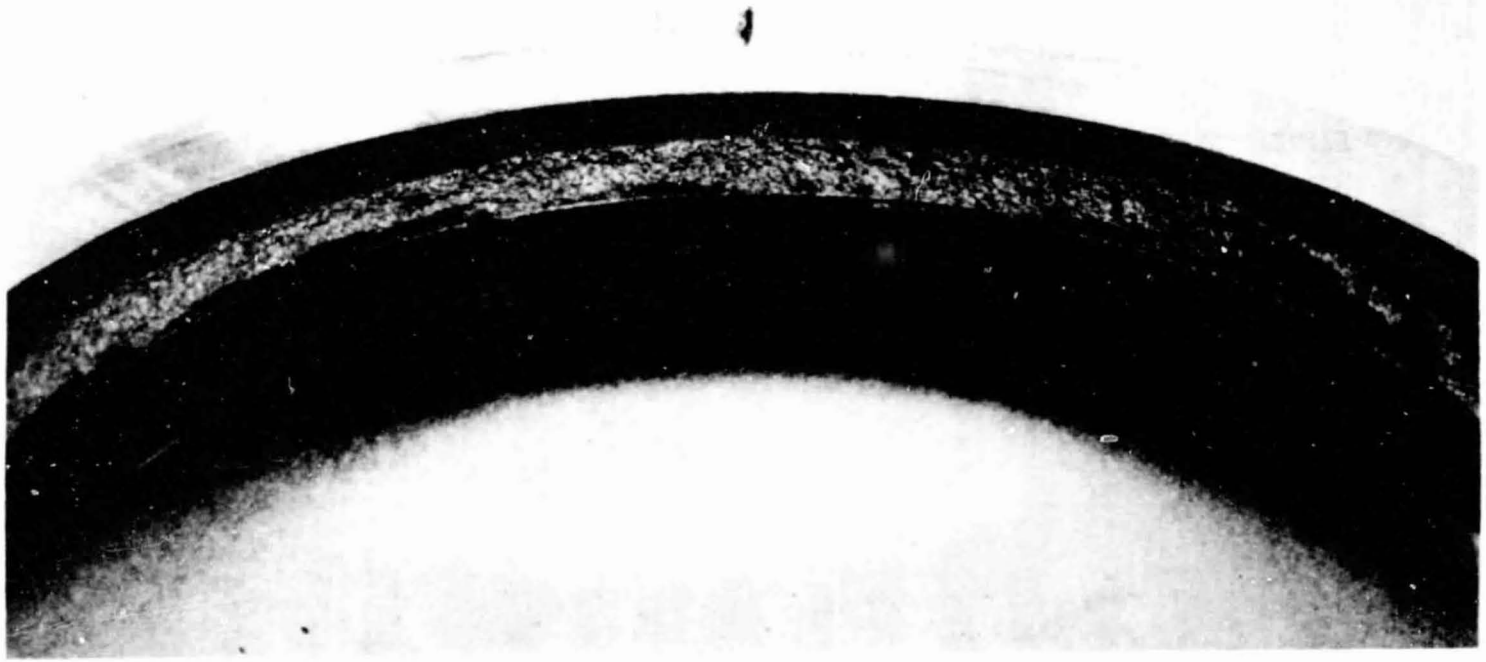
Figure 55. Turbine End Primary Seal Ring Position 1, P/N 99RS010303, S/N 067605
Build 9, Posttest 107

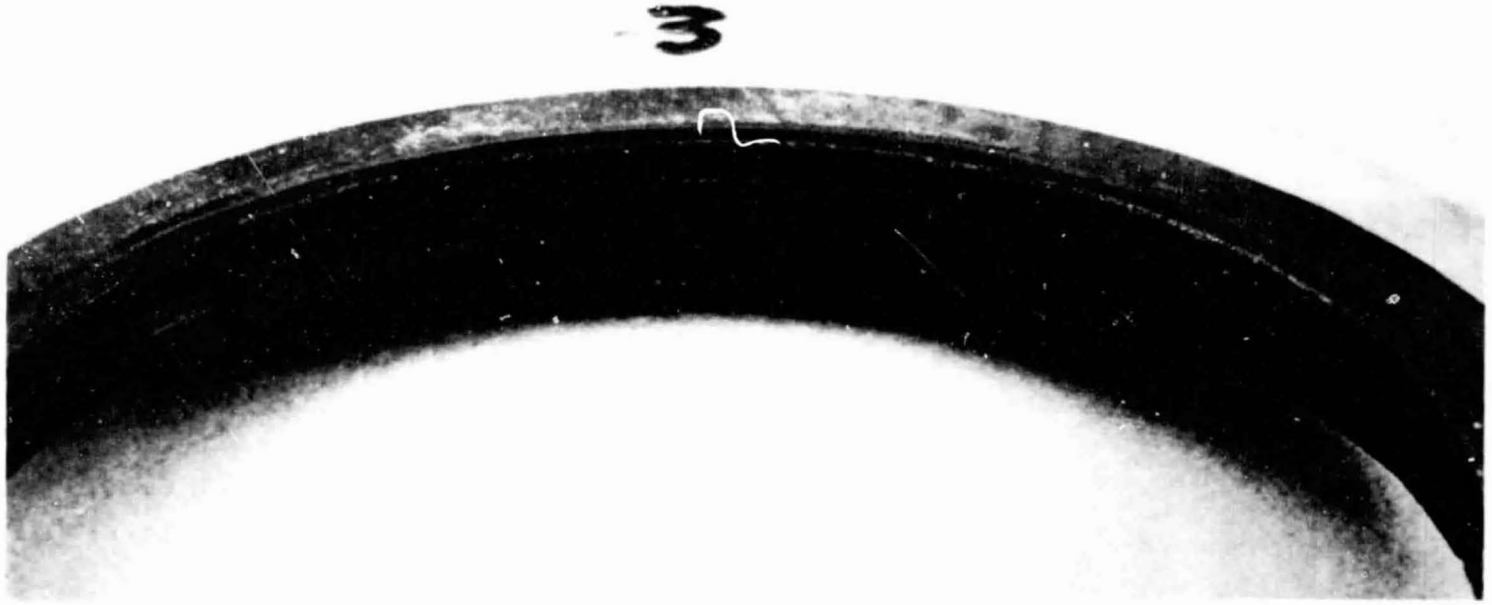
Figure 57. Turbine End Secondary Seal Ring, P/N 99RS010305, S/N 067604, Build 9, Posttest 107

A summary of seal ring diametral wear is given in Table 8 . The lift pads were completely worn away on the turbine end primary and secondary seal rings. The wear on the pump end seal lift pads varied from .00000508 to .00002032 m (.0002 to .0008 in.) with some of the pads completely worn away. A summary of the lift pad post test depths is given in Table 8 .

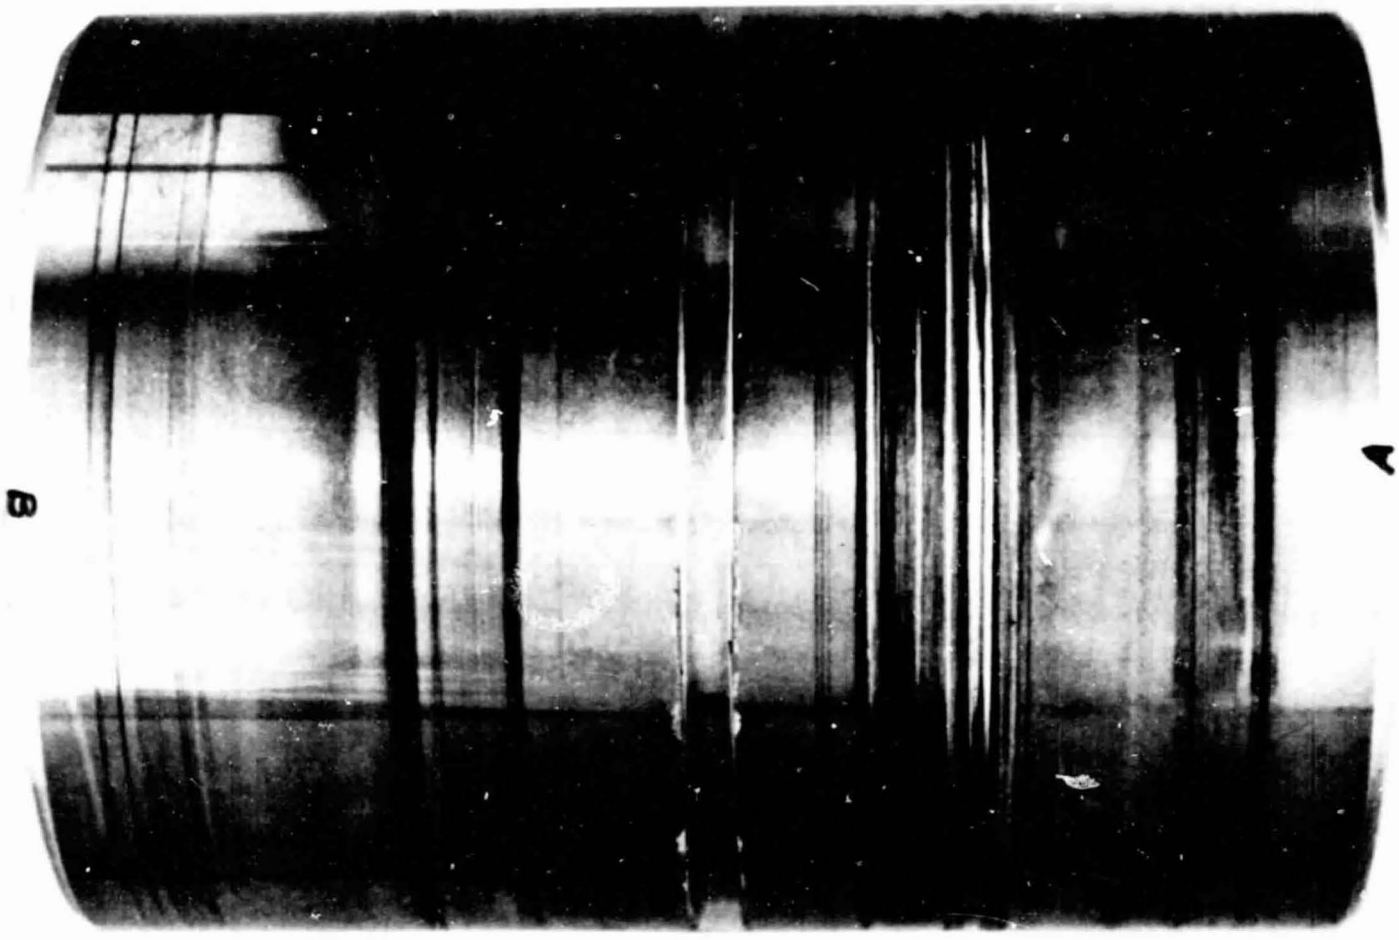
Figure 58. Mating Ring Sleeve, P/N RS005092X-005, S/N 3, Build 9, Posttest 107

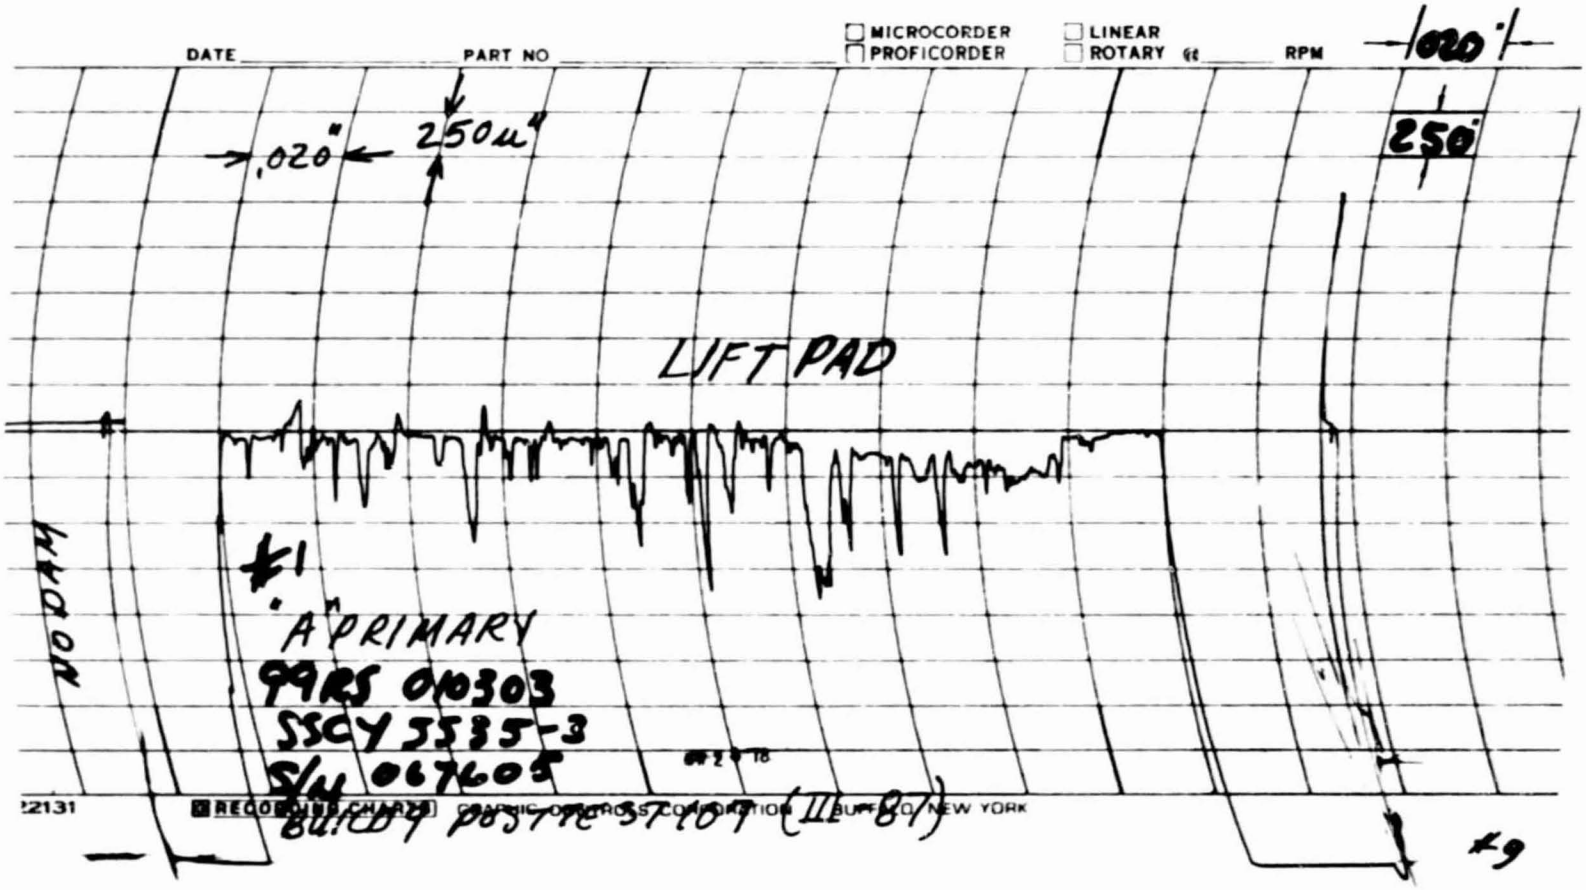
Figure 59. Surface Profile Trace Turbine End Primary Seal Lift Pad 1, P/N 99RS010303, S/N 05, Build 9, Posttest 107
