NASA CR-165392
RI/RD80-186

HIGH-PRESSURE HOT-GAS SELF-ACTING FLOATING RING SHAFT SEAL FOR LIQUID ROCKET TURBOPUMPS

R. E. Burcham and W. A. Diamond

Rockwell International
Rocketdyne Division

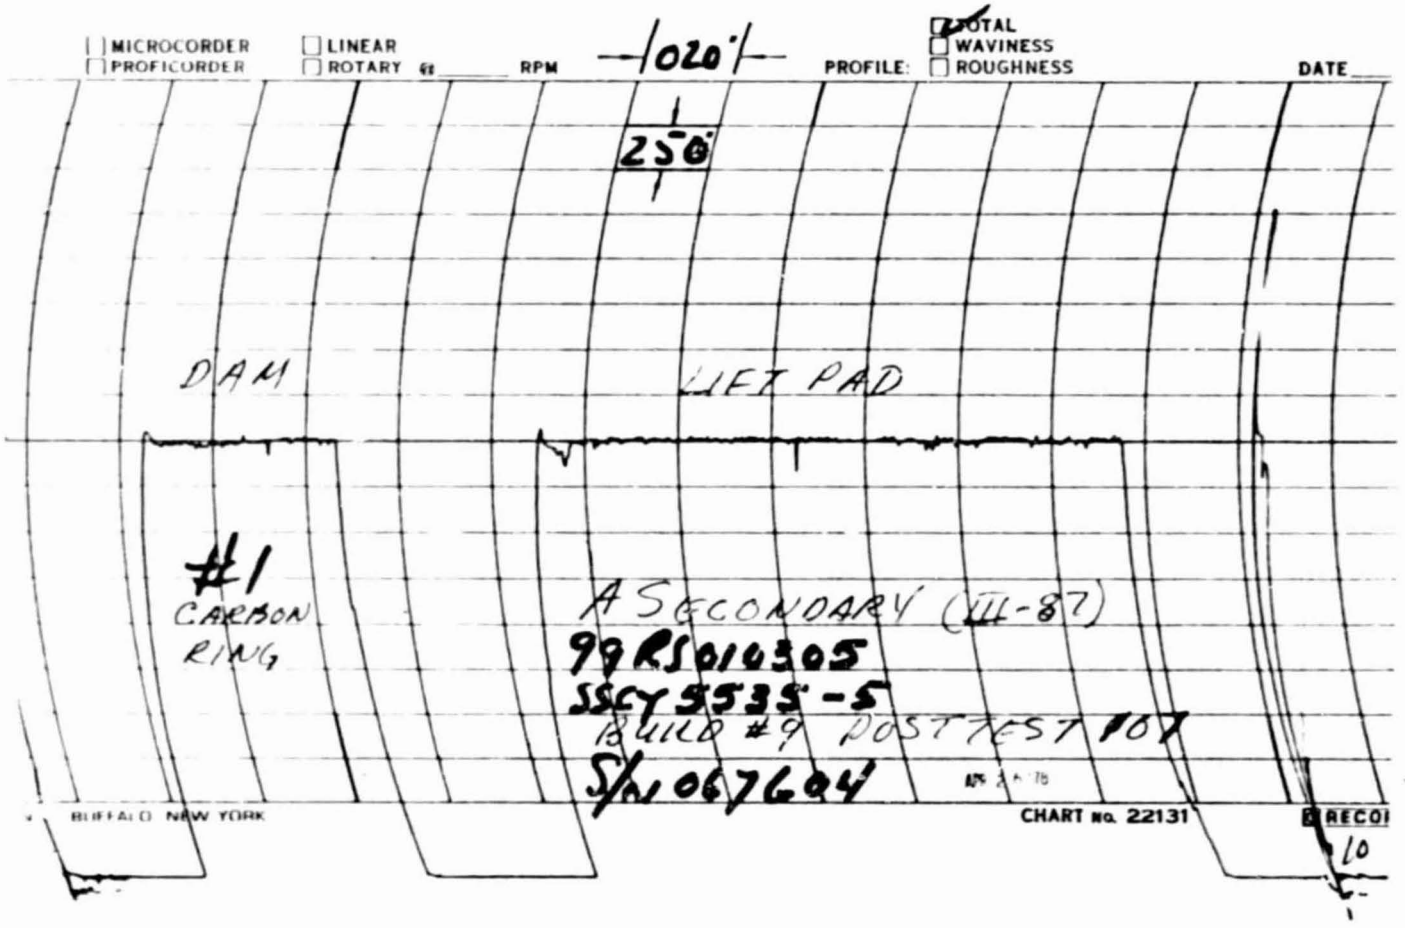
Figure 60. Surface Profile Trace Turbine End Secondary Seal Lift Pad 1, P/N 99RS010305, S/N 04, Build 9, Posttest 107

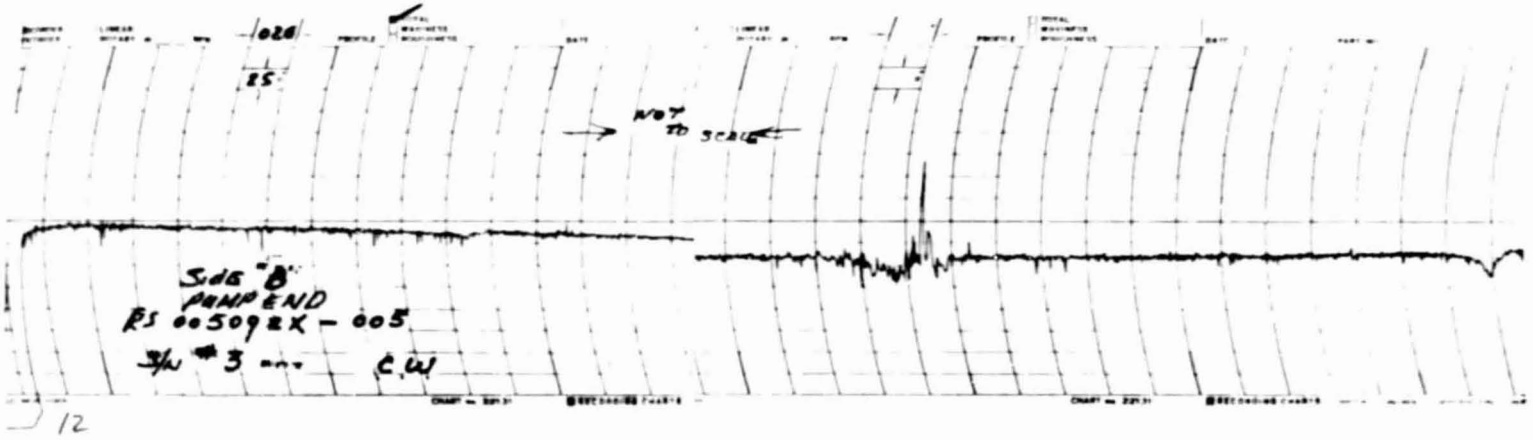
Figure 61. Surface Profile Trace of Tester Mating Ring Sleeve Pump End, P/N RS005092X-005, S/N 3, Build 9, Posttest 107

The mating ring ring sleeve rub pattern appeared the same as pretest 081, except the turbine end primary seal ring area surface was worn .0002413 M(.0095 in.) at the dam location and .0001651 M (.0065 in.) at the lift pad location.

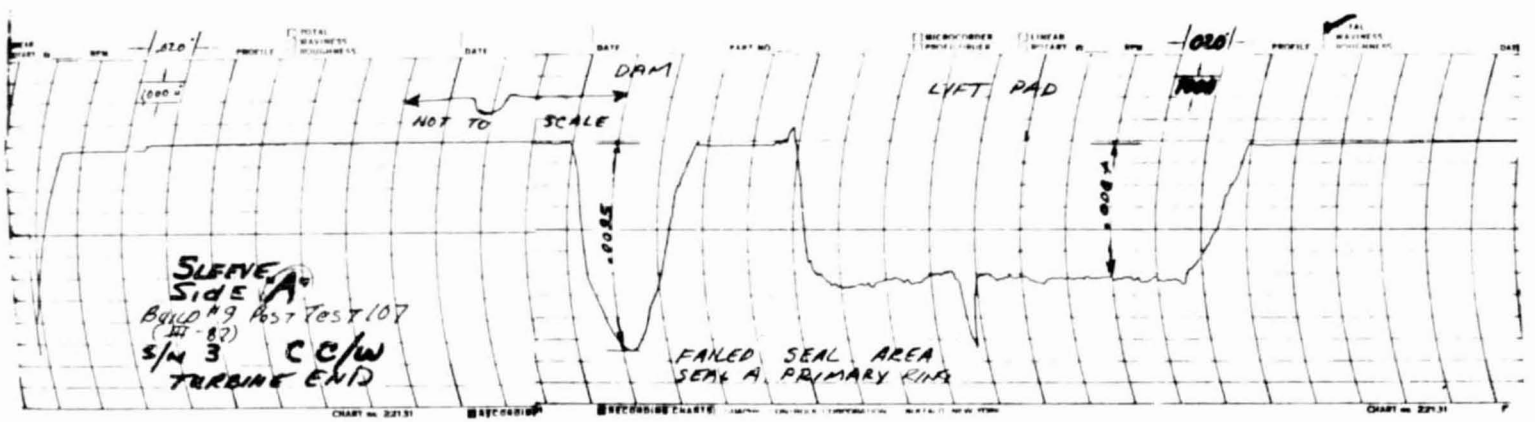
Figure 62. Surface Profile Trace of Tester Mating Ring Sleeve Turbine End, P/N RS005092X-005, S/N 3, Build 9, Posttest 107

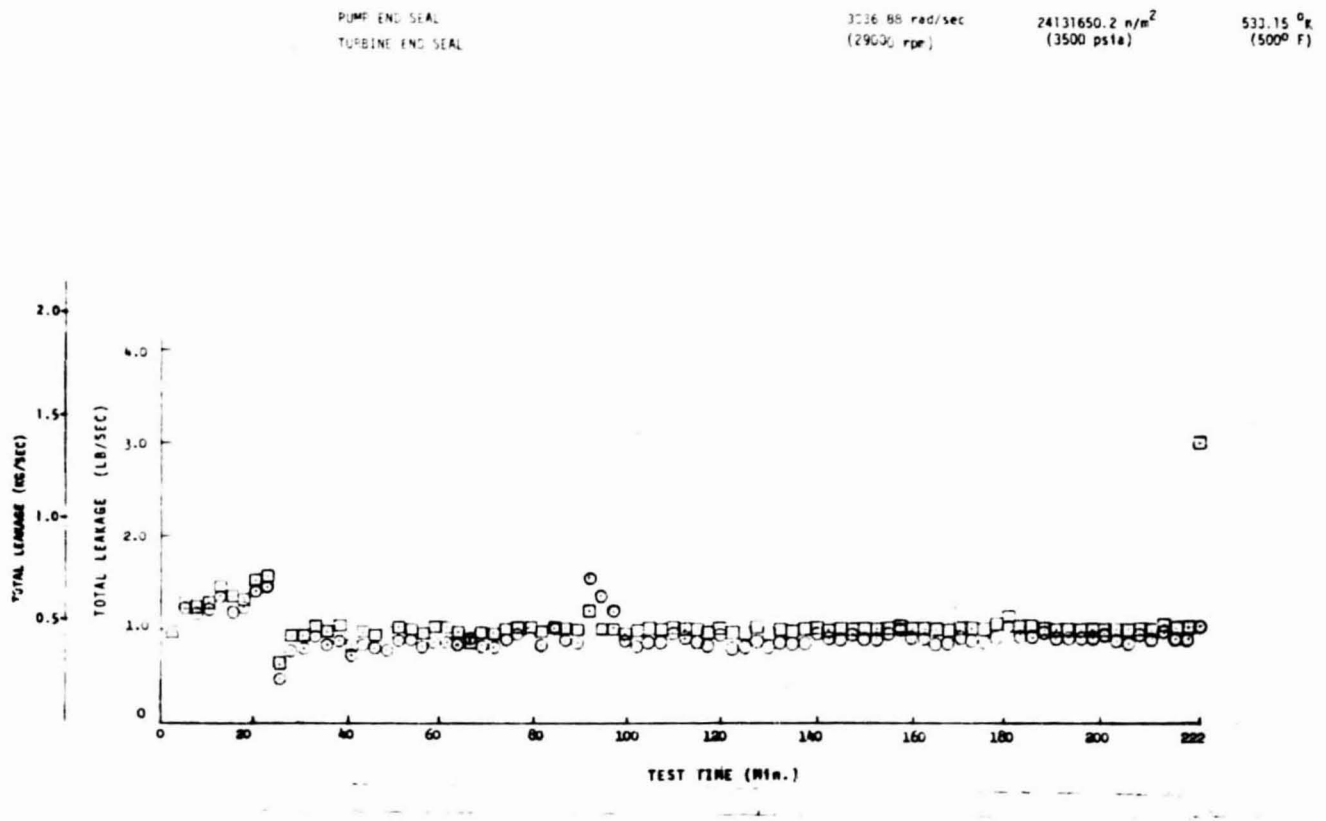
Figure 63. Rayleigh Step Seal Total Leakage vs Test Time, Tests 021-107

As a result of the failure caused by excessive wear due to shaft rubbing it was decided to change to a hydrostatic tapered bore design. The test program was modified to include testing of the new design.

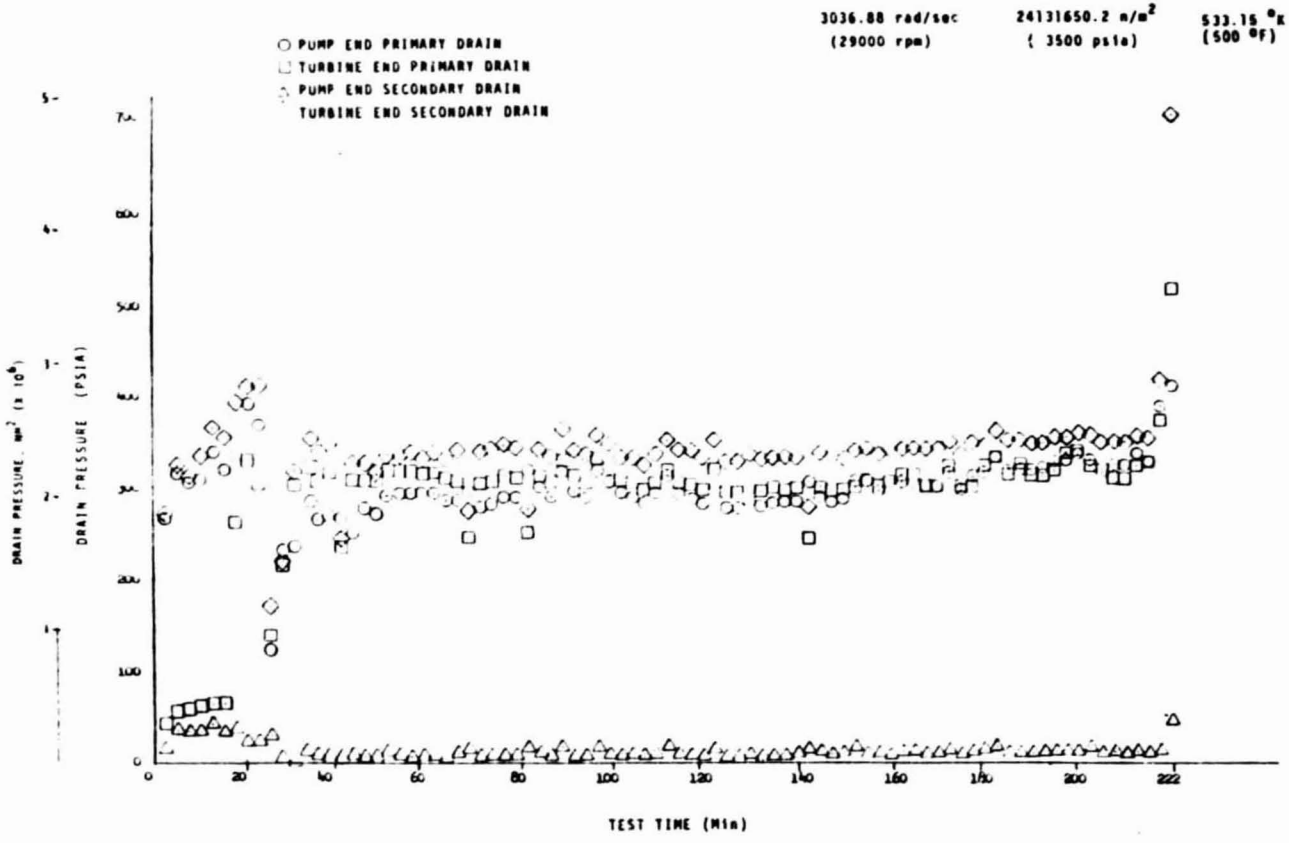
Figure 64. Rayleigh Step Seal Drain Pressure vs Test Time, Tests 021-107

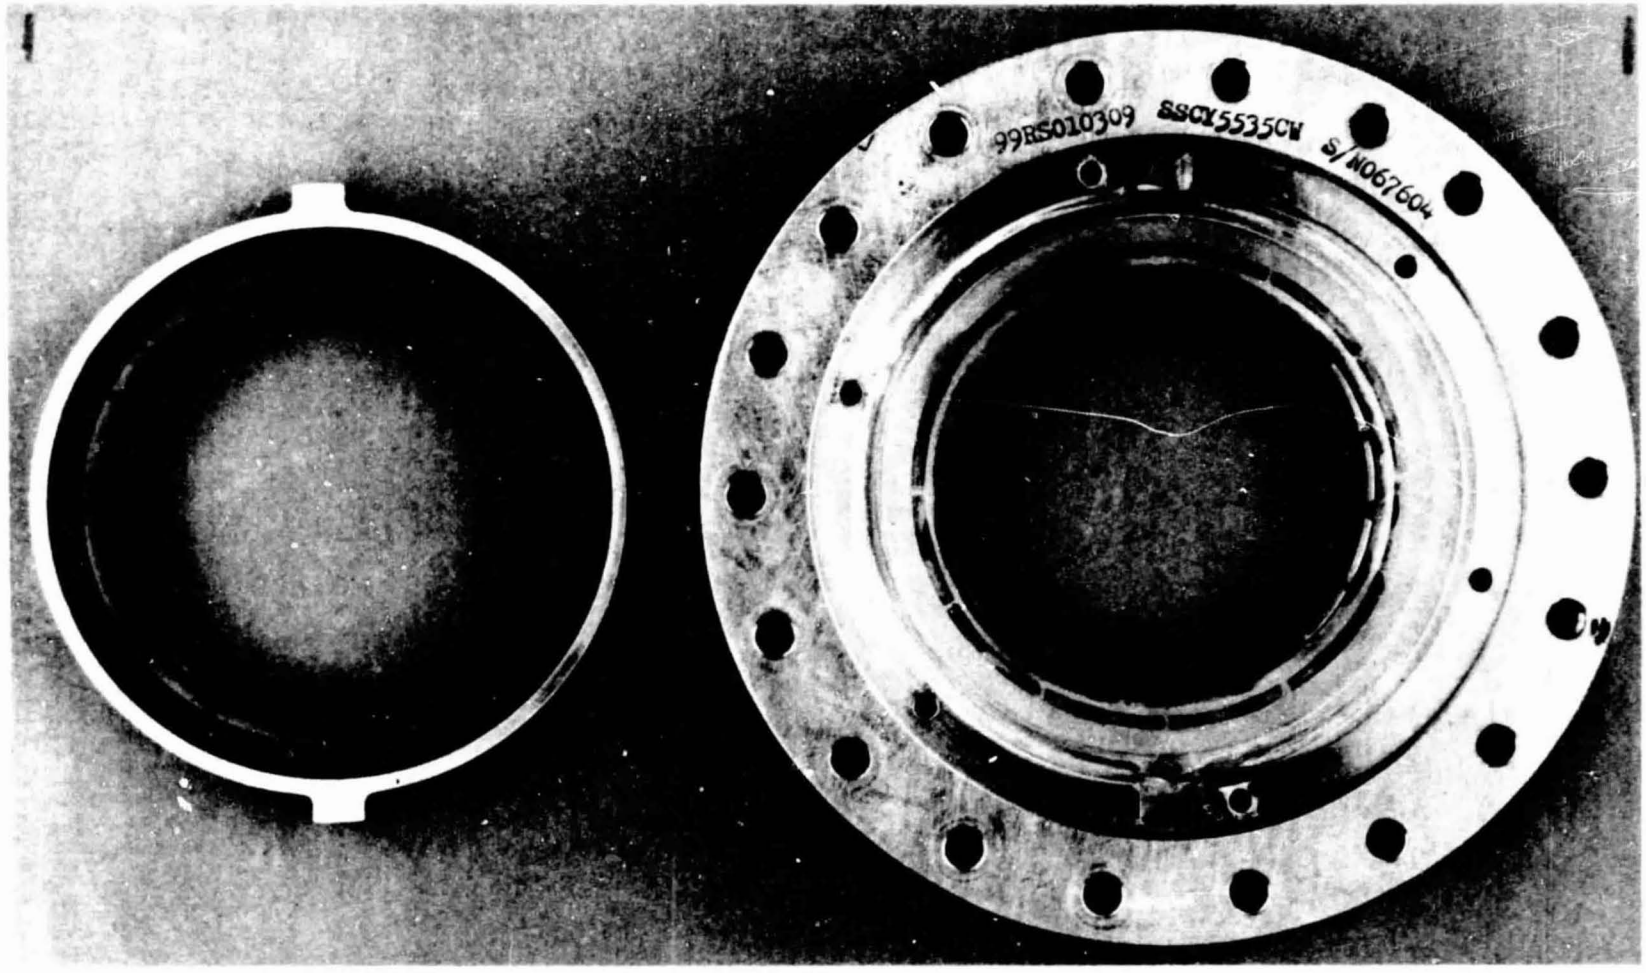
Figure 65. Pump End Primary Seal, P/N 7R0011525, S/N 047906, Build 11, Posttest 115

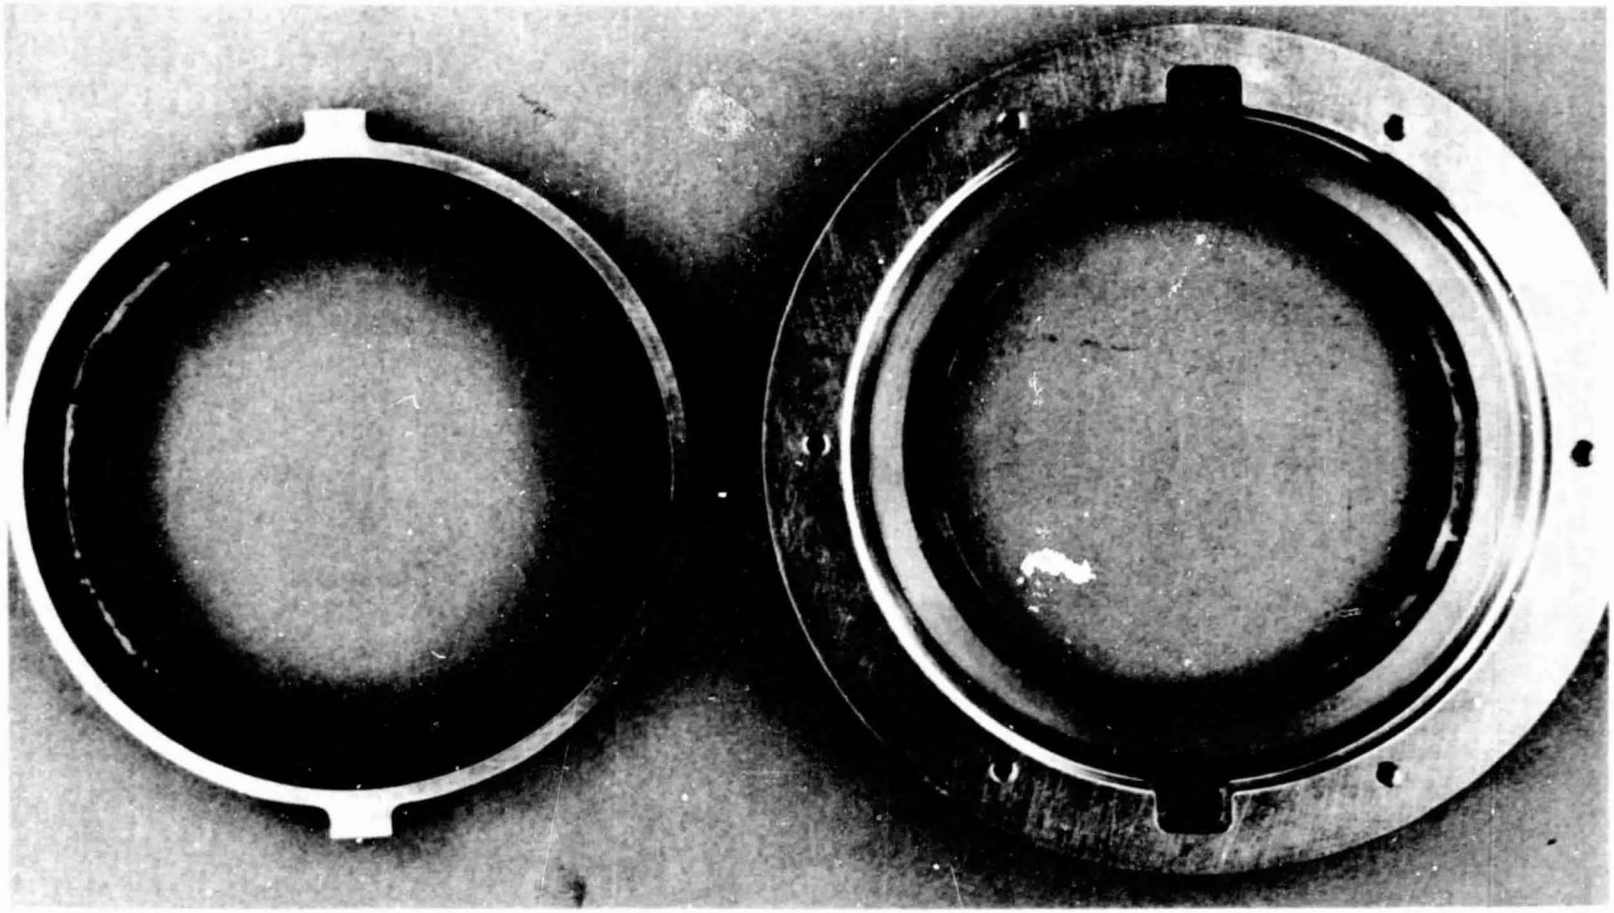
Figure 66. Pump End Secondary Seal, P/N 7R0011526, S/N 047902, Build 11, Posttest 115

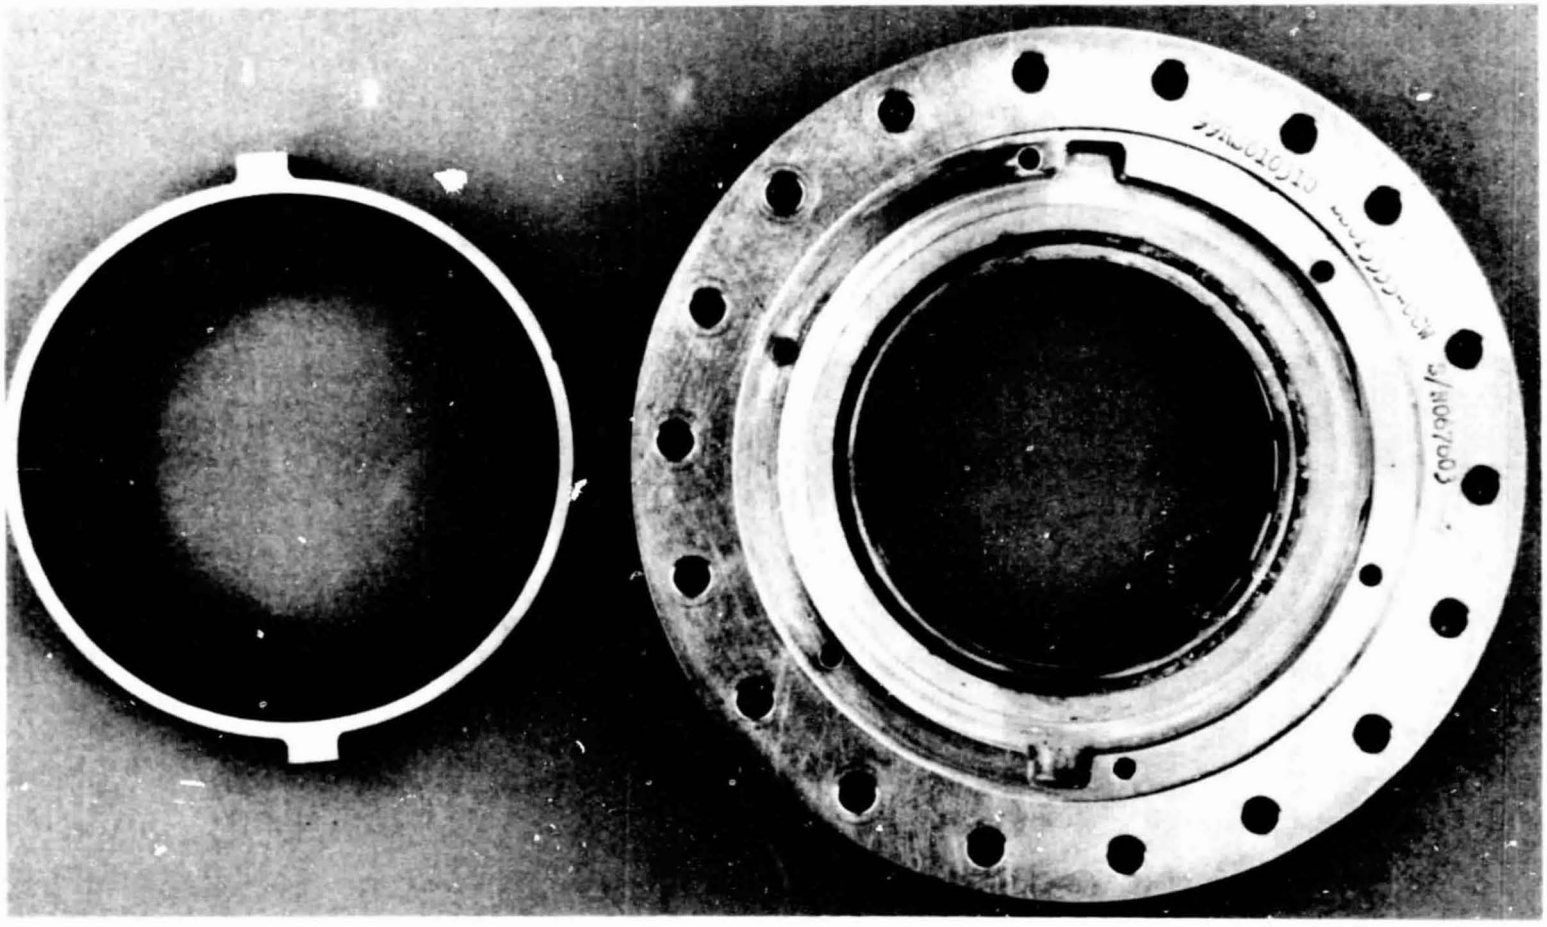
Figure 67. Turbine End Primary Seal, P/N 7R0011525, S/N 047901, Build 11, Posttest 115

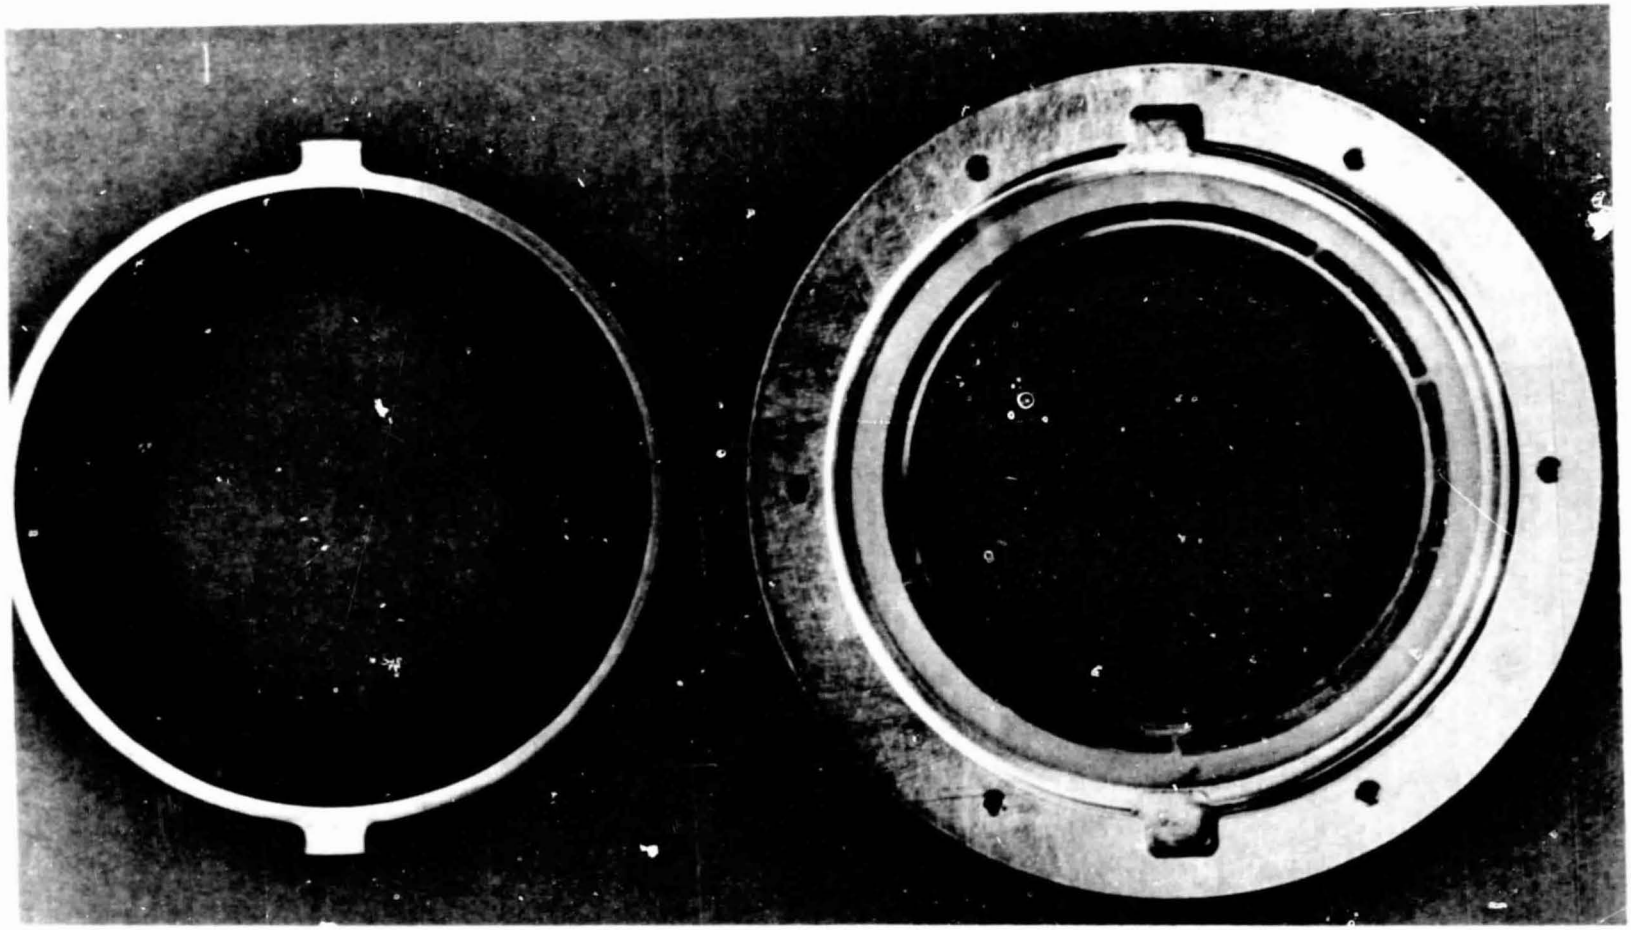
Figure 68. Turbine End Secondary Seal, P/N 7R0011526, S/N 047901, Build 11, Posttest 115

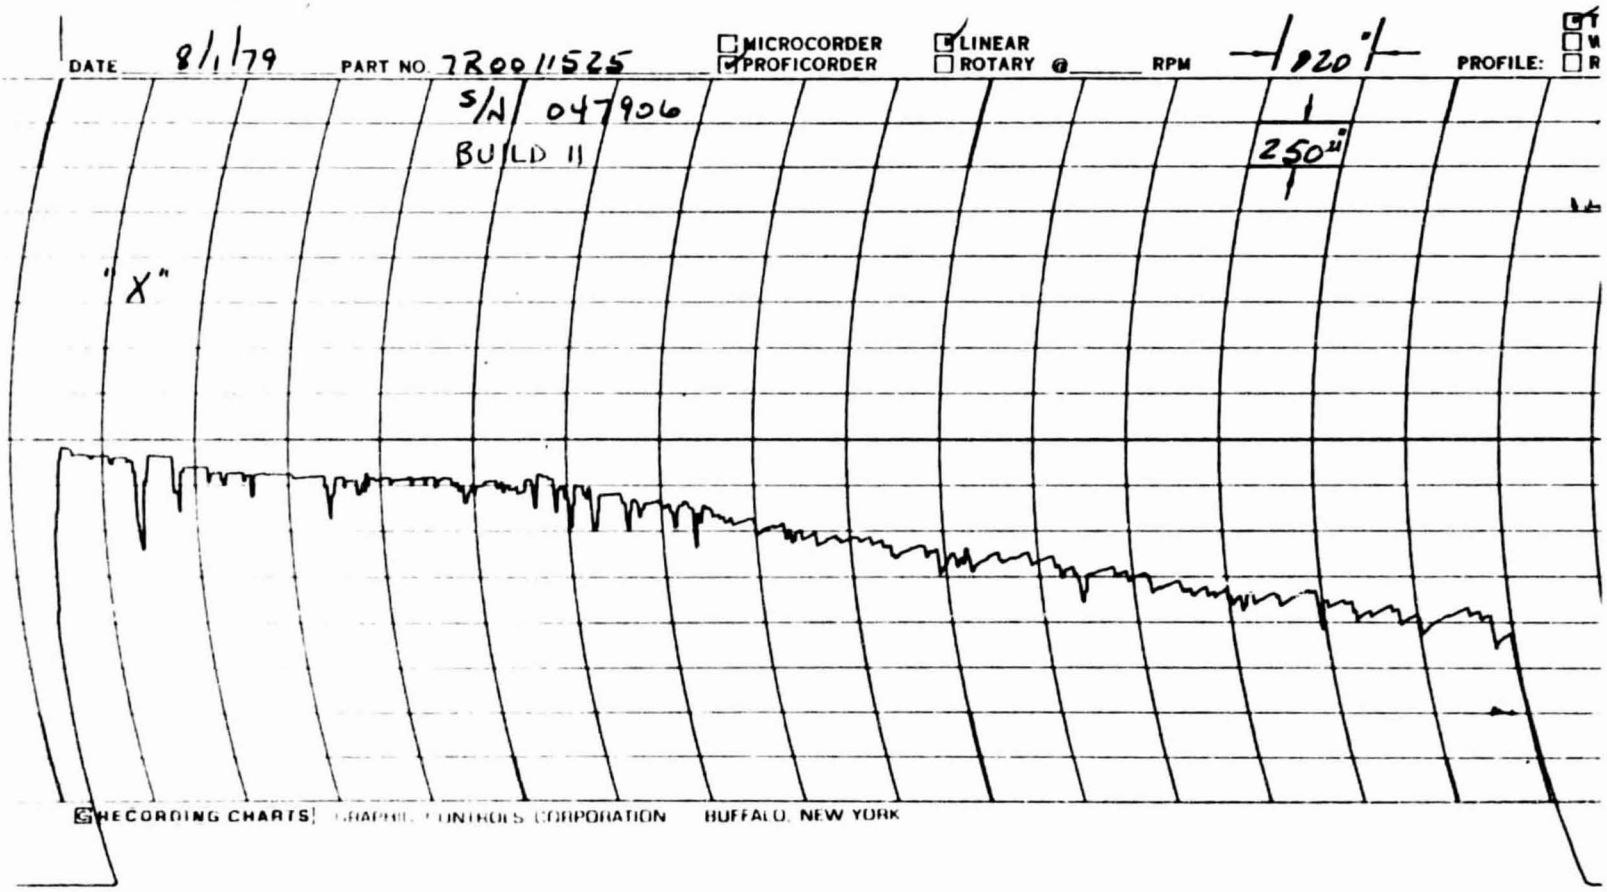
The surface profile traces of the seal ring inside diameters indicate no significant wear. The surface profile traces of the mating ring sleeve at the seal contact locations also indicate no significant wear except for slight erosion at the turbine end secondary seal location. The surface profile traces are shown in Fig. 74 through 79. The seal hardware was in satisfactory condition to be used for the acceleration test series.

Figure 74. Surface Profile Trace Pump End, Primary Seal Ring, P/N 7R0011525, S/N 047906, Build 11, Posttest 115

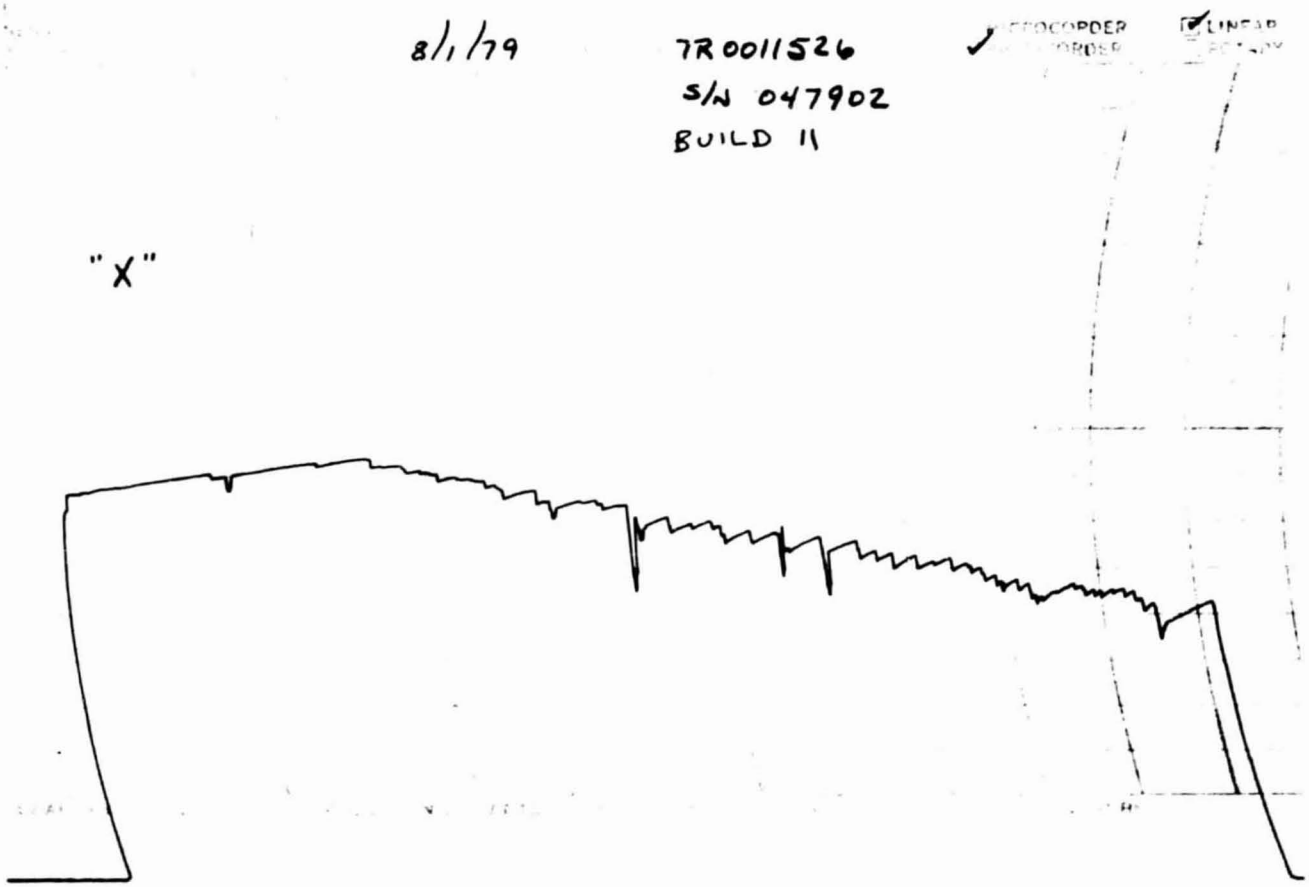
Figure 75. Surface Profile Trace Pump End, Secondary Seal Ring, P/N 7R0011526, S/N 047902, Build 11, Posttest 115

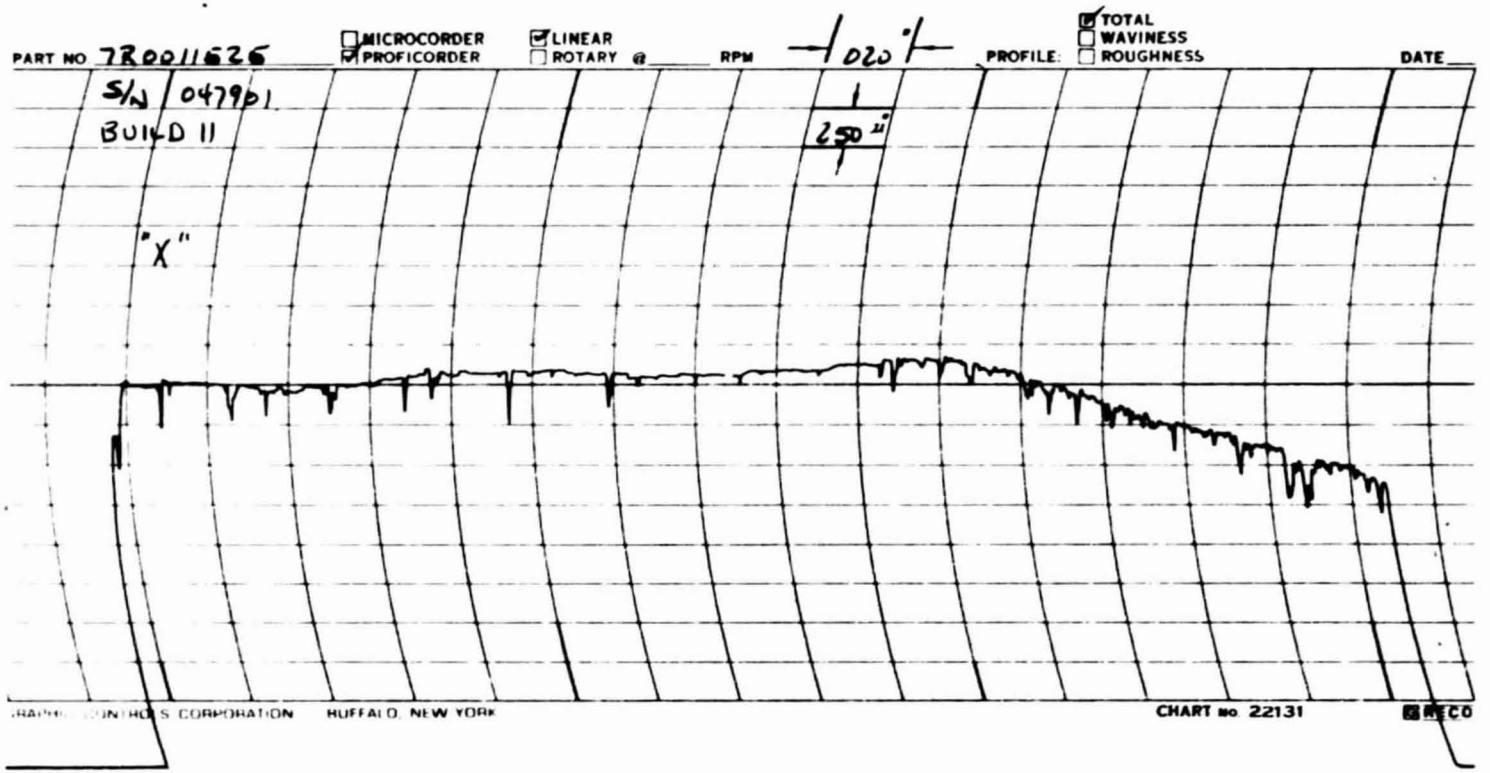
Figure 76. Surface Profile Trace Turbine End, Primary Seal Ring, P/N 7R0011525, S/N 047901, Build 11, Posttest 115

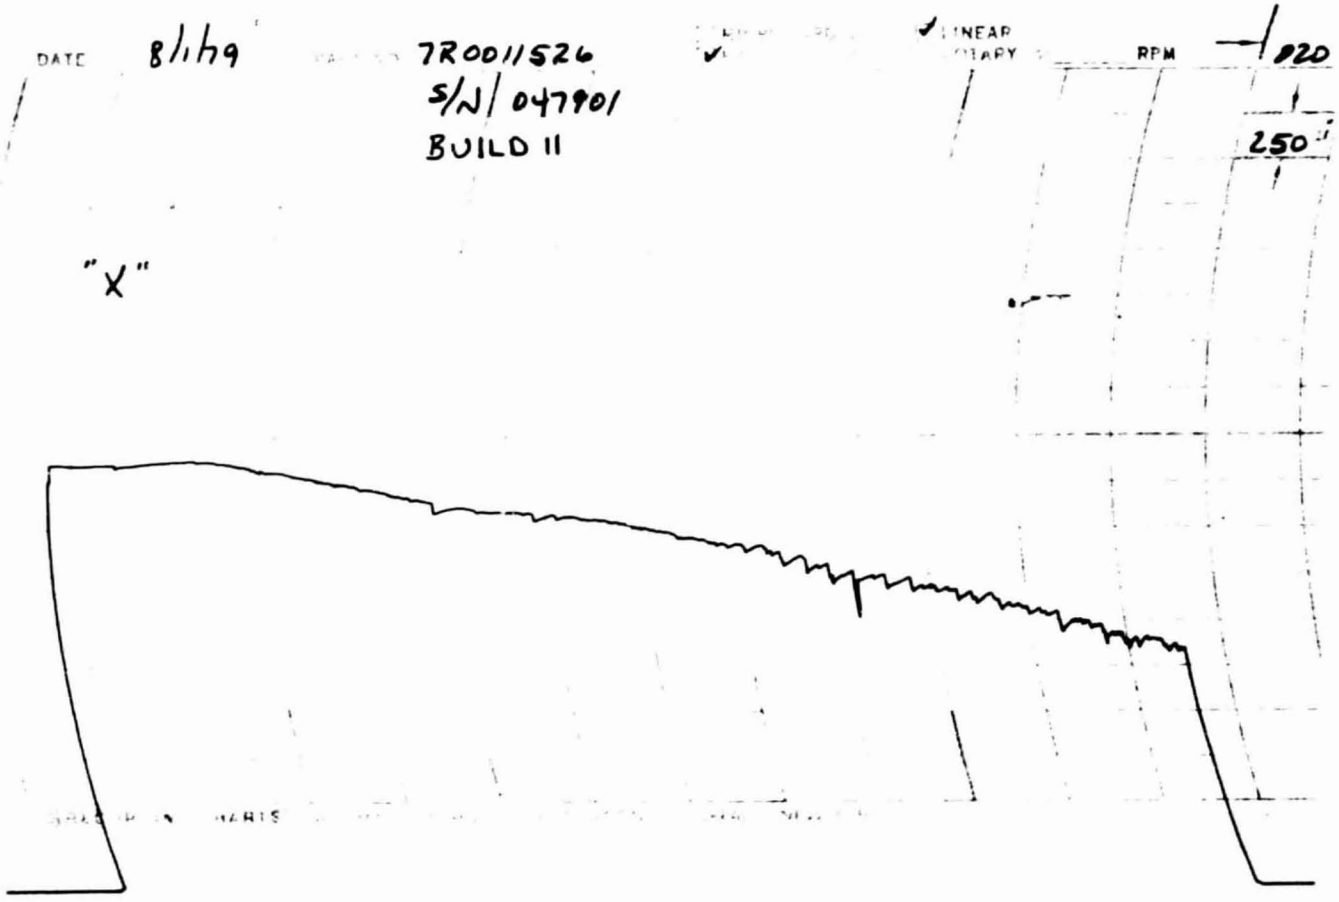
Figure 77. Surface Profile Trace Turbine End, Secondary Seal Ring, P/N 7R0011526, S/N 047901, Build 11, Posttest 115

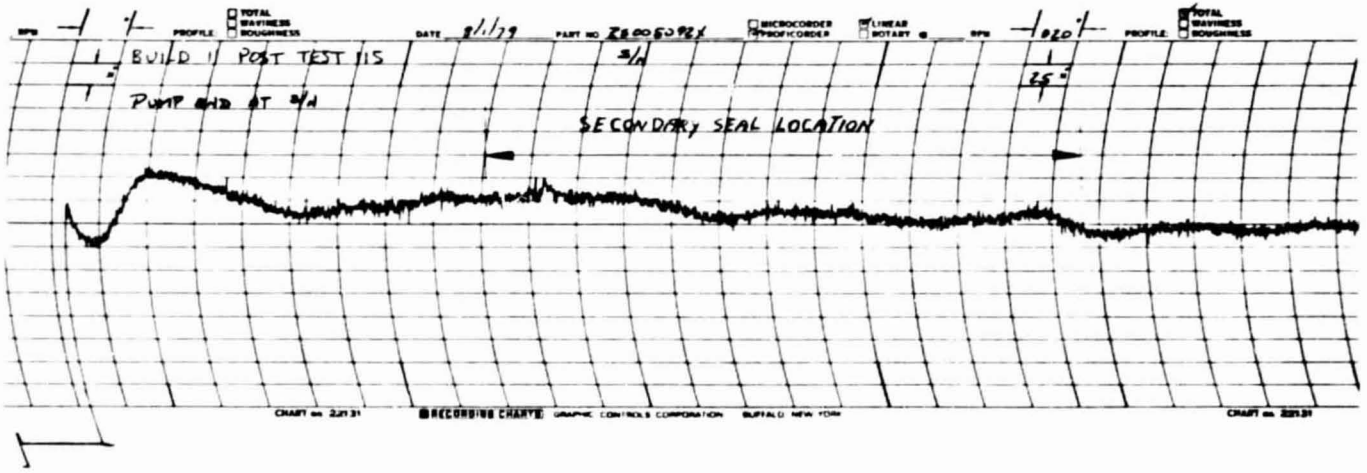
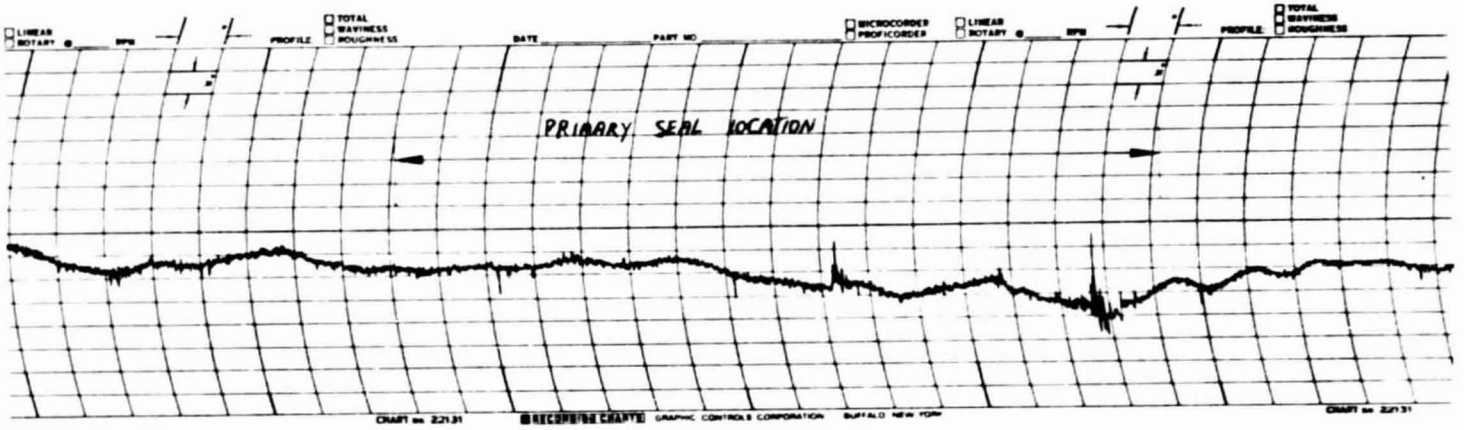
Figure 78. Surface Profile Traces of Tester Mating Ring Sleeve Pump End, P/N RS005092X, S/N 4, Build 11, Posttest 115

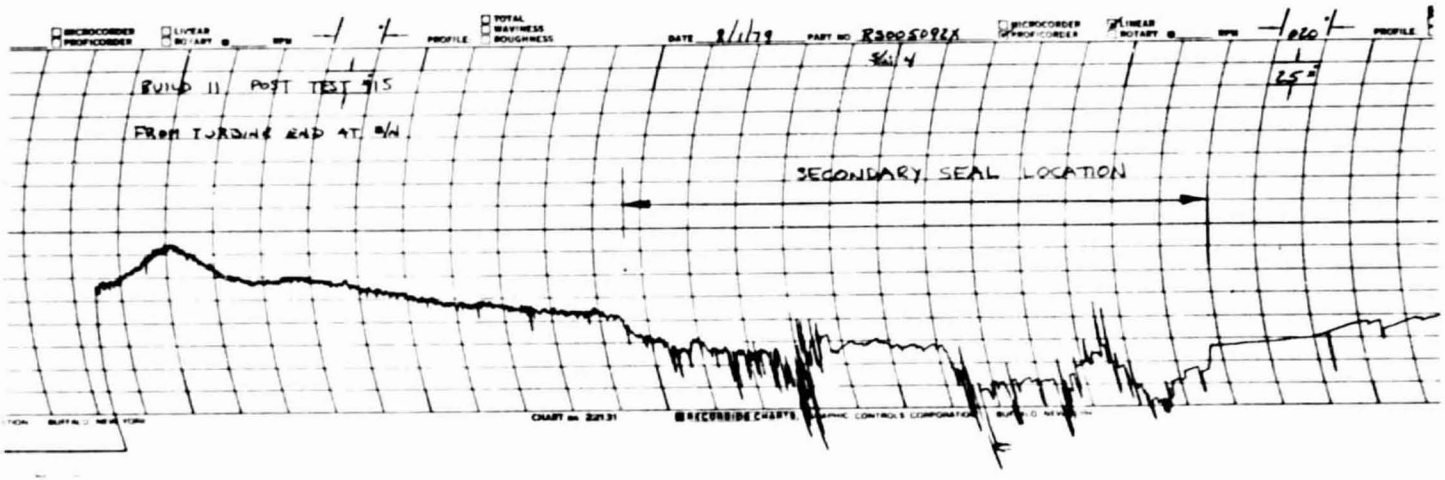
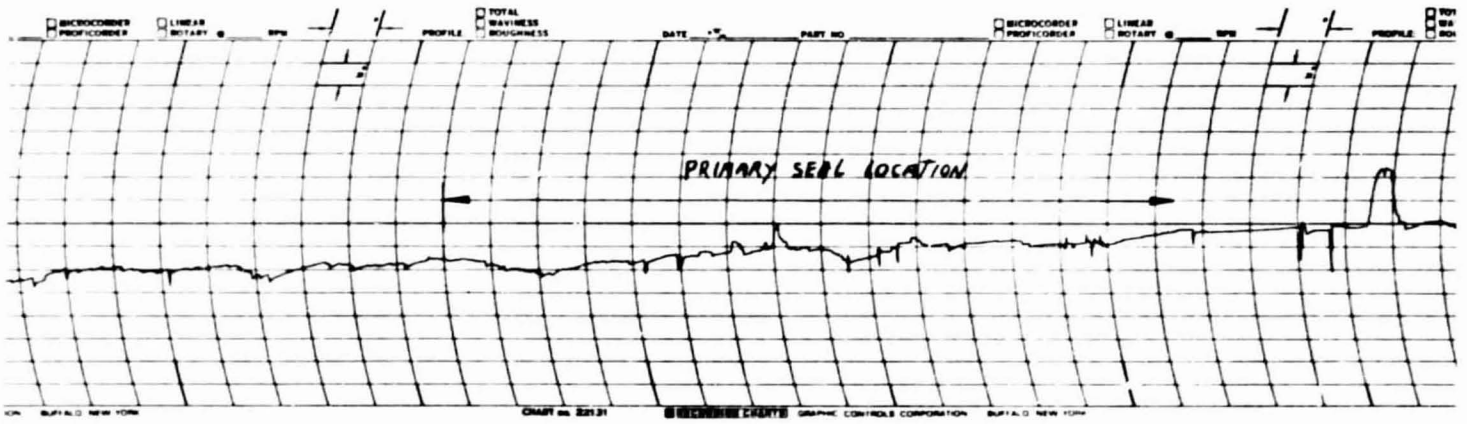
Figure 79. Surface Profile Traces of Tester Mating Ring Sleeve Turbine End, P/N RS005092X, S/N 4, Build 11, Posttest 115

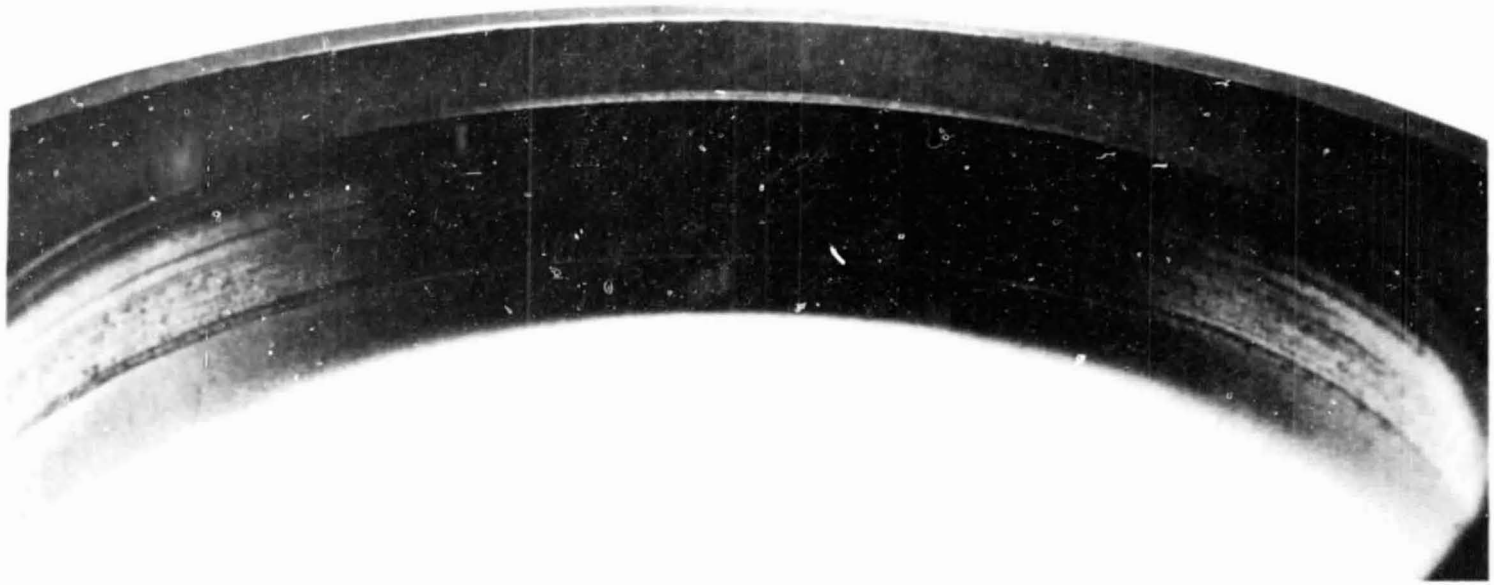
Figure 82. Turbine End Primary Seal Ring, P/N 7R0011525, S/N 047901, Build 12, Posttest 158

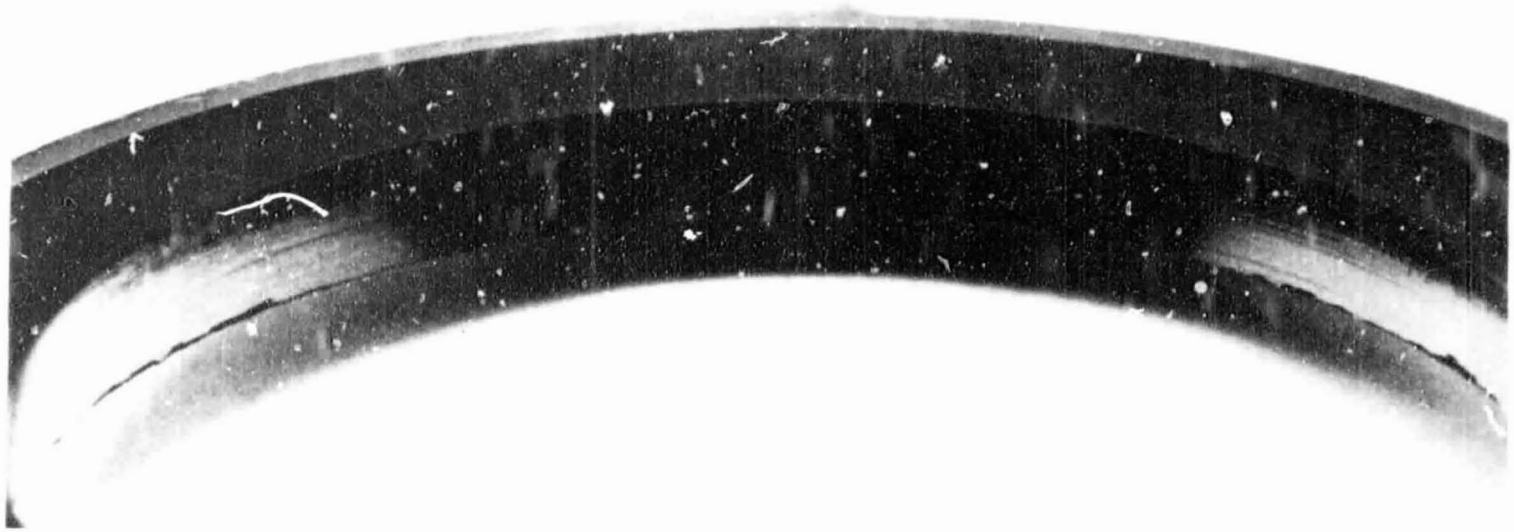
The seals were in good condition with negligible wear, except for the turbine end secondary seal. The axial sealing dam and bearing pad was worn an additional .0003022 m (.0119 in.) for a total of .0003937 m (.0155 in.). The pad was worn with a taper across the ring. The pad height remaining was .0000635 m (.0025 in.) on one side and .00024892 m (.0098 in.) opposite. The carbon bore was worn .0001295 to .00027178 m (.0051 to .0107 in.) diametral on the inlet and .000076 to .0002463 m (.003 to .0097 in.) diametral on the outlet. The hardware condition is shown in Fig. 80 through 84. The inspection summary is

Figure 83. Turbine End Secondary Seal Ring, P/N 7R0011526, S/N 047901, Build 12, Posttest 158

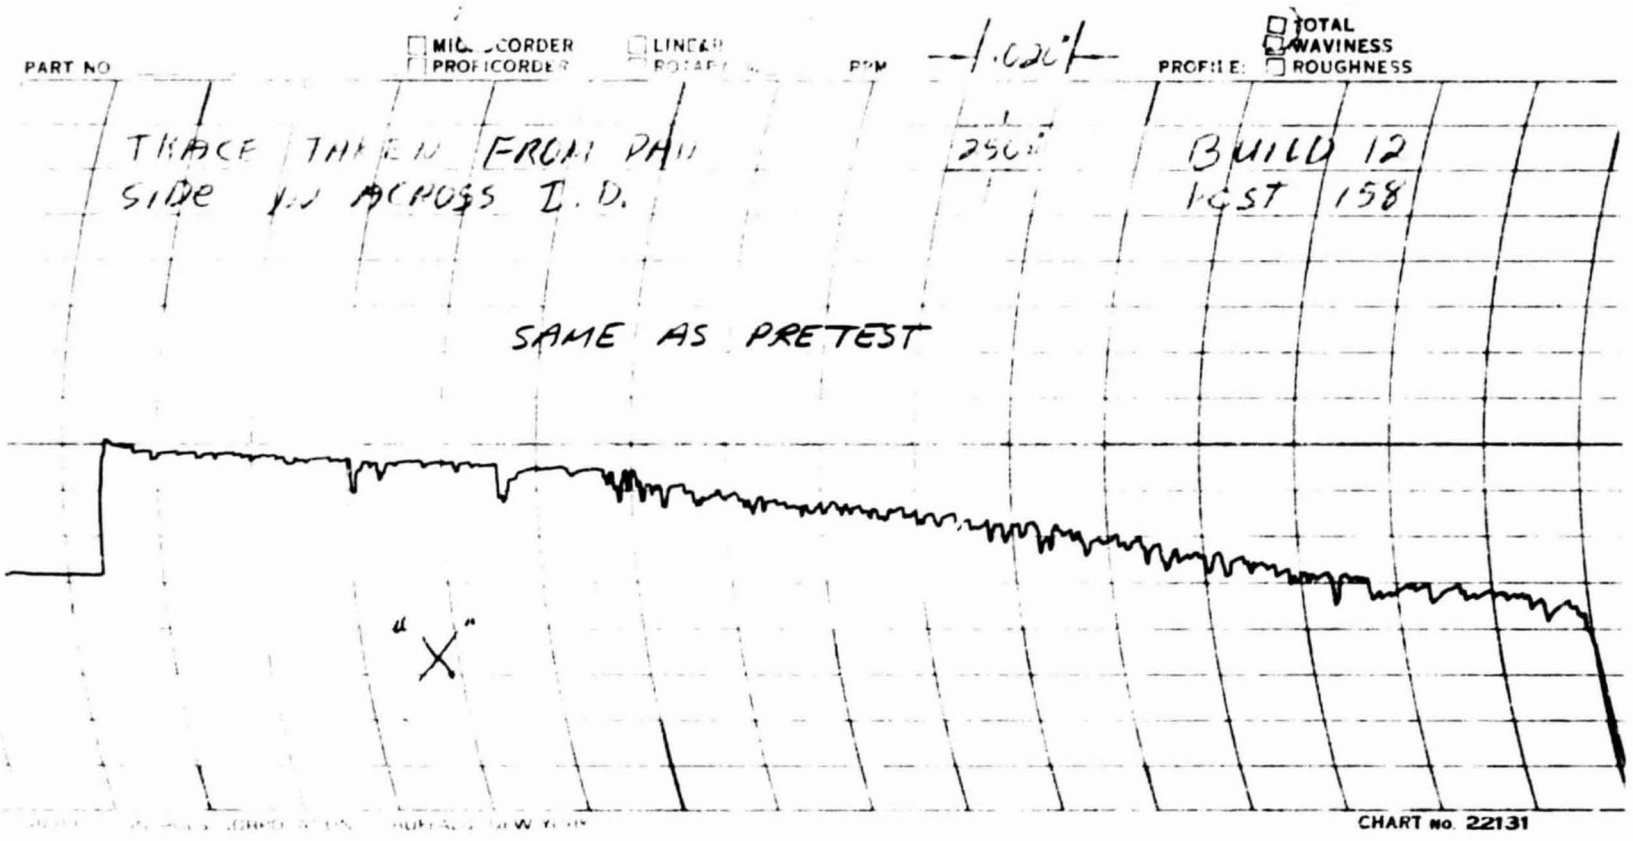
PUMP END	TURBINE END
PRIMARY	NONE	NONE
SECONDARY	.000635m (.00025 in.)	.0000127 (.0005 in.)

Figure 85. Surface Profile Trace Pump End, Primary Seal Ring, P/N 7R0011525, S/N 047906, Build 12, Posttest 158
