NASA CR-165392
RI/RD80-186

HIGH-PRESSURE HOT-GAS SELF-ACTING FLOATING RING SHAFT SEAL FOR LIQUID ROCKET TURBOPUMPS

R. E. Burcham and W. A. Diamond

Rockwell International
Rocketdyne Division

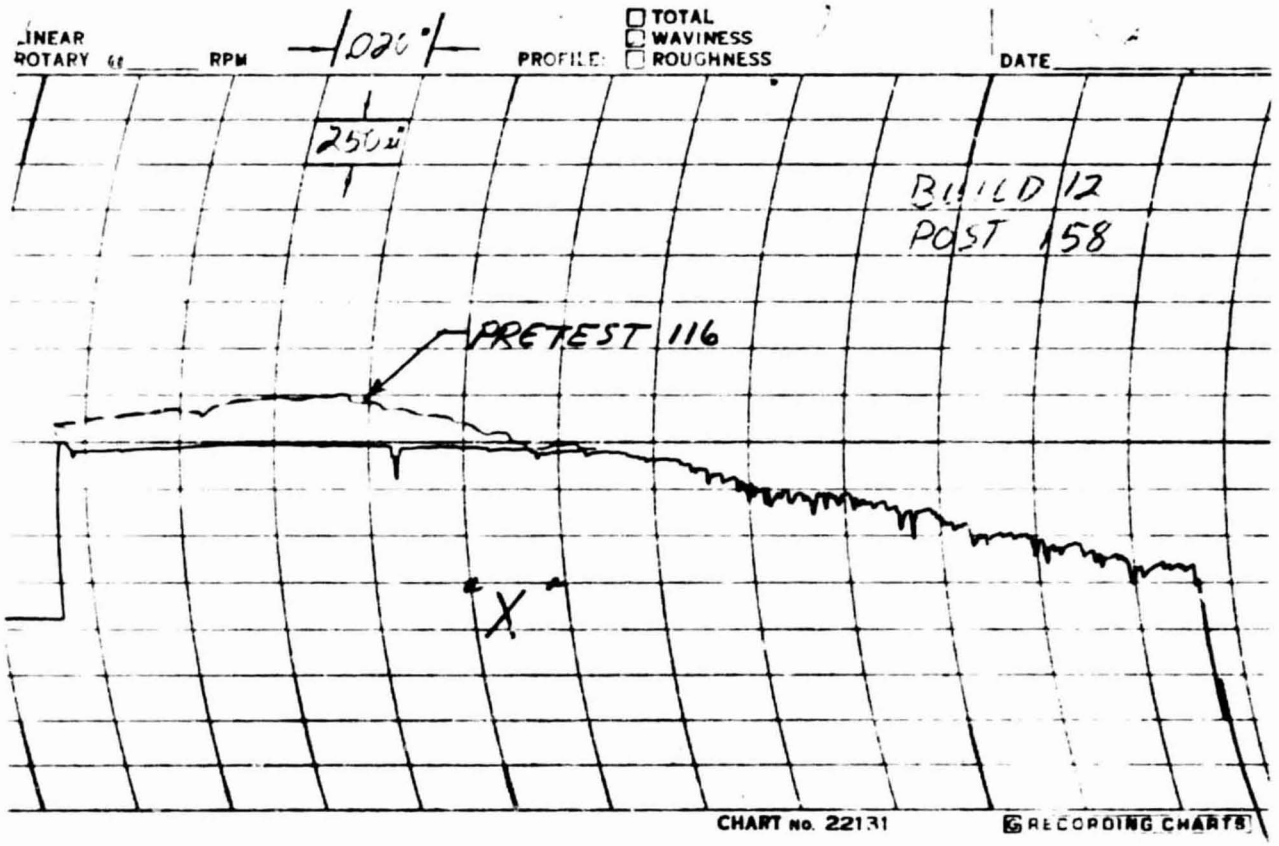
PUMP END	TURBINE END
PRIMARY	NONE	NONE
SECONDARY	.000635m (.00025 in.)	.0000127 (.0005 in.)

Figure 86. Surface Profile Trace Pump End, Secondary Seal Ring, P/N 7R0011526, S/N 047902, Build 12, Posttest 158

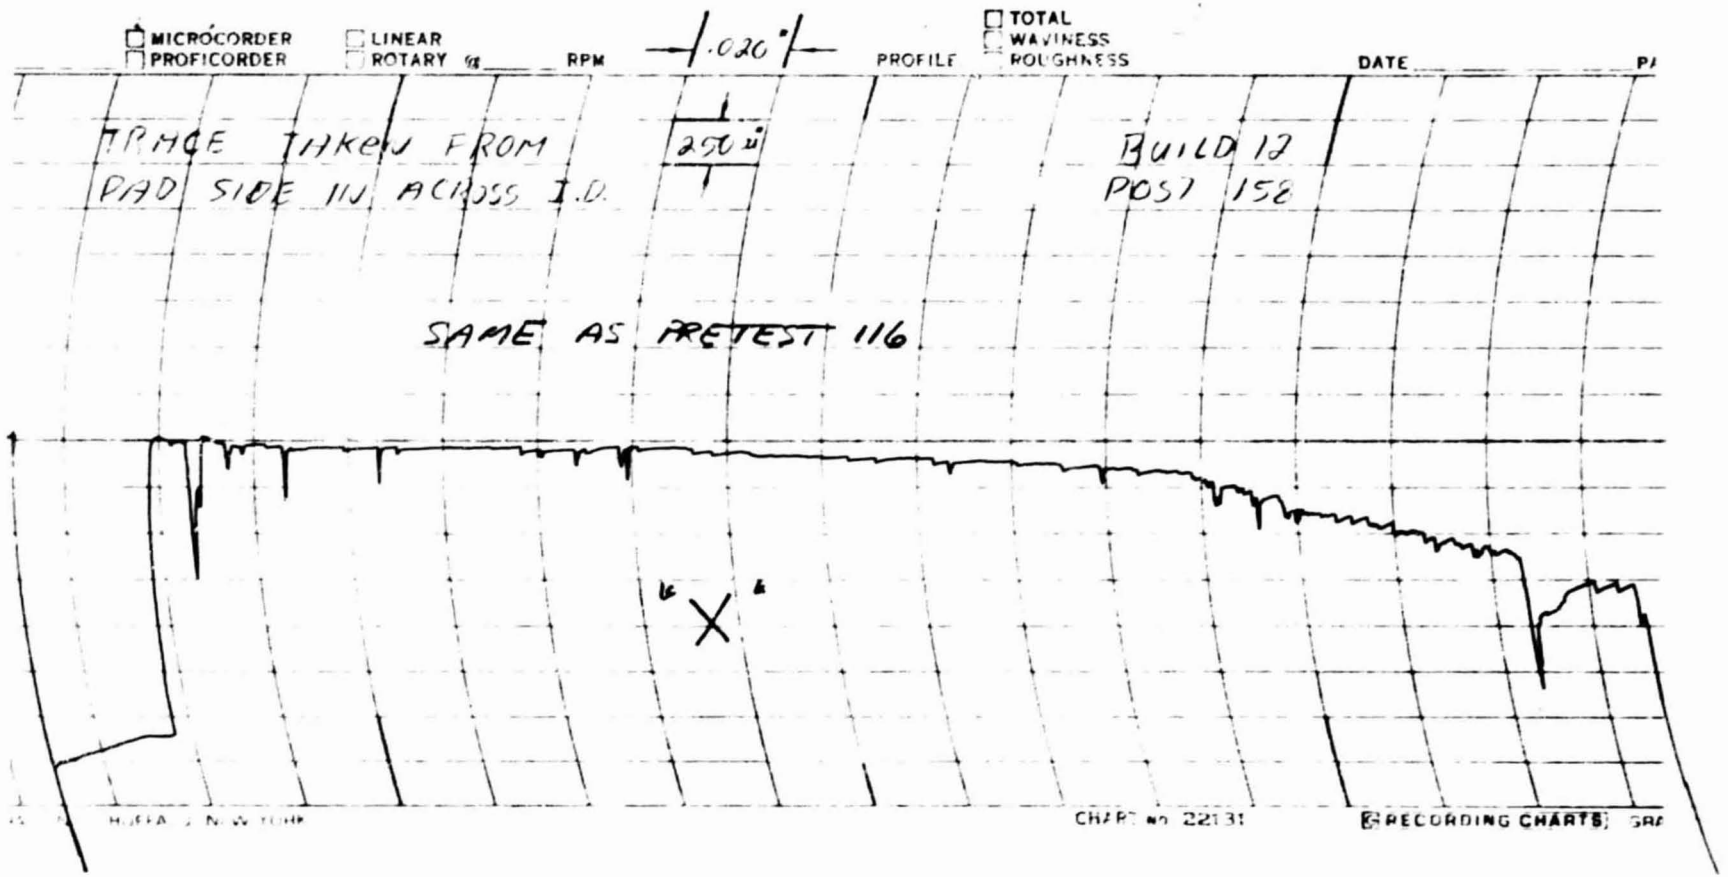
Figure 87. Surface Profile Trace Turbine End, Primary Seal Ring, P/N 7R0011525, S/N 047901, Build 12, Posttest 158

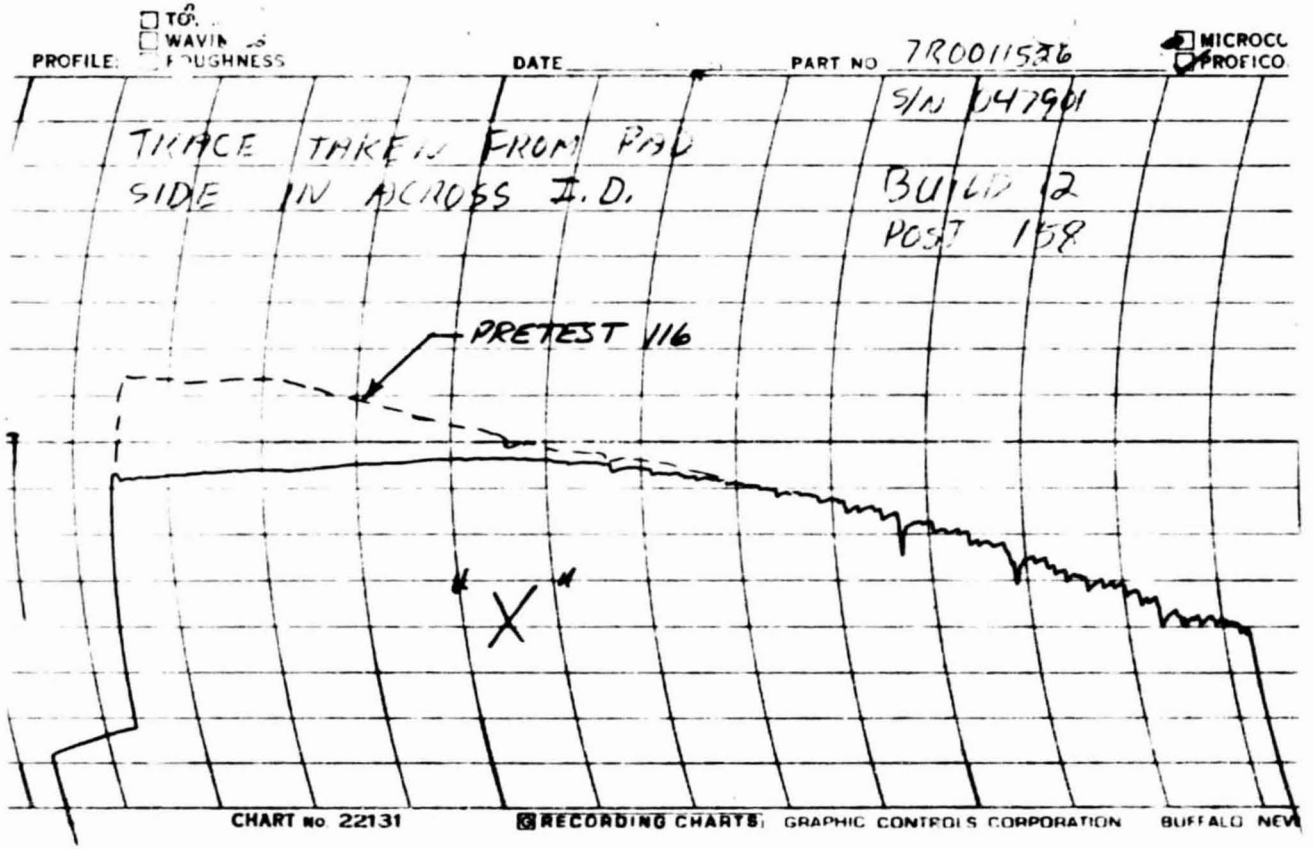
Figure 88. Surface Profile Trace Turbine End, Secondary Seal Ring, P/N 7R0011526, S/N 047901, Build 12, Posttest 158

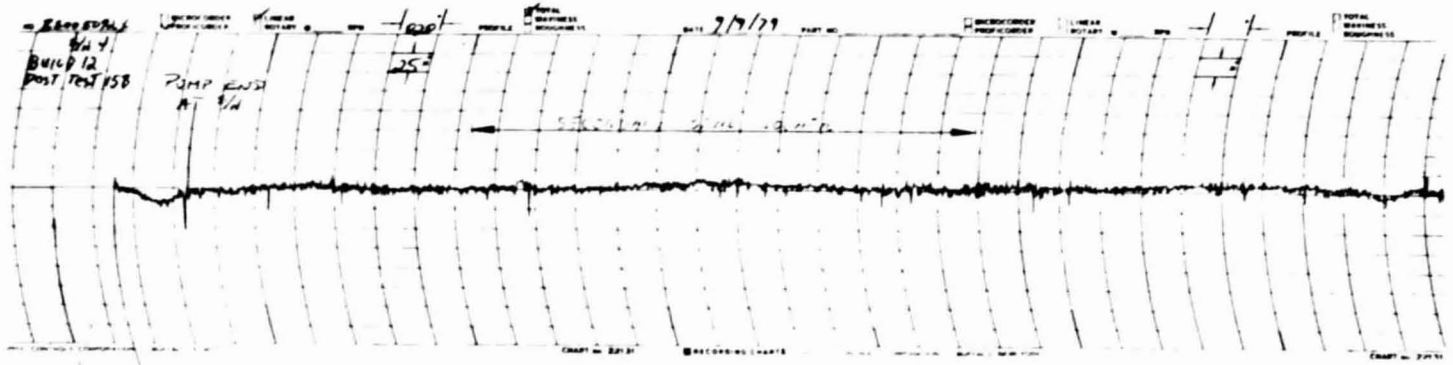
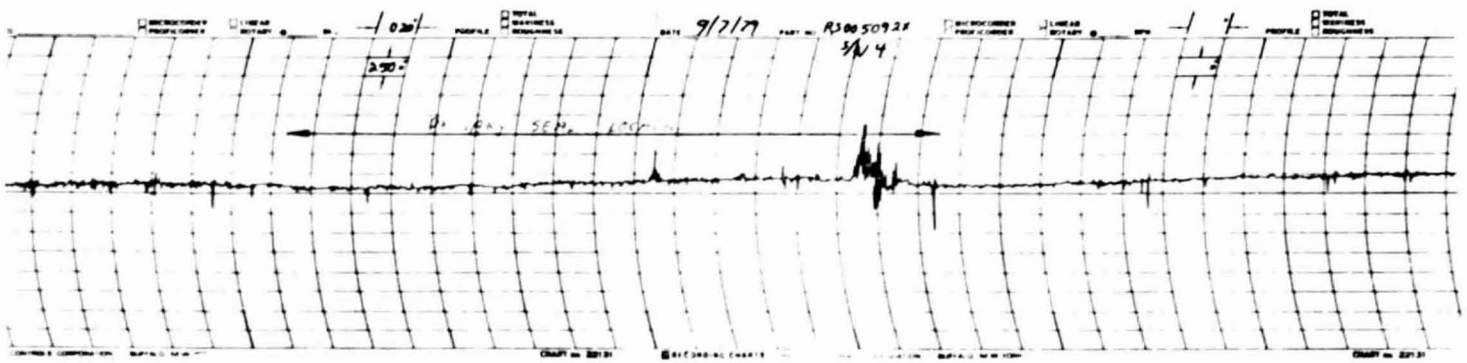
The surface profile traces of the shaft mating ring sleeve at the seal contact locations indicated no significant wear, except for the turbine end secondary seal which was worn .00000381 to .000007b2m (.00015 to .00030 in.), (Fig. 89 and 90).

Figure 89. Surface Profile Traces of Tester Mating Ring, Sleeve Pump End, P/N RS005092X, S/N 4, Build 12, Posttest 158

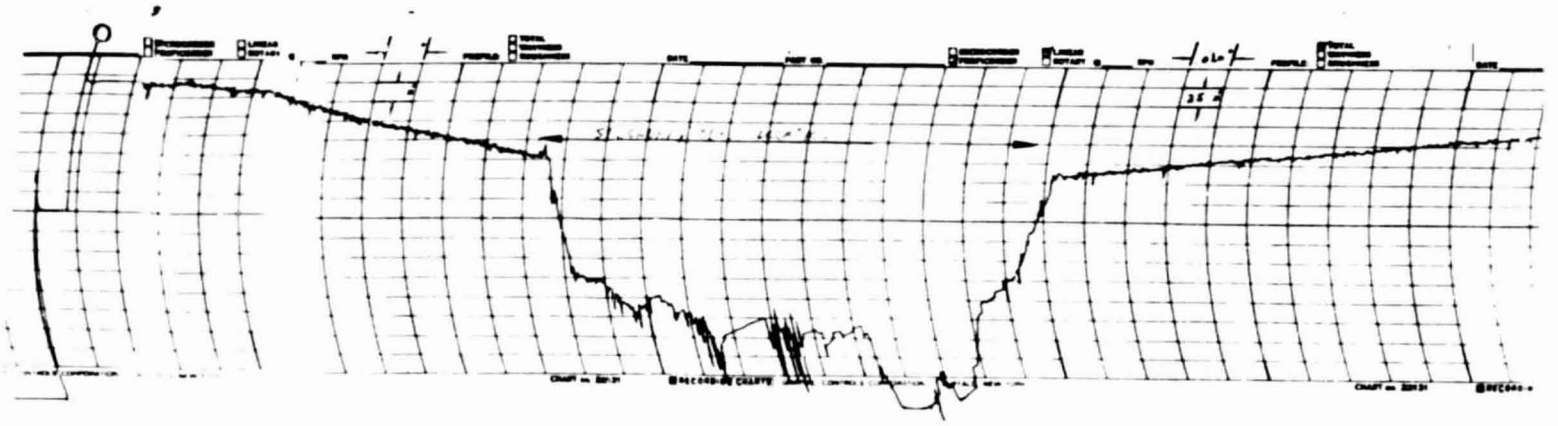
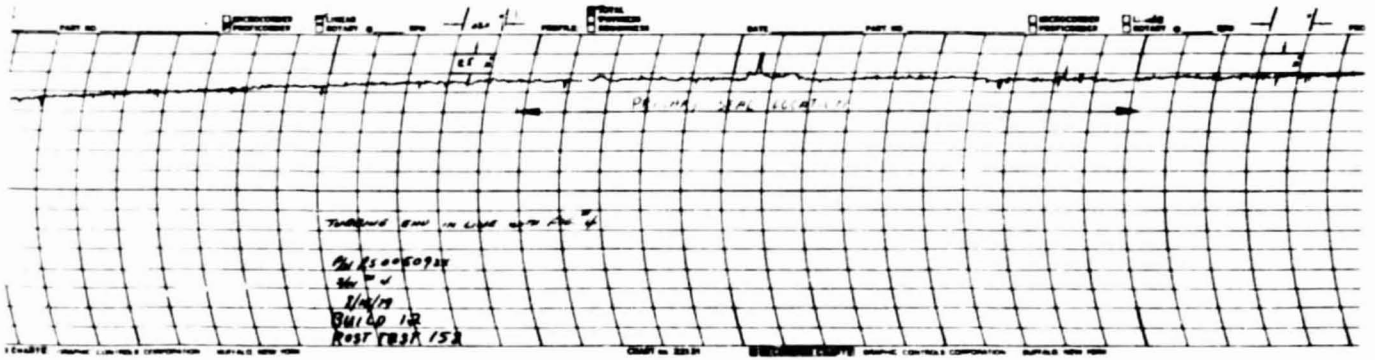
Figure 90. Surface Profile Traces of Tester Mating Ring Sleeve Turbine End, P/N RS005092X, S/N 4, Build 12, Posttest 158

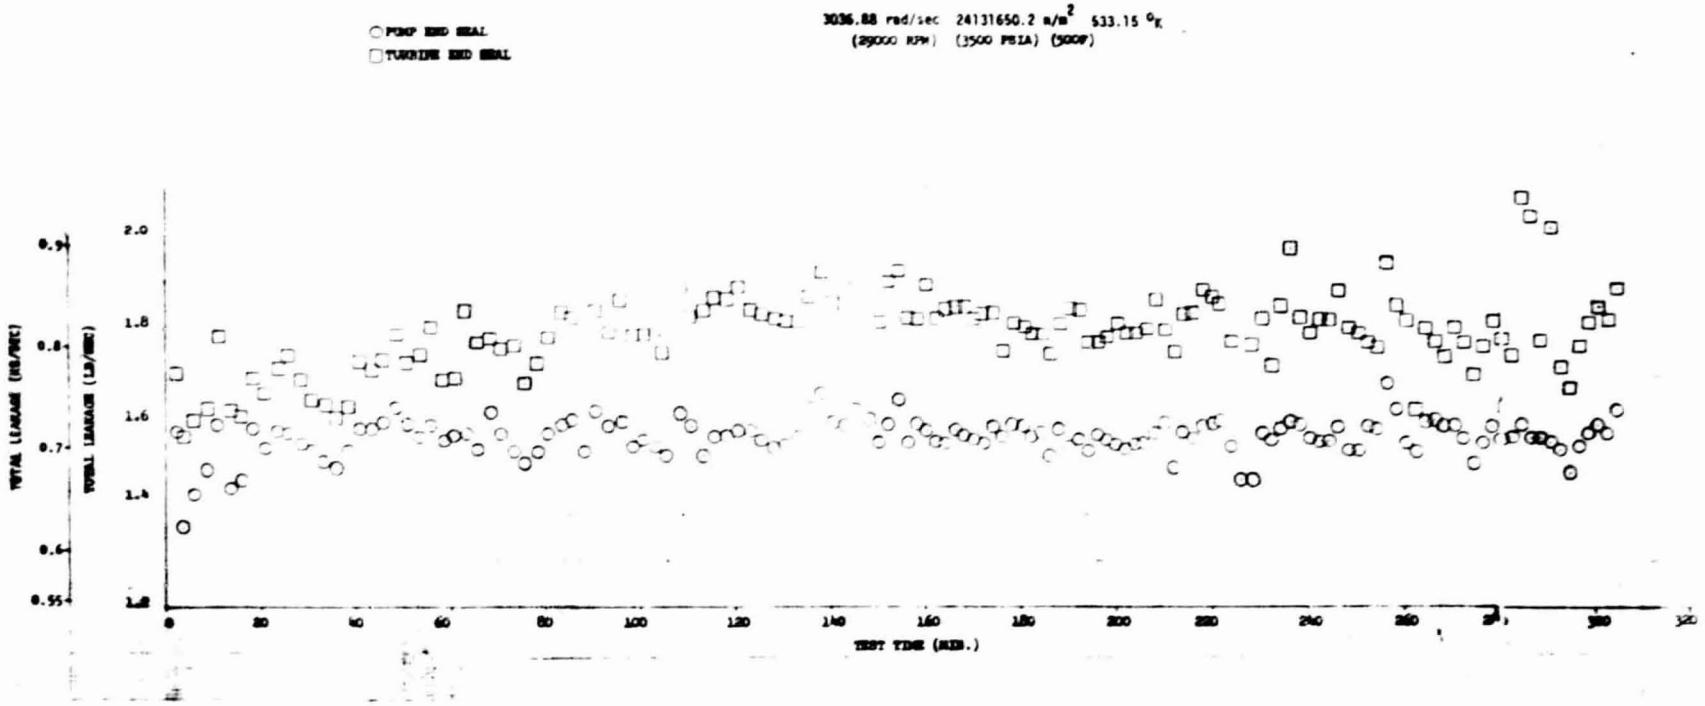
.95254 kg/sec (1.7 to 2.1 lb/sec) on the turbine end seal (Table 12). The leakage rates adjusted to 24131640.2 n/m^2 (3500 psig) inlet pressure (Fig. 91) show nearly constant total leakage for the pump end seal from start of test through 358 minutes of accumulated test time. The turbine end seal total leakage shows a gradual increase from .72574 to .7711 kg/sec (1.6 to 1.7 lb/sec) at start to .86182 to .909185 kg/sec (1.9 to 2.0 lb/sec) at 358 minutes. The leakage data indicate relatively little wear on the pump end seal and gradual wearing of the turbine end seal.

Figure 91. Tapered Bore Seal Total Leakage vs Test Time Tests 159-297

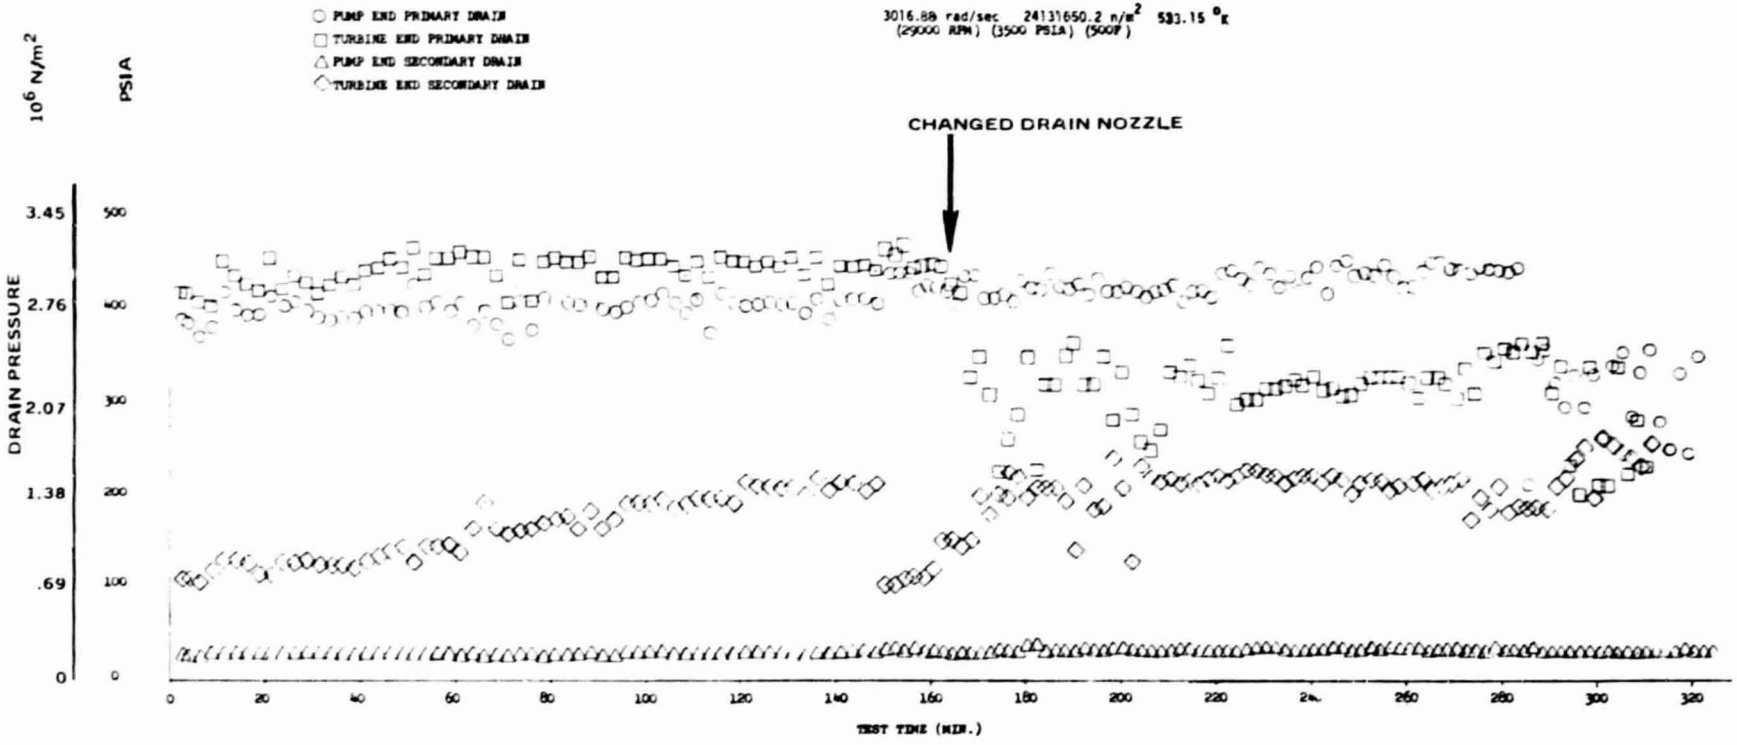
The seal drain pressure plots versus test time (Fig. 92) show nearly constant drain pressures on the pump end primary and secondary seal drains. The turbine end primary seal shows a decreasing drain pressure. The secondary seal drain pressure also shows a decrease. This decrease, however, is due to a different size nozzle placed on the drain outlet pipe. Once this different nozzle is accounted for the pressure was found to be gradually increasing. The drain pressure data indicate relatively little wear on the pump end primary seal, the pump end secondary seal and the turbine end secondary seal. Both seals maintained satisfactory drain pressures throughout the total accumulated test time.

Figure 92. Tapered Bore Seal Drain Pressure vs Test Time, Tests 159-297

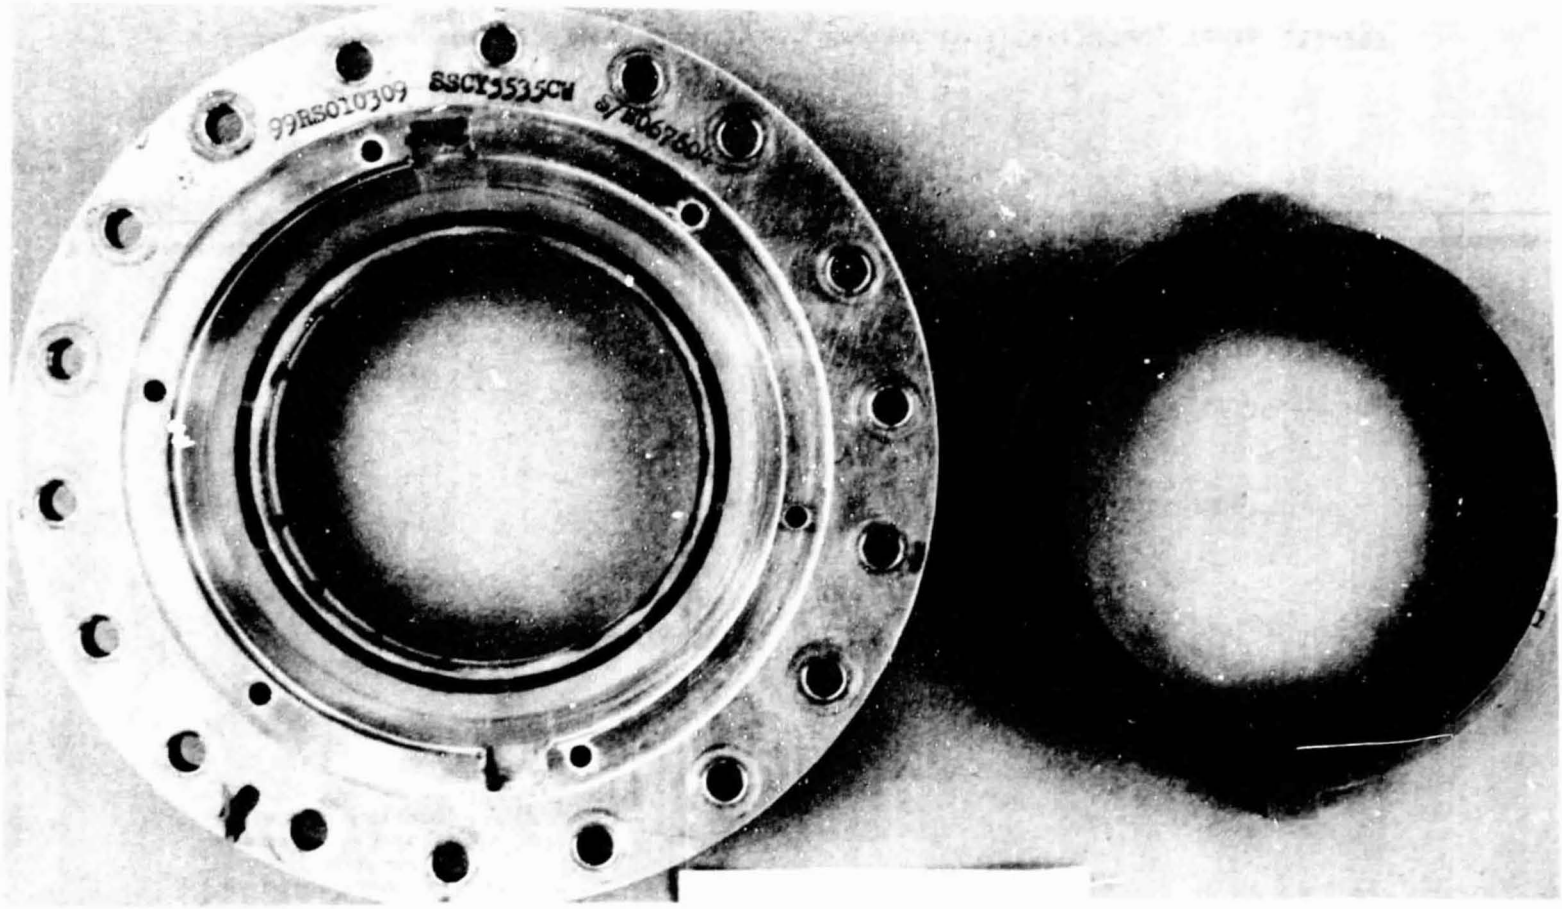
Figure 93. Pump End Primary Seal, P/N 7R0011525, S/N 047909, Build 15, Posttest 297

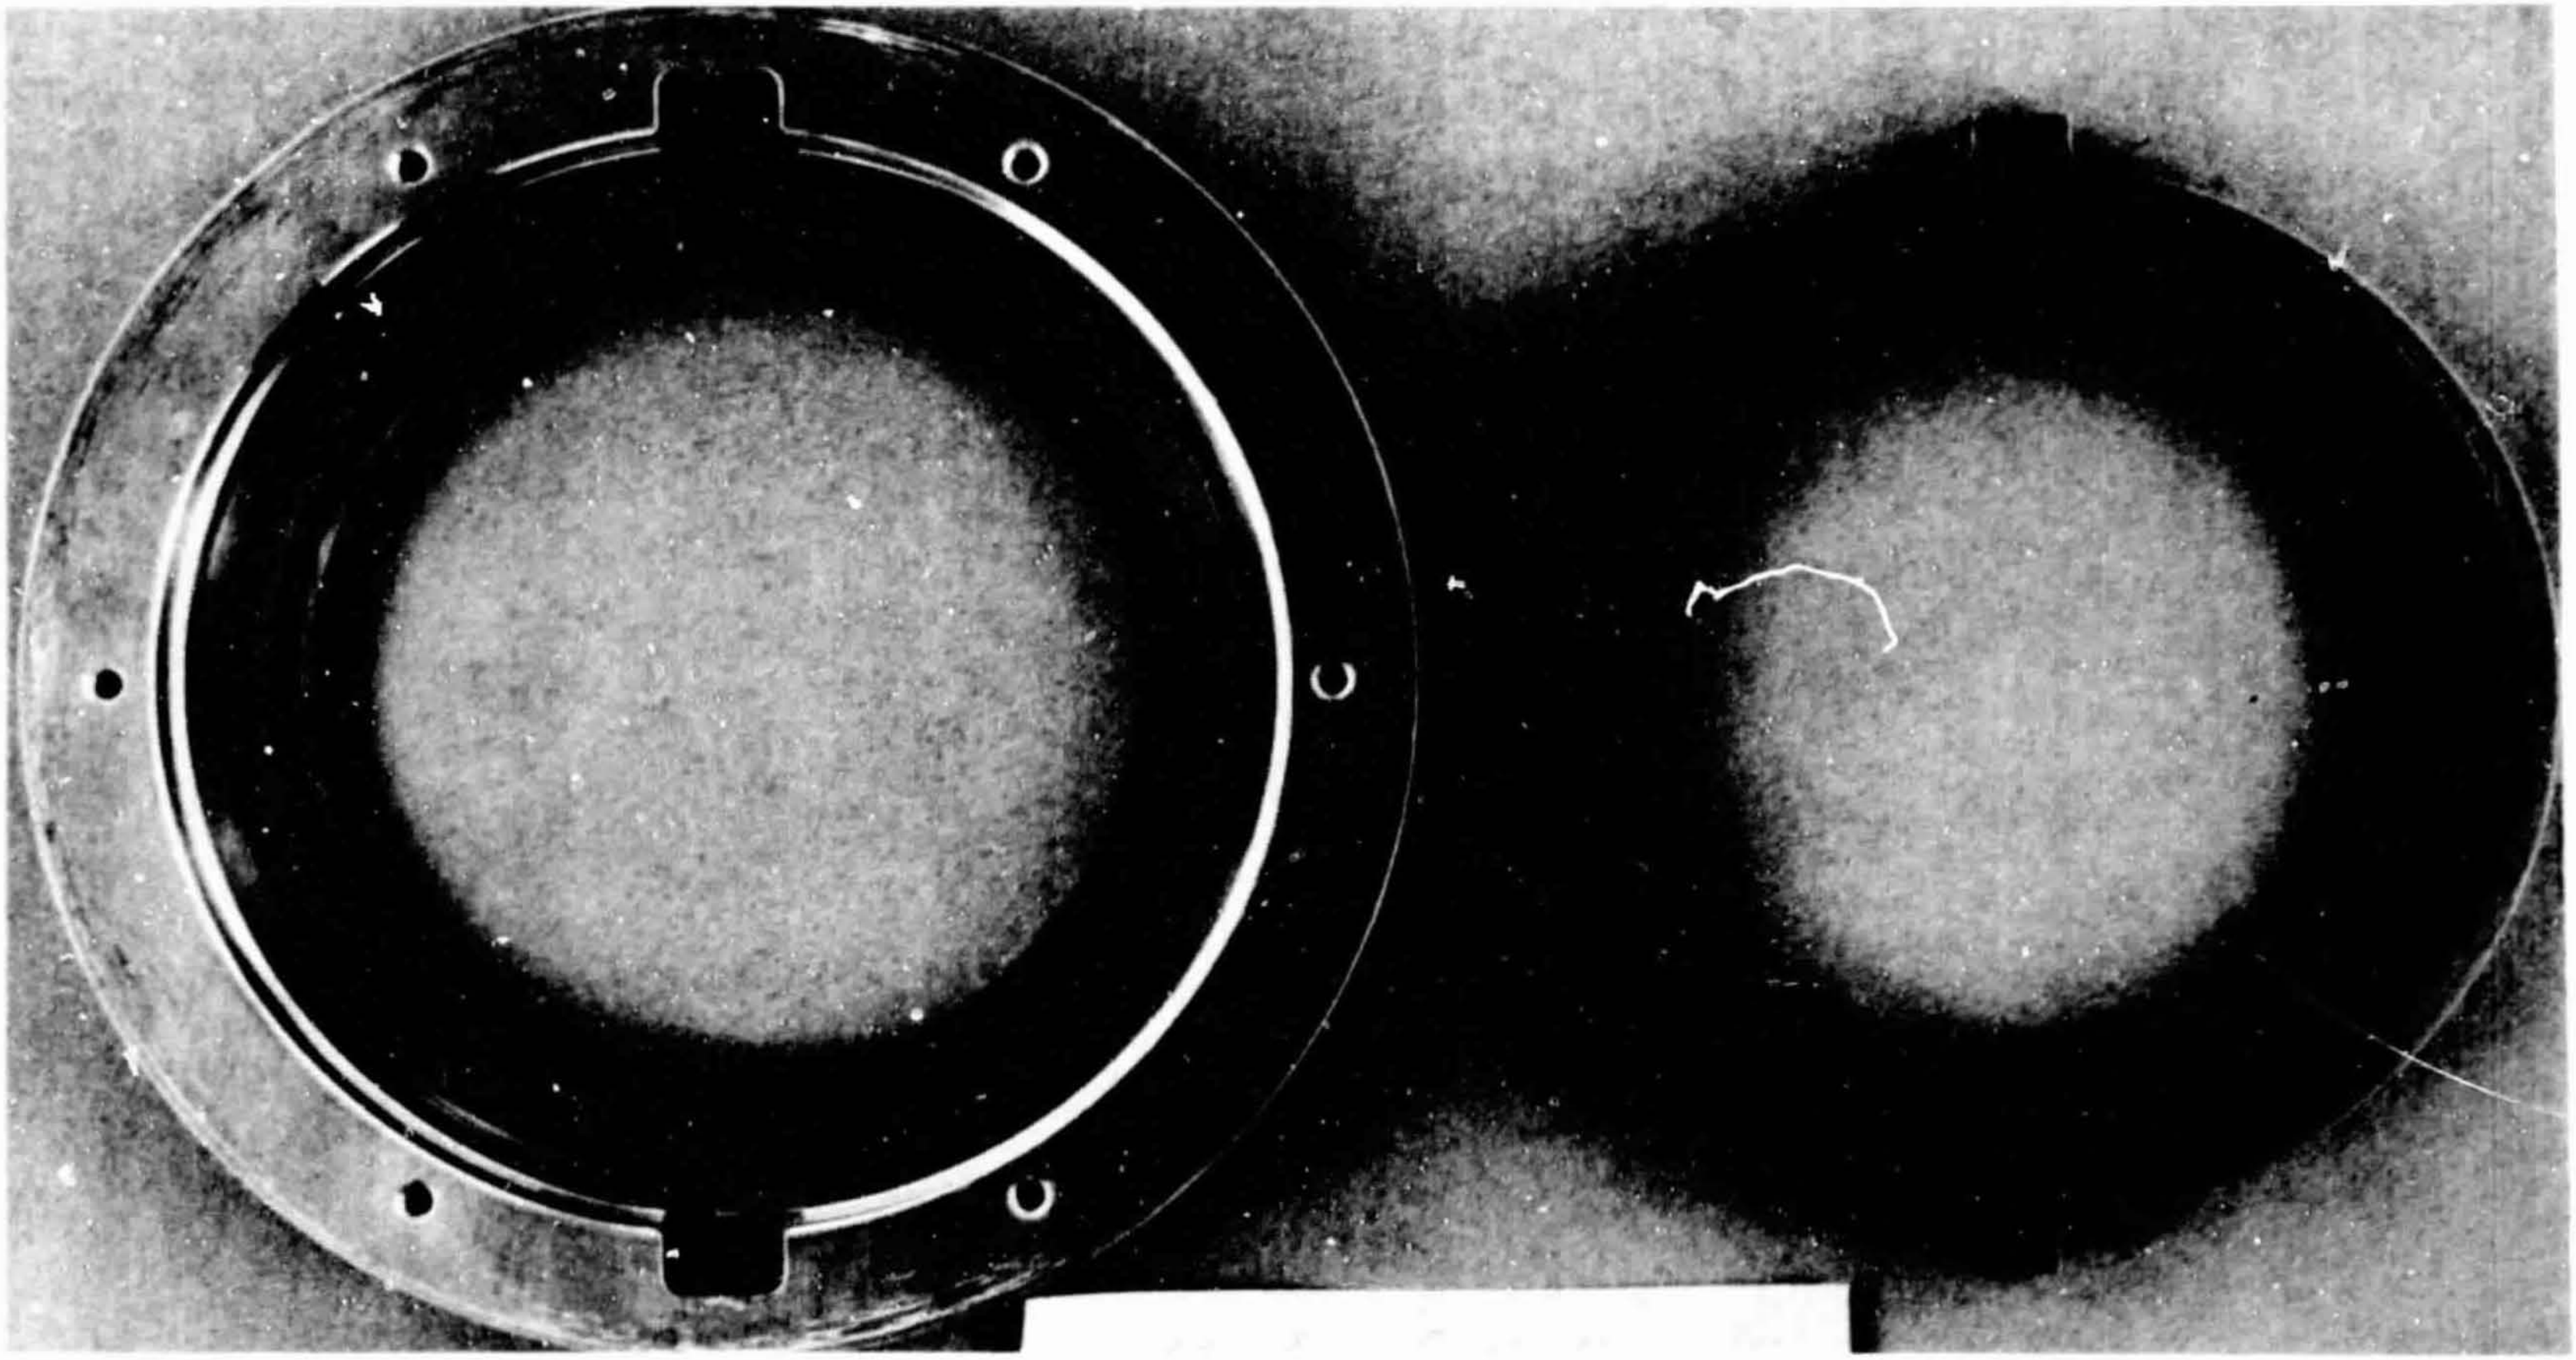
Figure 94. Pump End Secondary Seal, P/N 7R0011526, S/N 047909, Build 15, Posttest 297

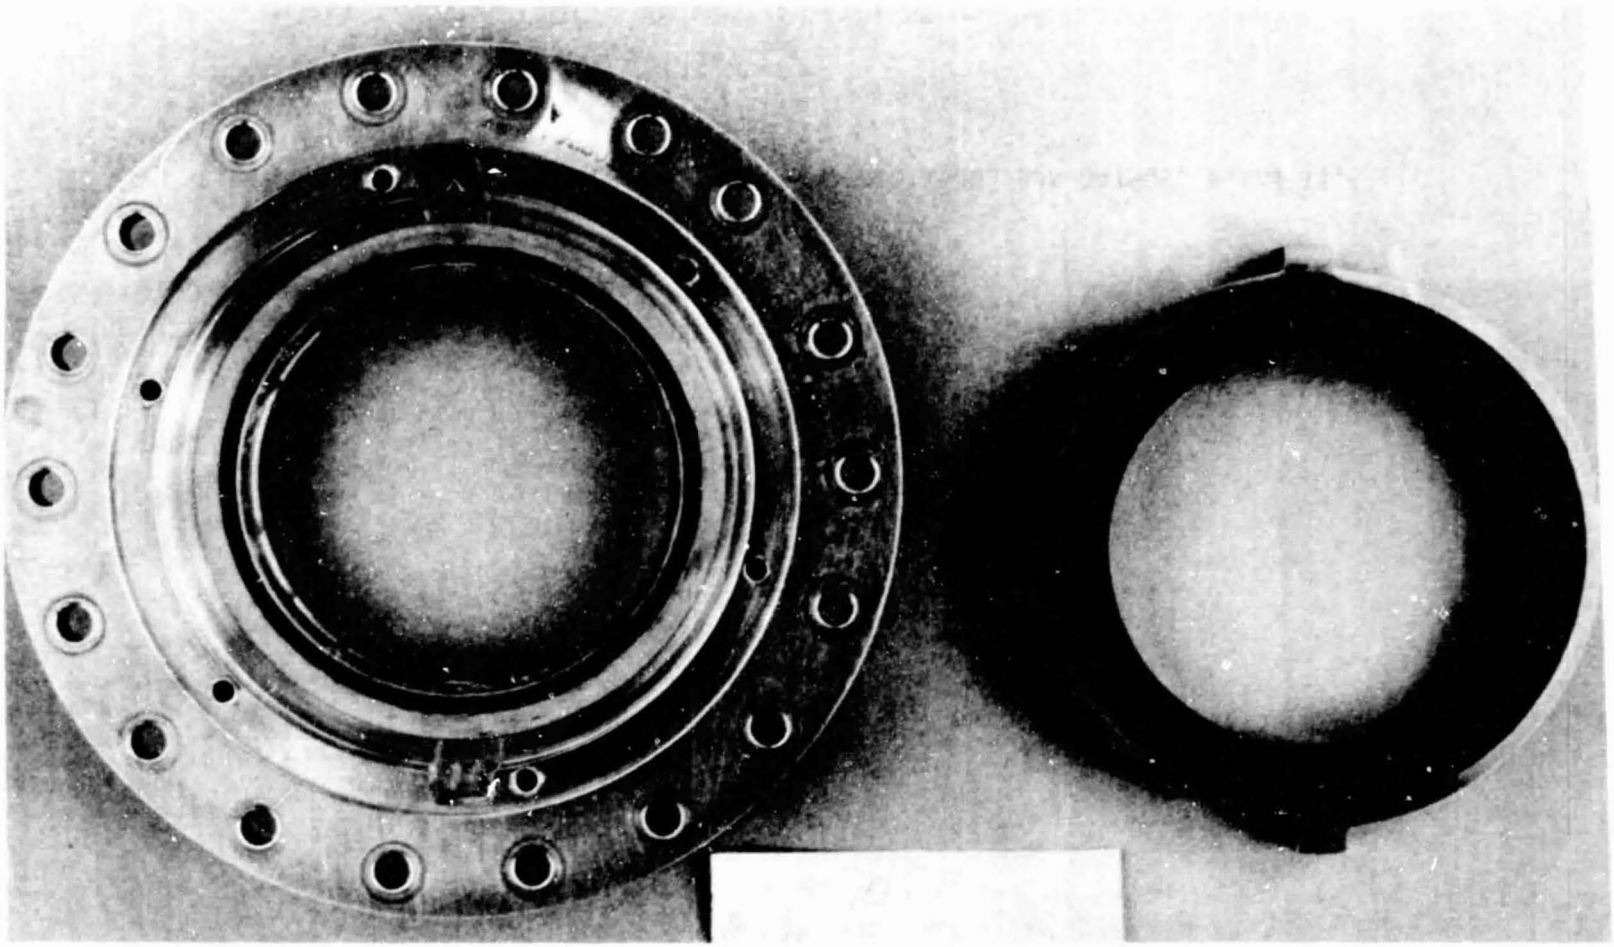
Figure 95. Turbine End Primary Seal, P/N 7R0011525, S/N 047907, Build 15, Posttest 297

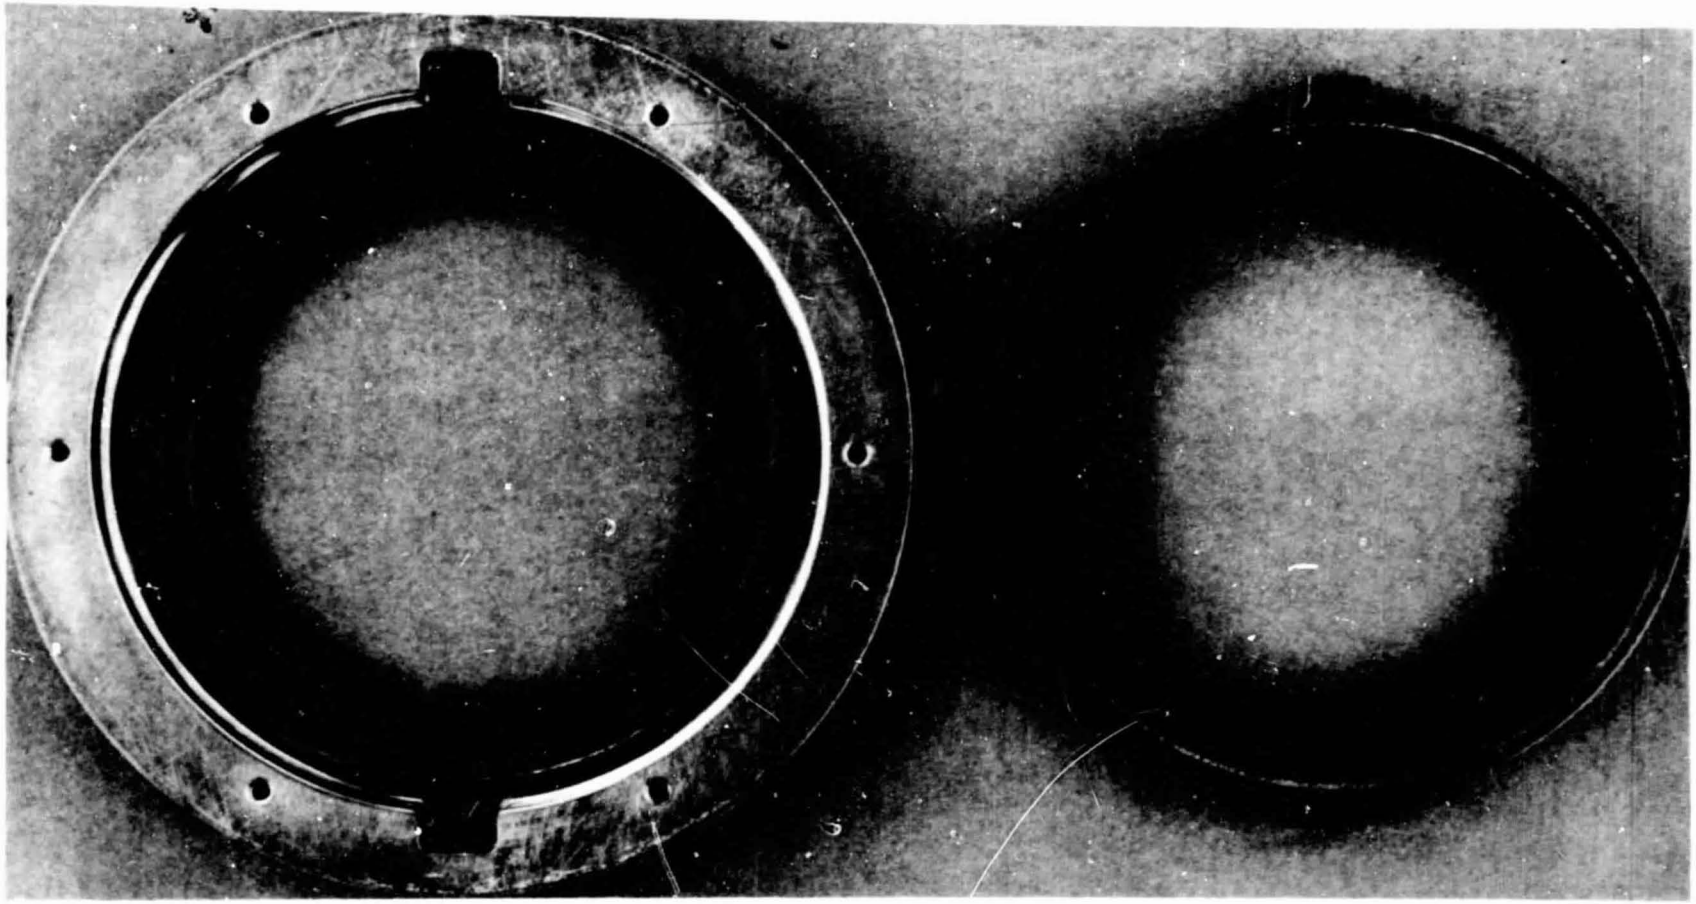
Figure 96. Turbine End Secondary Seal, P/N 7R0011526, S/N 047907, Build 15, Posttest 297

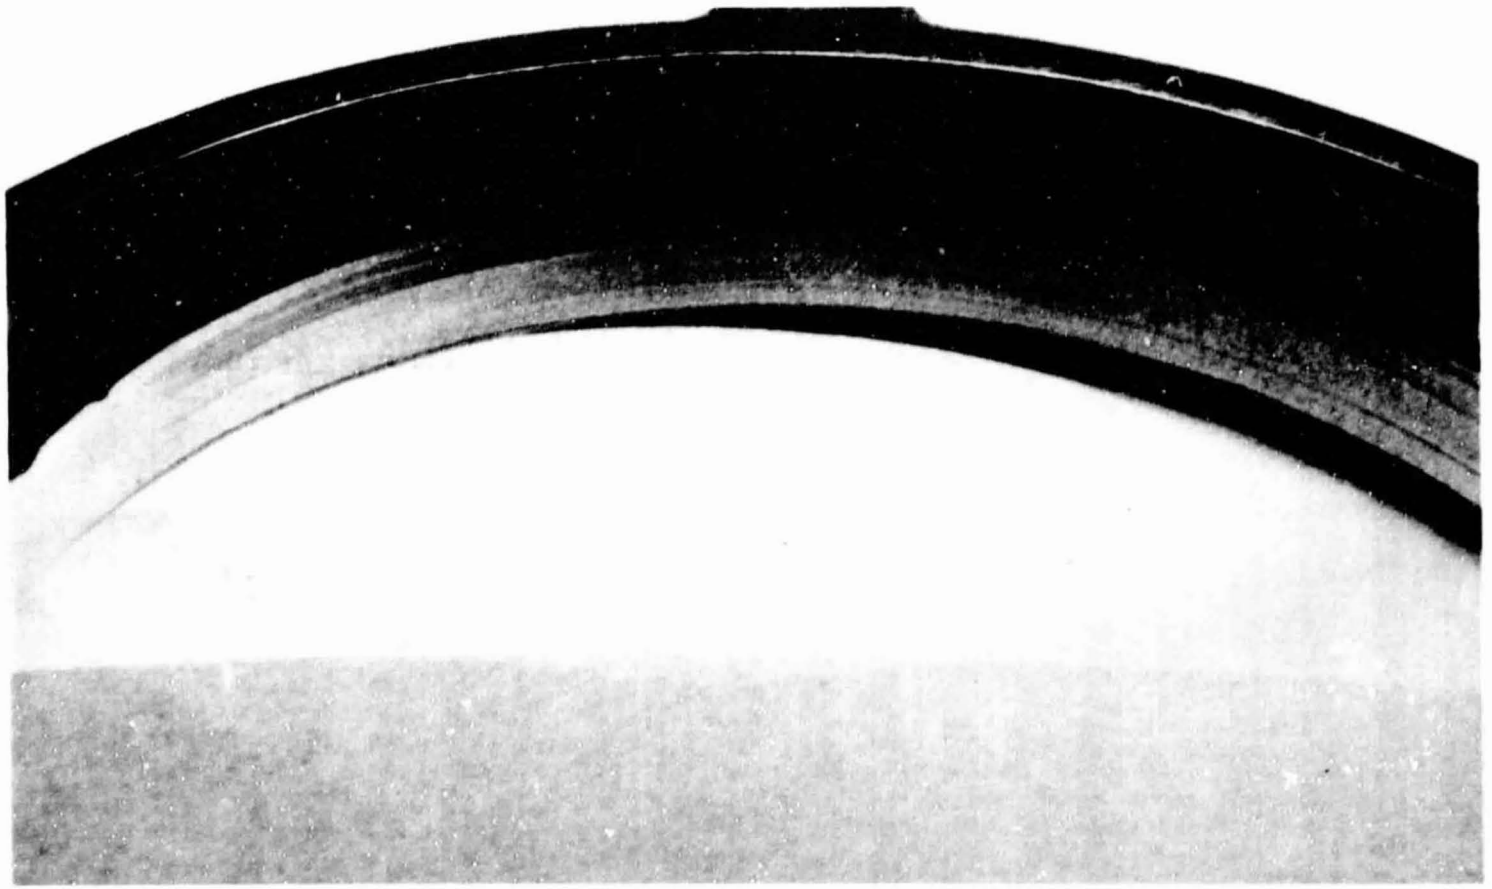
The turbine end primary seal was in good condition with negligible wear. Visual inspection revealed a uniform rubbing contact pattern over 90% of the bore toward the downstream edge. The turbine end secondary seal was worn .0007035 to .0010134 m (.0277 to .0399 in.) diametral on the inlet and .0007848 to .0010566 m (.0309 to .0416 in.) diametral on the outlet. The axial sealing dam and bearing pad showed .0004038 to .0004673 m (.0159 to .0184 in.) wear. Visual inspection showed heavy rubbing contact across the bore and excessive chipping on the downstream edge of the bore. The bearing pads were completely worn off over one-third of the face and nearly all worn off over the remainder.

Figure 103. Turbine End Secondary Seal Ring (Position 1), P/N 7R00011526, S/N, 047907, Build 15, Posttest 297

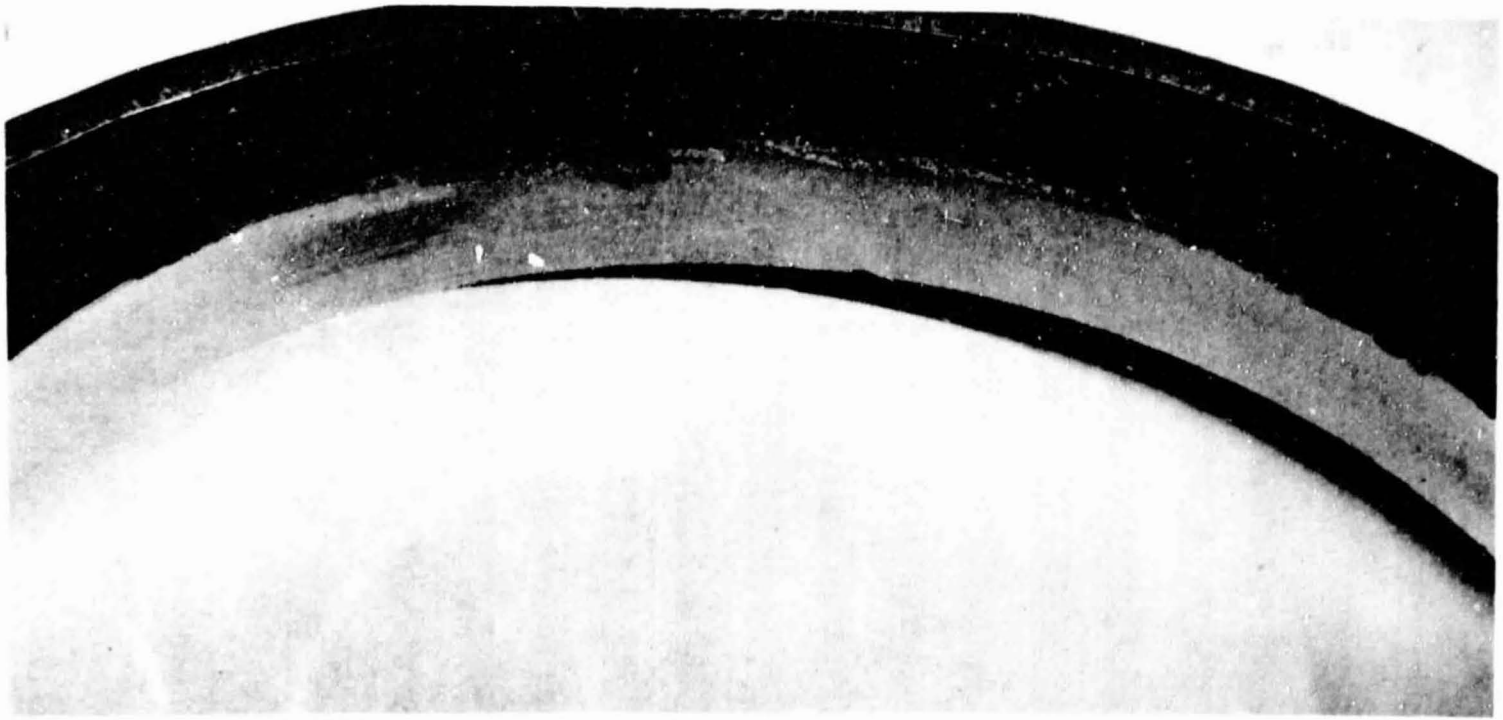
Figure 104. Turbine End Secondary Seal Ring (Position 2), P/N 7R00011526, S/N, 047907, Build 15, Posttest 297
