NASA CR-165392
RI/RD80-186

HIGH-PRESSURE HOT-GAS SELF-ACTING FLOATING RING SHAFT SEAL FOR LIQUID ROCKET TURBOPUMPS

R. E. Burcham and W. A. Diamond

Rockwell International
Rocketdyne Division

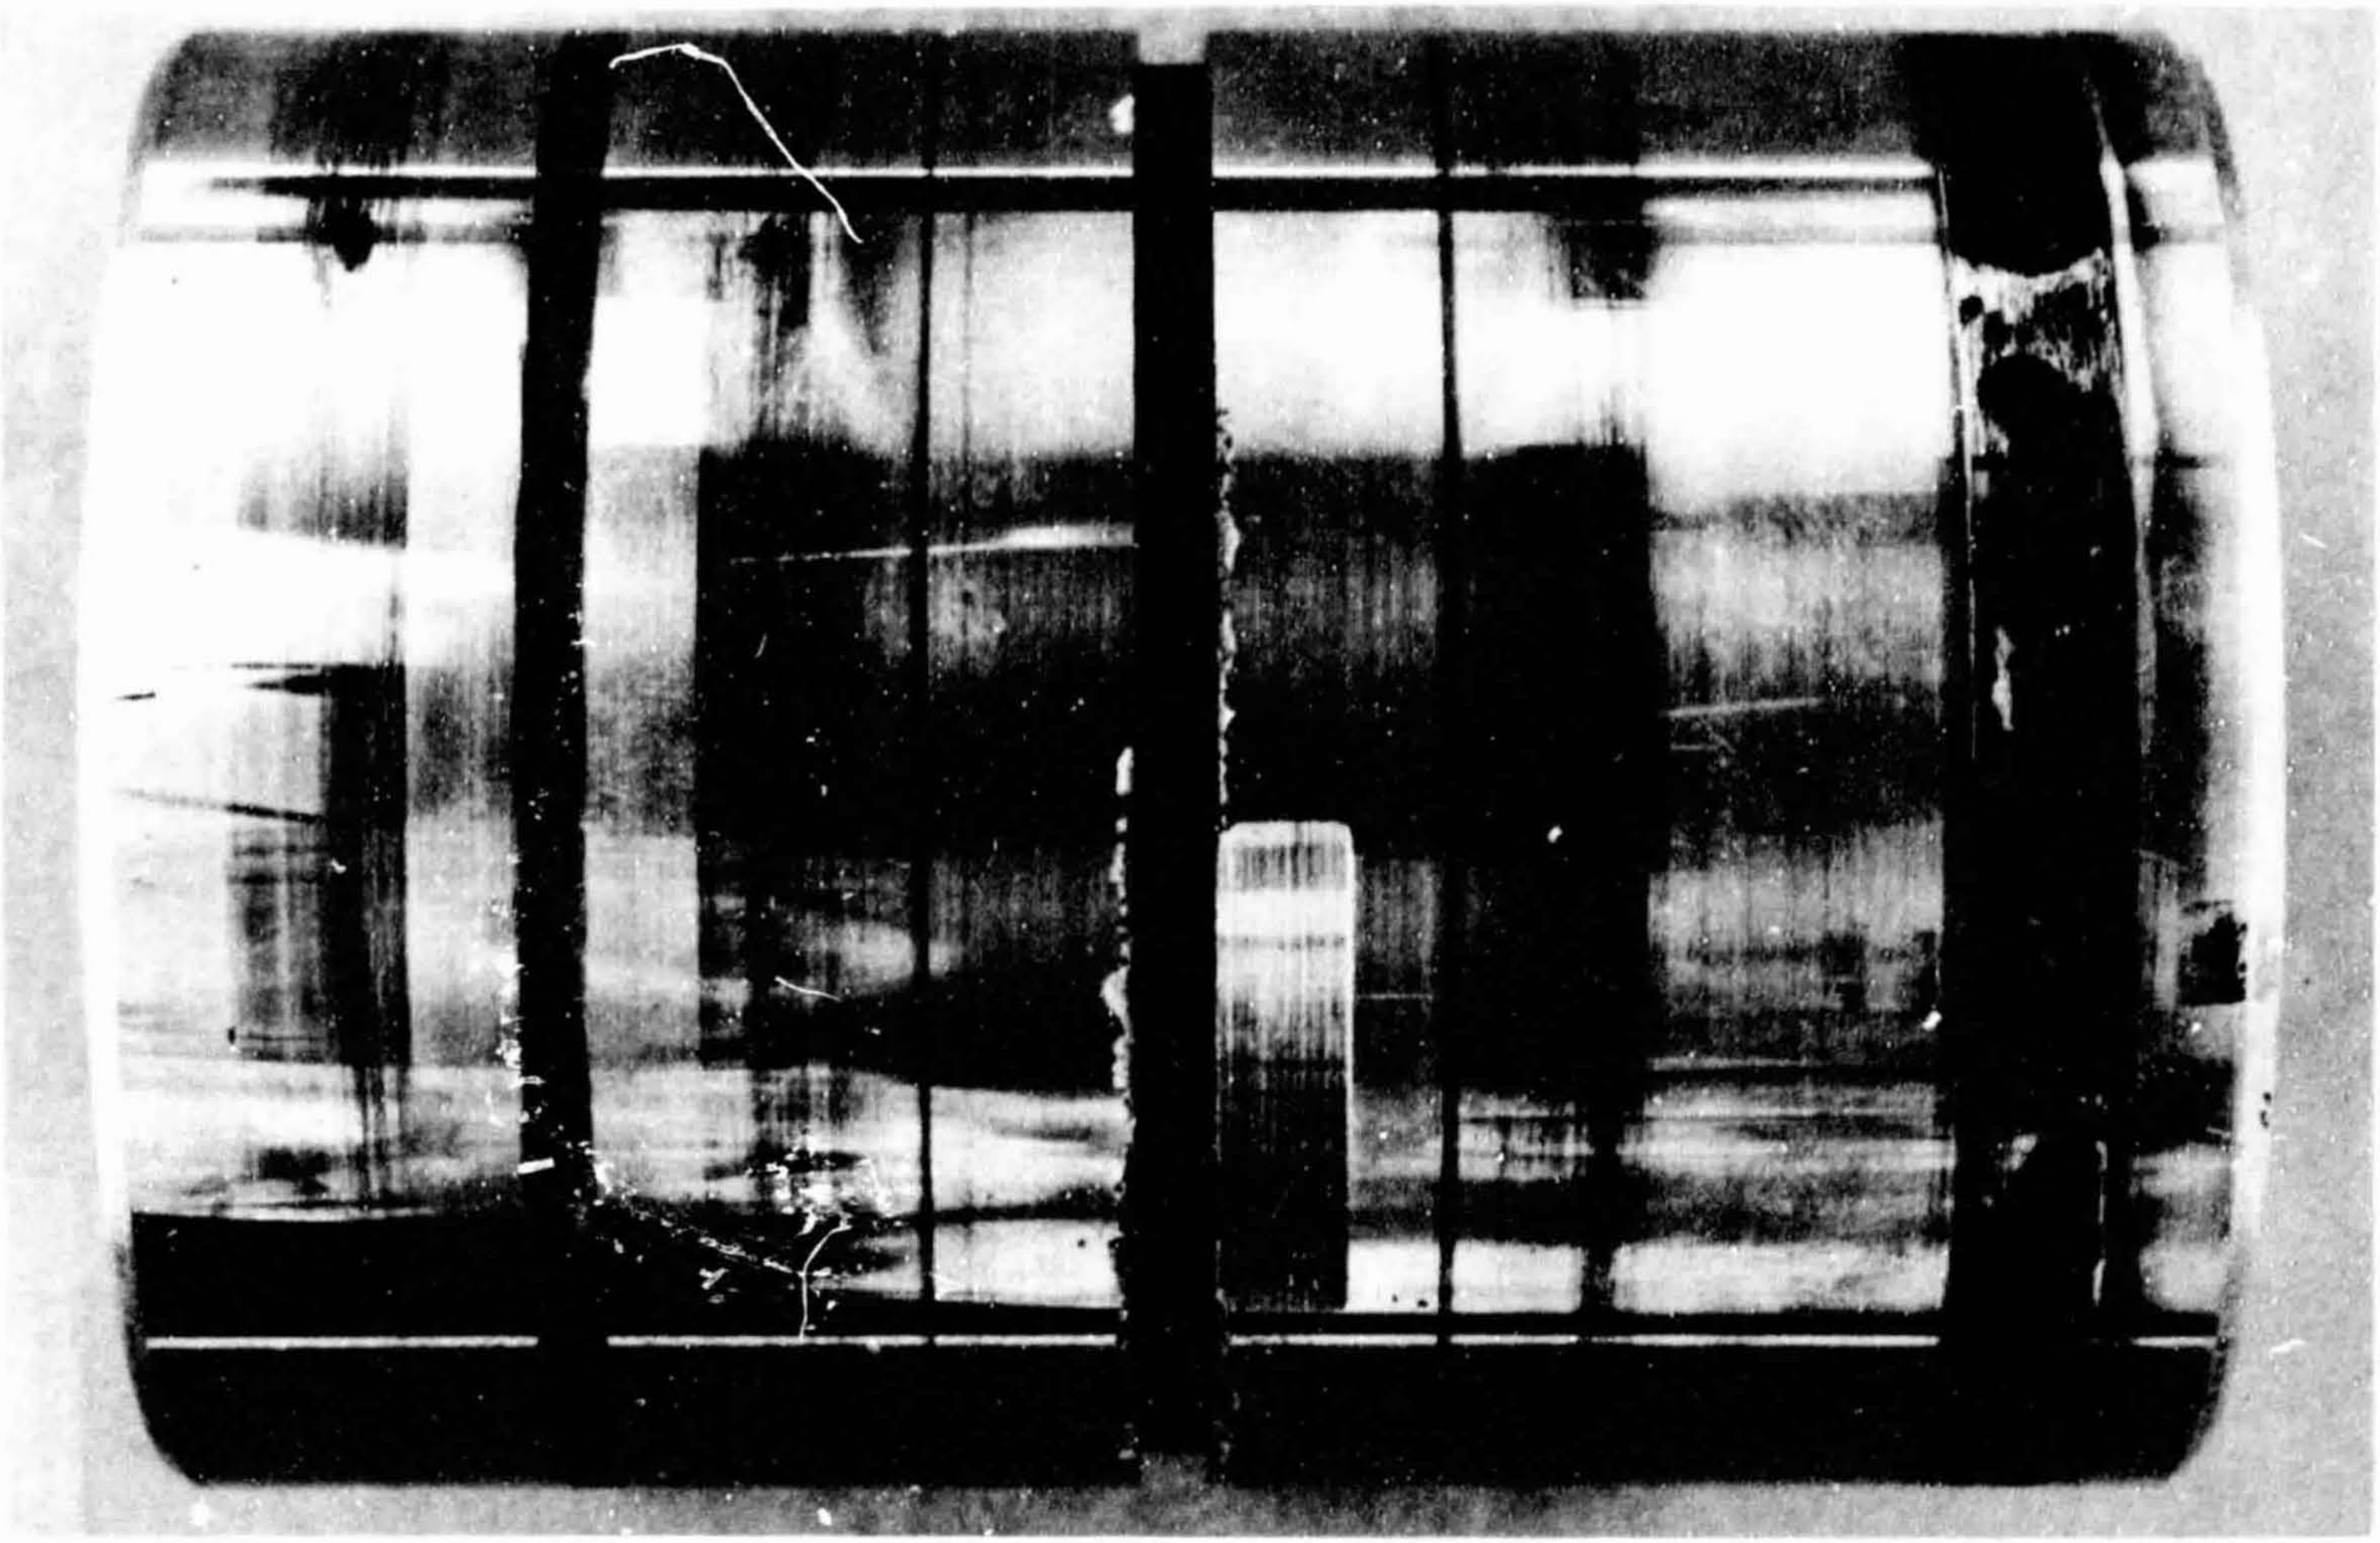
The fact that the turbine end seals consistently showed more wear than the pump end seals implies that the wear may be a result of shaft deflections which caused contact at the turbine end of the shaft sleeve. Supporting this is the fact that shaft sleeve total wear at the turbine end .0000385 m (.001518 in.), was far greater than at the pump end, .0000127 m (.0005 in.). The hardware condition is shown on Fig. 93 through 105. The inspection summary is given in

Figure 105. Mating Ring Sleeve, P/N RS005092X-005, S/N 1, Build 15, Posttest 297

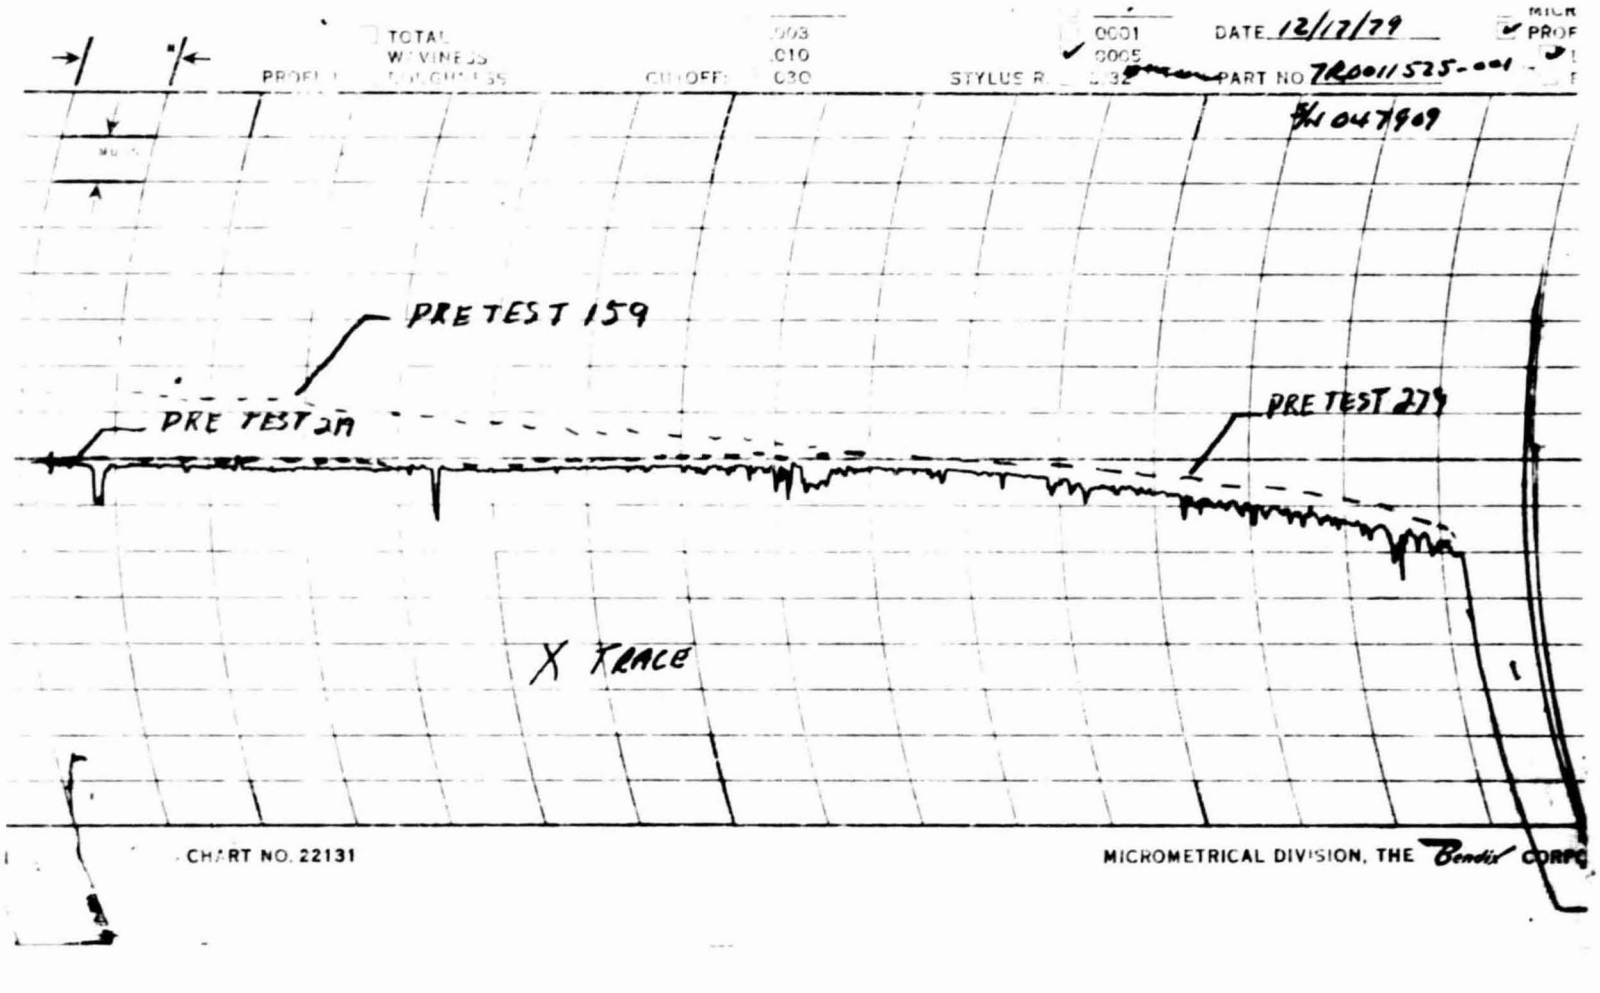
Figure 106. Surface Profile Trace Pump End Primary Seal Ring, P/N 7R0011525, S/N 047909 Build 15, Posttest 297

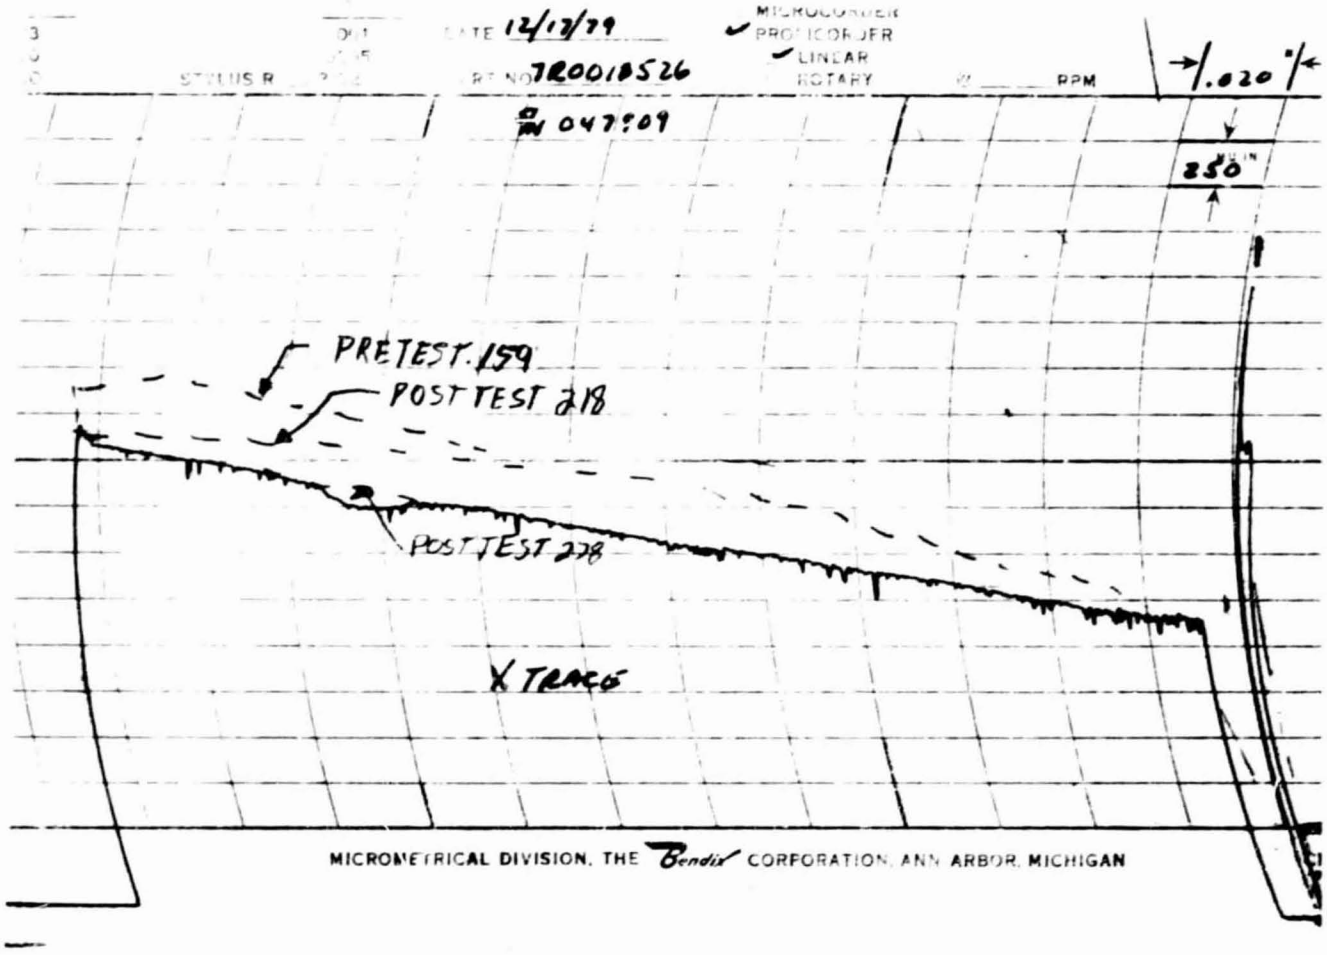
Figure 107. Surface Profile Trace Pump End Secondary Seal Ring, P/N 7R0011526, S/N 047909, Build 15, Posttest 297

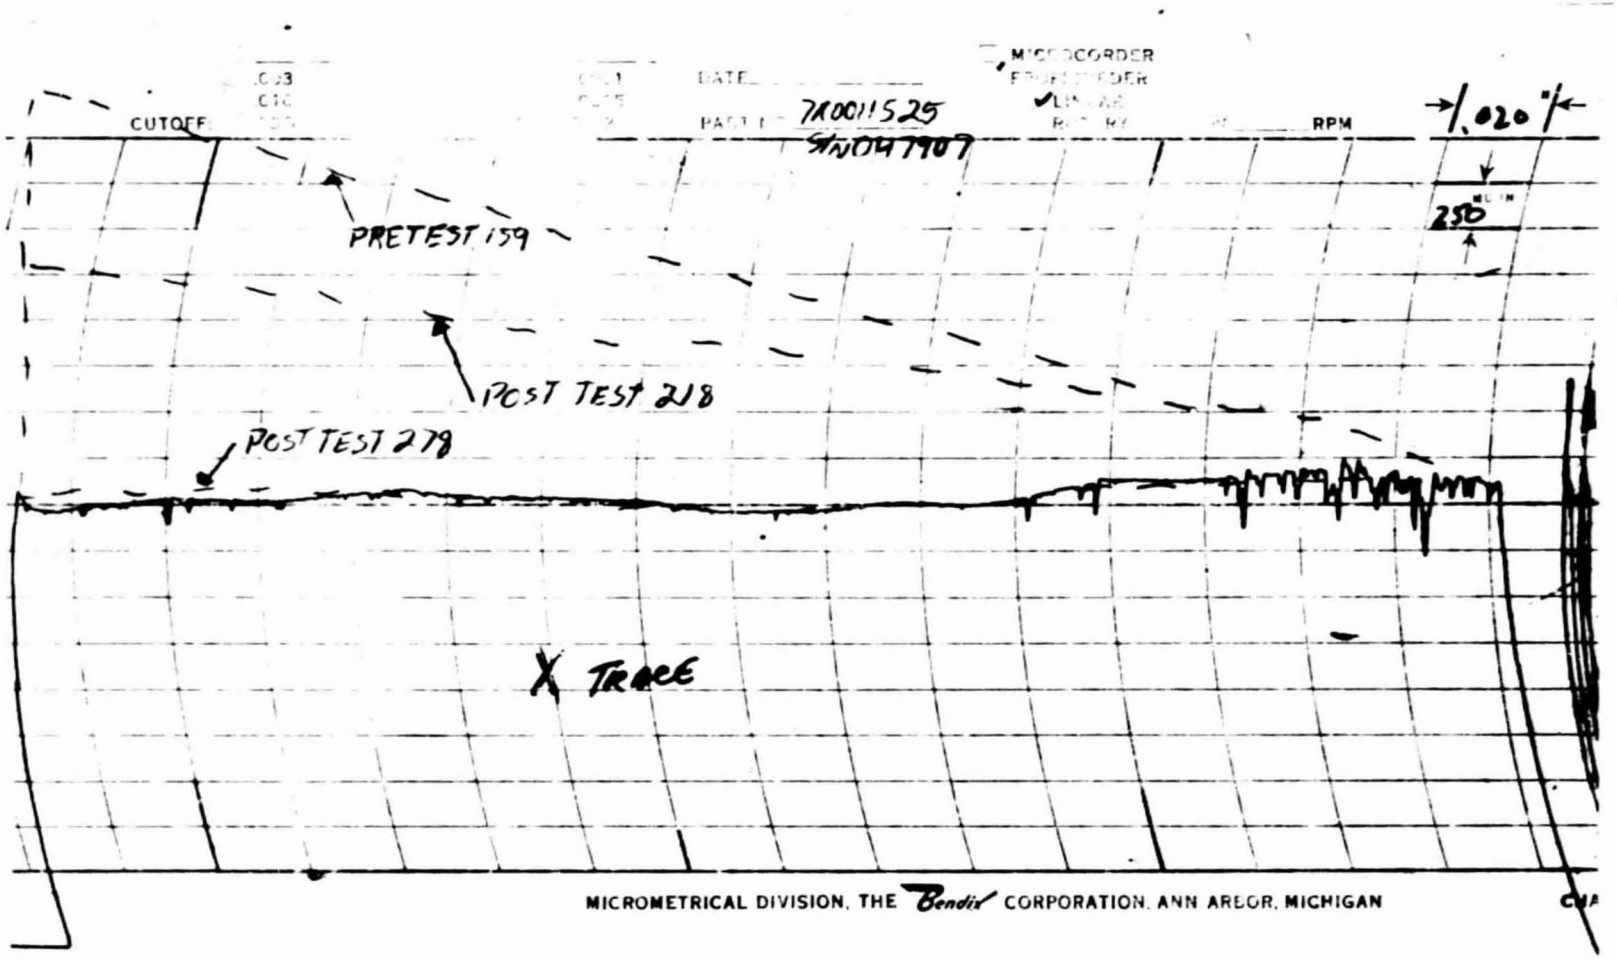
Figure 108. Surface Profile Trace Turbine End Primary Seal Ring, P/N 7R0011525, S/N 047907, Build 15, Posttest 297

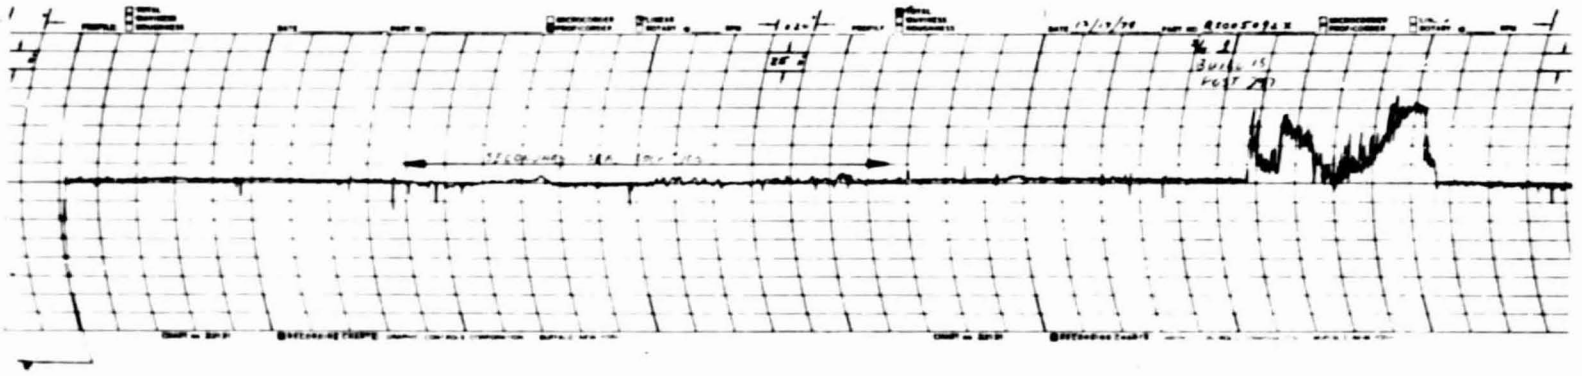
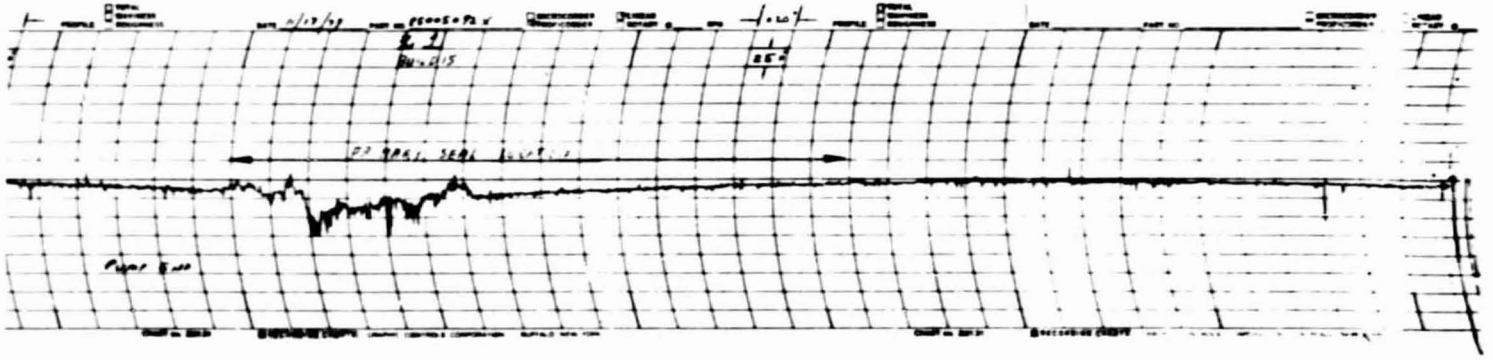
Figure 110. Surface Profile Traces of Tester Mating Ring Sleeve Pump End, P/N RS005092X. S/N 1, Build 15, Posttest 297

The surface profile traces of the shaft mating ring sleeve at the seal contact locations (Fig. 110 and 111) indicate no signficant wear except for the turbine end secondary seal which was worn .0000385 m (.001518 in.), after the total test time.

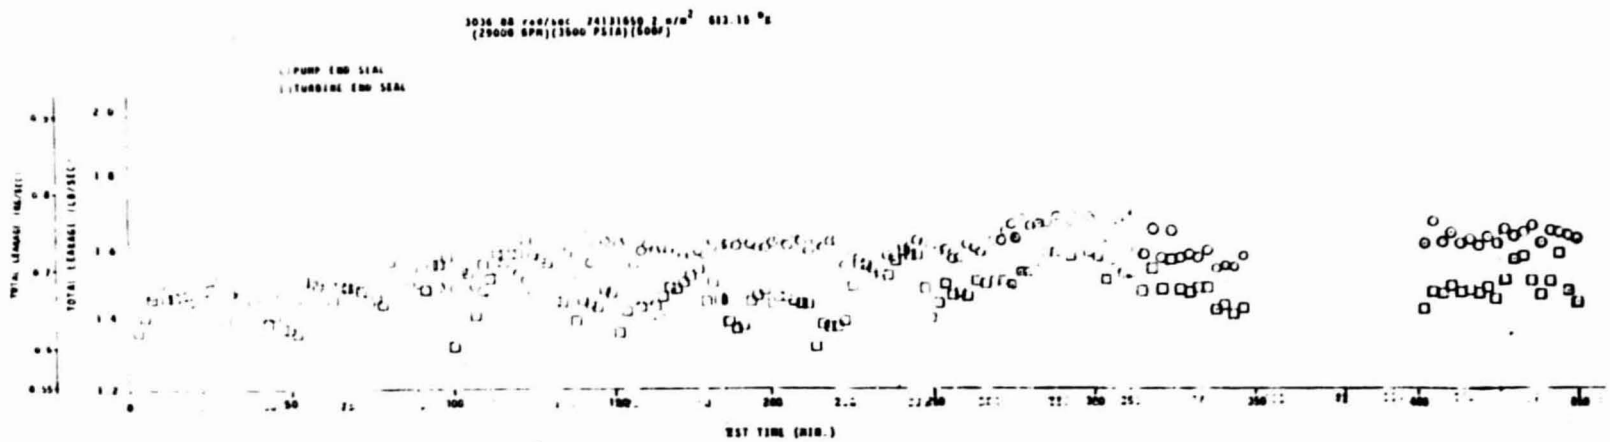
Figure 112. Tapered Bore Seal Total Leakage vs Test Time, Tests 298-477

The seal performance was satisfactory with measured total leakage rates of .7257 to .7711 kg/sec (1.6 to 1.7 lb/sec) on the pump end seal and .6350 to .7257 kg/sec (1.4 to 1.6 lb/sec) on the turbine end seal (Table 12. The leakage rates adjusted to 24131650 n/m^2 (3500 psig) inlet pressure (Fig. 112) show gradually increasing leakage for the pump end seal from .6350 to .6803 kg/sec (1.4 to 1.5 lb/sec) at start of test to .7257 to .7711 kg/sec (1.6 to 1.7 lb/sec) at 450 minutes accumulated test time. The turbine end seal total leakage shows a cyclical, but gradually increasing pattern from .6350 to .5896 kg/sec (1.4 to 1.3 lb/sec) at start to .6350 to .7257 kg/sec (1.4 to 1.6 lb/sec) at 450 minutes total test time. The leakage data indicate gradual wearing of both the turbine end and the pump end seals.

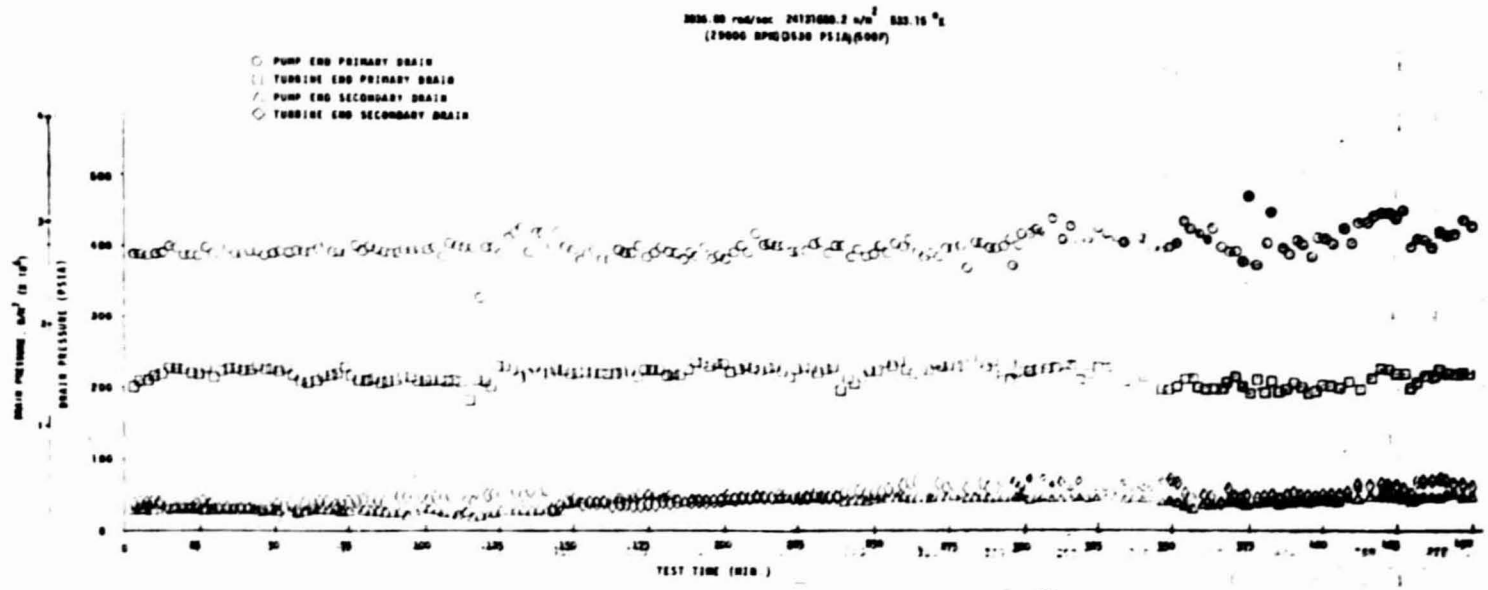
Figure 113. Tapered Bore Seal Drain Pressure vs Test Time, Tests 298-477

The seal drain pressure plots versus test time (Fig. 113) show nearly constant drain pressure in the pump end primary and the turbine end primary drains. The pump end secondary and the turbine end secondary drain pressure both show a slight but gradual increase from start of test through 450 minutes total test time. The data indicate no significant wear of the pump end primary and the turbine end primary seals, and gradual wearing of the pump end secondary and the turbine end secondary seals.

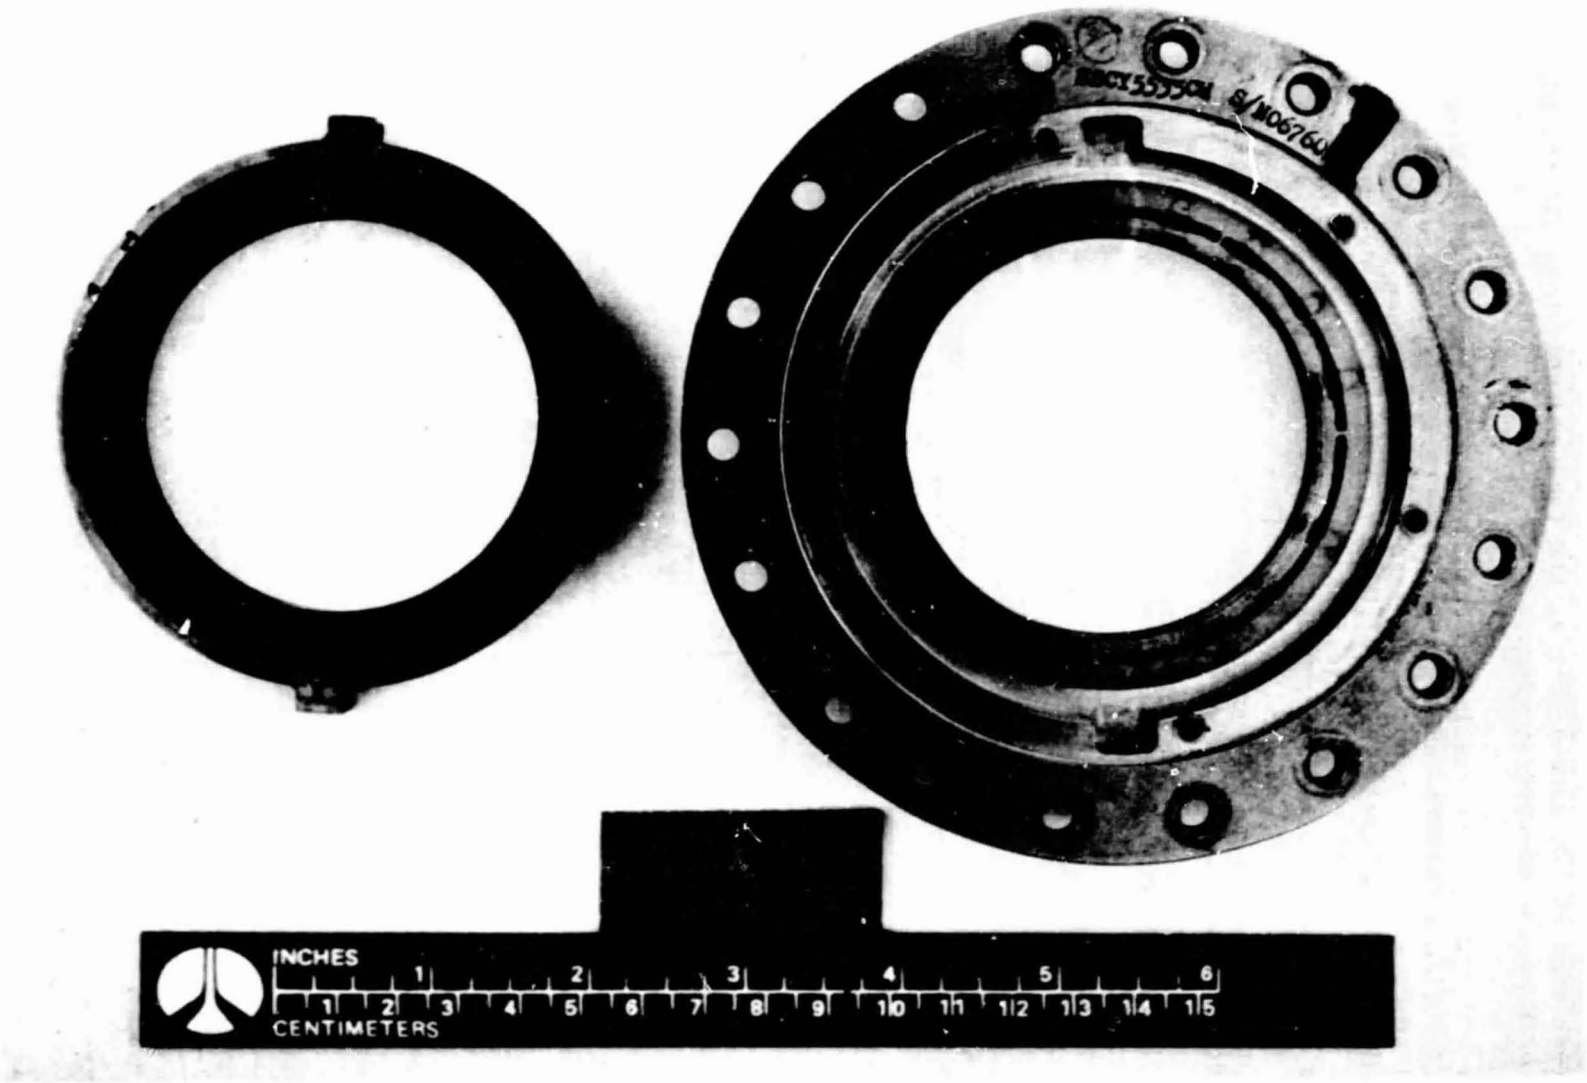
1XY55-5/23/80-C1E

The scheduled inspection after 7.5 hours accumulated test time revealed the seals to be in satisfactory condition. The pump end seal was in very good condition with little wear throughout the total accumulated test time. The pump end secondary seal axial sealing dam and bearing pad total wear was .0000325 to .0004114 m (.0013 to .0162 in.). The carbon bore was worn .00001279 to .0001244 m (.0005 to .0049 in.) diametral on the inlet and .0000279 to .0001168 m (.0011 to .0046 in.) diametral on the outlet. Visual inspection of the pump end secondary seal showed some chipping on

Figure 114. Pump End Primary Seal, P/N 7R0011525, S/N 047905, Build 20, Posttest 477

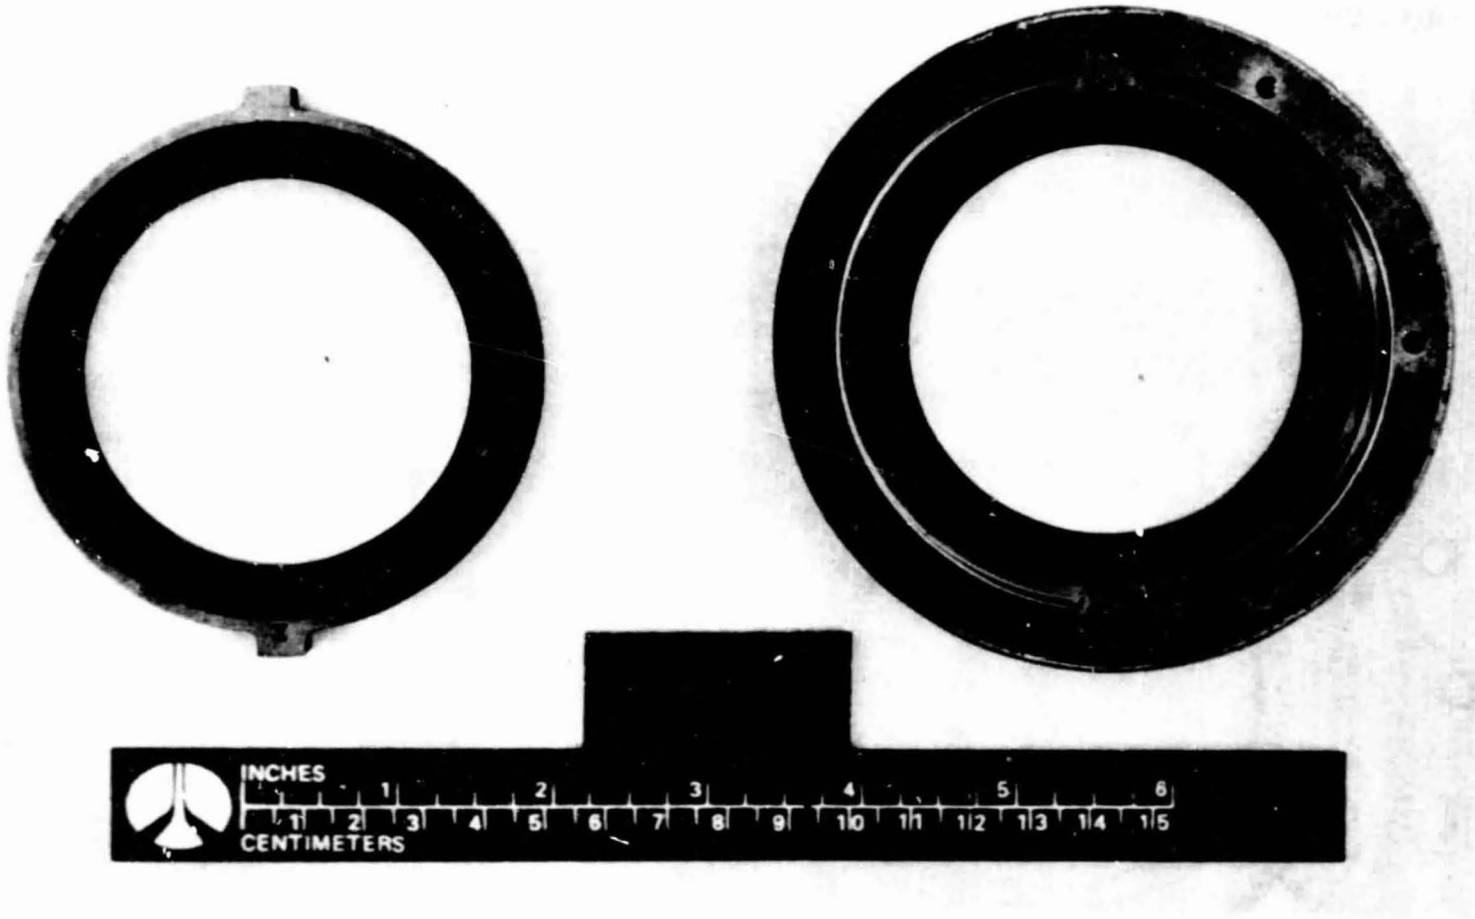
1XY55-5/23/80-C1D

Figure 115. Pump End Secondary Seal, P/N 7R0011526, S/N 047905, Build 20, Posttest 477

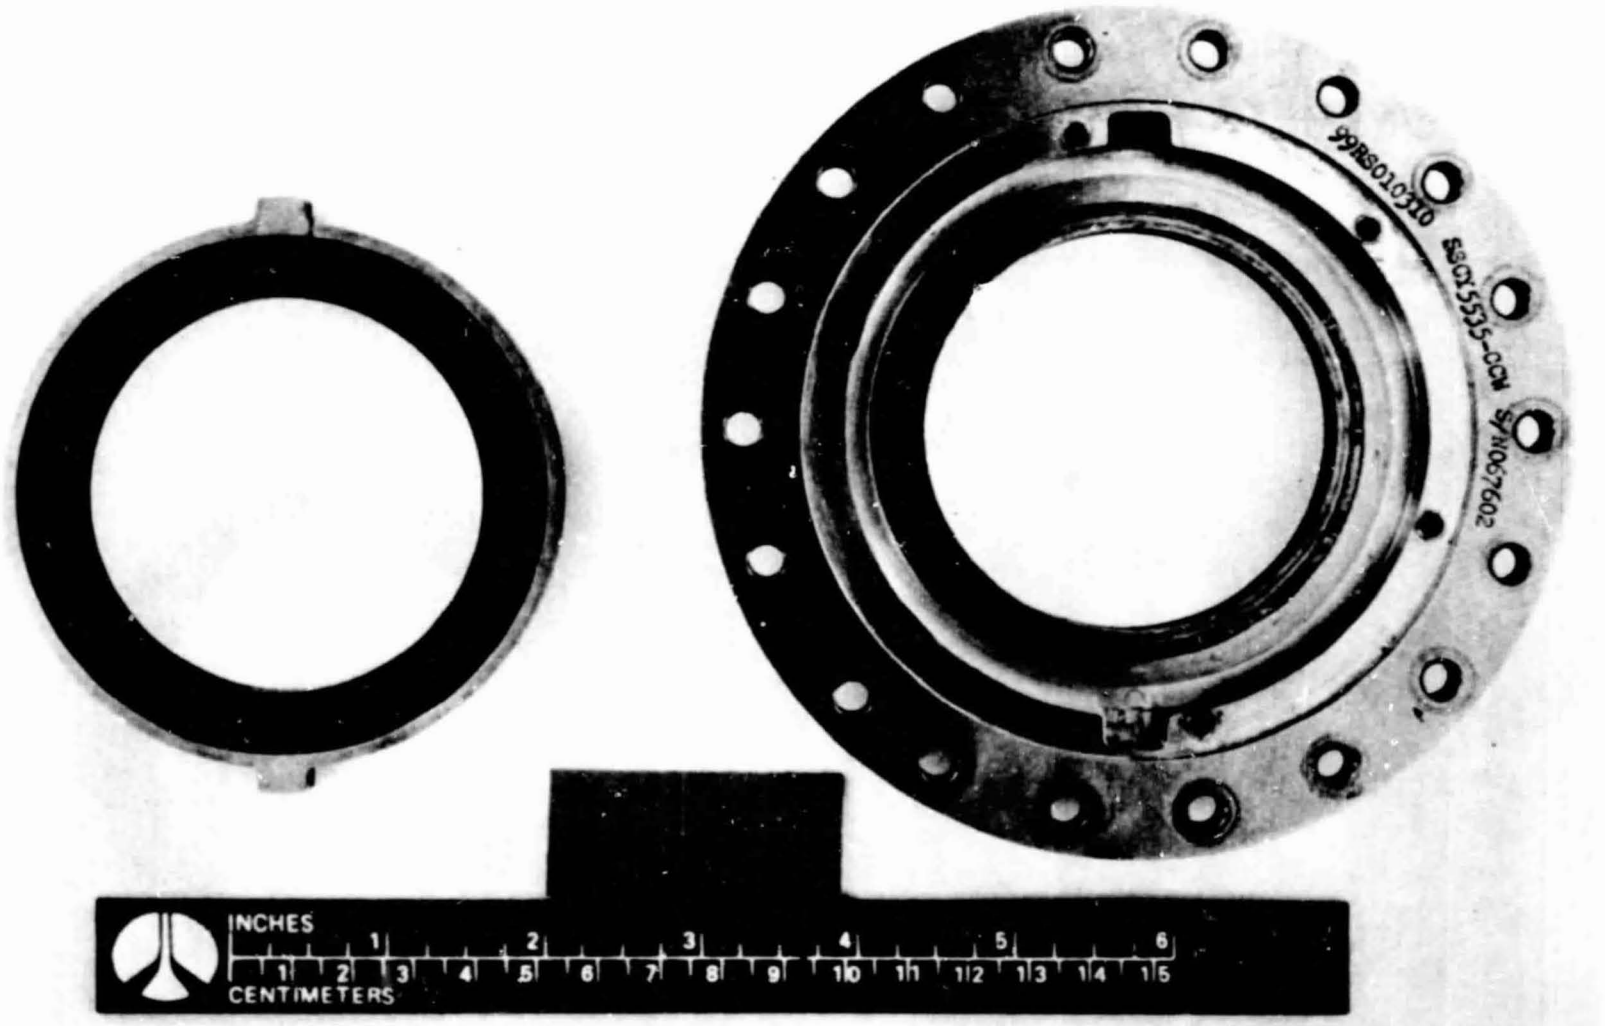
1XY55-5/23/80-C1D

Figure 116. Turbine End Primary Seal, P/N 7R0011525, S/N 047908, Build 20, Posttest 477

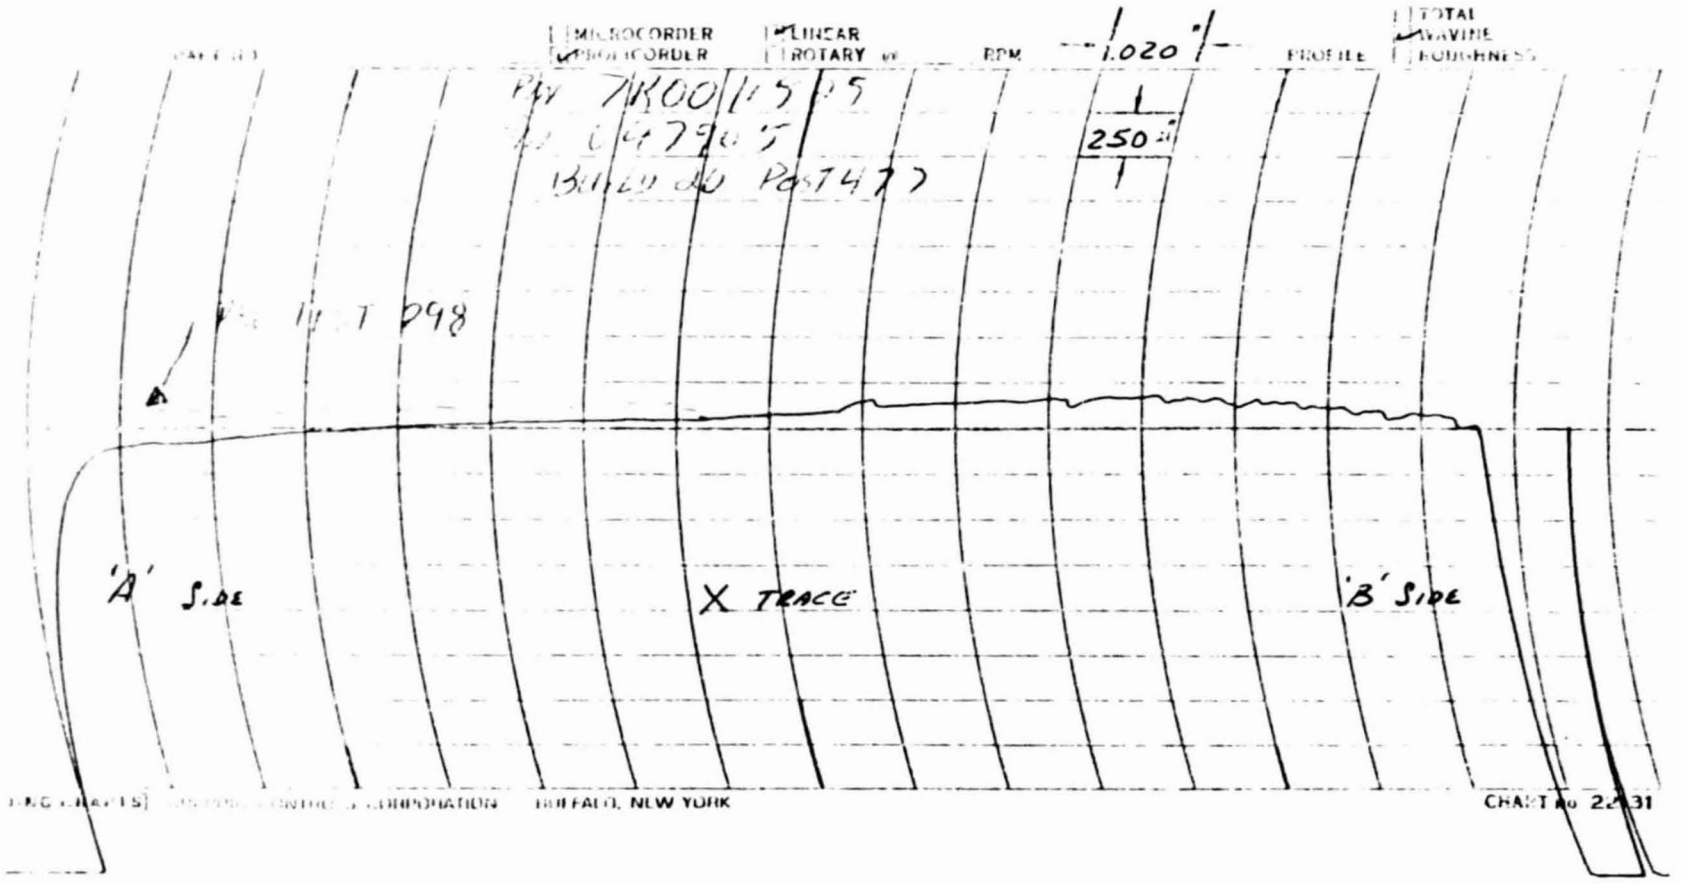
Figure 123. Surface Profile Trace Pump End, Primary Seal Ring, P/N 7R0011525, S/N 047905, Build 20, Posttest 477

Surface profile traces (Fig. 123 through 126)of the tapered carbon seal ring indicate the following radial wear from pretest 298 to posttest 477:

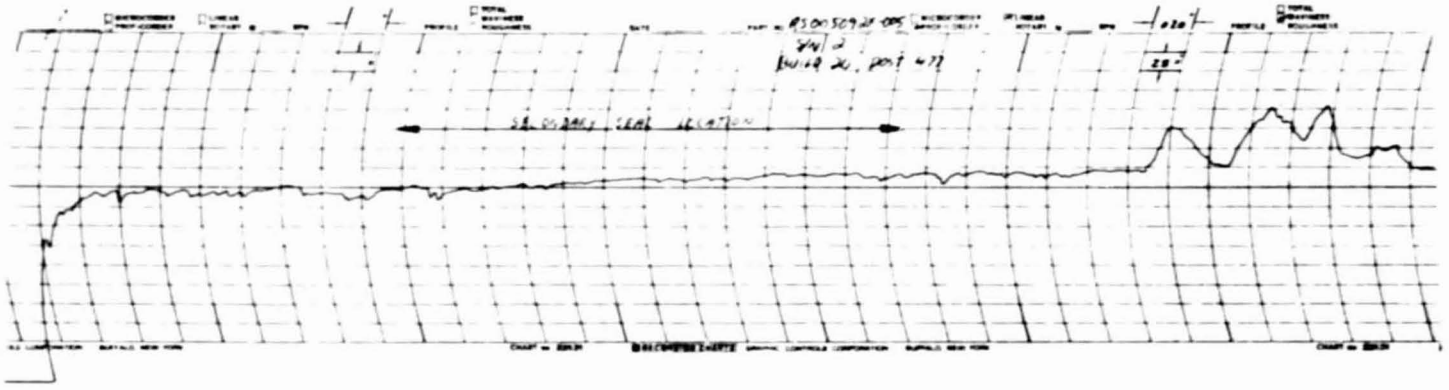
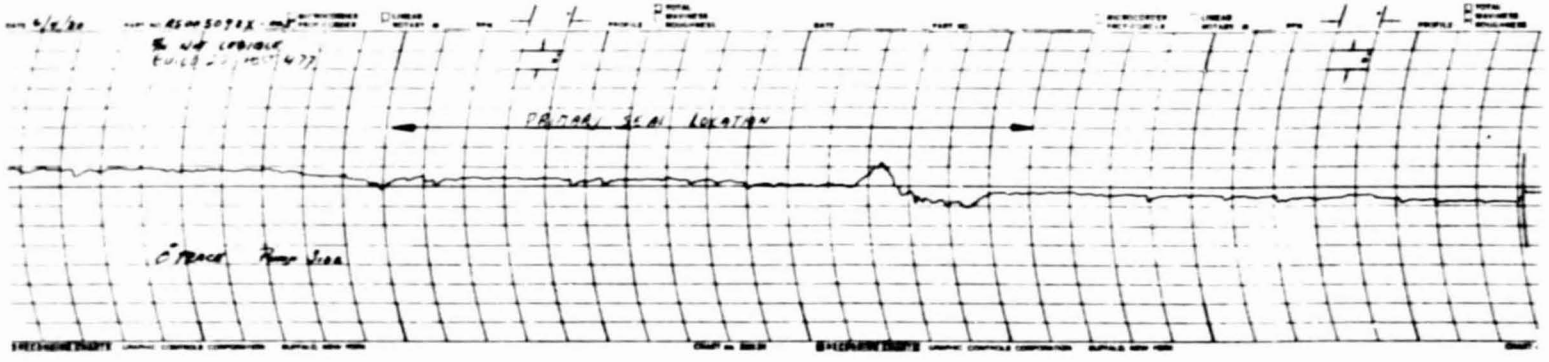
Figure 127. Surface Profile Traces of Testing Mating Ring Sleeve Pump End, P/N RS005092X-005, S/N 2, Build 20, Posttest 477

The surface profile traces of the shaft mating ring sleeve at the seal contact locations (Fig. 127 through 128)indicate no significant wear except for the turbine and secondary seal which was worn .0000028 m (.0001125 in.) after 7.5 hours test time. A ring of carbon residue buildup had formed in between the pump end primary and the pump end secondary seal locations as indicated on the sleeve pump end surface profile trace.
