ANALYSIS OF A TURBINE ROTOR CONTAINING A

TRANSVERSE CRACK AT OAK CREEK UNIT 17

G. W. Rogers and C. A. Rau, Jr.
Failure Analysis Associates
Palo Alto, California 94303

J. J. Kottke and R. H. Menning
Wisconsin Electric Power Company
Milwaukee, Wisconsin 53201

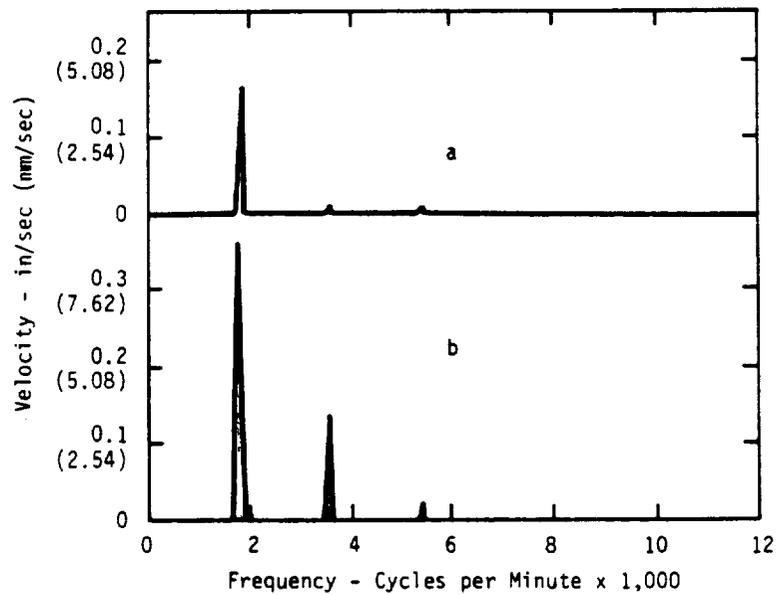
Figure 1a is the normal steady state vibration signature obtained with a shaft rider probe at the number 1 turbine bearing. A strong synchronous 1800 rpm signal and very slight two and three per revolution signals are present. Figure 1b, on the other hand, shows the signature at peak vibration levels subsequent to a thermal down ramp of 140°F (77°C). Note the increase in the one, two, and three per revolution amplitudes.

Figure 1. - Vibration signatures of amplitude vs. frequency in a radial direction, a) during normal full load operation, b) during peak vibration subsequent to a thermal down ramp.

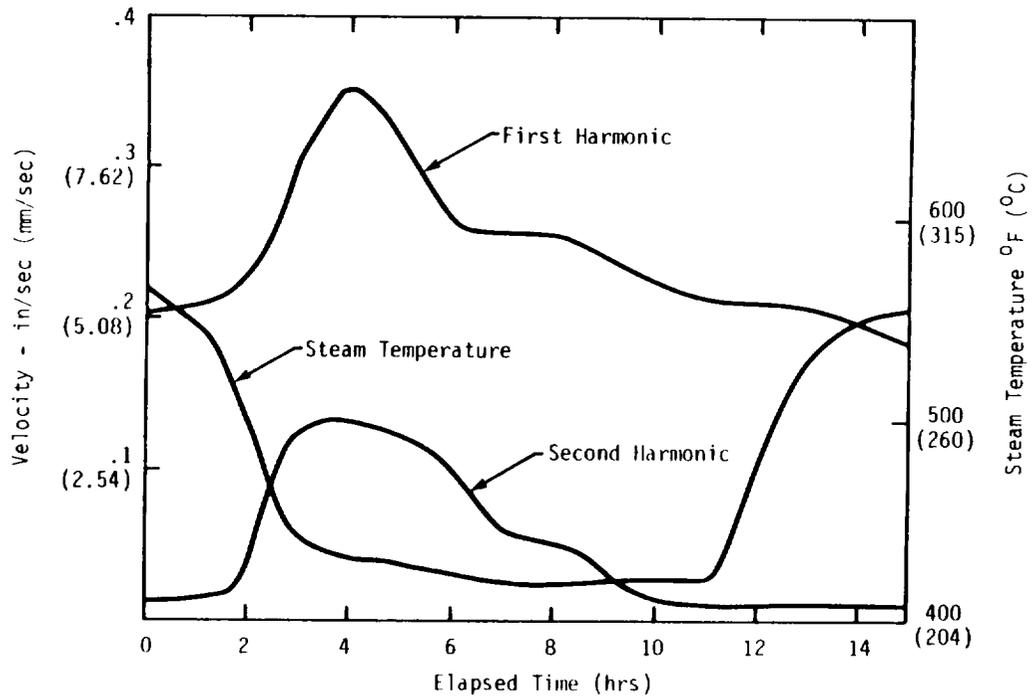
As shown in Figure 2, the amplitude of the second harmonic vibration is near a maximum for a period of approximately three (3) hours. It was estimated that the crack is fully open for this period of time due to the state of transient thermal stress. The total number of deslag operations performed on the OC7 unit between installation and the time such procedures were eliminated was approximately 1100. Using the three (3) hour time estimate for each, the total number of high thermal stress state cycles can thus be calculated as

At the time of this writing, sufficient data reduction to establish similar time history amplitude curves for individual synchronous and twice-synchronous components of the unfiltered bearing cap vibration data has not been completed. Figure 2, however, shows an example of expected differences between the first and second harmonics. Whereas the absolute magnitude of change in velocity for the two harmonics is of the same order, the percentage change in the second harmonic is much greater than in the first harmonic.

Figure 2. - Vibration amplitude of first and second harmonic and inlet steam temperature vs. time.

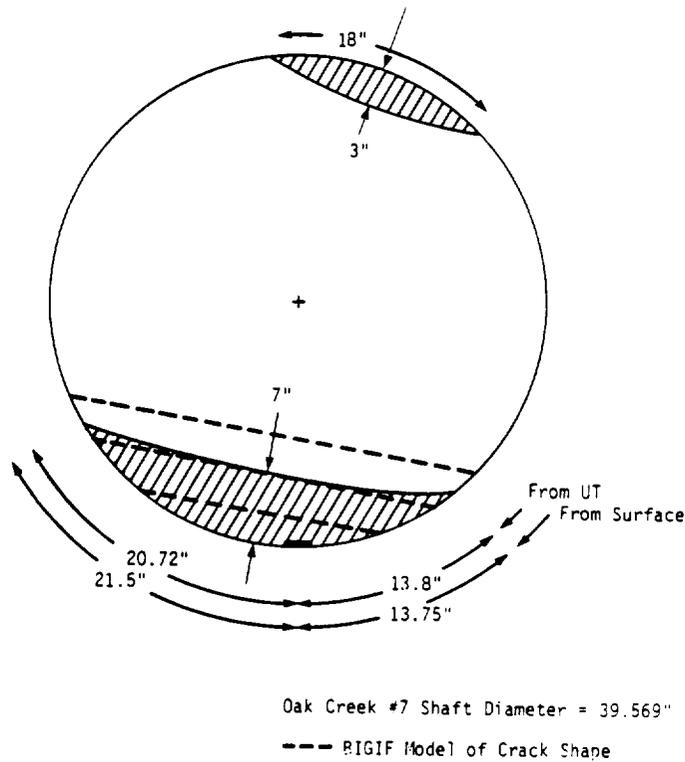
Fractography of the cracked rotor shaft after removal from service showed the presence of a fatigue crack of size and shape illustrated by Figure 3. Fracture mechanics calculations of fatigue crack growth were performed by integration of the material's crack growth rate law over the range of crack driving forces to obtain the crack progression between some initial size and the final size.

Figure 3. - Representation of Oak Creek #7 LP turbine shaft transverse cracking including BIGIF model.

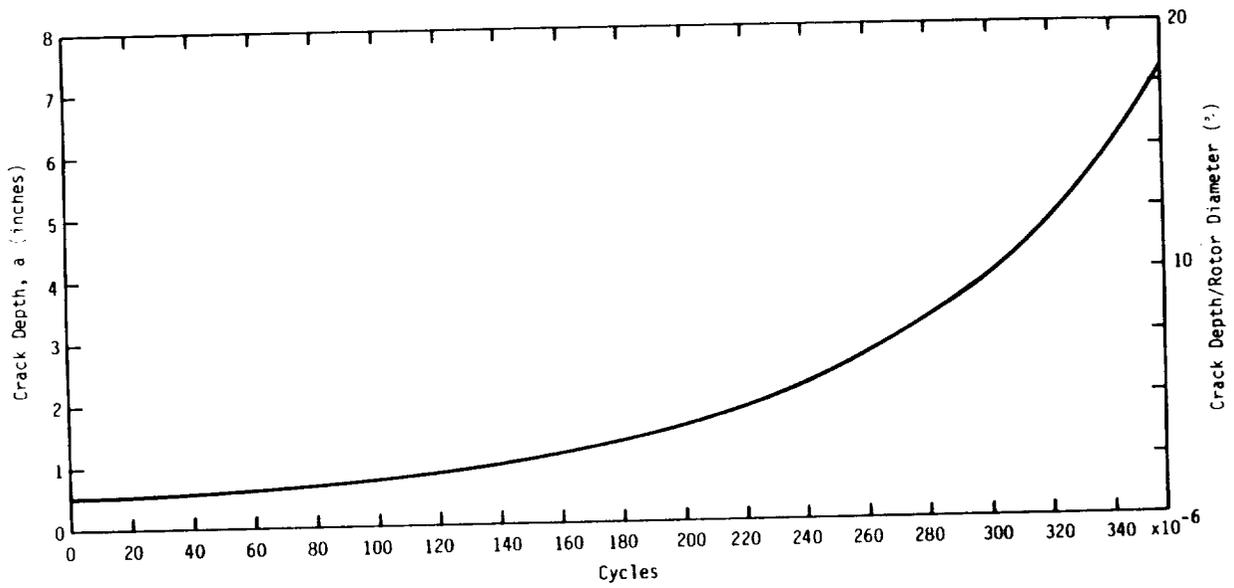
Utilizing BIGIF, the crack driving force, ΔK, corresponding to $\Delta\sigma = 3.2$, was calculated for a range of crack depths. BIGIF was also used to numerically integrate equation (1) to obtain the increase in crack depth, a, caused by rotating bending during the periods of the high steady stresses produced during deslagging. The results are shown in Figure 4 for the case where C, in equation (1), is elevated by the high mean stress during the deslag cycle to 5.7 times the value at $K_{min}/K_{max} = 0$.

Figure 4. – Transverse crack growth rate due to deslag thermal transients predicted using BIGIF transverse crack model.

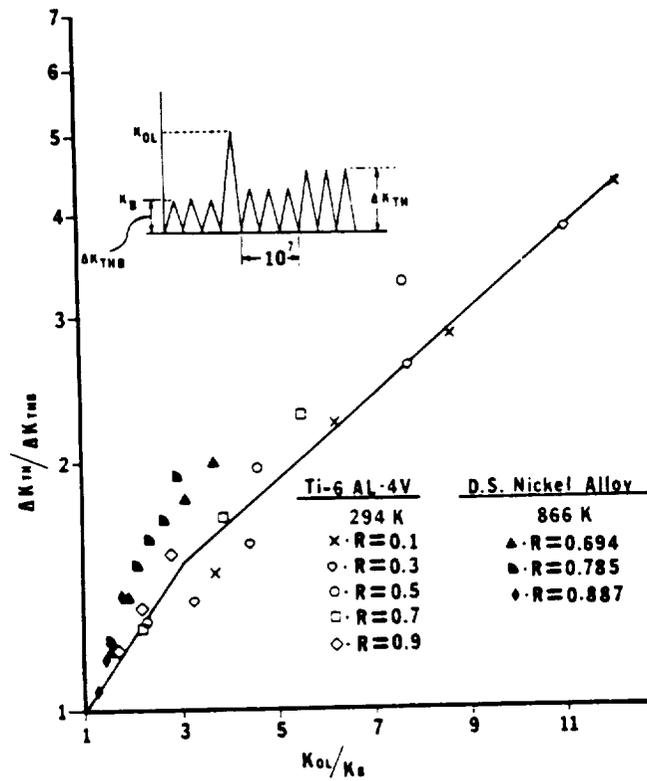
growth during deslag also served as an overload, increasing the effective threshold above which fatigue crack growth can occur. Figure 5 shows published results of Hopkins, Rau, Leverant and Yuen [3]. These results indicate a major increase in the apparent threshold stress intensity factor, ΔK_{th}, when preceded by an overload. The larger the relative overload, the higher the apparent threshold for subsequent crack growth. In the case of the OC7 rotor, the ratio of maximum overload stress to maximum steady state stress is at least

The data of Figure 5 show that the corresponding apparent threshold for fatigue crack growth during turbine operation after a deslag cycle will be at least 1.6 times higher and may be more than five times higher than the threshold would have been without the deslag overload cycle. Specifically, the cyclic nominal stress above which the 6.7-inch crack can continue to grow when σ_s = 0, is between 1.6 x 3 = 4.8 ksi and 5 x 3 = 15 ksi. If steady-state operation produces some small tensile steady stress, the apparent threshold will be reduced by the factor computed by equation (2). Nevertheless, the magnitude of the overload produced by the deslag was sufficient to prevent continued propagation during subsequent steady operation.

Figure 5. – Relative change in fatigue threshold after single cycle overloads as a function of the relative overload for the alloys and R ratios shown.

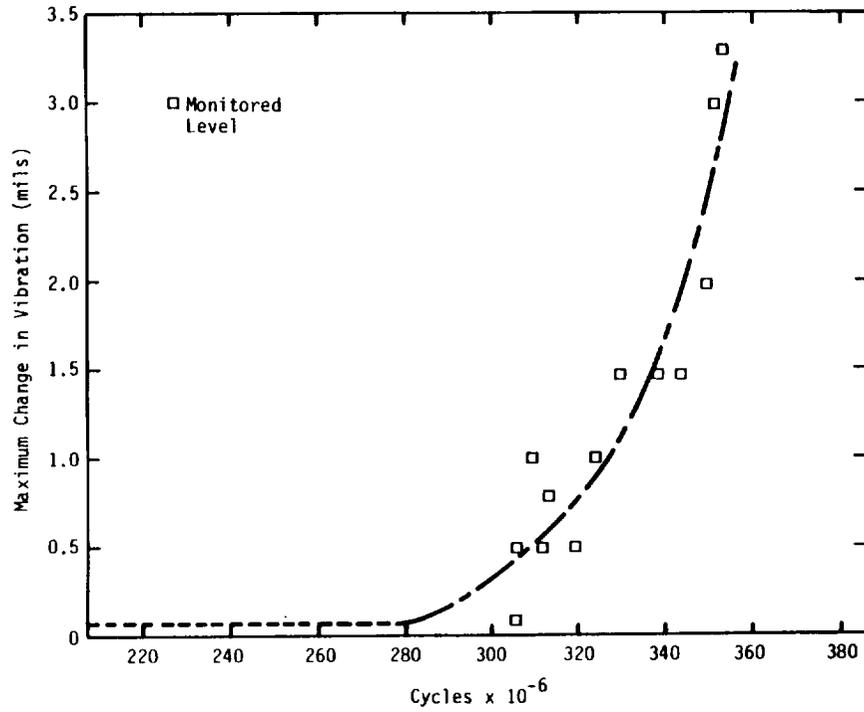
recorded maximum increase in vibration during selected deslag operations. The form of the recorded data is unfiltered peak to peak displacement, in mils, as sensed on the number 1 bearing cap in the vertical direction. A curve fit of these data as a function of cycles under the thermal transient conditions as calculated in equation (3) is shown in Figure 6. Figure 7 shows the correlation of the maximum change in low-pressure turbine bearing cap vibration during deslag with predicted rotor crack growth.

Figure 6. - Maximum changes in LP turbine bearing cap vibration during deslag as a function of total number of cycles at thermal transient stress state.

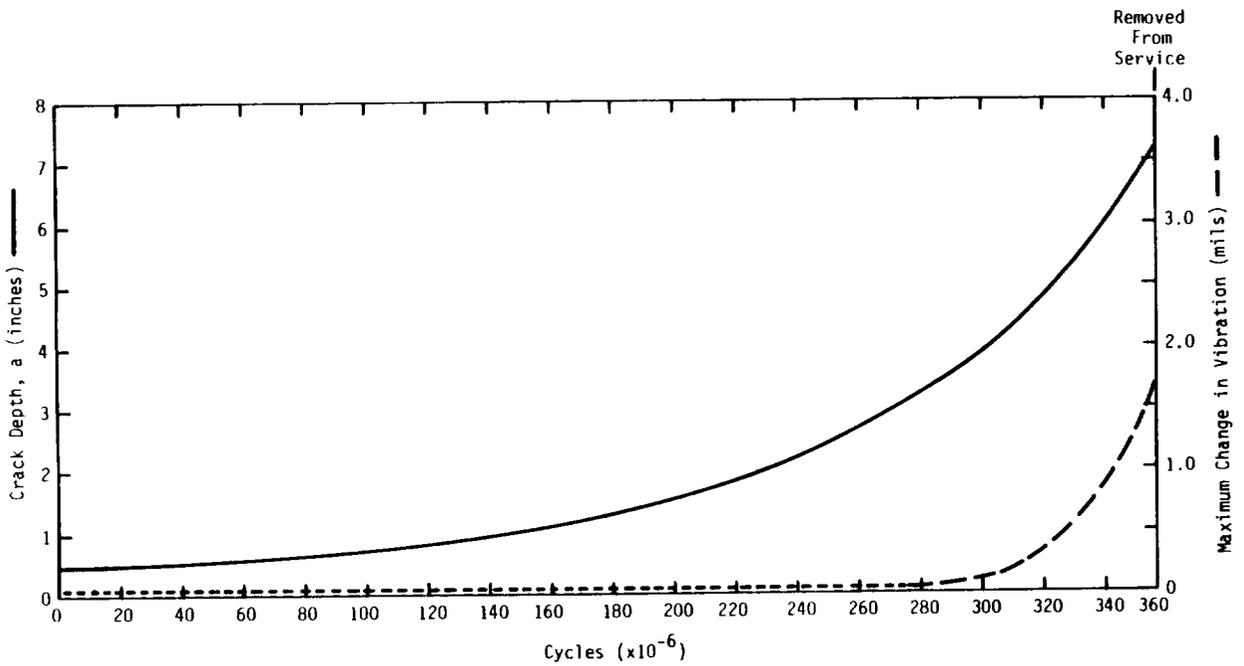
The graph shows that the point at which the change in vibration becomes recognizable corresponds to a crack depth between 3 and 4 inches: or between 8% and 10% of the shaft diameter. This correlates very well with the crack depth (10% of rotor diameter) predicted analytically by Grabowski [9] as necessary for significant increase in rotor vibration response.

Figure 7. - Correlation of maximum change in LP turbine bearing cap vibration during deslag with predicted rotor crack growth.

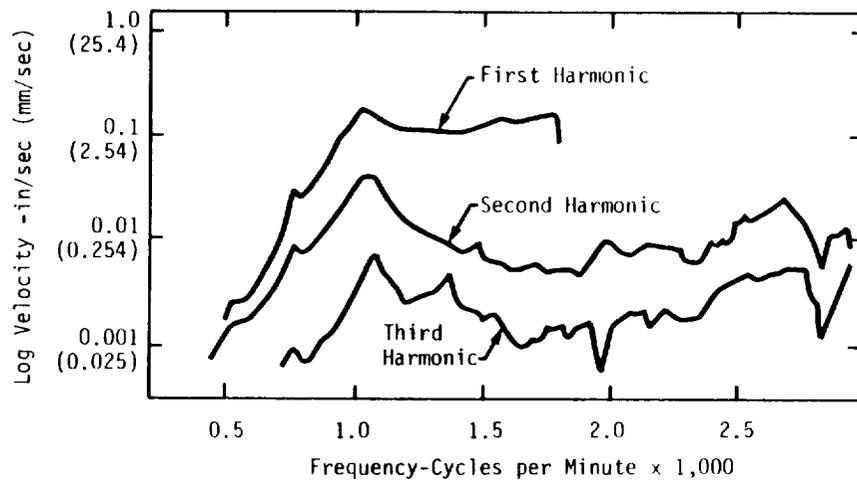
Vibration data for certain rotor coast downs were also recorded on magnetic tape. Bode plots of amplitude vs. frequency for first, second, and third harmonics of rotor speed were generated as shown in Figure 8. Note that the ordinate is a logrithmic scale of velocity. The first critical speed was observed to be approximately 1035 cpm. The second and third harmonics responded at 1050 and 1080 cpm, respectively, most probably due to the increase in stiffness in the bearing oil film with reduced rotor speed.

Figure 8. - Bode plot of amplitude vs. frequency for first, second, and third harmonics of running speed.
