SPACE SHUTTLE MAIN ENGINE HIGH PRESSURE
FUEL TURBOPUMP TURBINE BLADE CRACKING

By Henry Lee

May 1988

1. REPORT NO. NASA TM-100327	2. GOVERNMENT ACCESSION NO.	3. RECIPIENT'S CATALOG NO.
4. TITLE AND SUBTITLE Space Shuttle Main Engine High Pressure Fuel Turbopump Turbine Blade Cracking		5. REPORT DATE May 1988
		6. PERFORMING ORGANIZATION CODE
7. AUTHOR(S) Henry Lee		8. PERFORMING ORGANIZATION REPORT #
9. PERFORMING ORGANIZATION NAME AND ADDRESS George C. Marshall Space Flight Center Marshall Space Flight Center, Alabama 35812		10. WORK UNIT NO.
		11. CONTRACT OR GRANT NO.
12. SPONSORING AGENCY NAME AND ADDRESS National Aeronautics and Space Administration Washington, D.C. 20546		13. TYPE OF REPORT & PERIOD COVERED Technical Memorandum
		14. SPONSORING AGENCY CODE

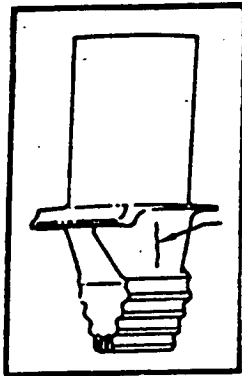
(e)
RADIAL SHANK

Figure 3. First-stage turbine blade cracks.

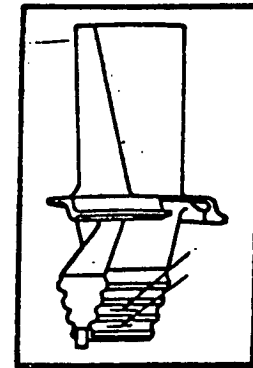
(h)
TRANSVERSE
FIRTREE LOBE

At the onset of the blade analysis effort, it was determined that the pressure side fir tree transverse lobe cracks (Fig. 3-h) on the first stage and the transverse downstream fir tree face/corner cracks (Fig. 4-f) on the second stage were the most critical, and should be analytically assessed. The criticality of these two crack occurrences stemmed from the fact that their continued growth could result in a potentially catastrophic event. The first stage cracks, although with a low frequency of occurrence, had accumulated fairly large depths on several blades (Fig. 5). This gave substance to the possibility of a complete fir tree neck 1 or neck 2 failure, which would greatly increase the loads on the remaining two lobes. The second-stage cracks also appeared infrequently, but one blade from HPFTP 0407 gave considerable concern because of a single large through crack 0.160 in. deep after only eight engine test cycles (Fig. 6).

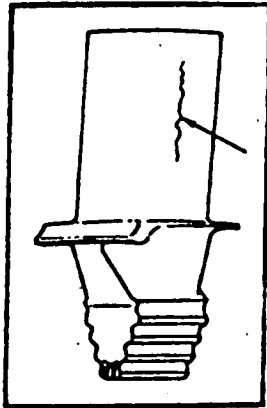
(a)
RADIAL AIRFOIL

Figure 4.   Second-stage turbine blade cracks.

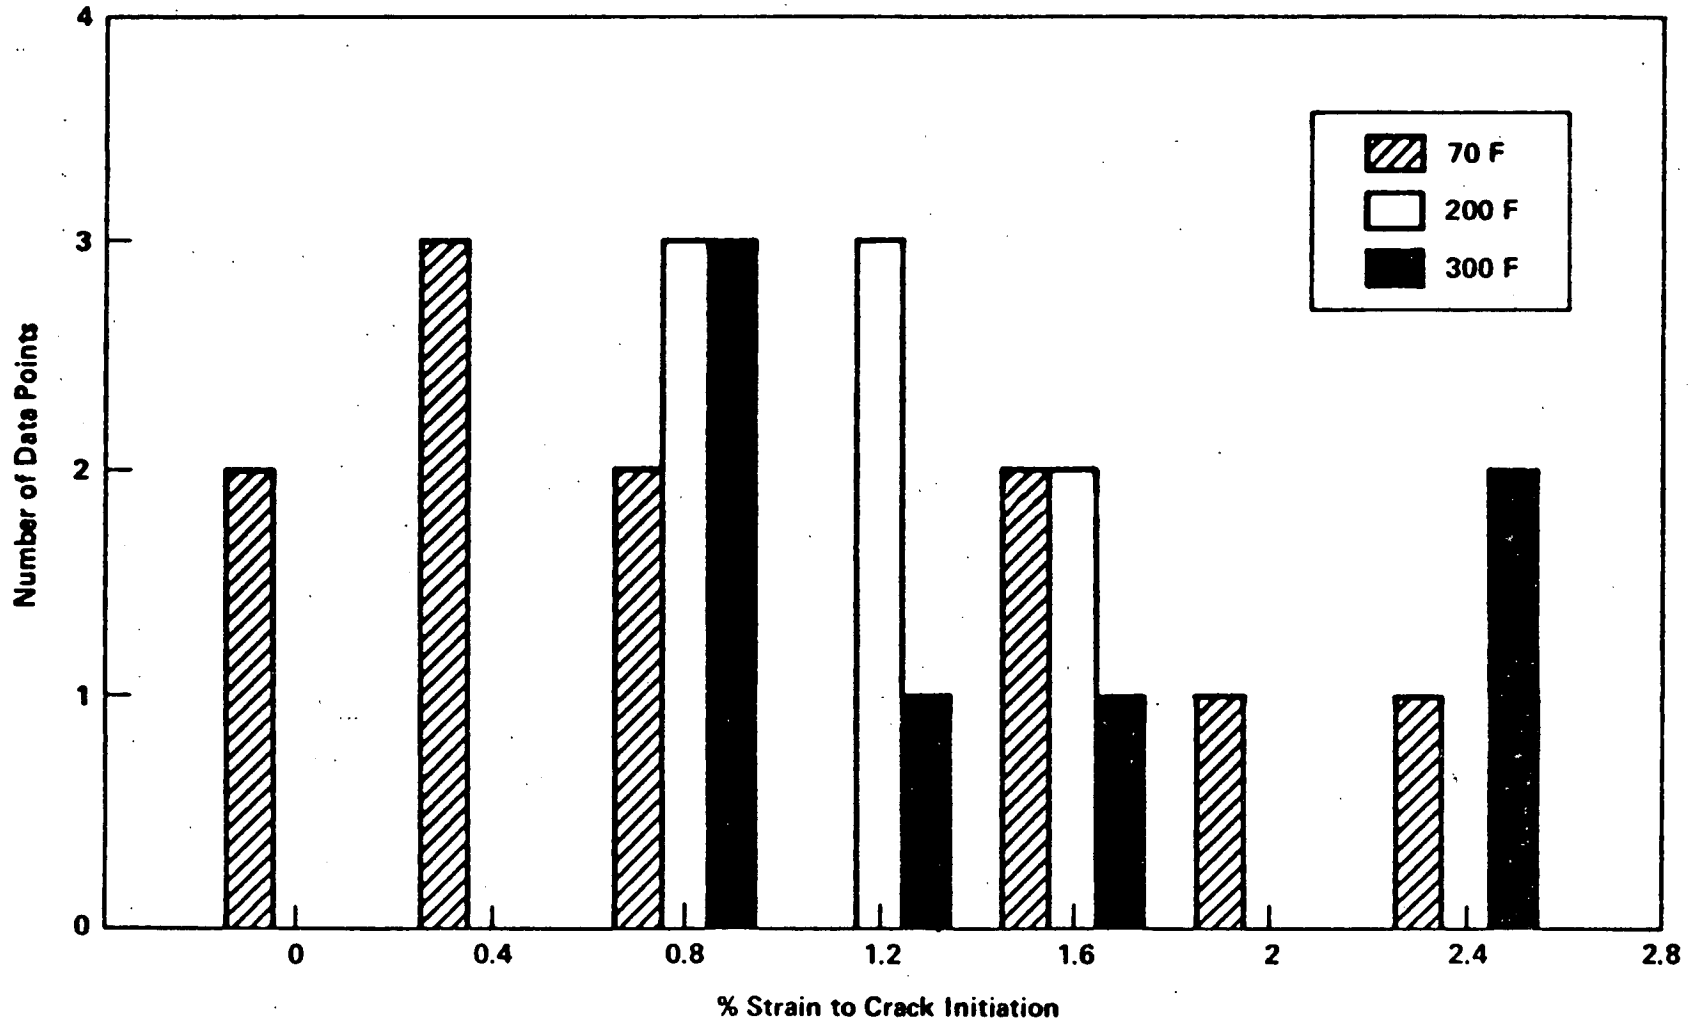
Figure 7. MAR-M-246 plastic strain to crack initiation.

Since the mode of crack initiation has been established as hydrogen assisted low cycle fatigue, the proper conditions including strain level, temperature, and the presence of hydrogen must therefore all occur simultaneously. The only opportunity for this to happen below the platform in the fir tree area is during the steady-state mainstage portion of the engine firing. The other two conditions in the firing sequence are the start-up and shut-down transients, where all the pertinent load factors are not present at the same time. The baseline environment chosen for the ensuing analysis was the full power level (FPL-109%) steady-state condition. This phase of the engine operation represents the period of performance when all engine parameters such as speed, pressure, coolant flow, temperature, and thrust have stabilized.

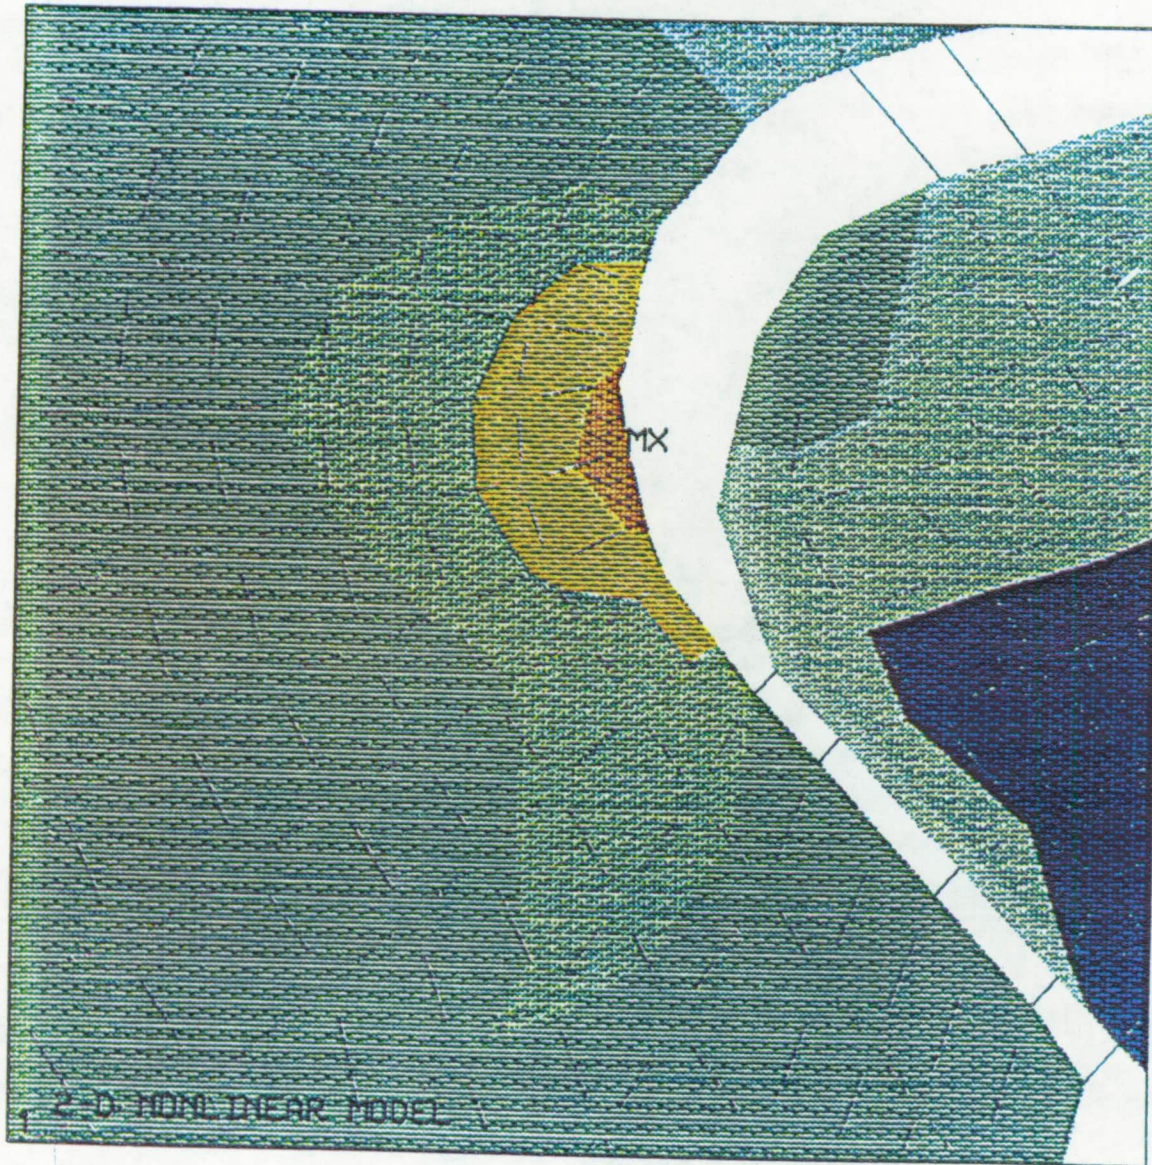
Figure 21. First-stage 2D strain contour.

Comparing these two tables, it is pretty convincing that any blade fir tree analysis without a disk is futile. The distribution of strains along each neck is completely different when disk effects are included. The highest strains for the first stage occurred in neck 2 pressure side with a magnitude of 0.56 percent. A closeup view of this neck showing the strain contours present can be seen in Figure 21. As shown previously in Figure 7, the MAR-M-246 DS material is highly susceptible to cracking in the presence of hydrogen if the temperature and strain level are right. In the room temperature regime, the material appears to tolerate almost no plastic strain prior to crack initiation. The yield strain of the parent material, as ground, is 0.57 percent. Thus, the predicted 2D strain of 0.56 percent would indicate that there is a reasonably high probability of cracks forming in this neck. When the effects of friction and fit-up tolerance are included, the neck strain is at least 0.80 percent and cracking would be assured.

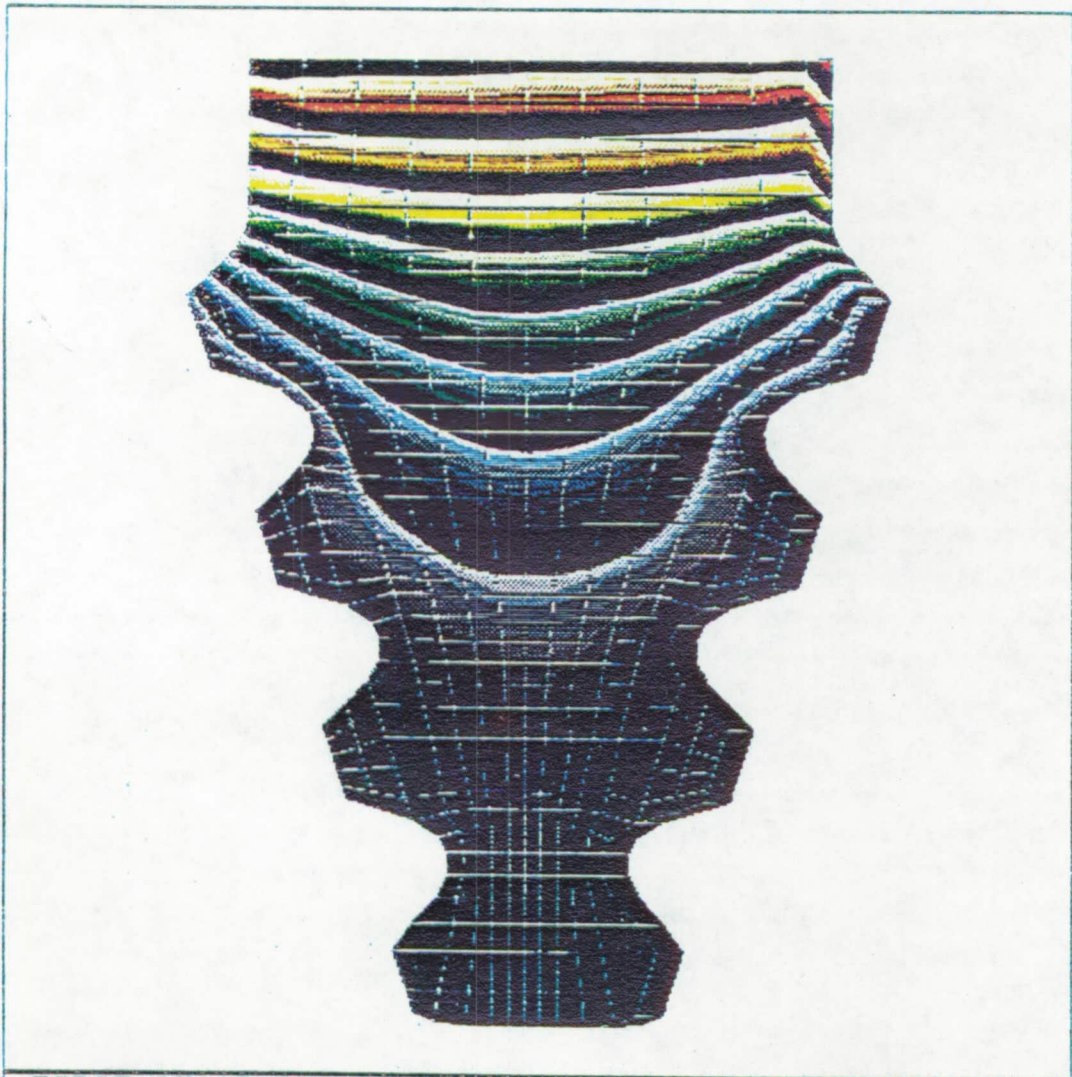
Figure 24. First-stage 3D section temperatures.

included, the neck strain would be at least 0.65 percent and cracking could occur. Figure 24 shows the same center section with the predicted temperature profile contoured. This chart indicates temperatures near -100°F in the high stress areas. Thus, the results of the 3D first-stage analysis indicate that crack initiation would probably be most likely to occur when a fit-up tolerance is introduced. This fact along with potentially low temperatures may well explain the minimal occurrence rate at which this particular crack has surfaced on actual test hardware.

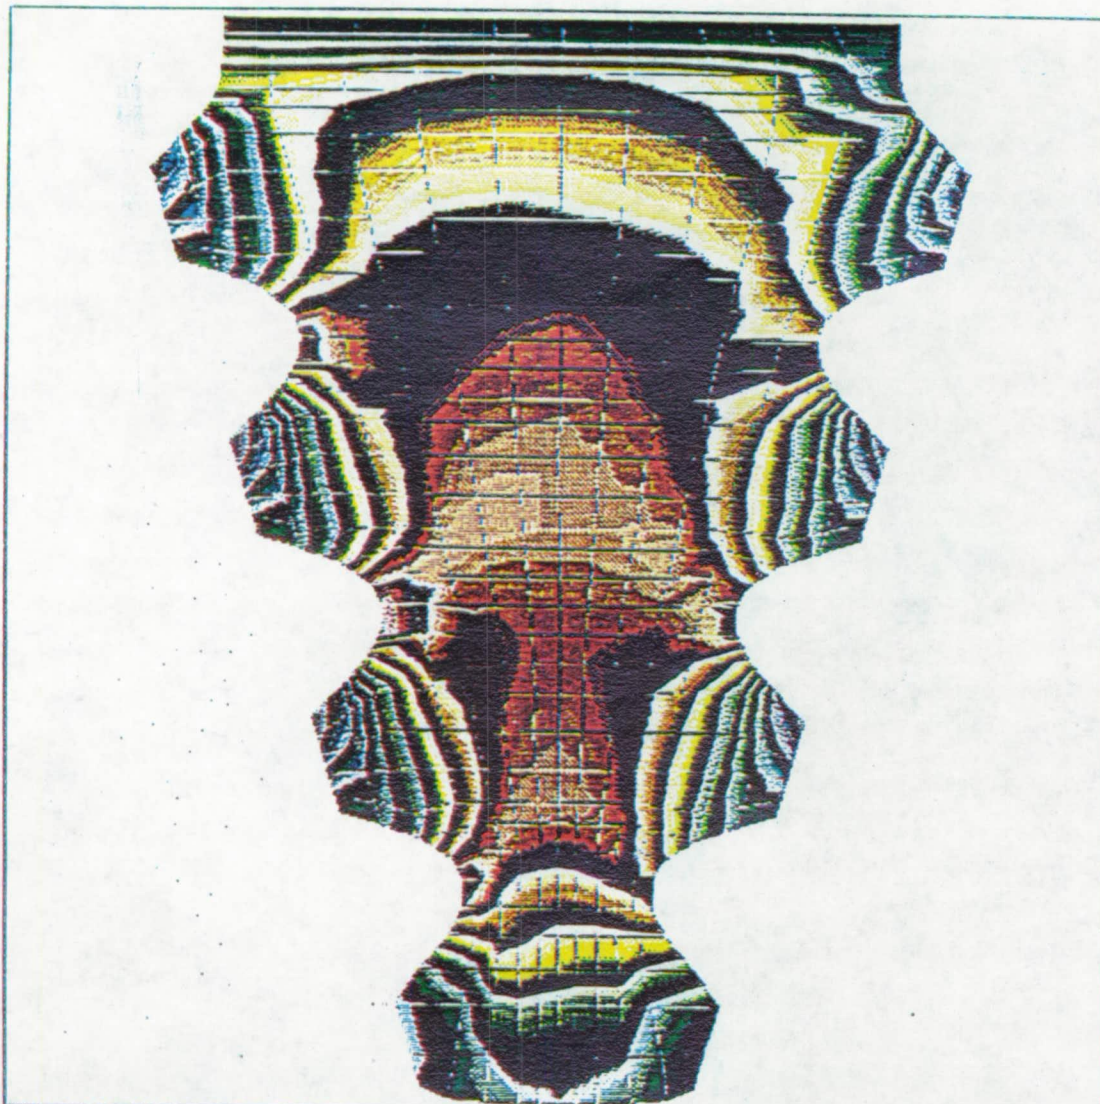
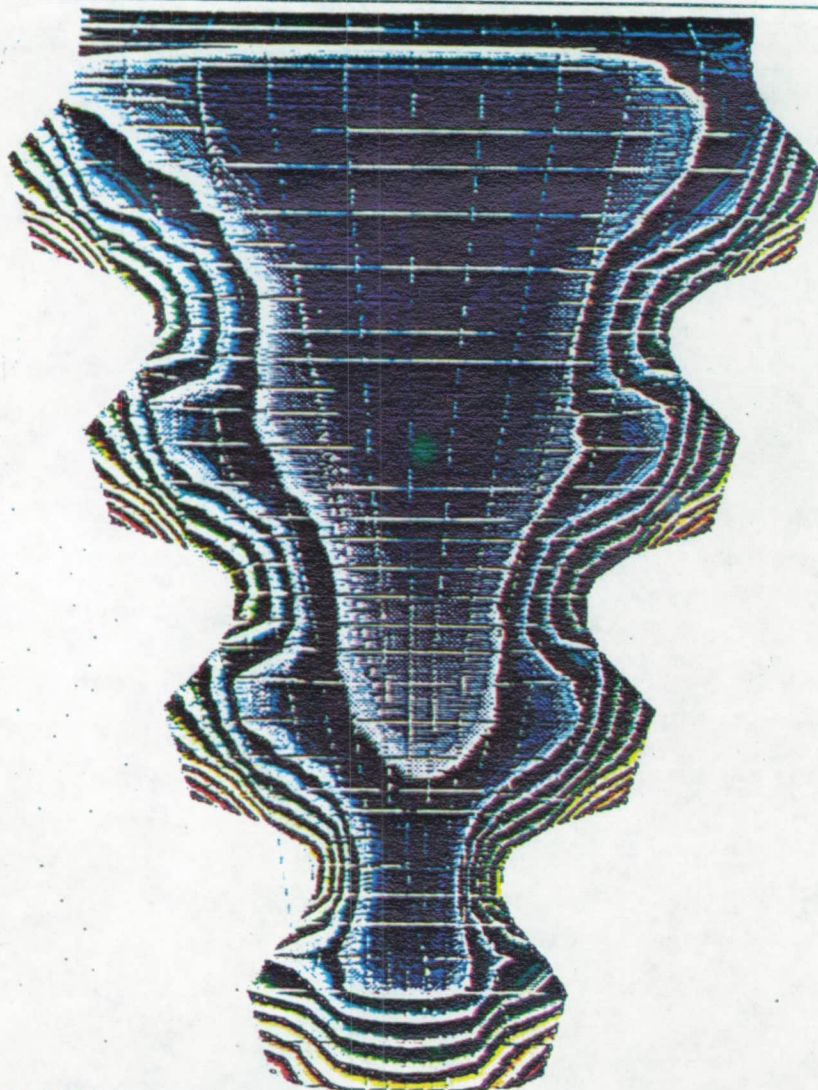
Figure 30.   Second-stage 3D section strain contour.

Like the first stage, the second stage 3D model was run using linear elastic material properties, frictionless gap elements, all lobes in contact, and a disk. Figure 29 shows the strain contour on five selected fir tree sections from the downstream face to the upstream face. Figure 30 depicts the downstream face section of elements that were extracted from the model. This section developed the highest strains in the fir tree and this location also is correlated by test hardware cracking evidence. Table 12 shows the strain levels predicted by the 3D model for the downstream face surface as well as 0.015 in. below the surface.

The main emphasis in Table 12 is to show the change in strain levels from 15 mils below the surface to the downstream surface itself. The prime loads driver here being a steep thermal gradient normal to the surface. Figure 31 shows the downstream face surface temperature contour which shows magnitudes near room temperature for the majority of the face. Figure 32 is a planer "slice" through the fir tree across neck 3. This "slice" clearly reveals the large thermal gradient (about 6000°F per inch) which leads to additional surface strain.
