NASA Contractor Report 178166

Laminar Flow Control Perforated Wing Panel Development

J. E. Fischler et al

Douglas Aircraft Company
McDonnell Douglas Corporation
Long Beach, California

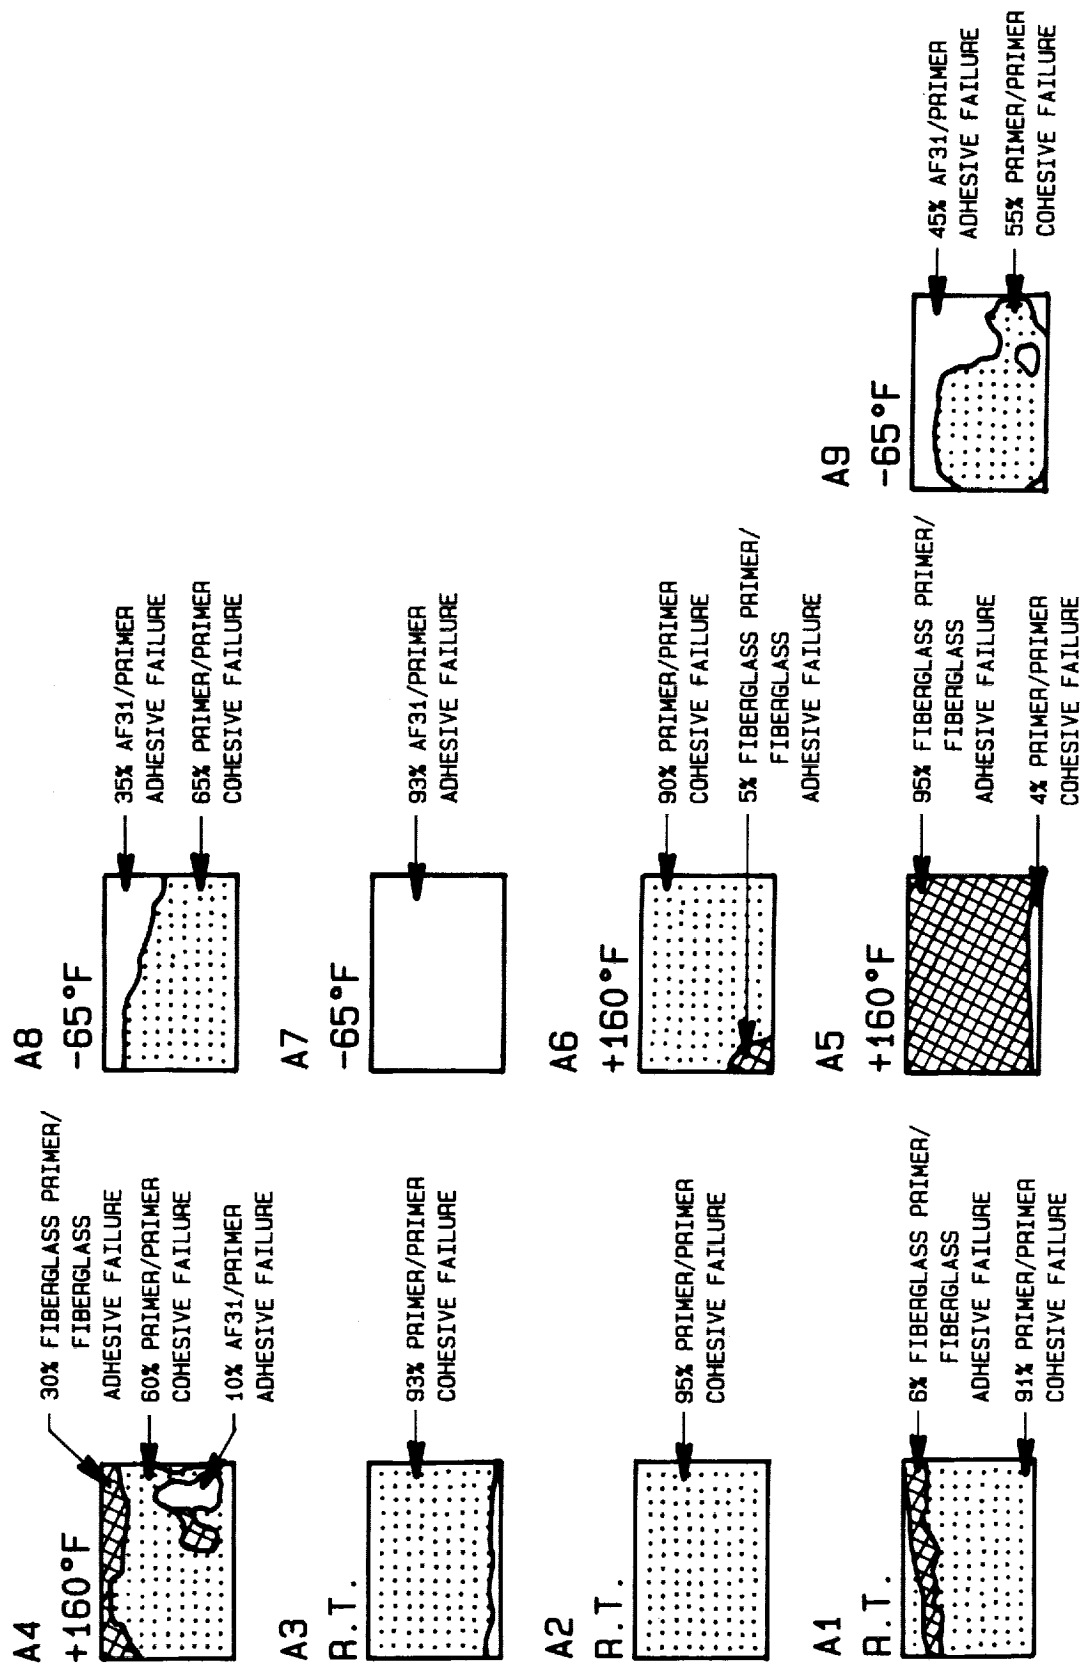
FIGURE 1.28 FAILURE FACES FOR "A" CURE CYCLE SHEAR SPECIMENS
(SEE FIGURE 1.26 PHOTOGRAPH)

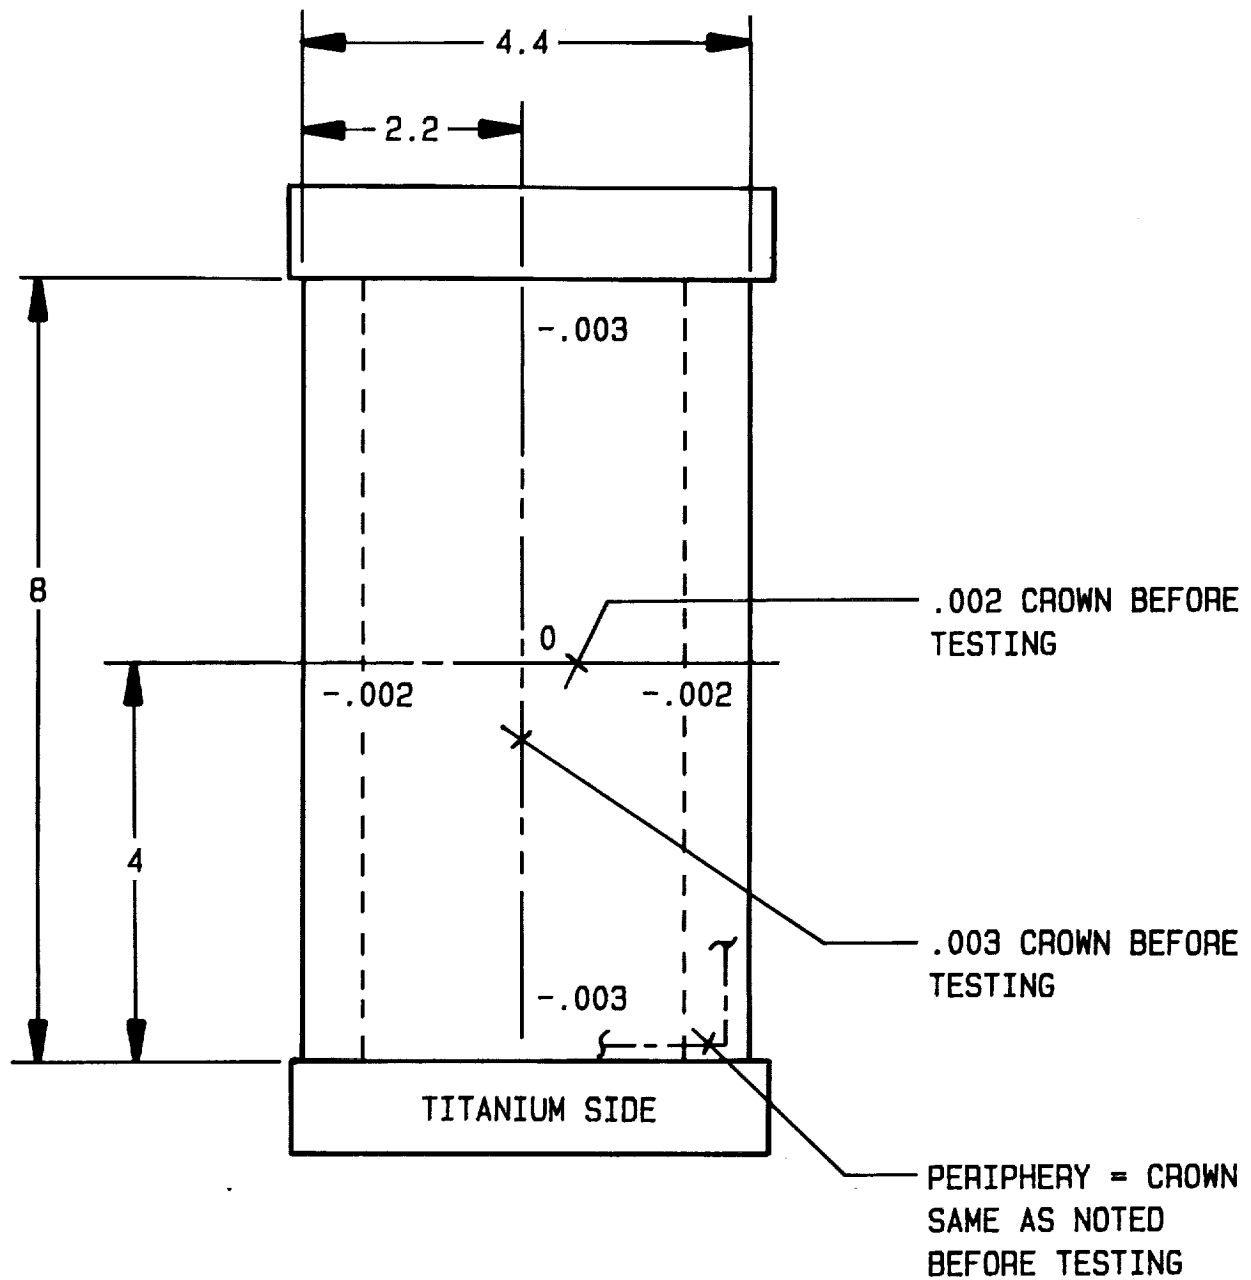
FIGURE 1.34 FAILURE OF TEST SPECIMEN 10E

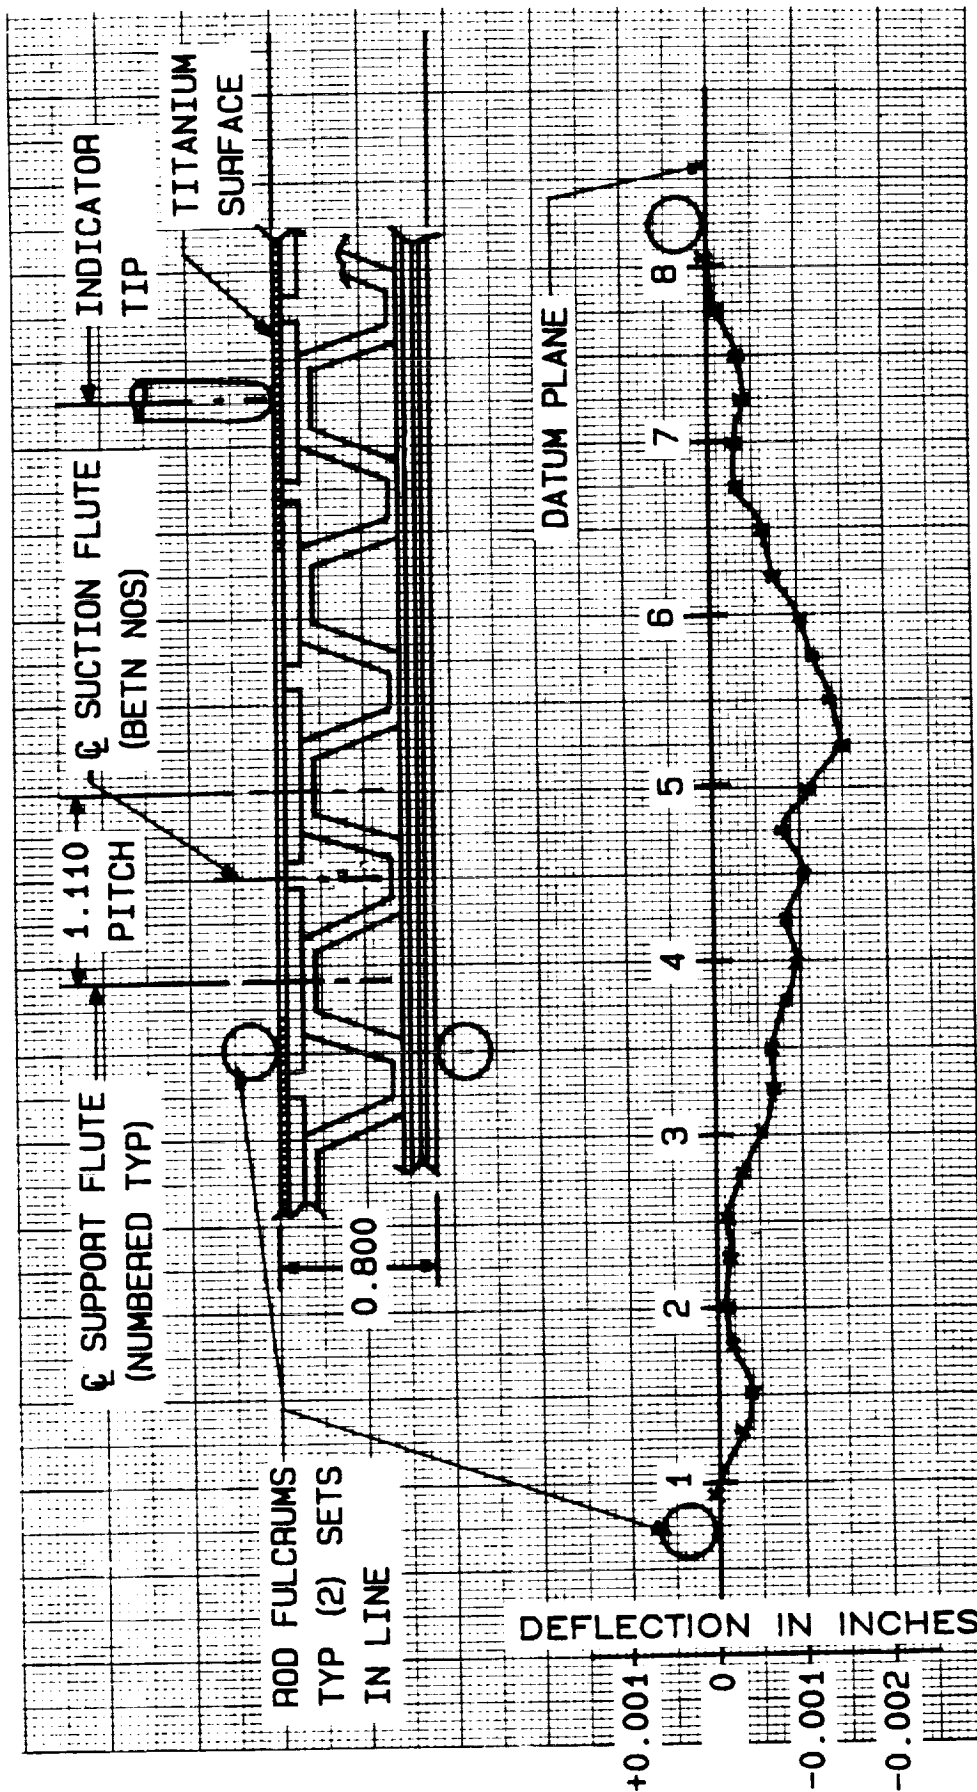
FIGURE 1.61 WAVINESS AND WARPAGE DEFLECTIONS FOR PANEL LA1-11-1
(PERFORATED 12- BY 20-INCH PANEL)
