NATIONAL ADVISORY COMMITTEE FOR AERONAUTICS

REPORT No. 862

AN INVESTIGATION OF A THERMAL ICE-PREVENTION SYSTEM FOR A TWIN-ENGINE TRANSPORT AIRPLANE

1946

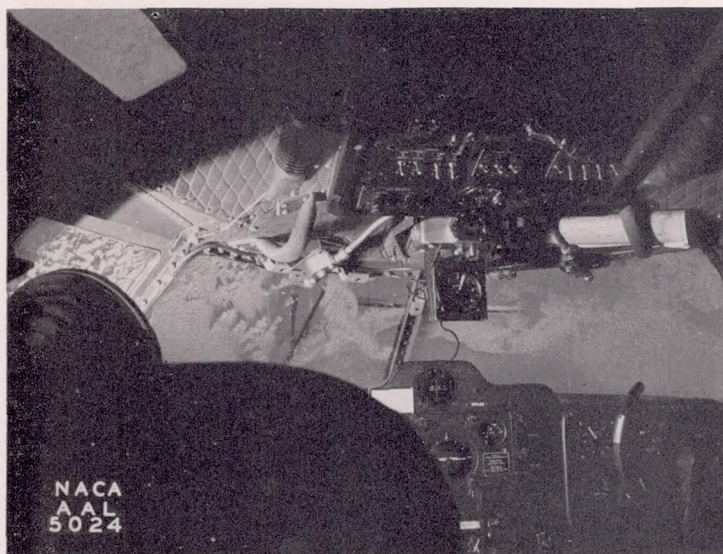
FIGURE 26.—Ice accumulation on pilot's and copilot's windshields after 45 minutes in heavy-icing conditions with only primary heated air directed over outside surfaces of windshields. Photograph taken in flight.

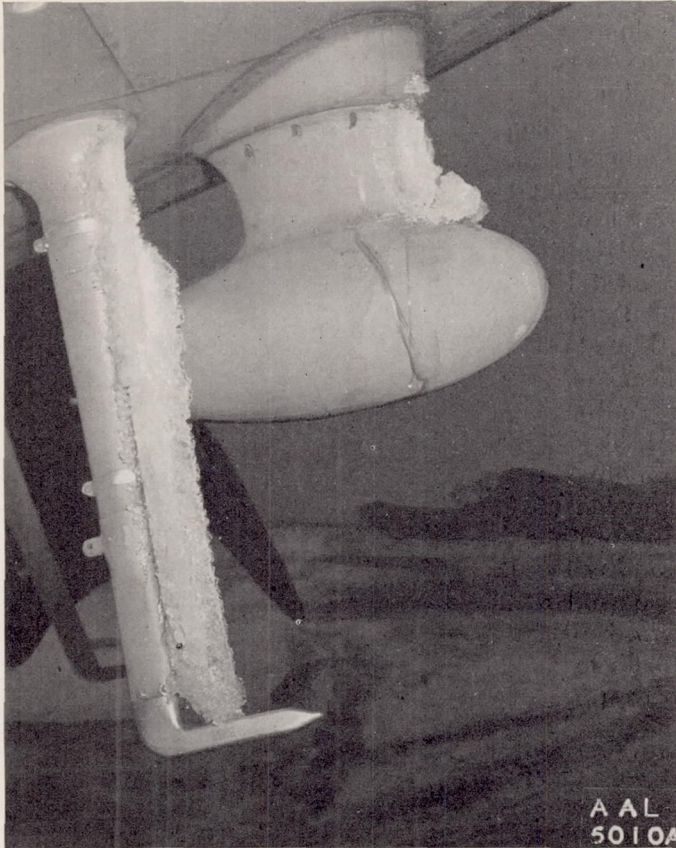
FIGURE 29.—Ice accumulations on the right airspeed mast and loop antenna of the test airplane after flight 29. Photograph taken after landing.

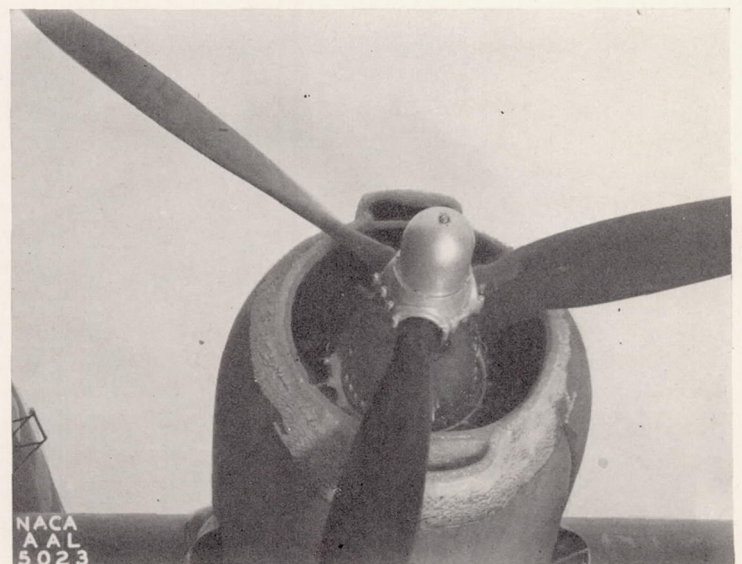
FIGURE 32.—Ice accretion on the left engine cowl after flight 50.

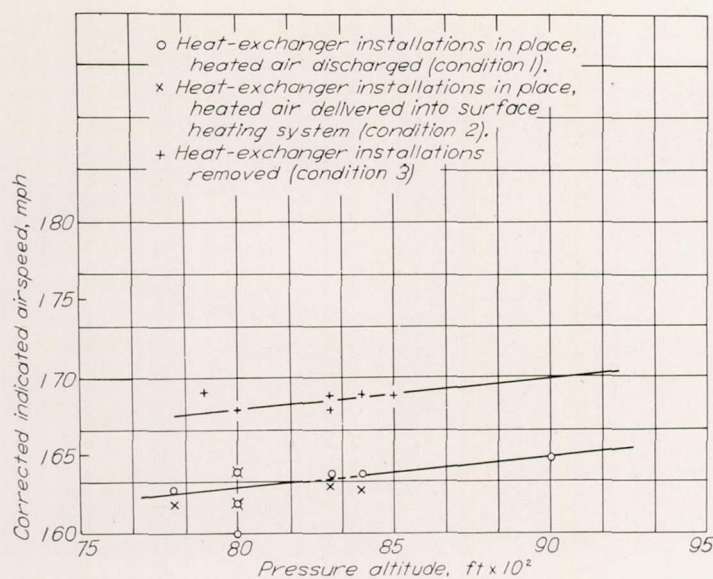
The curves of figure 34 indicate that the performance change resulting from the installation of the thermal system amounted to approximately 6 miles per hour indicated air-

FIGURE 34.—Variation of indicated airspeed with pressure altitude for the test airplane with and without the heat exchanger installations in place. Flight conditions: 10,000-feet density altitude; 30 inches of mercury manifold pressure and 1,900 rpm.

speed, or 1.4 inches of mercury manifold pressure at the test conditions. Sufficient performance data are available for the test airplane to interpret these performance changes in terms of brake horsepower. The calculations are presented in reference 12 and indicate that the airspeed loss expressed in terms of equivalent horsepower loss was 96 thrust horsepower, and computed from the manifold pressure data was 88 thrust horsepower. The experimental data used for computing these two values were taken independently of each other, and the methods provide reasonable agreement. Therefore, the performance change in terms of thrust horsepower caused by the installation of the thermal system may be considered as 92 thrust horsepower, which is an average of the values obtained by the two methods.

Reduction of power attributed to internal drag of the thermal system.—As indicated in figure 34, there was no measurable difference between the performance of the airplane when the heated air was discharged (condition 1) and when the heated air was delivered into the surface-heating system (condition 2).

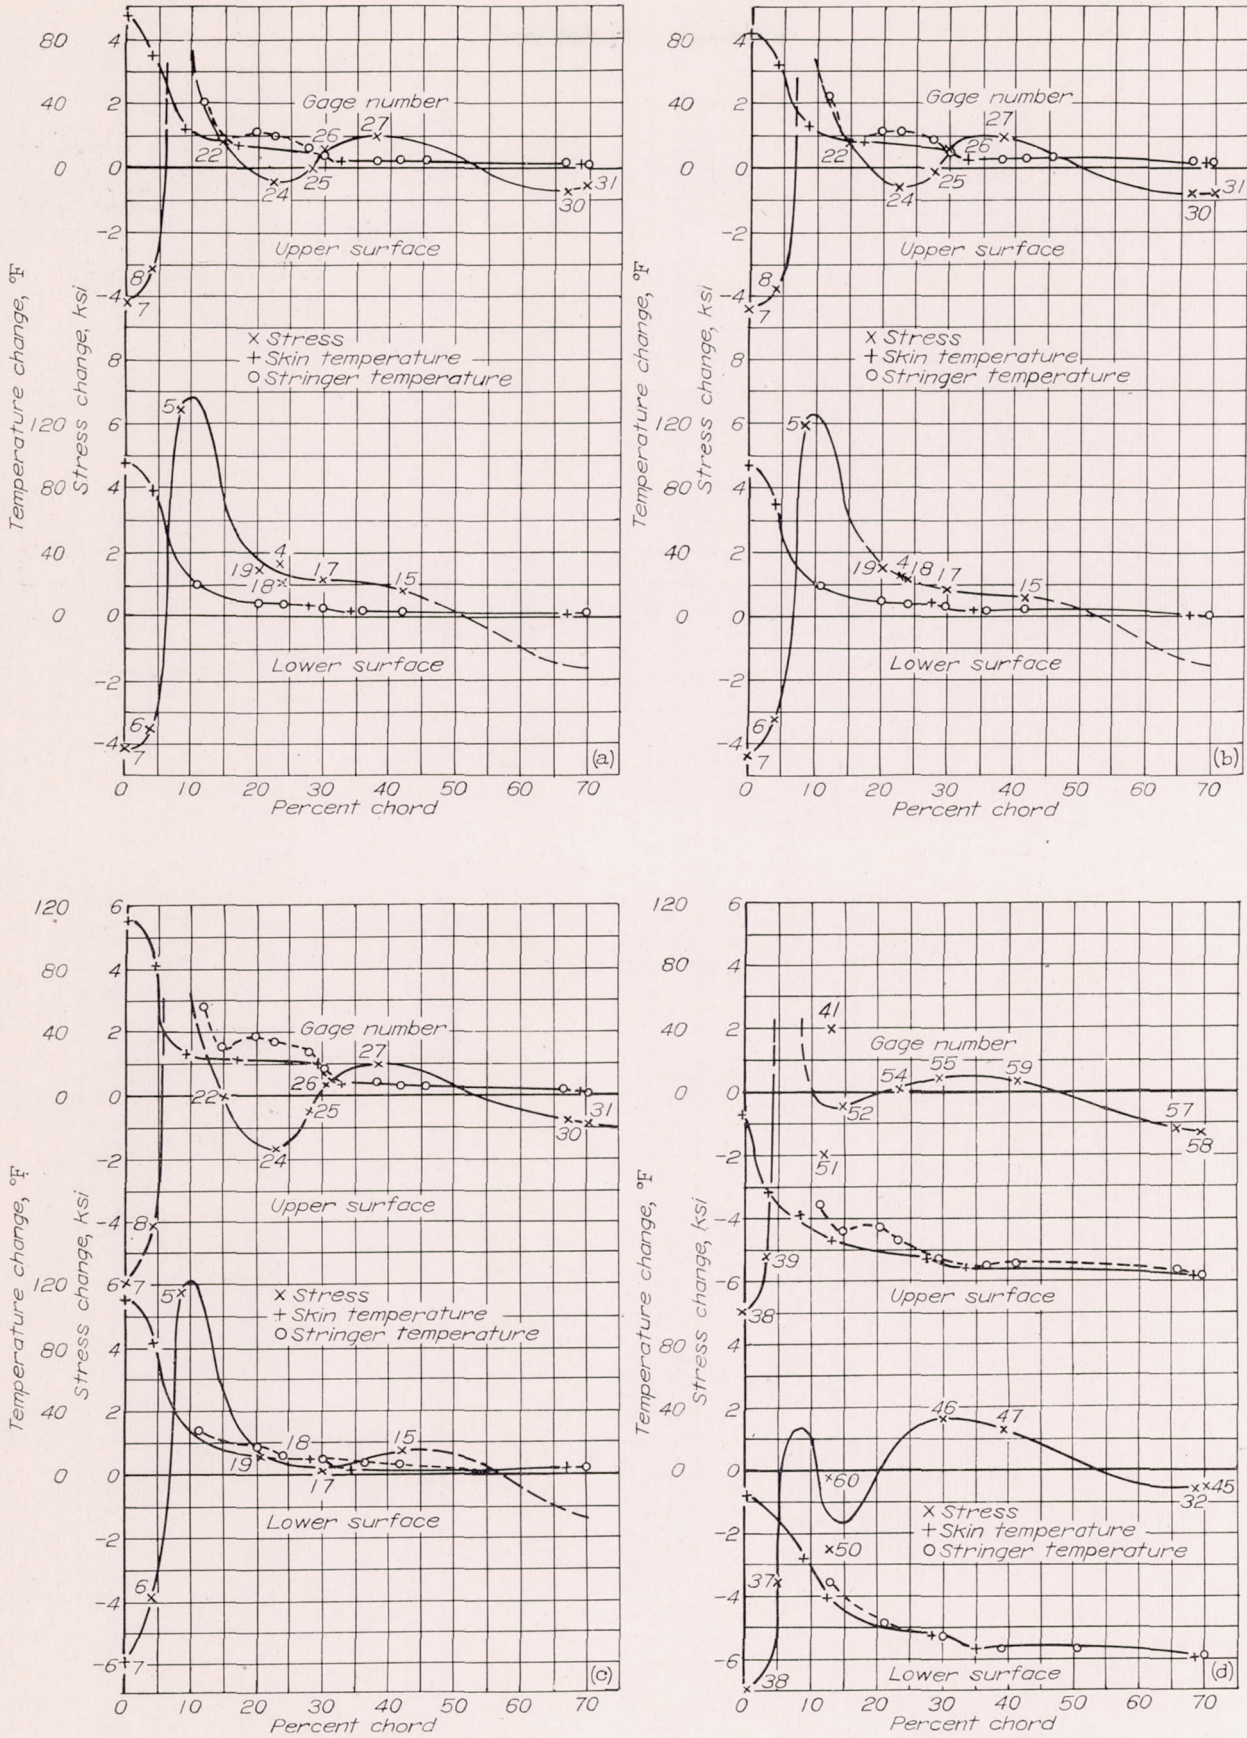
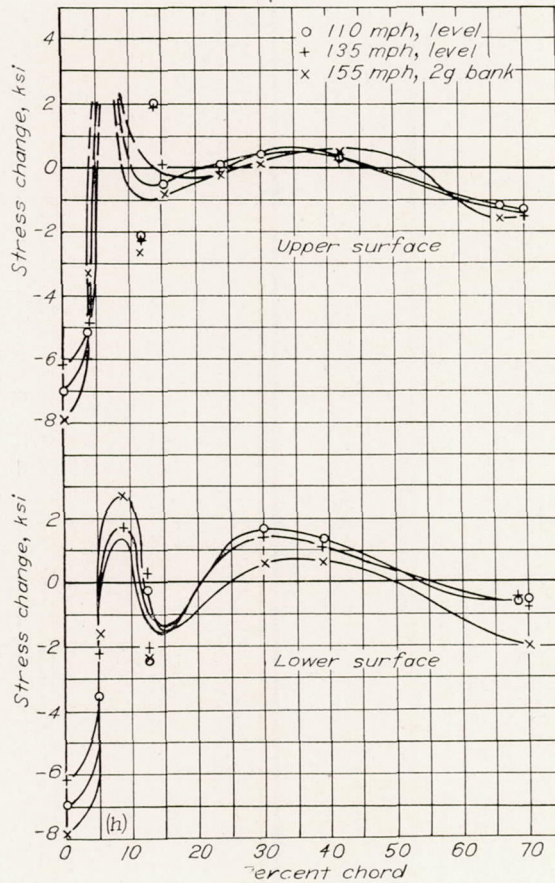
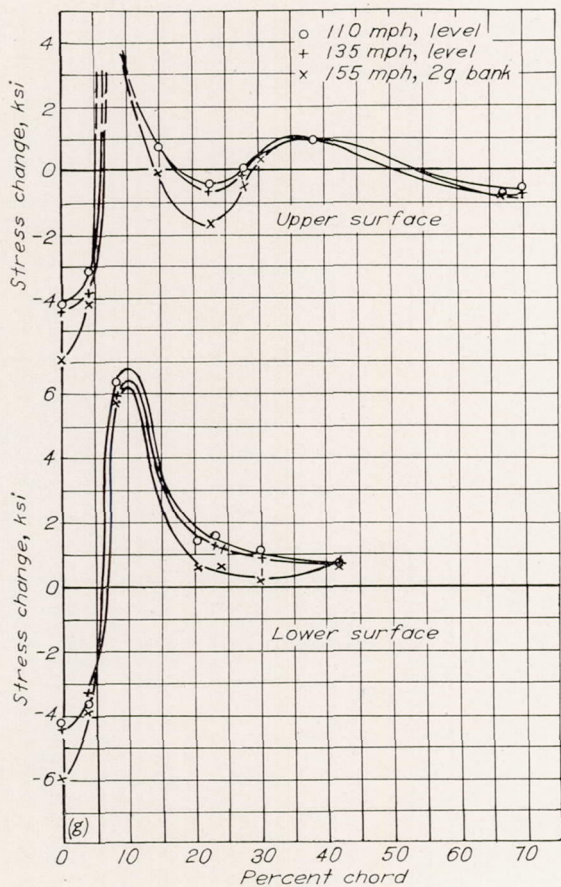
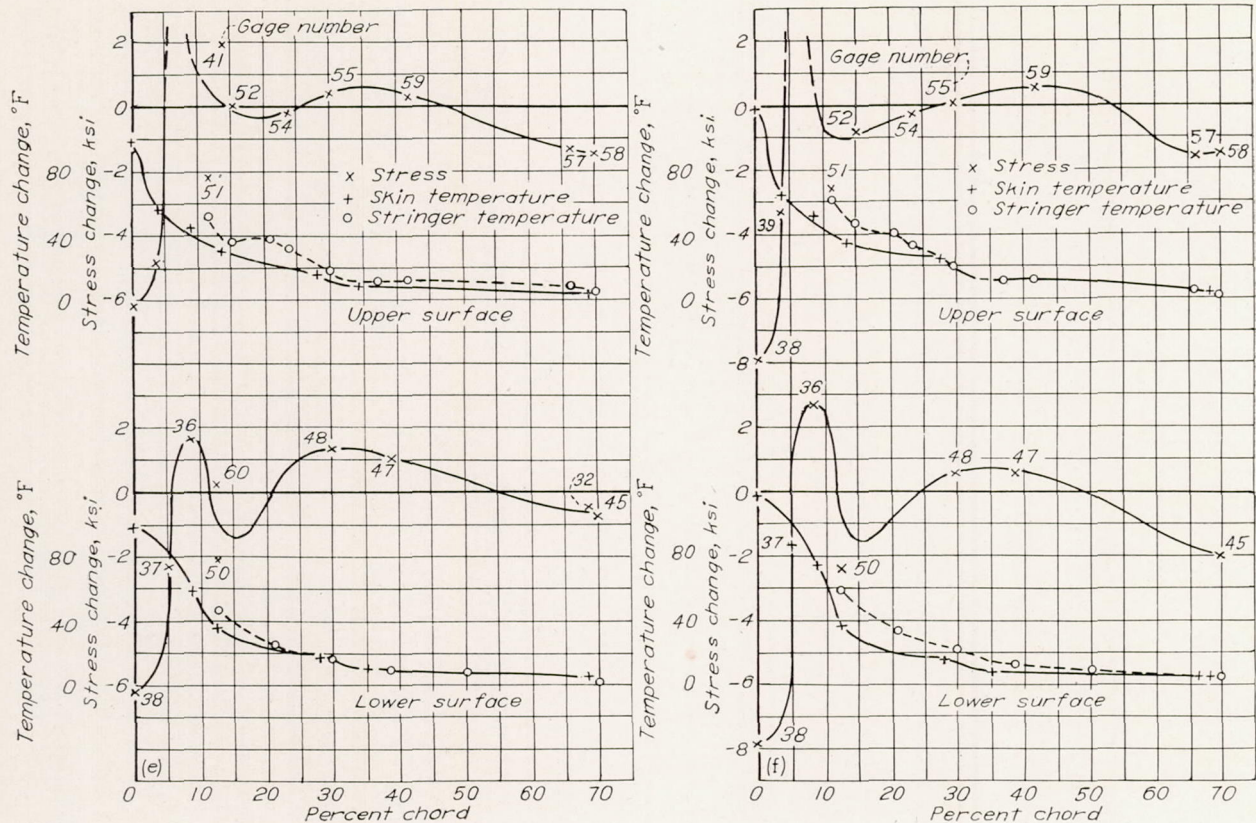
FIGURE 40.—Chordwise distribution of stress change in the wing resulting from operation of the thermal ice-prevention system.

Discussion.—The anticipated effect of heating the wing leading edge on the chordwise wing stress distribution was (1) an increase in compression for the double-skin region as a result of resistance to thermal expansion, (2) an increase in tension in the region between the double skin and the 30-percent spar caused by the expanded leading edge pulling on the relatively cool afterbody, and (3) an increase in compression at the 70-percent spar caused by the two spars and the wing skin acting as a box beam to resist the moment imposed by the expanding leading edge. This general trend is evident in all the curves showing the chordwise distribution of stress change. (See fig. 40.) These curves are based on the values of stress change normal to the chord. The chordwise temperature distribution has been added to the stress-distribution curves in order to facilitate the interpretation and explanation of the test data.

A comparison of the stress changes for the three flight conditions is presented in figures 40 (g) and 40 (h). Although the increased heat supplied to the wing in the 2g bank is evidenced by increased compression at the leading edge and some deviation of the 2g curve from the level-flight curves at other chord positions, the over-all agreement between the stresses for the three conditions is considered sufficient to allow them to be discussed as one general trend.

The expected compression at the leading edge and 70-percent spar is evident in figure 40. From 10- to 30-percent chord, however, considerable variation in the data is noted. This apparent discrepancy at first appears to refute the anticipated general trend, but on further examination is seen to be the result of local conditions superimposed upon the over-all pattern. An example of this effect is shown by the data presented for gages 41, 51, and 52 in figure 40 (d). The expansion of the leading edge would be expected to pull on the hat section containing gage 51 and exert tension similar to gage 36 on the lower surface. Apparently, however, the heated air discharging from the double skin heated the hat section considerably (note temperature distribution) and the restrained expansion induced compressive stresses which were larger than the induced tension. The expansion forces of the hat section, in turn, placed the colder skin in tension as signified by the indication of gage 41. At the location of gage 52 the stress has again reversed, the actual value at gage 52 being the result of the combined effects of several factors of unknown magnitude.

The belief that the scatter of data between 10- and 30-percent chord is largely attributable to localized heating rather than inaccurate measurements is verified by an inspection of figures 40 (g) and 40 (h). These curves show consistency of the data between the three flight conditions

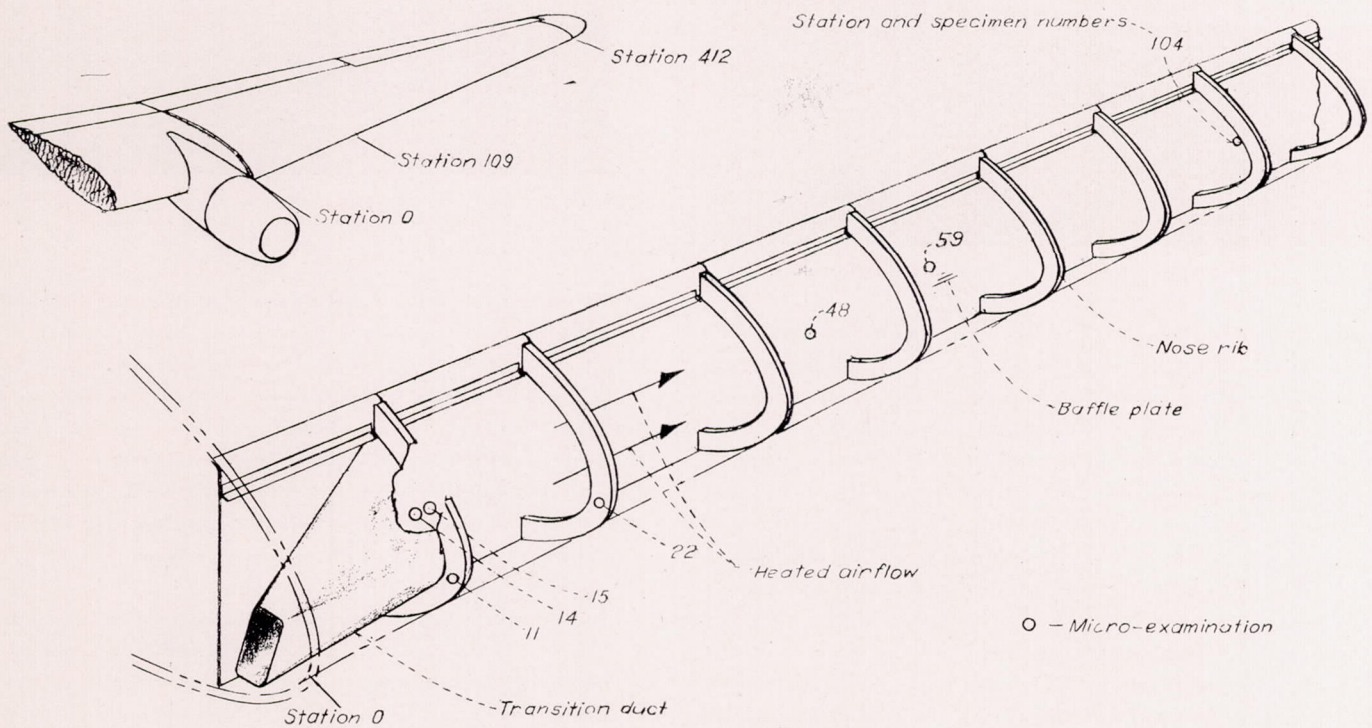
FIGURE 41.—Leading edge of the left wing outer panel showing location of specimens taken for micro-examination.

Selection of specimens.—Representative specimens were removed from the wing after about 225 hours of flight operation of the thermal system. The locations at which the specimens were removed were selected by a visual examination for pitting or any other indication of corrosive action. Samples were taken from the baffle plate at stations 14, 15, 48, 59 and 104, from the nose ribs at stations 11 and 22, and from the nose outer skin at station 11, as shown in figure 41.

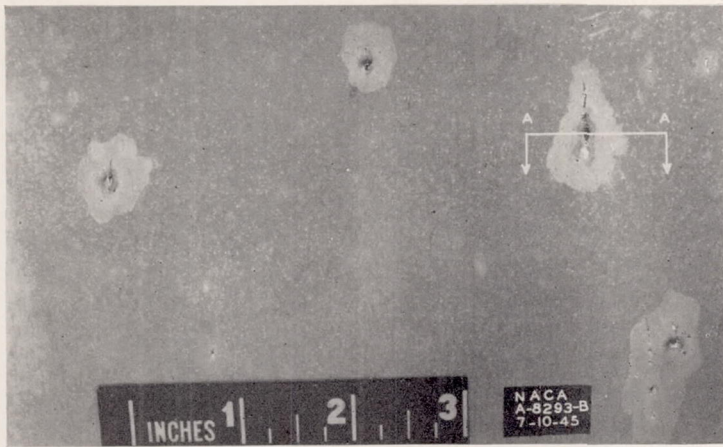
FIGURE 42.—Corrosion and soil deposit on baffle plate between stations 56 and 60. The large black spots are particles from a synthetic sponge-rubber gasket.

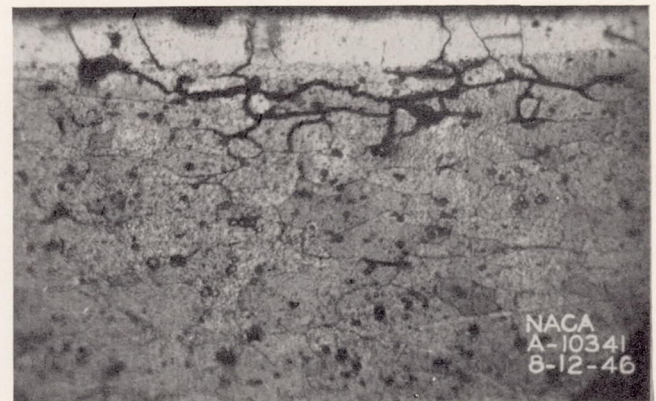
FIGURE 45.—Cross section of baffle-plate cladding and core at station 14, showing intercrystalline corrosion. Magnification, 250X; Keller's etch, and hot 25-percent solution of nitric acid.
