Low Earth Orbit Durability Evaluation of Protected Silicone for Advanced Refractive Photovoltaic Concentrator Arrays

Kim K. de Groh
Lewis Research Center
Cleveland, Ohio

National Aeronautics and
Space Administration

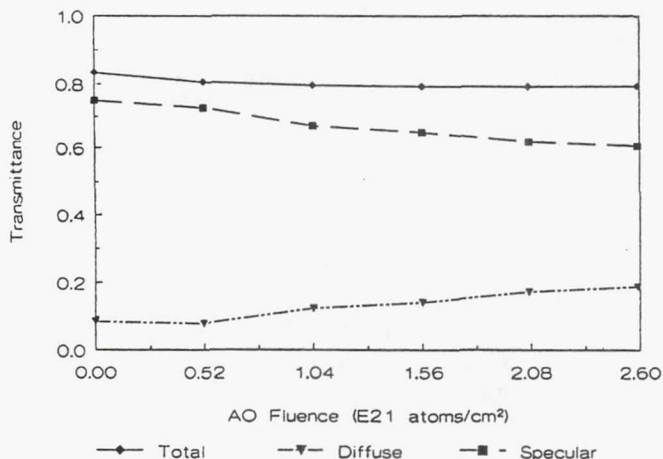
The total transmittance of sample G7 was found to decrease from 0.834 to 0.796, a decrease of 0.038 after a fluence of 1.0 X 10^{21} atoms/cm^2, then remained stable around 0.793 until the final fluence of 2.6 X 10^{21} atoms/cm^2 (see Figure 2). The specular transmittance was found to decrease continuously with exposure from 0.749 to 0.606 a decrease of 0.143 (also shown in Figure 2). Interference fringe patterns were observed in the spectral data for both the total and specular transmittance scans. Figure 3 shows an interference pattern in the total transmittance spectra between 350 nm - 1200 nm, which developed during atomic oxygen exposure. A single maximum (≈ 550 nm) and minimum (≈ 460 nm) of the interference pattern was first observed after a fluence of 1.0 x 10^{21} atoms/cm^2 (96 hours of exposure). This interference pattern continued to develop throughout exposure, extending to larger wavelengths. The development of the interference pattern is likely to be the result of the deposition of a thin film on the surface of the sample. Silicone contamination of the Kapton witness coupon was observed during initial exposure (this is why the effective fluences were estimated based on previous flux calculations for that asher). Space flight exposures such as on the Long Duration Exposure Facility (LDEF) have provided evidence of spacecraft silicone contamination with exposure to a vacuum environment containing atomic oxygen and UV radiation.[5,9] The interference pattern therefore appears to be the result of cross contamination from sili-

Figure 2. Transmittance changes as a function of atomic oxygen fluence for sample G7.

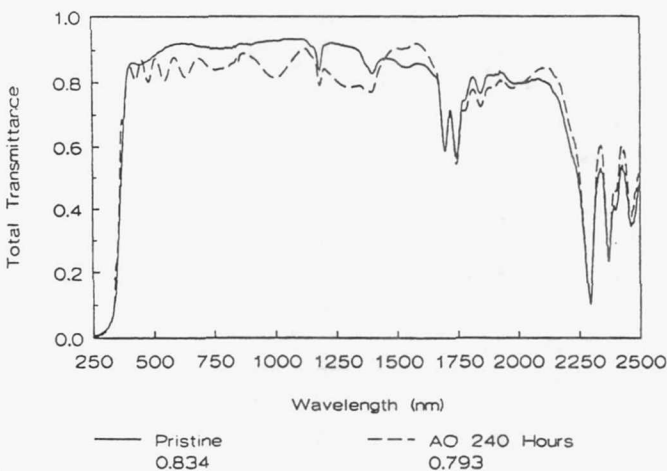
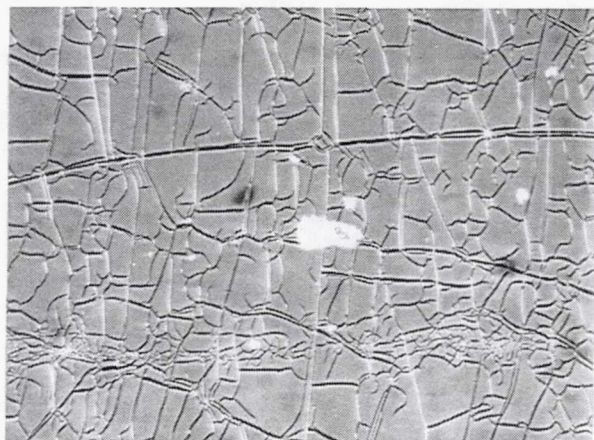
cone at the coating crack sites which reacted with atomic oxygen (in a UV containing vacuum environment) resulting in a contaminant layer on the metal oxide coating. One of the LEO durability concerns with coated silicone advanced refractive concentrators is the possibility of cross contamination from the silicone. These results indicate that some initial total and specular transmittance loss appear to be due to silicone contamination.

Figure 3. Total transmittance spectra of sample G7, before and after atomic oxygen exposure. A strong interference pattern is present in the spectra after an atomic oxygen fluence of 2.6 x 10^{21} atoms/cm^2 (240 hours).

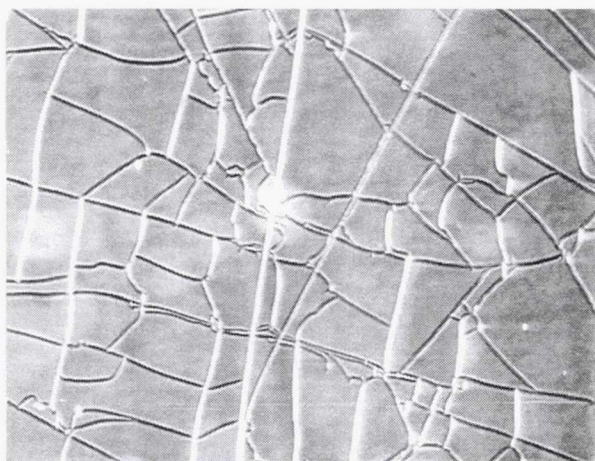
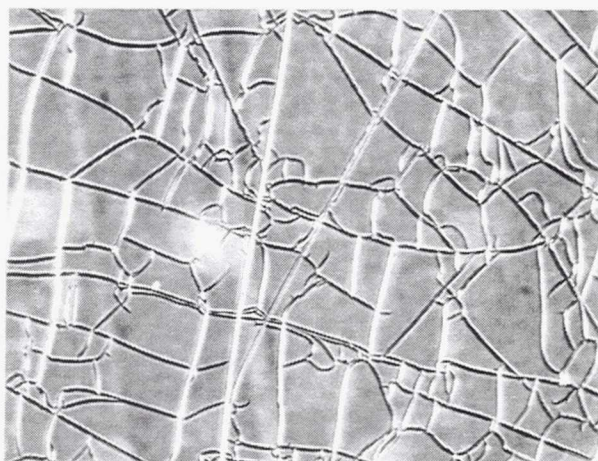
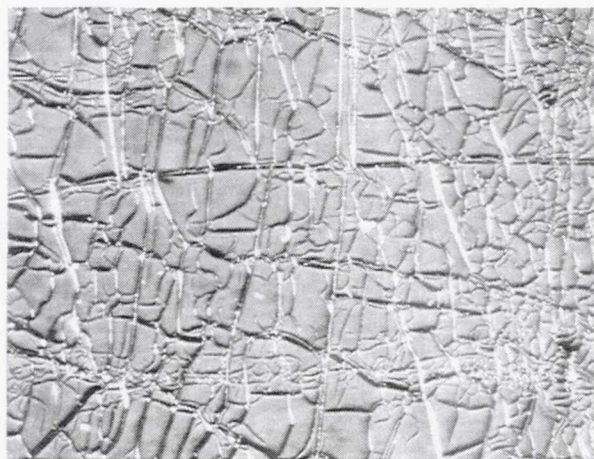
Optical microscopy examination of sample G7 revealed the development of additional coating cracks with continued atomic oxygen exposure (see Figure 4). The extent of additional coating cracking with plasma asher exposure was found to be very area specific. Figure 4 shows the area before and after atomic oxygen plasma exposure, with the most severe additional cracking observed. Note the non-uniform cracking density in the micrograph in Figure 4c after a fluence of 2.1×10^{21} atoms/cm^2. Cracking associated with atomic oxygen plasma exposure was found to continue to progress with increased exposure time. This is likely to be due to the thermal cycling which was induced during the iterative ashing exposure. Refractive concentrators in space would also experience thermal cycling. The development of coating cracks will result in decreased specular transmittance.

Figure 4. Development of additional coating cracks on sample G7 with atomic oxygen plasma exposure: a. pristine, b. F= 5.2×10^{20} atoms/cm^2, and c. F= 2.1×10^{21} atoms/cm^2.

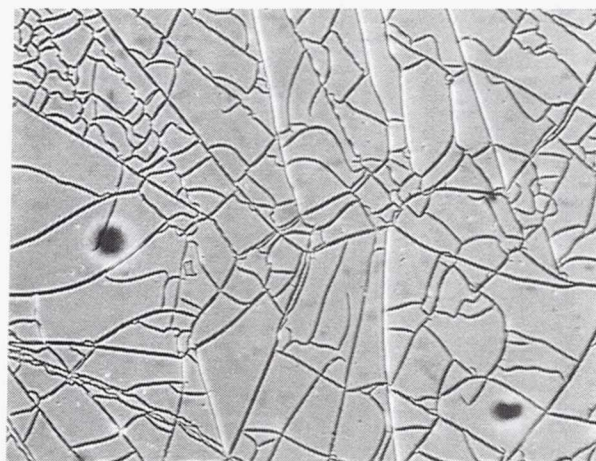
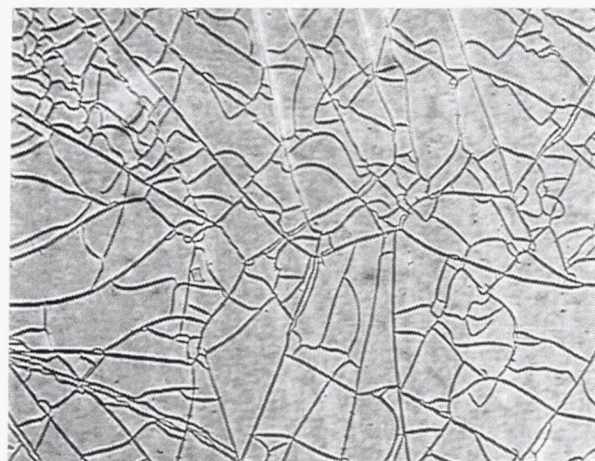
To determine if the additional cracking of the multi-layer coating during ground-laboratory exposure was due to atomic oxygen interactions or due to heating which can occur during plasma ashing (particularly with metals), additional experiments were conducted. Using adhesively attached temperature indicators, it was found that coated silicone samples were exposed to temperatures above 116°C in the plasma environment when they were completely protected with Al foil and to approximately 49°C when the samples were not in contact with metal (i.e. wrapped in organic material). Both of these temperatures were found to cause equivalent amounts of additional cracking of the protective coating. Sample G7 was protected on one side by Al foil during asher exposure so it's maximum temperature reached during ashing was probably at the high end of this temperature range. This cracking is attributed to the differences in CTE between the silicone and the metal oxide thin films ($\approx 10^{-4}$/°C and $\approx 10^{-6}$/°C, respectively). Figure 5 shows additional cracking of a coated silicone sample (G8) after being totally encased in Kapton during plasma ashing. Encasing the sample in Kapton resulted in sample heating, with no atomic oxygen exposure. This sample was exposed for 42 hours (equivalent to a fluence of 4.5×10^{20} atoms/cm^2). When a sample was placed onto a small water-cooled holder in a heated asher, and maintained at 18°C for 48 hours the amount of cracking was significantly decreased. The few additional cracks were likely to be caused by handling. It was originally estimated that during LEO operation, the mini-dome Fresnel lenses would be exposed to temperatures up to ≈ 40.5°C. A coated sample (sample G9), placed into a regular furnace maintained at ≈ 40.5°C, was found to show an in-

Figure 5. Additional coating cracking of a coated silicone sample (G8) after being totally encased in Kapton during plasma ashing (≈49°C): a. prior to exposure, and b. after 42 hours of plasma exposure.

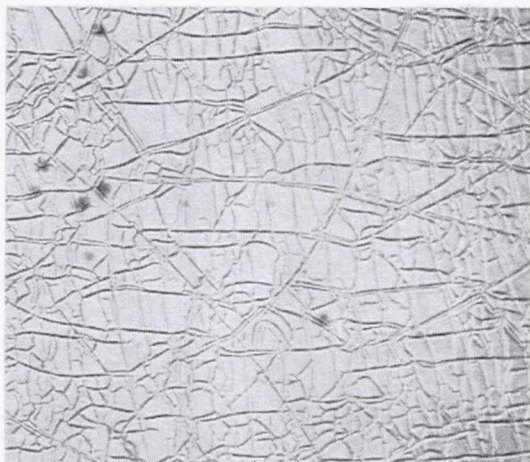
More tests were performed to evaluate the effect of additional cracking on the optical properties. An unexposed coated sample (sample B1) was characterized for transmittance and optical micrographs were taken. This sample was bent in half, then rolled along the bend line several times, and optical microscopy revealed extreme additional cracking of the coating had occurred, as can be seen in Figure 7. The post-bend optical measurements revealed a decrease in total and specular transmittance by only 0.005 and 0.023, respectively. Therefore, any decreases in total and specular transmittance in excess of these values

Figure 7.   Effect of severve bending (sample B1) on additional coating cracking: a. prior to bending, and b. after bending.

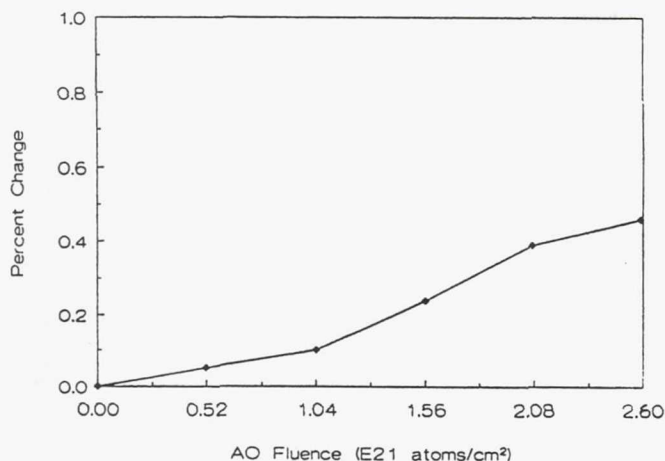
In addition to the changes in transmittance of sample G7, there was a gain in mass of 0.46% with atomic oxygen exposure (see Figure 8). Scanning electron microscopy evaluation of samples G2-G6 showed the apparent formation of a smooth glassy layer on the exposed silicone in coating crack sites with atomic oxygen exposure. The mass gain and microscopy analysis provided evidence which suggested the formation of an SiO_x layer on the exposed silicone areas. To confirm this silicone to SiO_x conversion process XPS analysis was performed on four uncoated DC 93-500 samples. Two of these samples were pristine and two were exposed to atomic oxygen in a plasma asher with effective fluences of 6.11×10^{19} atoms/cm^2 and 4.12×10^{20} atoms/cm^2. The oxygen concentration on the surface of these samples showed a marked increase from ≈ 31 atomic percent (A%) to ≈ 59 A%, after an atomic oxygen fluence of 4.12×10^{20} atom/cm^2, while the percent of silicon remained constant. The majority of oxygen concentration increase had occurred after an atomic oxygen fluence of 6.11×10^{19} atoms/cm^2 (≈ 57 A%), indicating that the rate of oxygen increase slowed with exposure time (see Figure 9). Further analysis of the above samples revealed that the percent of SiO_x on the surface of the samples increased from $\approx 26\%$ to $\approx 77\%$ after a fluence of 4.12×10^{20} atoms/cm^2. The majority of the SiO_x conversion occurred within a fluence of 6.11×10^{19} atoms/cm^2 ($\approx 72\%$) (see Figure 10). The decrease in the rate of this conversion process with longer fluences is attributed to less surface area of the silicone being exposed to the atomic oxygen as the silicate layer forms. Depth profiling of the above samples showed that the SiO_x layer increased in depth as the atomic oxygen effective fluence increased. At 6.11×10^{19} atoms/cm^2 the depth of the SiO_x layer was measured to be ≈ 1000 Å and at an effective fluence of 4.12×10^{20} atoms/cm^2 the depth of the SiO_x layer was measured to be greater than 2000 Å. The continued conversion of silicone to SiO_x after an initial surface SiO_x layer has formed, is speculated to be due to the ability of atomic oxygen to diffuse through the SiO_x layer (due to incomplete conversion of the silicone to silica) to react with underlying silicone.

Figure 8.   Gain in mass of Sample G7 with atomic oxygen plasma exposure.

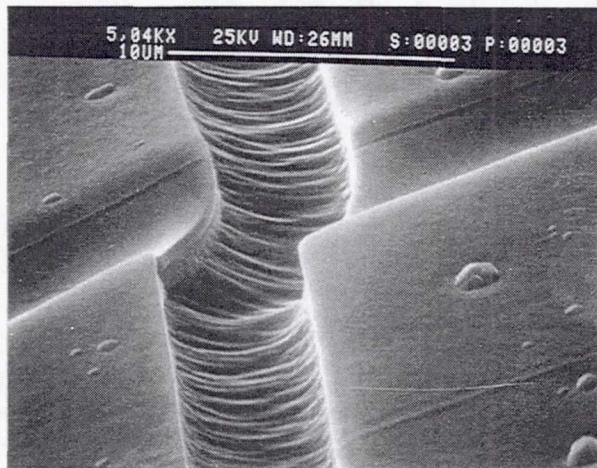
When the surface of silicone converts to SiO_x with atomic oxygen exposure, it typically looses organic side groups such as methyl groups, shrinks and causes mud tile like cracks (note the loss of carbon in Figure 9). SEM evaluation of samples G2-G6 provided images where silicone in the coating cracks had converted to SiO_x, cracked, formed SiO_x in that crack and cracked again. This type of SiO_x conversion cracking propagation is shown in Figure 11. Figure 11a shows a freshly opened crack with a stretched appearance (vertical), and an older crack which has a smoothed out glassy appearance (horizontal). Figure 11b shows cracking of the converted SiO_x layer inside a coating crack. "Bulging" of the coated areas be-

Figure 11. SEM micrographs showing the development of coating cracks after an atomic oxygen fluence of 2.6 x 10^{21} atoms/cm^2: a. freshly opened crack (stretched appearance), and an older SiO$_x$ converted crack (smooth glassy appearance), and b. cracking of SiO$_x$ converted film inside a protective coating crack.

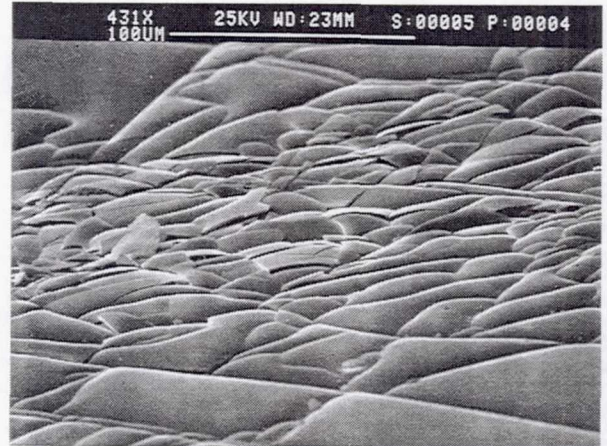
tween cracks (islands) was also observed with SEM. Typically this bulging, as observed at room temperature, was found to increase with increased atomic oxygen exposure. This effect is observable as extra shadowing in the higher fluence optical micrographs, such as the one in Figure 4c. In some isolated areas the bulging islands actually appear to have partially delaminated from the silicone substrate such that the edges are free and lifted up, as can be seen in Figure 12. These islands appear to be adhered to the silicone. Only a few islands were actually found to have flaked off. SEM evaluation also provided evidence that the multi-layer coating remained protective and did not appear eroded by atomic oxygen in the areas where it was not cracked.

Figure 12. Isolated area of partically delaminated "bulged" coating islands.

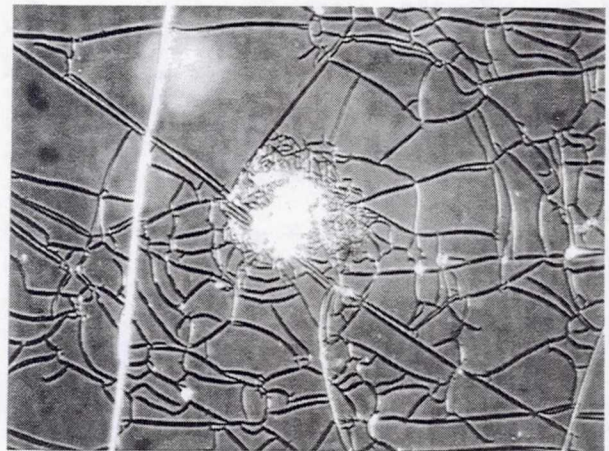
Sample F2, the coated DC 93-500 sample, exposed to directed ram space atomic oxygen experienced essentially no change in the integrated total transmittance and a 0.031 decrease in the integrated specular transmittance (sample F3 is still being characterized). No decrease in total transmittance, and a slight decrease in specular transmittance is consistent with the changes observed in the bend test sample. However, optical post-flight macrographs of sample F2 show only a slight amount of additional cracking (see Figure 13), not enough to account for the specular transmittance change based on results from the bend test sample (the defect in the center of the macrograph was purposely put there prior to flight). The additional decrease in specular transmittance for the LEO exposed sample is not currently

Figure 13. Coated DC 93-500 silicone exposed to LEO on STS-46: a. pre-flight, and b. post-flight (F= 2.3x10^{20} atoms/cm^2).

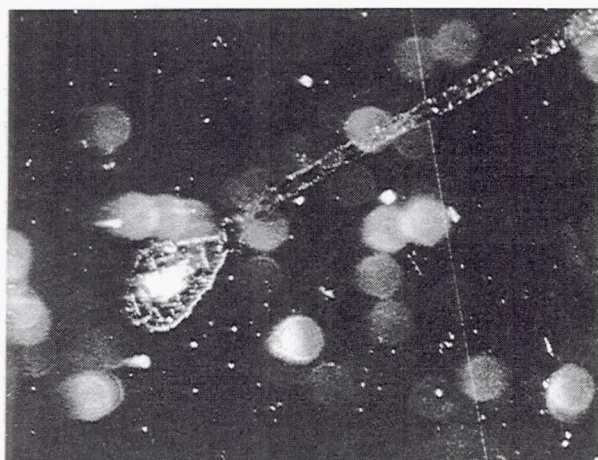
understood. SEM analysis of sample F2 has not yet been performed. It is possible that such analysis will give insight into this decrease in specular transmittance. It has been observed that the EOIM III mission fluence was high enough to cause the uncoated silicone sample to craze (see Figure 14).

Figure 14. Uncoated DC 93-500 exposed to LEO on STS-46: a. pre-flight (no cracks), and b. post-flight (SiO_x conversion cracks).
