GROUND-BASED TESTING OF REPLACEMENT THERMAL CONTROL MATERIALS FOR THE HUBBLE SPACE TELESCOPE

Jacqueline A. Townsend, Patricia A. Hansen, Mark W. McClendon,
NASA Goddard Space Flight Center, Greenbelt, Maryland, 20771 USA

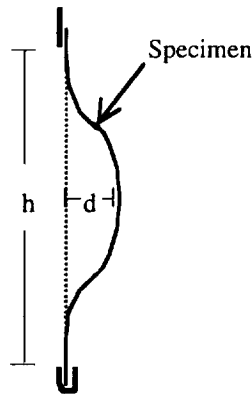
FIGURE 1: FRACTIONAL DISTORTION, d/h [8]

Specimens were subjected to at least 1500 cycles with a roughly 9 minute period in the thermal chamber described in section 3.2.1.3. Before and after cycling, the specimens were evaluated for fractional distortion. Fractional distortion was defined as d/h, where h was the height of the suspended specimen and d was the maximum displacement from true vertical (see Figure 1). The values are reported in Table 3 [8].

The LeRC investigators concluded that shape distortion was a major concern for materials 4 and 7 [8]. This conclusion was based on both the initial fractional distortion and the condition following thermal cycling. Although material 6 also had considerable distortion, because the

specimen was wavy, rather than curled in a single direction, the distortion was not considered to be a major concern.

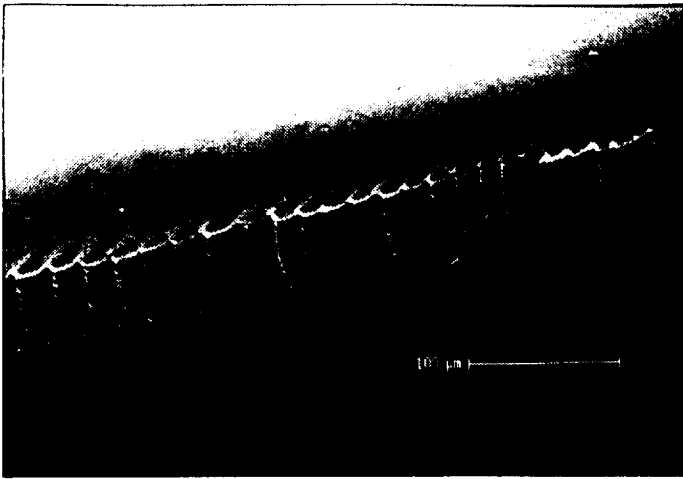
The SC2 crack surfaces were wavy, with some deformation at the specimen surface in the direction perpendicular to the specimen surface. Ductile tearing was observed between and at the crests of wavy striations (see Figure 3). As with the SC1, the crack front progressed during thermal cycles. The tension on the specimen was sufficient to cause some plastic deformation.

Figure 3a. Specimen B1.8, Five mil FEP with VDA, Spring loaded during thermal cycling. Shows wave-like striations. Crack propagation was right to left.

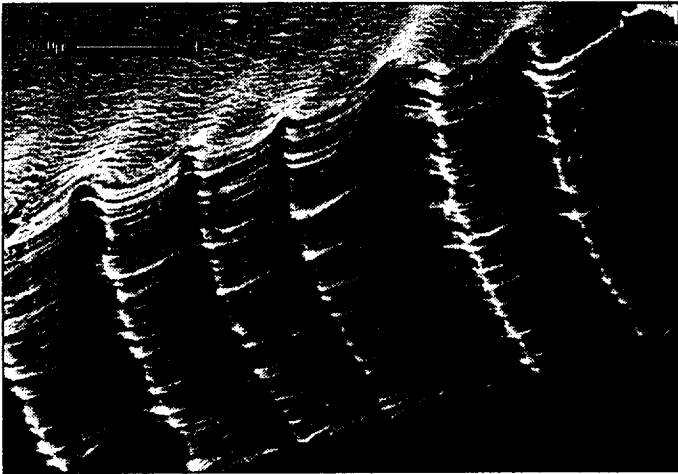
Figure 3b. Detail of the crack surface of specimen B1.8. Crack propagation was right to left.

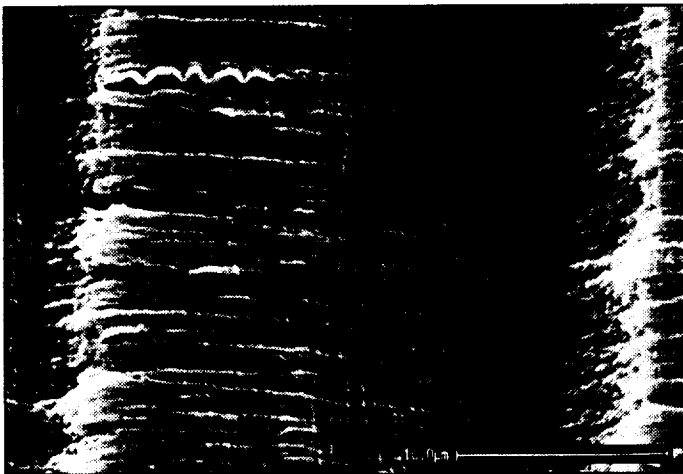
Figure 3c. Detail of wave-like striations showing ductile tearing features, specimen B1.8.
