Failure Engineering Study and Accelerated Stress Test Results for the Mars Global Surveyor Spacecraft's Power Shunt Assemblies

Mark Gibbel
Jet Propulsion Laboratory
California Institute of Technology
mark.gibbel@jpl.nasa.gov

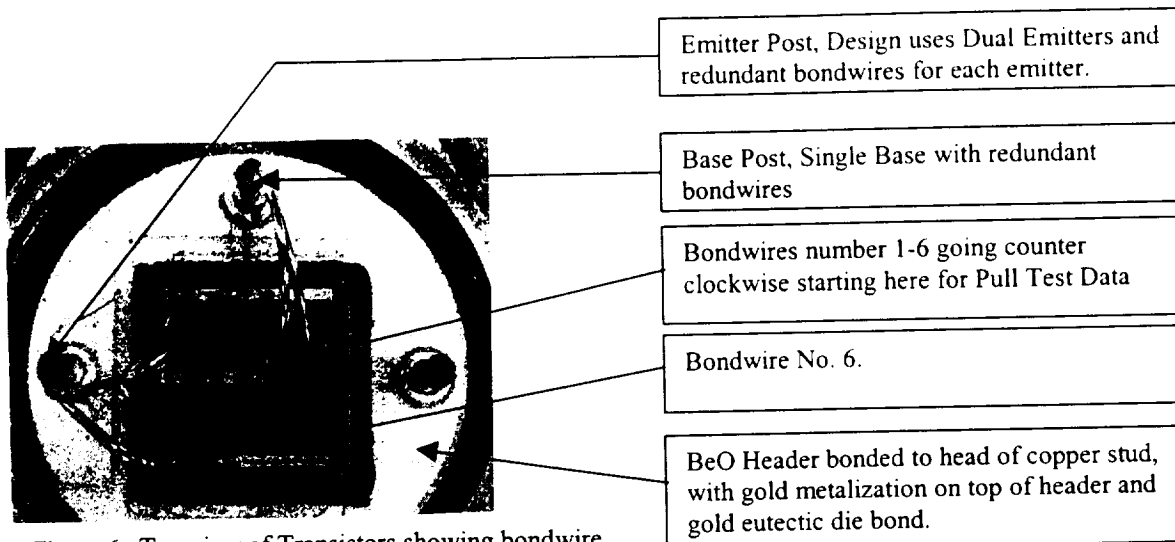
Figure 6. Top view of Transistors showing bondwire configurations. Bondwires are dead soft Aluminum 0.010 inches in Diameter on Aluminum metalization. Posts are Nickle. All are bonds ultrasonic. Bonds to die are orthodyne bonds while bonds to post are wedge bonds.

Emitter Post, Design uses Dual Emitters and redundant bondwires for each emitter.

Base Post, Single Base with redundant bondwires

Bondwires number 1-6 going counter clockwise starting here for Pull Test Data

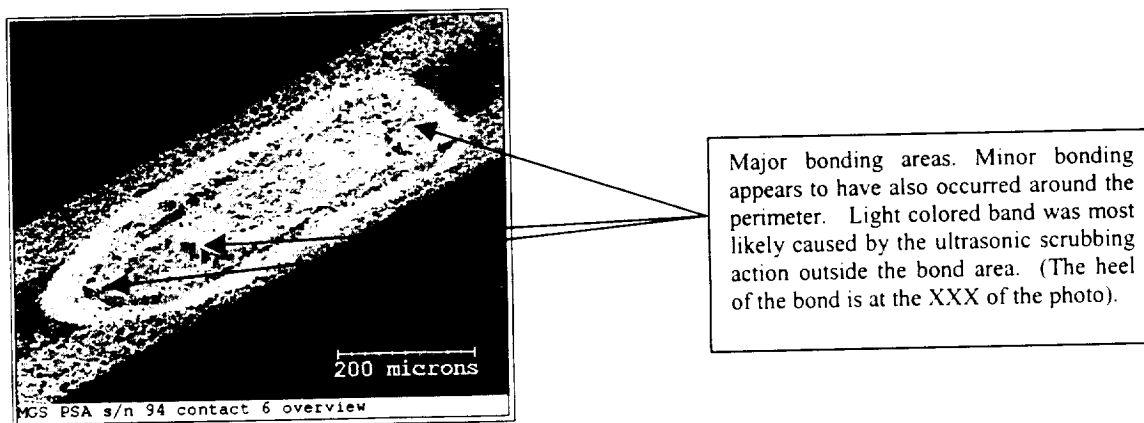
Figure 7. View of bond pad #6 in S/N 094 showing area where bonding occurred.

The SEM photograph shown in Figure 7 indicates that the primary bonding area was at the heel and toe, with some minor bonding around the perimeter. Moreover, the SEM photograph in Figure 8 confirms that fatigue of the bond was the life limiting failure mechanism.

Major bonding areas. Minor bonding appears to have also occurred around the perimeter. Light colored band was most likely caused by the ultrasonic scrubbing action outside the bond area. (The heel of the bond is at the XXX of the photo).
