NASA/TM-2002-211770

Compression Buckling Behavior of Large-Scale Friction Stir Welded and Riveted 2090-T83 Al-Li Alloy Skin-Stiffener Panels

August 2002

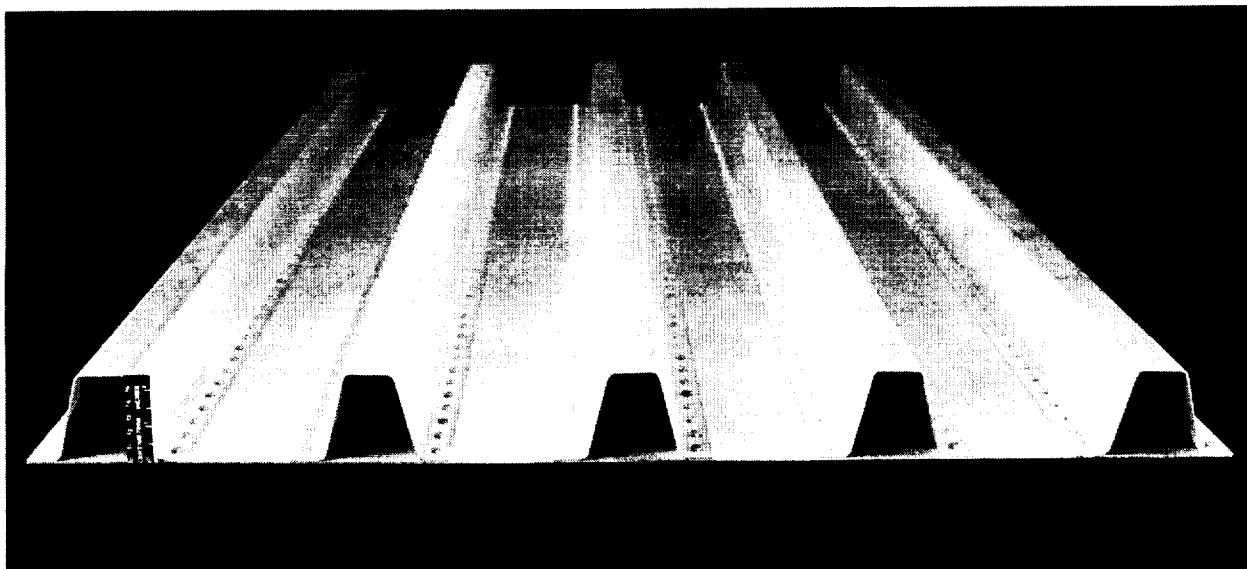
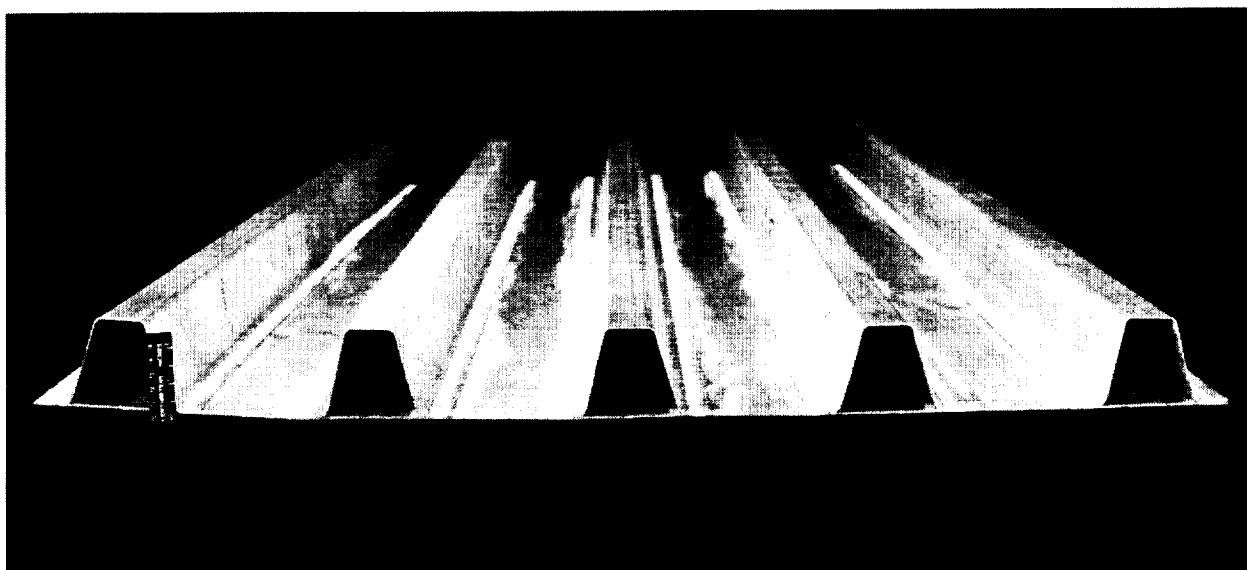
Following fabrication, the panels were non-destructively inspected using visual, ultrasonic, and radiographic techniques. With the exception of one cold lap defect (CLD), all welds passed both ultrasonic and radiographic inspection. The weldments exhibited the typical concentric ring pattern characteristic of the FSW process and no surface galling was observed (Figure 4b). It was noted, however, that excessive weld flash was present on the welds located in the central regions of the panel. The excessive weld flash suggests non-optimized weld parameters and/or insufficient clamping of the panel to the steel backing anvil. Visual inspection of the riveted and FSW panels also revealed bowing of

the stiffeners in the longitudinal direction and warping of the face skin in the transverse direction (Figure 3). The FSW panel showed significantly more distortion than the riveted panel, possibly due to the effects of the non-optimized FSW schedule employed and the simple anvil and clamping support system used.

Figure 3.   Photographs of riveted and friction stir welded skin-stiffener-test panels which exhibit panel warpage.

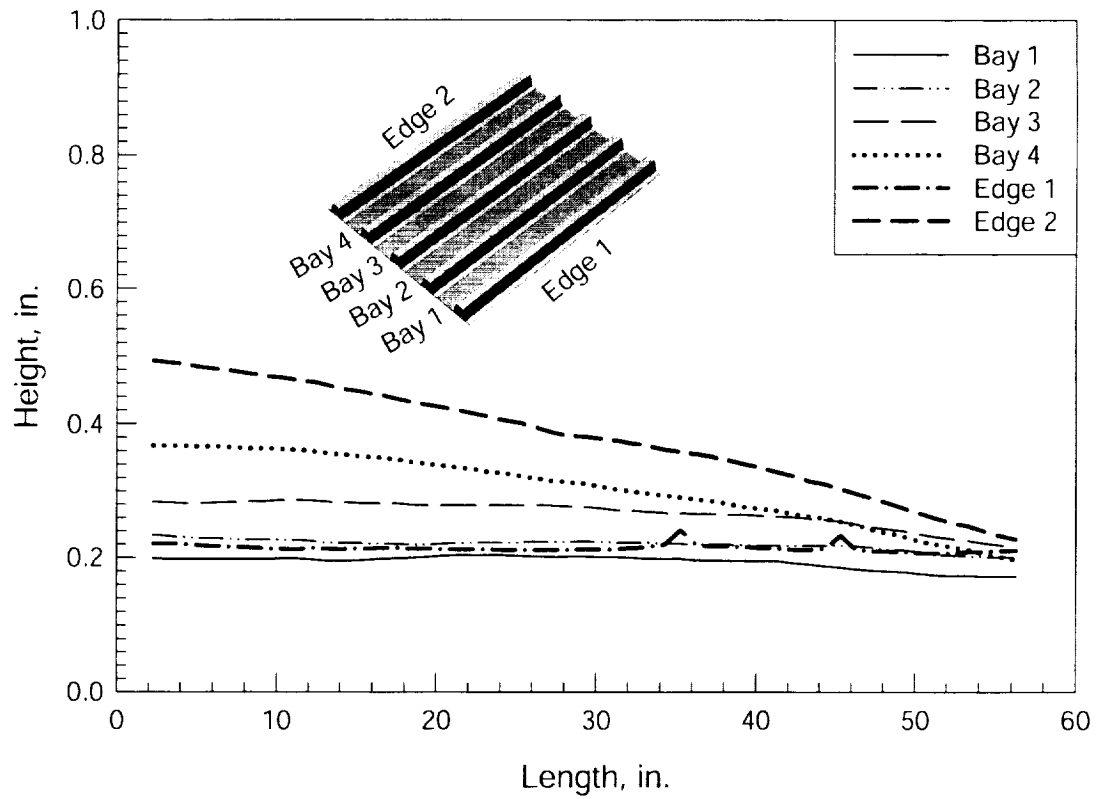
(a) Riveted panel.

Measurements of the panels were taken to determine the effectiveness of the strongbacks in flattening the panels. All measurements were conducted on a Brown and Sharpe 300 series automatic coordinate machine that uses a probe stylus for measurement. Relative height measurements were taken at fixed positions across the width of the panel corresponding to the bays between the stiffeners, stiffener caps, and edges at 1.0 - in. intervals along the length of the panel. After the incorporation of the strongbacks, the riveted and FSW panels still showed significant distortion along the panel length and width (Figure 6). Maximum out-of-plane distortion for the riveted panel was approximately 0.3 in. (Figure 6a) compared to 0.6 in. for the FSW panel (Figure 6b).

Figure 6.   Out-of-plane distortion of the riveted panel and the friction stir welded panel following strongback installation and potting.

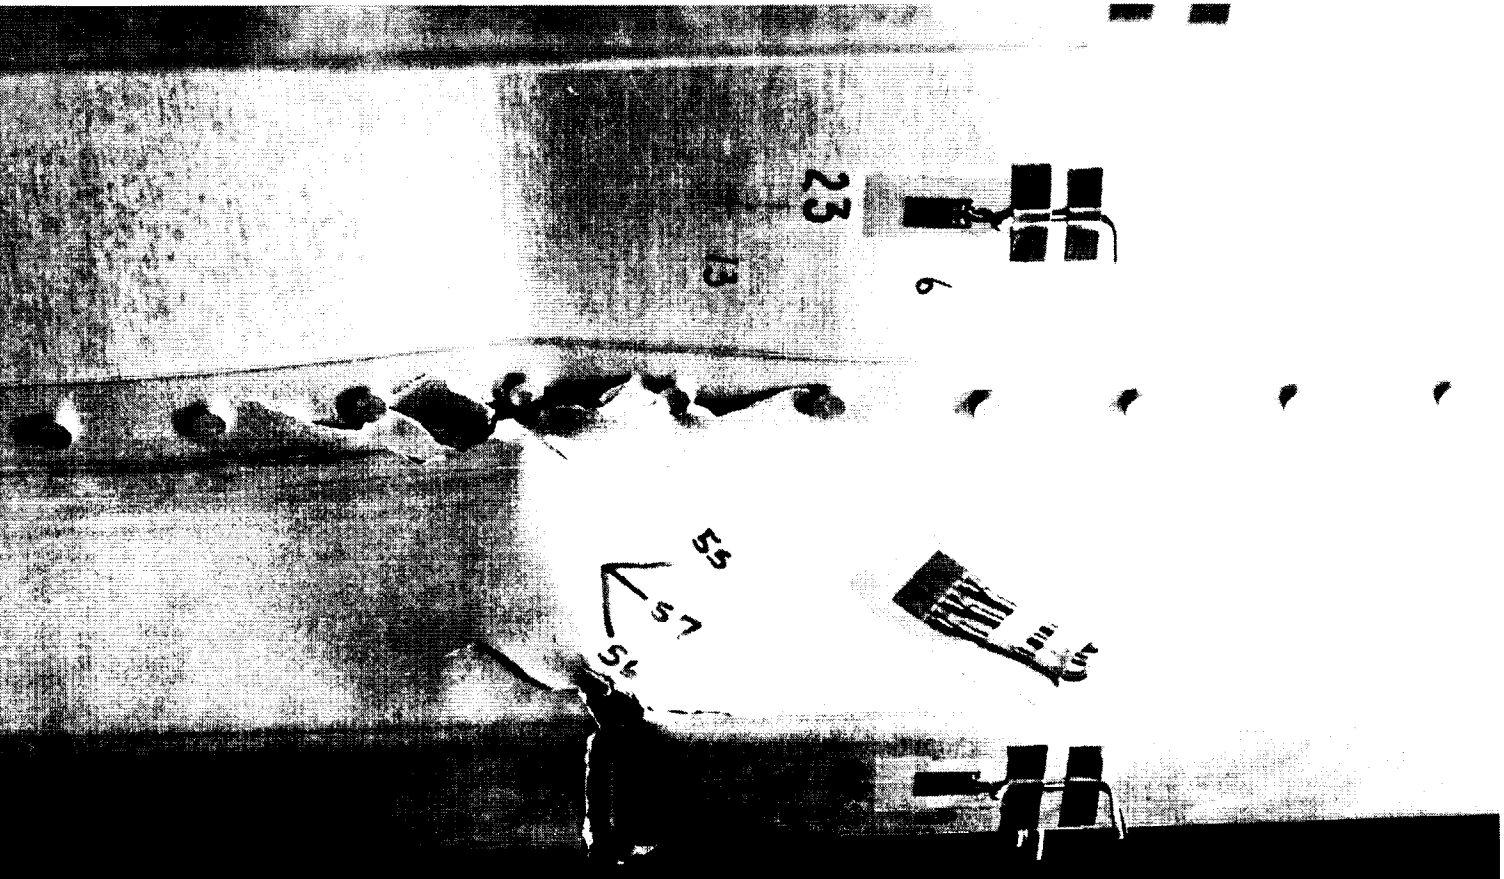
(a) Buckle at centerline of panel.

Buckling initiated in the skin between the stiffeners in both panels prior to failure. Once skin buckling occurred, additional load was forced into the stiffeners, resulting in added stress in the stiffeners and in the joint between the skin and the stiffener flanges. The riveted panel failed catastrophically with damage occurring across the entire width of the panel at approximately the centerline location as shown in Figure 18a. The riveted panel exhibited several failure mechanisms including rivet pull-out through the stiffener flanges, flange tearing between the rivets, permanent buckling deformation between the rivets, and fracture across the stiffener caps (Figure 18b).

Figure 18.   Buckled riveted panel.

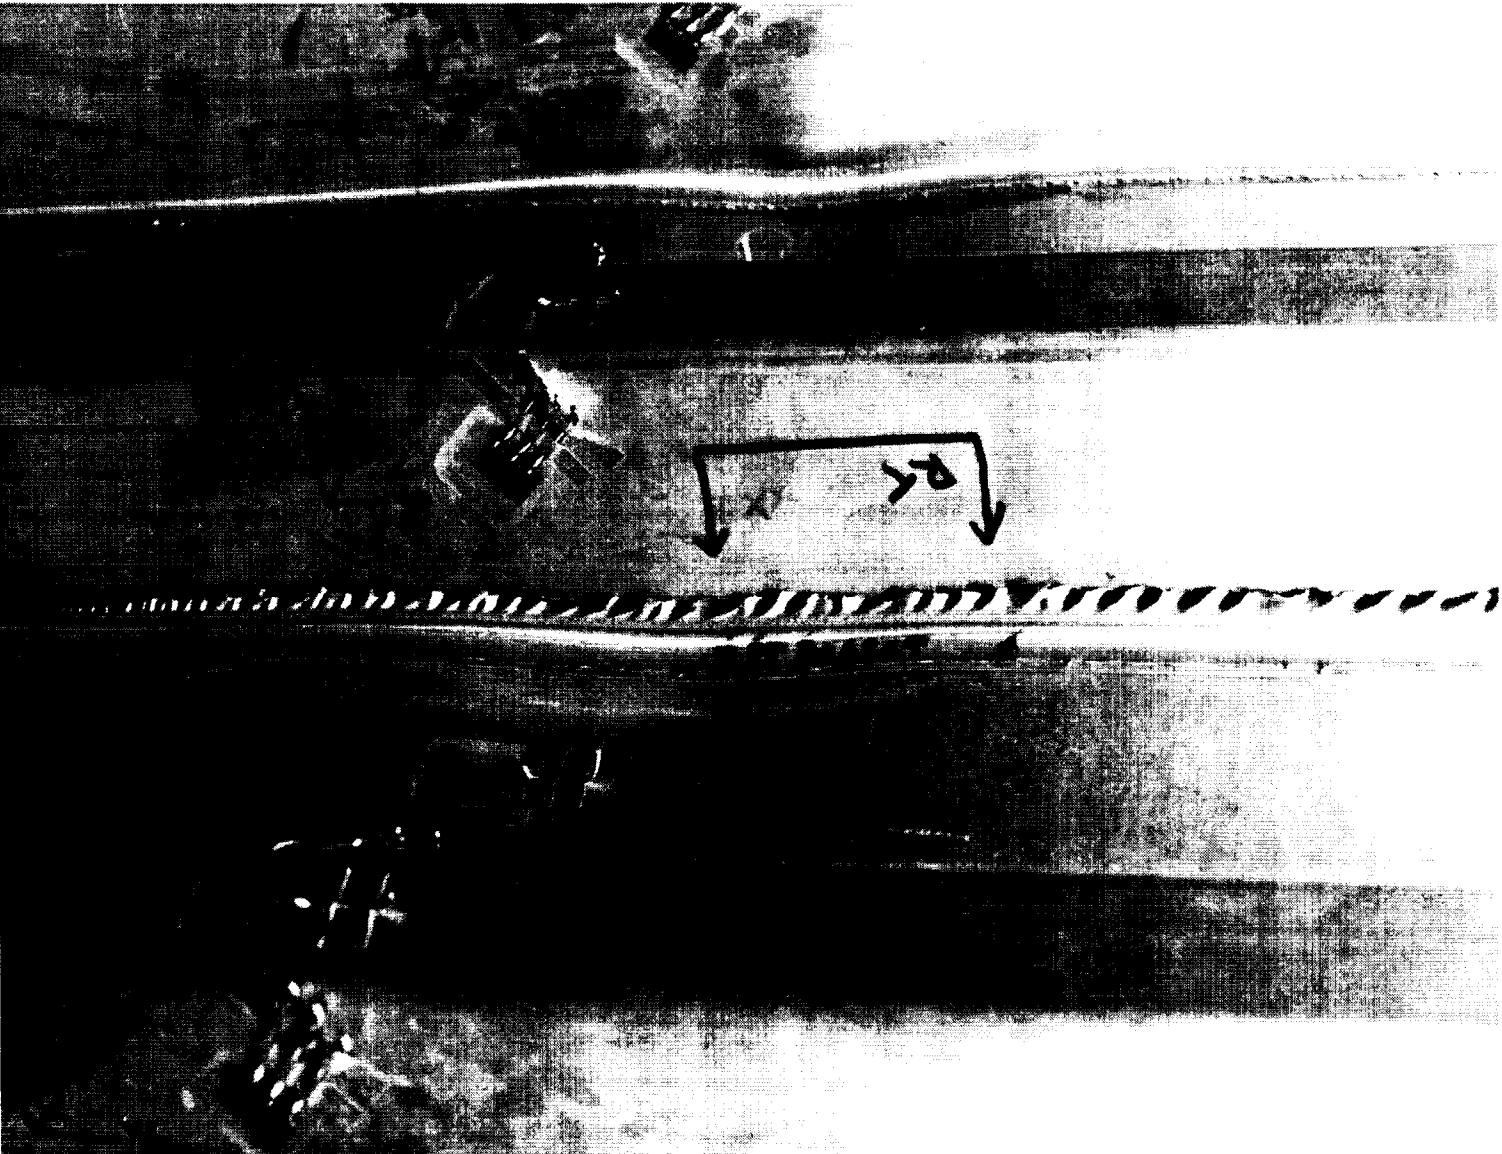
(b) Stiffener at centerline of panel showing stiffener failure at rivets and cap.
