# EVALUATION OF THE SPHERICAL FLANGE CONCEPT FOR A ROCKET ENGINE

Jay Nichols, Engineer, Space Transportation Directorate TD62
Philip Tygielski, Engineer, Space Transportation Directorate TD62
Marshall Space Flight Center, Huntsville, Alabama
Ronald Urquidi, Senior Principal Engineer, Rocketdyne Propulsion and Power, Boeing Corp.
Maynard L. Stangeland, Chief Designer, Rocketdyne Propulsion and Power, Boeing Corp.
6633 Canoga Ave., Canoga Park, California

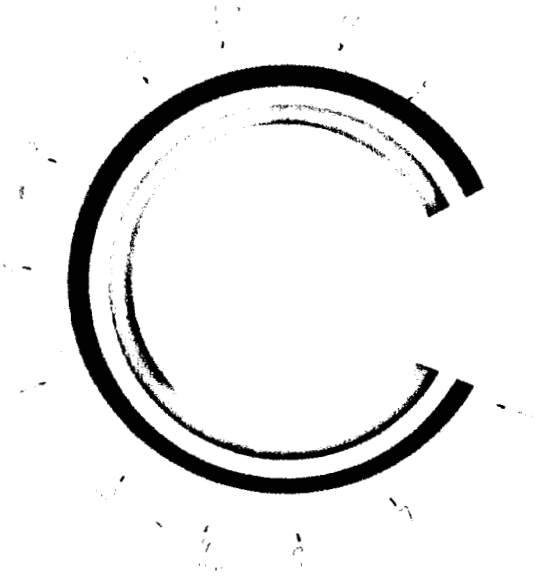
Zero Degree Misalignment
Torque 160 ft-lb.

The image of Figure 4 shows the contact region of the spherical flange halves. The white gap between the two circles is the seal gland region.

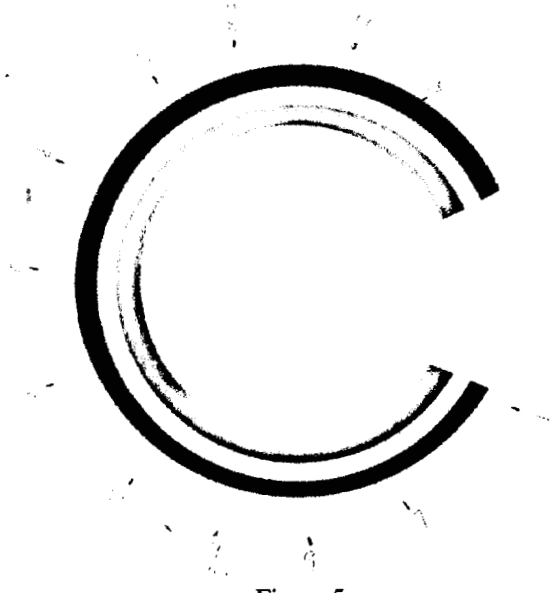
Figure 5

1 Degree Misalignment
Torque 160 ft-lb.

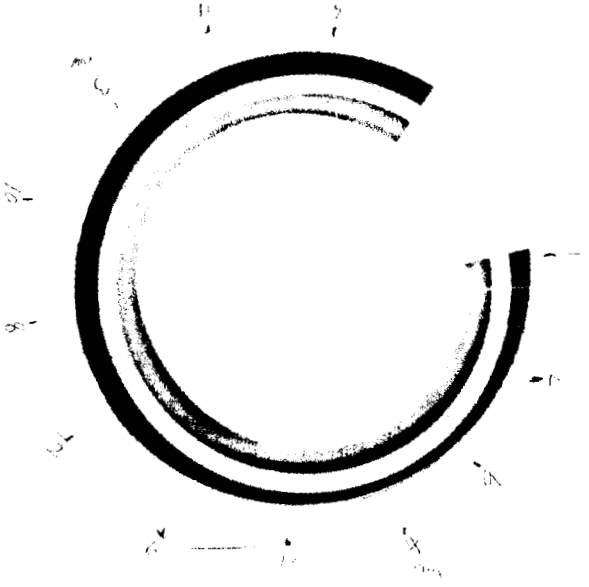
2 Degree Misalignment
Torque 160 ft-lb.
Figure 6

The results of the Fuji paper tests indicate the contact region made between the flange halves was subject to "flange roll". Flange roll is caused by the applied moment due to bolt torque. This torque induced flange distortion causes the inside heal of the flange to not make full contact. This phenomenon was verified by performing subsequent Fuji paper tests at bolt torques of 50, 80, 100, and 150 ft-lb. The visual indication of flange roll begins between 80 to 100 ft-lb bolt torque.

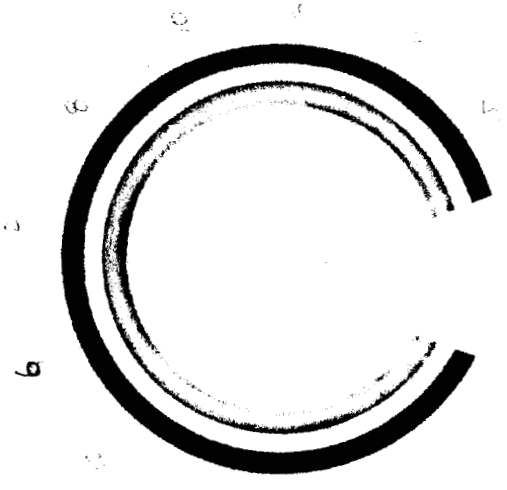
Figure 7
Zero Degree Misalignment

Zero Degree Misalignment
80 ft-lb Bolt Torque

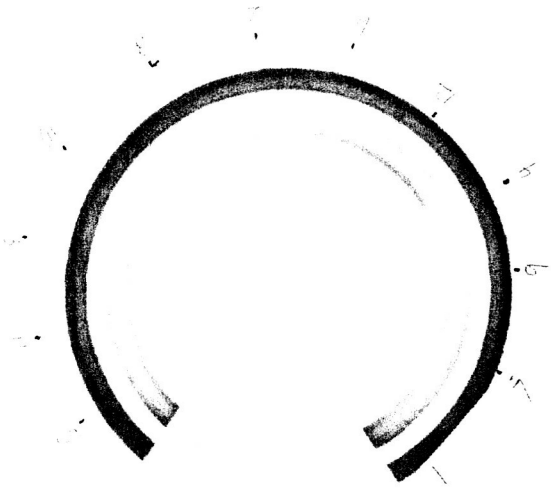
Figure 8

100 ft-lb Bolt Torque

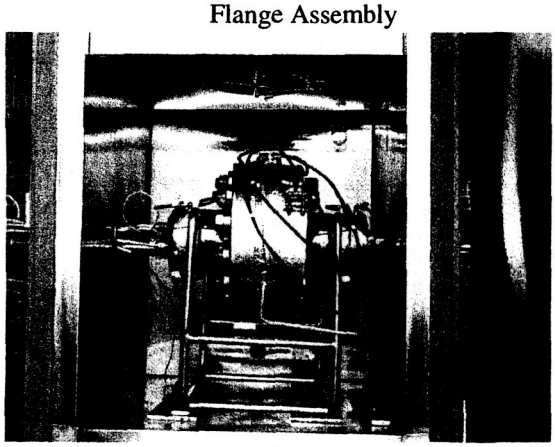
Figure 9

The flange design was tested to evaluate and compare performance parameters such as misalignment and leakage. The environmental conditions ranged from –100 to +400 degrees Fahrenheit (°F) and with 1000 to 4000 pounds per square inch gage (psig) pressure. The spherical flange half containing the seal grove was modified with an intentional groove flaw to insure leakage measurements were obtained for the seal only. This flaw made any leak protection from metal to metal contact of the spherical surfaces impossible. The assembly and testing of the spherical flange hardware was performed at building 4656 in the Component Development Area (CDA) of MSFC. A thermal chamber was used to maintain environmental temperature and band heaters were used to facilitate the direct heating of the flange assembly (see Figure 9).

Flange Assembly

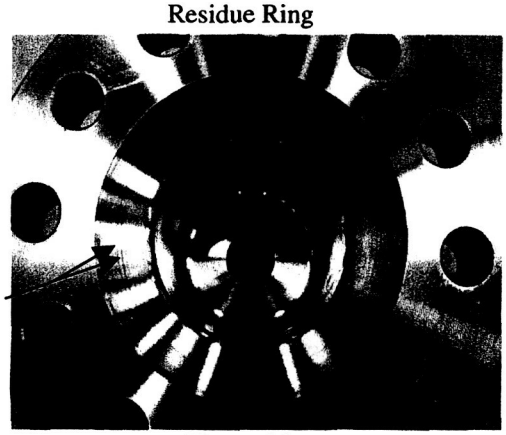
Figure 11

The flange surface was marked with what appeared to be residue rings at the contact point of the seal to flanges (see Figure 11).

Residue Ring

The surface marks on the spherical flange were analyzed using the profilometer, which had been calibrated to remove the surface curvature. The results indicated the surface marks caused by fretting to be a depth of 0.08 thousands of an inch (mils) from the average surface. This had essentially no effect on the surface finish value. The bars on the profilometer graph represent the region corresponding to the surface mark.
