Goddard Space
Flight Center

Beam Steering Mechanism (BSM) Lessons Learned

Proceedings of the 43rd Aerospace Mechanisms Symposium
NASA Ames Research Center
May 4-6, 2016

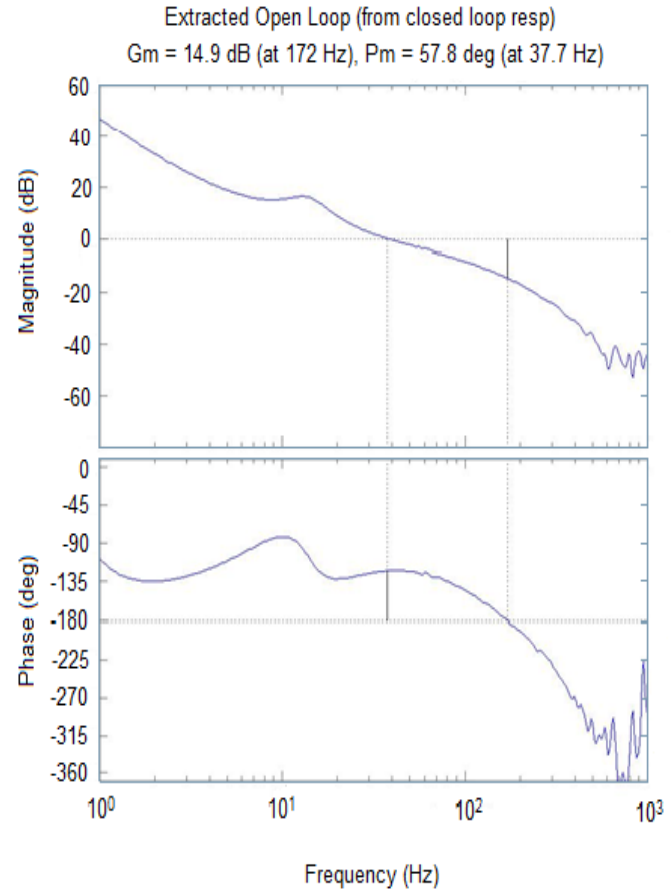
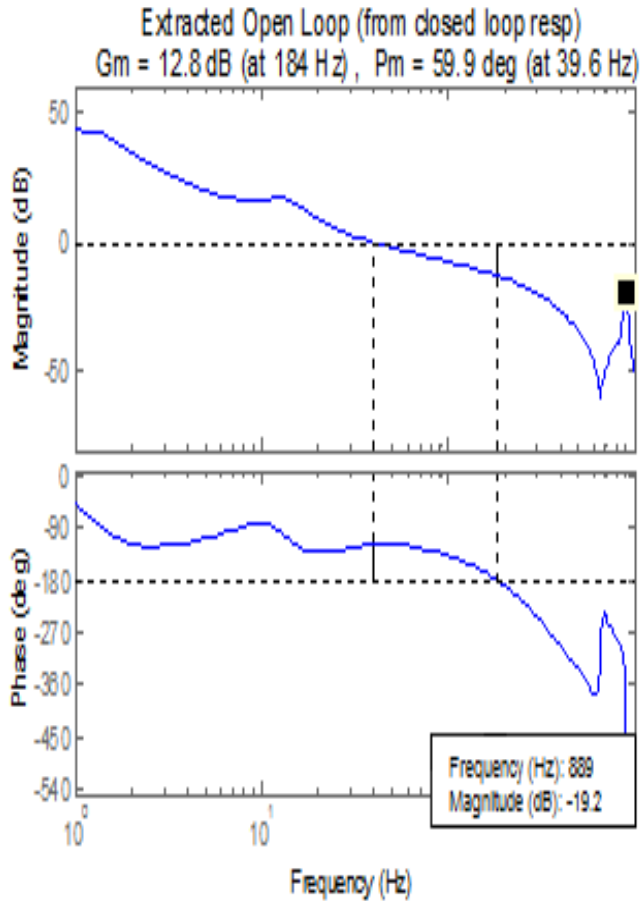
# Before/After Balance Shaft Replacement

- Measurement of the frequency response revealed a very undesirable structural mode near 900 Hz.

- Using FEM modal analysis, we were unable to determine the source of this very troubling behavior.

- It was theorized that the counterweight shaft was lacking stiffness, so a ribbed shaft was designed and fabricated.

- A brute force approach was utilized by replacing components.

- The stiffer shaft solved the problem.

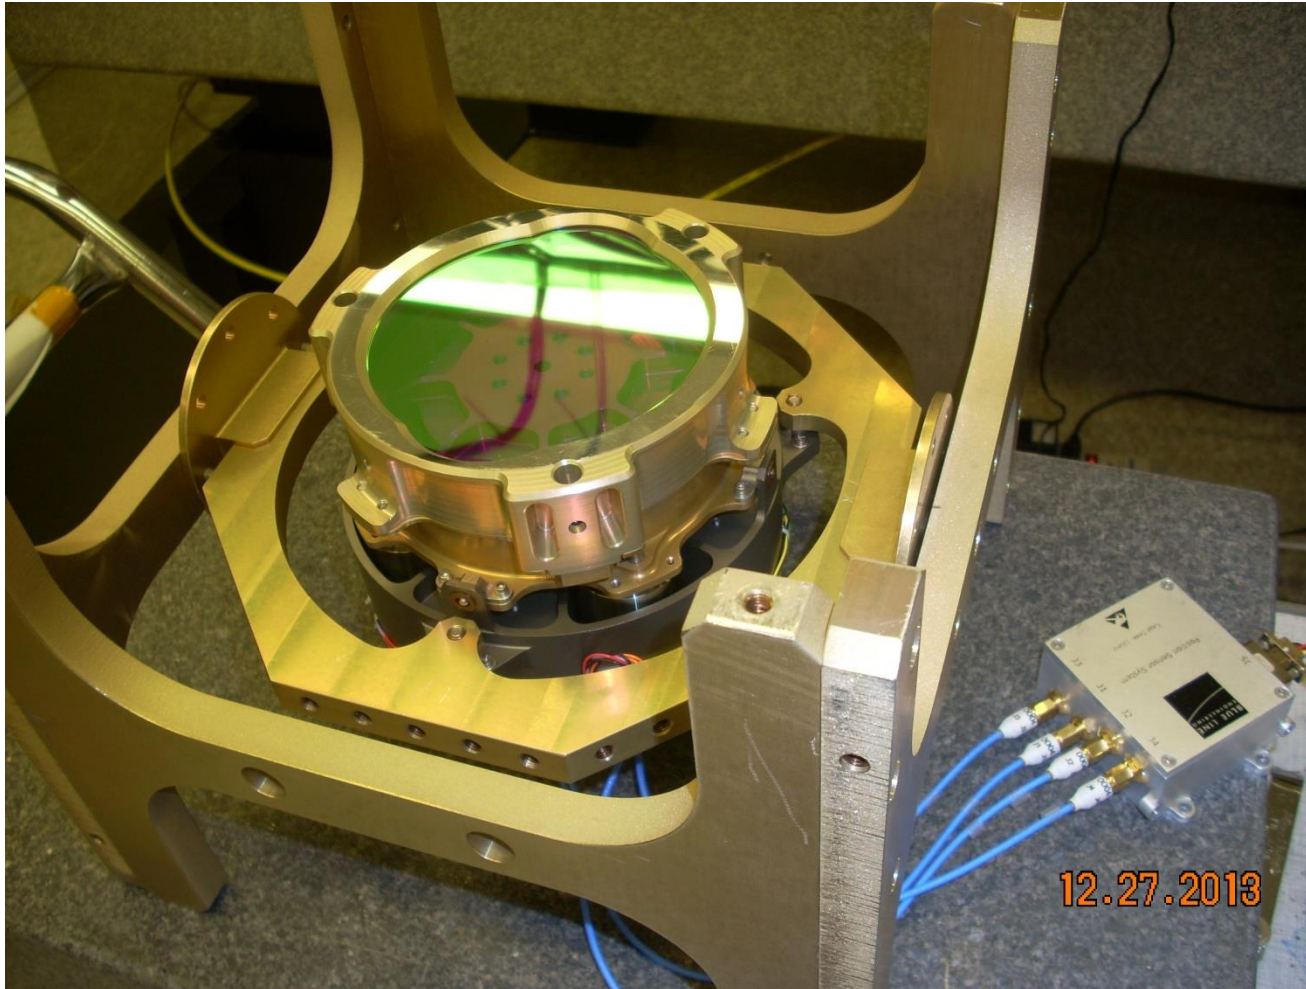
BSM FM in the 6-Axis Balancing Fixture

- Mirror motions from Point A to Point B resulted in passing the target and circling back at greater magnitudes than previously observed.

- Controls engineers believed there to be a balance problem

- Balancing was achieved by using a balance fixture to change the gravity vector by 180 degrees; then the counterweight was adjusted such that minimal motion occurs upon 180 degree gravity vector changes .

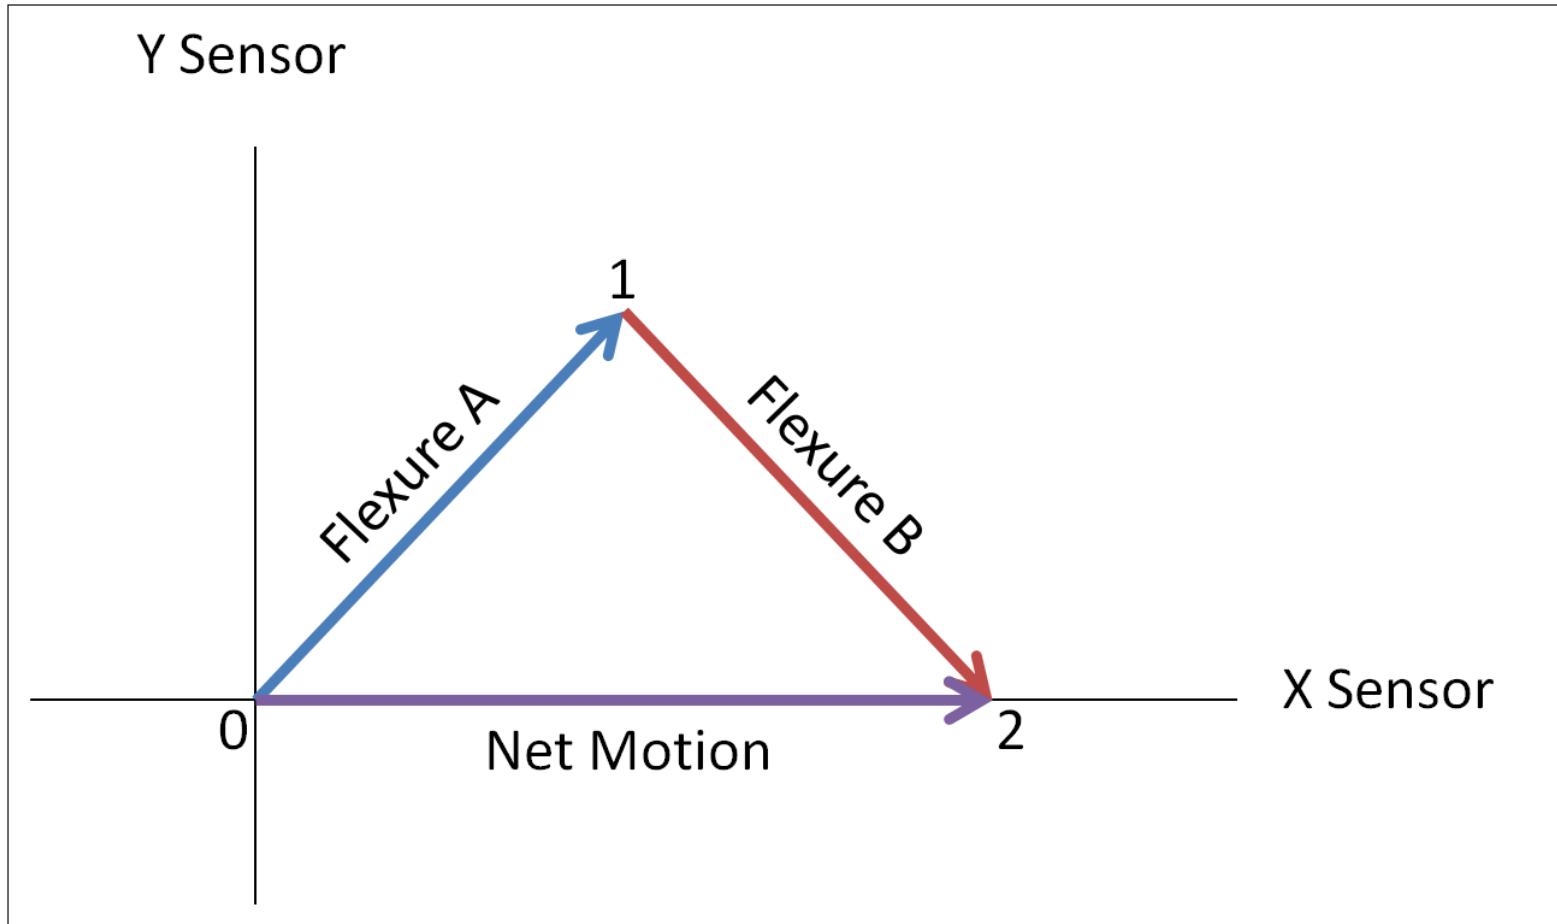
Imbalance Phenomena Graphic

- It so happened that the flexure axes were rotated 45 degrees from the sensor axes.

- If the two flexure axes do not have their rotation axes located in the same place, the counterweight can balance one or the other flexure axis, or find a compromise.

- In this case, one flexure axis was balanced mirror light and the other flexure axis equally balanced mirror heavy, resulting in horizontal motion.

- The problem was in the manufacturing tolerance of the flexure being out of spec, resulting in a 9 mil (0.009 inch) separation of rotation axes.

- We suffered a painful schedule slip to await flexure remanufacture, integrate into the Flight Model hardware, and repeat performance testing.

- It turned out that we had previously used our best flexure for vibe/life testing, so we needed to remanufacture as good or better for the Flight Model, which was achieved.
