Origins of line defects in self-reacting friction stir welds and their impact on weld quality

Judy Schneider, Professor
University of Alabama in Huntsville, Huntsville, Al 35899

Arthur C. Nunes, Jr., Weld Theoretician
NASA, Marshall Space Flight Center, Al 35812

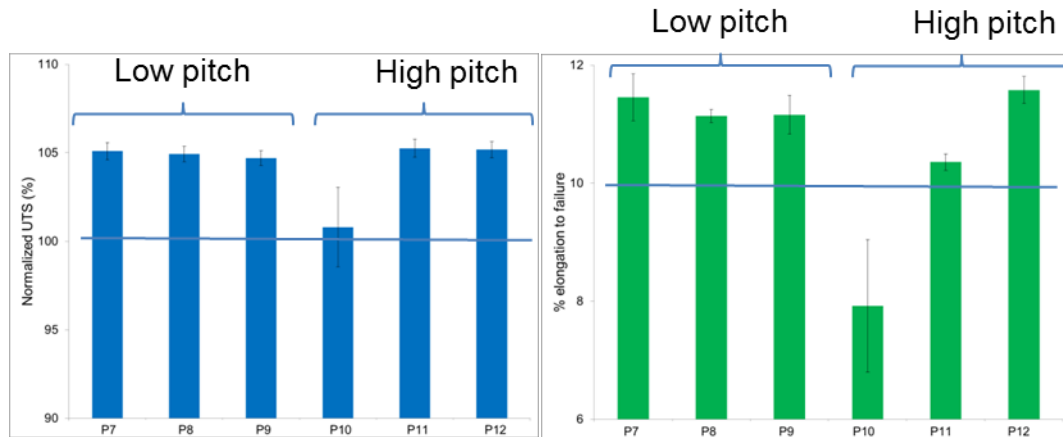
Only one of the butt welded panels displayed reduced UTS and elongation to failure at the higher weld pitch. A similar reduction in strength was observed for BOP 3, which was run at the same SR-FSW process parameters as 625-P10.   Overall the differences in the properties between the butt weld and the BOP SR-FSWs could be attributed to the difference in weld length. The butt weld was 61 cm long vs the 18 cm long BOP. Both the butt weld and the BOP weld showed reduced UTS at the higher weld pitch. Thus the faying surfaces of the weld seam are not solely responsible for reduced properties.

Figure 4. Summary of the normalized UTS (a) and % elongation to failure (b) of the 1.59 cm thick SR-FSW panels tested at RT.

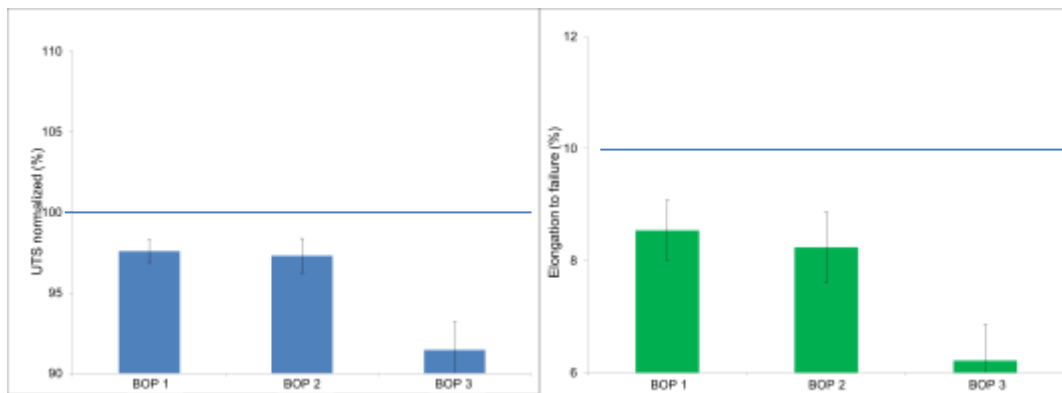
Figure 5. Summary of the normalized UTS (a) and % elongation to failure (b) of the 1.59 cm thick SR-FSW BOP panels tested at RT.

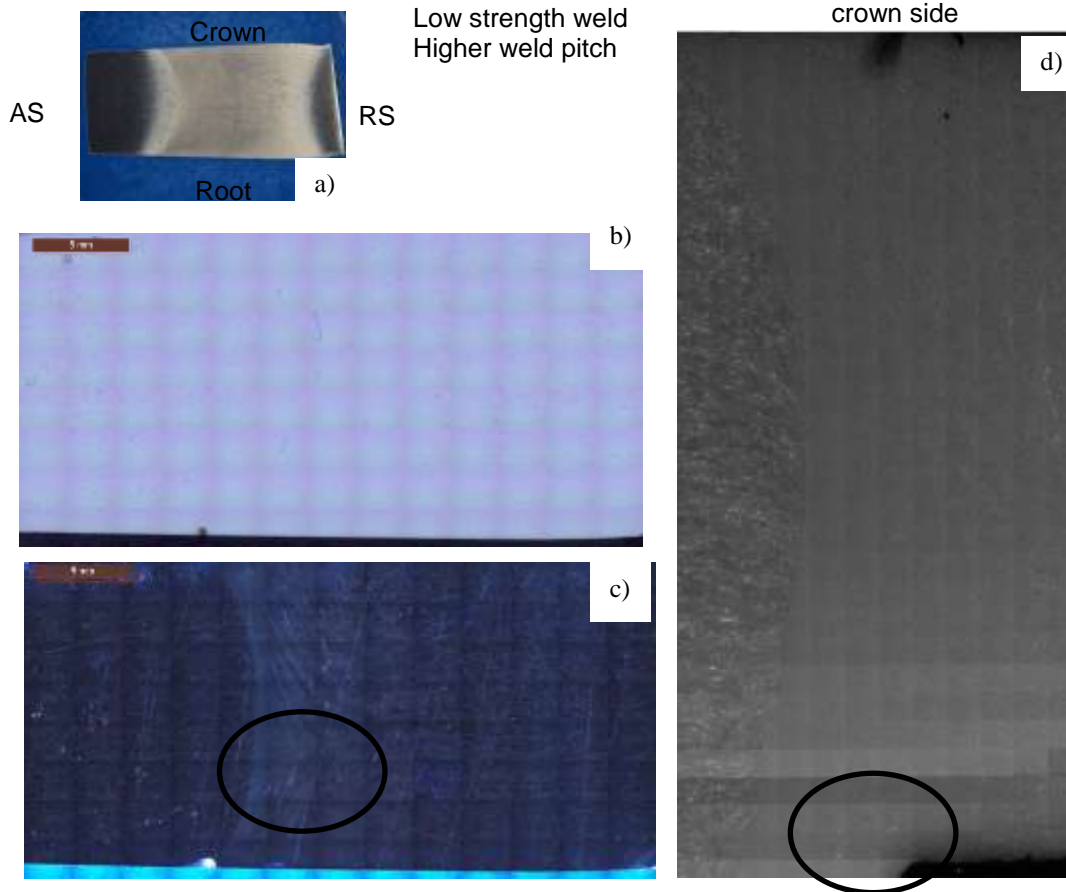
An overall photograph of the transverse section of the etched weld is shown in Figure 6a. Image montages were made of the specimen in the unetched condition to show the location of line features. Montages were made of the specimen using bright field (Figure 6b) and dark field (Figure 6c). Various line features were found and are highlighted on Figure 6b and 6c. This area was marked with carbon tape and a corresponding BSI montage was made in the SEM and is shown in Figure 6d. These line features were common to all the SR-FSWs made in this study.

Figure 6. Optical images of the unetched metallographic of specimen 650-P10. This specimen was welded at the higher weld pitch and displayed the lowest UTS and ductility. An overall photograph of the transverse section of the weld is shown (a). Montages were made of the specimen using bright field (b) and dark field (c). Identified regions (shown in circle on (c) were imaged in the SEM and a montage is shown of this region (d).

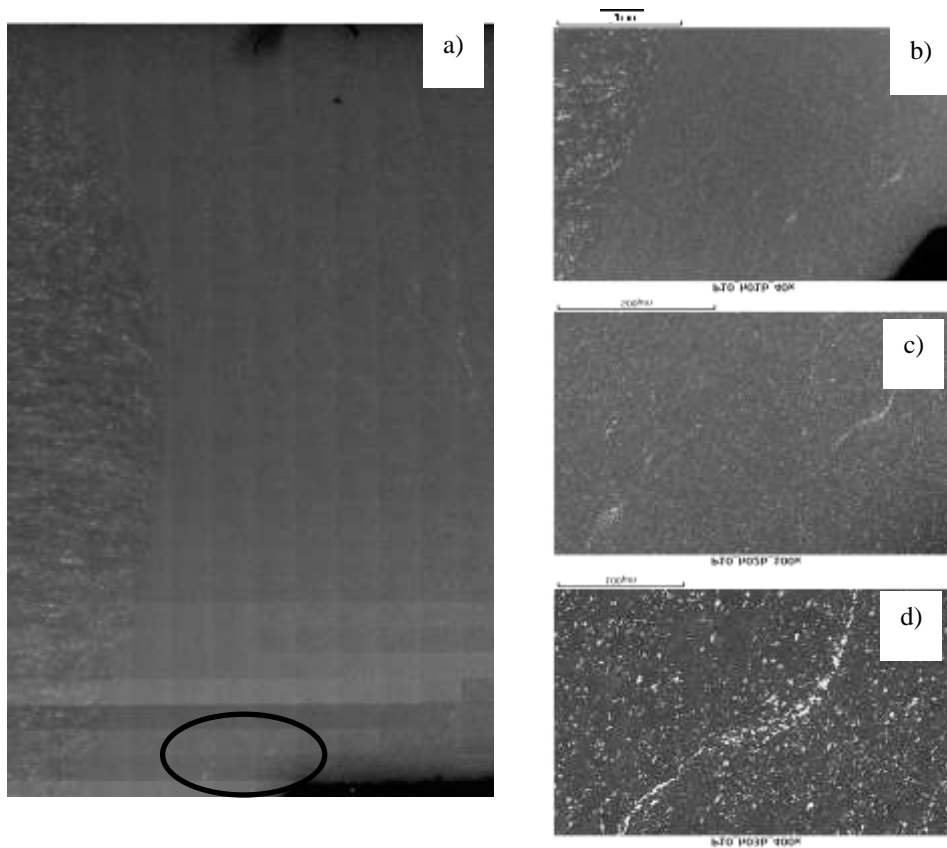
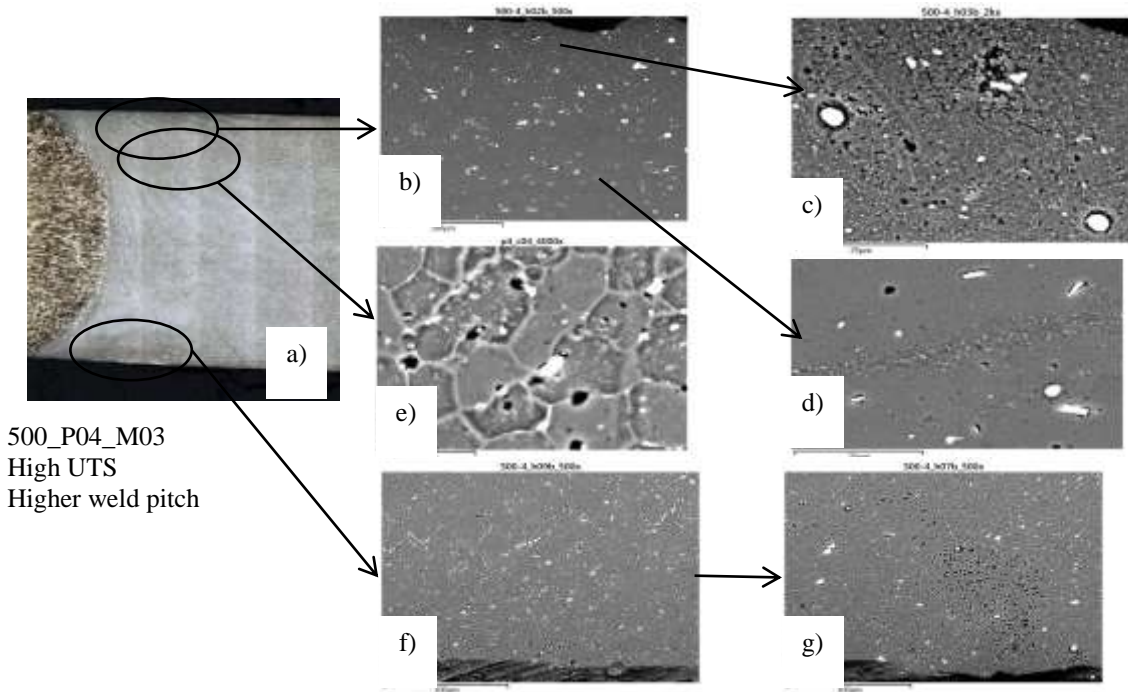
Figure 7 shows higher magnification SEM BSI of the region of the unetched metallographic specimen circled in Figure 6d. The white regions observed are Cu rich (30 to 35 wt%). The Cu rich regions also showed slight amounts of Mn (1-2 wt%) and Fe (4 to 6 wt%). EDS analysis showed no appreciable indication of oxides present (0.5 to 0.6 wt%) in any of the regions.

Figure 7. SEM of the unetched metallographic BS image of specimen 650-P10 (a). This specimen was welded at the higher weld pitch and displayed the lowest UTS and ductility. The white regions are Cu rich with negligible indication of oxides present. (b-d) show magnifications of the region circled in (a).

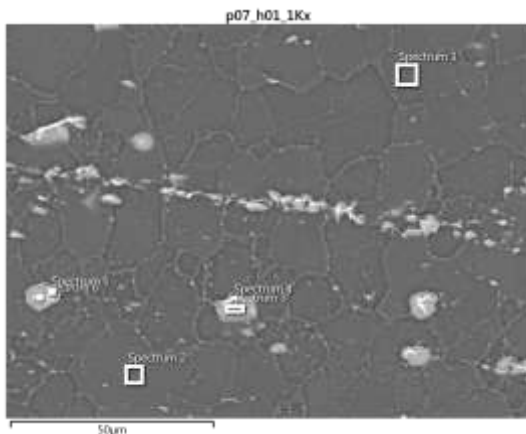
Figure 11 shows additional images from specimen 625-P07 in which Cu particles are aligned within the weld nugget, presumable along shear bands from the SR-FSW process. Most noteworthy on these Cu particles are the features within them which resemble the forehead of a Klingon. The light regions have a high concentration of Cu (42-45 wt%) with 1-2 wt% of oxygen. A similar amount of Mn and Fe are noted as in the areas in Figure 7 and 8, but there now appears Sb (2-3 wt%). The lighter region surrounding the bright Cu particle has approximately 34 wt% Cu with minor 0.5 wt% oxygen and none of the trace elements (Mn, Fe, Sb). The Cu rich regions are approximately 7 μm in diameter.

Figure 11. Cu rich bands in weld nugget of specimen 625-P07. This specimen was butt welded at the lower weld pitch in 1.59 cm thick panels.

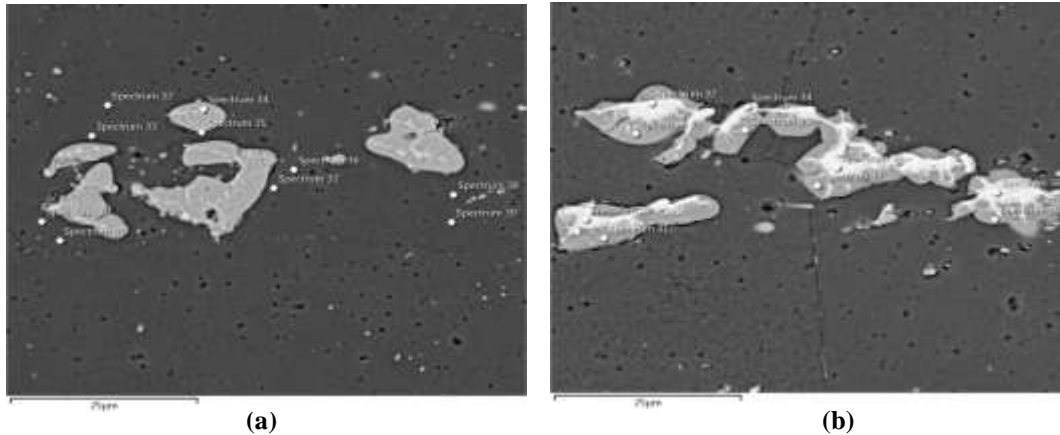
For comparison, Figure 12 shows the Cu rich regions in the parent material used in 2015 welds vs 2016 welds. The morphology and elemental content is similar to that shown in Figure 11 for the refined Cu rich region in the FSW nugget. Figure 12b shows larger light regions which correspond to the θ phase. This area is surrounded by a slightly lower concentration of Cu which corresponds to the eutectic composition.

Figure 12. SEM BSI of Cu rich regions in the parent material from SR-FSWs made in 2015 with an average size of 10 μm (a) and in in 2016 with an average size of 20 x 7 μm.

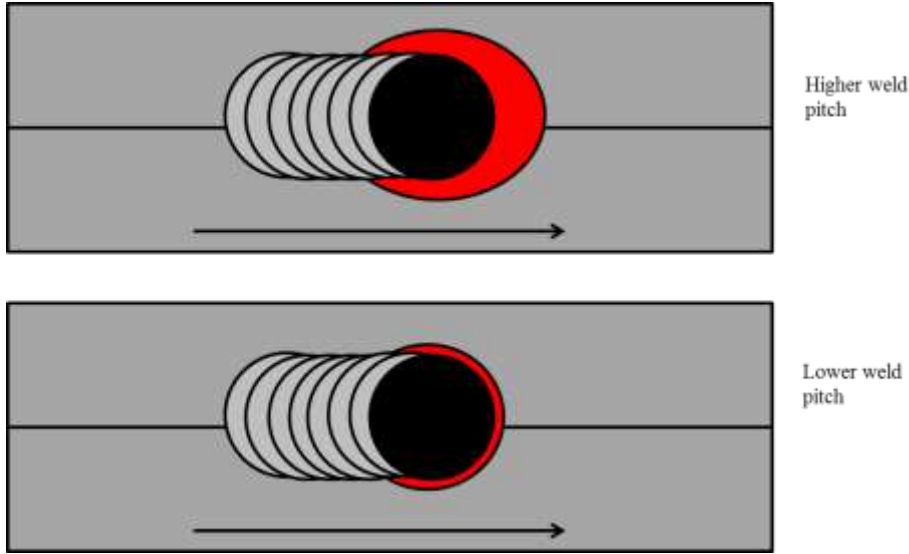
Additionally at higher weld pitches, the heat profile may extend outside the shoulder envelope as shown in Figure 14a. This would expose high temperature surface material to air promoting oxidation. Under lower weld pitch, the heat profile maybe kept within the shoulder envelope as shown in Figure 14b. This would reduce the potential for surface oxidation during the SR-FSW.

Figure 14. At higher weld pitch, the heat profile extends past the tool shoulder (a) while at lower weld pitch, it is possible to keep the heat profile within the tool shoulder envelop.
