Liquid Nitrogen Bulk Storage Maintenance

September 19, 2016

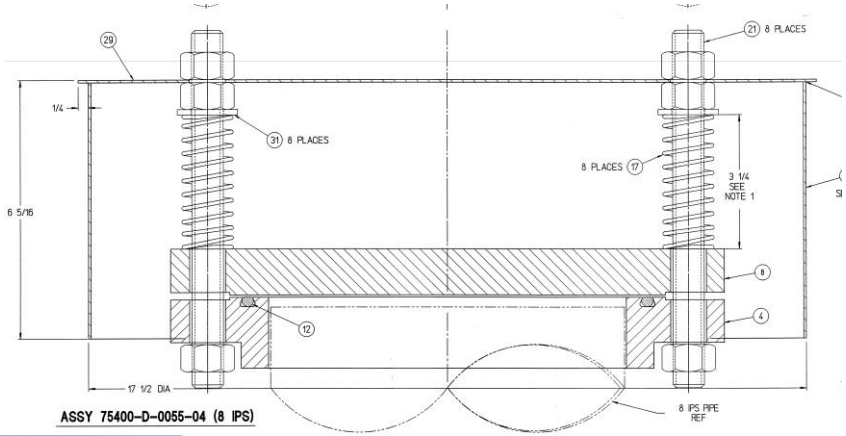
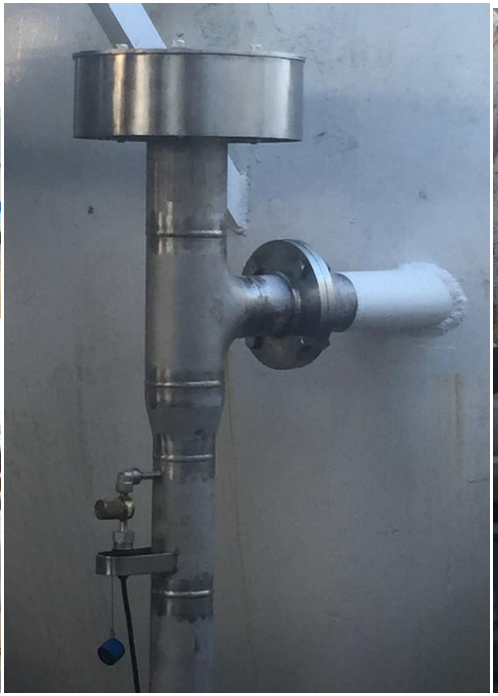
- Relief devices replaced (2 tanks).

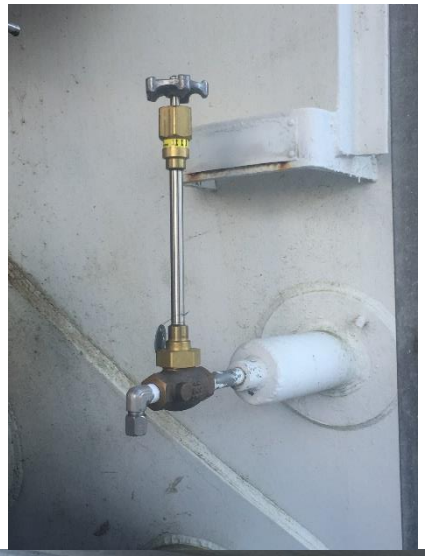
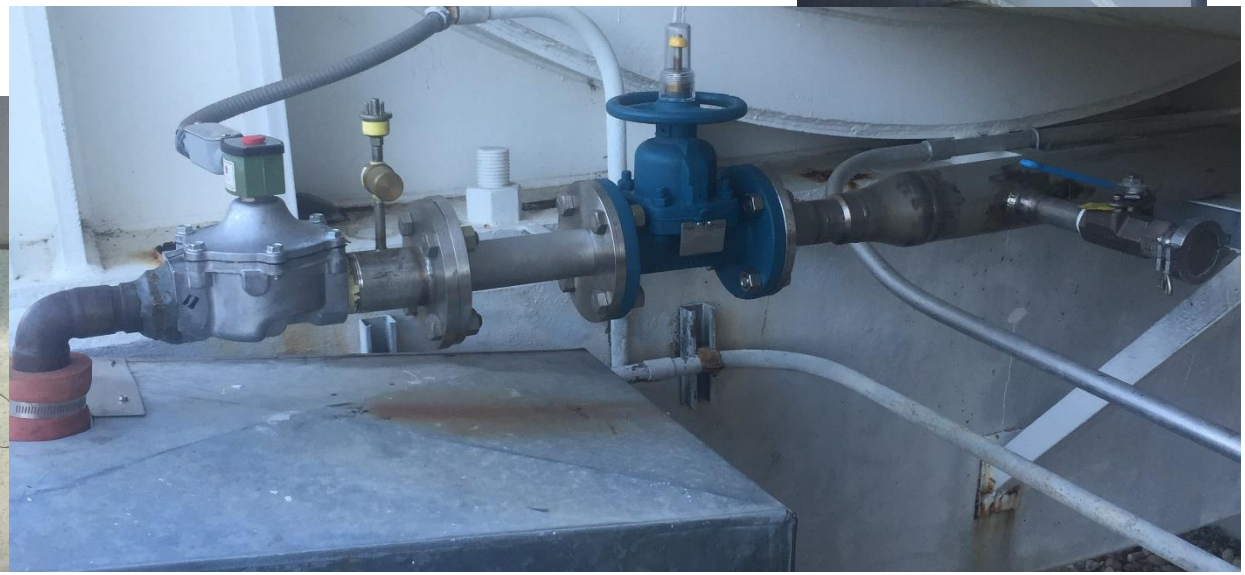
- Replaced non-vacuum valves on various ports
- Added new vacuum sensor ports
- Capped/sealed extraneous ports
- Replaced manual vacuum isolation valves
- Replaced solenoid vacuum isolation valves
