Analysis of WFPC-2 Core Samples for MMOD Discrimination

P. Anz-Meador [1], L. Le [1], M. Ward [1], K. Thomas-Keprta [2], and D.K. Ross [3]

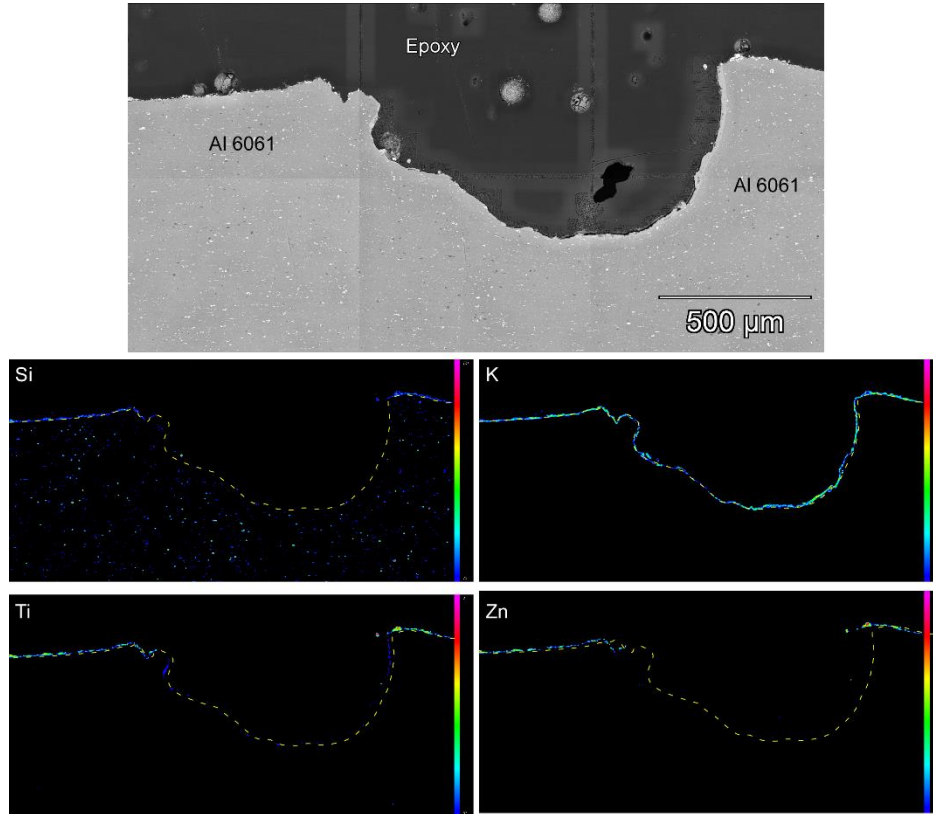
Fig. 3. *Upper*: FESEM/LABE image mosaic of the lateral surface of the cut core from crater A, core 471. *Lower*: Element X-ray mosaic maps for Si, potassium (K), Ti and Zn. Regions enriched in Si and K are binder and regions enriched in Ti and Zn are composed of paint. Potassium-rich regions not associated with Si are interpreted as potassium hydrogen carbonate. Yellow dash lines indicate the location of the edge of the Al 6061 matrix.

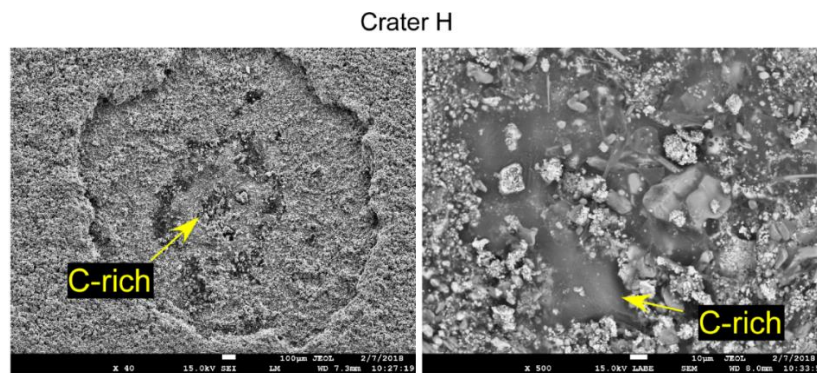
Fig. 4. FESEM/LABE images of Crater H. A low magnification (40X) image is shown at left with higher magnification (500X) image at the right. Locations of C-rich matter are noted for both. Visible in the left image is the entire spallation zone surrounding the central crater feature and the "walls" denoting the remnant paint layer.

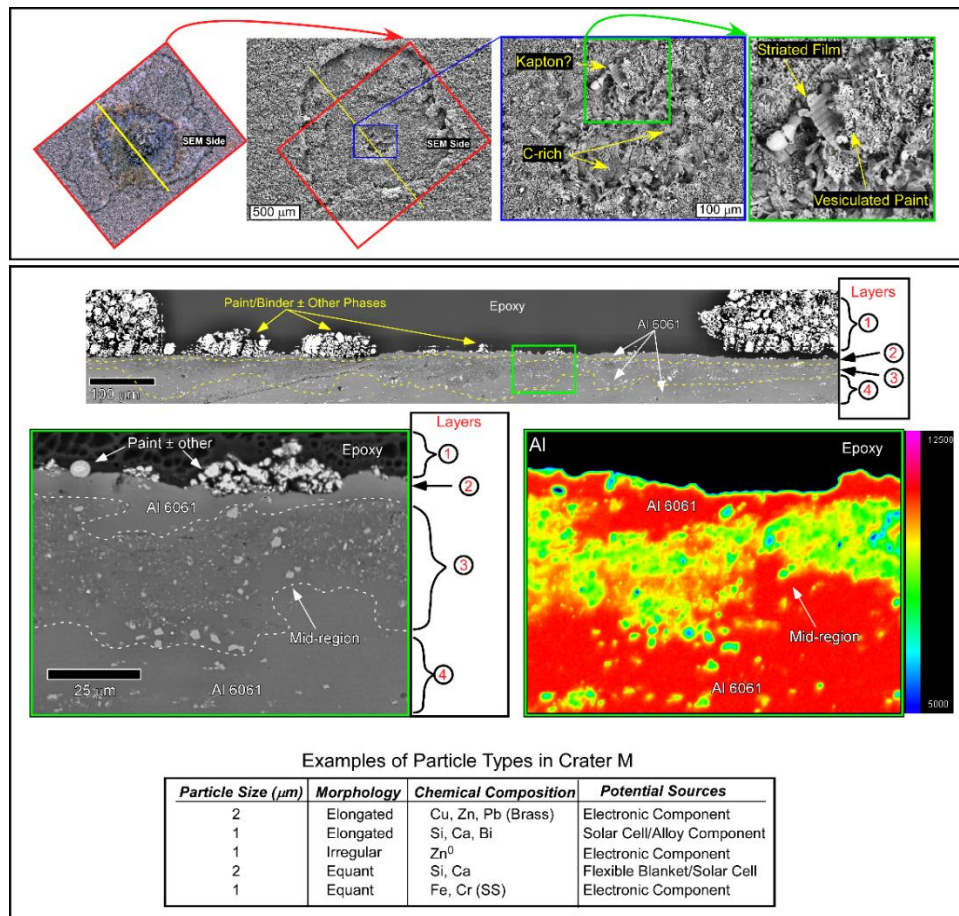
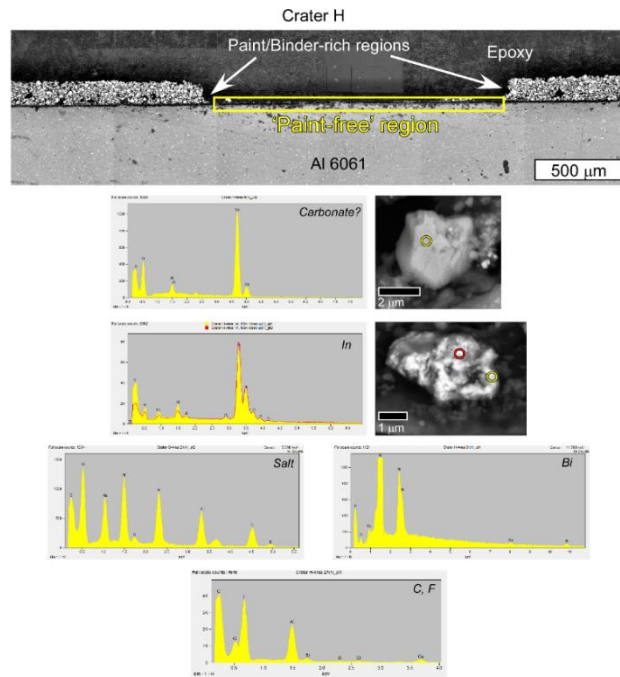
view and the Al element map. The overview image of Crater M suggests a compound crater composed of multiple distinct, local depressions with a relatively flat geometry. Such craters are typical for aggregate particles in which dense components/minerals float in a friable and much less dense matrix. The detailed mass distribution of such an aggregate manifests itself in a compound crater morphology. If one accepts this interpretation, melts from neighboring depressions can overlap with each other to form layers 2 and 3—specifically layer 3 ('mid region') —a mixture of projectile and target-derived melts with Al being the dominant element. Interestingly, this outcome is consistent with internal hydrocode studies conducted in 2010. In this study, stainless steel (SS) projectile material was entrained in Kelvin-Helmholtz instabilities that form as the denser SS impacts the less dense Al target material. Particles located at the epoxy/layer 1 interface and within layer 3 in Crater M (Fig. 5) include brass (Cu/Zn), bismuth (Bi), Zn, and SS (Fe, Cr). The latter particle type (SS) displayed a composition different from that of the SS particles embedded within the Al 6061 matrix, as they did not contain detectable copper.

Fig. 5. Sample M imaged as a complete crater and after sectioning. ***Upper Box***, <u>*Left to right*</u>: Optical view of crater M with the Line of Interest/cut line in yellow. Location of the region outlined by the red box is shown in the FESEM/LABE view at right. Cut line (yellow) is also noted in this view. The region in the blue box is magnified at right and highlights the central crater depression. Locations of carbon-rich regions and a piece of film, possible Kapton, are noted. The region in the green box shows a magnified view of striated film with one edge embedded in vesiculated paint/binder. ***Lower Box***, *Top to Bottom:* FESEM/LABE image of a region of the polished section produced from crater M. Region in the green box is magnified in the lower left image. *Lower left*: High magnification of the region highlighted by the green rectangle in the upper view. An increase in particle density is seen in the 'Mid region' layer compared to layers 2 and 4. *Lower right*: EDX Al element map is shown for the region outlined by the green rectangle in the view at left. A decrease in Al concentration is seen in the 'mid-region' layer due to the increase in particle density. The table provides chemical composition and possible sources for particles associated with the crater M impactor.
