FINAL REPORT

BEARING RETAINER MATERIALS DEVELOPMENT

NERVA Program Contract SNP-1 MASTER

October 1969

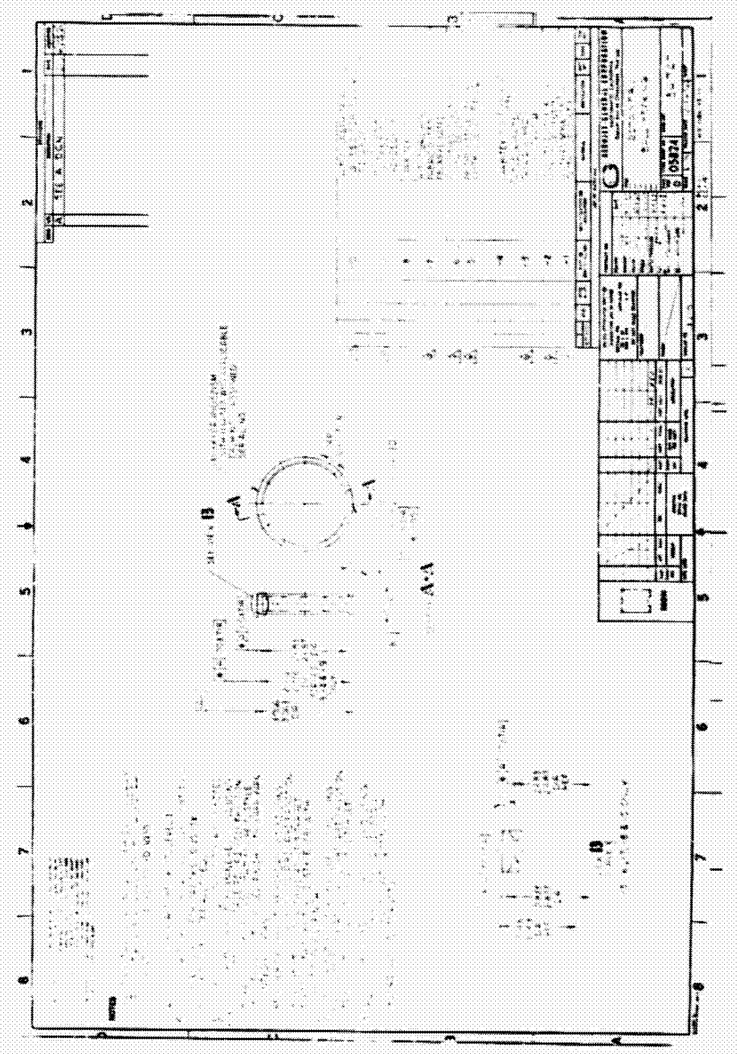
Figure 1 - AGC Drawing 1134747 - Ball-Bearing Retainer

Figure 2 - AGC Drawing 1118584 - Ball-Bearing Retainer

This test was the first to utilize an improved thrust-bearing retainer design, P/N 1134747, (see Figure 1). This configuration was necessitated by several problems noted in tests of the earlier configuration, P/N 1118584 (see Figure 2), wherein it was noted that ball-retainer contact was concentrated at the retainer ID resulting in both point and line loading and excessive wear. Measurement of reinforced PI and PBI thermal expansion indicated that these materials had greatly reduced coefficients of thermal expansion in the -423°F to room temperature range, as compared with those of the reinforced fluorocarbon materials which served as models for the P/N 1118584 configuration. Consequently, the new configuration had a smaller ID (2.685 as compared with 2.875-in.), enabling positive ball-to-retainer-pocket contact and, theoretically, preventing the high rate of edge wear noted earlier.

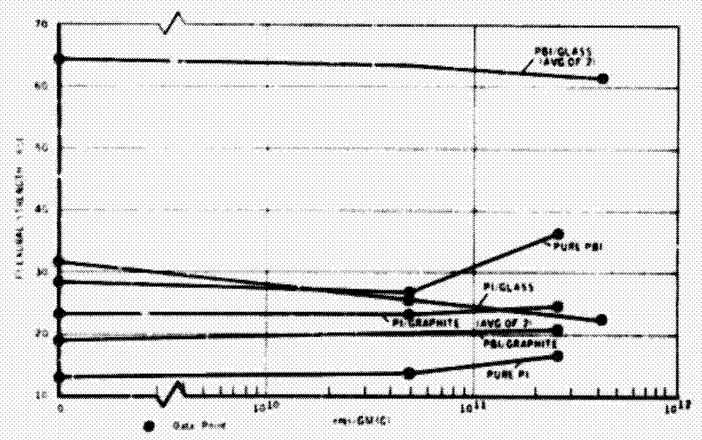
As shown in Figures 4 and 5, degradation was not observed in GTR-20A and the damage threshold appears to be at an unrealistically high dose, compared with bearing-retainer dose levels expected at the NERVA turbopump.

An anomaly was observed in tests of glass-reinforced PI. Because of excessive specimen thickness, this material failed in a mixed tension-shear mode during control tests, attaining an average strength of approximately 31 ksi.

Irradiation apparently strengthened the reinforcement sufficiently to cause failure at the fiber-matrix bond in horizontal shear at a characteristically lower stress of approximately 25 ksi. This failure mode resulted in the absence of outer fiber breaks and was manifested by delamination in the neutral axis area and buckling at the compression side of the specimens. In view of the upward flexural strength trend in both the pure PI and graphite-reinforced PI (as shown in Figure 4), the observed trend in glass-reinforced PI was not attributed to irradiation degradation.

Figure 4 - Effect of Gamma Radiation on Flexure Strength of Retainer Materials (Average of Three Except Where Noted)

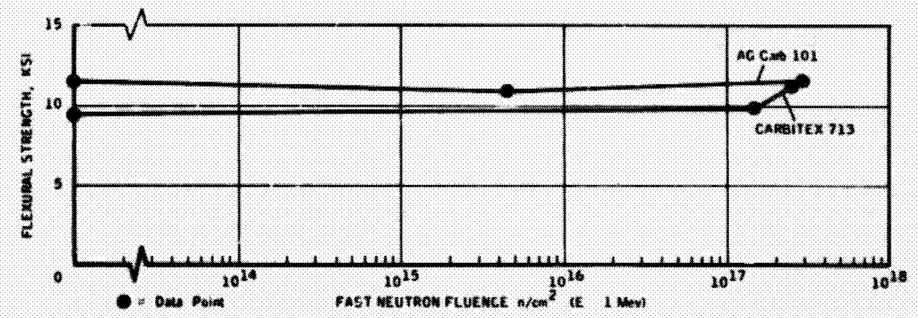
Both graphite materials, Carbitex and AGCarb-101, exhibited strengthening, as would be expected at these relatively low-neutron dose levels (see Figures 6 and 7).

Figure 6 - Effect of Fast-Neutron Fluence on Flexural Modulus of Graphite Bearing-Retainer Materials (Average of Three)

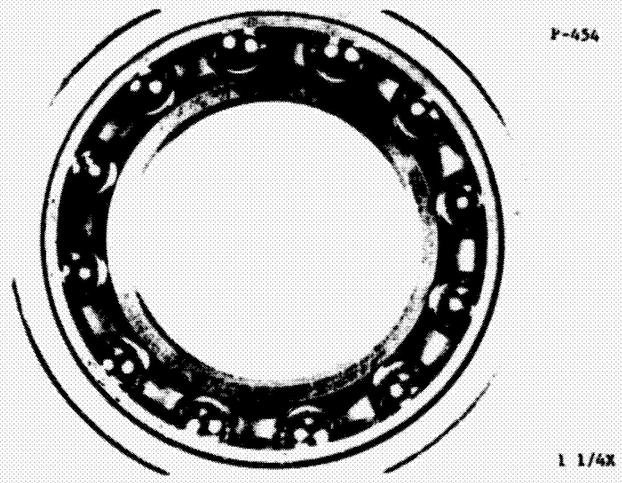
The tester ran smoothly at amperages varying from 30 to 40. As the test progressed, amperage declined to the 28 to 32 range. After operating satisfactorily for 3 hr, the test was terminated. Disassembly of the tester revealed that bearing components were in excellent condition (see Figures 9 and 10). Having successfully endured the minimum 3-hr testing duration required to qualify the material, a second 3-hr test was scheduled in an attempt to establish time for failure.

Figure 9 - Posttest Appearance of PBI-Glass Retainer in its Bearing With Portion of Inner Race Removed Showing Excellent Condition of Components After 3-hr Testing

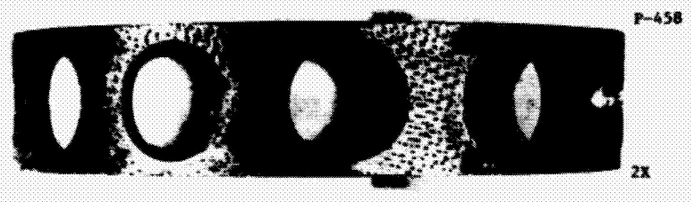
Figure 10 - Posttest Appearance of PBI-Glass Retainer After 3-hr Testing Showing Lack of Wear on OD and Good Condition of Ball Pockets

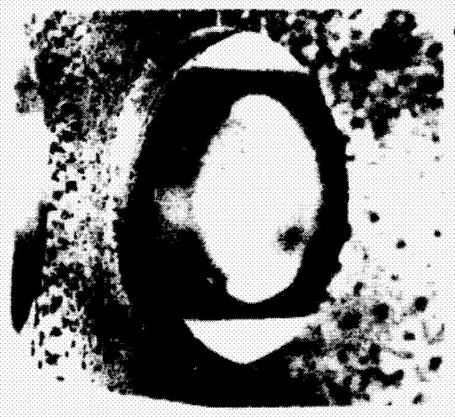
The tester ran smoothly at amperages varying from 35 to 45 for the scheduled 3 hr. Disassembly of the tester again revealed that the retainer was in excellent condition (see Figures 11 and 12).

Figure 12 - Appearance of Ball Pocket After 6-hr Testing Showing Barely Visible Evidence of Wear on ID Edge

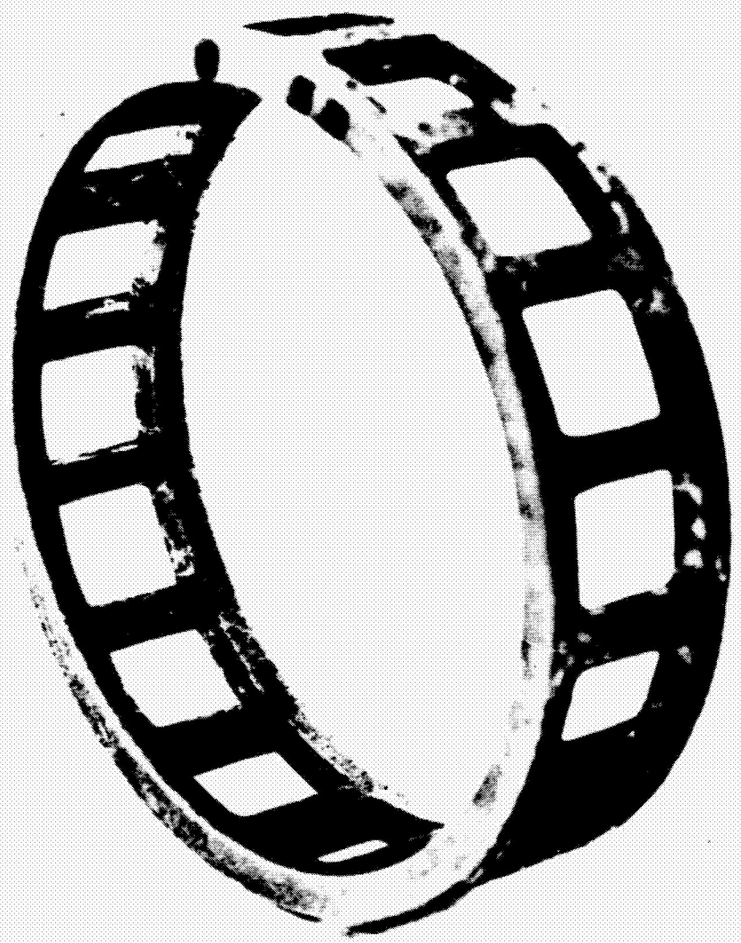
Figure 14 - Appearance of PBI-Graphite Roller Retainer After 1.8-hr Operation

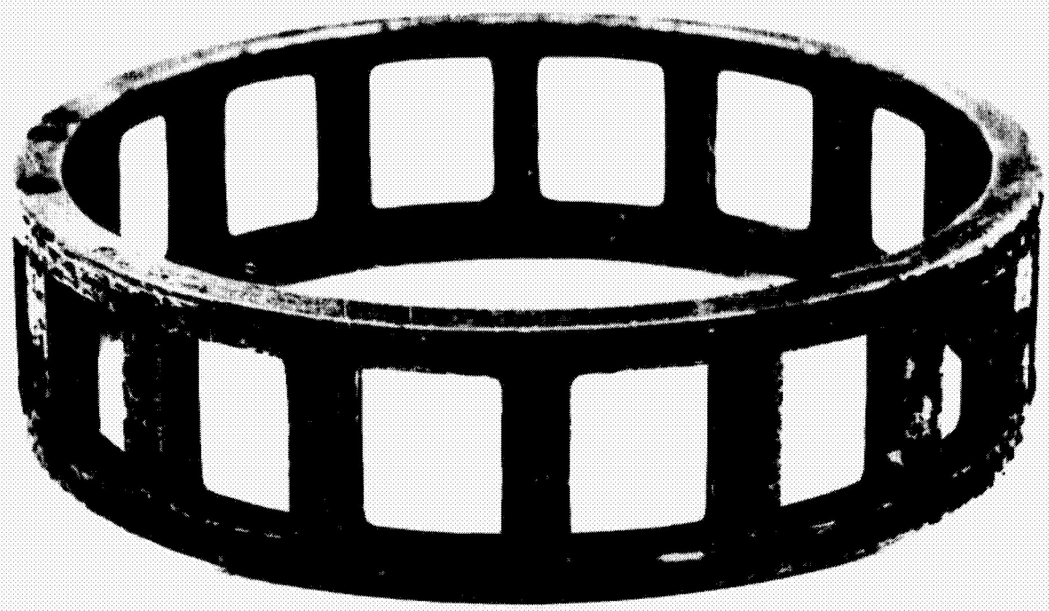
Figure 15 - Posttest Appearance of PBI-Graphite Roller-Retainer After 6-hr Operation

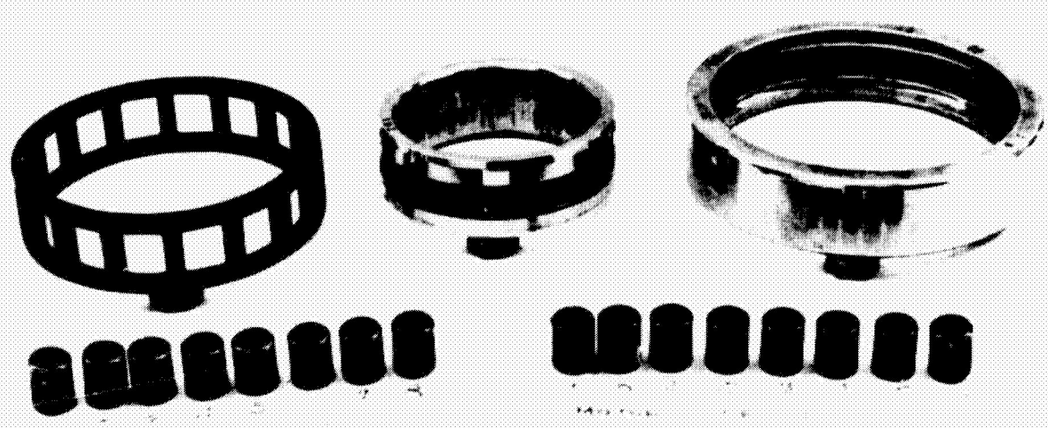
Figure 16 - Posttest Appearance of Roller-Bearing Components After 6-hr Operation

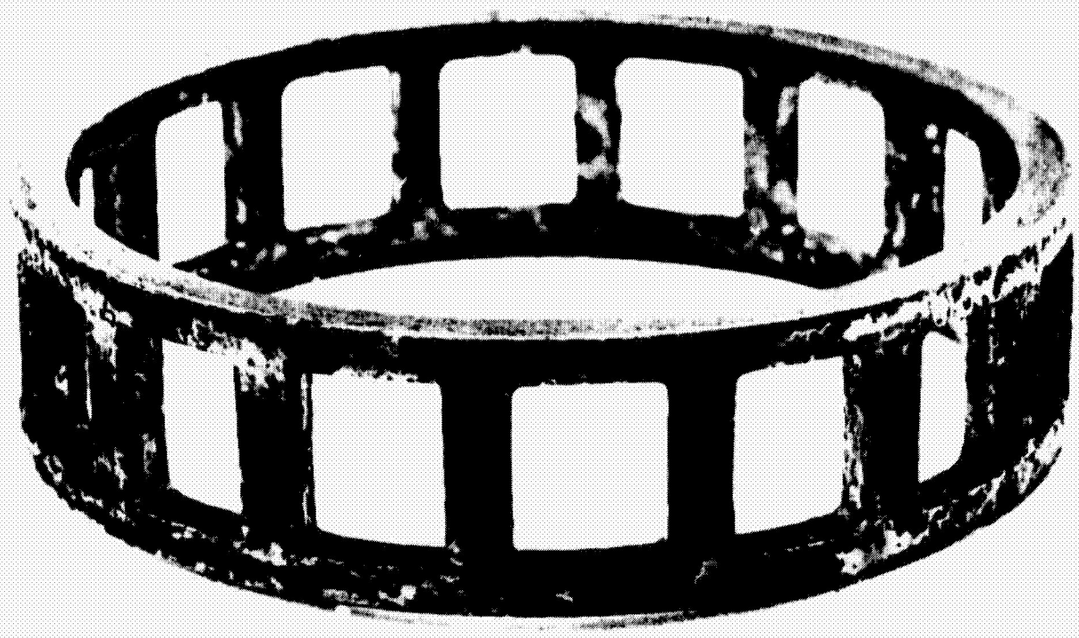
Posttest radiographic inspection of the S/N 880009 retainer, as well as the retainer tested previously (S/N 880008), revealed no visible signs of degradation (e.g., delaminations or cracks). Therefore, both parts were scheduled for further testing in an attempt to establish material endurance limits.

Figure 17 - Posttest Appearance of PBI-Graphite Roller-Bearing Retainer S/N 880009 After 7 hr, 40 min Operation

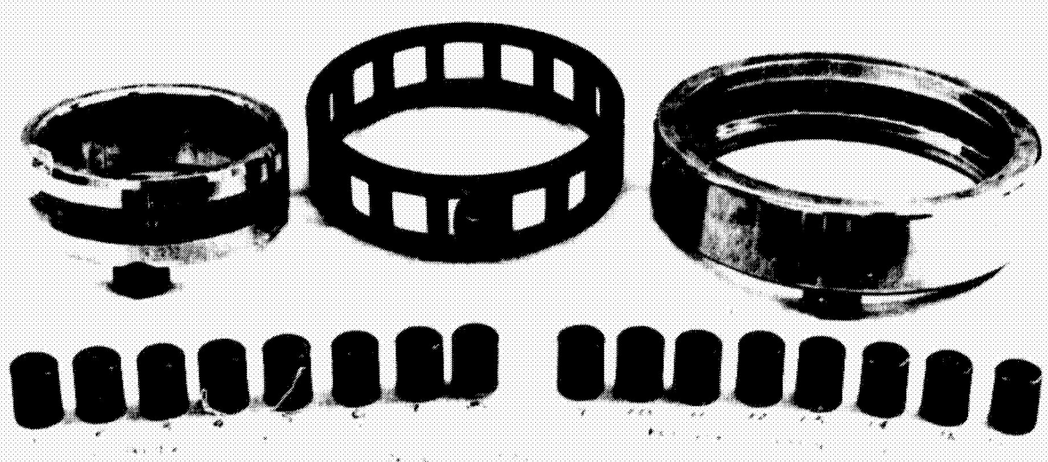
Figure 18 - Posttest Appearance of Roller-Bearing Components, Including PBI-Graphite Retainer After 7 hr, 40 min Operation

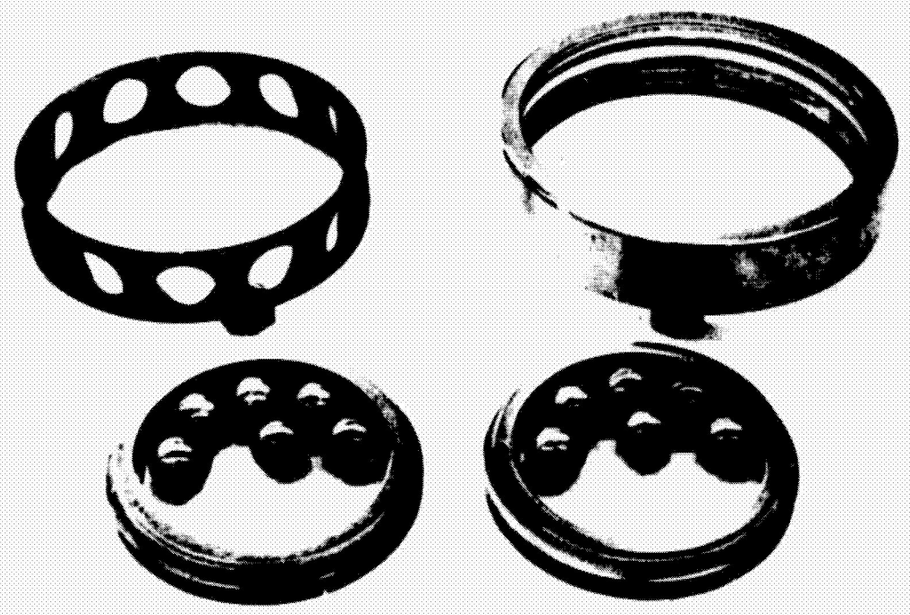
The condition of the components of this bearing, including the S/N 880027 irradiated ball retainer, is shown in Figure 19. Although generally in good condition, the rolling elements of the bearing

Figure 19 - Appearance of Thrust-Bearing Components, Including Irradiated PBI-Glass Retainer S/N 880027, After 7.75 hr Operation

(i.e., the balls, the outer race, and the loaded half of the inner race) had lost their pretest finish and had a finely frosted surface condition (see Figure 20). Closer examination revealed small dents and gouges in several balls and in the outer race track. The cause of the surface degradation (i.e., abrasive debris from the ball retainer) was evident from examination of the retainer. As shown in Figures 21 and 22, each ball pocket contained wear scars at both driven and trailing walls, resulting in the generation of considerable debris. Table 7 shows that a total of more than 0.69 gm of material (solid lubricant and retainer material) was lost during the test.

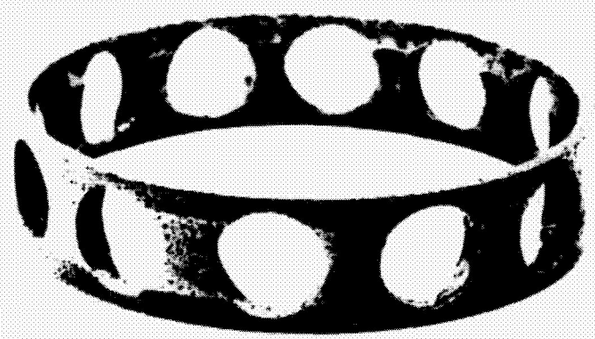
Figure 21 - Posttest Appearance of Irradiated PBI-Glass Ball-Retainer After 7.75 hr Testing, Showing Outer-Surface Wear and Ball-Pocket Scars

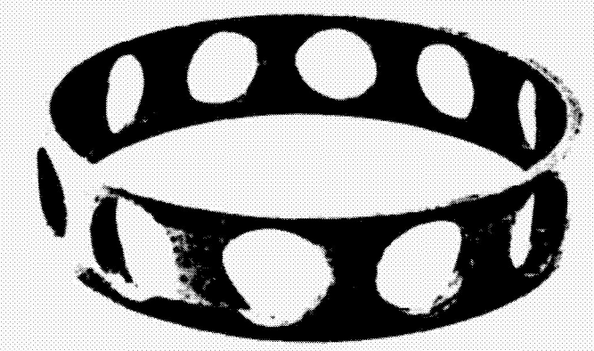
Figure 22 - Posttest Appearance of Irradiated PBI-Glass Ball-Retainer After 7.75 hr Testing, Showing Inner-Surface and Ball-Pocket Scars

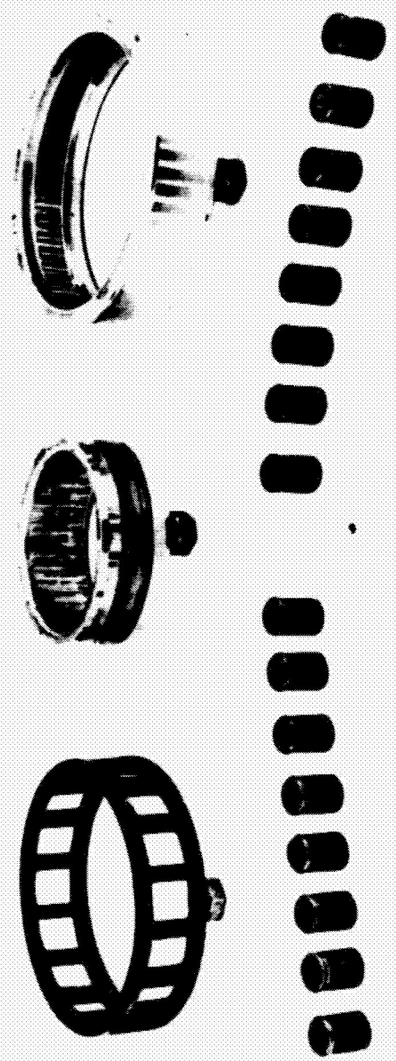
Figure 23 - Posttest Appearance of Loader Roller-Bearing, Including Experimental PBI-Graphite Retainer After More Than 15 hr Testing

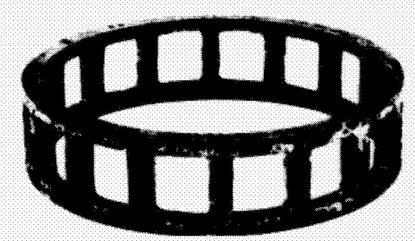
Figure 27 - Posttest Appearance of PBI-Graphite Loader Roller-Bearing Retainer Showing Light Pocket-Wear Scars

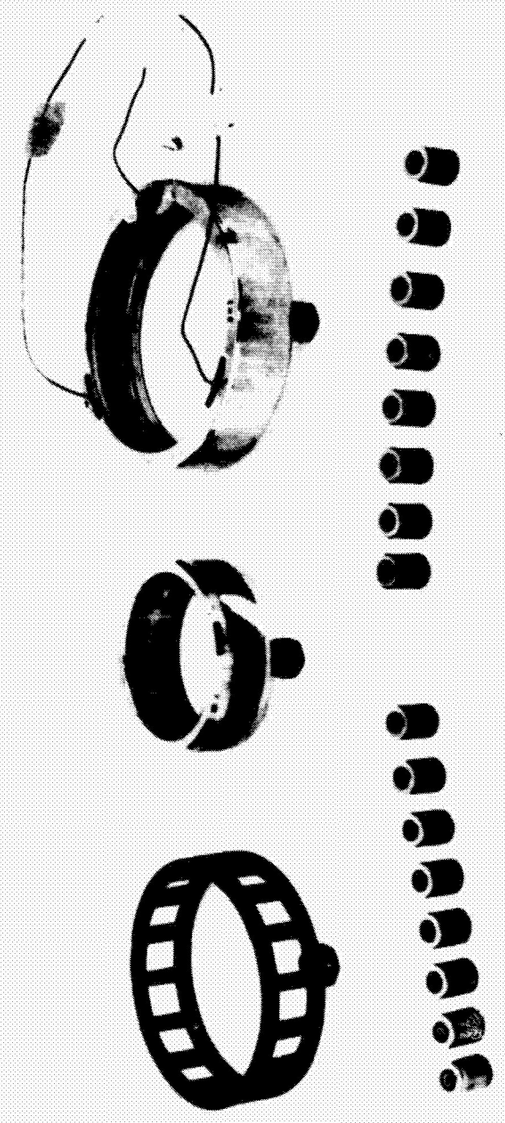
was adversely affected. Operating within the motor armature and furthest from the coolant inlet, the bearing operating-temperature may be several degrees higher than that of the loader roller bearing. Consequently, reducing coolant flow through this bearing had drastic effects upon its components, as the thermocouple instrumentation described above predicted. The appearance of the bearing components is shown in Figure 28. Immediately evident is the end wear exhibited by each roller on both ends: the downstream end, for example, was worn by approximately 0.01 in. (see Figures 29 and 30) while upstream (loader) end-wear was approximately 0.002 in. (see Figure 31). The roller ends, as well as the race lands against which the rollers bear, were chattered, exhibiting the extreme effects of cold welding and tearing. The resultant metal debris caused denting of both races and rollers and also appeared to have removed the normal blue layer of FeN developed during the test. The roughened roller surfaces greatly affected the retainer operation and accounts for the somewhat high weight loss of 0.4 gm shown in Table 7. It should be recalled that during its initial 6-hr test run, the weight loss of this retainer was negligible.

Figure 28 - Posttest Appearance of Motor Roller-Bearing Components, Showing Roller End Wear from Reduced-Coolant-Flow Rate Experiments

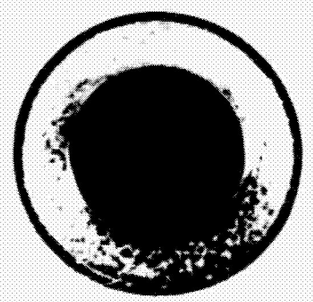
Figure 30 - Appearance of Motor-Roller End-Wear Surface Showing Effects of Cold Welding and Tearing on Downstream Roller Face

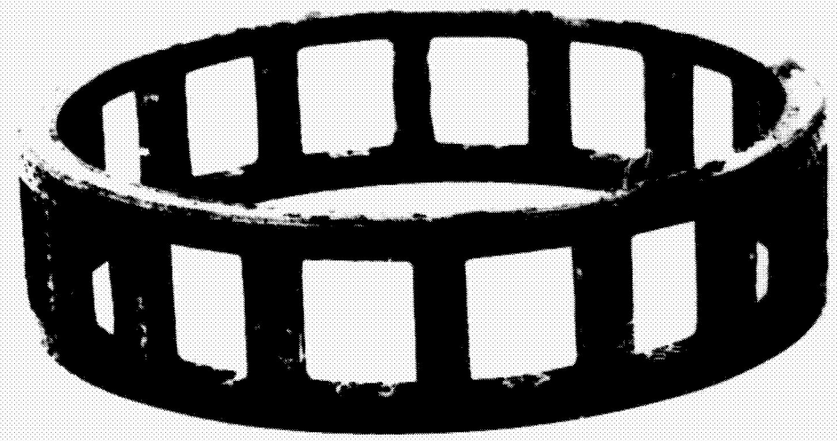
Appearance of the experimental PBI-graphite retainer is shown in Figures 32 and 33. Indentations on the retainer OD caused by the outer race support lands are evident in Figure 32. The wear caused by roller sideloads are evident as elliptical marks on the retainer side-rings (see Figure 33). Heavier-than-usual wear was manifested by wear scars in the separator bars (see Figure 33): these are hour-glass shaped because of a lack of line-to-line contact with the roller. Generally, all retainer degradation was directly attributable to flow-rate-caused bearing anomalies.

Figure 32 - Posttest Appearance of Experimental PBI-Graphite Motor Roller-Retainer S/N 880008 with More Than 13.5 hr of Accumulated Testing, Showing Generally Satisfactory Condition and Light Pocket Scars

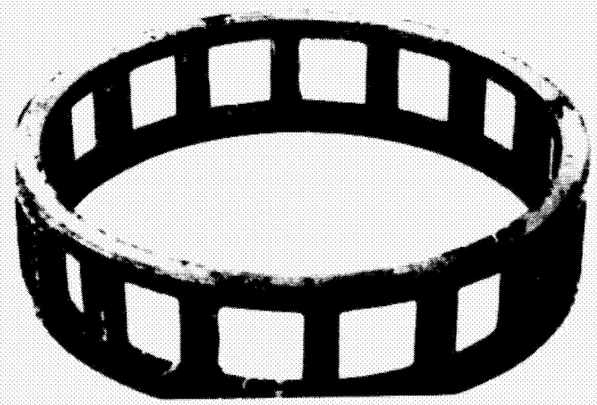
Figure 33 - Posttest Appearance of Experimental PBI-Graphite Motor-Roller Retainer S/N 880008, Showing Inner-Surface and Pocket Scars

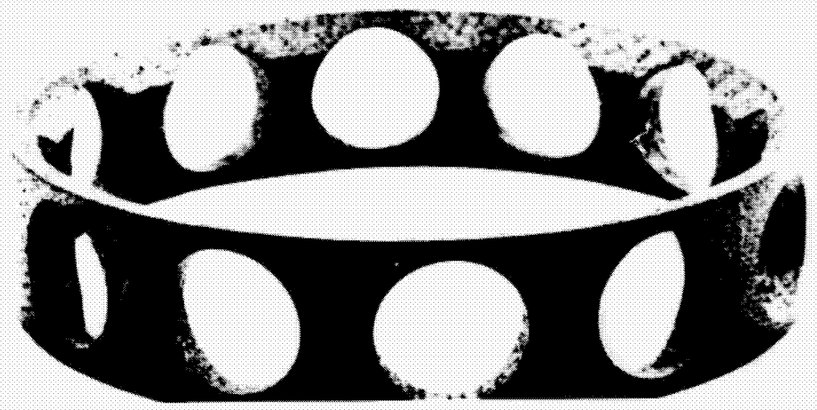
Figure 34 - Pretest Appearance of Irradiated PBI-Glass Ball Retainer S/N 880028, Outside Surface

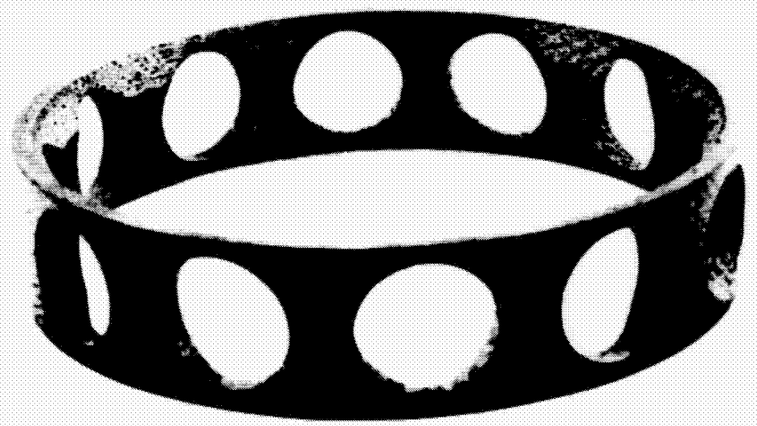
Figure 35 - Pretest Appearance of Irradiated PBI-Glass Ball Retainer S/N 880028, Inside Surface (Note Porous Nature of Laminate)

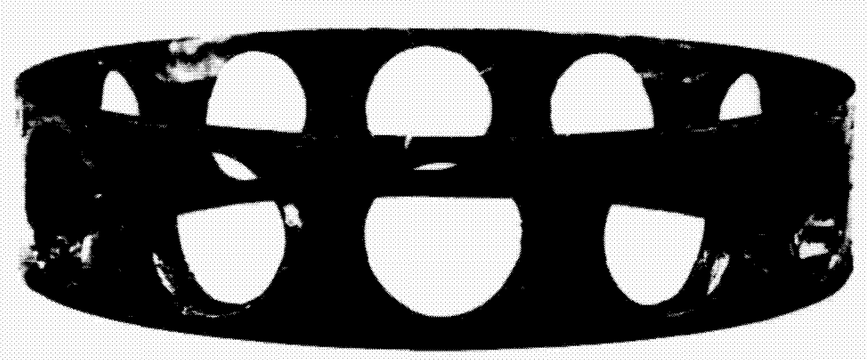
Figure 36 - Pretest Appearance of Irradiated PBI-Glass Ball Retainer S/N 080028, After Application of MoS_2, Outside Surface

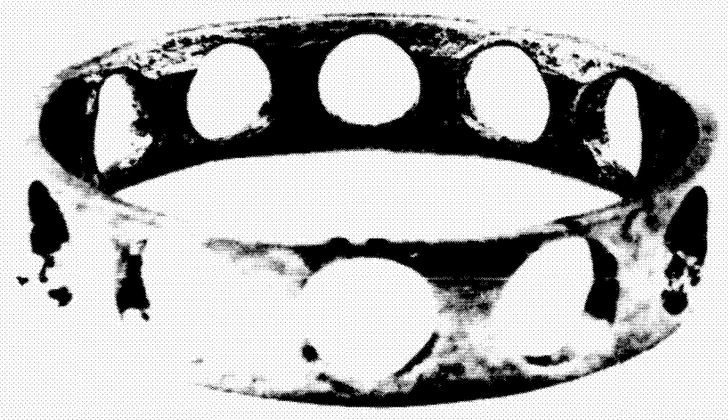
Figure 37 - Pretest Appearance of Irradiated PBI-Glass Ball Retainer S/N 880028, After Application of MoS_2, Inside Surface

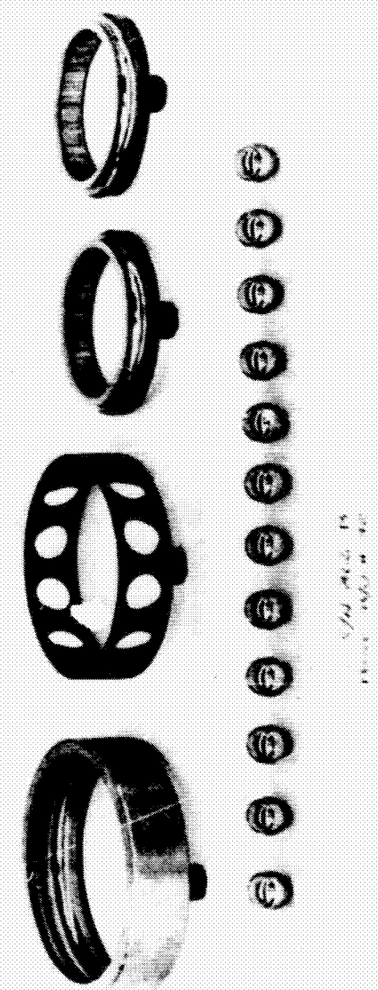
The excellent condition of the components of this bearing, including the irradiated ball retainer, is shown in Figures 38 through 40. Inspection revealed that the magnitude and severity of debris-caused damage was greatly reduced in this test, compared with that of the S/N 880027 retainer test, indicating the importance of maintaining adequate coolant flow-rate and low interfacial temperature. The surface finish of the rolling elements of the bearing was intact with only isolated pits and dents evident. The PBI-glass retainer wear scars at the driving and trailing pocket walls had rubbed through the lubricant coating at the ID portion of the pocket wall. However, the scars did not extend across the entire retainer thickness and wear was considered light. Weight-change data indicated a loss of over more than 0.5 gm was sustained (see Table 8). Since wear was light, it was assumed that most of the weight loss represented loss of the excessively heavy Molykote coating.

Figure 38 - Posttest Appearance of Thrust-Bearing Components, Including Satisfactory Condition of Irradiated PBI-Glass Retainer S/N 880028

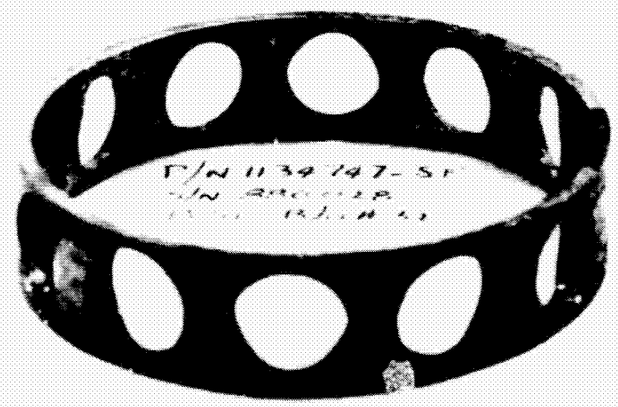
Figure 39 - Posttest Appearance of Irradiated PBI-Glass Ball Retainer, Showing Inside Surface and Ball-Pocket Scars

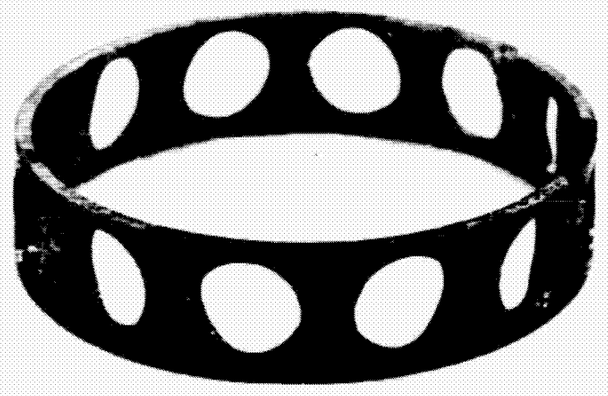
Figure 40 - Posttest Appearance of Irradiated PBI-Glass Ball Retainer, Showing Outside Surface and Ball-Pocket Scars

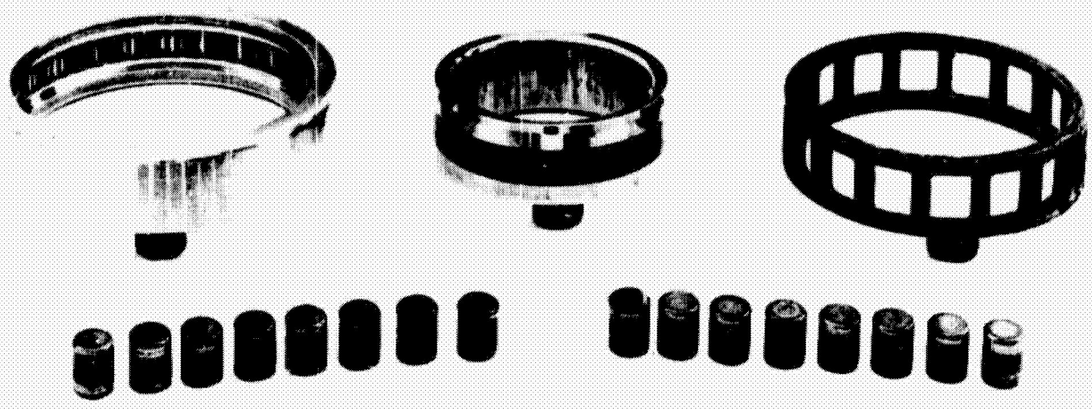
The loader roller-bearing components were, again, in excellent condition after more than 23 hr of testing (see Figure 41). Examination of races and rollers failed to reveal any evidence of significant wear and no signs whatsoever of end wear (see Figures 42 and 43). The PBI-graphite retainer was in good condition with partial roller wear scars in the roller pocket-driven walls (see Figures 44 and 45). These scars, as well as the wear marks on the retainer OD, were essentially unchanged from their appearance following both previous tests of this bearing, as reflected by the negligible weight changes recorded in Table 9.

Figure 41 - Satisfactory Posttest Appearance of Loader Roller-Bearing Components

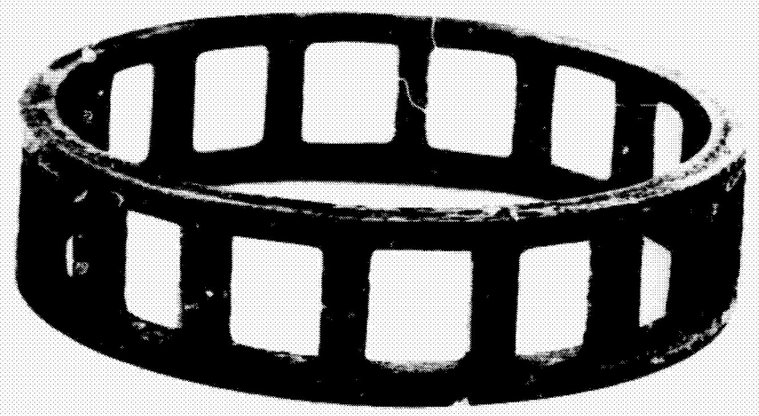
Figure 44 - Excellent Appearance of Loader Roller-Bearing Retainer S/N 880009 After More Than 23 hr of Testing, Outside Surface

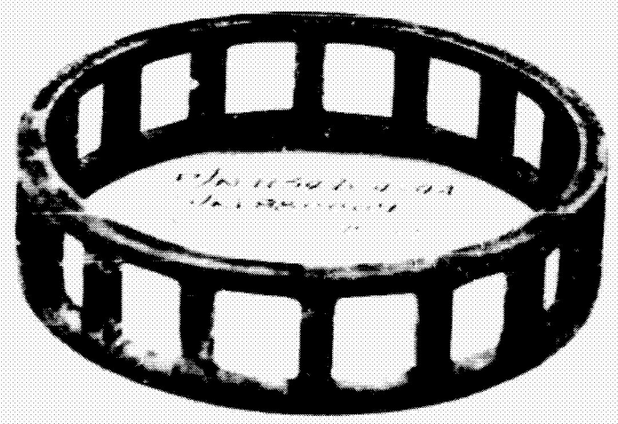
Figure 45 - Posttest Appearance of Inside Surface of Loader Roller-Bearing Retainer After Testing

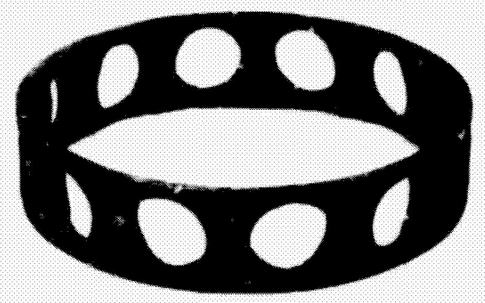
The part was radiographically inspected and found to be structurally sound. It was submitted to the General Dynamics/Ft. Worth GTR reactor as part of the GTR-20 irradiation experiment. Retainers S/N 880002 and 880003 were irradiated to 4.8×10^{10} ergs/gm (C) gamma dose and 4.3×10^{15} nvt fast neutron irradiation in liquid nitrogen and subsequently returned to Aerojet-General. S/N 880003 was selected for bearing testing and, following removal of loosely adhering material, the part was lubricated with brush applications of Molykote 321. The appearance of the part prior to testing is shown in Figure 46.

Figure 46 - Pretest Appearance of Irradiated PI-Glass Ball Retainer S/N 880003

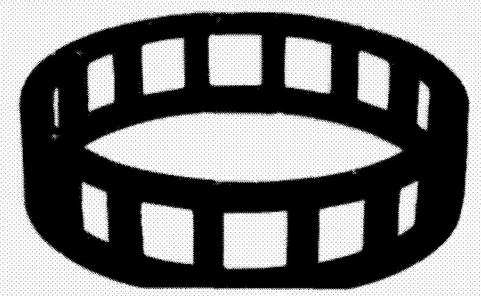
Similar lubricant application was performed on the loader roller-bearing PBI-glass retainer S/N 880005 (see Figure 47). The roller-retainer appearance before Molykote application, showing the degree of porosity commonly obtained with highly volatile aromatic polymers, is shown in Figure 48.

Figure 47 - Posttest Appearance of Experimental PBI-Glass Roller-Bearing Retainer S/N 880005

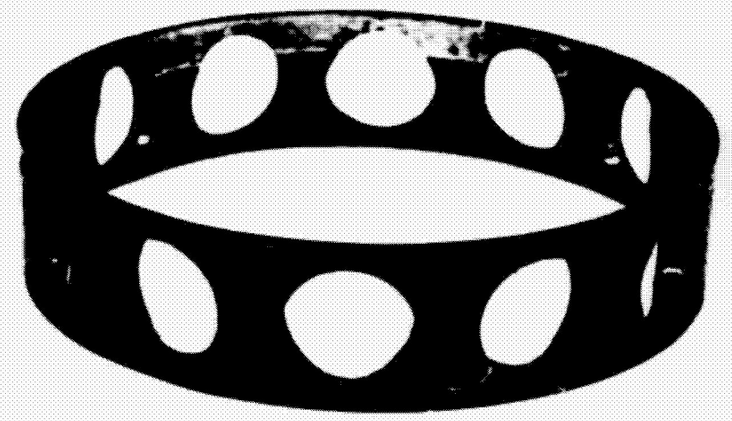
Figure 49 - Appearance of Irradiated PBI-Glass Ball Retainer S/N 880003 After Initial 1743 sec Test (No Evidence of Degradation or Incipient Failure was Noted)

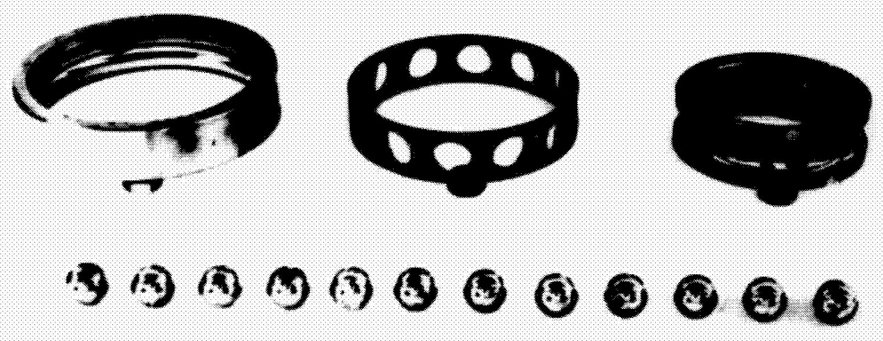
Figure 50 - Satisfactory Appearance of Ball-Bearing Components After First Test Segment

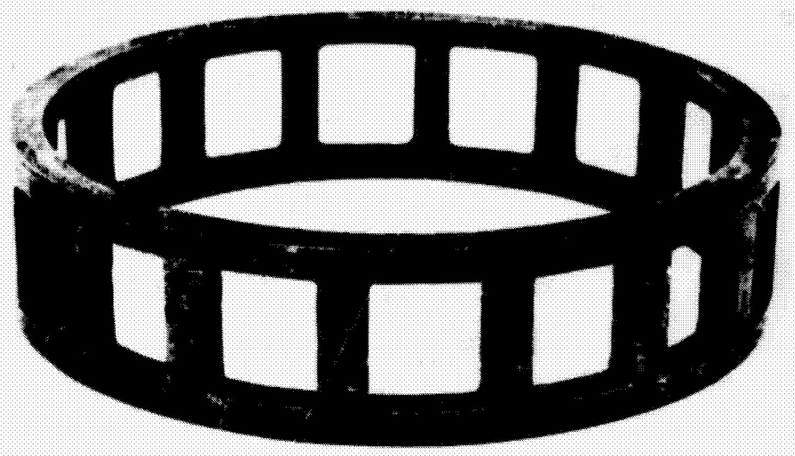
Figure 51 - Satisfactory Appearance of Experimental Roller Retainer S/N 880005 After First Test Segment

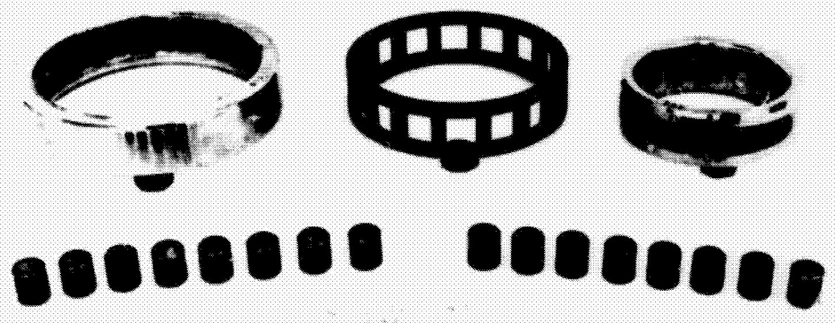
Figure 52 - Satisfactory Appearance of Loader Roller-Bearing Components, Including Experimental PBI-Glass Retainer, After First Test Segment

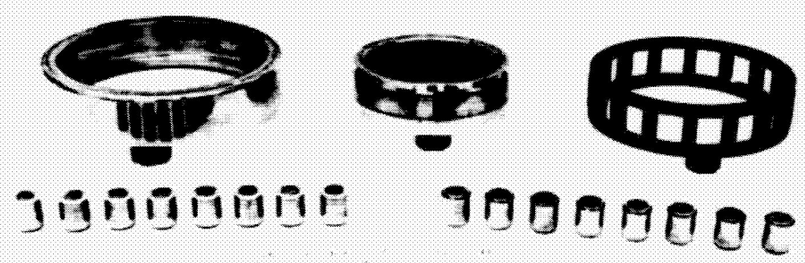
In the detailed tester component investigation which followed, it was determined that a condition had existed in the previous two test segments analogous to coolant leakage between the tester and the flow meter. This discovery indicated that flow through the test bearing was significantly lower than registered by instrumentation, resulting in roller-bearing end wear and an excessively high motor-current requirement. The high current resulted in abnormal heat input to the already inadequately cooled motor roller-bearing. The combination of a low flow-rate and high motor-current

Figure 57 - Posttest (Second Segment) Appearance of Motor Roller-Bearing Components Showing Heavy End-Wear on Roller Downstream Faces (Left Side)

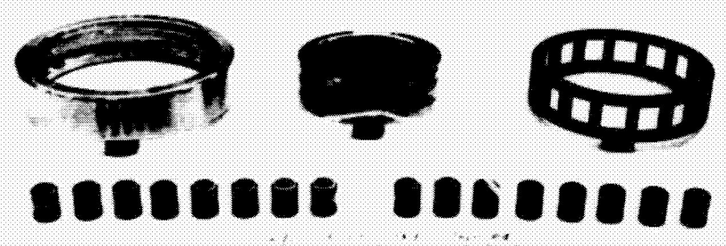
Figure 58 - Posttest (Second Segment) Appearance of Loader Roller-Bearing Components Including Experimental PBI-Glass Retainer S/N 880005

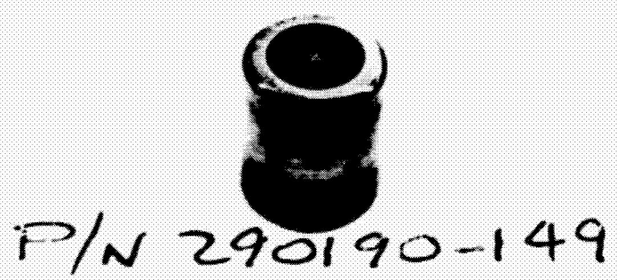
Figure 59 - Posttest (Second Segment) Appearance of Loader Roller-Bearing Roller End-Wear, Indicative of Abnormally Low Coolant Flow-Rate During Testing

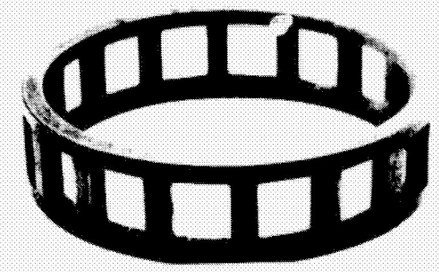
Figure 60 - Satisfactory Appearance of Loader Roller-Bearing Retainer S/N 880005 After Second Test Segment

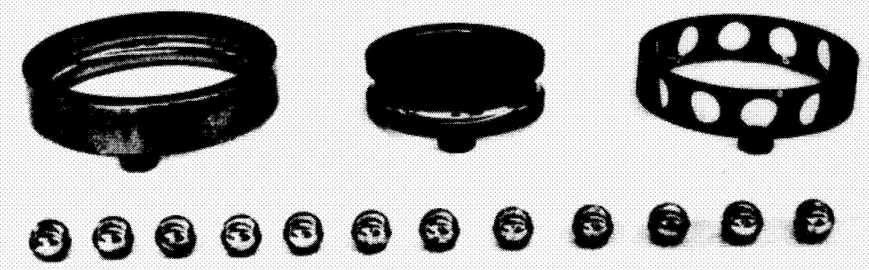
Figure 61 - Satisfactory Appearance of Ball-Bearing Components, Including Irradiated PI-Glass Ball Retainer S/N 880003, After Second Test Segment

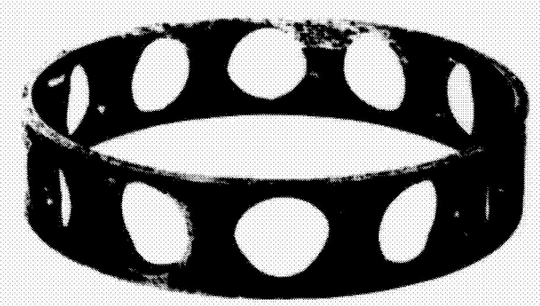
Figure 62 - Posttest (Second Segment) Appearance of Irradiated PI-Glass Ball Retainer S/N 880003 Showing Very-Light Burnishing on Outer Diameter and Light Pocket Scars

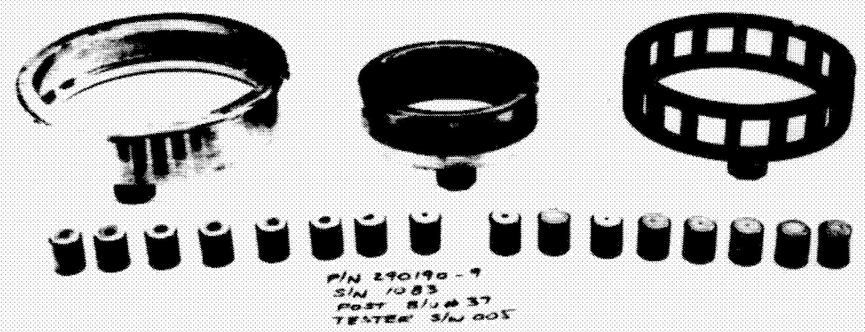
Figure 63 - Posttest (Third Segment) Appearance of Motor Roller-Bearing Components with No Evidence of End-Wear or Other Damage

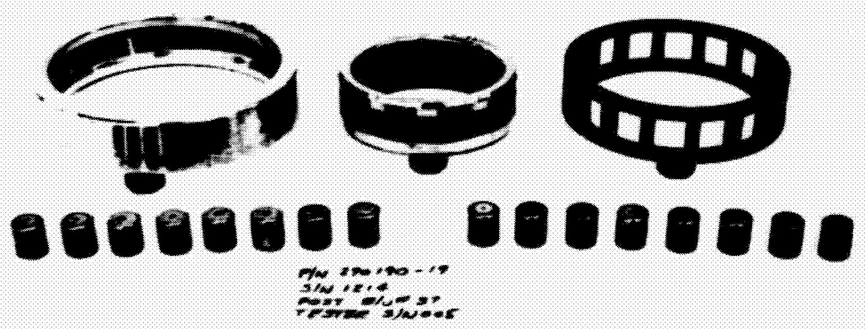
Figure 64 - Posttest Appearance of Loader Roller Bearing Showing Satisfactory Condition of All Components

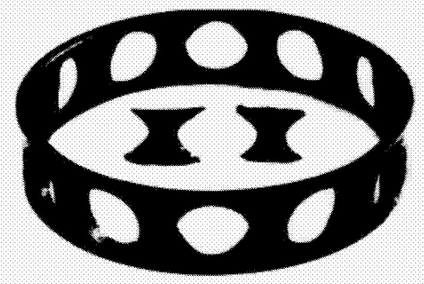
Figure 65 - Posttest Appearance of Irradiated PI-Glass Ball-Bearing Retainer S/N 880003 Showing Nature of Failure (Delamination of Ball Separator)

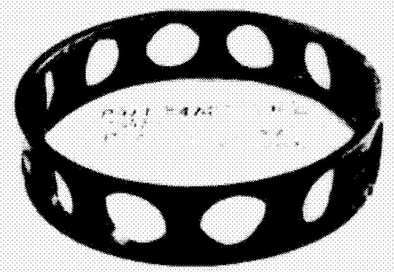
Figure 66 - Posttest Appearance of Irradiated PI-Glass Ball-Bearing Retainer S/N 880003 Showing One Delaminated Area and Adjacent Separator Section About to Fail

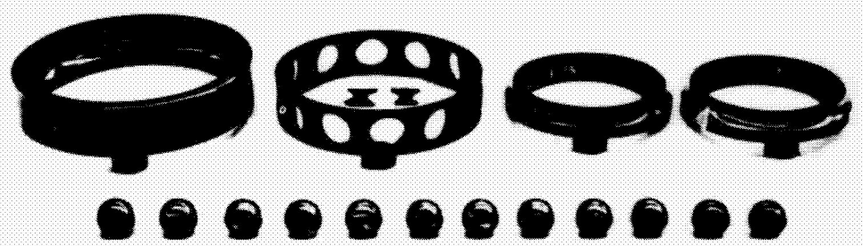
Figure 67 - Posttest Appearance of Ball-Bearing Components Including Irradiated PI-Glass Ball Retainer S/N 880003 with Ball Separator Sections Which Failed During Testing
