APOLLO RCS POSITIVE EXPULSION TANKAGE
PRODUCT IMPROVEMENT PROGRAM
FINAL REPORT - TASK E

# SOLUTION OF COMMAND MODULE AND SERVICE MODULE BLADDER REPOSITIONING PROBLEMS

Bell Report No. 8514-928006
19 March 1970

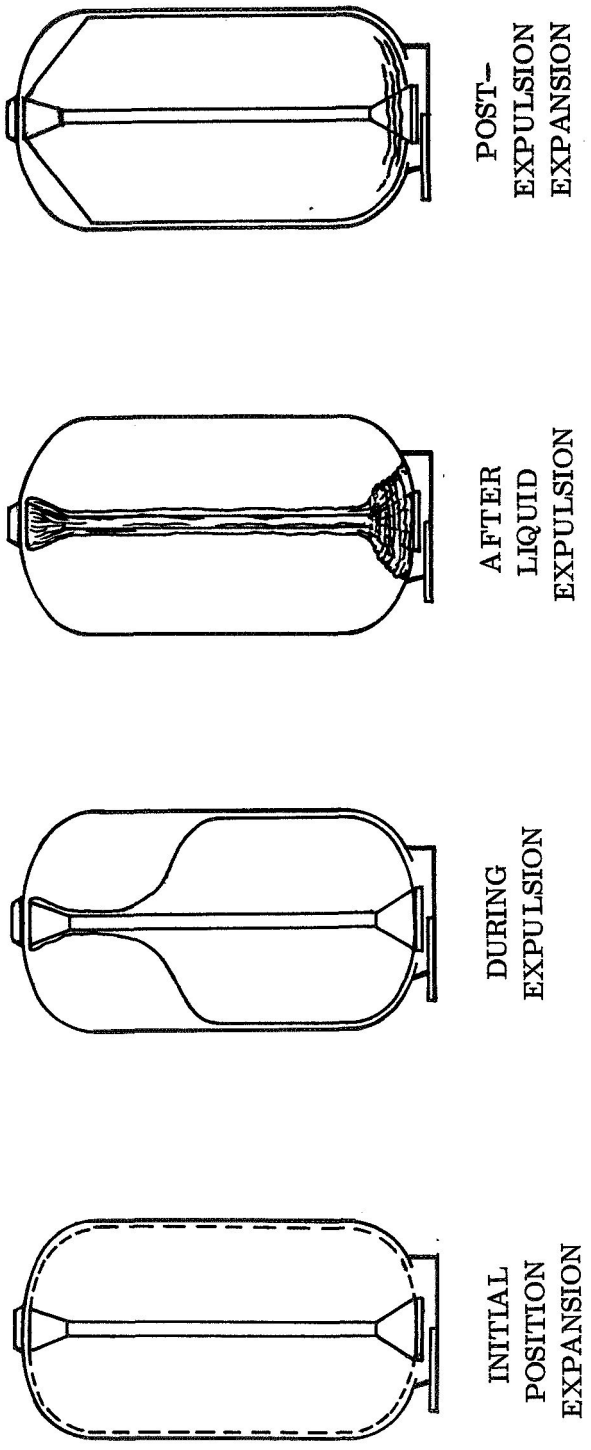
FIGURE 1. SEQUENCE OF TENSION DEVELOPMENT IN BLADDER

It has been determined by observation of previous twist tests in plexiglass tanks that twist forces buckle the hemispheres of the bladder and produce a pattern of folds which become tighter as the bladder is pressurized. Since the folds take up bladder material, the hemispherical bladder sections are initially reduced in volume. This creates a gap between the bladder and tank wall which is bridged by deformation of the bladder material

when internal pressure is applied. The folds are in diagonal tension and the bladder material between the folds is subjected to biaxial tension stresses and is thereby strained to increase the bladder volume to comply with the internal volume of the shell. After subsequent expulsion and fill operations, new folds develop, depending upon twist angle, and sequences of tight creasing and biaxial tension tend to occur in many parts of the bladder hemispherical surfaces. This sequence of loads is damaging.

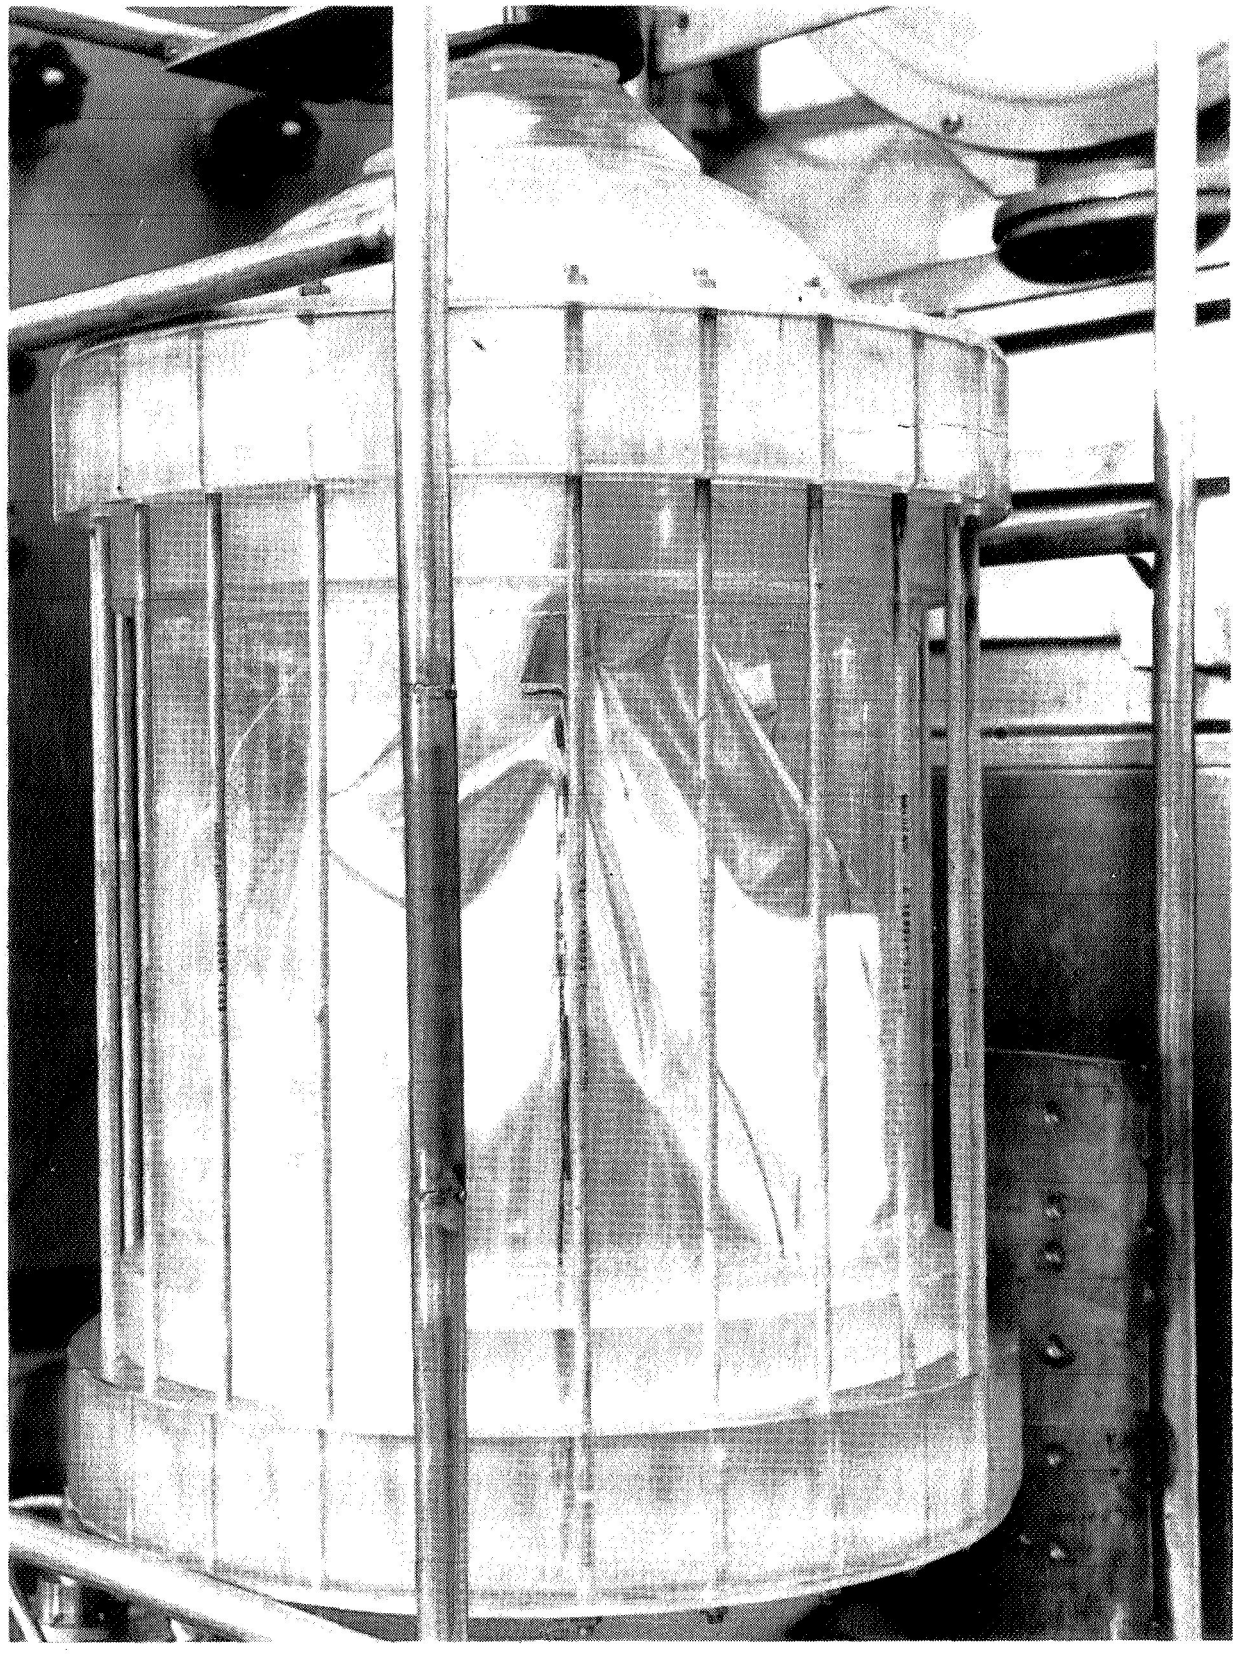
FIGURE 8. TEFLON/FOIL LAMINATE BLADDER - VERTICAL EXPULSION - 50% EXPELLED

As expected, the bladder repositioned itself completely within the tank when re-expanded after each vertical expulsion with no visible evidence of strain. The cylindrical section of the bladder did not touch the tank wall until complete vertical positioning had occurred. Figure 8 shows the bladder half-way through the first expulsion and Figures 9 and 10 show the bladder appearance after completion of expulsion. As shown in Table 1 and Figure 11, expulsion efficiencies exceeded 99% at a tank assebmly $\Delta P$ of 6 psi.

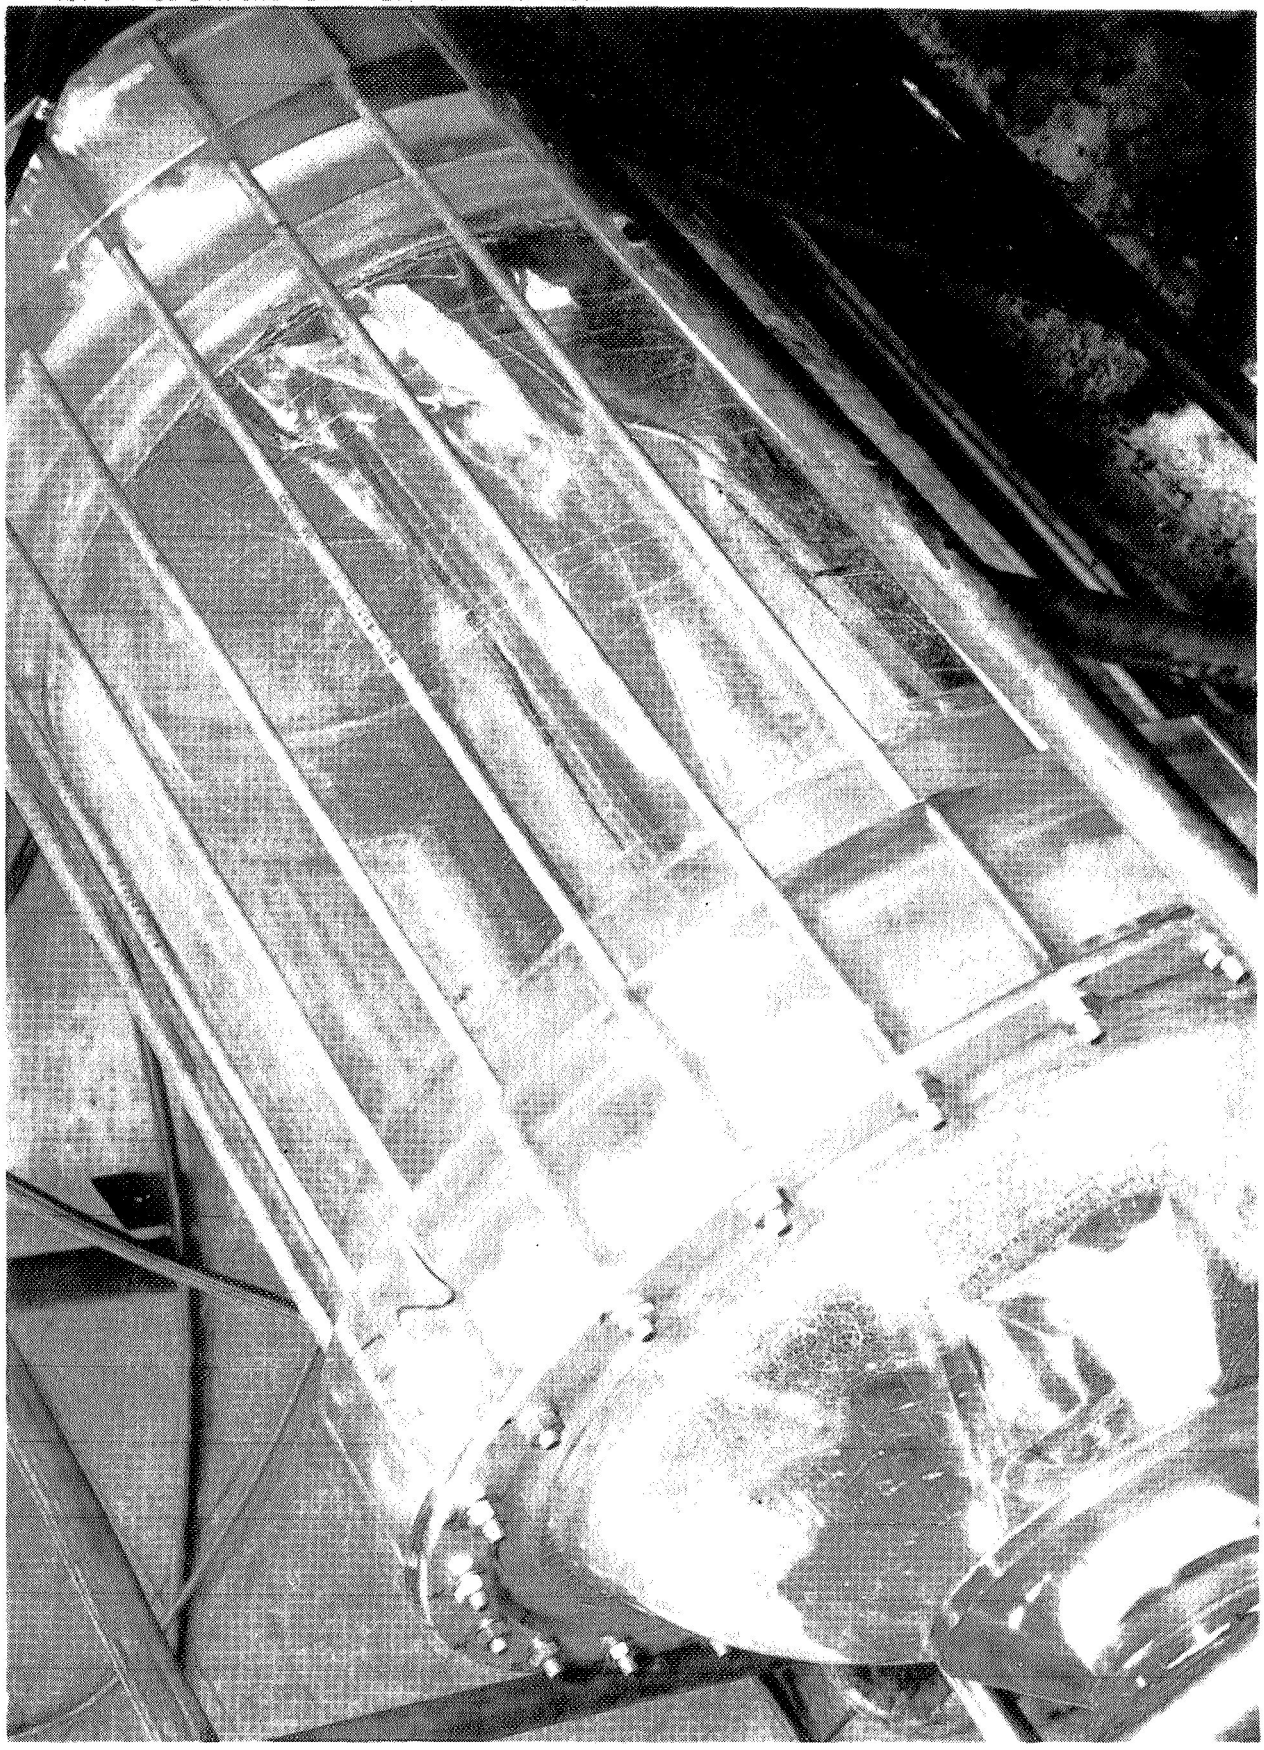
FIGURE 15. POST-EXPULSION BLADDER CONDITION IN HORIZONTAL CMO TANK

Since the Command Module RCS tanks are mounted horizontally, the bladders are susceptible to twisting during fill operations. Bladder twist is a random occurrence which depends upon folding patterns developed in the bladder during expulsion and/or subsequent evacuations as shown in Figure 15. Figure 16 is a sketch showing bladder folding patterns after expulsion and evacuation and indicates the downward rotation of a point on a fold due to propellant weight during filling. As fold A rotates and expands, it reaches the tank wall and a twist angle $\theta$ is established. At complete fill pressurization, the bladder membrane develops torsional restoring moments which are opposed by the friction between the bladder and the tank wall. In Apollo-type tanks, the friction forces are generally large enough to prevent reduction of the angle of rotation by bladder slippage and the result is incomplete repositioning of the bladder within the shell. The Apollo Command Module shell and bladder geometries are such that a bladder twist angle of 20° can be experienced without bladder damage; however in some cases bladder twist angles as great as 80° have been observed after a few expulsion cycles in Command Module oxidizer tanks. Figure 17 shows examples of twist damage on a Command Module oxidizer tank after repetitive expulsion cycle testing with propellant.

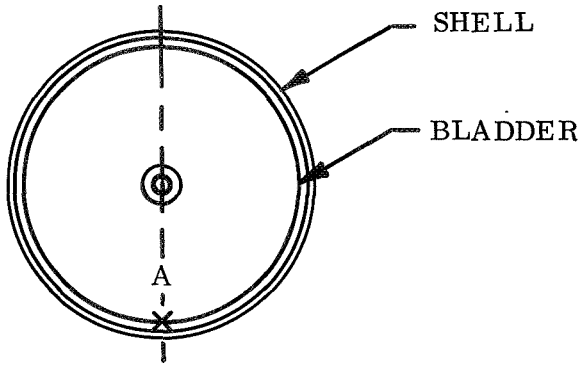
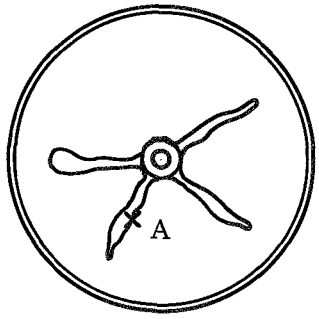
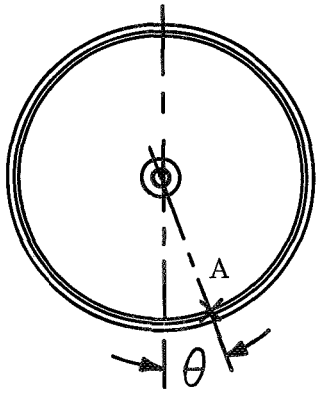
FIGURE 16. SKETCH SHOWING TYPICAL HORIZONTAL FOLDING PATTERN AND TWIST

Several design approaches were studied and evaluated. These included variation of the diffuser cone flow pattern and $\Delta P$ by varying the number, size, and pattern of the holes in order to control the orientation of the bladder extremities. The objective of these modifications (as listed in Table 2) was to minimize bladder twist at the end of an expulsion and, if possible, prevent the bottom of the bladder from lifting at the end of an expulsion. If this could be accomplished, position A on the bladder as shown in Figure 16 would not change and the twist angle would remain zero.
