THE EFFECT OF SUNSHINE TESTING ON TERRESTRIAL SOLAR CELL SYSTEM COMPONENTS

by Americo F. Forestieri and Evelyn Anagnostou
Lewis Research Center
Cleveland, Ohio 44135

TECHNICAL PAPER to be presented at
Eleventh Photovoltaic Specialists Conference
sponsored by the Institute of Electrical and
Electronics Engineers
Phoenix, Arizona, May 6-8, 1975

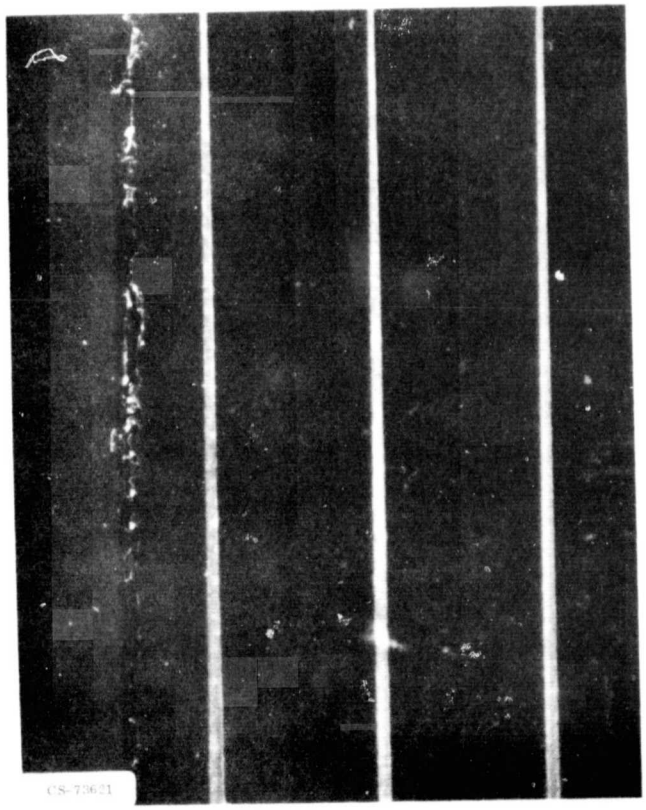
Photographs taken before the solar cell samples were removed for the last measurement indicated delamination was occurring. On examination at the Lewis Research Center, the samples showed that delamination was taking place primarily at the interconnect areas and along the sample edges. Cracking of the FEP in these areas was also observed and is shown in Figs. 3 to 5. Figure 3 shows cracking along one edge of the solar cell. As a result of the lamination process the FEP is thinner in this region. It is believed that the cracking occurs as a result of high stresses in the thinner FEP. Figure 4 shows cracking of the FEP above the cell interconnect. It is known from stress analysis of the laminated structure that a region of high stress occurs at the edge of the interconnect and can cause fatigue of the FEP after severe temperature cycling (2). Figure 5 shows another sample with cracked FEP at the cell interconnect. In addition the light circular spot in the center shows delamination.

Figure 3. - FEP encapsulated solar cell showing cracking and delamination.

(4) FEP encapsulated solar cells performed well in spite of delamination and cracking of the FEP. It appears that the cause of the problems is in the fabrication process and can be remedied.

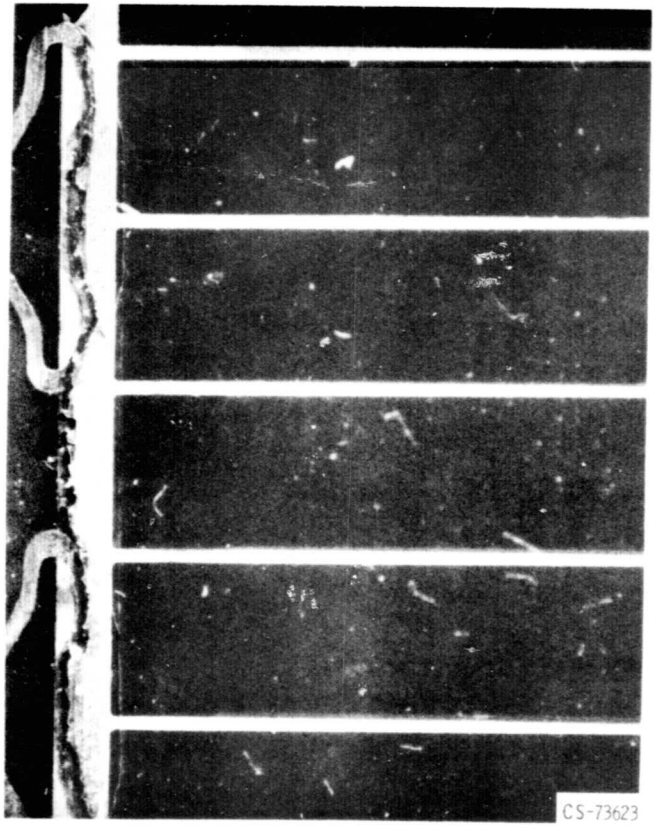
Figure 4. - FEP encapsulated solar cell showing cracking above cell interconnect.

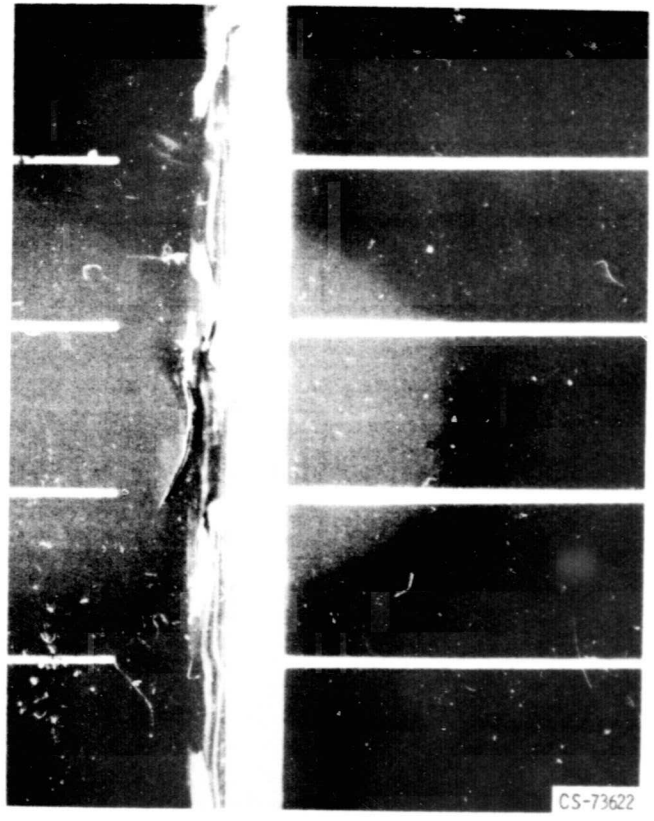
Figure 5. - FEP encapsulated solar cell showing cracking and delamination.
