APOLLO 12 MISSION REPORT

National Aeronautics and Space Administration
LYNDON B. JOHNSON SPACE CENTER
Houston, Texas
MARCH 1970

Mission Evaluation Team

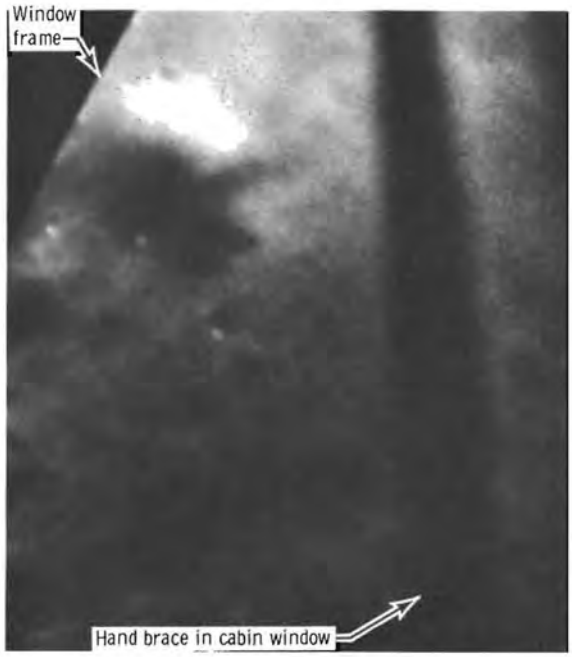
MSC-01855

Data on the degradation of visibility during landing are derived from crew observations and photographs. The photographic record is obtained from film (fig. 6-1) exposed by a 16-mm sequence camera, which is mounted

The first time that dust is detected from the photographic observations occurs 52 seconds before touchdown. This time corresponds to an altitude of about 100 feet. There is no commentary in the voice transcription relative to dust at this point, but postflight debriefings indicate the crew noticed the movement of dust particles on the surface from a relatively higher altitude. At 180 feet altitude the Lunar Module Pilot made the comment that they could expect to get some dust before long. However, the initial effect of the dust, as first observed in the film or by the crew, indicates that there was no degradation in visibility prior to about 100 feet in altitude. However, the crew stated that dust was first observed at an altitude of about 175 feet (section 9.0). Dust continued to appear in the sequence camera photographs for the next 10 or 12 seconds as the lunar module descended to about 60 to 70 feet in altitude. Visibility is seen to have degraded, but not markedly. Beyond this point, the film shows the dust becoming more dense. Although surface features are still visible through the dust, impairment of visibility is beginning. Degradation of visibility continues until the surface is completely obscured and conditions are blind. The point at which this total obscuration occurs is somewhat subjective. At 25 seconds before touchdown, the dust cloud is quite dense, although observations of the film show some visibility of the surface. From the pilot's point of view, however, visibility is seen to be essentially zero at this time, which corresponds to an altitude of about 40 feet. Therefore, the pilot's assessment that total

Compared to the Apollo 11 landing, the degradation in visibility as a result of dust erosion was much more severe during Apollo 12. During Apollo 11, the crew likened the dust to a ground fog; that is, it reduced the visibility, but never completely obscured surface features. On Apollo 12 the landing was essentially blind for approximately the last 40 feet. In order to better understand the reasons for these differences, a detailed analysis was initiated of the factors which affect erosion and visibility. The results of that analysis, although not completed, are summarized here.

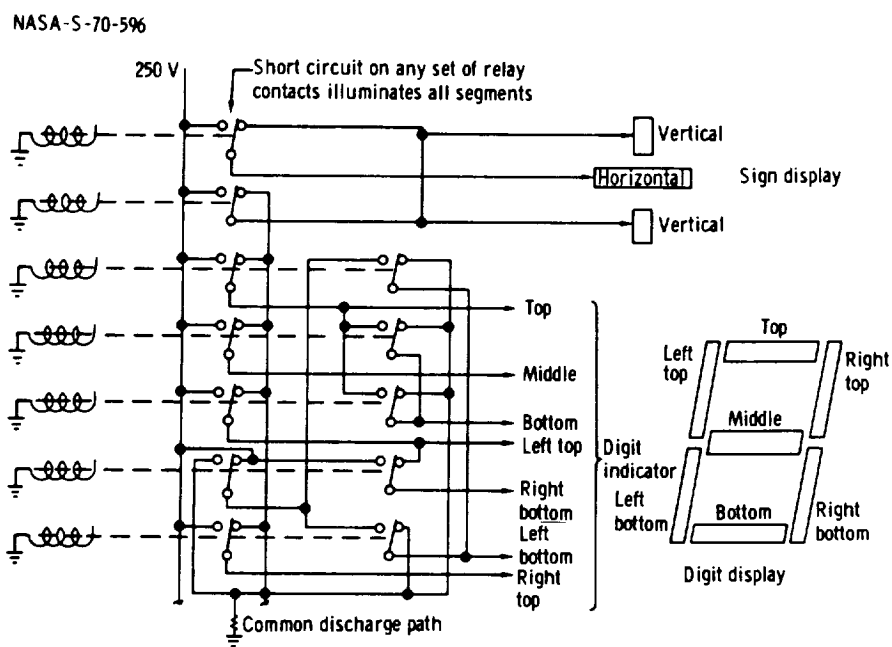
Figure 14-1. - Simplified schematic diagram of relay matrix.

The crew reported several intermittent, all-"8's" displays on the main display and keyboard assembly approximately 1-1/2 hours before launch, but no display malfunction occurred in flight. The display segments are illuminated by applying 250 V ac through the contacts of miniature relays, as shown in figure 14-1. When a segment is off, it is grounded through a resistor and the normally closed contacts of a relay to avoid residual illumination. The normally closed contacts of all relays are tied together; consequently, a short across the contacts of any one relay will apply the voltage to all segments of each display. The effect of the short in conjunction with the common discharge path is shown in figure 14-1 for a typical character and one sign. A short across the relay contacts will affect only the display function of the unit.

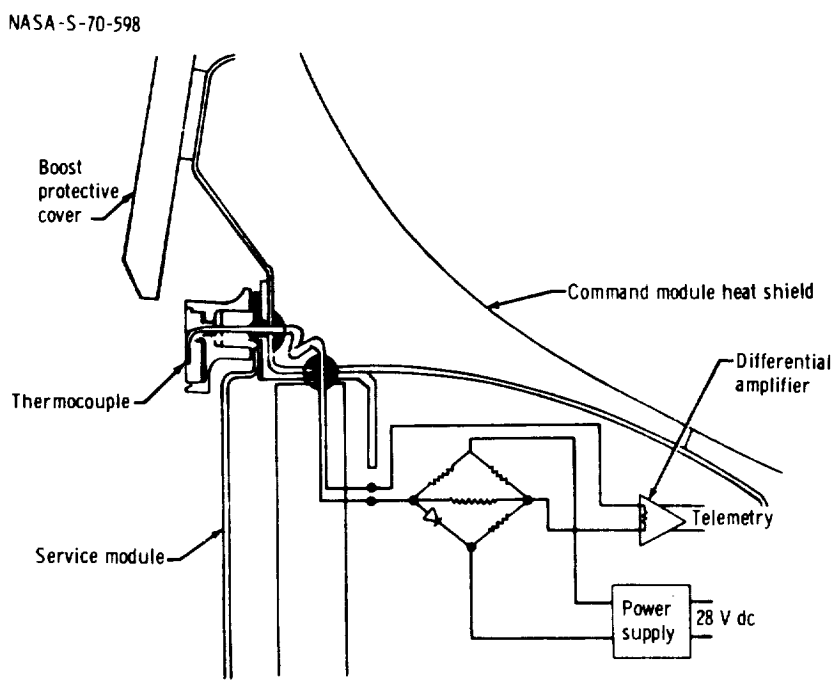
Figure 14-3. - Simplified schematic and location of a typical outer skin temperature sensor.

The service module outer surface temperature measurements use a chromel-constantan thermocouple and a reference junction. The reference junction is a bridge made up of three resistors and a temperature-sensitive diode (fig. 14-3). The resistors normally operate at about 0.020 ampere and will open in the region of 0.100 ampere. An open bridge resistor would drive the signal output off-scale high or low depending upon which resistor fails.

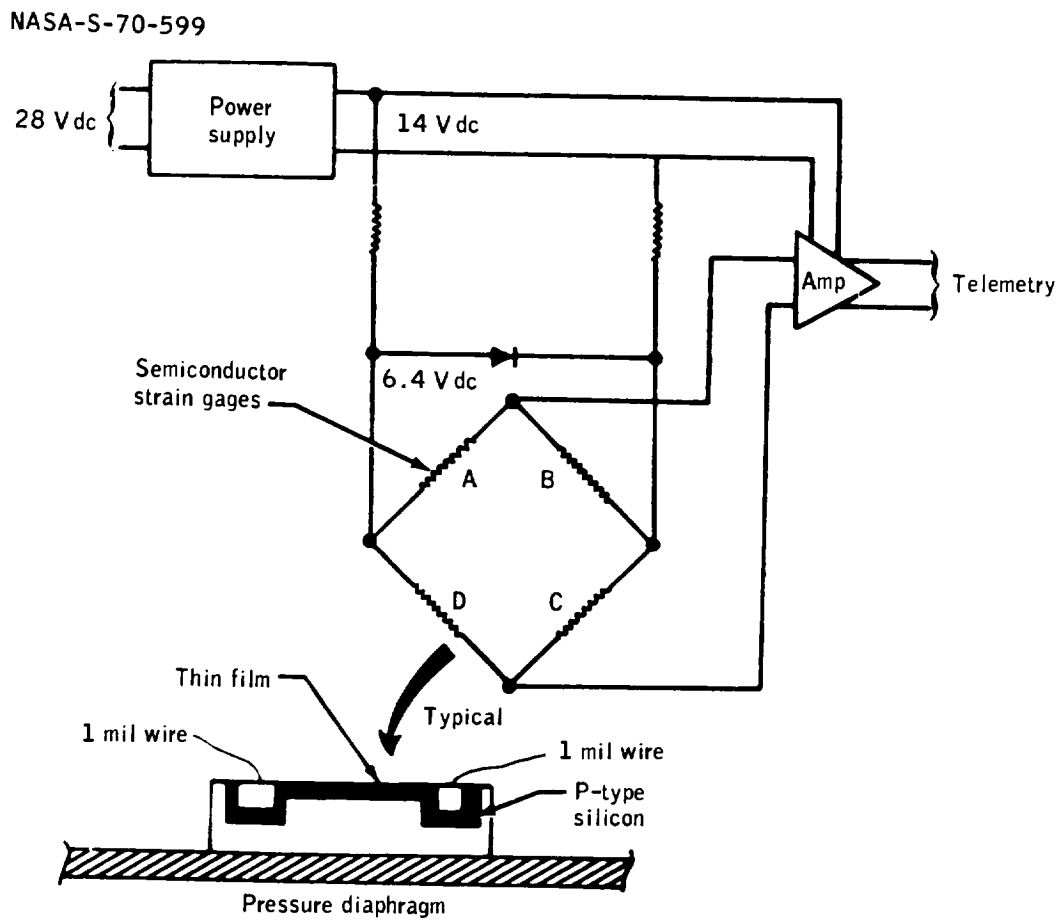
Figure 14-4.- Propellant quantity transducer schematic.

The reaction control propellant quantity measurements use semiconductor strain gages on a pressure-sensitive diaphragm (fig. 14-4). The semiconductors are a thin film type, and excessive current would probably damage their capability to operate as pressure-sensitive resistors. An alternate possibility is that the Zener diode, used to regulate the 14-volt supply to 6.4 volts, was burned out. Loss of this diode would explain the instrumentation symptom, which in all four cases was full-scale and unchanging.

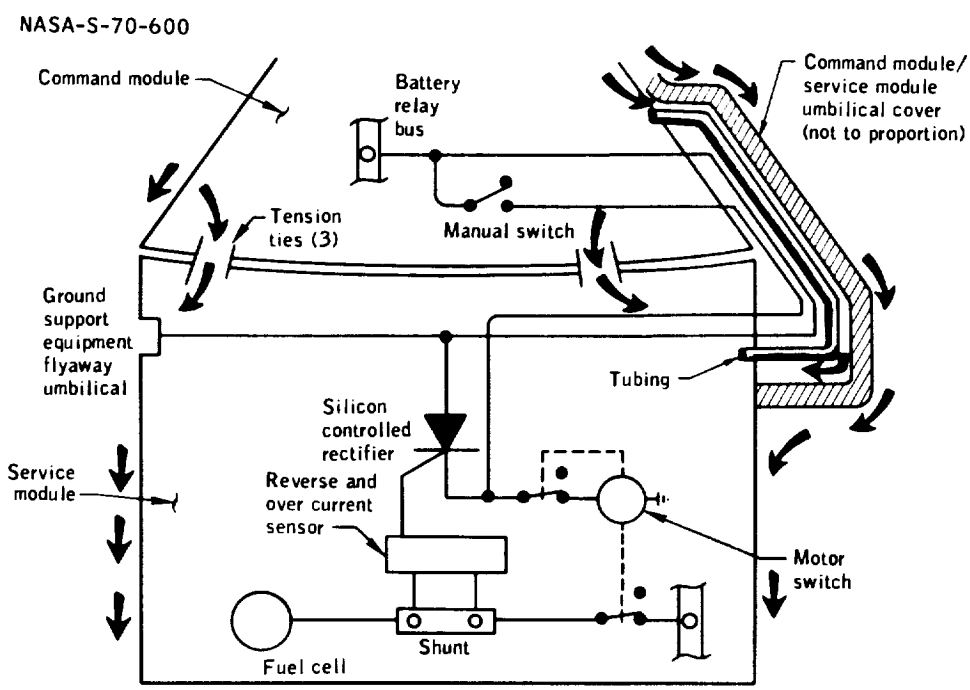
Figure 14-5.- Fuel cell disconnection circuitry.

The voltage transient that was induced on the battery relay bus by the static discharge exceeded the current rate-of-change characteristics of the silicon controlled rectifiers in the fuel cell overload sensors and disconnected the fuel cells from the bus (fig. 14-5). As a result, the main bus loads of 75 amperes were being supplied totally by entry batteries A and B, and the main bus voltages dropped momentarily to approximately 18 or 19 volts, but recovered to 23 or 24 volts within a few milliseconds. The low dc voltage on the main buses resulted in the illumination of undervoltage warning lights, a drop out of the signal conditioning equipment, and a lower voltage input to the inverters. The momentary low-voltage input to the inverters resulted in a low output voltage which tripped the ac undervoltage sensor causing the ac bus 1 fail light to illuminate. The transient that disconnected the fuel cells from the buses also caused the silicon controlled rectifier in the overload circuits to indicate an ac overload. At 2 minutes 22 seconds into the flight, the crew restored fuel cell power to the buses. All bus voltages remained normal throughout the remainder of the flight.

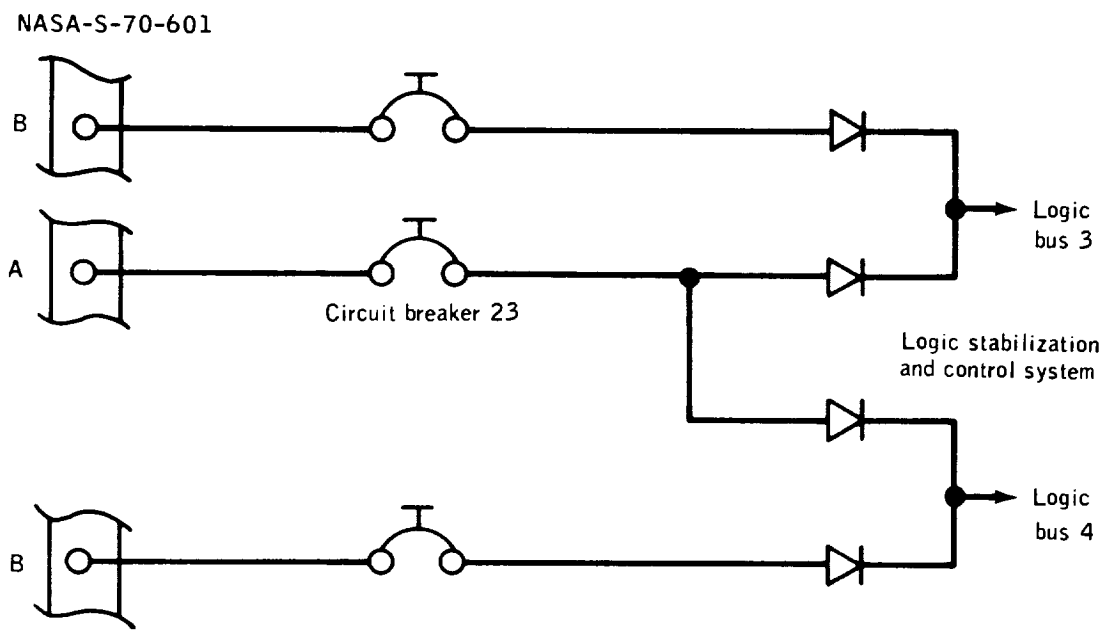
Figure 14-6.- Stabilization and control circuit breaker schematic.

it remained closed throughout the rest of the mission. Complete electrical and mechanical tests were performed and the results were normal. The circuit breaker and associated circuitry showed no cause for the breaker to have opened either because of launch vibrations or an electrical fault.

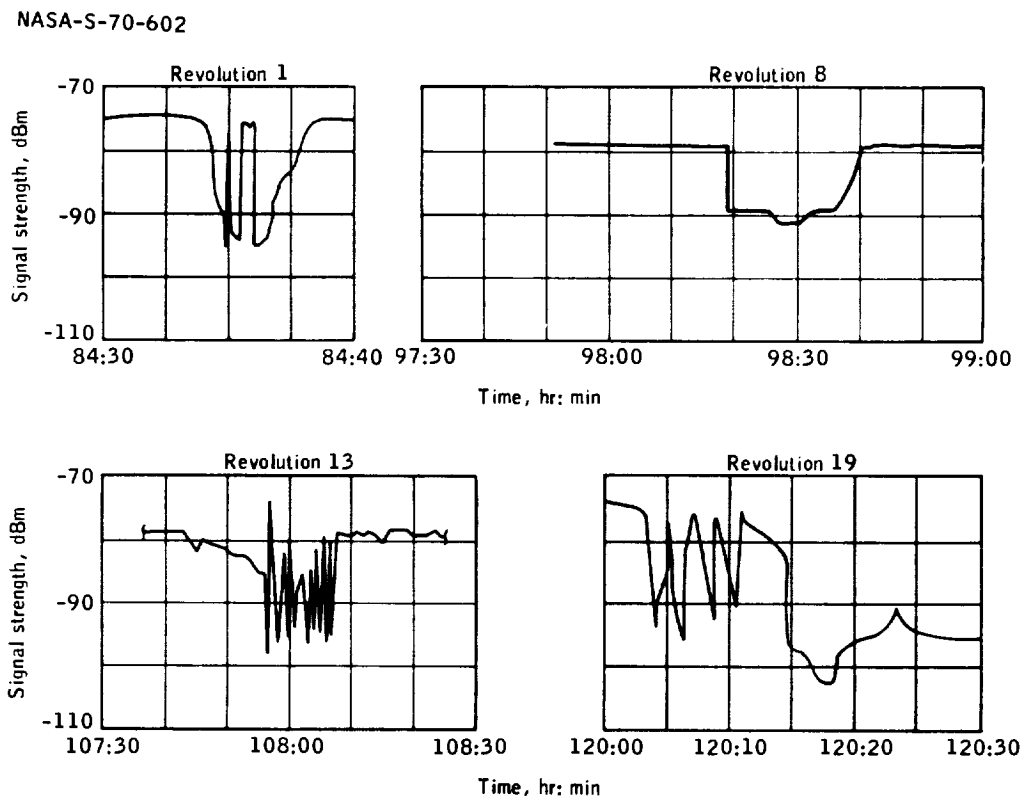
Figure 14-7.- Typical high gain antenna uplink signal strengths during abnormal operations.

Operation of the S-band high gain antenna in the narrow beam mode resulted in a decrease of approximately 10 to 12 dB in both uplink and downlink signal strength on several occasions. Illustrations of the first and other unexpected signal-strength variations are shown in figure 14-7. The first decrease occurred in lunar orbit revolution 1.

Two special tests were conducted during transearth coast with the spacecraft in attitude hold to isolate the malfunction. The sun angle was within approximately a 12-degree cone about the minus X axis to induce thermal stress on the antenna. In both tests, the narrow-beam and reacquisition modes were maintained until fluctuations in the uplink and

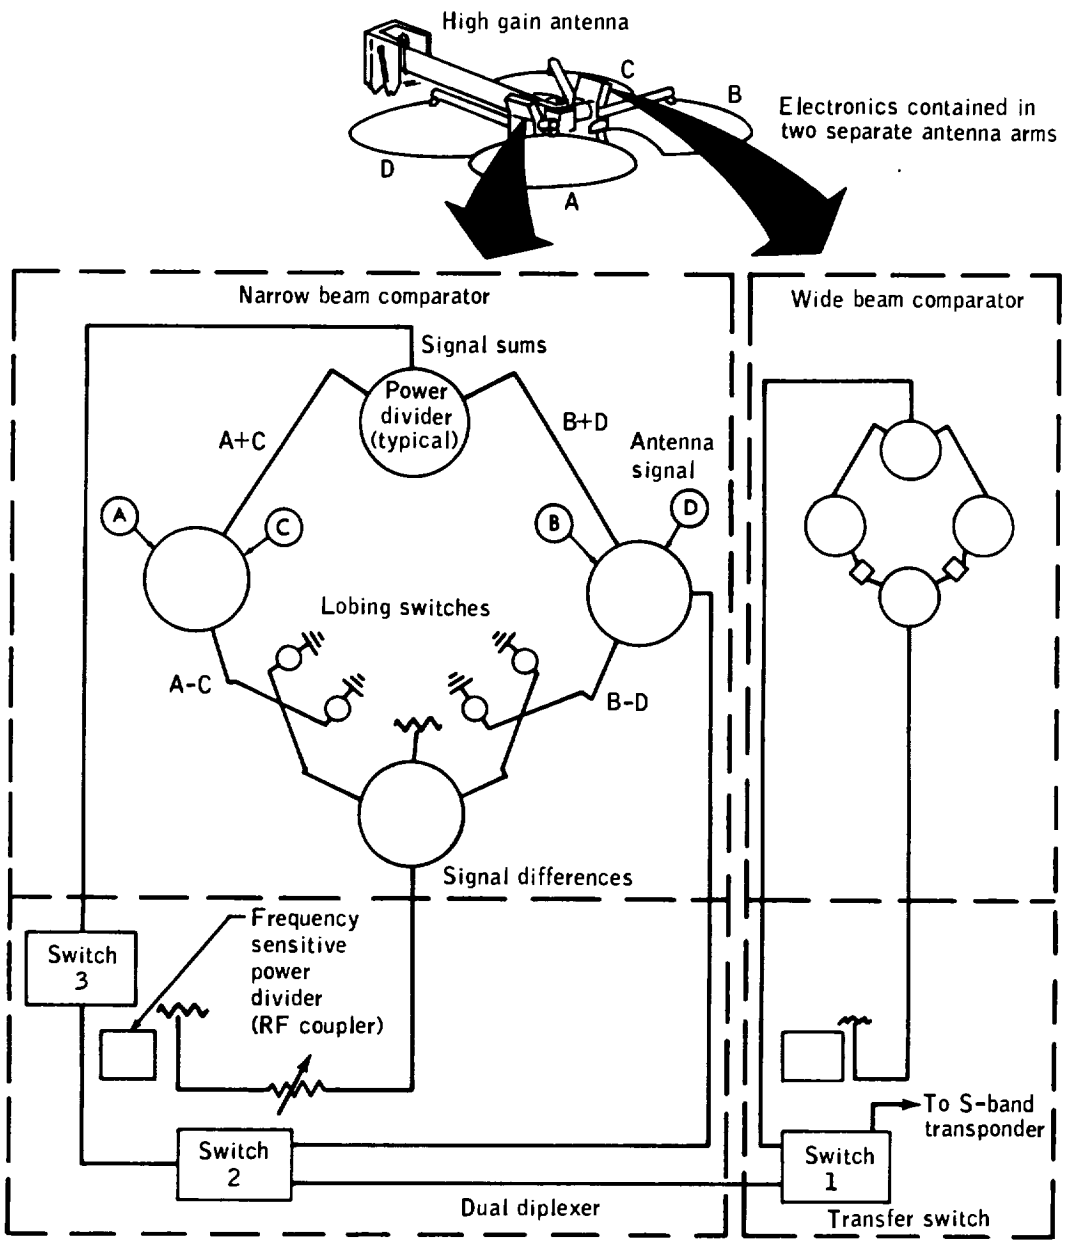
Figure 14-8.- S-band high gain antenna electronics.

There is a total of four stripline units with one contained in each of the following antenna components: narrow-beam comparator, transfer switch, and dual diplexer, as shown in figure 14-8. Based on the inflight tests, the wide beam comparator has been eliminated as a cause of the anomaly. Also, investigation of the circuitry and correlation of data has ruled out the transfer switch as being the anomaly cause. Therefore, the malfunction could only have been in the narrow beam comparator or the dual diplexer.

The narrow beam comparator combines the patterns of four dish antennas to provide the sum and difference patterns which provide the angle pointing information. Two malfunctions that could produce boresight shifts have been identified in the narrow beam comparator. Under normal operating conditions, the lobing switches function as digital phase shifters and provide either a zero or 180-degree phase shift. If a diode fault occurs that changes the phase or amplitude characteristics of either switch, tracking errors can be produced. The opening of one set of diodes would have to be intermittent to produce the observed flight anomaly, thus suggesting the presence of temperature or pressure sensitive connections in the traces that connect the diode switches. Another diode fault which can occur is a loss of the drive voltage to one of the lobing switches. In this case, the switch will provide a constant phase shift. The multiplexed difference signal for the case when the phase shift of switch 1 (fig. 14-8) is constant at 180 degrees results in unsymmetrical lobing. The antenna, in this case, will seek those pointing angles that make the elevation and azimuth angles equal in magnitude, thus suggesting that the resultant tracking error could be large and not repeatable. This condition would give the observed antenna performance characteristics. Therefore, a malfunction in the diode wiring or circuit connections is suggested. The intermittence associated with this malfunction could be explained by a temperature sensitive circuit connection (solder crack or wire break).

The major components of the dual diplexer are switches 2 and 3 and the frequency-selective power divider. The power divider is the most susceptible component for generating tracking errors. If the difference signal is attenuated by a high impedance feed-through or by incorrect phasing between the sum and difference signals, the slope of the antenna index-of-modulation curve is reduced. This decrease, in effect, reduces the total loop gain and results in an overdamped tracking system. In this case, large tracking errors would result and an antenna drift would be observed; these were the observed symptoms. Attenuation of the multiplexed difference signal can result from a trace crack or intermittent feed-through between the narrow beam comparator and the dual diplexer. Both types of failures tend to be temperature sensitive.

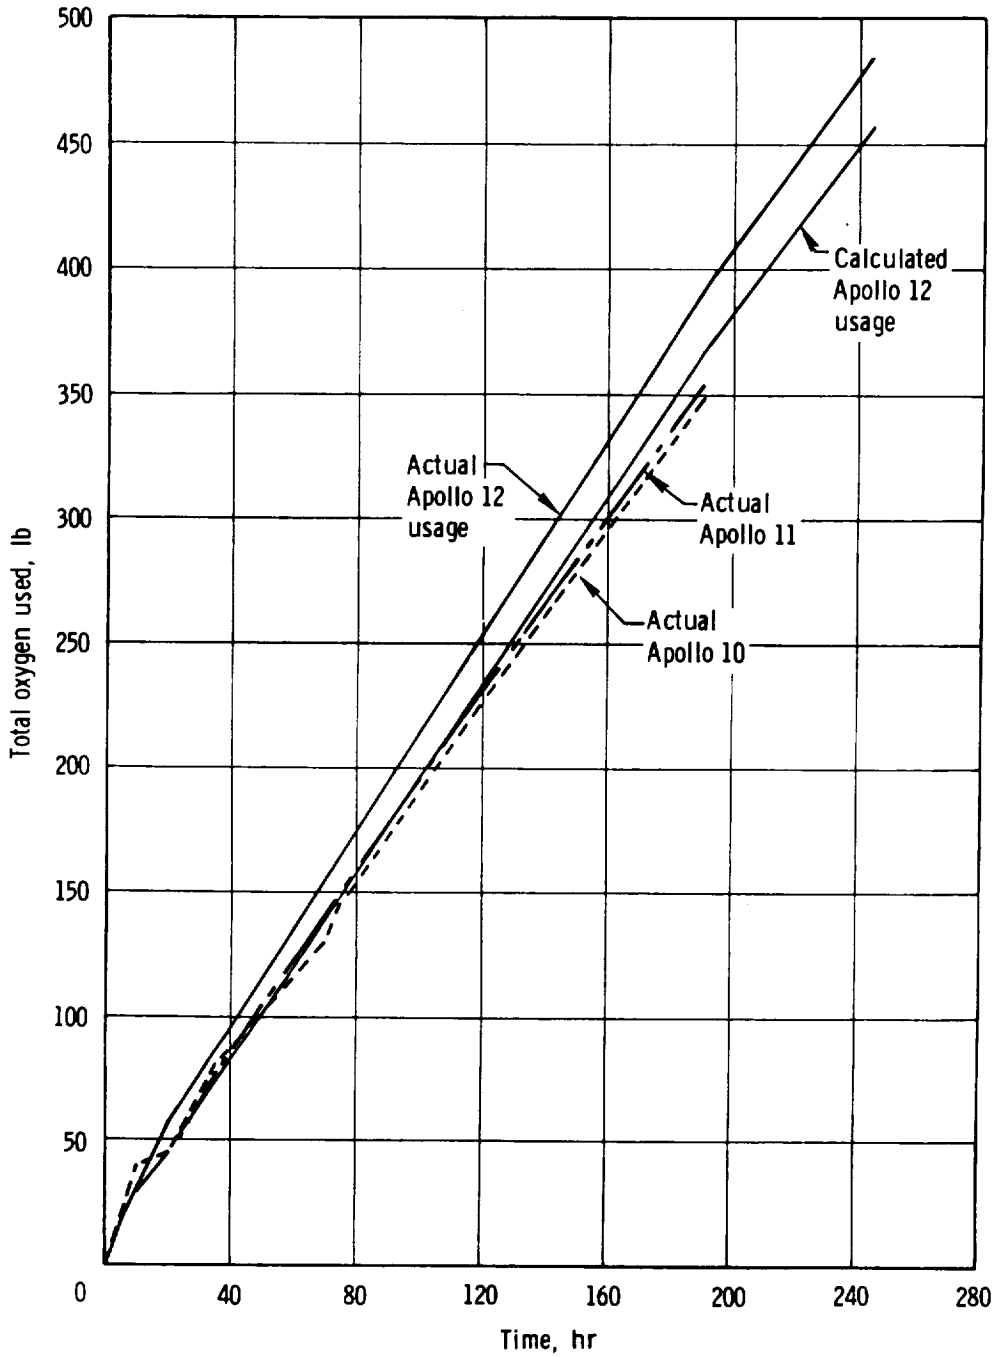
Figure 14-9. - Comparison of oxygen consumption for Apollo 10, 11, and 12.

At the end of the mission there was a discrepancy of approximately 27 pounds of oxygen between the measured total cryogenic oxygen usage and the calculated combined environmental control system and fuel cell oxygen usage, as shown in figure 14-9.

Fuel cell oxygen usage was calculated from the produced electrical current and then verified by comparison with hydrogen consumption data. Environmental control system usage is measured on a flowmeter and compared with calculated usage based on purge rates, cabin leakage rates, metabolic consumption and urine dump losses. Cabin leak rates are determined by ground tests in conjunction with flight pressure decay rates. Purge rates are calculated based on ground tests and known times for purges. Oxygen losses during urine dump operations can only be estimated. Since no excessive flow was detected downstream of the flowmeter, the source of any command module environmental control system leakage is therefore limited to the 900-psi system upstream of the meter. Figure 14-10 shows the 900-psi oxygen system and that portion of the system outside the command module that could have leaked.

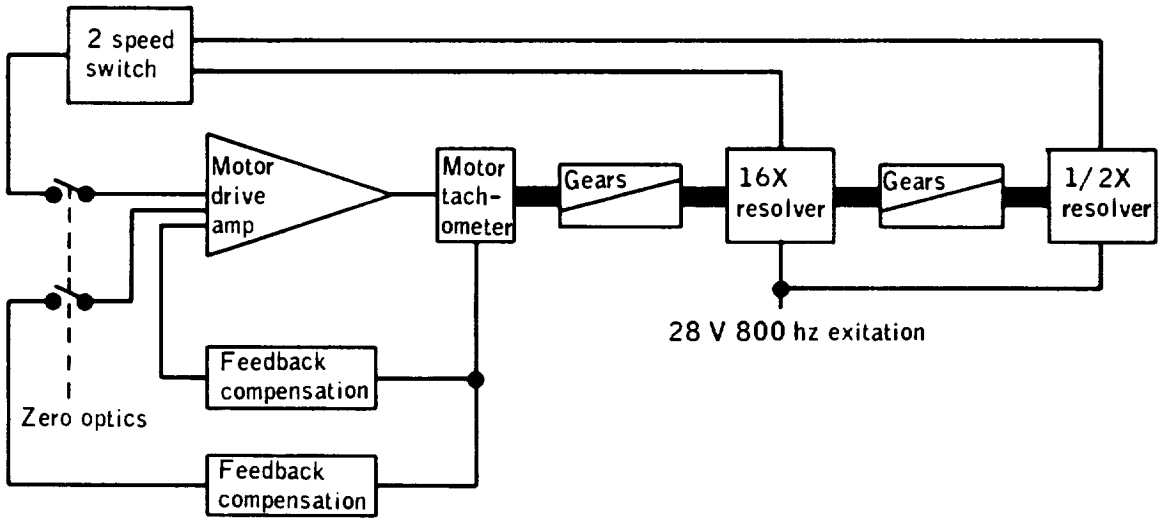
Figure 14-11.- Zero optics mode circuitry.

A number of components in the optics drive servomechanism (fig. 14-11) are used only in the zero optics mode. The optical unit and the power-and-servo assembly were removed from the spacecraft, and the servo assembly was subjected to thorough testing. The flight symptoms, however, could not be reproduced. Because of extensive sea-water corrosion, the optical unit could not be tested, but an analysis and testing of a similar unit demonstrated the cause of the zero optics anomaly to be within the power-and-servo assembly. The flight assembly was installed in a working system and has operated properly under a variety of thermal conditions. The modules associated with the optics servo were also thermally cycled in an oven, operated in a vacuum, and subjected to acceptance test vibration levels with no degradation of their performance. The modules were depotted and examined, but no cause of the anomaly could be isolated.

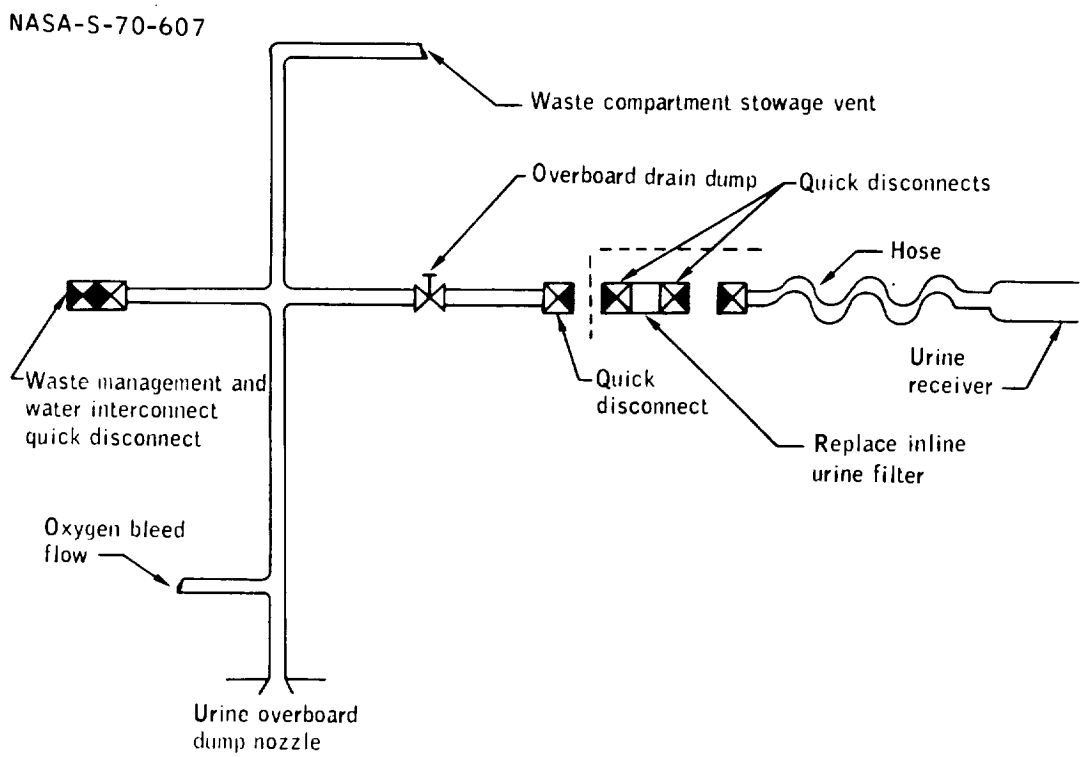
Figure 14-12.- Urine dump system flow schematic.

By about 215 hours, the crew reported that both urine filters had clogged and that the urine overboard dump system was being operated without a filter. The inline filter (fig. 14-12) clogged the day after the Commander and the Lunar Module Pilot returned to the command module from the lunar surface activity (day 7). The filter was then replaced by a spare unit which also clogged 2 days later. The urine dumping system operated satisfactorily without a filter for the remainder of the mission (approximately 30 hours).

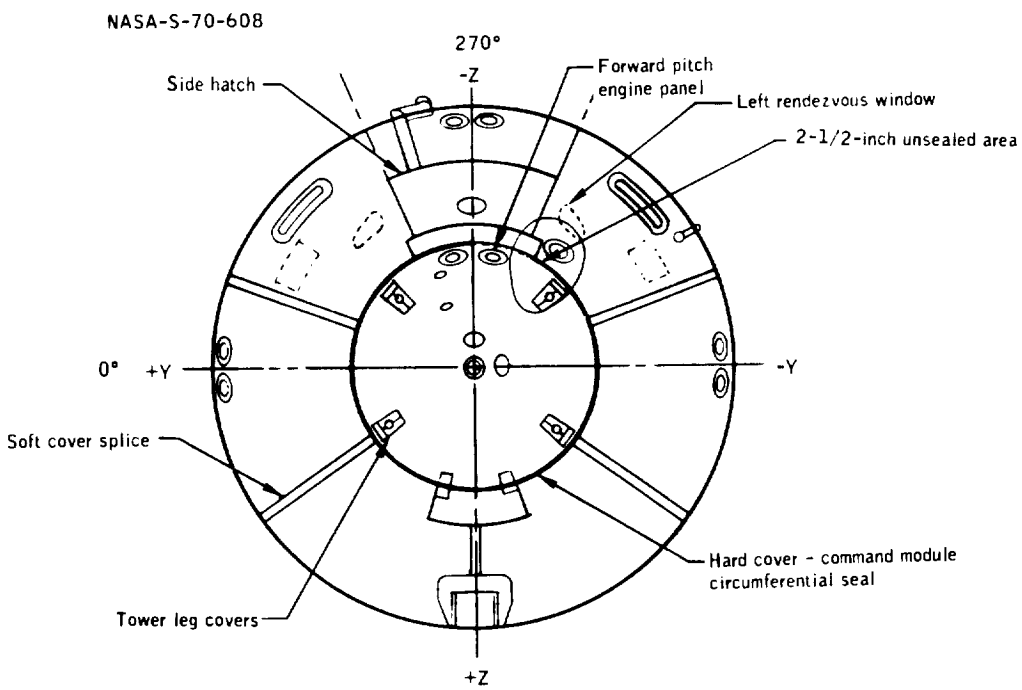
Figure 14-13.- Boost protective cover view looking aft.

The hatch, left-hand side, and both rendezvous windows of the command module had considerable amounts of contamination appearing as vertical streaks on the exterior surfaces. Before flight, gaps in the boost protective cover were noted in the hard-to-soft transition region over the left rendezvous window (fig. 14-13). A procedure requires that these gaps be sealed with a composition sealant on final installation of the boost protective cover; however, some gaps were not sealed. The crew reported that during the heavy rain just prior to launch they saw water on the exterior window surfaces and also observed water flowing over the windows at tower jettison. The water rivulets acted as collection sites for the exhaust residue during escape motor firing. After the water evaporated, the residue deposits remained on the surfaces of the windows.

Contamination was also noted on the inside surface of the heat-shield panes on the left-hand side and hatch windows. The contamination, which disappeared on the left-hand side window after the first day, probably resulted from water entrapped between the heat shield and pressure structure in the general area of this window. The contamination on the inside surface of the hatch heat shield window remained throughout the flight and varied in size with the thermal cycles of the spacecraft. This contamination could have resulted from either entrapped moisture in the hatch area between the heat shield and the pressure structure or from outgassing of sealant materials in this area (fig. 14-14). Such outgassing has been minimal in the past three flights because the curing processes were changed to alleviate this problem. However, a chemical analysis of the contamination on the inside surface of the hatch window has shown the concentration of silicone oils to be higher than expected. These oils are the outgassed products from the material used to seal the thermal blankets near the window.

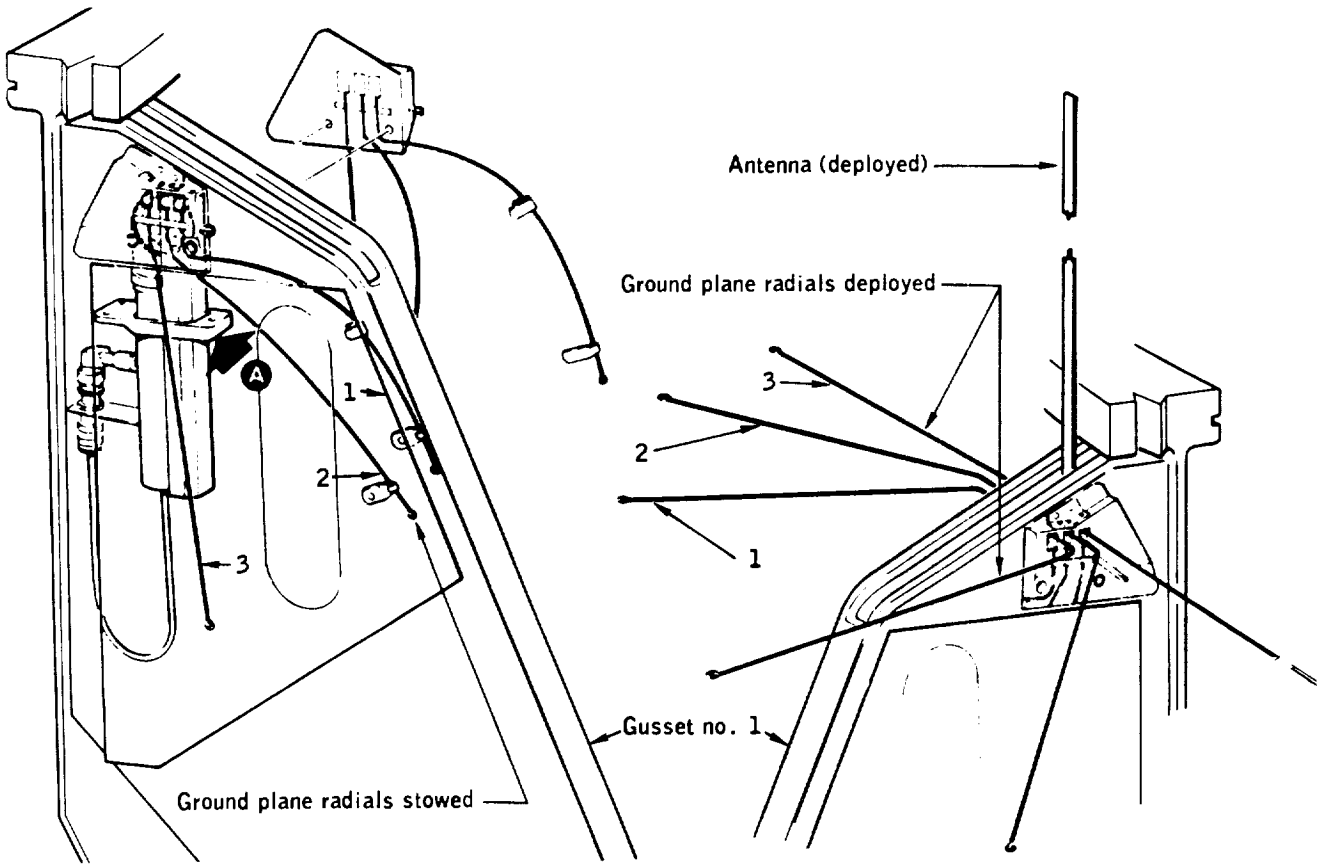
Figure 14-15.- VHF recovery antenna configuration.

During the command module descent on the main parachutes, ground plane radials 1 and 3 of VHF recovery antenna 2 (fig. 14-15) did not properly deploy. However, voice communications with the recovery forces while using this antenna were not significantly affected. Postflight examination of the antenna revealed that the cloth flap which normally covers the radials to prevent entanglement with the parachutes could be made to stick to the gusset by an adhesive substance which was inadvertently present on both the flap and the gusset. The radials would not deploy when the flap had stuck to the gusset; however, radial 1 would not always deploy, even when the flap was not stuck. A slight binding at the spring end or at the retaining clip has been experienced on radial 1.

For Apollo 13 and subsequent missions, recovery antenna 2 will be used for recovery beacon transmissions instead of voice. However, even

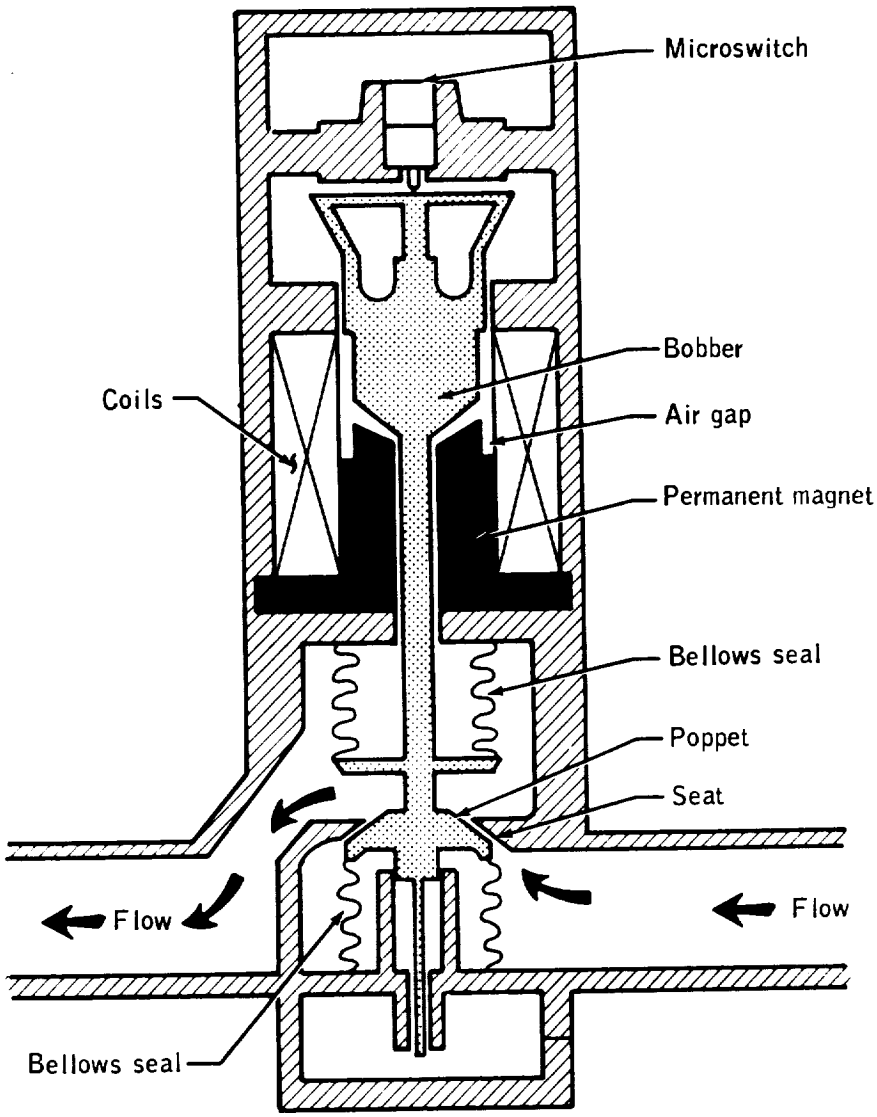
Figure 14-16.- Cross sectional view of reaction control system isolation valve.

When the oxidizer isolation valve was disassembled after flight, the inlet-side bellows had been deformed enough to prevent the valve from staying in the closed position. The bellows in the system 1 propellant

isolation valve had also been deformed, but not enough to prevent the valve from staying closed. A review of the test and checkout history, as well as inspection records, for the Apollo 12 isolation valves indicates the valves were not degraded prior to flight. The necessity for having the valves open prior to system activation and purging will be emphasized to future crews.

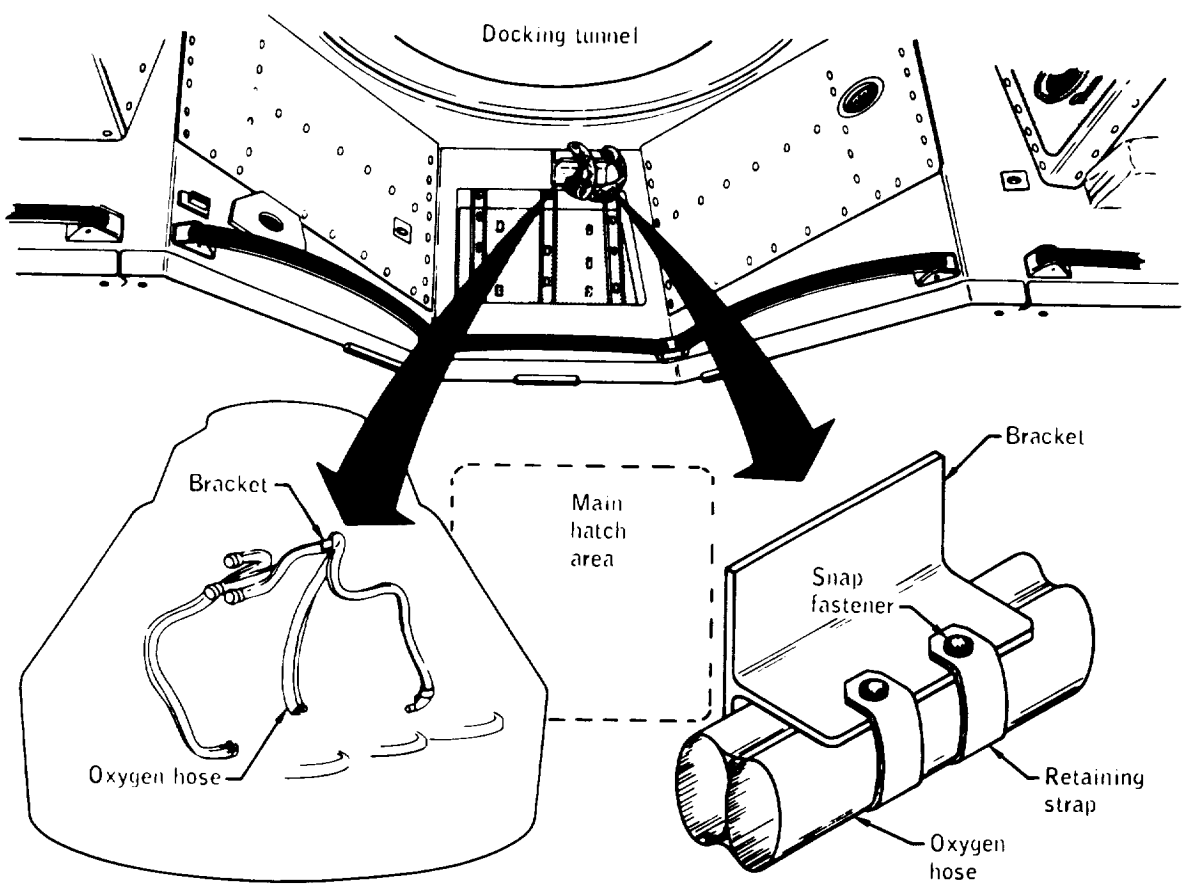
Figure 14-17.- Oxygen hose retention bracket.

At earth landing, an aluminum retention bracket for the oxygen hoses pulled loose from the main display panel (fig. 14-17). The bracket is bonded to the panel and supports four oxygen hoses, which are attached to the bracket by Beta cloth straps that snap to the panel.

Postflight inspection of the bracket revealed an inadequate adhesion area between the bracket and the panel. The adhesive material was not uniformly spread under the bracket, thereby creating large voids. A non-uniform application of pressure during the cure cycle is the most probable cause of this condition. Manufacturing requirements have been changed to include torque testing of the bracket to assure that a proper bond has been achieved.

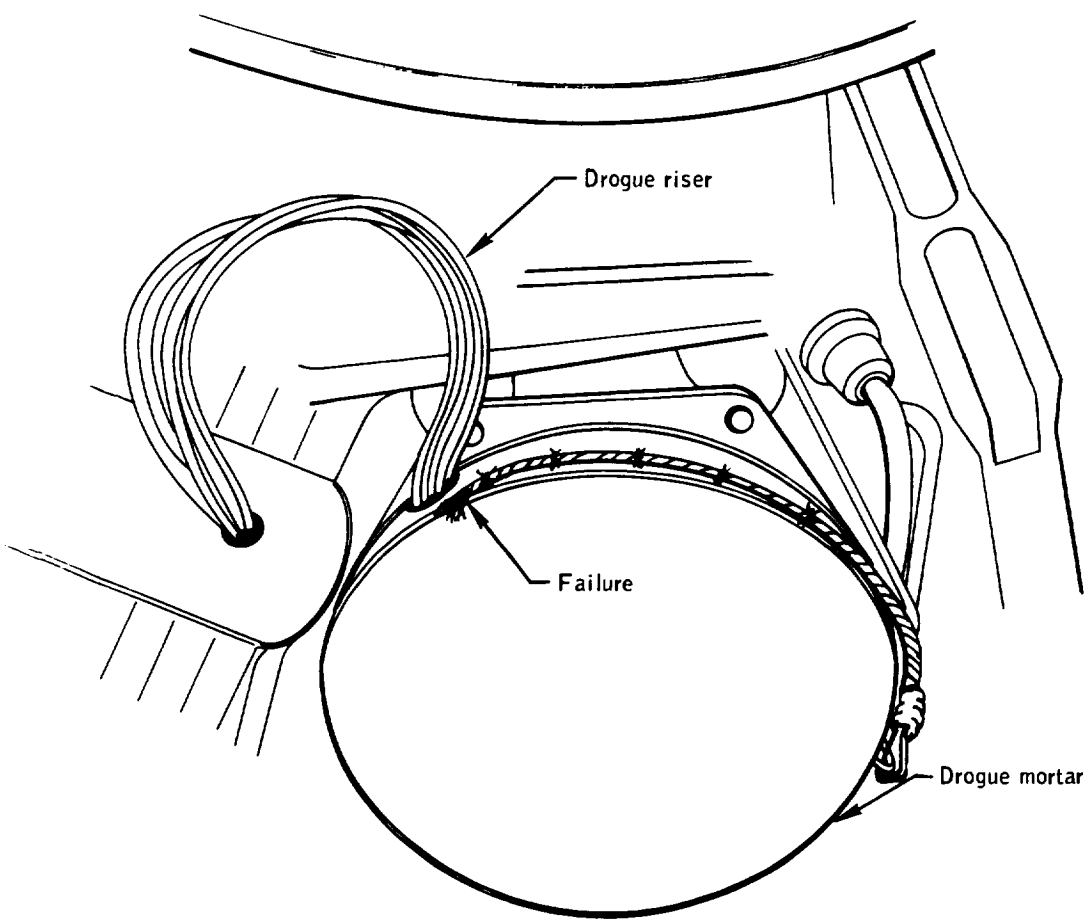
Figure 14-20.- Failed lanyard at right-hand drogue mortar.

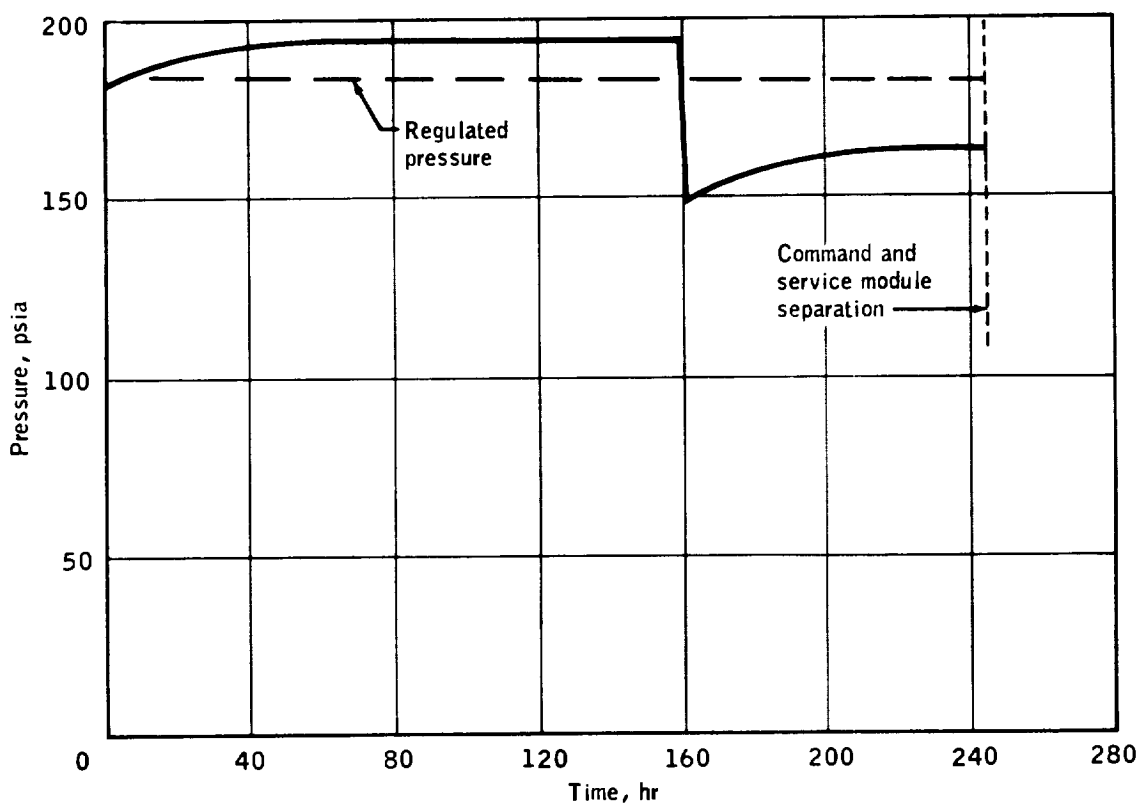
Figure 14-21.- Quad D helium manifold pressure.

Shift in quad D helium manifold pressure.- The measurement for reaction control quad D helium pressure indicated erroneous values throughout the flight. During the first 70 hours, the pressure exhibited a slow drift of about 14 psia upward. At approximately 160 hours, the measurement then shifted from 192 to 150 psia, followed by a second slow drift upward (fig. 14-21). Both the slow drifts upward and the jump shown on the figure tend to support the conclusion that the strain-gage bonding had weakened. The measurement is primarily used during preflight testing to indicate the helium manifold pressure downstream of parallel redundant pressure regulators and is not necessary for flight.

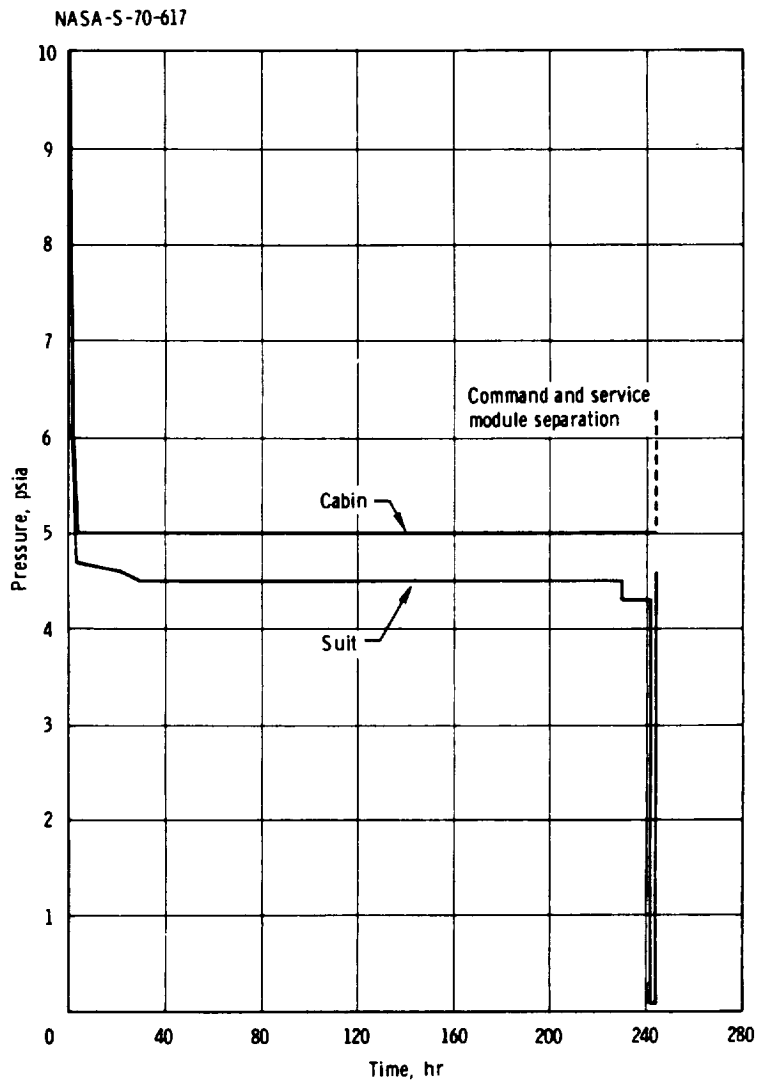
Figure 14-22. - Suit and cabin pressure history

The suit pressure transducer operated properly throughout the prelaunch and launch activities. When the helmets and gloves were removed after launch, the transducer indicated 0.2-psid less than cabin pressure and at approximately 22 hours the differential was 0.4 psid. A 0.4- to 0.6-psid disparity existed between the indicated suit loop and cabin pressures until the final hours of the mission (fig. 14-22).

At 241:41, the suit pressure transducer reading dropped to 0.1 psia, while cabin pressure was stable at 5.0 psia. About 3 hours later, at command module/service module separation, the transducer recovered to 4.6 psia. The transducer indicated a 0.4- to 0.5-psid discrepancy throughout entry. Postflight tests of the installed transducer repeated the flight anomaly. However, during subsequent tests of the removed transducer, the unit operated normally. The transducer was then returned to the manufacturer's facility, where flushing and disassembly revealed internal contamination from metallic nickel-plating particles. These particles could have caused an irregular transducer output by physically interfering with the Bourdon tube movement or by changing the inductance field of the unit. After the transducer was cleaned and reassembled, testing produced satisfactory operation. The noted contamination apparently resulted from either improper cleaning procedures or from self-generated particles within the unit.

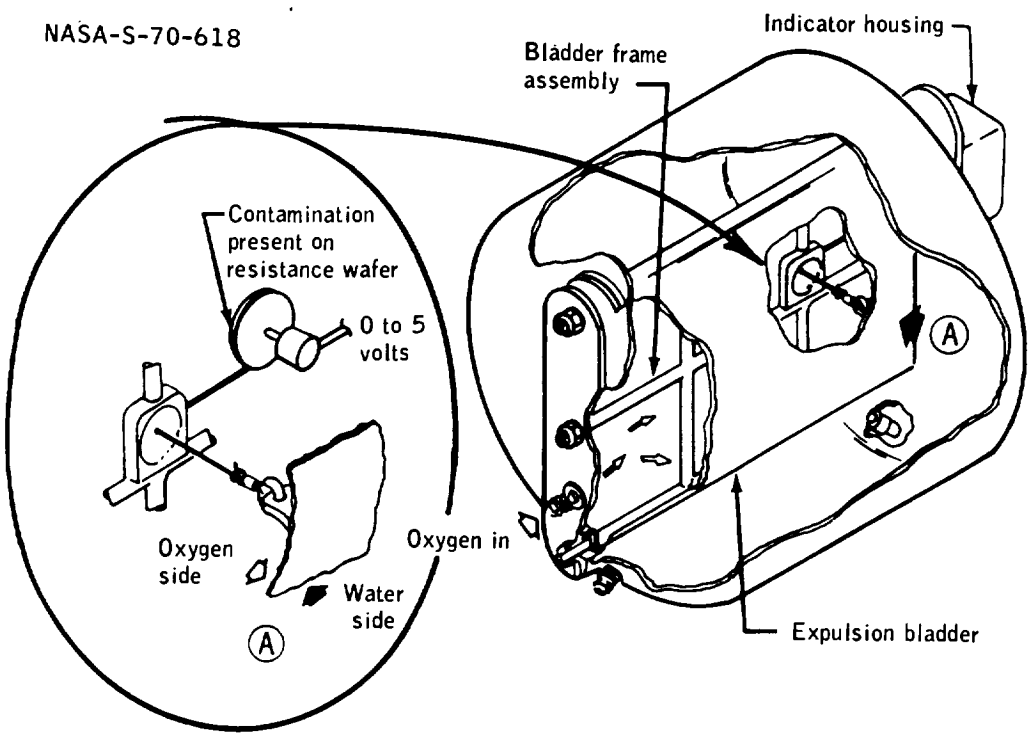
Tests of the potentiometer reproduced the output fluctuations for wiper positions equal to approximately zero quantity (zero volts) and full quantity (5 volts). The potentiometer was disassembled and appeared clean and free of contamination except for a slight stain on the end surfaces of the resistance wafer (fig. 14-24) corresponding to wiper positions for the 0 and 5 volts. The film was removed with a water-moistened swab, but the quantity of contaminate was too small to be identified.

Figure 14-23.- Area of failure in erratic potable water transducer.

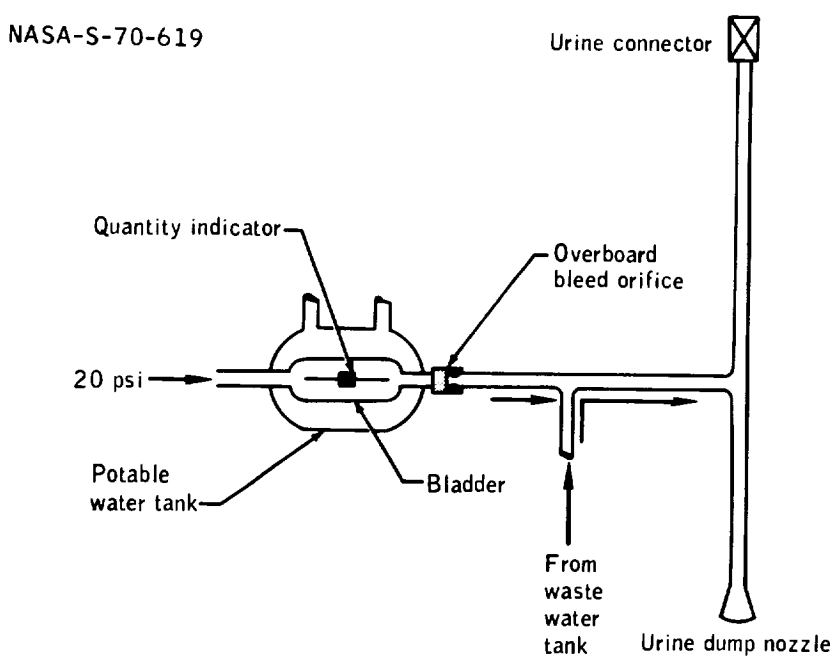
Figure 14-24.- Schematic of oxygen bleed flow and overboard urine dump line.

Tank calibration data after flight compared favorably with those from preinstallation calibrations. Disassembly and inspection revealed that corrosion had partially obstructed the oxygen overboard bleed orifice (fig. 14-23). No evidence was found of moisture or urine contamination on components of the water measuring system.
