APOLLO 12 MISSION REPORT

National Aeronautics and Space Administration
LYNDON B. JOHNSON SPACE CENTER
Houston, Texas
MARCH 1970

Mission Evaluation Team

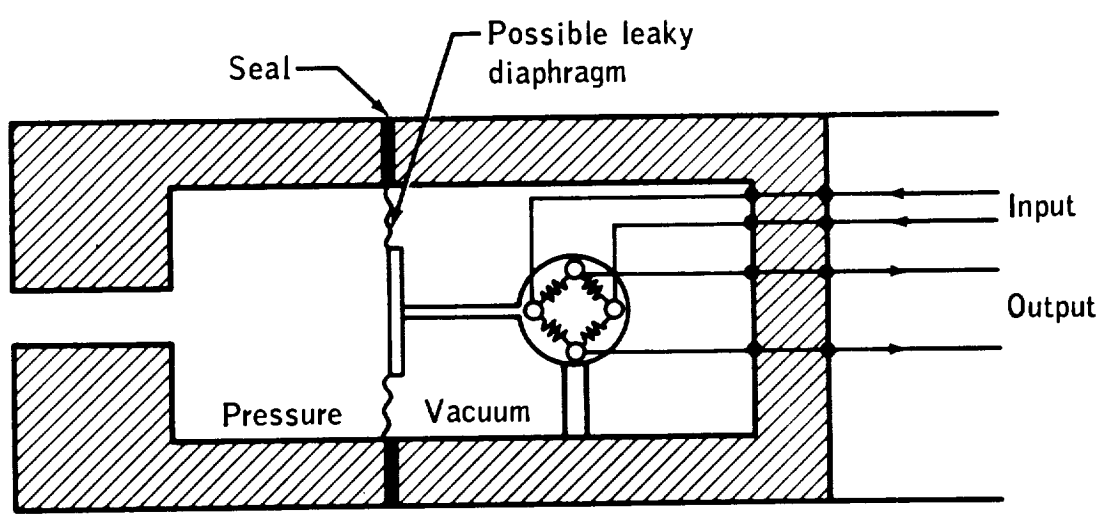
Figure 14-25.- Fuel cell 3 transducer schematic.

Fuel cell 3 regulated hydrogen pressure decay.- The fuel cell 3 regulated hydrogen pressure gradually decayed from 61.5 psia to about 59.5 psia, but remained within specification limits. The hydrogen regulator was eliminated as a possible cause of the decay, because the only regulator failure mechanism that would allow a 2-psi decay would be vent valve leakage at a rate of 2.6 pounds/hr. A 2.6-pound/hour flow rate is 38 times greater than normal for a 25-ampere individual fuel cell load and would have been easily observed on the fuel cell flowmeter.

The apparent pressure drop has been attributed to a pressure transducer failure, with the most probable failure mode being a small leak through or around the stainless steel diaphragm in the transducer (fig. 14-25). Such a leak would allow hydrogen to enter the vacuum reference chamber of the transducer, thus destroying the normal pressure differential across the diaphragm. This reduction would result in the indicated pressure decay observed during the flight. A similar transducer failure occurred during a production fuel cell pre-test checkout.

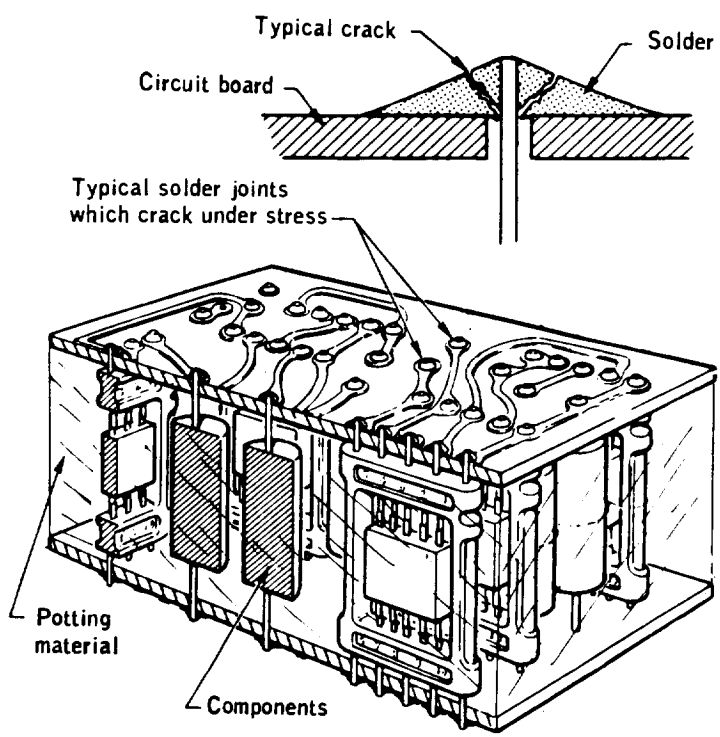
Figure 14-26.- Mission timer construction.

Based on previous mission clock failures, the most probable cause for this anomaly is a cracked solder joint in the cordwood construction. As seen in figure 14-26, electrical components (resistors, capacitors, diodes, etc.) are soldered between two circuit boards, and the void between the boards is filled with potting compound. The differential expansion between the potting compound and the component leads can cause solder joint cracks.

New mission timers, which will be mechanically and electrically interchangeable with present clocks, are being developed for Apollo 13 and subsequent spacecraft. The new clock design eliminates the cordwood construction and is less susceptible to electromagnetic interference.

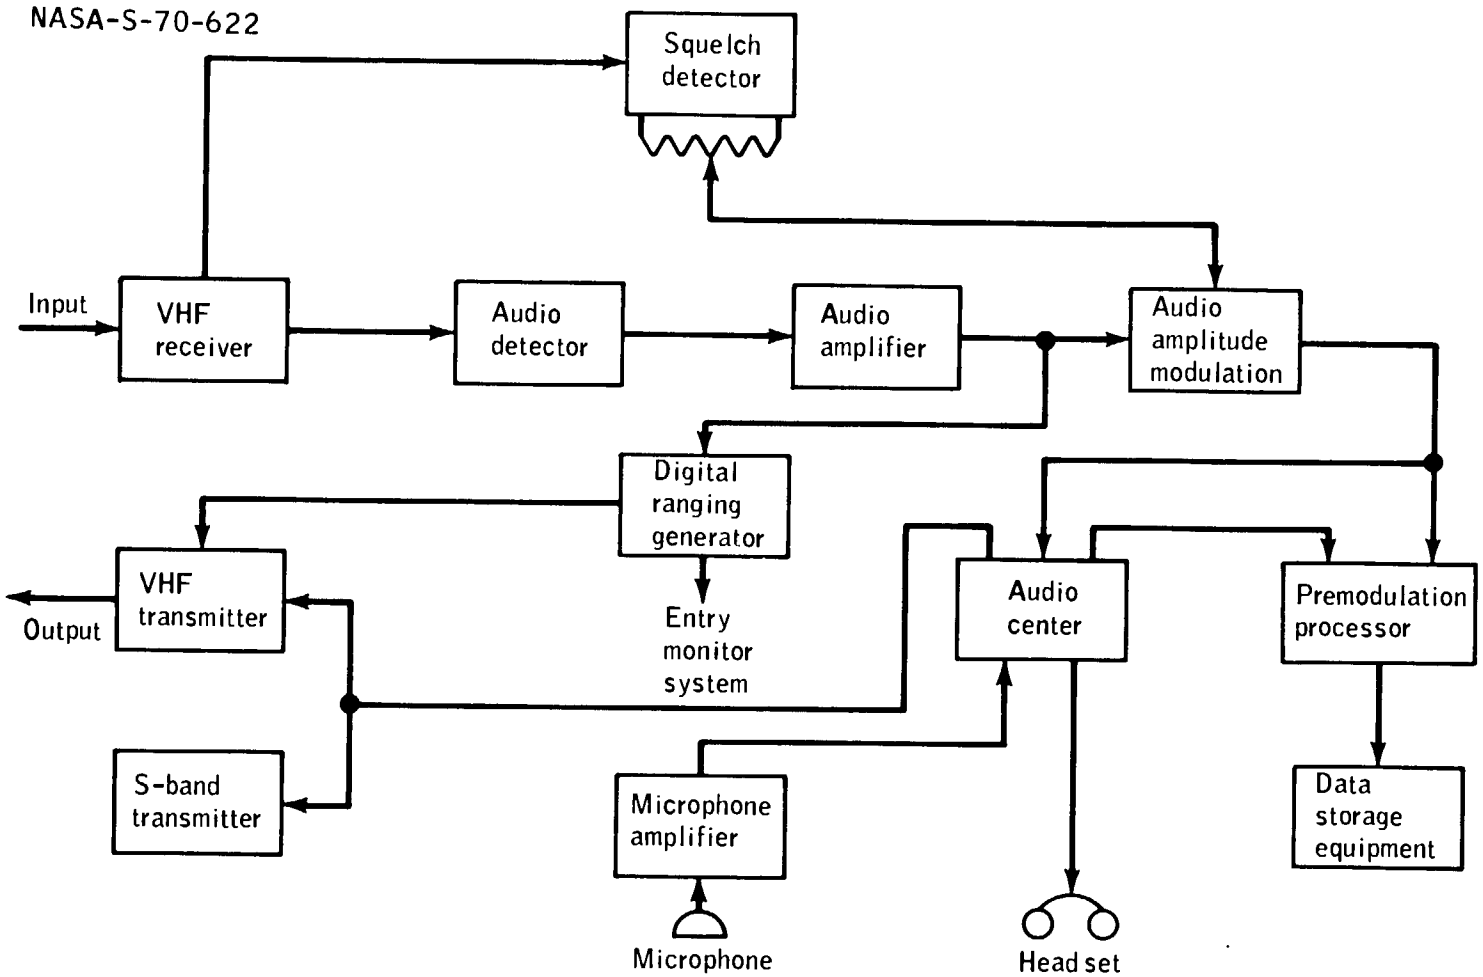
Figure 14-27.- Command module VHF communications configuration.

During ascent and rendezvous, there was a VHF communications problem between the command module and the lunar module. During this time period, there appeared to be only one problem associated with VHF voice but there were actually two separate problems. Figure 14-27 shows the VHF system as it was configured in the command module during these phases.

During ascent, there were communications from the command module to the lunar module using VHF through the lunar module aft and command module right antennas. However, beginning at 142 1/4 hours, communications from the lunar module to the command module had to be accomplished using an S-band network relay. In this case, the predicted RF signal strength (fig. 14-28) was below the sensitivity of the squelch thumbwheel setting. During the 23-minute time period following lunar module lift-off, the two vehicles had closed to a range of approximately 200 miles and the lunar module crew had switched to the forward antenna. At this point, the received signal strength at the command module improved and the Command Module Pilot began to understand the VHF voice communications.

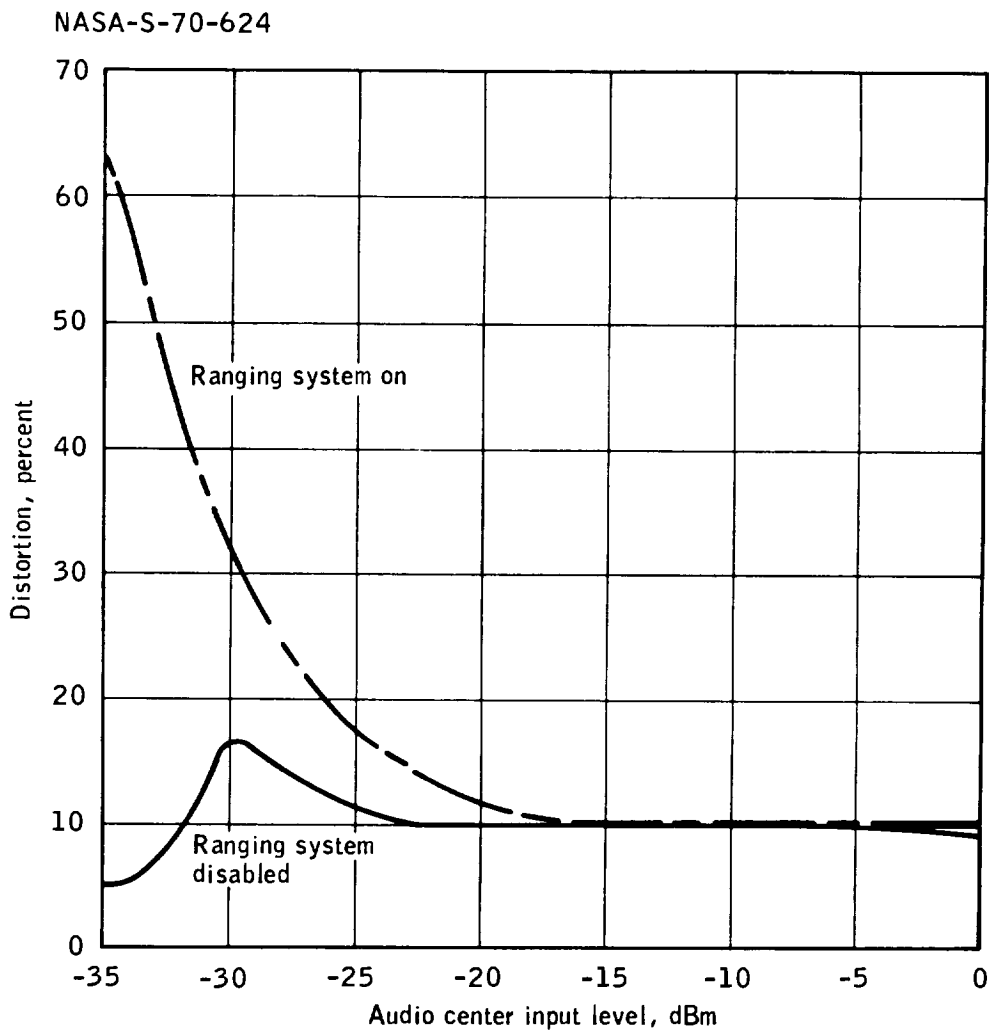
Figure 14-29.- Lunar module received VHF audio distortion.

reduced level can then cause a voice-operated dropout of the voice operated transmitter. Such dropout did not occur at this time, because the Command Module Pilot was using the push-to-talk mode. Figure 14-29 shows the percent distortion of the lunar module received signal versus the command module audio center input, both with and without ranging. The curve shows that, in the ranging mode as the input level to the audio center decreases, distortion of the received signal increases significantly. This distortion cannot be directly related to intelligibility, but it does indicate that system performance is degraded by the low input levels.

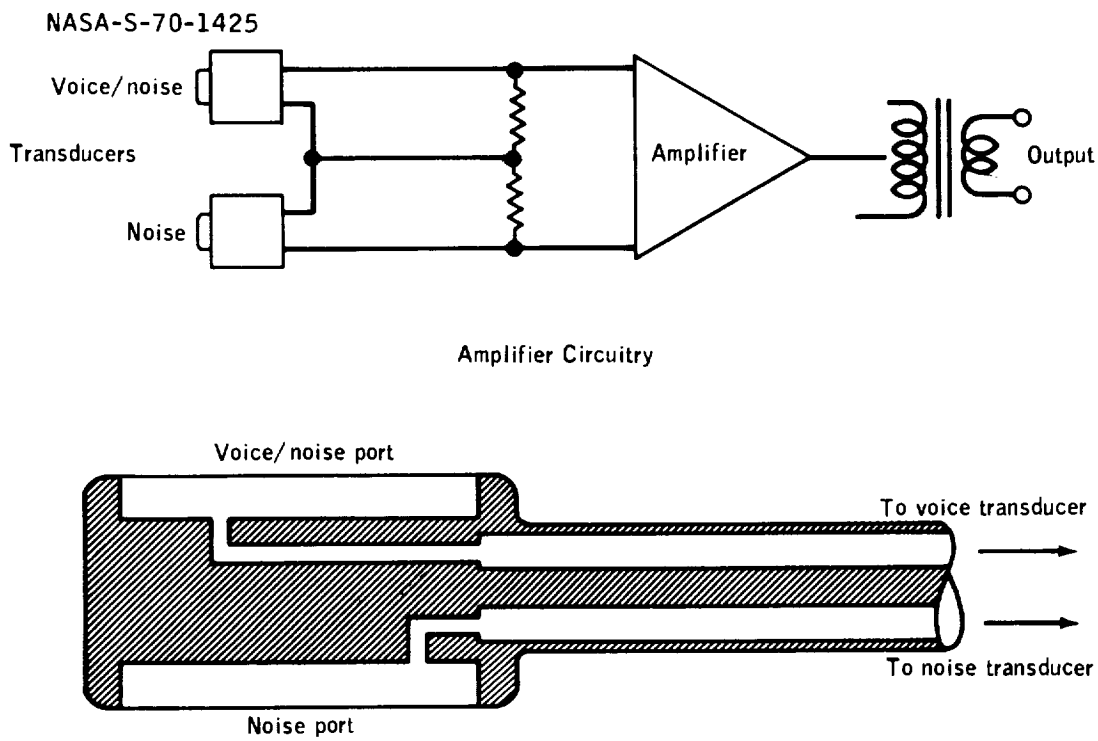
Figure 14-30.- Headset microphone voice/noise ports and amplifier circuitry.

The headset microphone was designed to provide noise cancelling through mechanical spacing of the voice-capture and noise-cancelling ports (fig. 14-30). The output of the microphone amplifier is the amplified difference between the voice and noise transducer outputs. Therefore, with improper microphone placement, voice transmissions also enter the noise port, partially cancel transmissions entering the voice port, and thereby reduce the overall voice output level.

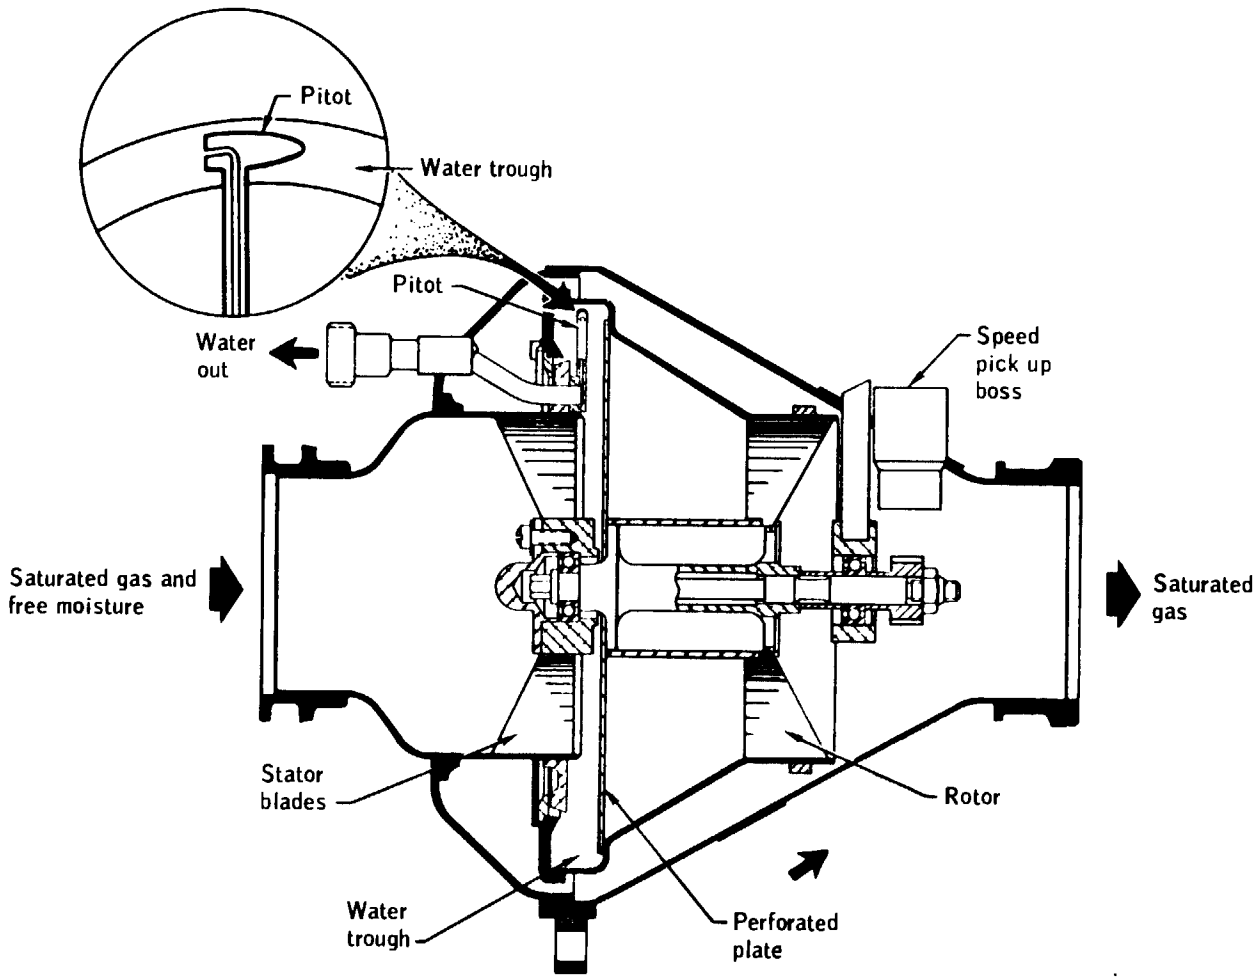
Figure 14-31.- Water separator and pitot configuration.

The water separator speed indication was above the upper limit (in excess of 3600 revolutions per minute) for about 50 percent of the mission. Since the water separator is a gas-driven centrifugal pump, this high speed indicates a higher than normal gas flow through the separator. Tests have shown that, at separator speeds in excess of 3700 revolutions per minute, water splashing occurs at the pitot tube (fig. 14-31) allowing water to bypass the separator.

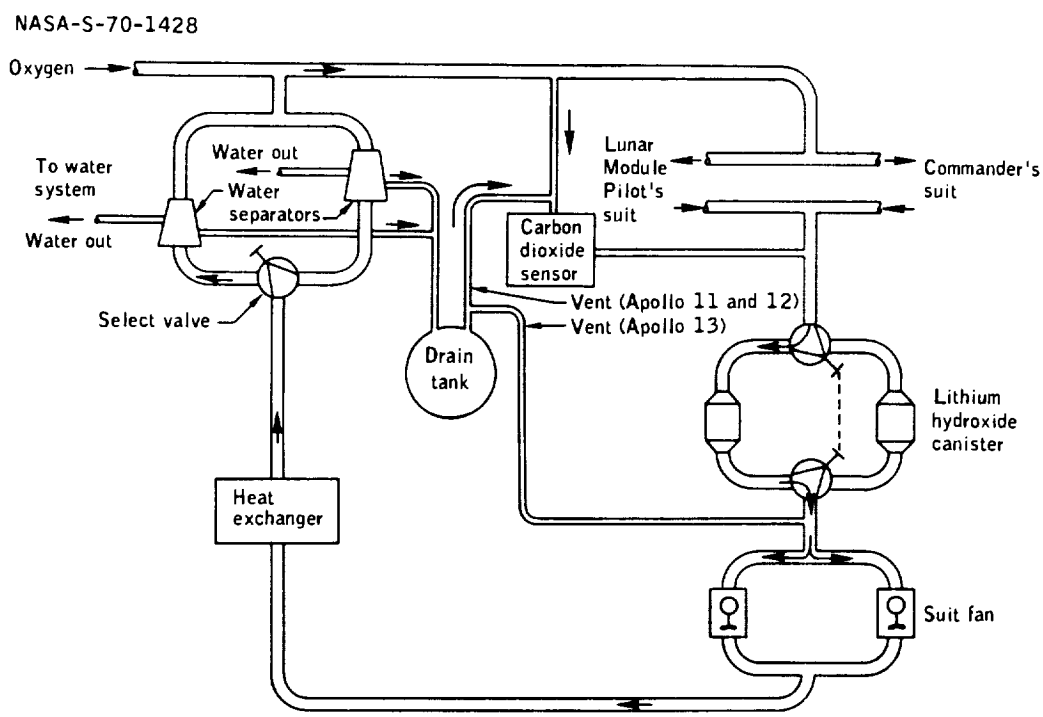
Figure 14-33.- Simplified suit loop schematic.

The carbon dioxide sensor is sensitive to free water, and the malfunction was probably caused either by water from the water separator sump tank entering the sensor or by water bypassing the water separator and entering the sensor. The water separator sump tank vent line joins the carbon dioxide sensor inlet sense line (fig. 14-33). This vent line has been rerouted for Apollo 13 and subsequent vehicles.

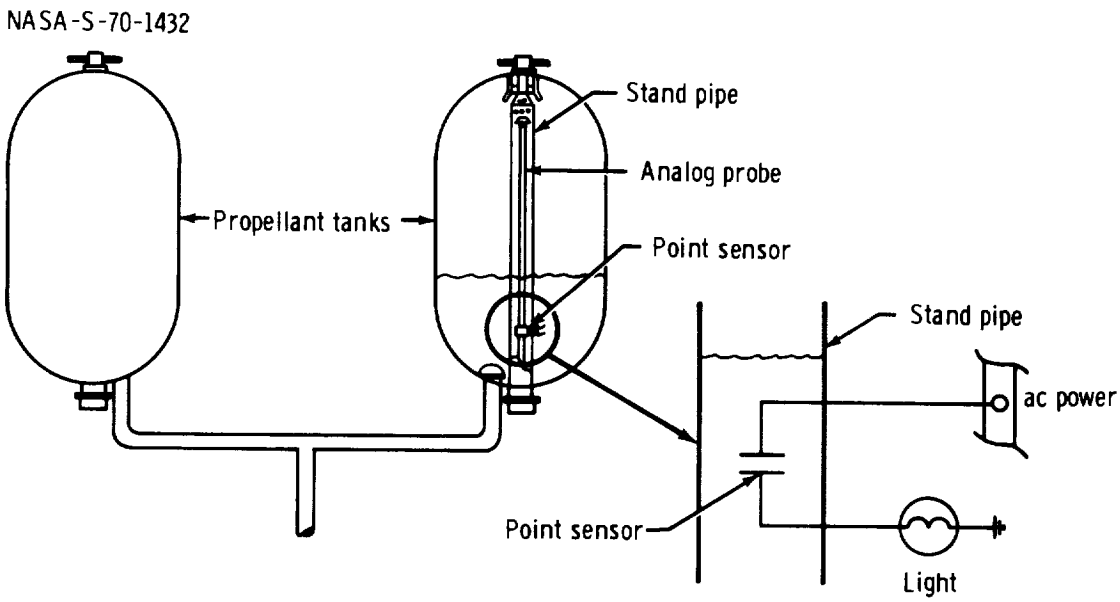
Figure 14-37. - Descent propellant tank low-level sensor schematic.

The low-level light for descent propulsion propellant quantities illuminated about 25 seconds early. The low-level light is activated and remains latched on when any one of the four low-level point sensors (one in each propellant tank) is uncovered (fig. 14-37).

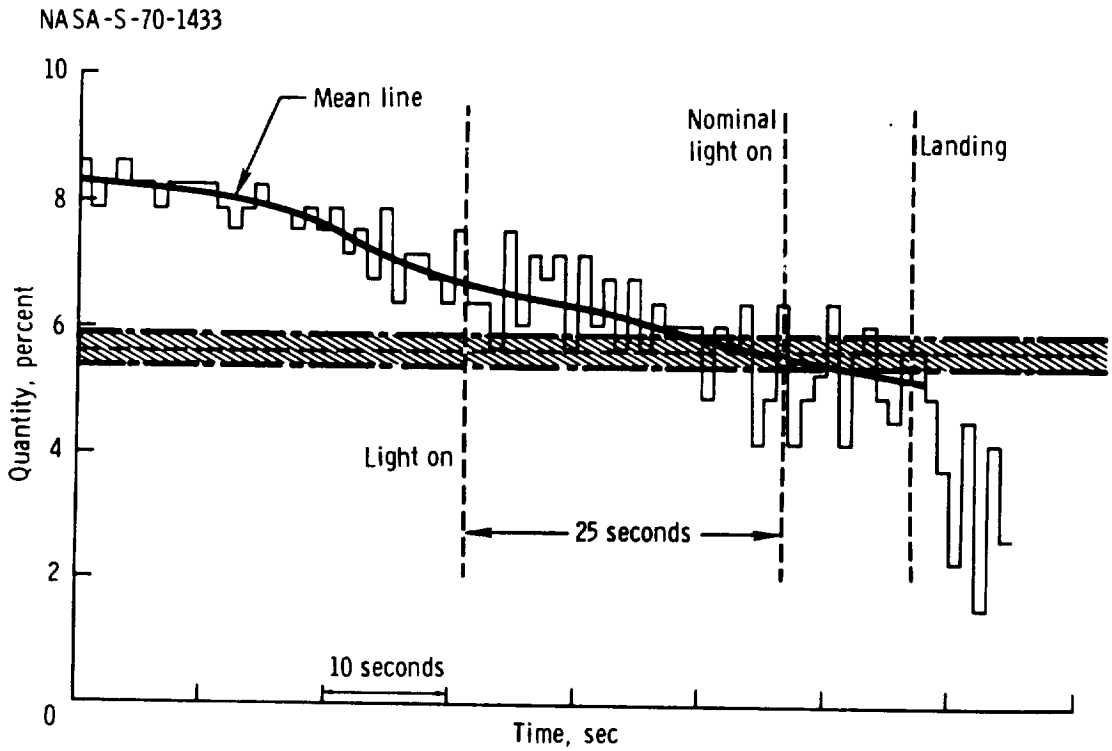
Figure 14-38. - Descent propellant quantity just prior to landing.

At low-level light activation, the gaging system indicated that fuel tank 2 had a mean propellant quantity of 6.7 percent. In addition, it had about a 2.3-percent peak-to-peak oscillation (fig. 14-38), probably caused by propellant slosh, which continued for some time after landing. The other three tank readings experienced similar oscillations, although at a slightly higher mean quantity level. One of the four low-level point sensors, probably fuel tank 2, uncovered momentarily because of propellant slosh, causing the low-level light to latch on.

The quantity warning light should illuminate when the lowest indicated propellant level remaining in any tank reaches a value of 5.6 ±1/4 percent. Since the light came on when the averaged quantity measurement indicated 6.7 percent with an oscillation of ±1.1 percent, the

lowest excursion of the quantity reading was 5.6 percent and the display operated properly. The averaged propellant quantity reached 5.6 percent about 25 seconds later.

For Apollo 13, the quantity measurements for the four descent propellant tanks have been increased in sampling rate from 1 to 100 samples per seconds. These data will be averaged automatically and used to determine the low-level point from which the remaining firing time can be calculated. The 100 samples per second rate will provide data that will permit an understanding of the particular dynamics of the fluid in the tanks.

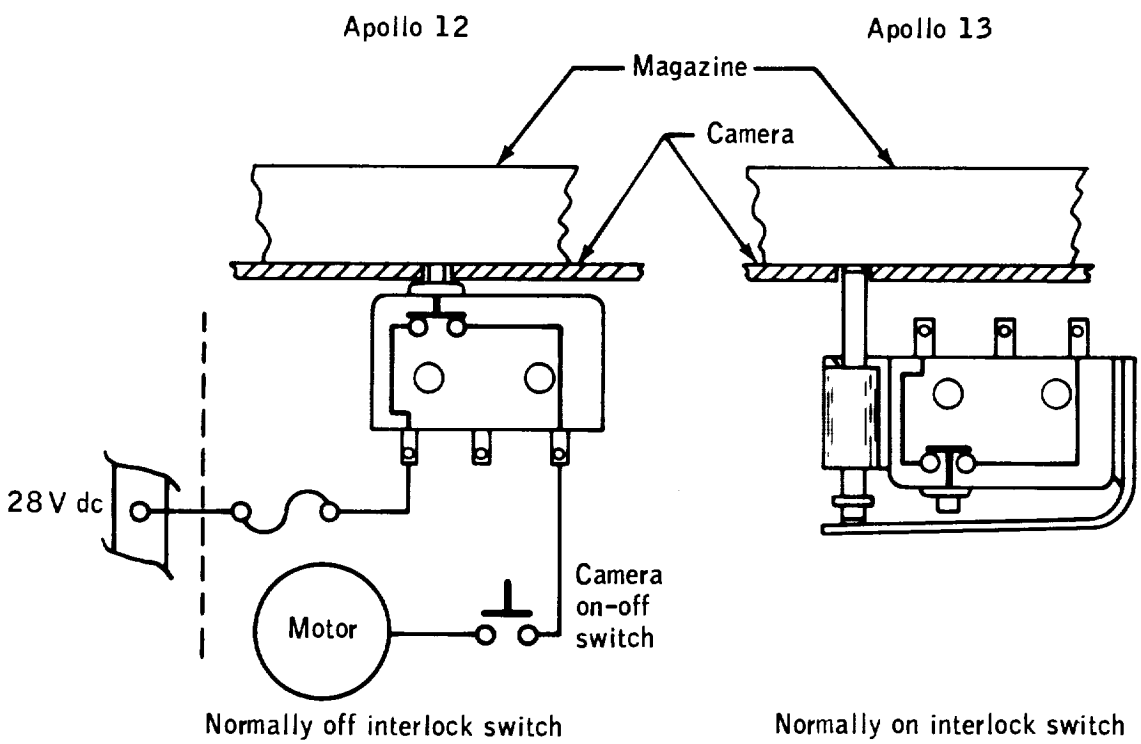
Figure 14-40.- Sequence camera interlock switch modification.

Although postflight tests showed the 16-mm camera and magazine to be in satisfactory operating condition, the characteristic sensitivity of the magazine interlock microswitch installation is such that the operating limits of the switch could cause intermittent actuation. The intermittent operation was duplicated on the flight and similar equipment by the application of pressure to the end of the magazine. The problem will be resolved by changing the interlock switch (fig. 14-40) to a configuration that is much less sensitive to variation in switch settings.

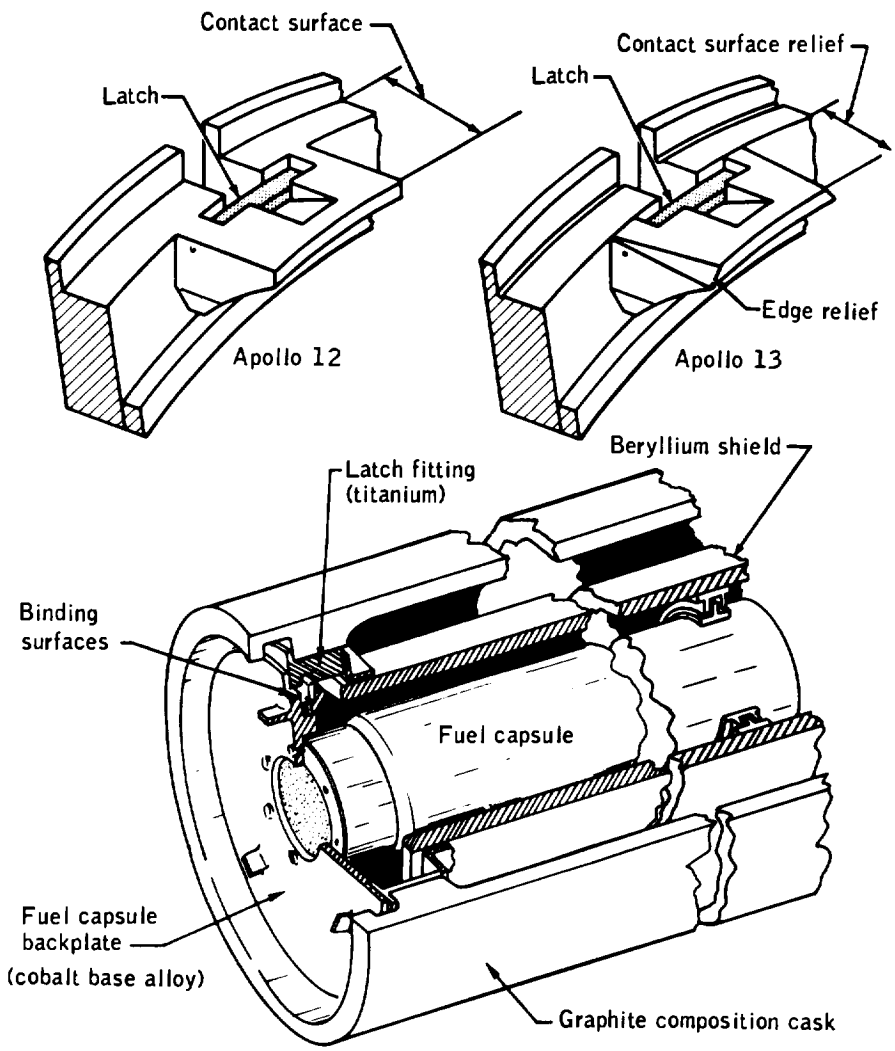
Figure 14-41.- Radioisotope fuel capsule configuration.

Thermal tests and analyses show that dimensional tolerances can diminish with temperature and result in binding between the latch fitting (C-ring) on the cask and the contact surface of the backplate on the fuel capsule (fig. 14-41). The longitudinal contact distance for these two surfaces is approximately 0.6 inch, and extraction was easily accomplished once this distance was negotiated.

As a result of the dimensional checks, the thermal tests, and analyses performed with both the qualification and Apollo 13 flight hardware, the contact surfaces of the fuel capsule backplates are being reworked as indicated in the figure. The outside diameter of the 0.10-inch long contact surface, while remaining within design limits, may be reduced as much as 0.005 inch for ease of capsule extraction. All existing capsule backplates will be reworked in this manner.

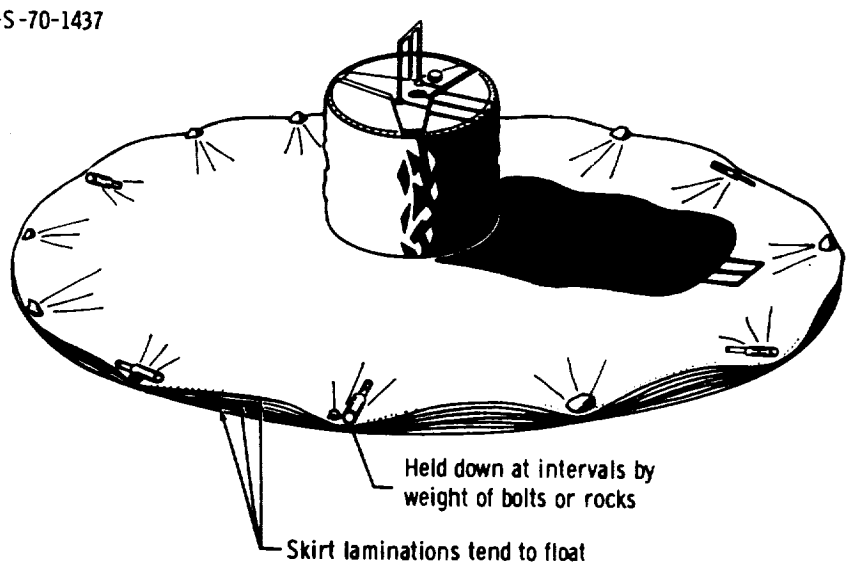
Figure 14-42. - Passive seismic experiment deployed.

The passive seismic experiment, shown in figure 3-5, has operated as planned with the exceptions noted. The sensor was installed at a location west-northwest from the lunar module (fig. 3-6) at a distance of 130 meters from the nearest footpad. The crew reported that tamping the surface material with their boots was not an effective means of preparing the surface for emplacement because the degree of compaction is small. Spreading the thermal shroud over the surface was difficult, because in the lunar gravity, the lightweight Mylar sheets of this shroud would not lie flat (see section 14.3.4).

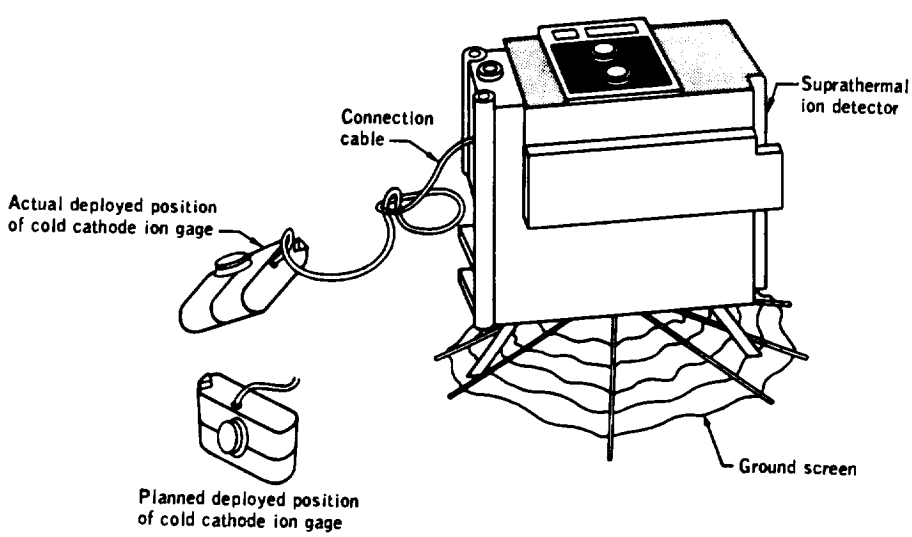
Figure 14-43.- Cold cathode gage deployed.

The cold cathode ion gage would not remain upright when deployed. Its final position was on its back with the sensor aperture at an angle of approximately 60 degrees from the horizontal but was satisfactory (fig. 14-43).

The cable connecting the cold cathode ion gage with the suprathermal ion detector was quite stiff. The combination of the spring effect in the cable, the reduced weight of the cold cathode ion gage under lunar gravity, and the softness of the lunar surface was apparently sufficient to cause the equipment instability during deployment. Final positioning of the equipment requires that the sensor aperture does not point directly at the surface nor directly at other experiment package components. The final positioning fulfilled this requirement.

The combination of the suprathermal ion detector with the cold cathode ion gage will not be included for Apollo 13. For Apollo 14 this equipment will be flown, and the wires of the connecting cable will be tied at 6-inch intervals instead of being wrapped with heavy Mylar tape. This modification not only reduces cable stiffness by 70 percent, which decreases the spring effect, but also decreases cable bulkiness to permit easier stowage.

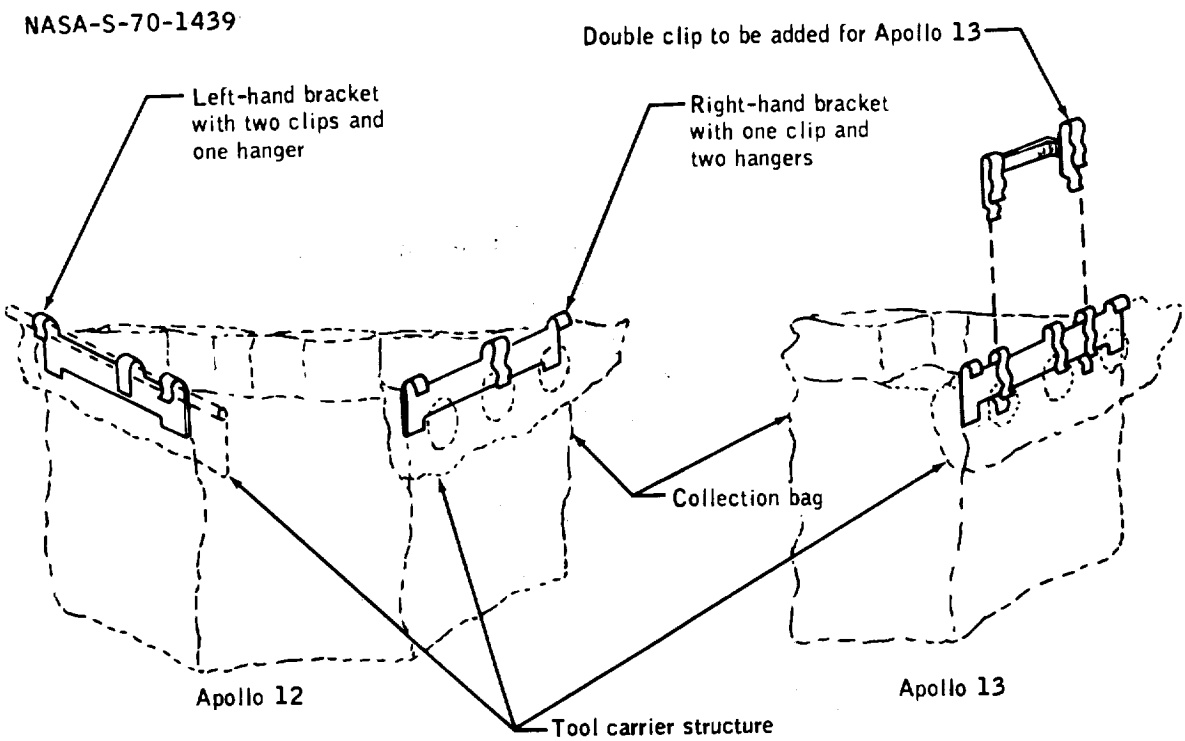
Figure 14-44.- Tool carrier collection bag retention.

At the beginning of extravehicular activity, the empty tool carrier collection bag tended to rise out of the tool carrier until some lunar surface soil was put in to hold it down. The bag is attached to the carrier structure by three aluminum spring clips (fig. 14-44). The weight of the loaded bag is shared by these clips and three hangers. The retention force is limited so that the loaded bag may be easily lifted out of the carrier.

The retention characteristics of the left side, with two spring clips over the 0.37-inch diameter rolled bead of the carrier structure, is satisfactory. However, the single spring clip over the 0.18-inch lip of the carrier on the right side did not provide sufficient positive retention. A separate double spring clip, which reaches over both the bag hanger and tool carrier structure, will be added for Apollo 13 to provide the necessary retention force as shown in the figure.

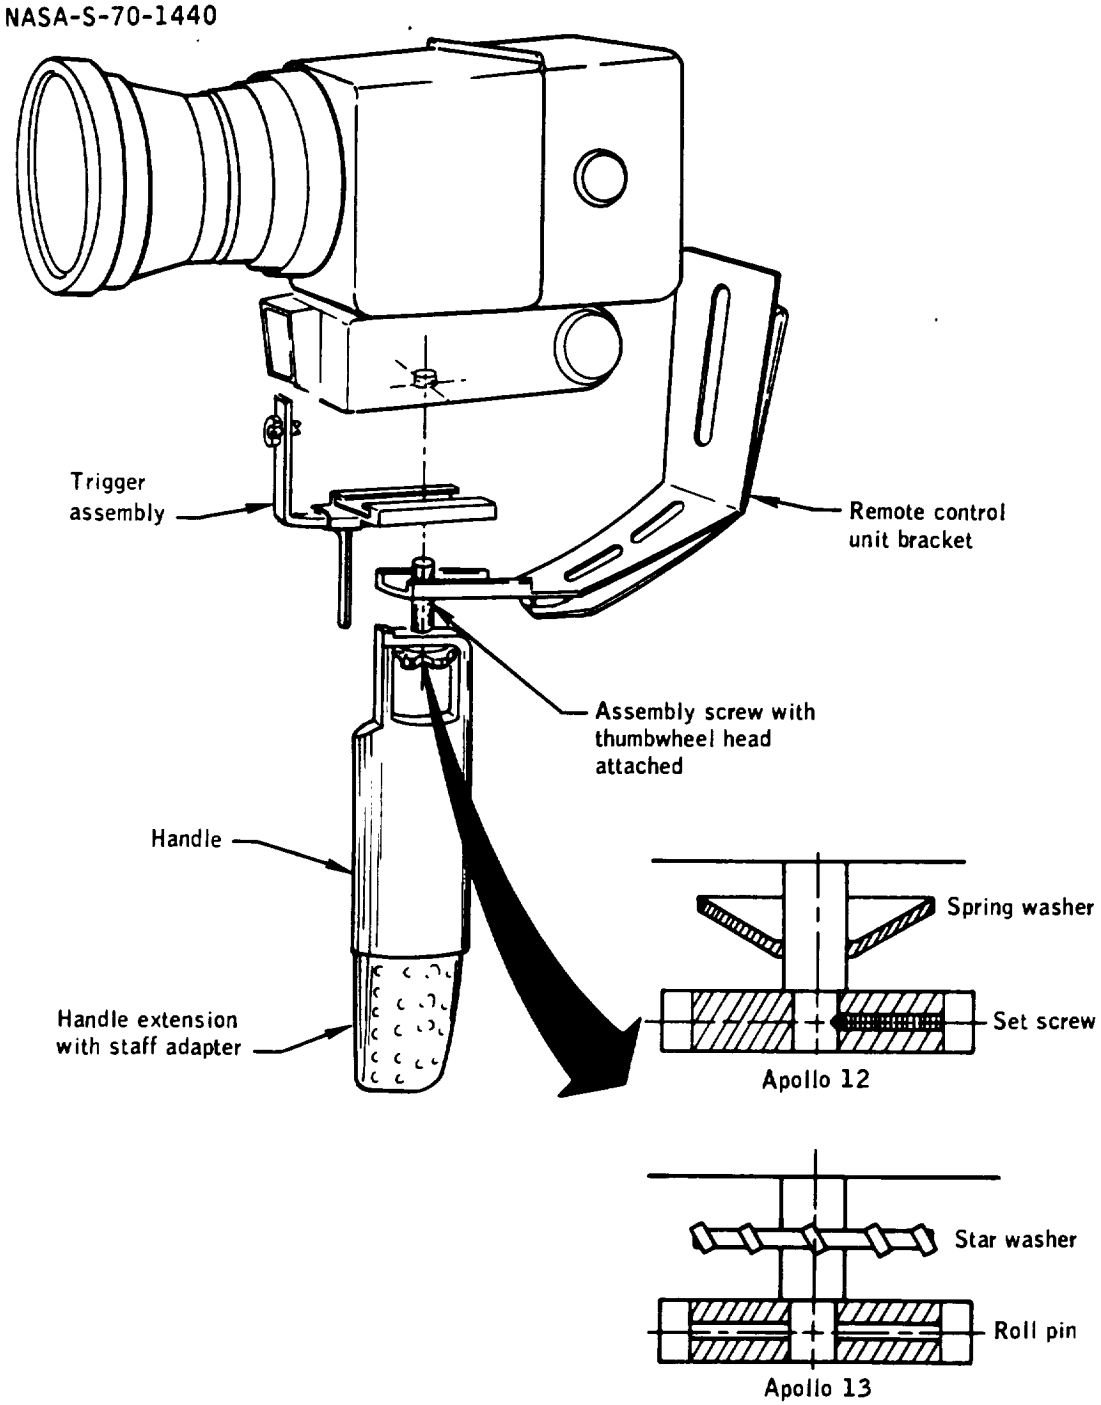
Figure 14-45.- 70-mm camera handle assembly.

During the second extravehicular period, the Commander's camera did not advance and count every time the trigger was squeezed. Shortly afterwards, when both the camera assemblies were being removed from the remote control units in order to exchange them, both assemblies were loose, although they had been well tightened before egress. In the process of retightening on the lunar surface, the thumbwheel fell off the Lunar Module Pilot's camera assembly, making reassembly impossible (fig. 14-45). The empty camera and faulty assembly were then discarded. The Commander's camera assembly was retightened and performed satisfactorily during the remainder of the extravehicular activity.

The intermittency experienced by the Commander in the shutter, counter, and film advance actions was the result of excessive trigger play caused by the loose assembly. The loss of the thumbwheel experienced by the Lunar Module Pilot was apparently the result of the improper installation of the thumbwheel setscrew.

For future missions, the cupped spring washer will be replaced by a star washer to resist rotation and loosening of the assembly screw, and the thumbwheel will be secured to the screw with a roll pin, instead of a setscrew.

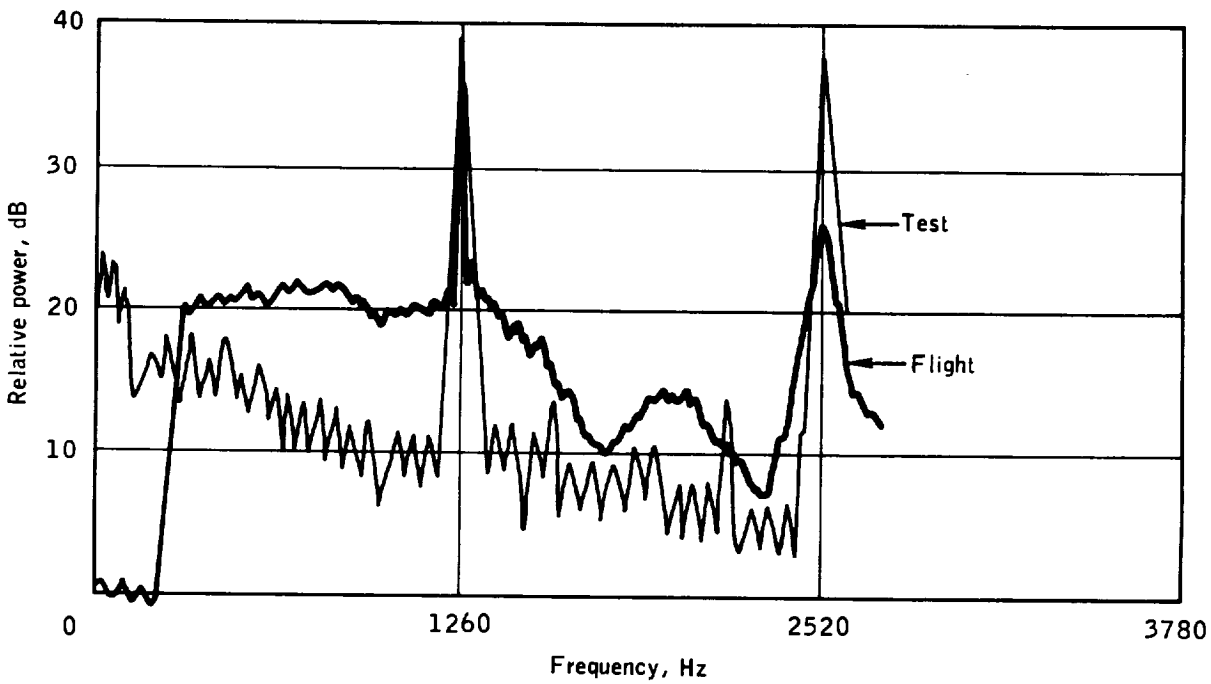
Figure 14-46.- Tone power spectral density.

An undesirable tone, accompanied by a random impulse noise signal, was present intermittently for the first 1-1/2 hours of initial extravehicular activity. The same tone, but without the noise, was present for approximately 12 seconds during the second extravehicular period. This condition did not degrade voice communication but was annoying to the crewmen.

A subsequent analysis of the telemetry data transmitted from the extravehicular mobility unit did not show any degradation of data quality as a result of the noise. Power spectral density plots, however, revealed a fundamental frequency of approximately 1260 hertz and a harmonic frequency of 2520 hertz. Postflight interference tests of an equivalent extravehicular mobility unit revealed the same 1260-hertz tone on the battery-bus leads and shield which originated from the fan-motor ripple current. This condition is normal and has been noted during qualification testing of the extravehicular mobility unit. Figure 14-46 illustrates the tone interference generated by the fan motor. However, during these initial tests, the noise interference could not be made to enter the audio system such that the audio tone heard in flight was simulated.

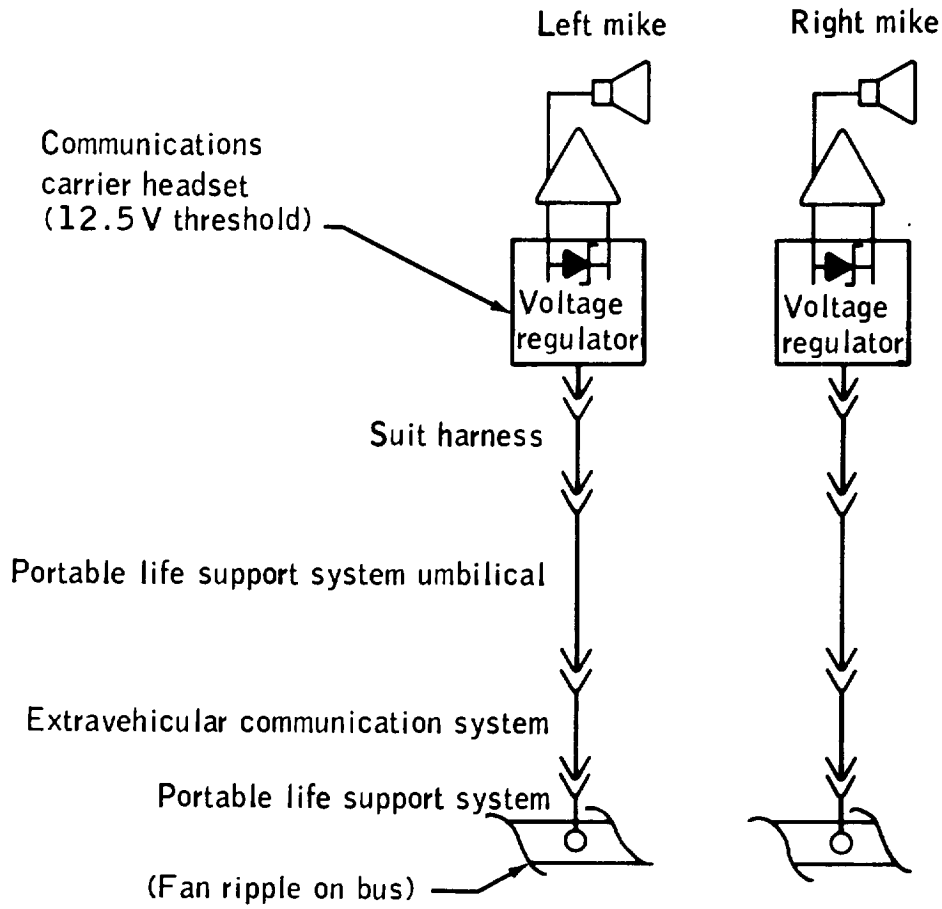
Figure 14-47.- Communications carrier headset power path.

Later laboratory testing of the communications carrier headset demonstrated that lowering a microphone amplifier supply voltage below the regulator threshold of 12.5 volts caused tone interference to enter the audio system. Subsequent analysis showed that a high resistance or the failure of a regulating diode or a transistor in the microphone amplifier regulator could result in a loss of regulator filtering action. The normal operating voltage for the microphone amplifier is from 15.7 to 20.5 volts. When the microphone amplifier supply voltage is above the regulator threshold of 12.5 volts, the tone interference does not enter the audio system.

Postflight tests of the flight communications carriers revealed that the Commander's left microphone was intermittent. Although this failure

could not be correlated to the tone phenomena, the random impulse noise heard inflight could be related to the intermittent microphone because a failure analysis has revealed an intermittent open-circuit condition in the primary winding of the amplifier transformer. Additional tests showed no further malfunctions in the communications carriers or harnesses.
