FINAL REPORT
(CONTRACT NO NAS 8-33075)

FEASIBILITY STUDY OF SILICON NITRIDE PROTECTION OF PLASTIC ENCAPSULATED SEMICONDUCTORS

AUGUST 1979

HUGHES AIRCRAFT COMPANY
CULVER CITY, CALIFORNIA

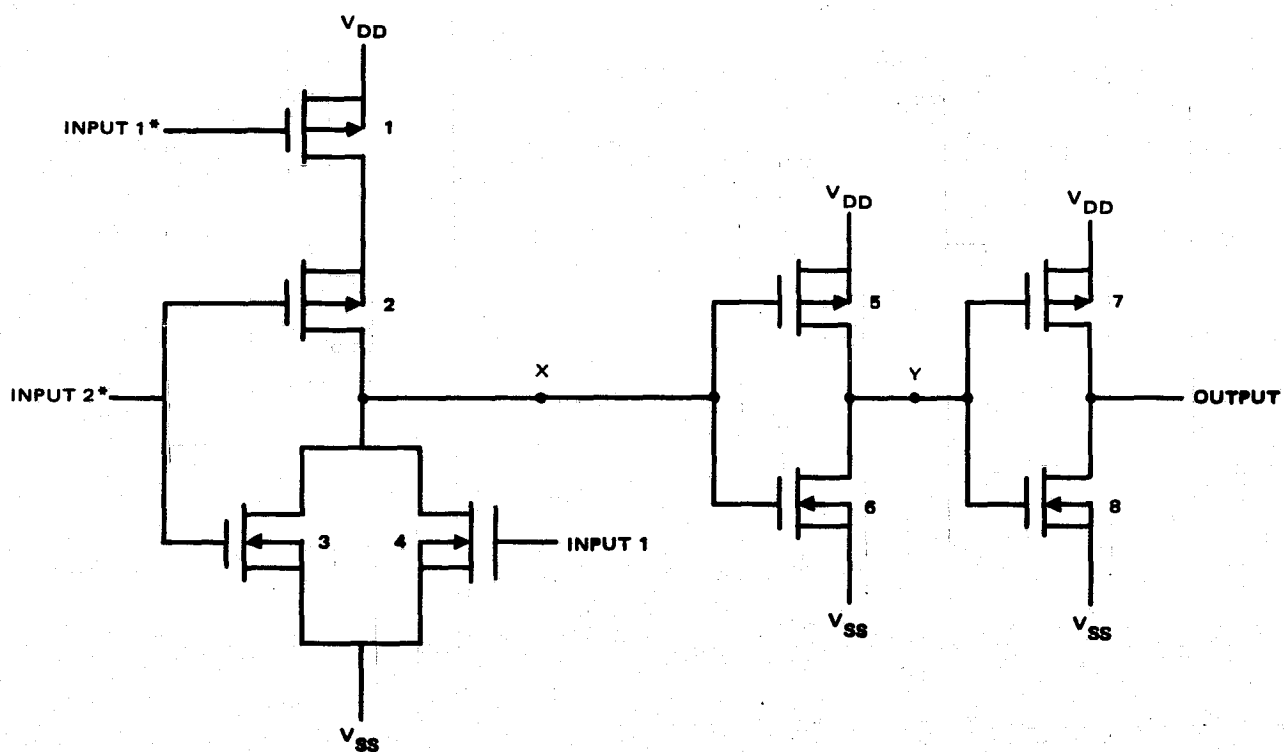
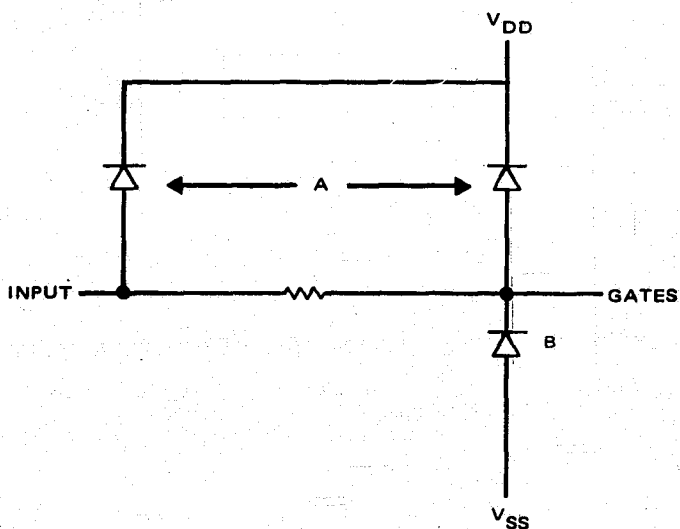
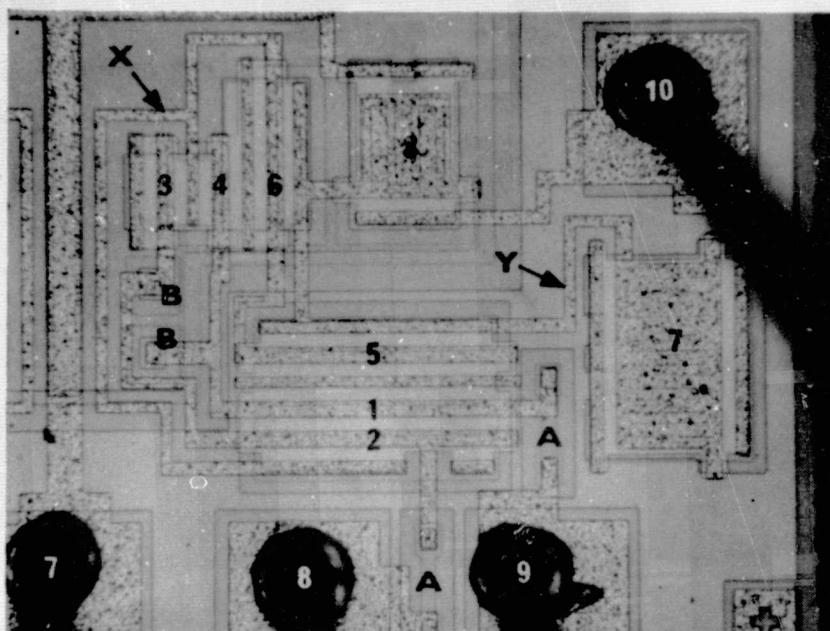
Figure 6. Circuit schematic of a 4001B NAND gate.

Figure 7. Photomicrograph of a NAND gate on the
4001B chip. Numbers on the bonds are
external pin numbers. The numbers
and letters on the chip correspond to the
numbers and letters on the circuit dia-
gram in Figure 6. Magnification = 115X.

probed on each of the NAND gates on each of the two devices are labeled X
and Y on the circuit diagram in Figure 6 and on the photomicrograph of the
NAND gate in Figure 7.

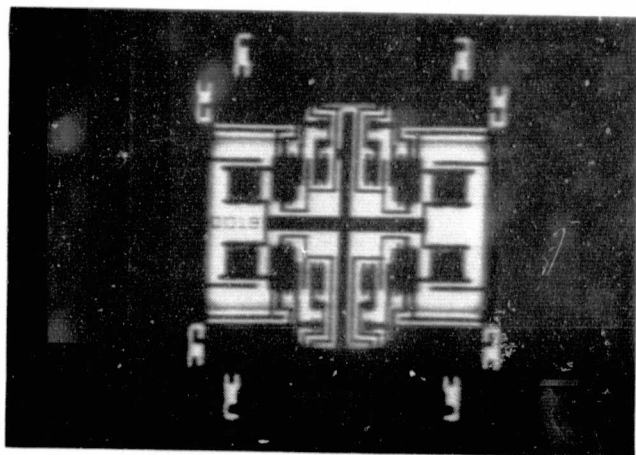
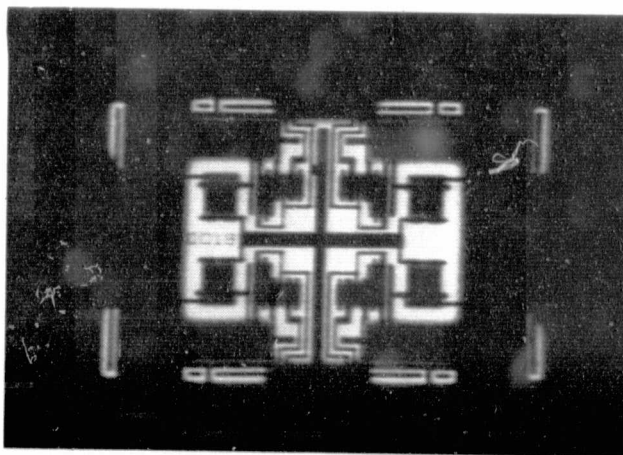
Reflected light images of the good and of the failed devices are shown in Figures 8a and 9a. The corresponding photovoltage images from the two devices are shown in Figures 8b and 9b.

Comparison of the photovoltage images of the two devices reveals significant differences. As is appropriate for a good device, the only area that appears in the photovoltage image (Figure 8b) is the p-well diffusion. On the

failed device, however, not only does the p-well diffusion appear but also all
of the p-channel MOSFETs (Figure 9b). For the set of test conditions
employed this implies that the n-channel MOSFETs are "ON" or are in the
conducting state in the failed device whereas for the test conditions the
MOSFETs should properly be "OFF".

The photocurrent images of the two devices under equivalent bias and
input conditions were also significantly different. Figures 8c and 9c show
the photocurrent images of the two devices with all of the inputs "low"
(0 volts). Figure 8d and 9d show the same images with all of the inputs
"high" (five volts). The differences between the photocurrent images again
imply that all of the n-channel transistors on the failed device are always in

the "ON" or conducting state.

Figure 8.   Reflected light image and photovoltage images of a good device obtained on the optical scanner.

Figure 9. Reflected light image and photovoltage images of a failed device obtained on the optical scanner.

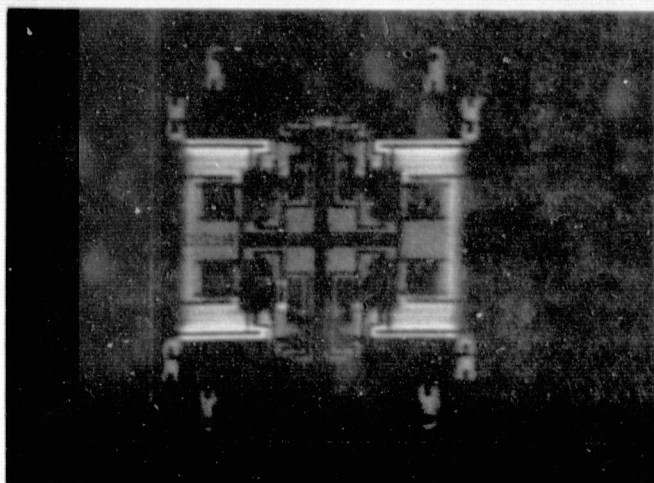
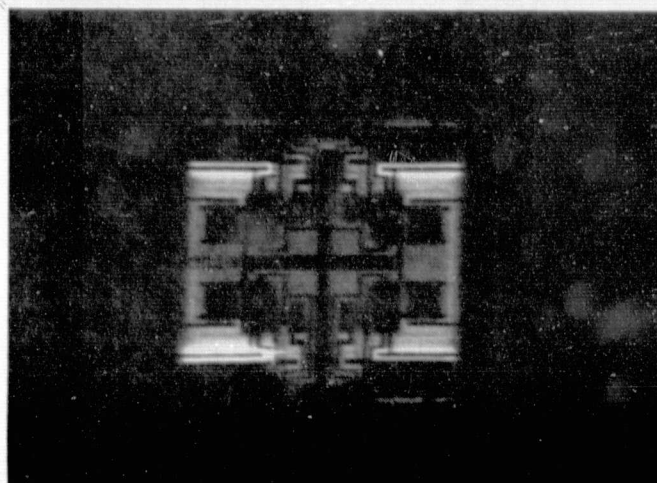
The results of the tests above suggest that there is an anomalous
positive charge in the surface passivation or trapped in the gate dielectric
of the failed device which is most probably an effect of the lead frame plasma
nitride passivation process on devices containing chips not previously passi-
vated. The presence of the positive charge causes the n-channel MOSFETs

to be permanently biased "ON" and also results in the failure of the p-channel
MOSFETs to turn completely "ON" with the usual applied biases.

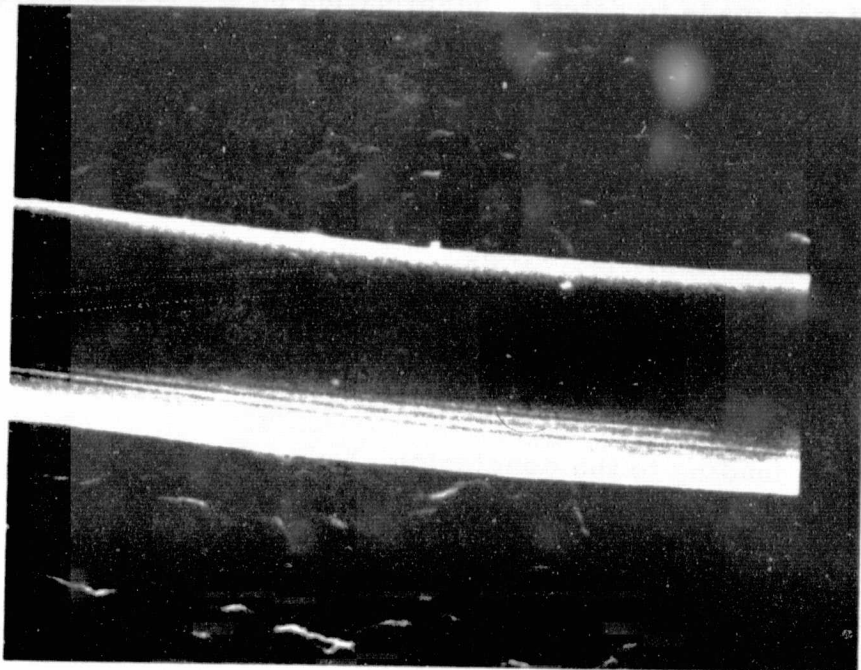
Figure 10.   Typical lead flexed 25 mils.

No evidence of mechanical damage to any flying lead was observed for
flexures up to and including 25 mils. A typical lead flexed 25 mils is shown
in Figure 10.

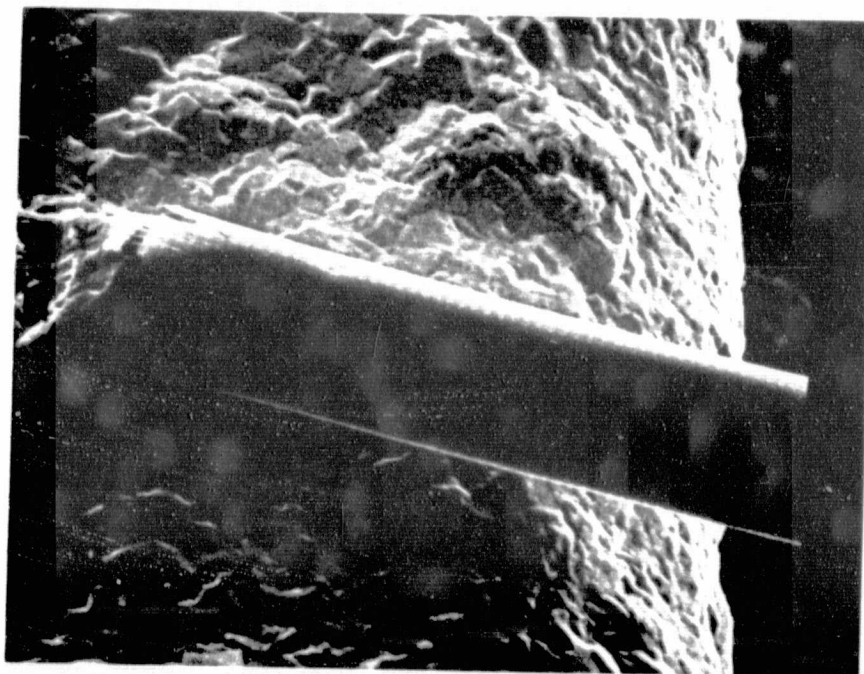
Inspection by SEM indicates that the threshold for cracking lies
between twenty-five and thirty mils for flying leads for the geometry of the
present test and for 2500Å photonitride films. Three of the six leads flexed
thirty mils developed moderate to severe cracking of the nitride film in the
vicinity of the bond where the lead experiences the most severe mechanical
distortion. Figure 11 shows the lead bond which experienced the most severe
cracking and loss of adhesion.

Figure 11.   Cracking and loss of adhesion on
lead flexed 30 mils.   Most severe
case.

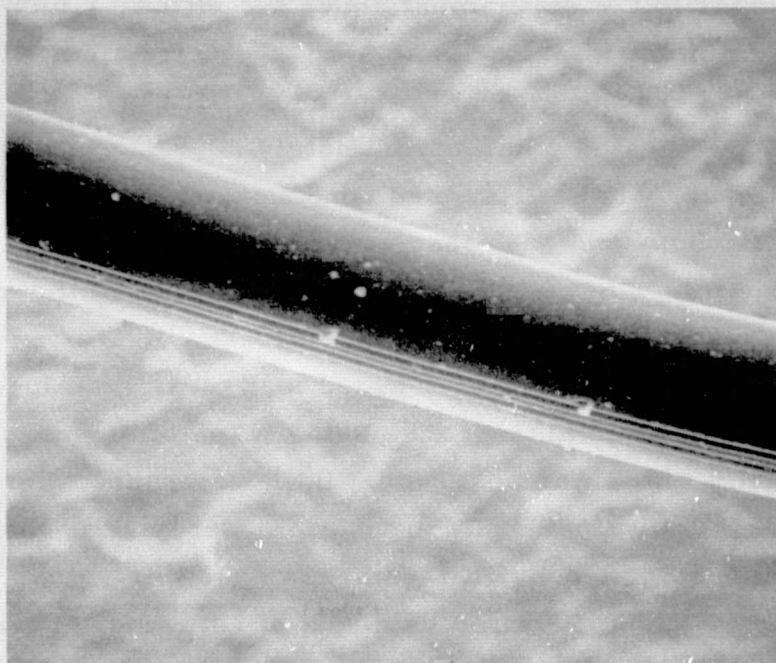
Figure 13.   Least favorably appearing of
leads flexed 10 mils.

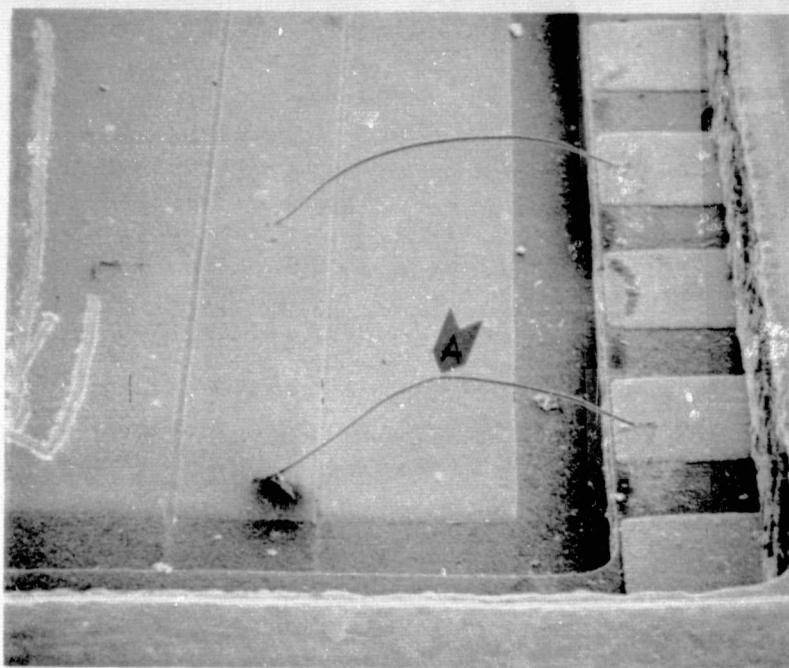
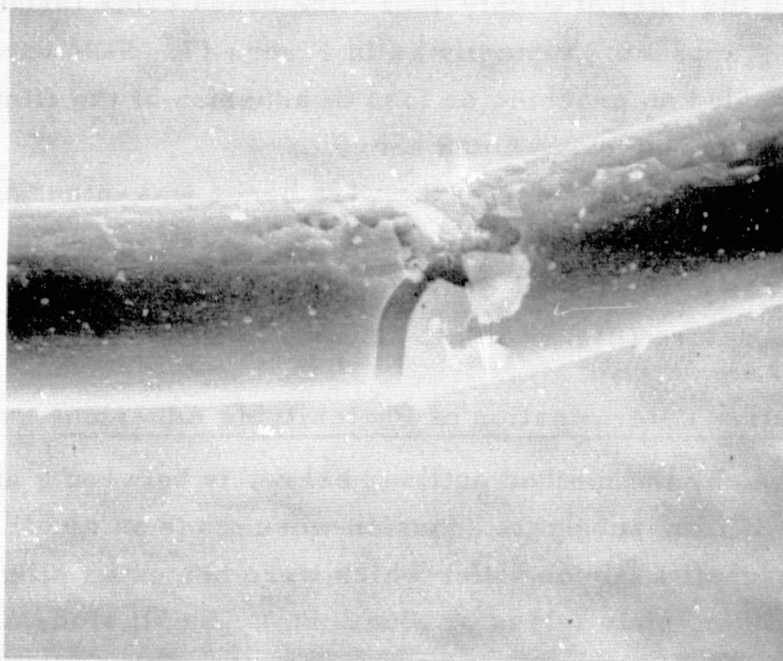
Cracking of the film was observed on only one lead, that coming from the group flexed 4 mils.   The evidence from Figures 14 and 15 suggests that the wire may have been stressed more severely than through a mere flexure of 4 mils.   It appears from the angular shape of the lead (Figure 14) and from the notch in the lead at the point of cracking (Figure 15), that it was inadvertently hooked and pulled upward, perhaps by the tool used to flex it.

Figure 14. Two leads from group four

showing site of probable
mechanical damage to lead.

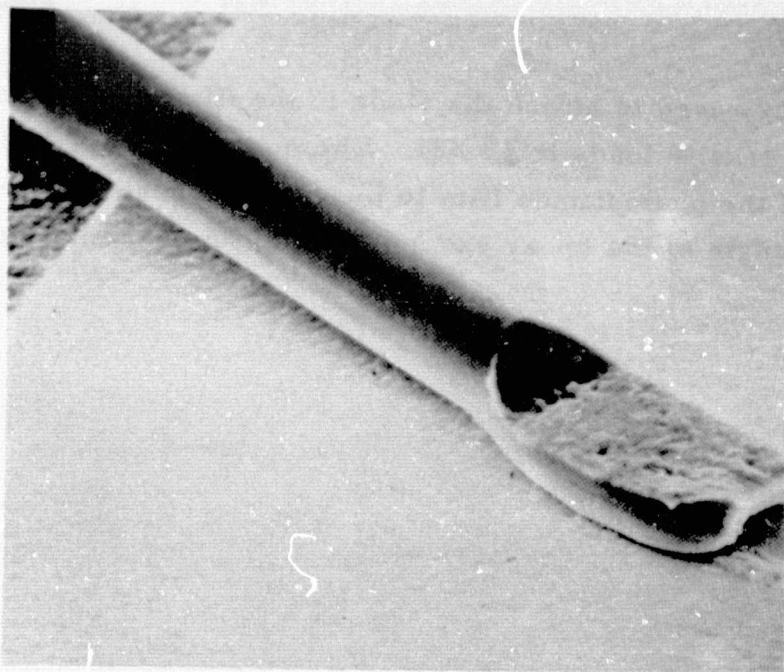
Twenty-three of the total of twenty-four wire bonds came through the flexure test undamaged, appearing typically as in Figure 17. SEM examinations of the devices revealed no cracking or loss of adhesion of the film to the wire bonds except for the one event noted above.

Figure 17. Typical example of coated wire bond after temperature cycling and mechanical flexing (650X).

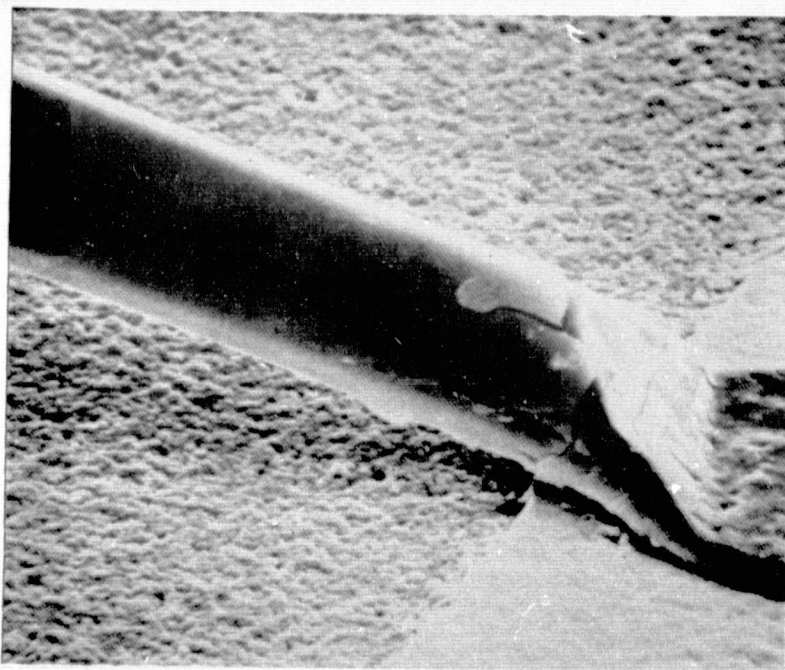
Figure 18. One of 24 wire bonds which exhibited evidence of coat cracking after severe flexing.
