CID FLIGHT/IMPACT

Russ Barber
Ames Dryden Flight Research Facility
Moffett Field, California

NASA/FAA Government/Industry CID Workshop
NASA Langley Research Center
April 10, 1985

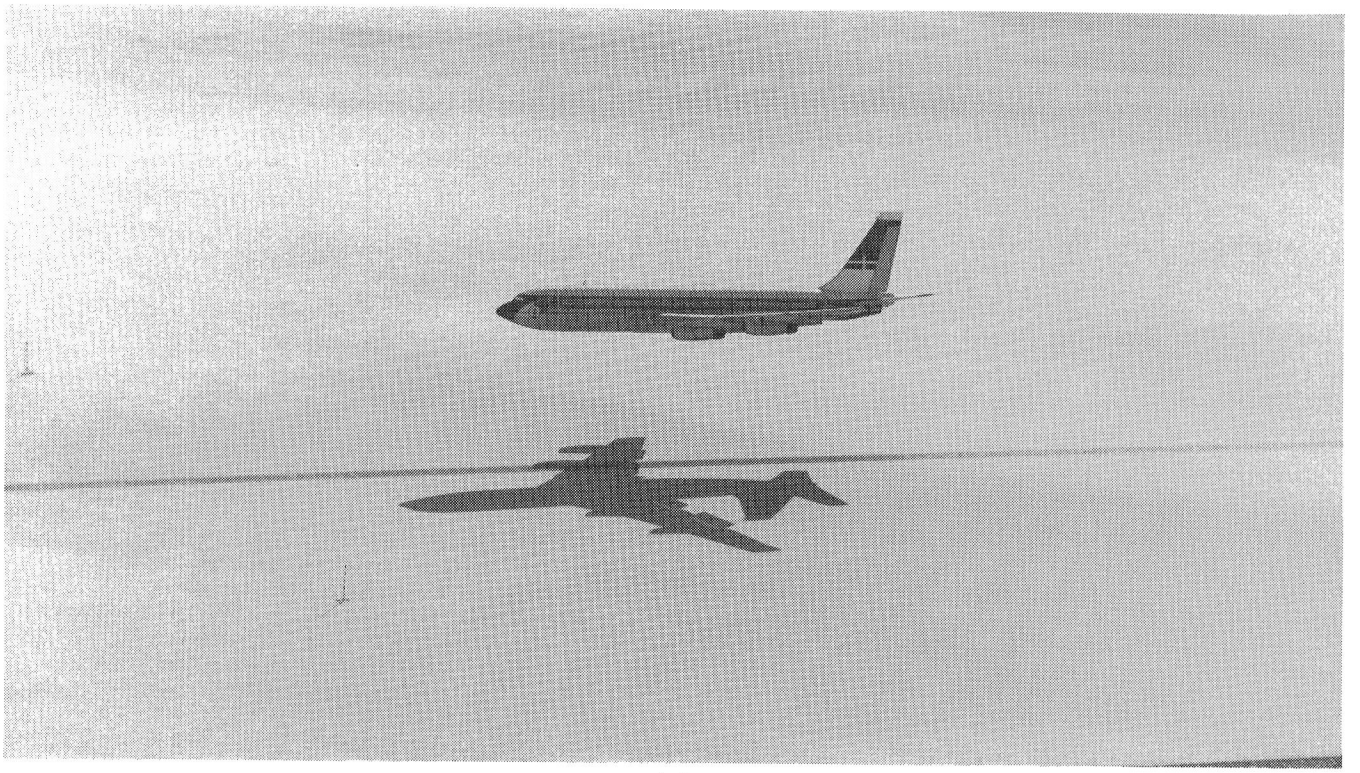
(a)

Figures 13a, 13b, 13c, and 13d are a sequence of photographs that show the airplane just prior to impact. They show the no. 1 engine impacting first and then the fuselage. It is interesting to note that the engines on the left wing are really distorted.
