Oxidation of SiC/BN/SiC Composites in Reduced Oxygen Partial Pressures

Elizabeth Opila, NASA Glenn Research Center, Cleveland, OH
Meredith Boyd, University of Rochester, Rochester, NY

Motivation

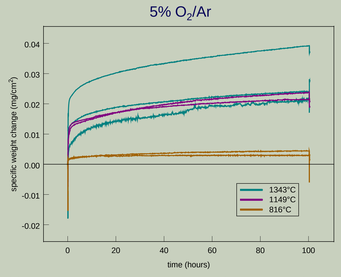
5% O_2/Ar

- Rapid transient weight gain followed by slow oxidation rate
- Variation in weight gain during transient phase at 1343°C
- Weight change at 1538°C not available due to extensive borosilicate bubble formation/interaction with furnace tube

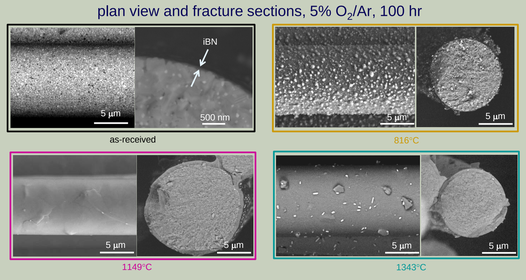
plan view and fracture sections, 5% O_2/Ar, 100 hr

Thickness of oxide scales consistent with weight change

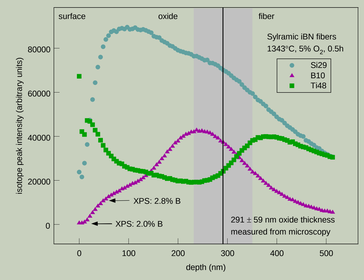
Sylramic iBN fibers

TOF-SIMS and XPS show boron gradient in oxide and boron depletion at surface.

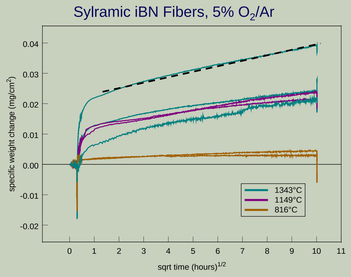
Sylramic iBN Fibers, 5% O_2/Ar

- Low rates and balance drift result in large uncertainty in measured slopes, rate constants
- Apparent parabolic rates are slower than those predicted for oxidation of pure SiC

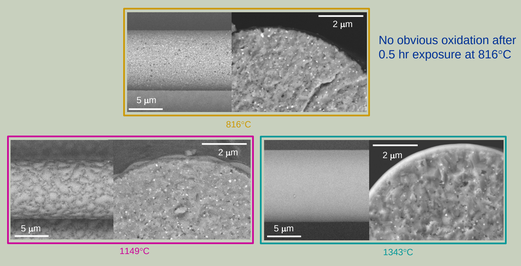
plan view and fracture sections, 5% O_2/Ar, 0.5 hr

No obvious oxidation after 0.5 hr exposure at 816°C

Thick oxide scales observed after oxidation at short times consistent with rapid transient weight change

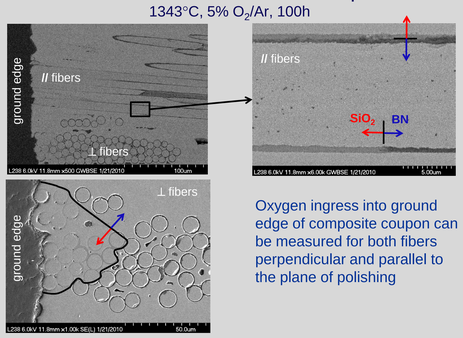
1343°C, 5% O_2/Ar, 100h

Oxygen ingress into ground edge of composite coupon can be measured for both fibers perpendicular and parallel to the plane of polishing

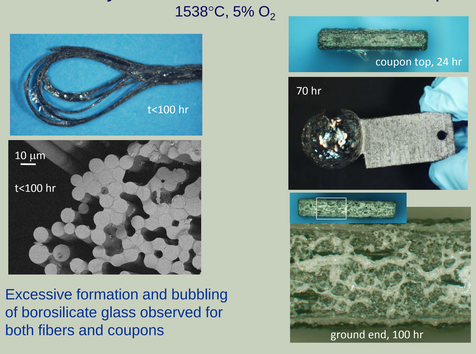
1538°C, 5% O_2

Excessive formation and bubbling of borosilicate glass observed for both fibers and coupons

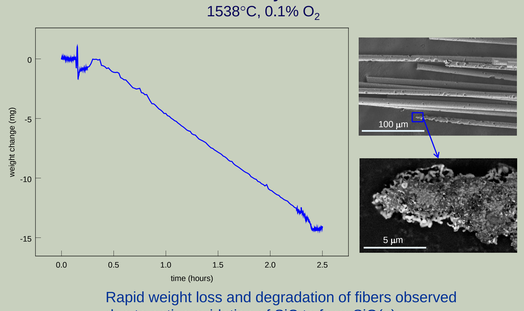
1538°C, 0.1% O_2

Rapid weight loss and degradation of fibers observed due to active oxidation of SiC to form SiO(g).

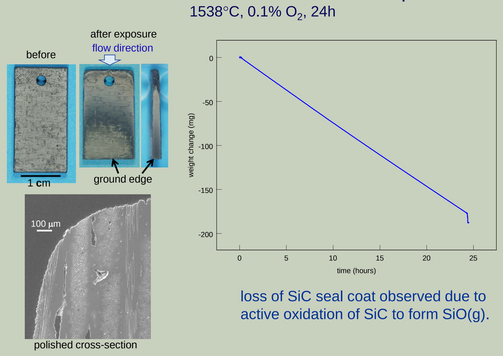
1538°C, 0.1% O_2, 24h

loss of SiC seal coat observed due to active oxidation of SiC to form SiO(g).
