NASA/TM—2018-219960 AIAA–2018–4645

Long Duration Wear Test of the NASA HERMeS Hall Thruster

Prepared for the
54th Joint Propulsion Conference
cosponsored by AIAA, SAE, and ASEE
Cincinnati, Ohio, July 9–11, 2018

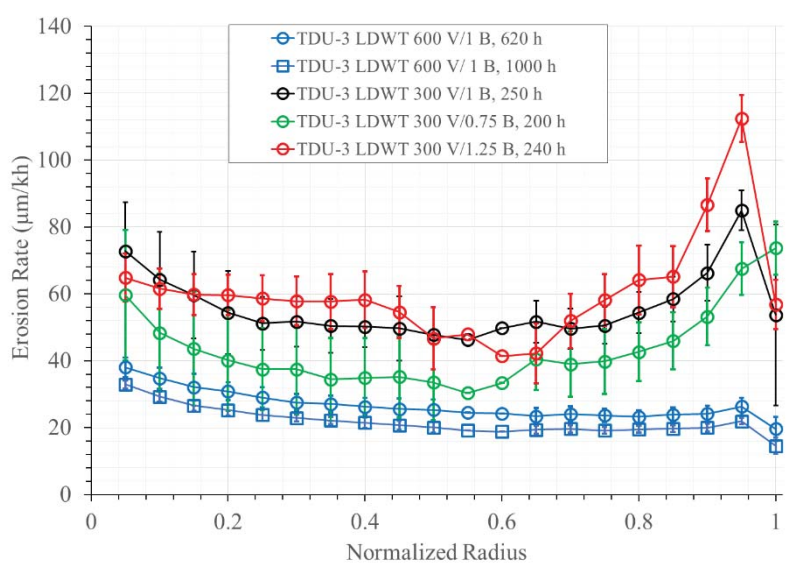
Figure 4 shows the IFPC erosion rates measured near the 8 o'clock mask during the LDWT as a function of normalized IFPC radius. In Figure 4, a normalized radius of 0 corresponds to the edge of the IFPC closest to the cathode whereas a radius of 1 corresponds to the edge closest to the discharge channel. It is important to note that the truncation of the data near the inner IFPC edge is due to the fact that the employed masks only cover approximately 95 percent of the IFPC.

Consistent with previous empirical and analytic results, for all operating conditions, the erosion rate is observed to minimize near the center of the IFPC and gradually increase towards the keeper and discharge channel (Refs. 5, 30, and 31). It is important to note that, as shown in Figure 5, the local maxima shown in Figure 4 near a normalized radius of 0.9 represent a continuous trend and are, therefore, not outliers. Despite the observed consistency in radial variation, the magnitude of the erosion rate is a strong function of discharge voltage. As shown in Figure 4, the radially-averaged erosion rate increases by approximately 76 percent between the 600 and 300 V conditions performed at the nominal magnetic field strength.

As discussed in previous work, the observed erosion trends with discharge voltage are likely driven by shifts in the axial location of the acceleration region (Refs. 5, 30 to 32). Specifically, laser-induced florescence (LIF) measurements have shown that the acceleration region shifts downstream at lower discharge voltages (Ref. 31). This shift results in a concomitant increase in beam divergence and, thus, the number of eroding ions reaching the IFPC (Refs. 5, 30, and 31).

Figure 4.—IFPC erosion rates near the 8 o'clock mask from the TDU-3 LDWT.

In addition to the impacts of discharge voltage and magnetic field on IFPC wear, the results in Figure 4 also provide insight into how IFPC erosion changes over the thruster lifetime. Specifically, the erosion rates measured after 1000 h of operation at 600 V were lower at all radii by an average of 20 percent compared to those measured after 620 h of operation. This decrease in erosion rate with time is outside of the empirical uncertainty and was also observed during previous wear testing of TDU-1 (Refs. 4 and 5).

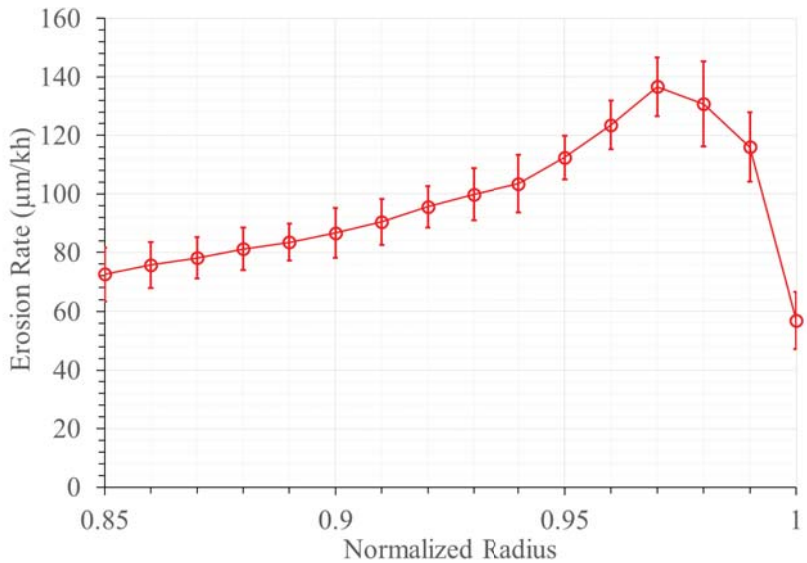
Figure 5.—IFPC erosion rates near a normalized radius of 0.9 for the 300 V/1.25 B condition.

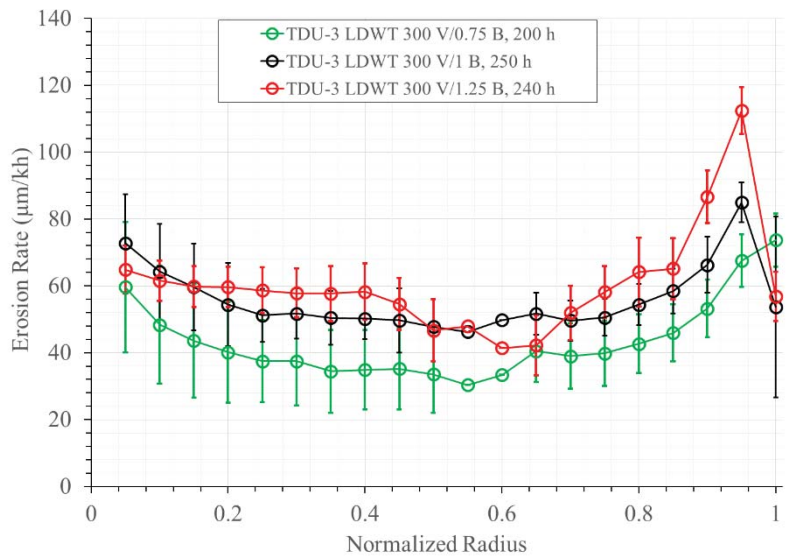
Figure 6.—IFPC erosion rates near the 8 o'clock mask for the three segments performed at 300 V.

Isolating the results from the three segments performed at 300 V provides some insight into the impact of magnetic field strength on IFPC wear. As shown in Figure 6, erosion rates at this discharge voltage largely increased with magnetic field strength. Specifically, the radially-averaged erosion rate increased by 42 percent between the 0.75 B and 1.25 B cases, which is greater than the measurement uncertainty. This increase in erosion with magnetic field strength is consistent with previous results obtained for 600 V operation (Refs. 5 and 31). Although true for most radial locations, the observed increase in erosion rates with magnetic field strength does not hold in the regions near the mask fastener and IFPC edges (i.e., for normalized radii less than 0.15 and between 0.55 and 0.65). However, as discussed previously, the measurements in these regions have a much higher measurement uncertainty due to the truncation of the unexposed reference surfaces by the hole for the mask fastener. Because of this, the observed differences in wear rates in these regions are likely artifacts of these increased uncertainties and no strong conclusions can be drawn.

Previous empirical studies performed for 600 V operation have shown a similar increase in IFPC erosion with increased magnetic field strength, despite the upstream shift of the acceleration zone observed at elevated magnetic fields by LIF (Refs. 5, 29, and 32). Modeling results have suggested that, for discharge voltages above 500 V, the divergence of the beam is never high enough to allow eroding ions to reach the IFPC, thus nullifying the mechanism by which a downstream shift in the acceleration zone caused an increase in IFPC erosion for operation at 300 V (Ref. 30). Instead, the models have shown that the higher magnetic field strength causes a concomitant increase in sheath potential at the pole, and therefore, an increase in energy (rather than quantity) of incident ions (Ref. 30). However, these same models predict that this trend should reverse for operation at 300 V, and, therefore, that the measured erosion rates should have decreased with increased magnetic field strength due to the upstream shift in acceleration zone (Ref. 30). The cause for this discrepancy is not presently known, and, as such, further investigation may be warranted.

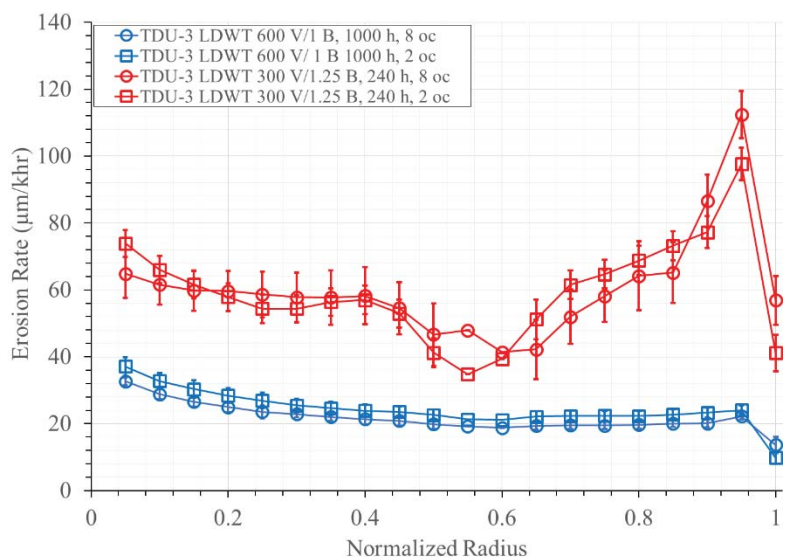
Similar to the approach taken in Williams et al. (Ref. 4), in order to assess the azimuthal symmetry of the IFPC wear mechanism, profilometry measurements acquired near the masked regions at both 8 and 2 o'clock were compared for each operating condition. The results are shown for two operating conditions in Figure 7. Consistent with previous results, the azimuthal variation in wear rates was less than the measurement uncertainty, suggesting that the IFPC wear process is symmetric (Ref. 4). It is important to note that although only two data sets are shown, the observed trends were consistent for all operating conditions.

Figure 7.—Comparison of IFPC erosion rates measured near the 8 o'clock (8 oc) and 2 o'clock (2 oc) masks.

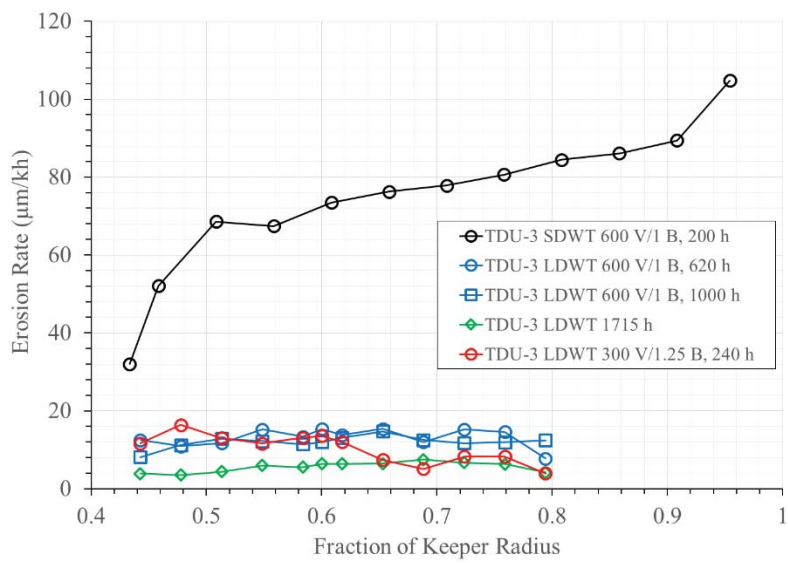
As stated in the introduction, one of the motivations of the LDWT was to determine if the change in cathode axial position could explain the differences in wear rates measured during the TDU-1 1700 h test and the SDWT. Towards that end, Figure 8 shows the keeper erosion rates measured during the LDWT and SDWT as a function of keeper radius. In Figure 8, a keeper radius fraction of 0 corresponds to the cathode orifice whereas a radius fraction of 1 corresponds to the edge closest to the IFPC. It is important to note that the truncation of the LDWT data near the outer keeper edge is due to the change in mask geometry relative to the SDWT and that the 1715 h LDWT data set corresponds to the average erosion rate over all completed test segments (Ref. 5).

Figure 8.—Keeper erosion rates from the TDU-3 SDWT and LDWT for operation at 600 V, 12.5 kW, and nominal magnetic field.

As shown in Figure 8, the keeper during the LDWT eroded at a radially-averaged rate of approximately 13 μm/kh independent of operating condition, which represents a decrease of 84 percent relative to the results acquired during the portion of the SDWT operated at the 600 V/ 1 B condition (Ref. 5). Furthermore, unlike during the SDWT, no significant radial variation in erosion rate was observed (Ref. 5). Qualitative confirmation of these results is shown by features visible in the 3D renderings of the cathode keeper acquired post-test and shown in Figure 9. Consistent with the results shown in Figure 8, the elevated plateaus corresponding to the masked regions of the keeper are much less pronounced for the LDWT than for the SDWT. This is particularly striking as each of the unmasked regions of the SDWT keeper accumulated approximately one-fifth the hours of those on the LDWT keeper (Ref. 5). It is important to note that the surface doming observed in Figure 9(b) was also present in pre-test scans and thus is likely an artifact of the pre-test polishing and not plasma exposure. Taken together, these results confirm the strong link between cathode position and keeper erosion rates and indicate that the upstream shift in cathode position successfully mitigated the elevated erosion rates observed during the SDWT.

As discussed by Lopez Ortega, et al. (Ref. 33), the decrease in keeper erosion for the upstream cathode location is likely due to an increase in shielding provided by the IFPC against ions originating close to the discharge channel. Specifically, the upstream shift reduces the effective downstream view factor of the keeper. Since it is postulated that thruster ions (i.e., those born in the thruster channel, acceleration region, or near-field plume) are the primary cause of IFPC and keeper erosion, this reduction in view factor should reduce the number of thruster ions incident on the keeper, resulting in the observed reduction in keeper erosion rates (Refs. 30 and 33).

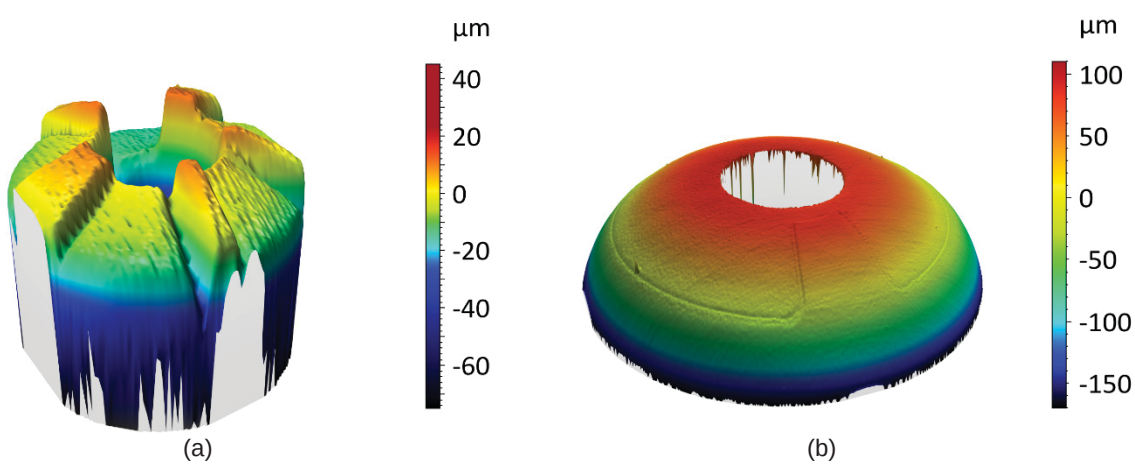
Figure 9.—3D view of the keeper after the (a) SDWT and (b) LDWT (Segment I).

It is important to note that the observed keeper step sizes were too small to be processed using the ISO method discussed previously. Instead, as done in both previous wear tests, the keeper data were analyzed manually using commercial software provided by the profilometer manufacturer. As discussed in Williams, et al. (Ref. 5), the SDWT keeper erosion data at the 600 V/1 B condition was acquired during the comprehensive performance characterization of TDU-3. As such, during the SDWT, TDU-3 was operated over a range of throttle conditions and magnetic field settings, resulting in increased uncertainty in the erosion measurements (Ref. 5). However, previous work has indicated that this increased uncertainty is smaller in magnitude than the wear rate reduction observed between the SDWT and LDWT (Ref. 5). As such, the increased uncertainty associated with nonwear point operation during the SDWT does not impact the overall conclusion that the upstream shift of the cathode significantly reduced keeper erosion rates.

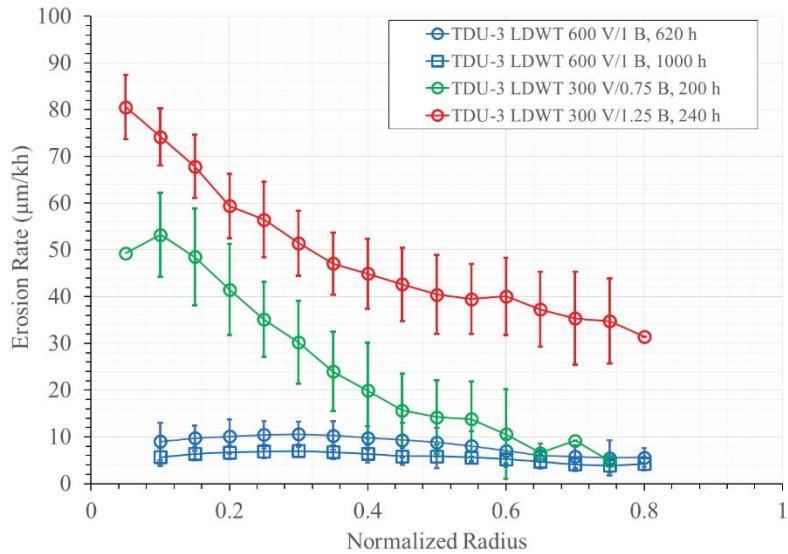
Figure 10 shows the OFPC erosion rates measured during the LDWT as a function of normalized OFPC radius. In Figure 10, a normalized radius of 0 corresponds to the edge of the OFPC closest to the discharge channel whereas a radius of 1 corresponds to the outer edge of the thruster. It is important to note that the truncation of the data near the inner edge is due to the fact that the employed masks do not cover the entire width of the OFPC. Near the outer edge, the mask fastener prevented the formation of a sufficiently large unexposed reference surface, thus precluding data analysis in this region.

As shown in Figure 10, the OFPC erosion rates largely follow the same trends as those for the IFPC. Specifically, OFPC erosion is observed to increase beyond the measurement uncertainty as the discharge voltage is decreased from 600 to 300 V and as the magnetic field strength is increased at a fixed discharge voltage of 300 V. Specifically, the erosion rate at 300 V/0.75 B is approximately 4 times higher, on average, at a given radius than for 600 V. Furthermore, the erosion rate is approximately 1.4 times higher, on average, at a given radius for operation at 300 V/1.25 B compared to 300 V/0.75 B. In addition, for all operating conditions, the OFPC erosion is shown to maximize near the discharge channel and then decrease with increasing radius. The observed variations in OFPC erosion with radial position and discharge voltage match results from previous empirical and analytic work, while the observed variation with magnetic field had not previously been investigated (Refs. 5 and 30).

Figure 10.—OFPC erosion rates measured during the TDU-3 LDWT.

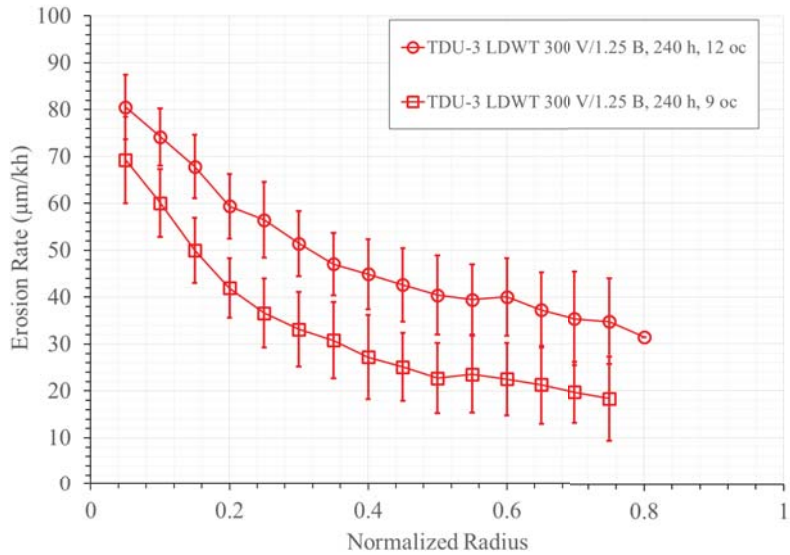
Figure 11.—Comparison of OFPC erosion rates measured near the 12 o'clock (12 oc) and 9 o'clock (9 oc) masks.

Similar to the approach taken with the IFPC, in order to assess the azimuthal symmetry of the OFPC wear mechanisms, profilometry measurements acquired near both the 12 and 9 o'clock masked regions were compared for the 300 V/1.25 B operating condition. The results are shown as a function of normalized OFPC radius in Figure 11. Contrary to the IFPC results, the azimuthal variation in wear rates was greater than the measurement uncertainty, suggesting that the OFPC wear was asymmetric for this operating condition. However, it is important to note that the pre-test surface finish in both of these regions was different. Specifically, the 12 o'clock mask was placed over a region of polished graphite whereas the region near the 9 o'clock mask was unpolished.

Taken together with the observed decrease in IFPC erosion rates over time, this result suggests a possible link between surface finish and erosion rates. Specifically, although polished pre-test, the IFPC has been observed to roughen after plasma exposure. Evidence of this can be seen in Figure 12(b), which is a post-test image of the pole cover shown in Figure 12(a) that shows evidence of significant roughening relative to the polished finish achieved pre-test. Once roughened, the results in Figure 4, suggest that the erosion rates of the IFPC decrease. If true, that would also explain the results in Figure 11, where the unpolished portion of the OFPC is shown to erode slower than the polished portion. This possibility will be further investigated during the remainder of the LDWT.
