LESSONS LEARNED FROM FLIGHT OBSERVATIONS OF THE GOES-R MAGNETOMETER

R. Schnurr(1), T. Bonalsky(1), M. Todirita(1), J. Kronenwetter(2), D. Early(2), M. Grotenhuis(3), R. Studer(4), D. Carter(5), R. Dence(6), M. Wolf(6), J. Mandi(6)

ESA Workshop on Aerospace EMC 2019 • May 20, 2019 • Budapest, Hungary

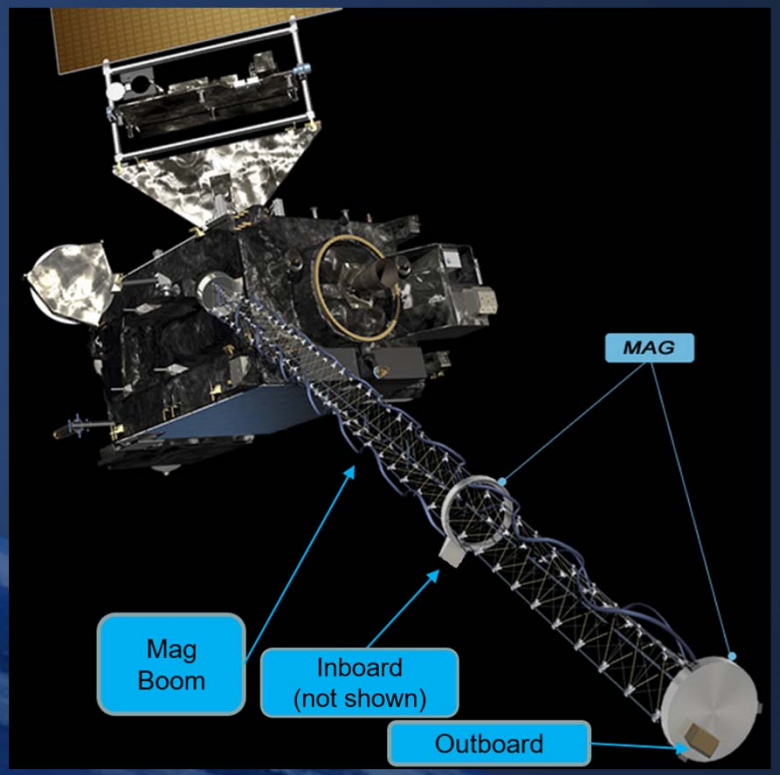
GOES-16 Magnetometer

- Measures the “in-situ” ambient magnetic field at geostationary orbit
- Consists of inboard (IB) and outboard (OB) fluxgate sensors mounted on a deployable boom 6.3 and 8.5 meters from the spacecraft, respectively
- Both the IB and OB measure the magnetic field in three orthogonal axes. The Z-axis follows the centerline of the deployed boom while X and Y are parallel to the mounting plate

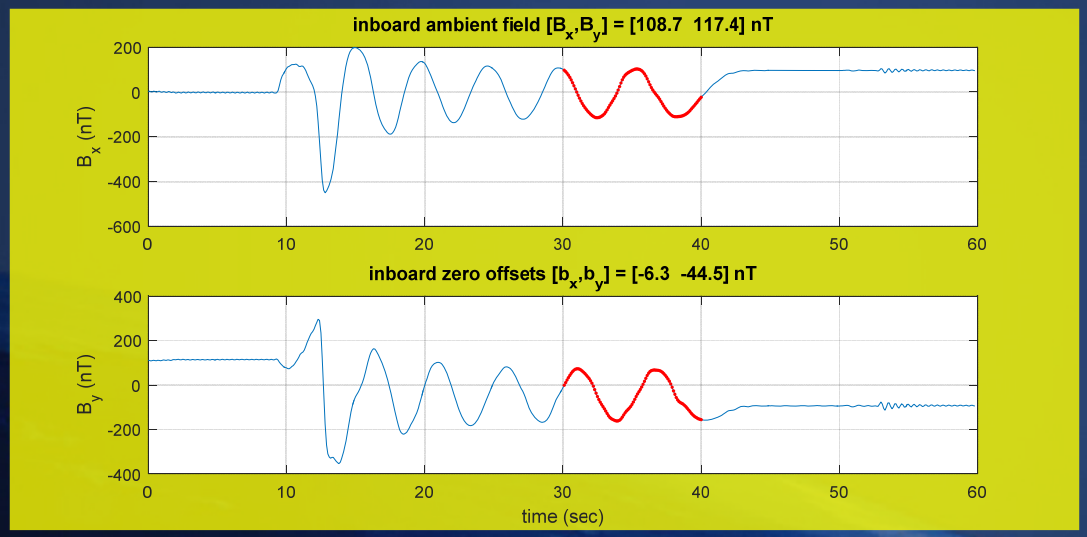
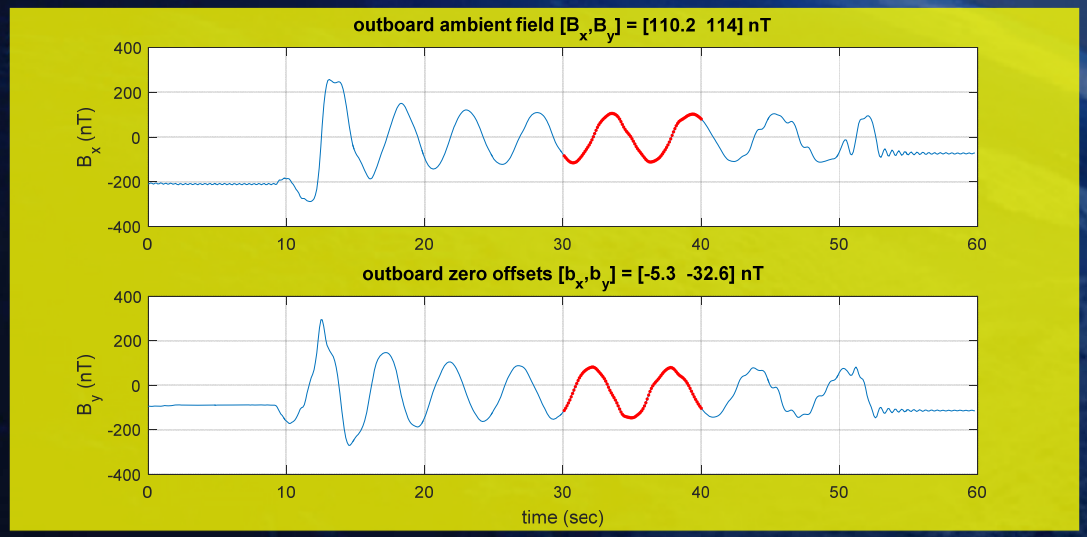
On-Orbit Observations
Large Zero Offset

- Boom rotates about sensor Z axis providing visibility into X and Y axis zero offset
- Inboard Offset:
  - X axis = -6.3 nT
  - Y axis = -44.5 nT
- Outboard Offset:
  - X offset = -5.3 nT
  - Y offset = -32.6 nT
- ~ 30 to 40 nT change in Y axis relative to ground calibration

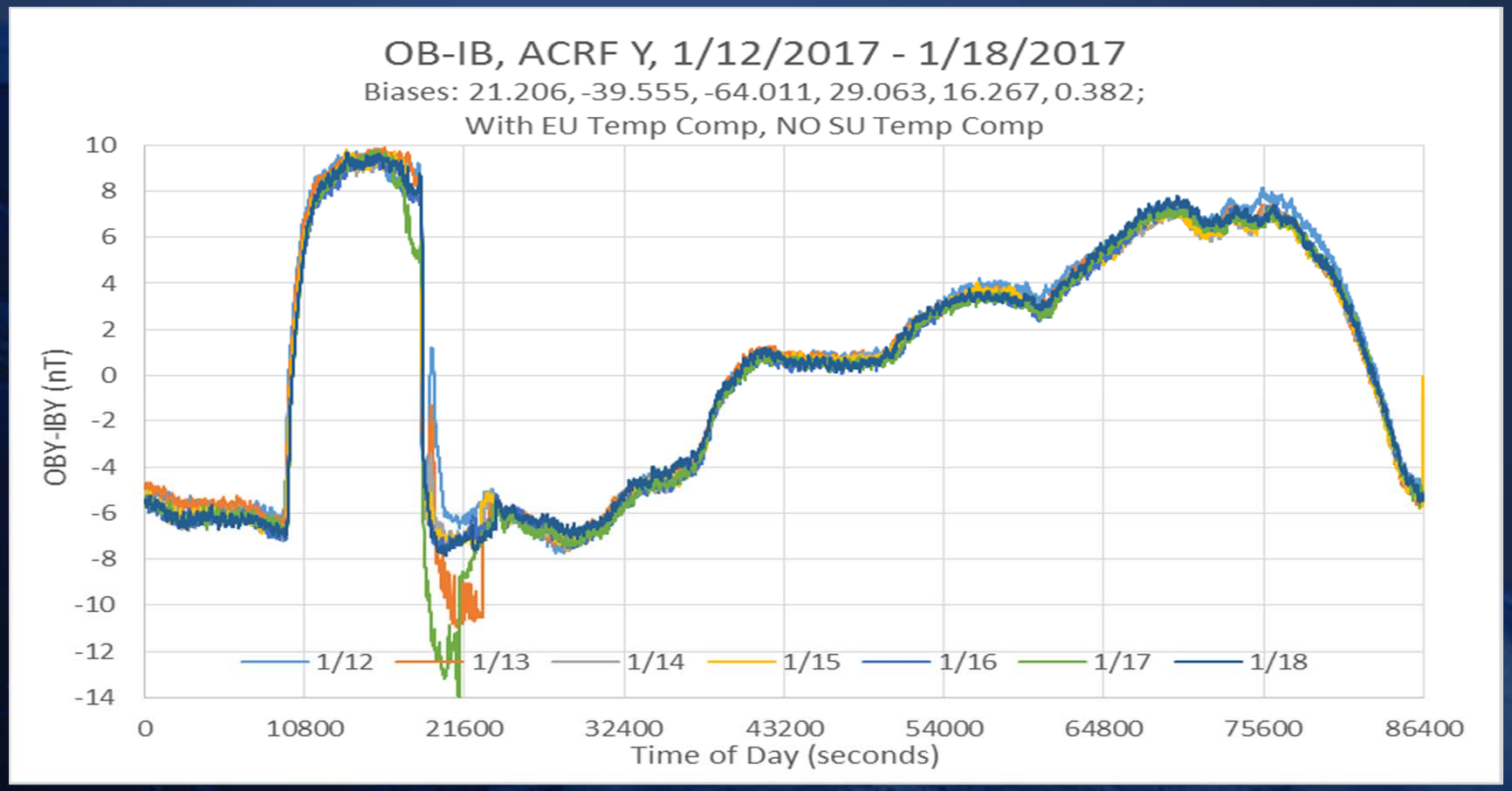
On-Orbit Observations
Large Variation Between Inboard and Outboard

- Expected difference between the two magnetometers should be <2 nT with small variances in the spacecraft field causing diurnal variation
- On-Orbit difference repeatable day to day with 15 to 20 nT swing in Y and Z axes
- Most of the variation is due to the Inboard Magnetometer

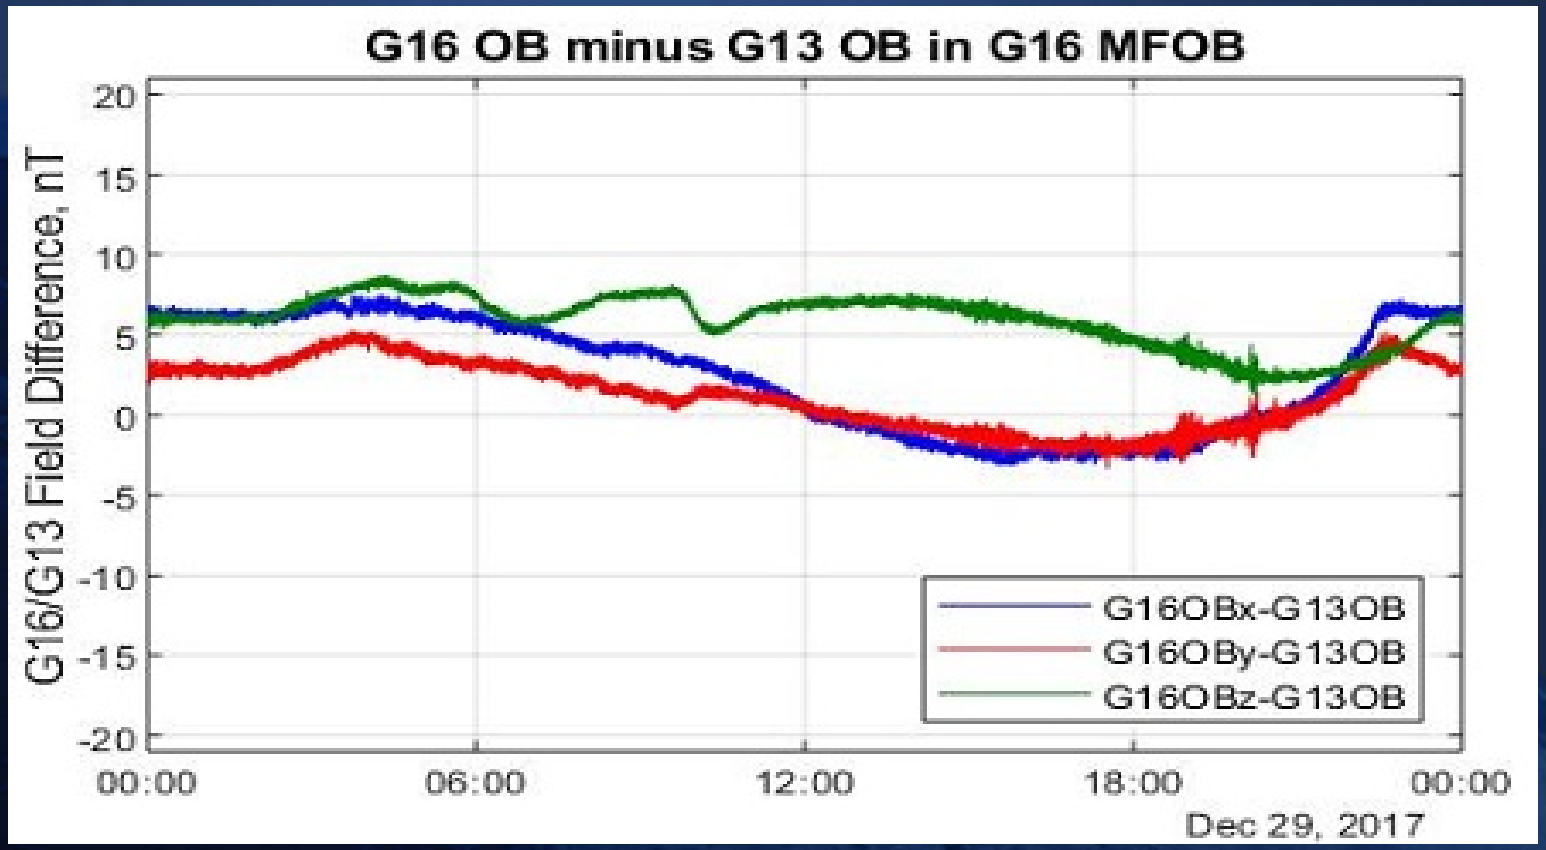
On-Orbit Observations
Variation In Outboard Magnetometer

- **Outboard Magnetometer has 5 to 10 nT variation when compared to existing on-orbit GOES satellites**

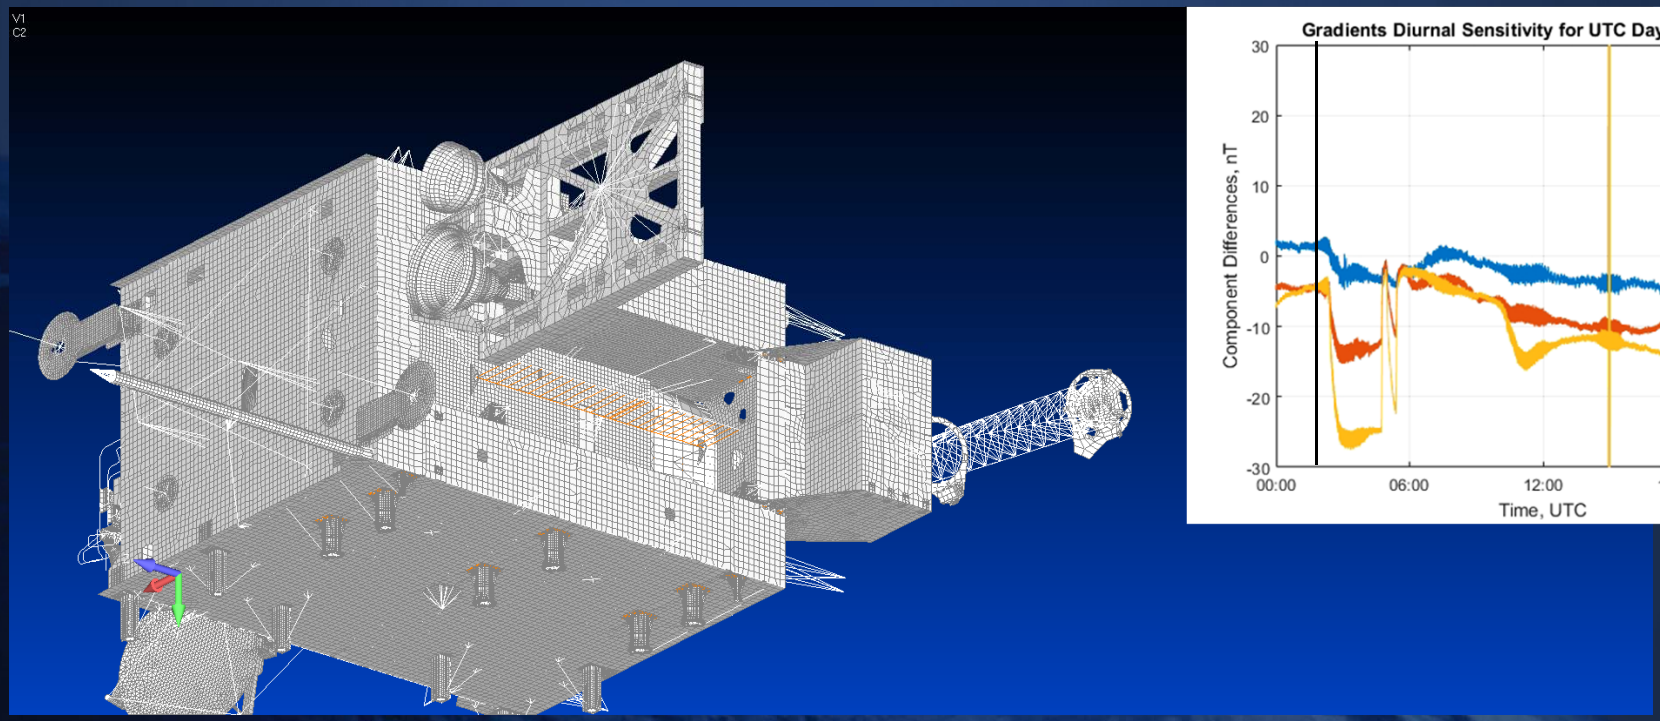
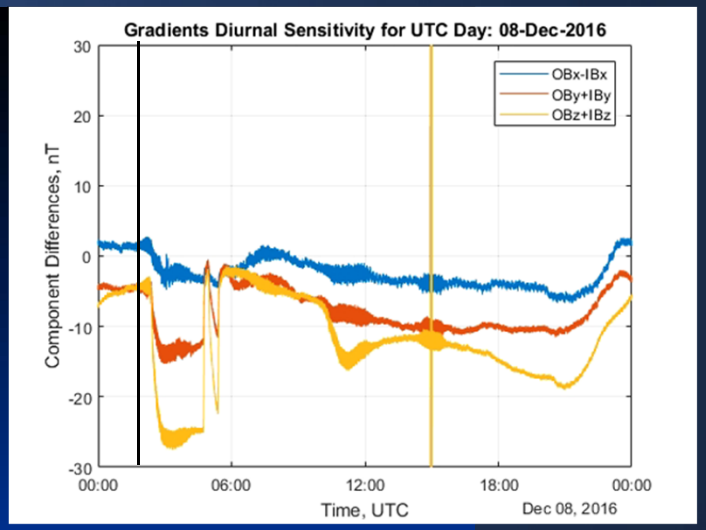
- **Large swings in Inboard measurements correlates to shadowing of magnetometer by Spacecraft body and antenna**

View from the Sun immediately prior to Inboard shadowing

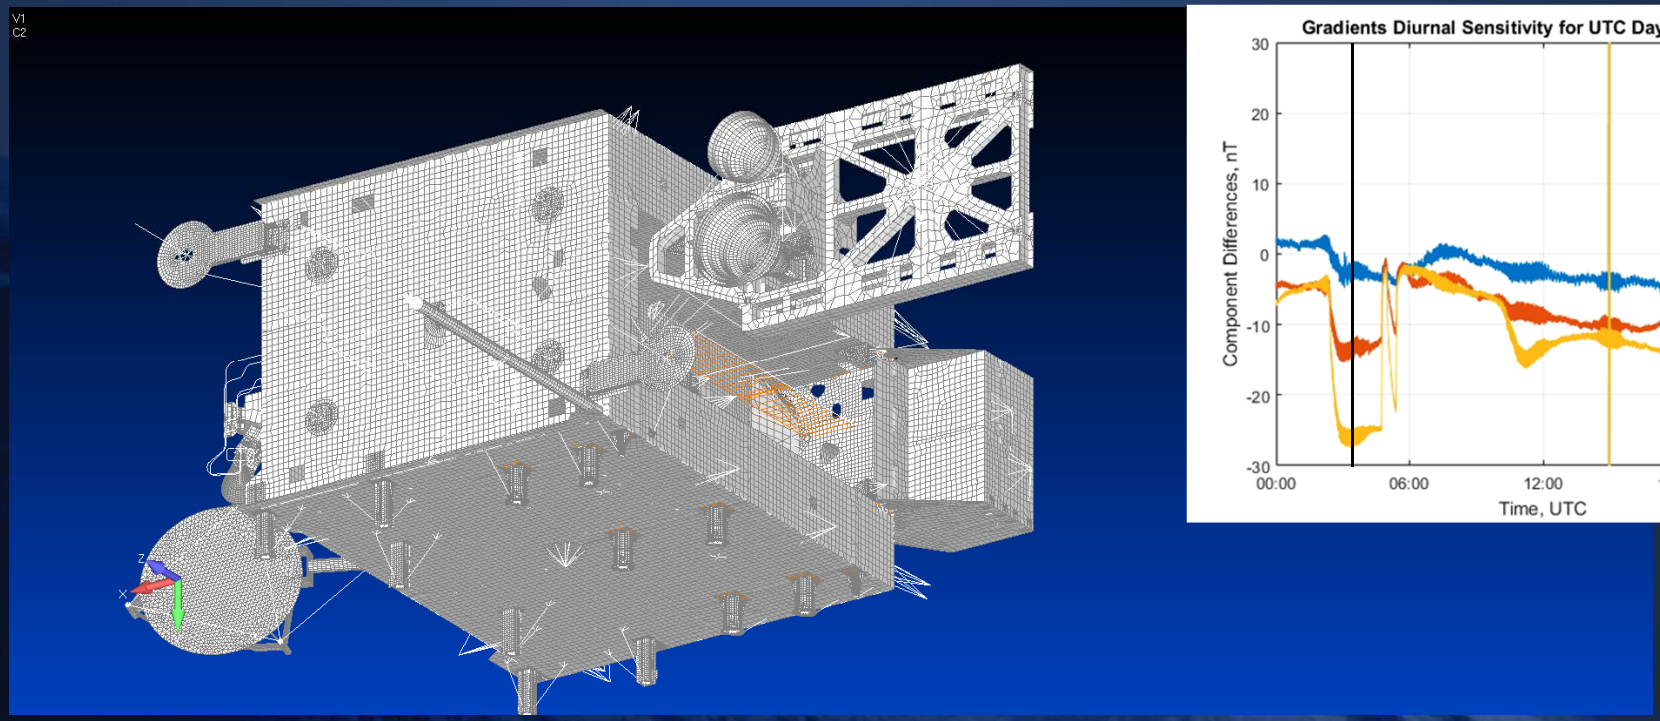
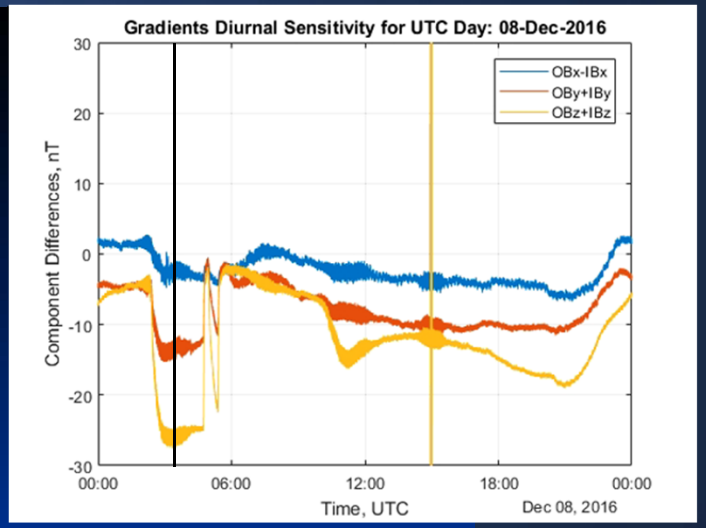
- **Large swings in Inboard measurements correlates to shadowing of magnetometer by Spacecraft body and antenna**

View from the Sun - Inboard shadowed

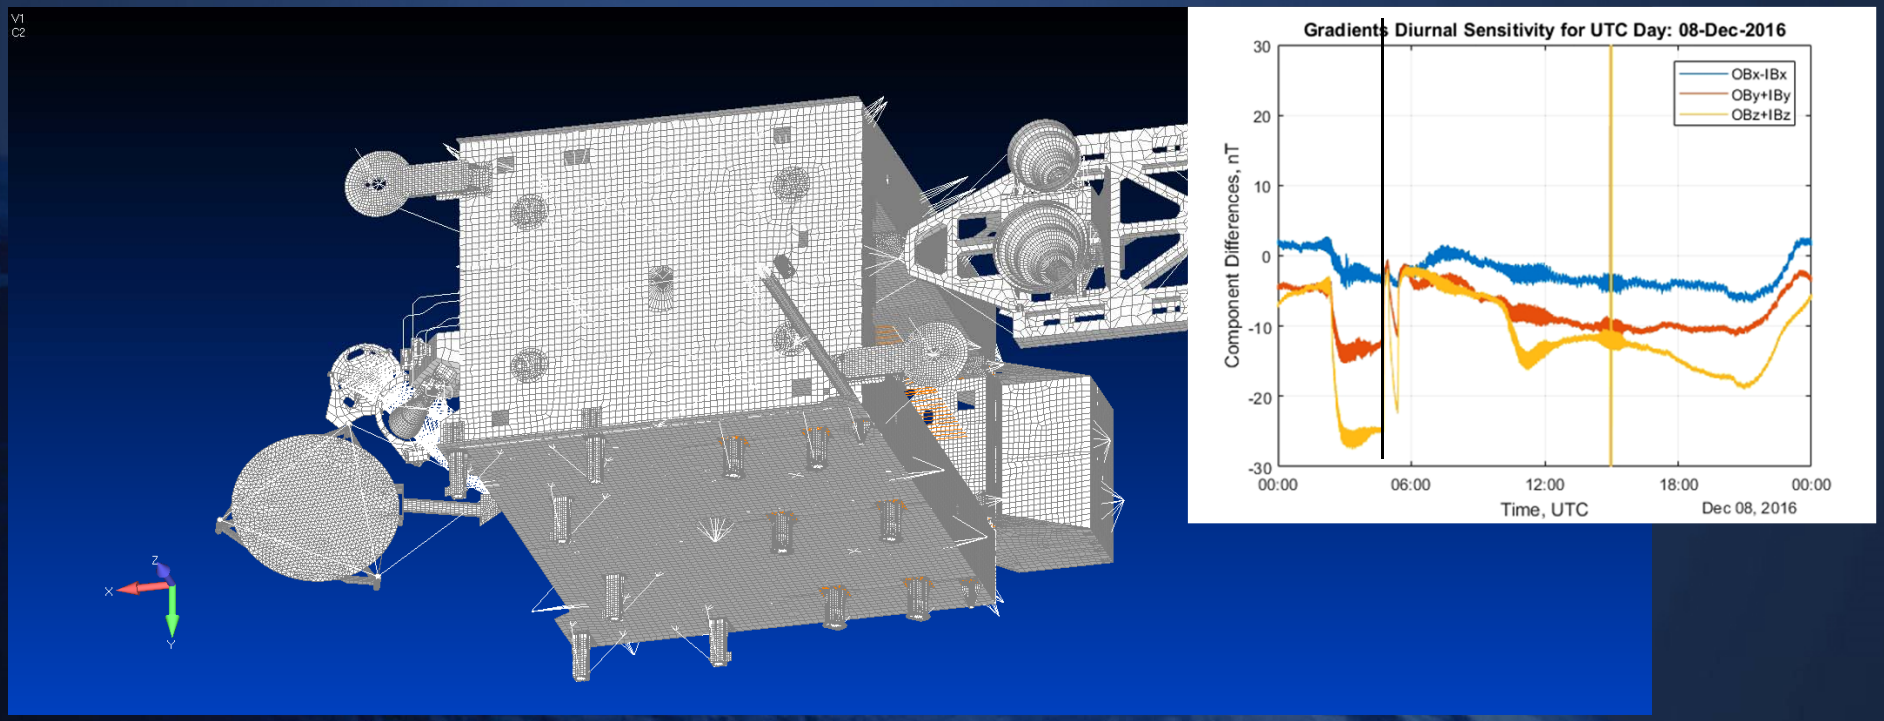
- Large swings in Inboard measurements correlates to shadowing of magnetometer by Spacecraft body and antenna

View from the Sun - End of Inboard shadowing by Spacecraft body

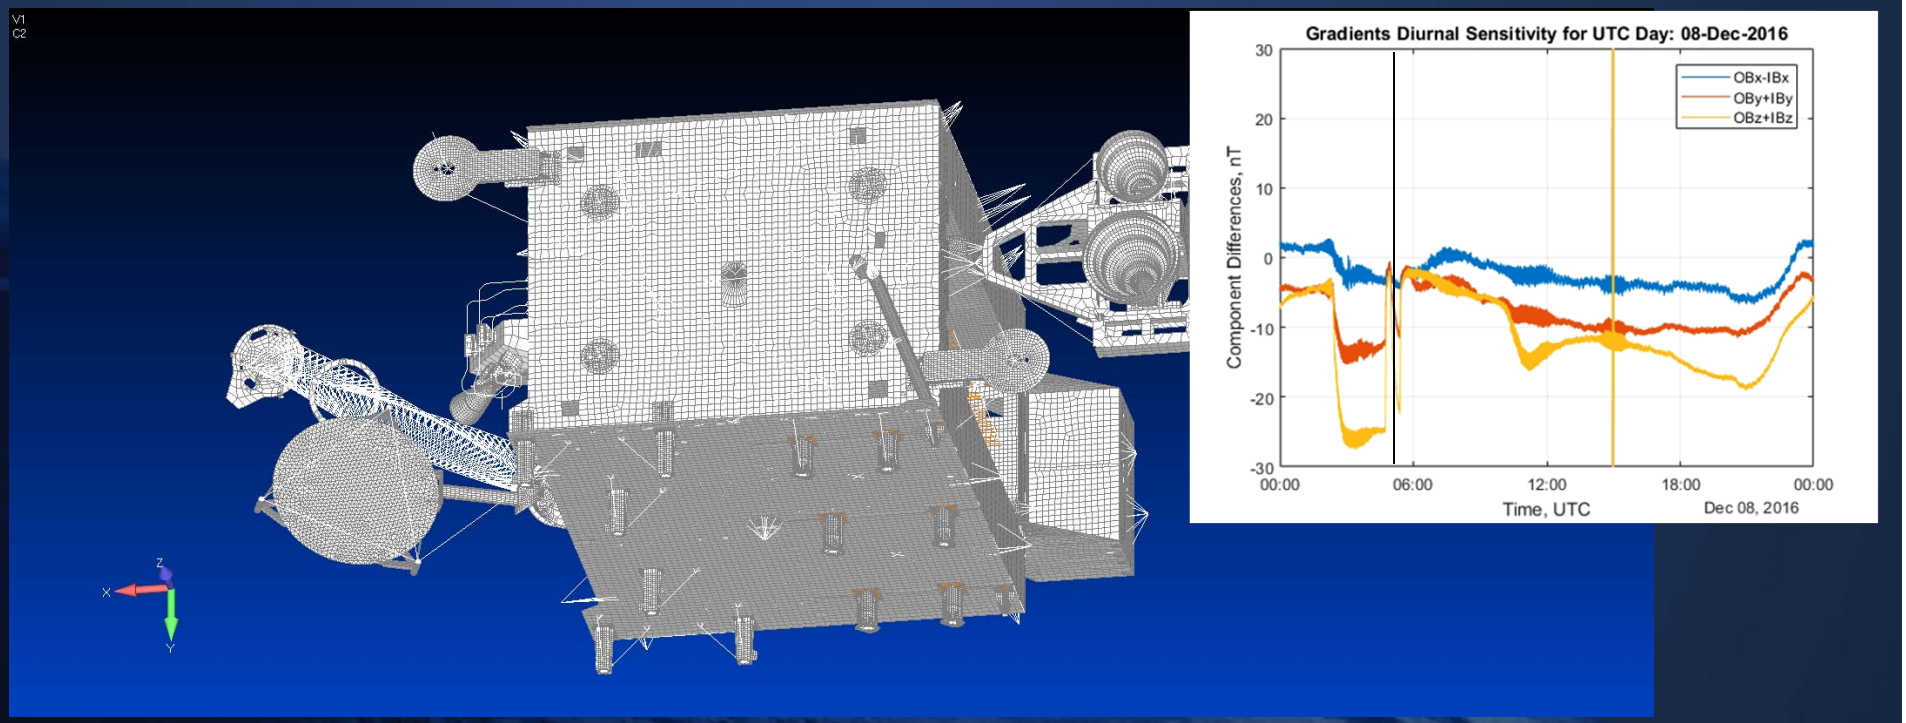
- **Large swings in Inboard measurements correlates to shadowing of magnetometer by Spacecraft body and antenna**

View from the Sun - Inboard shadowing by Spacecraft Antenna

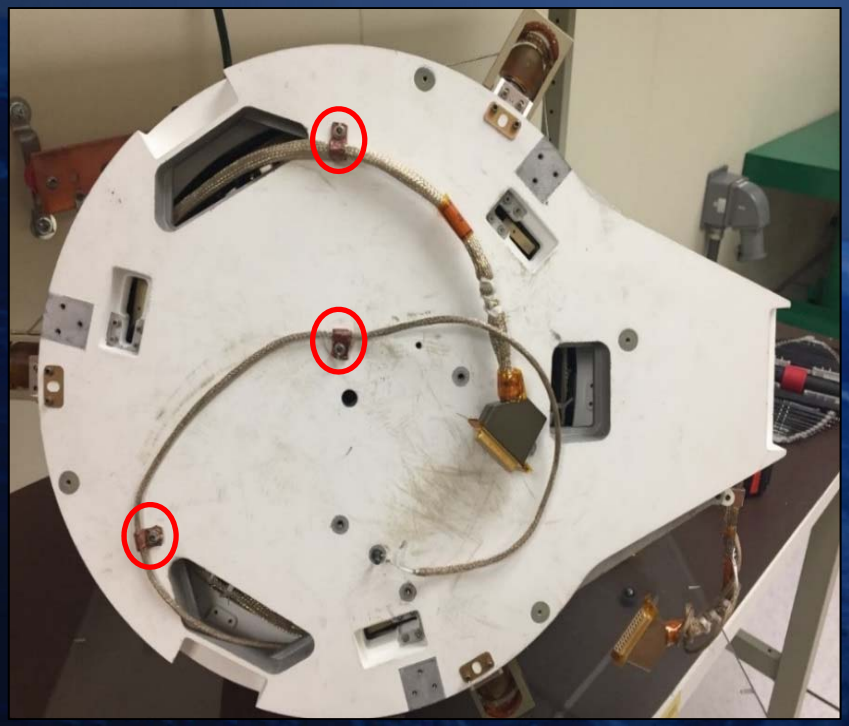
Corrective Action Sensor Plate

- Harness p-clamps wrapped in copper tape in contact with vapor deposited aluminum (VDA) on the magnetometer sensor plate
  - Potential for current loops in the VDA
  - Potential to create voltage difference (Seebeck effect) along the loop formed by the harness, cooper tape, and VDA.

Ground Testing did not generate stray magnetic field.

- Created 80C gradient across plate with harness and p-clamps
- Expected on-orbit gradient is ~90C

- Score inboard and outboard VDA-coated mounting plates
- Replace copper tape on the p-clamps with non-conductive GBK tape
- Isolate multiple harnesses from each

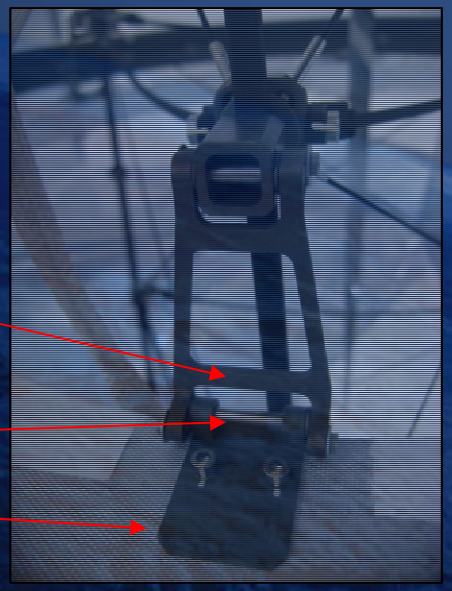
Corrective Action Mounting Bracket

- Mounting bracket of the inboard plate has a chromium plated pin in contact with aluminum and titanium.
  - Seebeck coefficient for chromium and aluminum is 20.1 and -2.9 μV/K
  - Potential for field at magnetometer of 0.26 nT/K.

No Ground Testing Performed
- 77C gradient needed to create field unlikely due to size and high thermal conduction

Design Change:
- Replace the chrome-plated pin with a ceramic pin

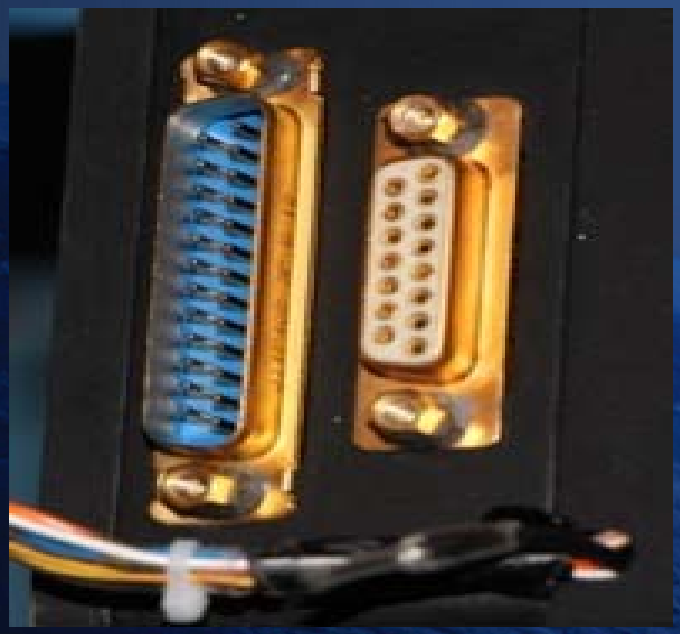
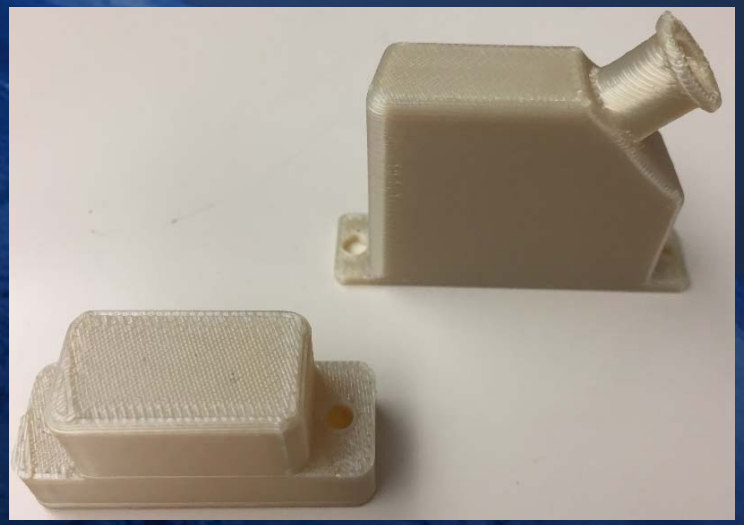
Corrective Action Backshells

- Metallic backshell and grounding plug allowing loop currents to form near the magnetometer

No Ground Testing Performed

- Replace backshell and grounding plug cover with non-conductive polymeric 3-D printed parts

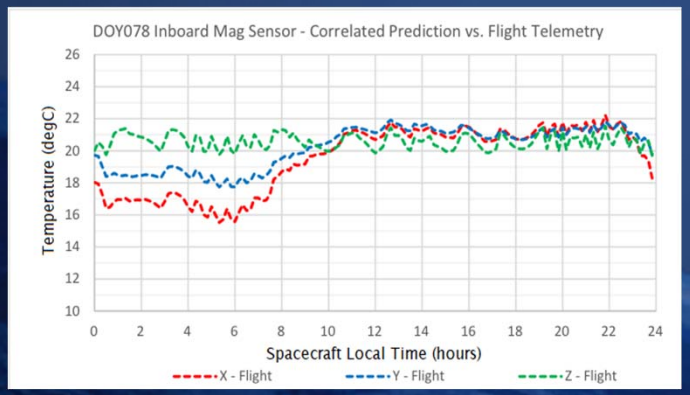
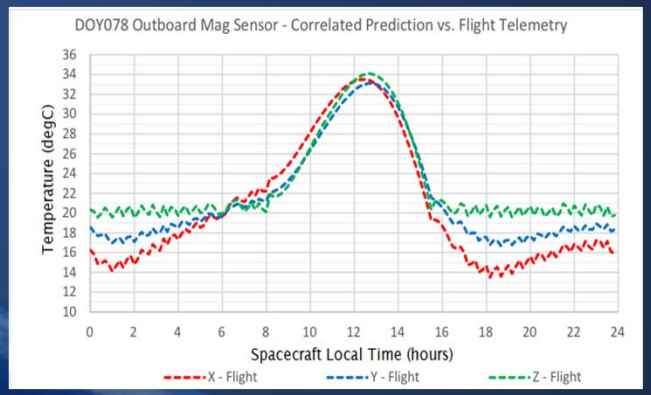
Corrective Action Thermal Control

- Insufficient thermal control requirements result in large swings in the bobbin temperature.
  - Temperature compensation applied but calibration accuracy and zero offset stability concern for such large temperature variations

- Design Changes:
  - Addition of blanket over the existing blanket
  - Addition of blankets over the harnesses
  - Addition of a heater and control thermistor to the harness adjacent to the sensor unit to reduce heat loss through the harness.

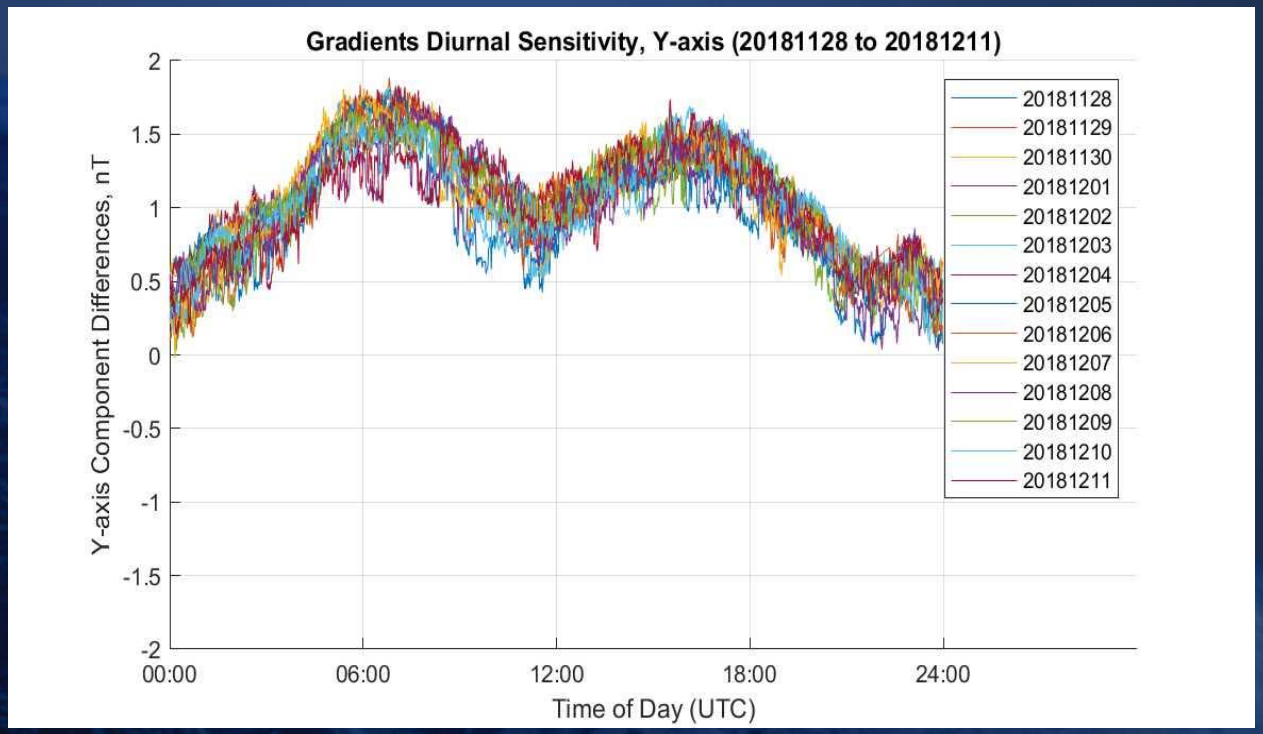
GOES-17 Results

- GOES-17 launched March 1, 2018.
- No large excursions during shadowing period from November December.
- Diurnal variation is greatly reduced.
