**ALTERNATOR INSULATION EVALUATION TESTS**

**NASA Lewis Research Center  
Contract NAS3-15691  
A. W. Nice, Project Manager**

Work under NASA Contract NAS3-15691 was conducted to evaluate the quality, determine predicted life and recommend improvements for the armature and field winding electrical insulations of two 60 KW, 120/208 Volts, 400-Hz, 12,000 RPM homopolar inductor alternators. The alternators completed endurance tests in SNAP-8 turbo-alternators accumulating 12,440 and 23,130 hours at rated load.

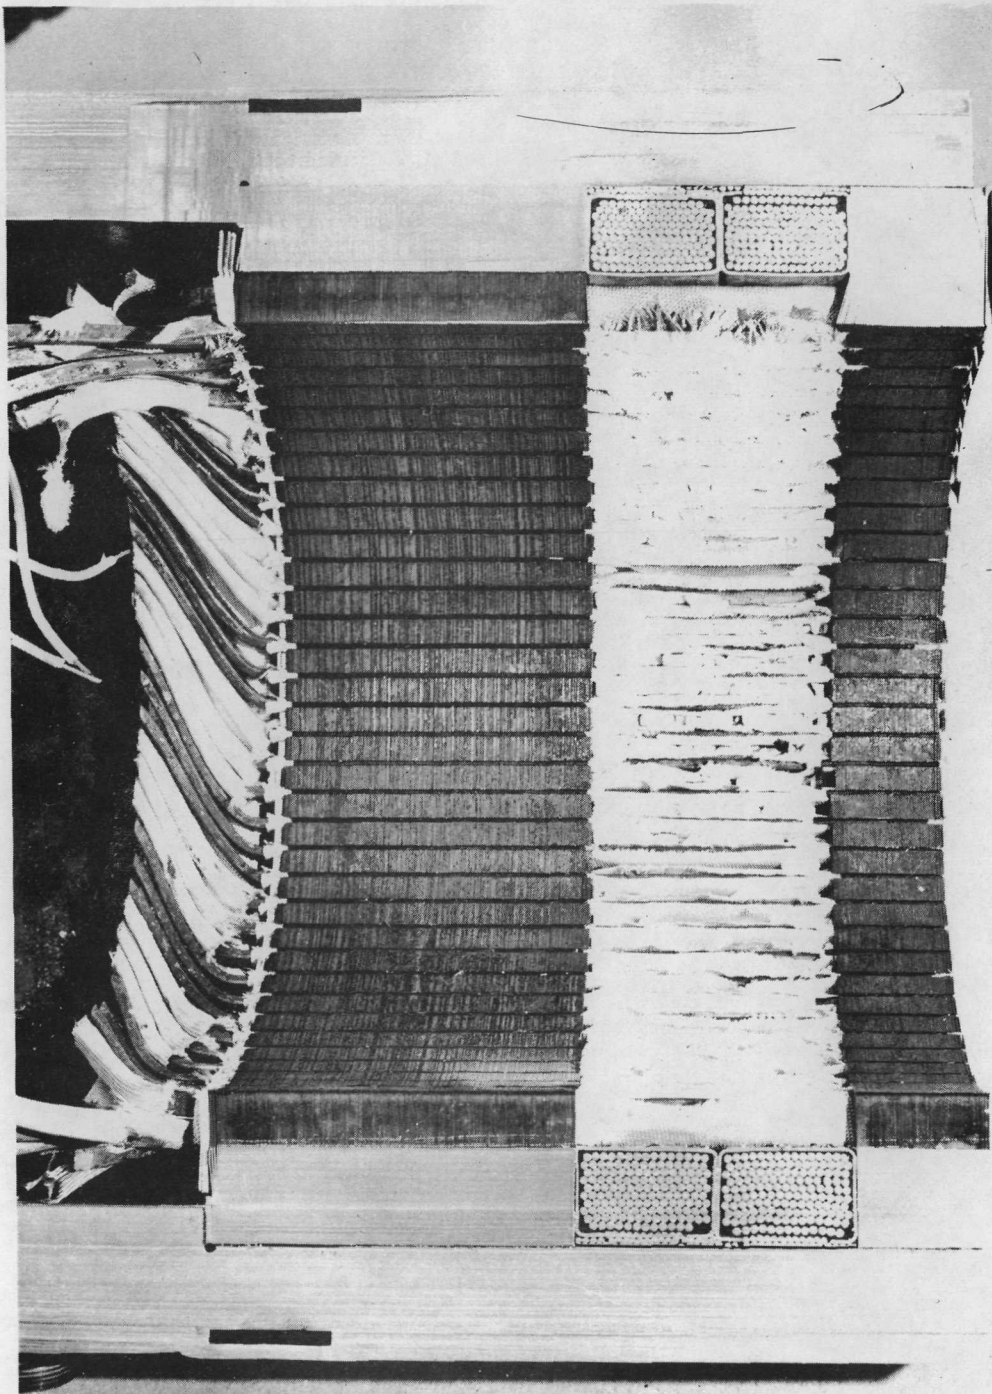
Fig. 20 - Stator No. 2, Mid-Stator Core Section,  
Lead Connection End, After Thermal  
Accelerated Aging

- a. All exposed glass had been burned free of treating or impregnating resin. This included tapes and sleeveings saturated with A50WB363A (Table II, Item 11) and slot tubes impregnated with polyimide resin. The glass was white in color. (Figures 20 and 22).
