APOLLO 12 MISSION REPORT

Mission Evaluation Team

NATIONAL AERONAUTICS AND SPACE ADMINISTRATION

March 1970

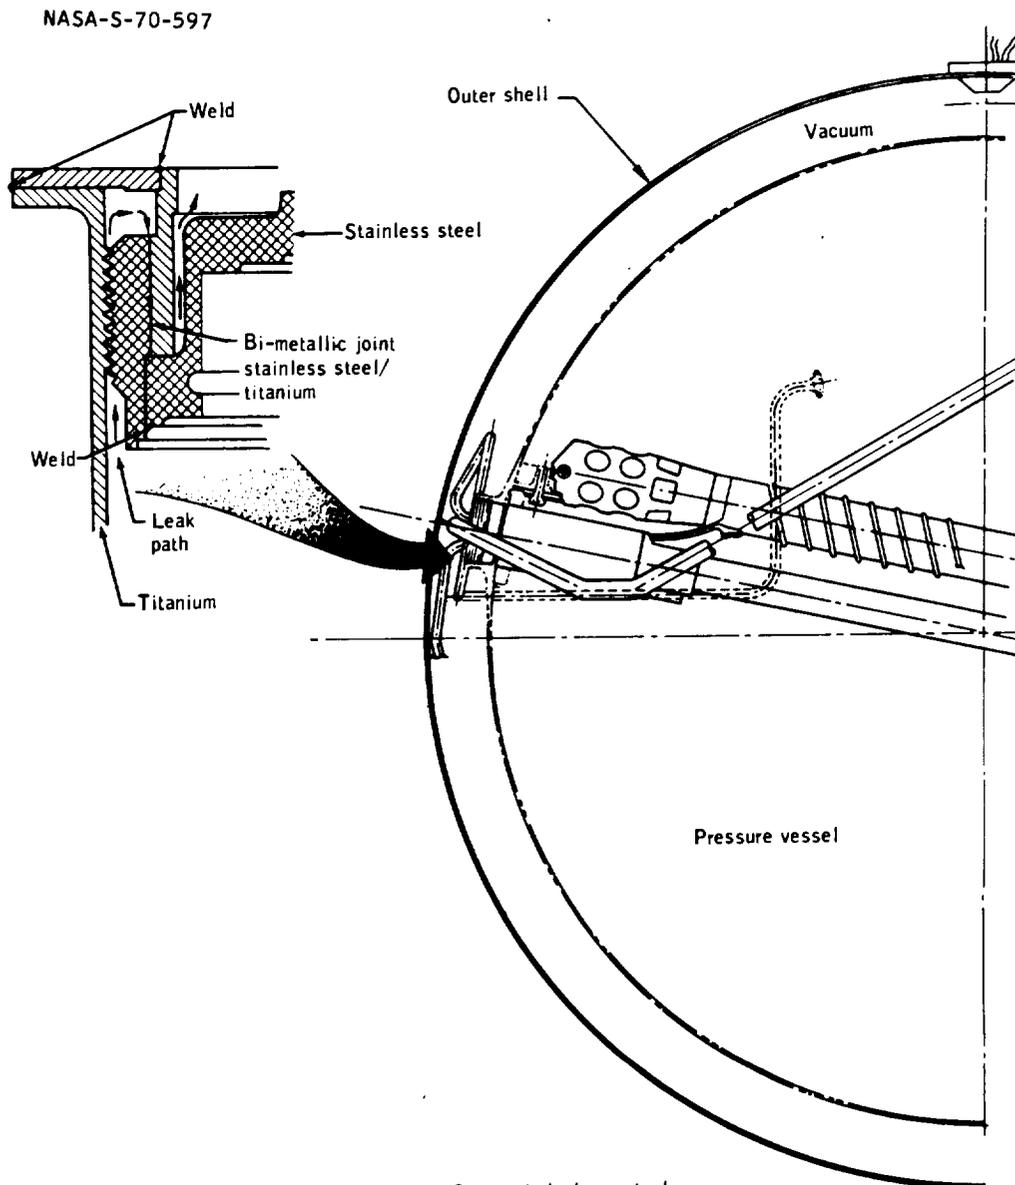
Figure 14-2.- Cryogenic hydrogen tank.

During cryogenic loading about 51 hours before launch, the heat leak of hydrogen tank 2 was unacceptable. Visual checks showed a thick layer of frost on the tank exterior, verifying an inadequate vacuum in the insulating annulus. The tank was removed and replaced. A failure analysis performed before launch identified the cause of the vacuum loss as an incomplete bond in the stainless steel/titanium bimetal joint, which permitted hydrogen to leak from the inner tank into the annulus (fig. 14-2). The bimetallic joint provides a seal between the two metals, which are not compatible for welding to each other. The joint is made from a billet such that the two metals are extruded together and machined. The machined fitting is welded in place, as shown in figure 14-2.

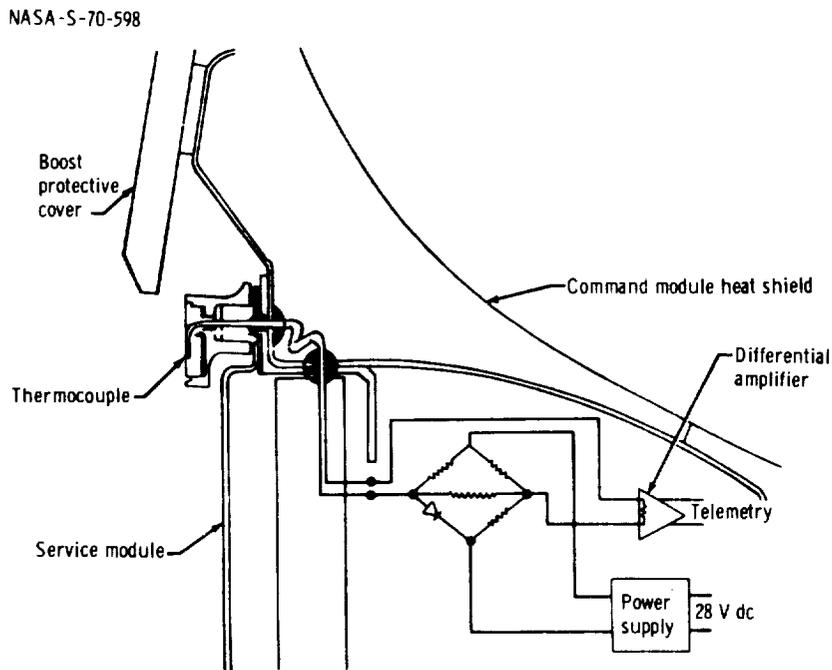
Figure 14-3. - Simplified schematic and location of a typical outer skin temperature sensor.

Instrumentation loss.- The only permanent effect on the spacecraft was the loss of nine measurements at the first discharge. Of these nine, four were service module outer surface temperature sensors, four were reaction control system propellant quantity measurements, and one was a temperature measurement on the nuclear particle analyzer. All of the failed measurements are located on the service module near the interface of the command and service modules.

The service module outer surface temperature measurements use a chromel-constantan thermocouple and a reference junction. The reference junction is a bridge made up of three resistors and a temperature-sensitive diode (fig. 14-3). The resistors normally operate at about 0.020 ampere and will open in the region of 0.100 ampere. An open bridge resistor would drive the signal output off-scale high or low depending upon which resistor fails.

It is probable that the nuclear particle analyzer temperature failed as a result of burning out a zone box resistor in a manner similar to the outer surface temperature sensor failures.

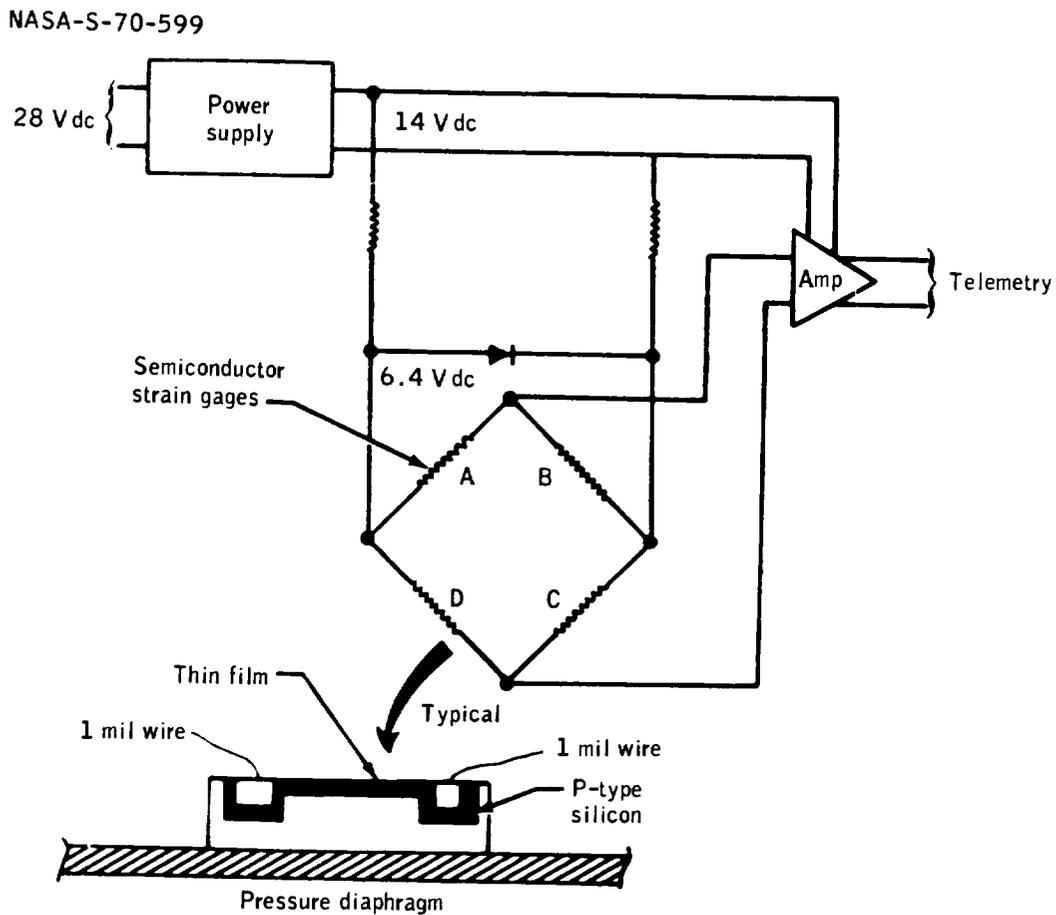
Figure 14-4.- Propellant quantity transducer schematic.

The reaction control propellant quantity measurements use semiconductor strain gages on a pressure-sensitive diaphragm (fig. 14-4). The semiconductors are a thin film type, and excessive current would probably damage their capability to operate as pressure-sensitive resistors. An alternate possibility is that the Zener diode, used to regulate the 14-volt supply to 6.4 volts, was burned out. Loss of this diode would explain the instrumentation symptom, which in all four cases was full-scale and unchanging.

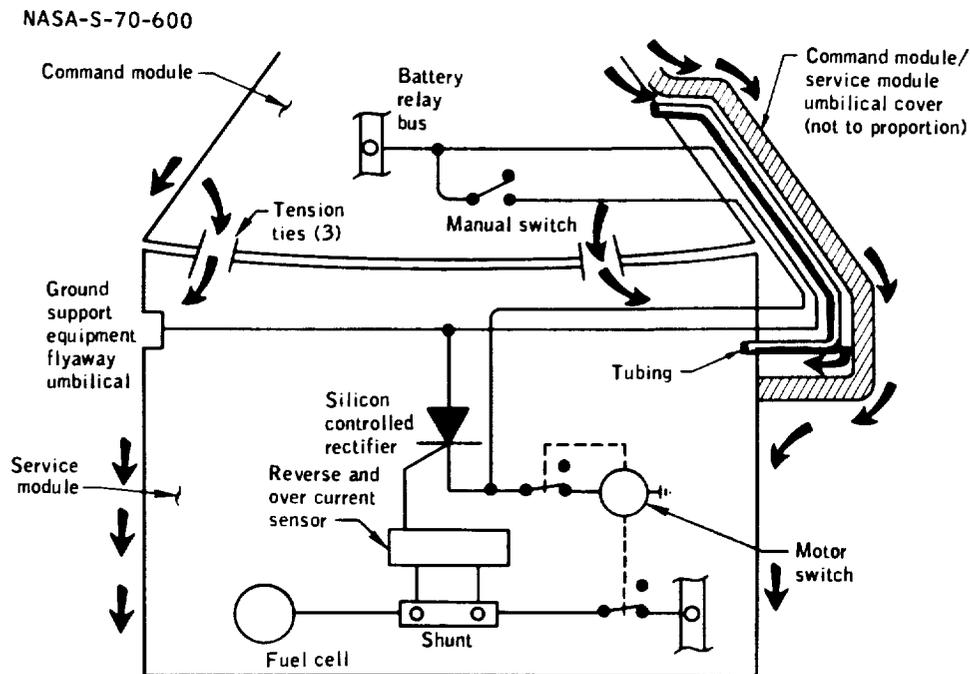
Figure 14-5.- Fuel cell disconnection circuitry.

Fuel cell disconnect.- At the time of the first lightning discharge, the fuel cells were automatically removed from the spacecraft buses with the resultant alarms normally associated with total fuel cell disconnection.

The voltage transient that was induced on the battery relay bus by the static discharge exceeded the current rate-of-change characteristics of the silicon controlled rectifiers in the fuel cell overload sensors and disconnected the fuel cells from the bus (fig. 14-5). As a result, the main bus loads of 75 amperes were being supplied totally by entry batteries A and B, and the main bus voltages dropped momentarily to approximately 18 or 19 volts, but recovered to 23 or 24 volts within a few milliseconds. The low dc voltage on the main buses resulted in the illumination of undervoltage warning lights, a drop out of the signal conditioning equipment, and a lower voltage input to the inverters. The momentary low-voltage input to the inverters resulted in a low output voltage which tripped the ac undervoltage sensor causing the ac bus 1 fail light to illuminate. The transient that disconnected the fuel cells from the buses also caused the silicon controlled rectifier in the overload circuits to indicate an ac overload. At 2 minutes 22 seconds into the flight, the crew restored fuel cell power to the buses. All bus voltages remained normal throughout the remainder of the flight.

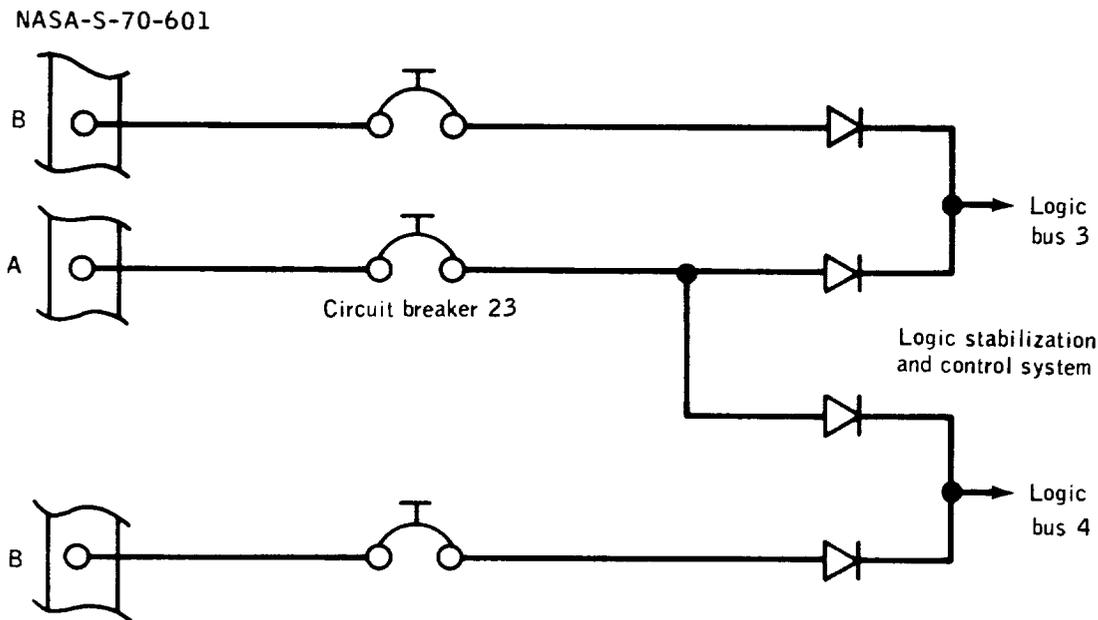
Figure 14-6.- Stabilization and control circuit breaker schematic.

During systems checks after earth orbit insertion, circuit breaker 23 for stabilization and control logic bus 3 and 4 on panel 8 was found in the open position (fig. 14-6). A crewman closed the circuit breaker and

it remained closed throughout the rest of the mission. Complete electrical and mechanical tests were performed and the results were normal. The circuit breaker and associated circuitry showed no cause for the breaker to have opened either because of launch vibrations or an electrical fault.

As shown in the figure, the breaker was supplying power in parallel with two other breakers which did not open. This fact plus no abnormalities indicate that the breaker was probably not set during the prelaunch switch and circuit breaker positioning checks. These breakers are not specifically verified to be in proper position.

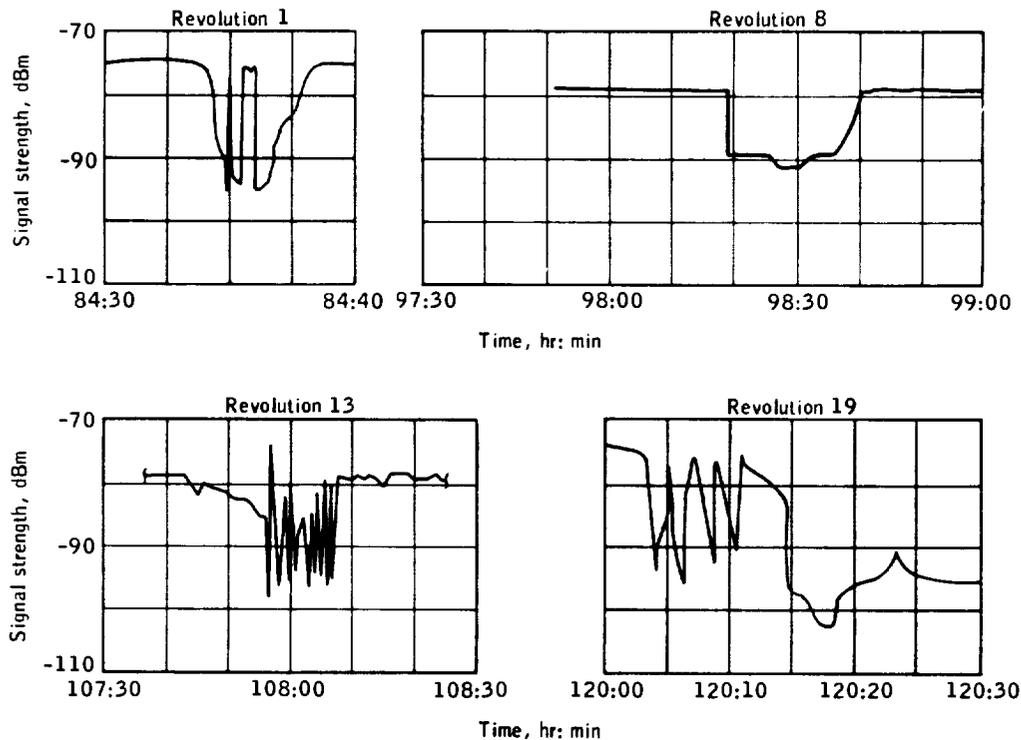
Figure 14-7.- Typical high gain antenna uplink signal strengths during abnormal operations.

Operation of the S-band high gain antenna in the narrow beam mode resulted in a decrease of approximately 10 to 12 dB in both uplink and downlink signal strength on several occasions. Illustrations of the first and other unexpected signal-strength variations are shown in figure 14-7. The first decrease occurred in lunar orbit revolution 1.

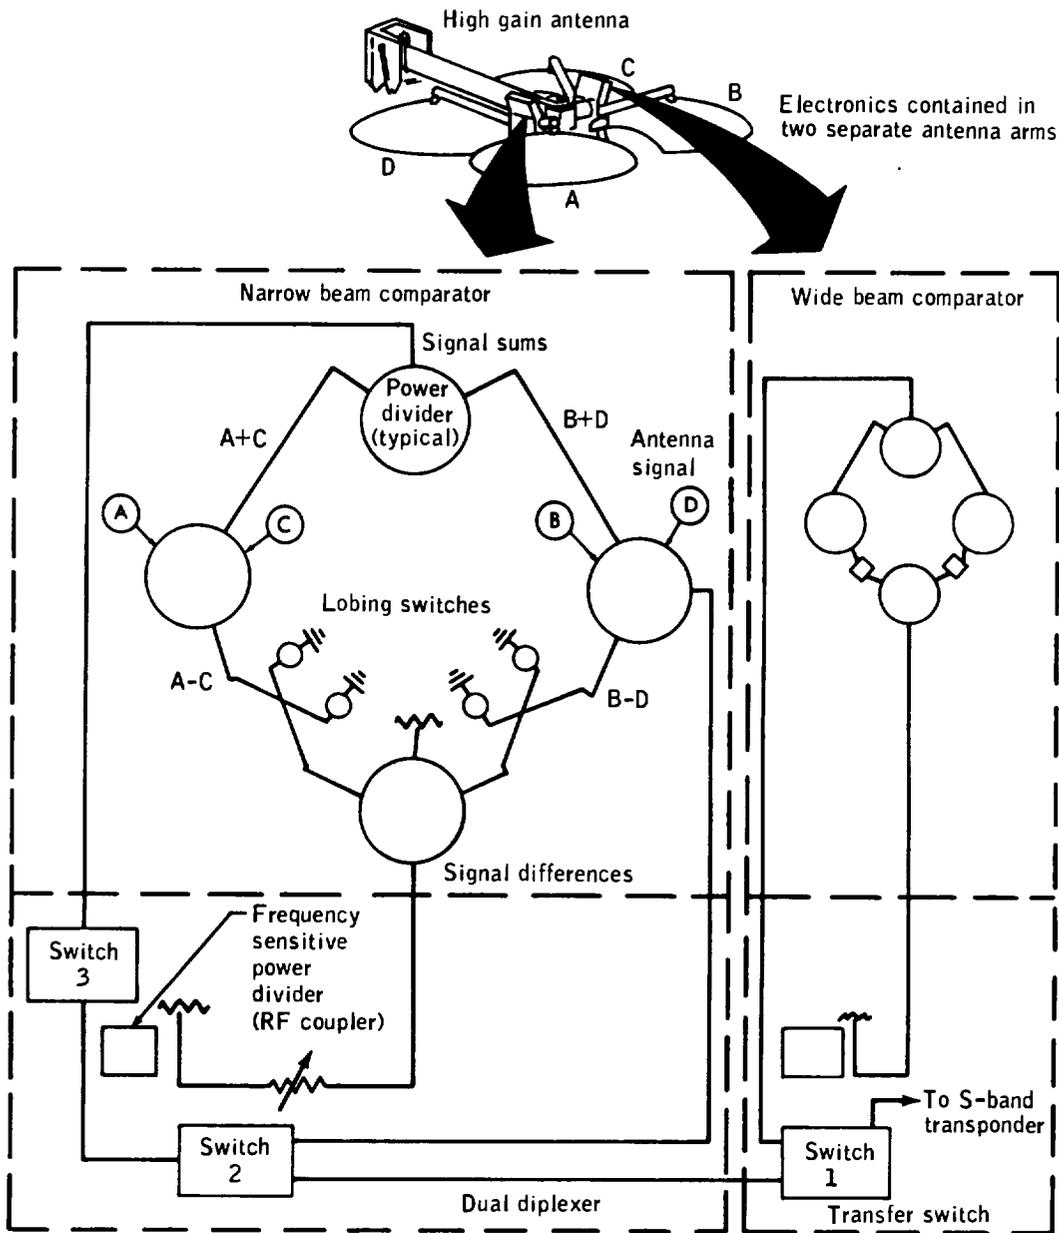
Figure 14-8.- S-band high gain antenna electronics.

There is a total of four stripline units with one contained in each of the following antenna components: narrow-beam comparator, transfer switch, and dual diplexer, as shown in figure 14-8. Based on the inflight tests, the wide beam comparator has been eliminated as a cause of the anomaly. Also, investigation of the circuitry and correlation of data has ruled out the transfer switch as being the anomaly cause. Therefore, the malfunction could only have been in the narrow beam comparator or the dual diplexer.

The narrow beam comparator combines the patterns of four dish antennas to provide the sum and difference patterns which provide the angle pointing information. Two malfunctions that could produce boresight shifts have been identified in the narrow beam comparator. Under normal operating conditions, the lobing switches function as digital phase shifters and provide either a zero or 180-degree phase shift. If a diode fault occurs that changes the phase or amplitude characteristics of either switch, tracking errors can be produced. The opening of one set of diodes would have to be intermittent to produce the observed flight anomaly, thus suggesting the presence of temperature or pressure sensitive connections in the traces that connect the diode switches. Another diode fault which can occur is a loss of the drive voltage to one of the lobing switches. In this case, the switch will provide a constant phase shift. The multiplexed difference signal for the case when the phase shift of switch 1 (fig. 14-8) is constant at 180 degrees results in unsymmetrical lobing. The antenna, in this case, will seek those pointing angles that make the elevation and azimuth angles equal in magnitude, thus suggesting that the resultant tracking error could be large and not repeatable. This condition would give the observed antenna performance characteristics. Therefore, a malfunction in the diode wiring or circuit connections is suggested. The intermittence associated with this malfunction could be explained by a temperature sensitive circuit connection (solder crack or wire break).

The major components of the dual diplexer are switches 2 and 3 and the frequency-selective power divider. The power divider is the most susceptible component for generating tracking errors. If the difference signal is attenuated by a high impedance feed-through or by incorrect phasing between the sum and difference signals, the slope of the antenna index-of-modulation curve is reduced. This decrease, in effect, reduces the total loop gain and results in an overdamped tracking system. In this case, large tracking errors would result and an antenna drift would be observed; these were the observed symptoms. Attenuation of the multiplexed difference signal can result from a trace crack or intermittent feed-through between the narrow beam comparator and the dual diplexer. Both types of failures tend to be temperature sensitive.

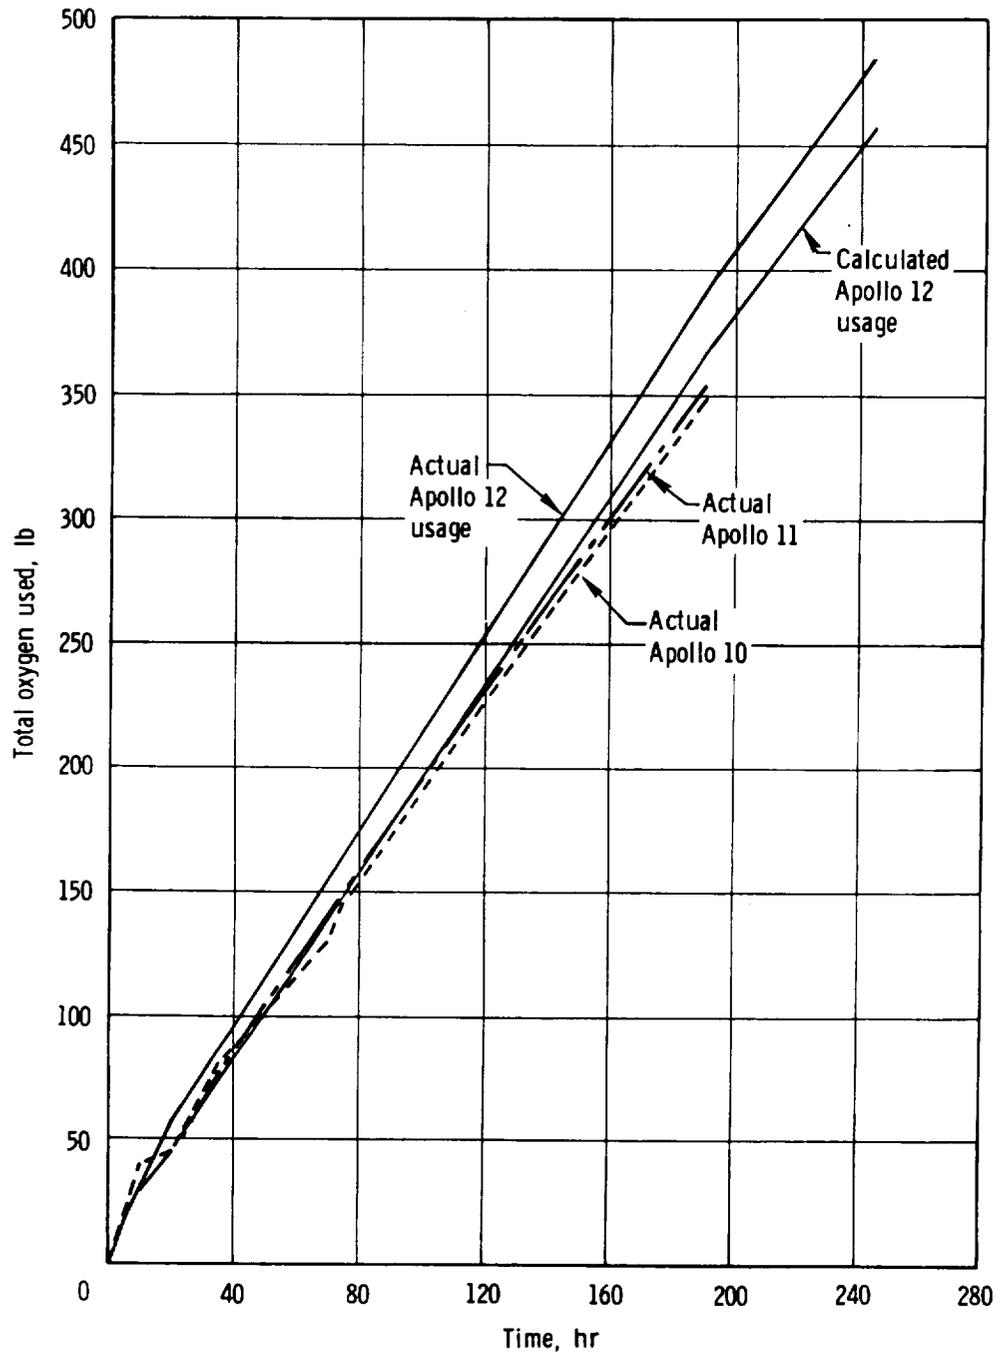
Figure 14-9. - Comparison of oxygen consumption for Apollo 10, 11, and 12.

At the end of the mission there was a discrepancy of approximately 27 pounds of oxygen between the measured total cryogenic oxygen usage and the calculated combined environmental control system and fuel cell oxygen usage, as shown in figure 14-9.

Fuel cell oxygen usage was calculated from the produced electrical current and then verified by comparison with hydrogen consumption data. Environmental control system usage is measured on a flowmeter and compared with calculated usage based on purge rates, cabin leakage rates, metabolic consumption and urine dump losses. Cabin leak rates are determined by ground tests in conjunction with flight pressure decay rates. Purge rates are calculated based on ground tests and known times for purges. Oxygen losses during urine dump operations can only be estimated. Since no excessive flow was detected downstream of the flowmeter, the source of any command module environmental control system leakage is therefore limited to the 900-psi system upstream of the meter. Figure 14-10 shows the 900-psi oxygen system and that portion of the system outside the command module that could have leaked.

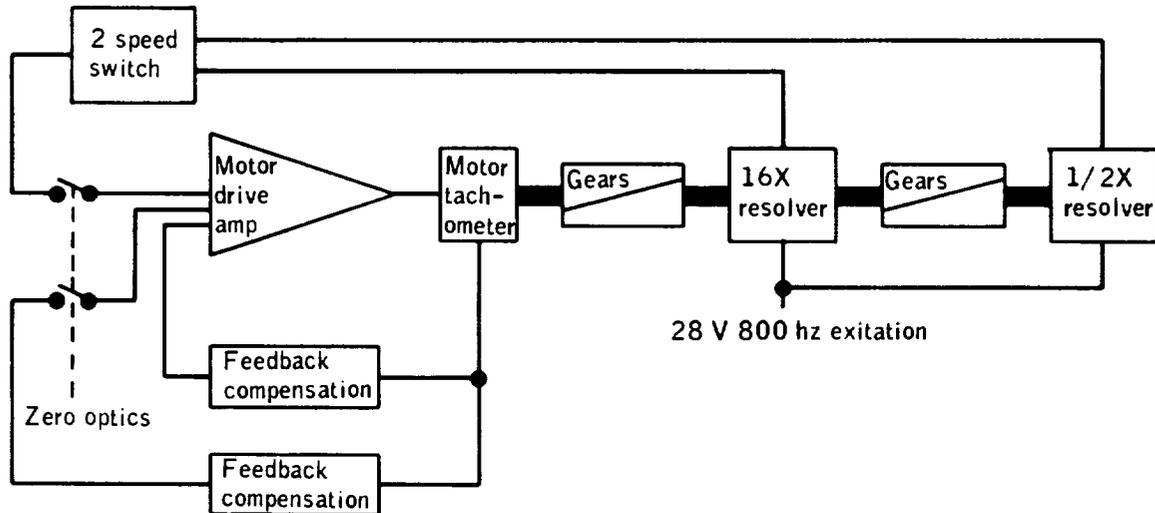
Figure 14-11.- Zero optics mode circuitry.

A number of components in the optics drive servomechanism (fig. 14-11) are used only in the zero optics mode. The optical unit and the power-and-servo assembly were removed from the spacecraft, and the servo assembly was subjected to thorough testing. The flight symptoms, however, could not be reproduced. Because of extensive sea-water corrosion, the optical unit could not be tested, but an analysis and testing of a similar unit demonstrated the cause of the zero optics anomaly to be within the power-and-servo assembly. The flight assembly was installed in a working system and has operated properly under a variety of thermal conditions. The modules associated with the optics servo were also thermally cycled in an oven, operated in a vacuum, and subjected to acceptance test vibration levels with no degradation of their performance. The modules were depotted and examined, but no cause of the anomaly could be isolated.

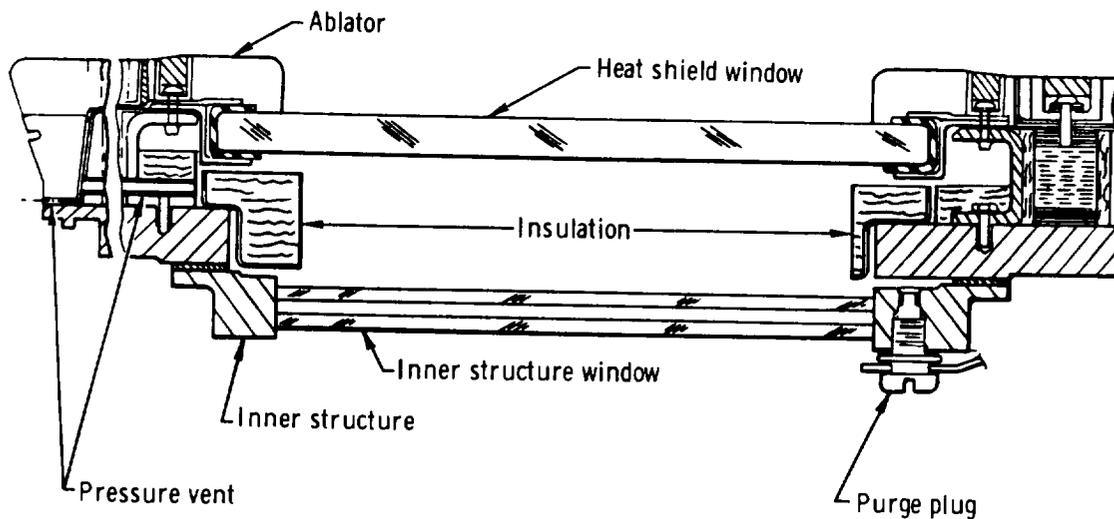
Figure 14-14. - Cross section of hatch window.

Contamination was also noted on the inside surface of the heat-shield panes on the left-hand side and hatch windows. The contamination, which disappeared on the left-hand side window after the first day, probably resulted from water entrapped between the heat shield and pressure structure in the general area of this window. The contamination on the inside surface of the hatch heat shield window remained throughout the flight and varied in size with the thermal cycles of the spacecraft. This contamination could have resulted from either entrapped moisture in the hatch area between the heat shield and the pressure structure or from outgassing of sealant materials in this area (fig. 14-14). Such outgassing has been minimal in the past three flights because the curing processes were changed to alleviate this problem. However, a chemical analysis of the contamination on the inside surface of the hatch window has shown the concentration of silicone oils to be higher than expected. These oils are the outgassed products from the material used to seal the thermal blankets near the window.

For Apollo 13 and subsequent spacecraft, seals will be added to the boost protective cover to prevent leakage of rain water. Prior to flight, the hatch window cavity will be purged with a 35/65-percent mixture of dry nitrogen and oxygen to remove entrapped moisture. To further alleviate the outgassing of silicone oils, the insulation material will be removed from between the outer and inner hatch windows on future spacecraft.

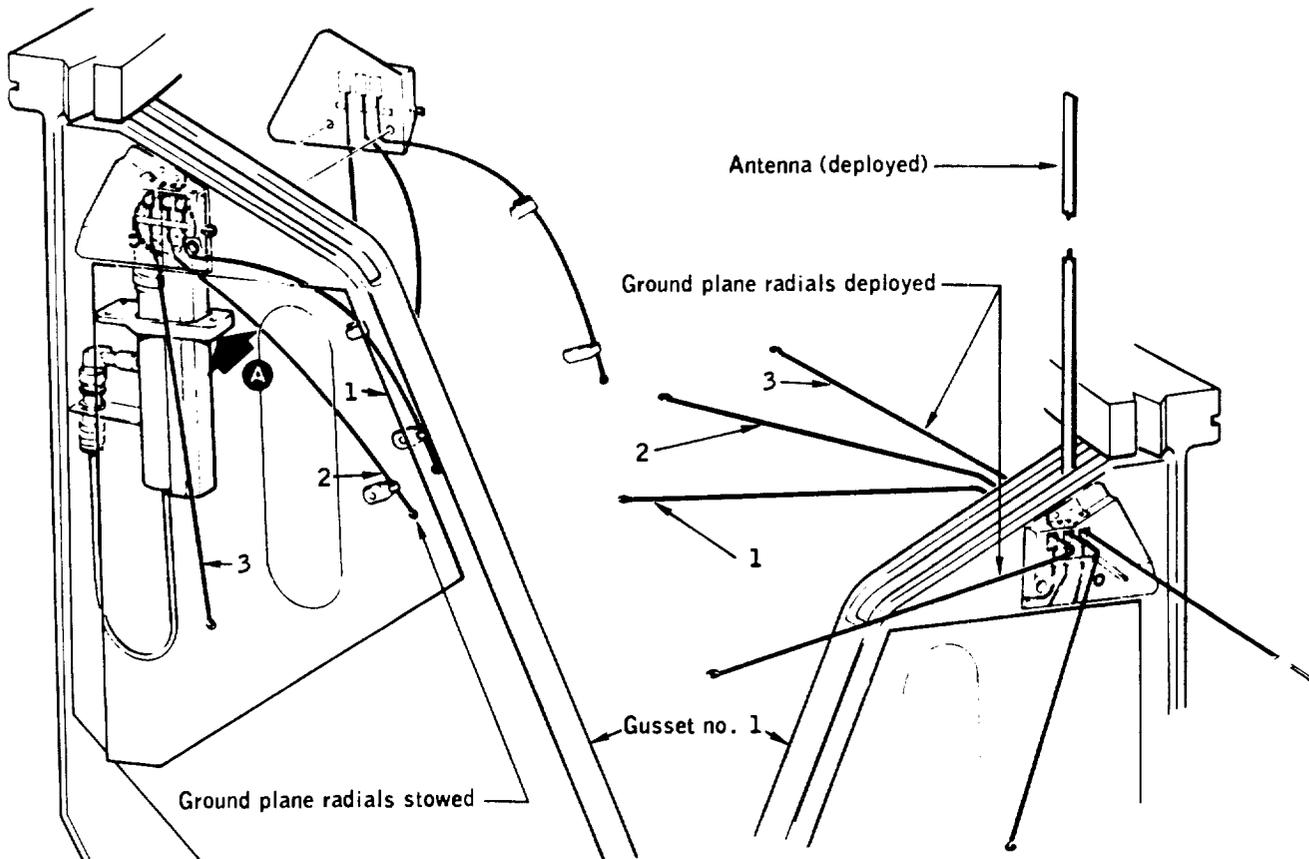
Figure 14-15.- VHF recovery antenna configuration.

During the command module descent on the main parachutes, ground plane radials 1 and 3 of VHF recovery antenna 2 (fig. 14-15) did not properly deploy. However, voice communications with the recovery forces while using this antenna were not significantly affected. Postflight examination of the antenna revealed that the cloth flap which normally covers the radials to prevent entanglement with the parachutes could be made to stick to the gusset by an adhesive substance which was inadvertently present on both the flap and the gusset. The radials would not deploy when the flap had stuck to the gusset; however, radial 1 would not always deploy, even when the flap was not stuck. A slight binding at the spring end or at the retaining clip has been experienced on radial 1.

For Apollo 13 and subsequent missions, recovery antenna 2 will be used for recovery beacon transmissions instead of voice. However, even

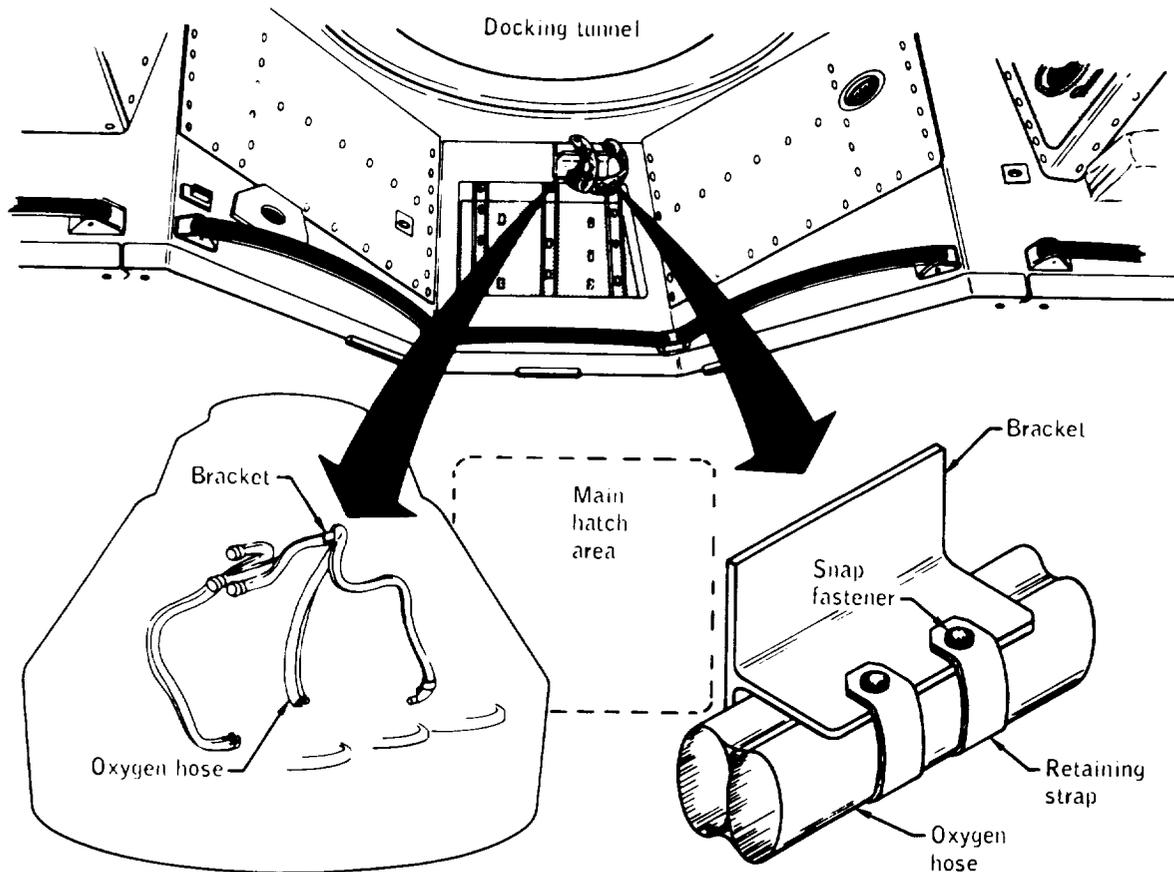
Figure 14-17.- Oxygen hose retention bracket.

At earth landing, an aluminum retention bracket for the oxygen hoses pulled loose from the main display panel (fig. 14-17). The bracket is bonded to the panel and supports four oxygen hoses, which are attached to the bracket by Beta cloth straps that snap to the panel.

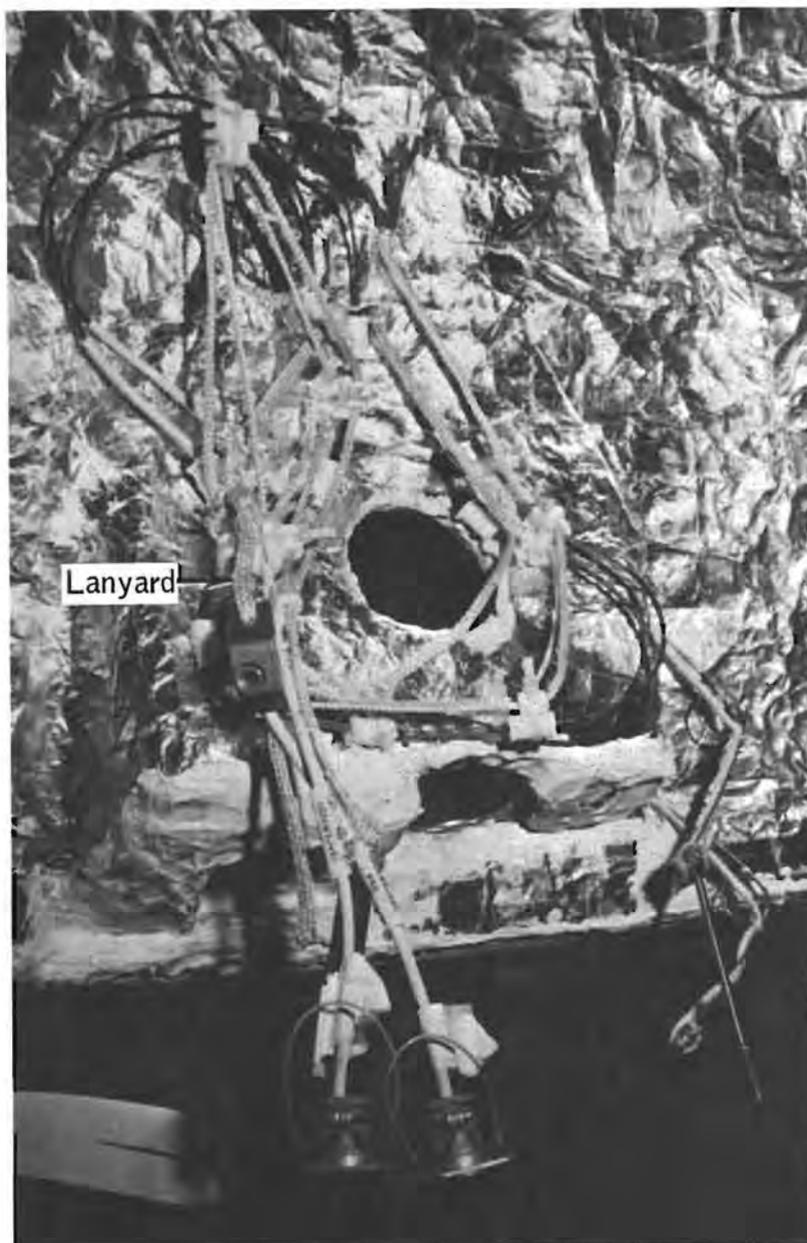
Figure 14-18.- Forward heat shield mortar umbilical.

During postflight inspection of the upper deck, the lanyard which retains the forward heat shield electrical cable had been severed, and only 18 inches of the approximately 45-inch lanyard remained. The lanyard is fabricated from natural Nomex cord with a breaking strength of approximately 600 pounds. The function of the lanyard is to provide for orderly deployment of the electrical wire bundle which connects the forward heat shield mortar cartridges and the electrical connectors on the upper deck. As the heat shield separates from the command module, the lanyard, which is anchored to the spacecraft at one end, sequentially breaks each of a series of 16- and 50-pound retainers which secure the wire bundle to the inner wall of the forward heat shield (fig. 14-18). The crew reported that parachute deployment was normal, and this is confirmed by onboard camera coverage.

Examination and comparative laboratory tests on a similar type cord disclosed that the failure is nearly identical to those which occur in lanyard knots when loaded in tension. A small flake of yellow material was found embedded in the weave of the severed end of the lanyard. Comparison of the flake with yellow Mylar tape, which is used to wrap the steel drogue riser, showed a definite similarity. Foreign material removed from the lanyard and a piece of tape from a drogue riser contained significant amount of a grayish-black material (fig. 14-19), which is believed to be deposits of a dry-film lubricant used on the steel risers.

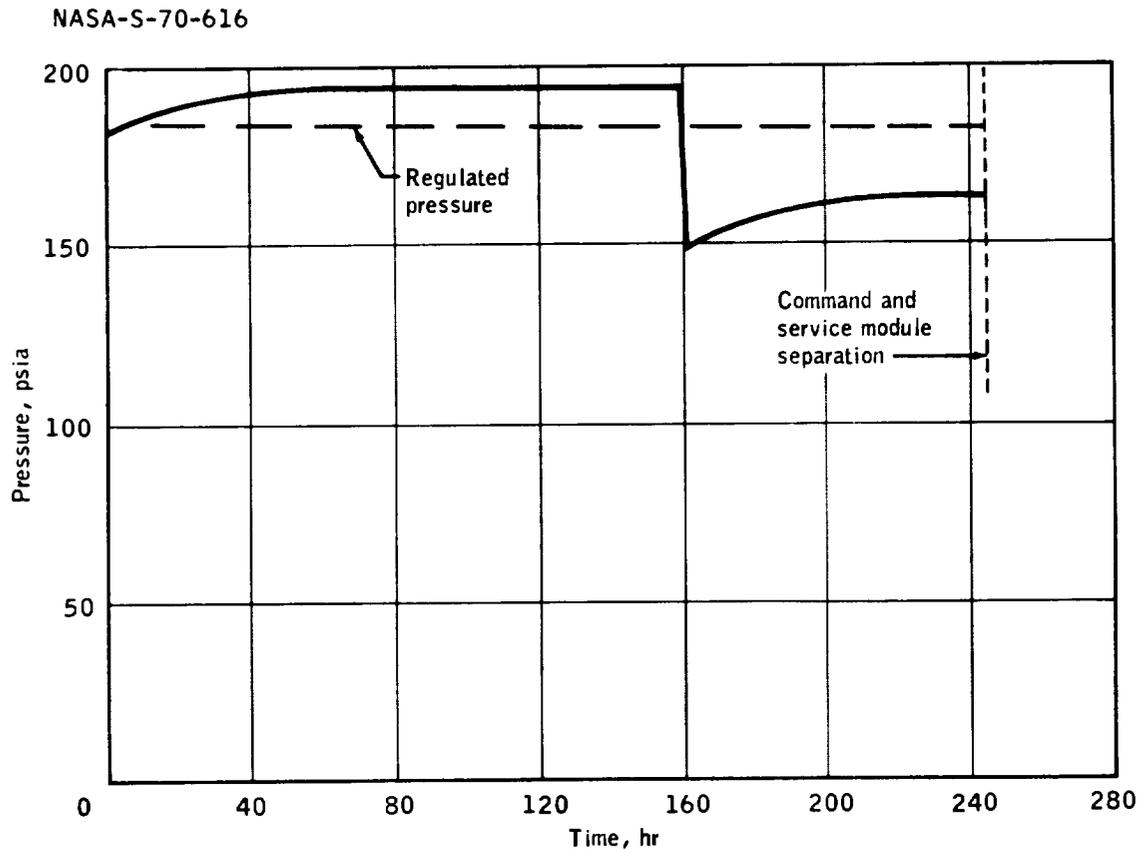
Figure 14-21.- Quad D helium manifold pressure.

Shift in quad D helium manifold pressure.- The measurement for reaction control quad D helium pressure indicated erroneous values throughout the flight. During the first 70 hours, the pressure exhibited a slow drift of about 14 psia upward. At approximately 160 hours, the measurement then shifted from 192 to 150 psia, followed by a second slow drift upward (fig. 14-21). Both the slow drifts upward and the jump shown on the figure tend to support the conclusion that the strain-gage bonding had weakened. The measurement is primarily used during preflight testing to indicate the helium manifold pressure downstream of parallel redundant pressure regulators and is not necessary for flight.

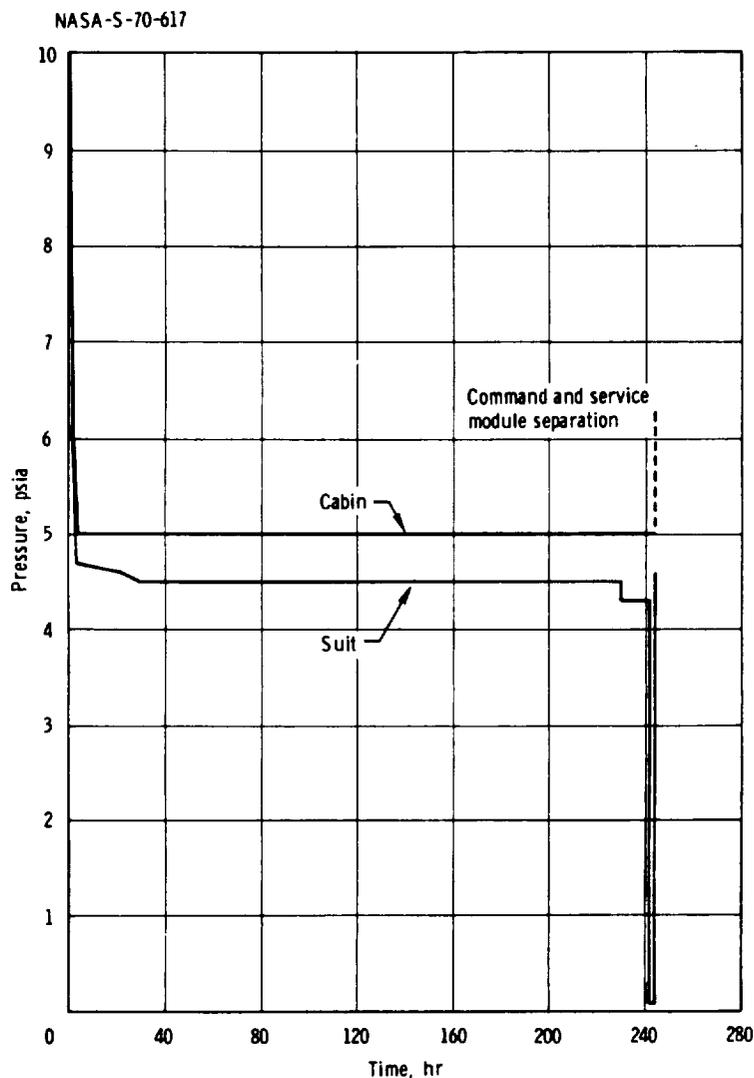
Figure 14-22. - Suit and cabin pressure history

Low readings from suit pressure transducer.- The suit pressure transducer indicated low throughout the mission.

The suit pressure transducer operated properly throughout the pre-launch and launch activities. When the helmets and gloves were removed after launch, the transducer indicated 0.2-psid less than cabin pressure and at approximately 22 hours the differential was 0.4 psid. A 0.4- to 0.6-psid disparity existed between the indicated suit loop and cabin pressures until the final hours of the mission (fig. 14-22).

At 241:41, the suit pressure transducer reading dropped to 0.1 psia, while cabin pressure was stable at 5.0 psia. About 3 hours later, at command module/service module separation, the transducer recovered to 4.6 psia. The transducer indicated a 0.4- to 0.5-psid discrepancy throughout entry. Postflight tests of the installed transducer repeated the flight anomaly. However, during subsequent tests of the removed transducer, the unit operated normally. The transducer was then returned to the manufacturer's facility, where flushing and disassembly revealed internal contamination from metallic nickel-plating particles. These particles could have caused an irregular transducer output by physically interfering with the Bourdon tube movement or by changing the inductance field of the unit. After the transducer was cleaned and reassembled, testing produced satisfactory operation. The noted contamination apparently resulted from either improper cleaning procedures or from self-generated particles within the unit.

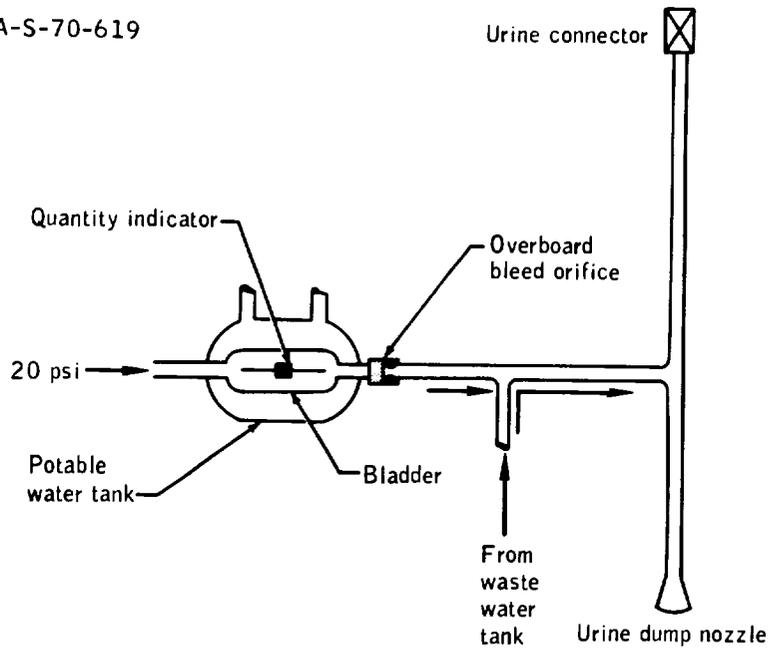
Figure 14-24.- Schematic of oxygen bleed flow and overboard urine dump line.

Tank calibration data after flight compared favorably with those from preinstallation calibrations. Disassembly and inspection revealed that corrosion had partially obstructed the oxygen overboard bleed orifice (fig. 14-23). No evidence was found of moisture or urine contamination on components of the water measuring system.

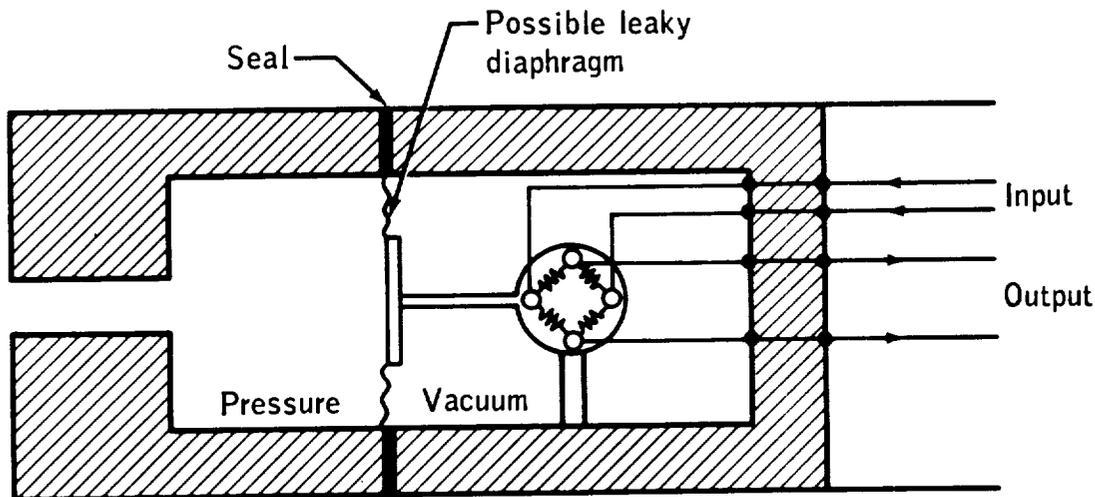
Figure 14-25.- Fuel cell 3 transducer schematic.

The apparent pressure drop has been attributed to a pressure transducer failure, with the most probable failure mode being a small leak through or around the stainless steel diaphragm in the transducer (fig. 14-25). Such a leak would allow hydrogen to enter the vacuum reference chamber of the transducer, thus destroying the normal pressure differential across the diaphragm. This reduction would result in the indicated pressure decay observed during the flight. A similar transducer failure occurred during a production fuel cell pre-test checkout.

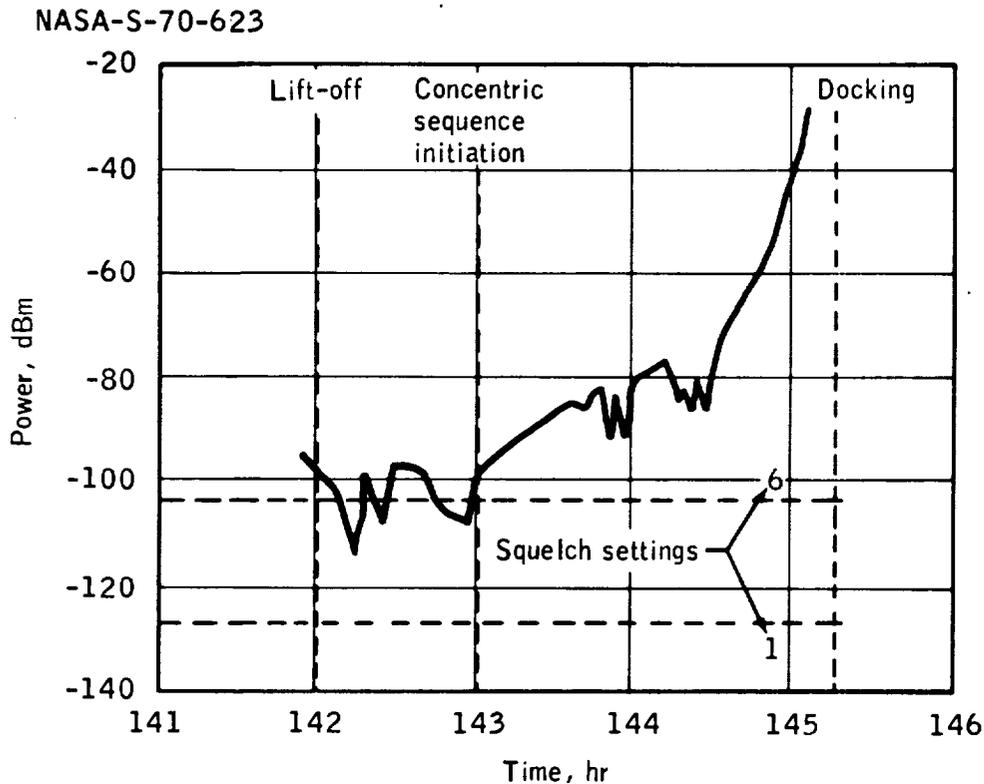
Figure 14-28.- Spacecraft received power.

During ascent, there were communications from the command module to the lunar module using VHF through the lunar module aft and command module right antennas. However, beginning at 142 1/4 hours, communications from the lunar module to the command module had to be accomplished using an S-band network relay. In this case, the predicted RF signal strength (fig. 14-28) was below the sensitivity of the squelch thumbwheel setting. During the 23-minute time period following lunar module lift-off, the two vehicles had closed to a range of approximately 200 miles and the lunar module crew had switched to the forward antenna. At this point, the received signal strength at the command module improved and the Command Module Pilot began to understand the VHF voice communications.

During the time period from 142:43:00 to approximately 142:53:00, the signal strength was strong enough to maintain the squelch circuit open, as verified by flight data. During the concentric sequence initiation maneuver, the squelch was noted as dropping in and out. According to predictions, the selection of either the left or the right command module antenna did not significantly affect voice communications. During this time, the received signal strength (fig. 14-28) was approximately minus 105 dBm while using the command module right antenna and lunar module forward antenna. This figure also shows the signal strength to be minus 102 dBm or less while using the command module left antenna and lunar module forward antenna according to the flight plan. From previous tests, the squelch thumbwheel, when set at approximately 6, requires from minus 100 to 105 dBm to unsquelch the audio signal.

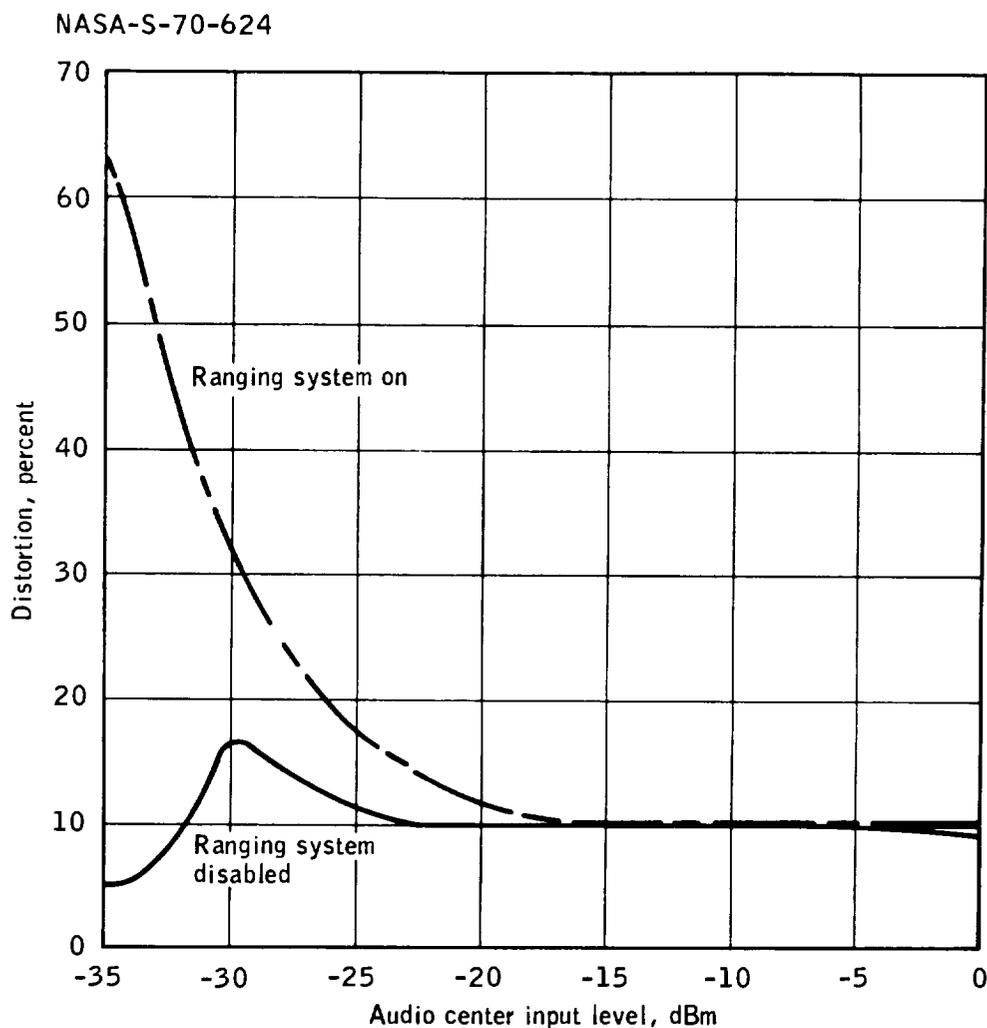
When the lightweight headset microphone is placed directly in front of the mouth at any distance, the headset microphone can, in effect, become a voice-cancelling circuit and reduce the voice signal level. The

reduced level can then cause a voice-operated dropout of the voice operated transmitter. Such dropout did not occur at this time, because the Command Module Pilot was using the push-to-talk mode. Figure 14-29 shows the percent distortion of the lunar module received signal versus the command module audio center input, both with and without ranging. The curve shows that, in the ranging mode as the input level to the audio center decreases, distortion of the received signal increases significantly. This distortion cannot be directly related to intelligibility, but it does indicate that system performance is degraded by the low input levels.

Figure 14-29.- Lunar module received VHF audio distortion.
