APOLLO 12 MISSION REPORT

Mission Evaluation Team

NATIONAL AERONAUTICS AND SPACE ADMINISTRATION

March 1970

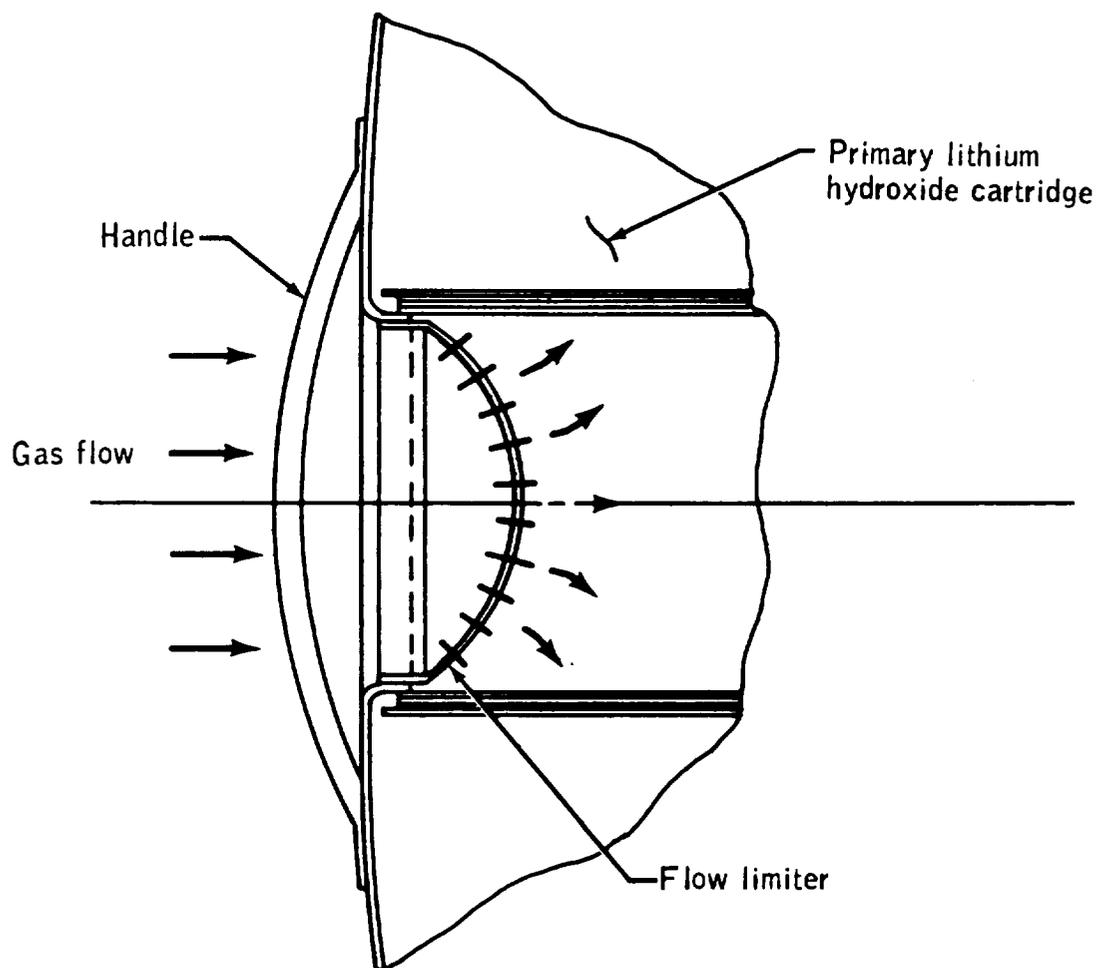
The water separator speed indication was above the upper limit (in excess of 3600 revolutions per minute) for about 50 percent of the mission. Since the water separator is a gas-driven centrifugal pump, this high speed indicates a higher than normal gas flow through the separator. Tests have shown that, at separator speeds in excess of 3700 revolutions per minute, water splashing occurs at the pitot tube (fig. 14-31) allowing water to bypass the separator.

Figure 14-32.- Suit circuit flow limiter.

For Apollo 13 and subsequent missions, a flow limiter (fig. 14-32) will be added to the primary lithium hydroxide canister to reduce suit-loop gas flow and consequently limit the separator speed to within the no-splash range. The flow limiter provides restriction of flow equivalent to the secondary canister. If necessary, this added resistance can be removed in flight.

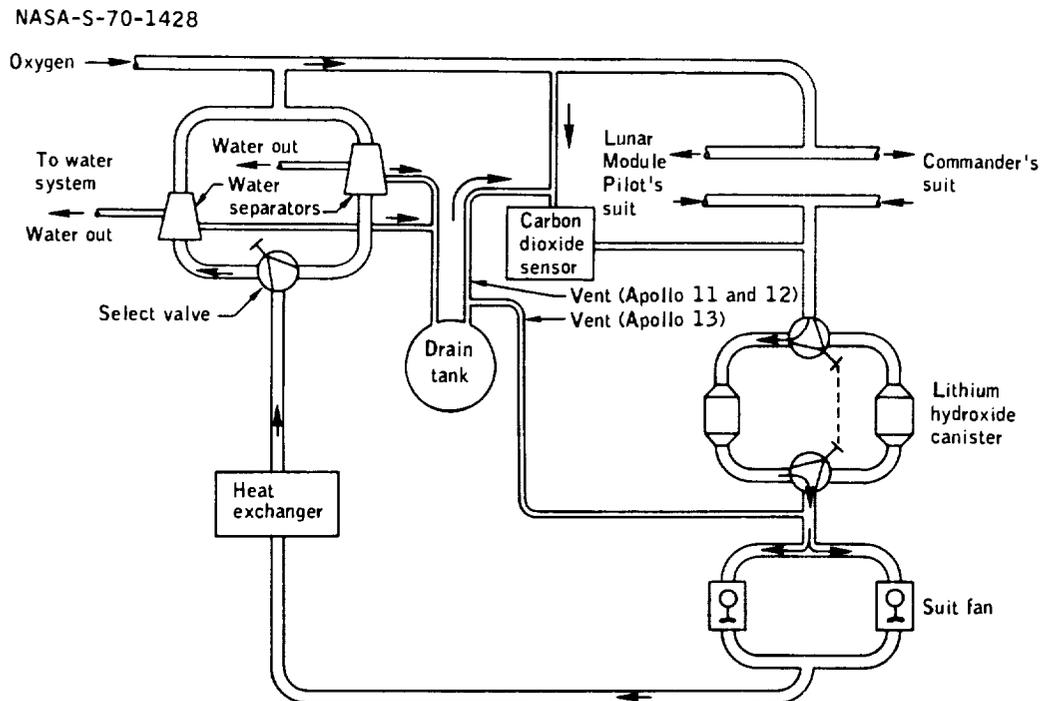
The carbon dioxide sensor is sensitive to free water, and the malfunction was probably caused either by water from the water separator sump tank entering the sensor or by water bypassing the water separator and entering the sensor. The water separator sump tank vent line joins the carbon dioxide sensor inlet sense line (fig. 14-33). This vent line has been rerouted for Apollo 13 and subsequent vehicles.

Figure 14-33.- Simplified suit loop schematic.

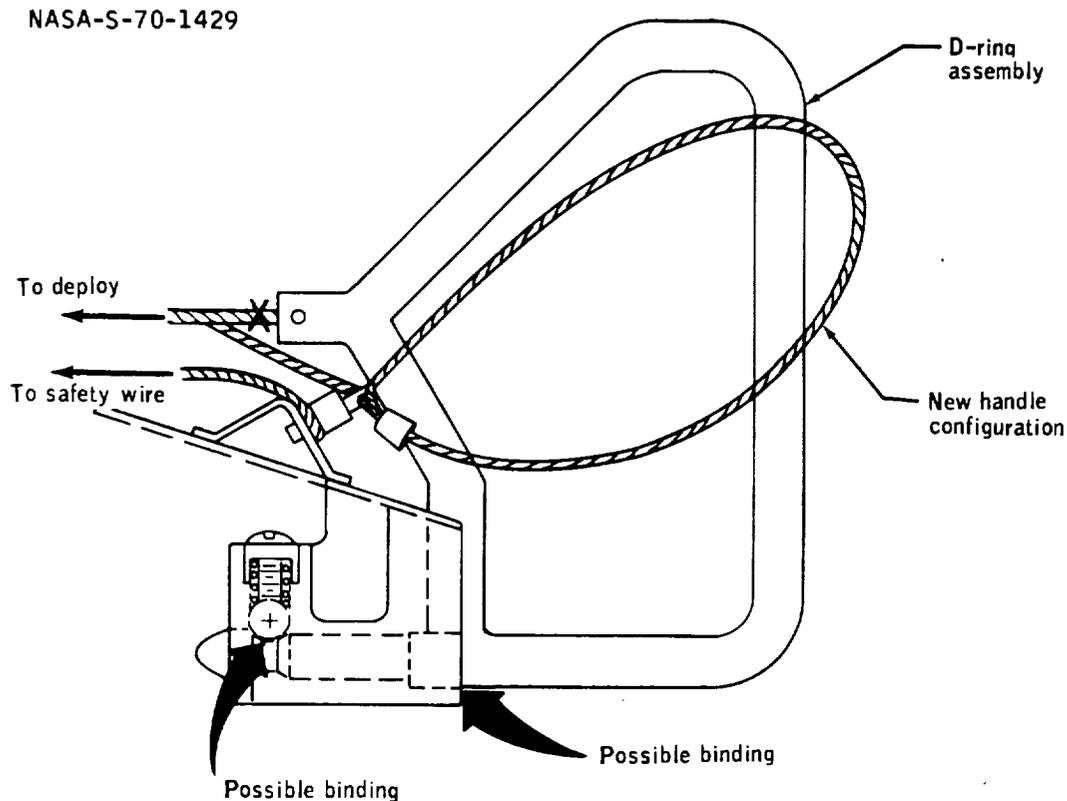
During the initial egress, the modularized equipment stowage assembly was to be deployed by pulling a special D-ring handle. Although the Commander was unable to release the handle from the support bracket, it could be rotated in its bracket. The equipment compartment was subsequently deployed by pulling on the bellcrank cable, which attaches to the center of the D-ring handle. A retention pin at the bottom of the D-ring handle plugs into a socket in the retaining bracket (fig. 14-34). This socket contains a ball detent mechanism which holds the D-ring to the bracket. Apparently, either there was binding in the ball detent or the crewman pulled on the D-ring handle at such an angle that a lateral load was applied to the retention pin, causing it to bind in the retention socket.

Figure 14-34.- Deployment handle (D-ring) on the modular equipment storage assembly.

For Apollo 13 and subsequent, the D-ring will be deleted and a loop will be clamped to the end of the deployment cable. The loop will be retained using the same type of pin presently installed to retain the safety wire (fig. 14-34).

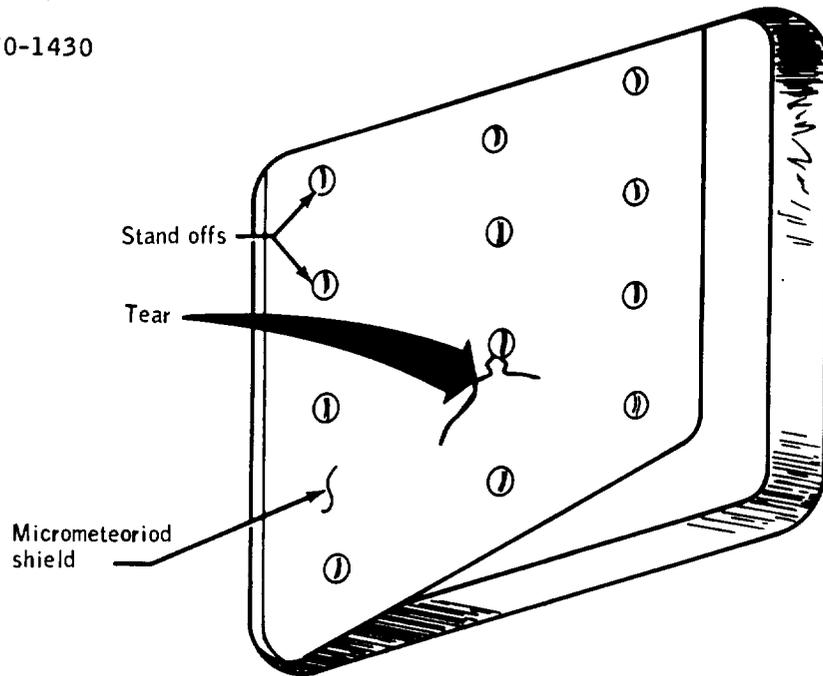
During egress, the Commander's portable life support system came in contact with and tore the hatch micrometeoroid shield (fig. 14-35). Such a tear could represent a potential hazard to the suit. For Apollo 13 and subsequent, the thermal shield thickness will generally be increased from 0.004 to 0.010 inch. At the standoff, however, the shield thickness will be increased from 0.020 to 0.040 inch. In addition, the diameter of the shield mounting holes will be increased from 0.375 to 0.5 inch (fig. 14-36). These modifications should strengthen the shield sufficiently to prevent tearing in any future contacts by the egressing crewmen.

Figure 14-35.- Tear in forward hatch outer skin.

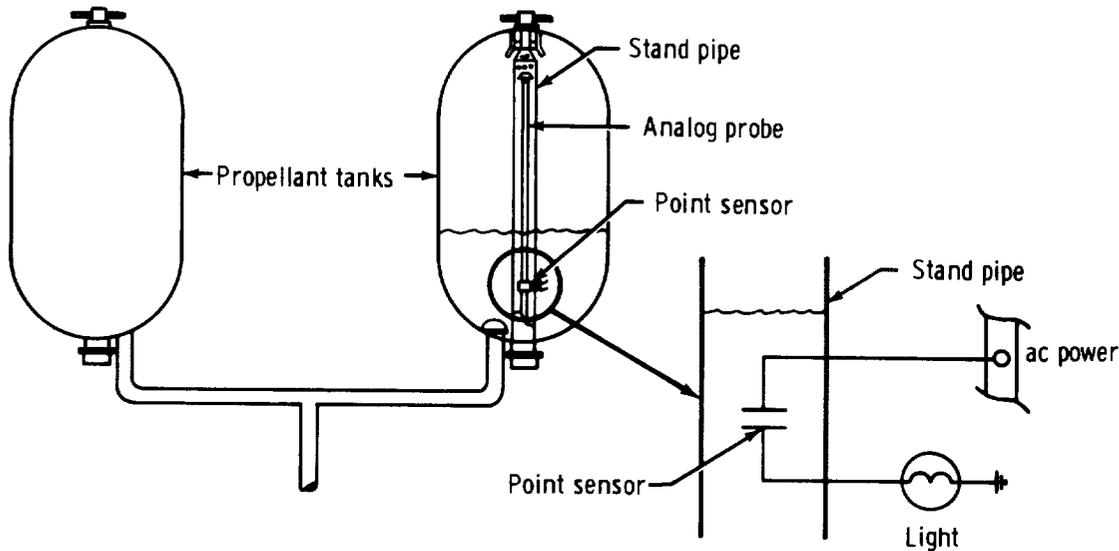
The low-level light for descent propulsion propellant quantities illuminated about 25 seconds early. The low-level light is activated and remains latched on when any one of the four low-level point sensors (one in each propellant tank) is uncovered (fig. 14-37).

Figure 14-37. - Descent propellant tank low-level sensor schematic.

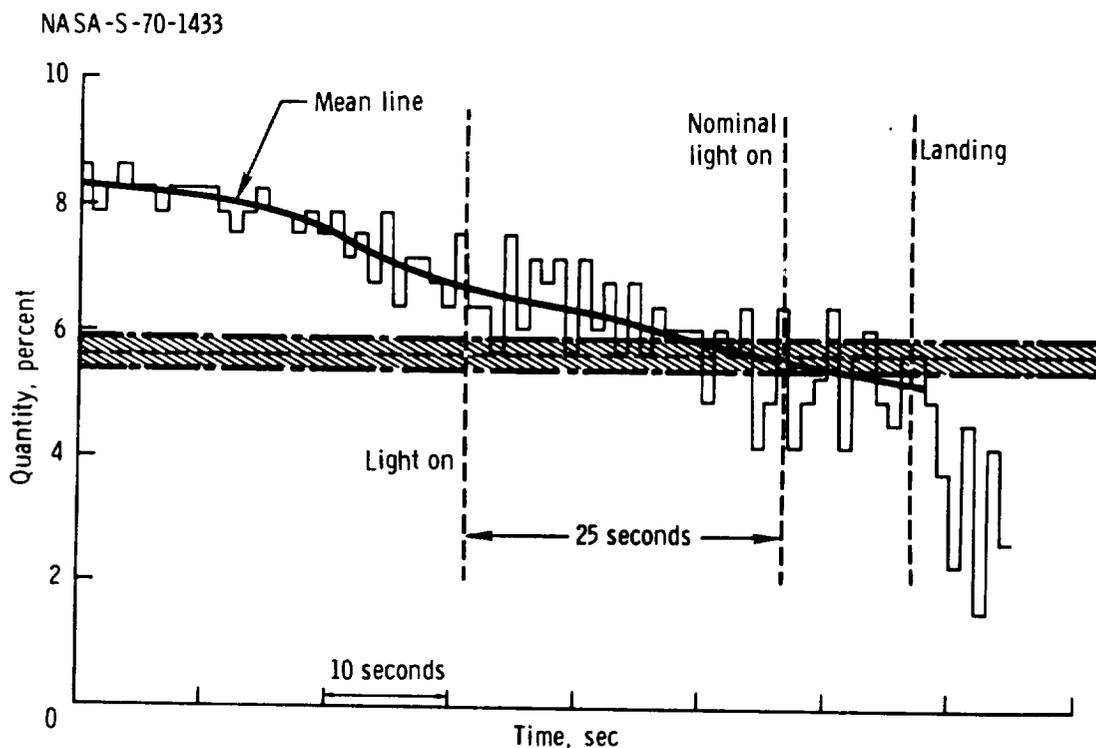
At low-level light activation, the gaging system indicated that fuel tank 2 had a mean propellant quantity of 6.7 percent. In addition, it had about a 2.3-percent peak-to-peak oscillation (fig. 14-38), probably caused by propellant slosh, which continued for some time after landing. The other three tank readings experienced similar oscillations, although at a slightly higher mean quantity level. One of the four low-level point sensors, probably fuel tank 2, uncovered momentarily because of propellant slosh, causing the low-level light to latch on.

The quantity warning light should illuminate when the lowest indicated propellant level remaining in any tank reaches a value of $5.6 \pm 1/4$ percent. Since the light came on when the averaged quantity measurement indicated 6.7 percent with an oscillation of ± 1.1 percent, the

lowest excursion of the quantity reading was 5.6 percent and the display operated properly. The averaged propellant quantity reached 5.6 percent about 25 seconds later.

Figure 14-38. - Descent propellant quantity just prior to landing.

For Apollo 13, the quantity measurements for the four descent propellant tanks have been increased in sampling rate from 1 to 100 samples per seconds. These data will be averaged automatically and used to determine the low-level point from which the remaining firing time can be calculated. The 100 samples per second rate will provide data that will permit an understanding of the particular dynamics of the fluid in the tanks.

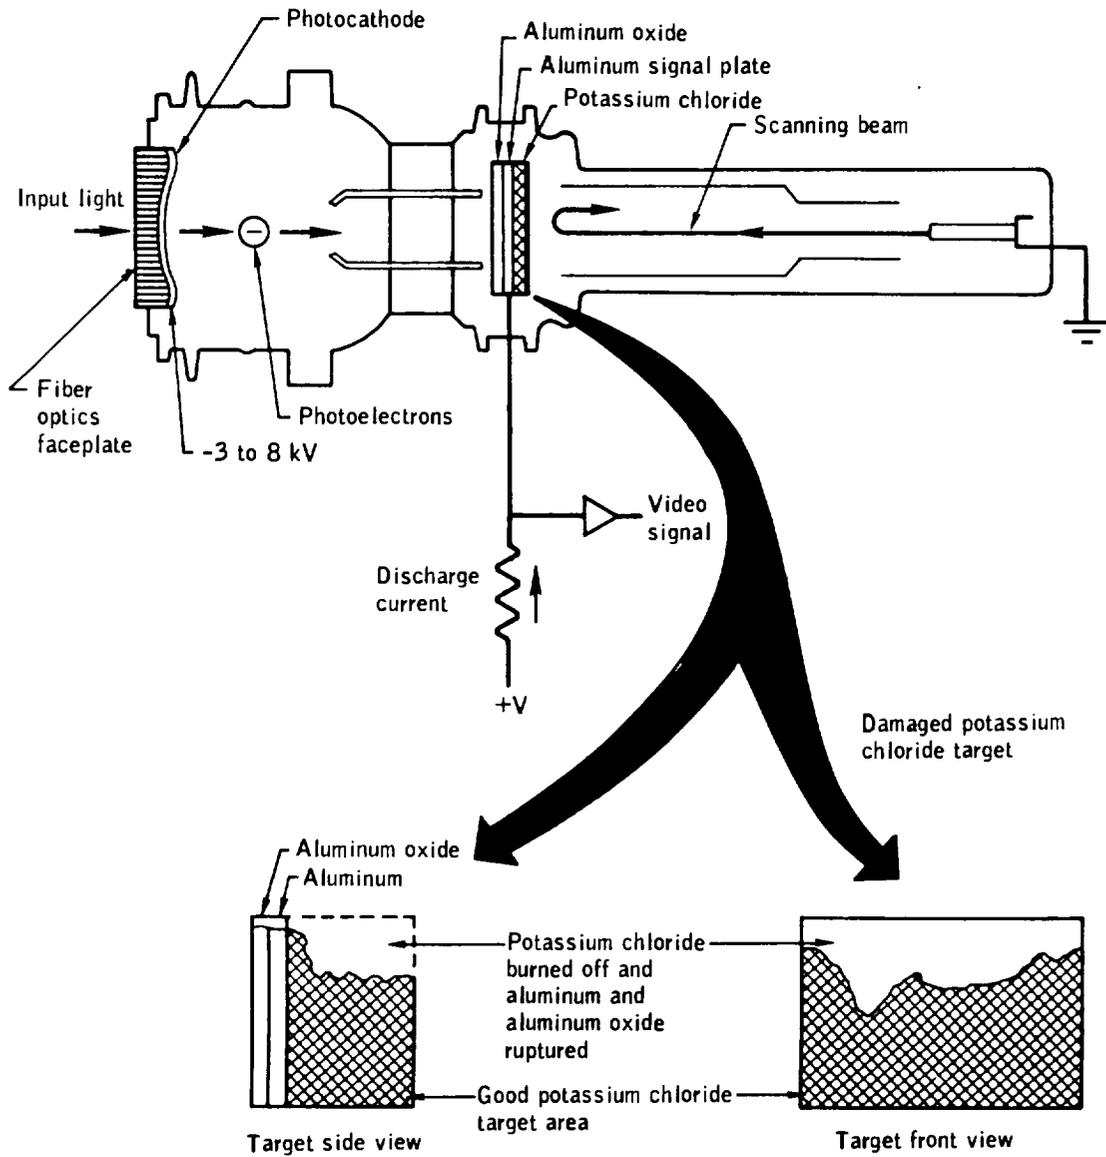
Ground tests using an Apollo-type image sensor (secondary electron conducting vidicon tube) exposed the camera system to extreme light levels. The resulting image on a monitor was very similar to that seen after the flight camera failure.

After decontamination and cleaning, the flight camera was inspected and power was applied. The image, as viewed on a monitor, was the same as that last seen from the lunar surface. The automatic light-level control circuit was disabled by cutting one wire. The camera then reproduced good scene detail in that area of the picture which had previously been black, verifying that the black area of the target was undamaged, as shown in figure 14-39. This finding also proved that the combination of normal automatic light control action and a damaged image-tube target caused the loss of picture. In the process of moving the camera on the lunar surface, a portion of the target in the secondary-electron conductivity vidicon must have received a high solar input, either directly from the sun or from some highly reflective surface. That portion of the target was destroyed, as was evidenced by the white appearance of the upper part of the picture.

Figure 14-39.- Secondary electron conductivity tube in the color television.

Training and operational procedures, including the use of a lens cap, are being changed to reduce the possibility of exposing the image sensor to extreme light levels. In addition, design changes are being considered to include automatic protection, such as the use of an image sensor which is less susceptible to damage from intense light levels.

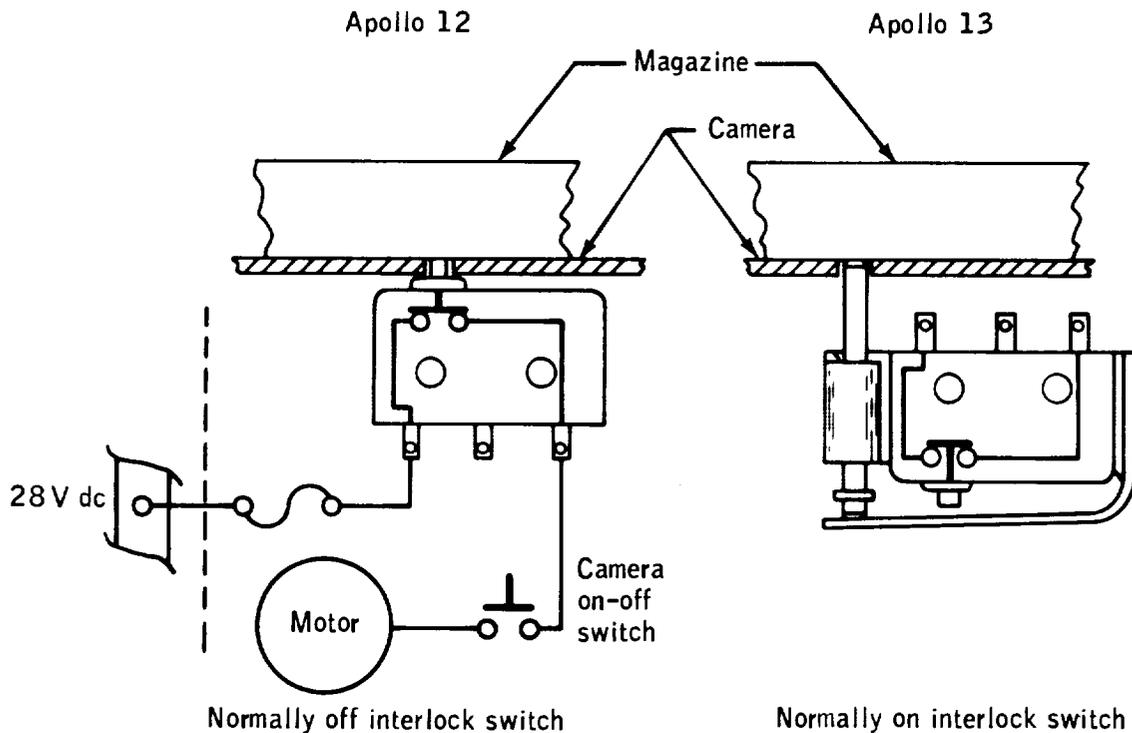
Although postflight tests showed the 16-mm camera and magazine to be in satisfactory operating condition, the characteristic sensitivity of the magazine interlock microswitch installation is such that the operating limits of the switch could cause intermittent actuation. The intermittent operation was duplicated on the flight and similar equipment by the application of pressure to the end of the magazine. The problem will be resolved by changing the interlock switch (fig. 14-40) to a configuration that is much less sensitive to variation in switch settings.

Figure 14-40.- Sequence camera interlock switch modification.

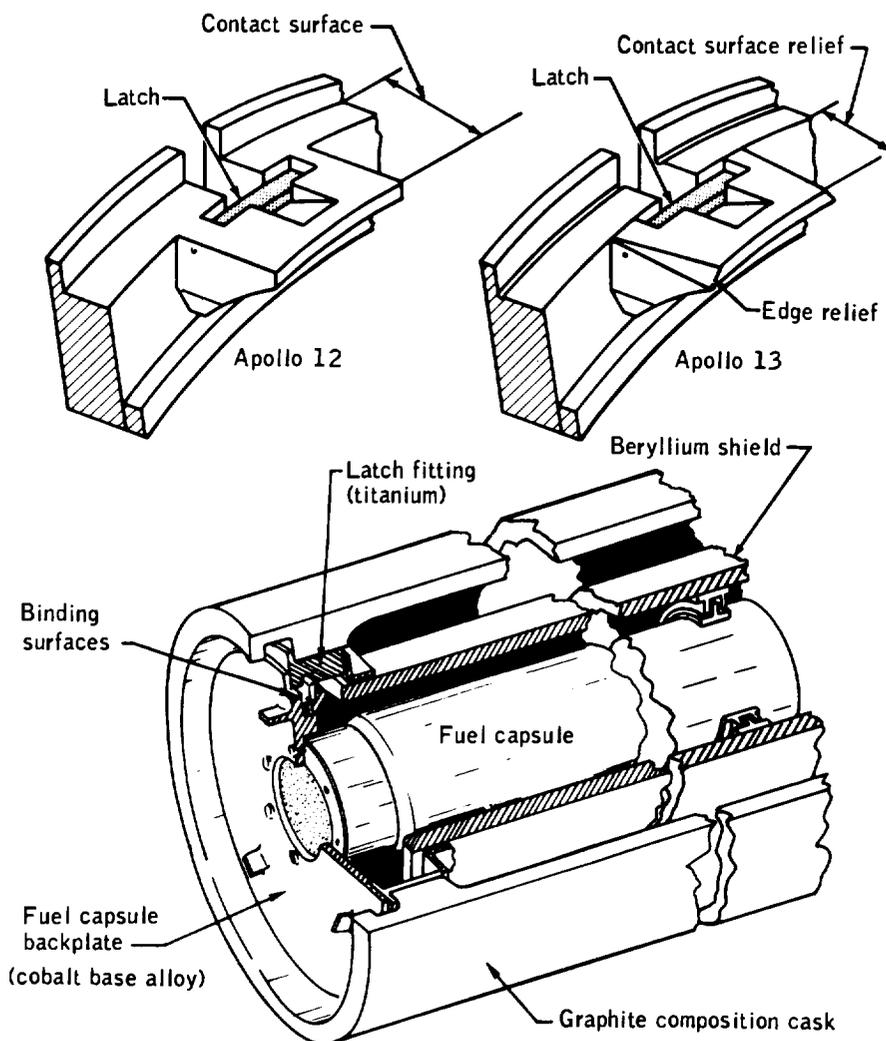
Thermal tests and analyses show that dimensional tolerances can diminish with temperature and result in binding between the latch fitting (C-ring) on the cask and the contact surface of the backplate on the fuel capsule (fig. 14-41). The longitudinal contact distance for these two surfaces is approximately 0.6 inch, and extraction was easily accomplished once this distance was negotiated.

Figure 14-41.- Radioisotope fuel capsule configuration.

As a result of the dimensional checks, the thermal tests, and analyses performed with both the qualification and Apollo 13 flight hardware, the contact surfaces of the fuel capsule backplates are being reworked as indicated in the figure. The outside diameter of the 0.10-inch long contact surface, while remaining within design limits, may be reduced as much as 0.005 inch for ease of capsule extraction. All existing capsule backplates will be reworked in this manner.

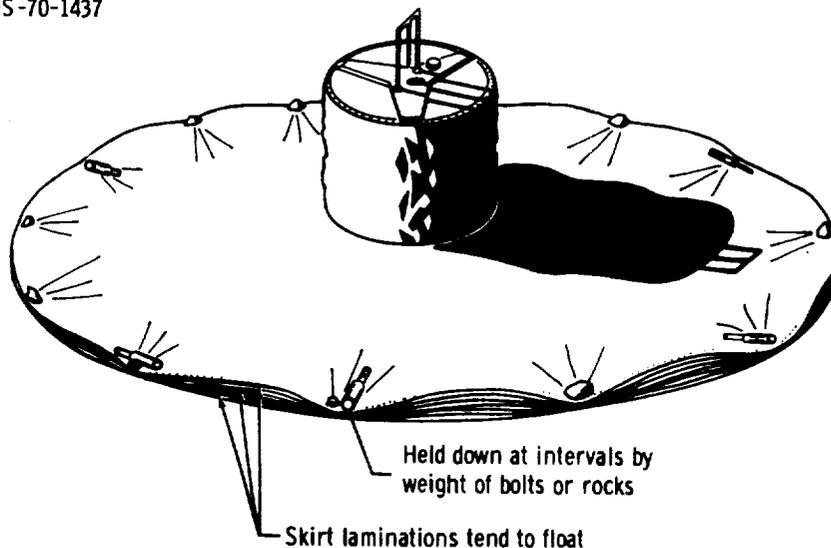
The thermal shroud tended to delaminate and rise up off the lunar surface. This condition had been anticipated, and lunar soil was placed on the periphery of the shroud to hold it down. When this operation proved difficult, tie-down bolts, which had been removed from the pallet during deployment of the experiments package, were placed on the shroud with satisfactory results (fig. 14-42).

Figure 14-42. - Passive seismic experiment deployed.

For Apollo 13 and subsequent spacecraft, the shroud laminations will be spot-sewed together at intervals around the periphery, a weight will be sewed to each of the six attach-pullout points on the shroud, and a 5-foot diameter Teflon blanket will be added for thermal control to decrease solar degradation.

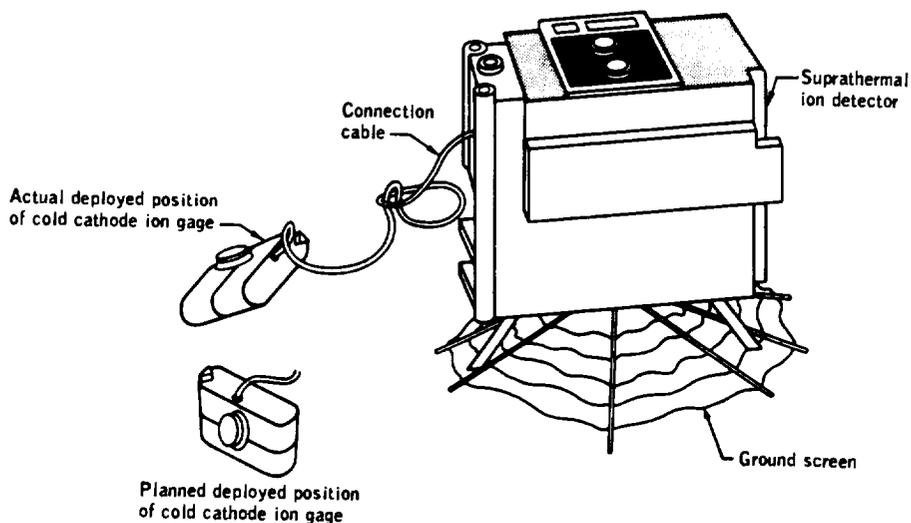
The cold cathode ion gage would not remain upright when deployed. Its final position was on its back with the sensor aperture at an angle of approximately 60 degrees from the horizontal but was satisfactory (fig. 14-43).

The cable connecting the cold cathode ion gage with the suprathermal ion detector was quite stiff. The combination of the spring effect in the cable, the reduced weight of the cold cathode ion gage under lunar gravity, and the softness of the lunar surface was apparently sufficient to cause the equipment instability during deployment. Final positioning of the equipment requires that the sensor aperture does not point directly at the surface nor directly at other experiment package components. The final positioning fulfilled this requirement.

Figure 14-43.- Cold cathode gage deployed.

The combination of the suprathreshold ion detector with the cold cathode ion gage will not be included for Apollo 13. For Apollo 14 this equipment will be flown, and the wires of the connecting cable will be tied at 6-inch intervals instead of being wrapped with heavy Mylar tape. This modification not only reduces cable stiffness by 70 percent, which decreases the spring effect, but also decreases cable bulkiness to permit easier stowage.

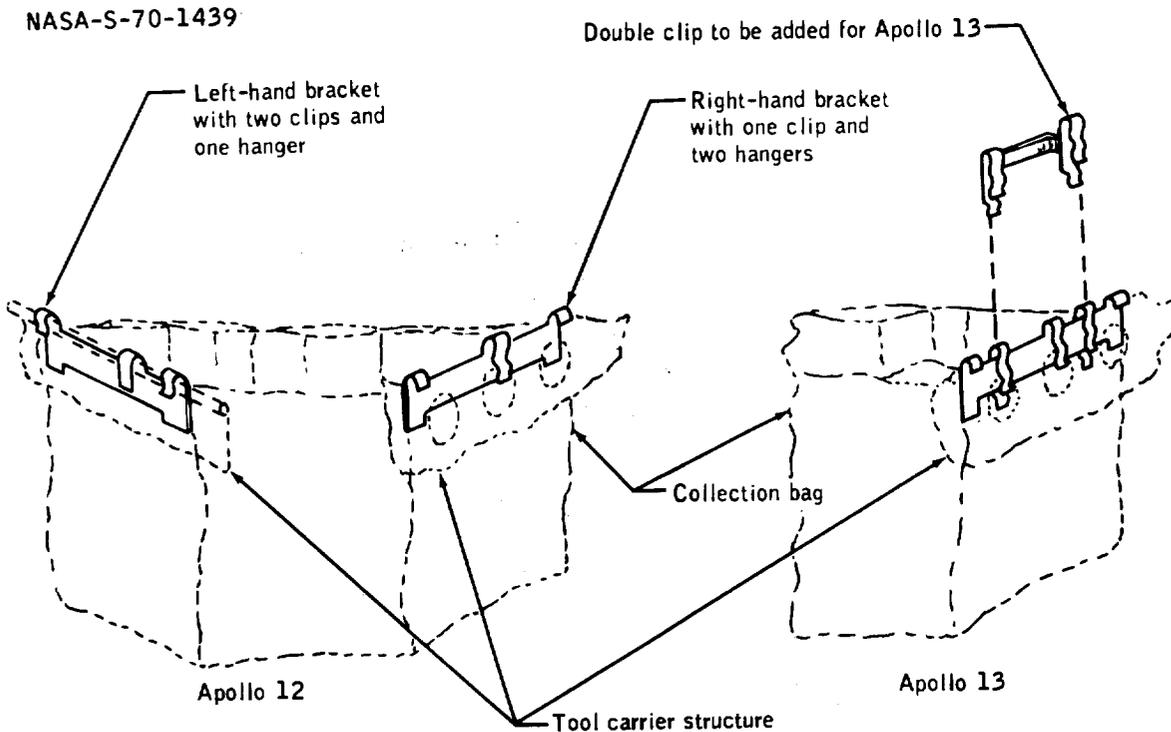
At the beginning of extravehicular activity, the empty tool carrier collection bag tended to rise out of the tool carrier until some lunar surface soil was put in to hold it down. The bag is attached to the carrier structure by three aluminum spring clips (fig. 14-44). The weight of the loaded bag is shared by these clips and three hangers. The retention force is limited so that the loaded bag may be easily lifted out of the carrier.

Figure 14-44.- Tool carrier collection bag retention.

The retention characteristics of the left side, with two spring clips over the 0.37-inch diameter rolled bead of the carrier structure, is satisfactory. However, the single spring clip over the 0.18-inch lip of the carrier on the right side did not provide sufficient positive retention. A separate double spring clip, which reaches over both the bag hanger and tool carrier structure, will be added for Apollo 13 to provide the necessary retention force as shown in the figure.

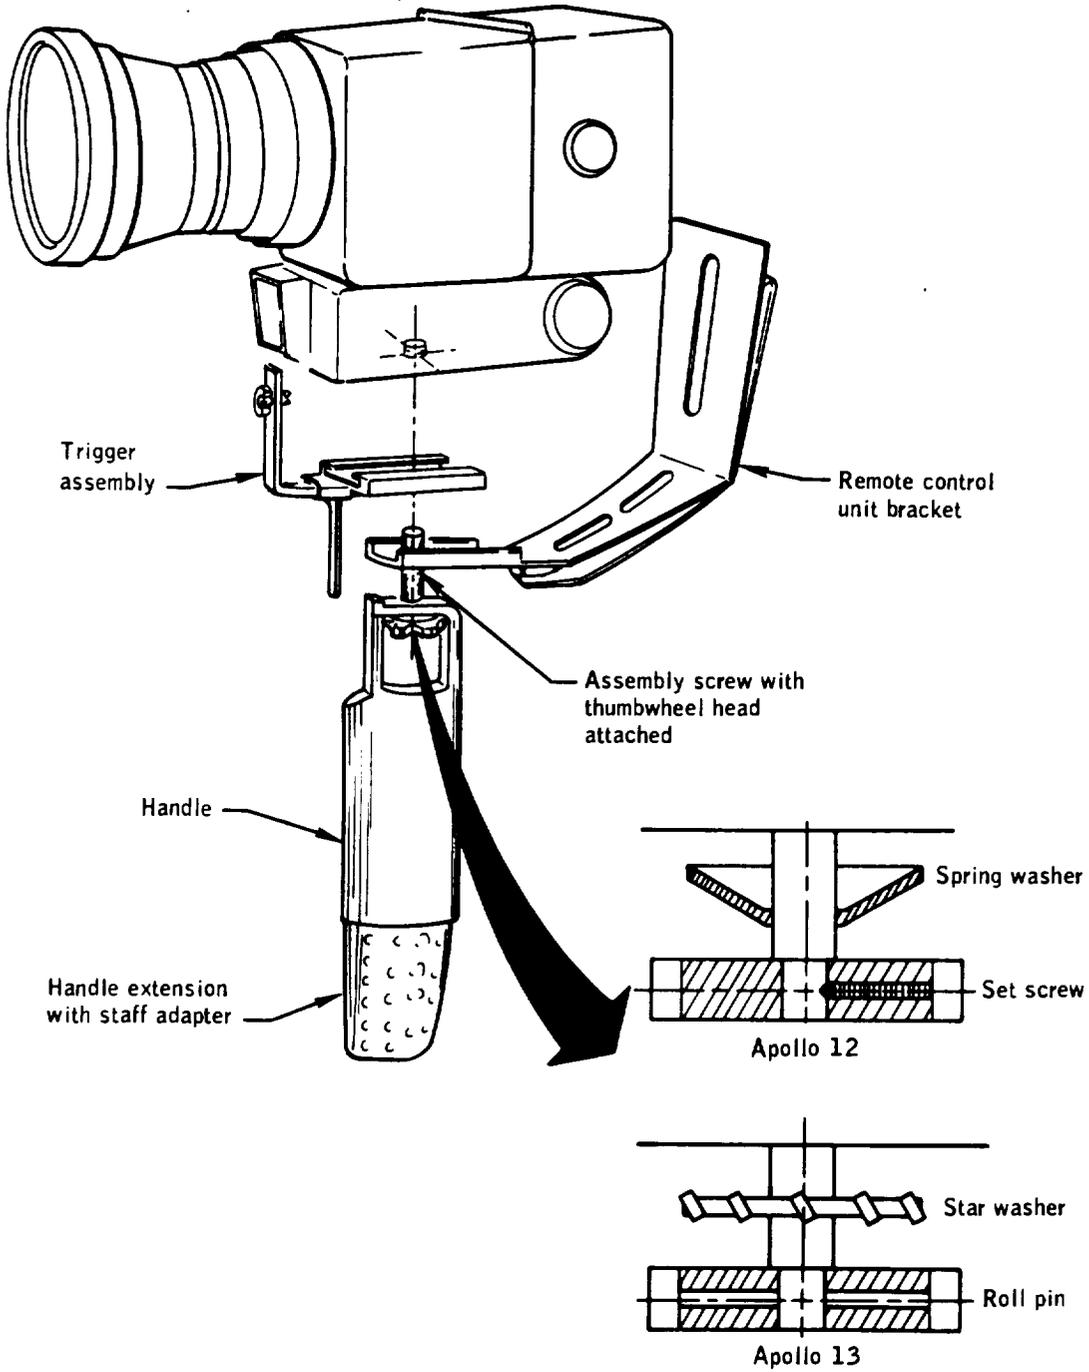
During the second extravehicular period, the Commander's camera did not advance and count every time the trigger was squeezed. Shortly afterwards, when both the camera assemblies were being removed from the remote control units in order to exchange them, both assemblies were loose, although they had been well tightened before egress. In the process of retightening on the lunar surface, the thumbwheel fell off the Lunar Module Pilot's camera assembly, making reassembly impossible (fig. 14-45). The empty camera and faulty assembly were then discarded. The Commander's camera assembly was retightened and performed satisfactorily during the remainder of the extravehicular activity.

Figure 14-45.- 70-mm camera handle assembly.

The intermittency experienced by the Commander in the shutter, counter, and film advance actions was the result of excessive trigger play caused by the loose assembly. The loss of the thumbwheel experienced by the Lunar Module Pilot was apparently the result of the improper installation of the thumbwheel setscrew.

For future missions, the cupped spring washer will be replaced by a star washer to resist rotation and loosening of the assembly screw, and the thumbwheel will be secured to the screw with a roll pin, instead of a setscrew.

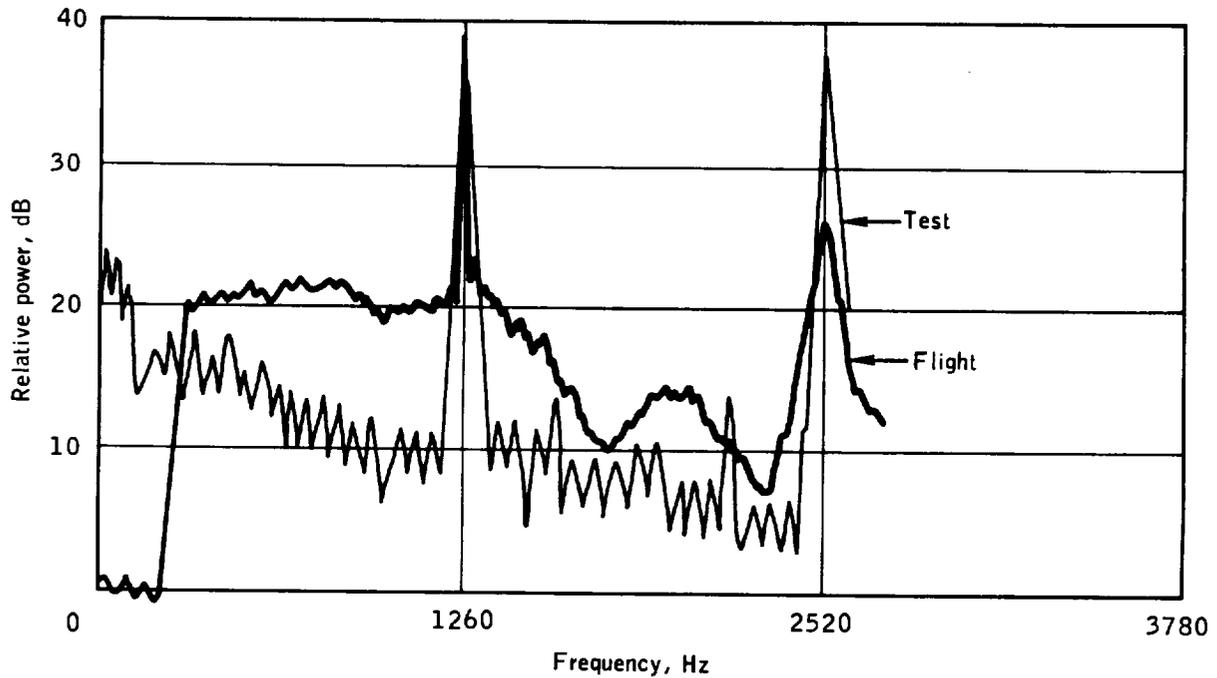
A subsequent analysis of the telemetry data transmitted from the extravehicular mobility unit did not show any degradation of data quality as a result of the noise. Power spectral density plots, however, revealed a fundamental frequency of approximately 1260 hertz and a harmonic frequency of 2520 hertz. Postflight interference tests of an equivalent extravehicular mobility unit revealed the same 1260-hertz tone on the battery-bus leads and shield which originated from the fan-motor ripple current. This condition is normal and has been noted during qualification testing of the extravehicular mobility unit. Figure 14-46 illustrates the tone interference generated by the fan motor. However, during these initial tests, the noise interference could not be made to enter the audio system such that the audio tone heard in flight was simulated.

Figure 14-46.- Tone power spectral density.

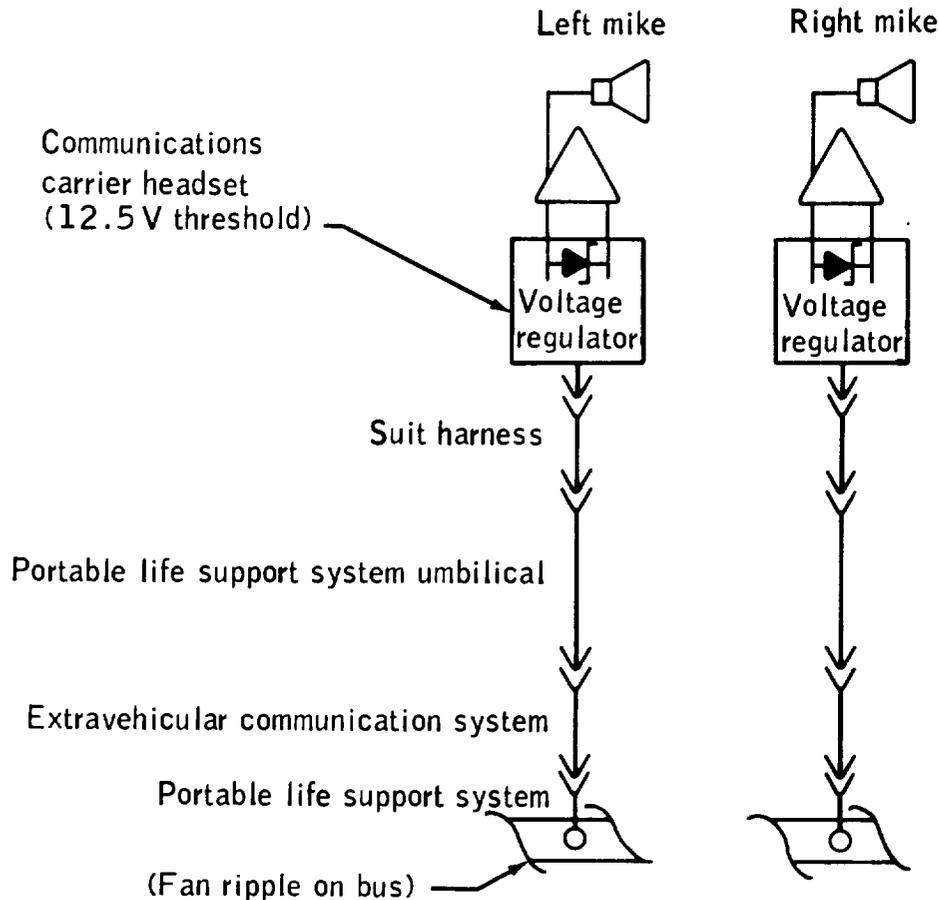
Later laboratory testing of the communications carrier headset demonstrated that lowering a microphone amplifier supply voltage below the regulator threshold of 12.5 volts caused tone interference to enter the audio system. Subsequent analysis showed that a high resistance or the failure of a regulating diode or a transistor in the microphone amplifier regulator could result in a loss of regulator filtering action. The normal operating voltage for the microphone amplifier is from 15.7 to 20.5 volts. When the microphone amplifier supply voltage is above the regulator threshold of 12.5 volts, the tone interference does not enter the audio system.

Figure 14-47.- Communications carrier headset power path.
