FIELD EXPERIENCES WITH ROTORDYNAMIC INSTABILITY
IN HIGH-PERFORMANCE TURBOMACHINERY

H. E. Doyle
Phillips Petroleum Company Europe-Africa
London, England

HEWETT GAS PLANT PROBLEM

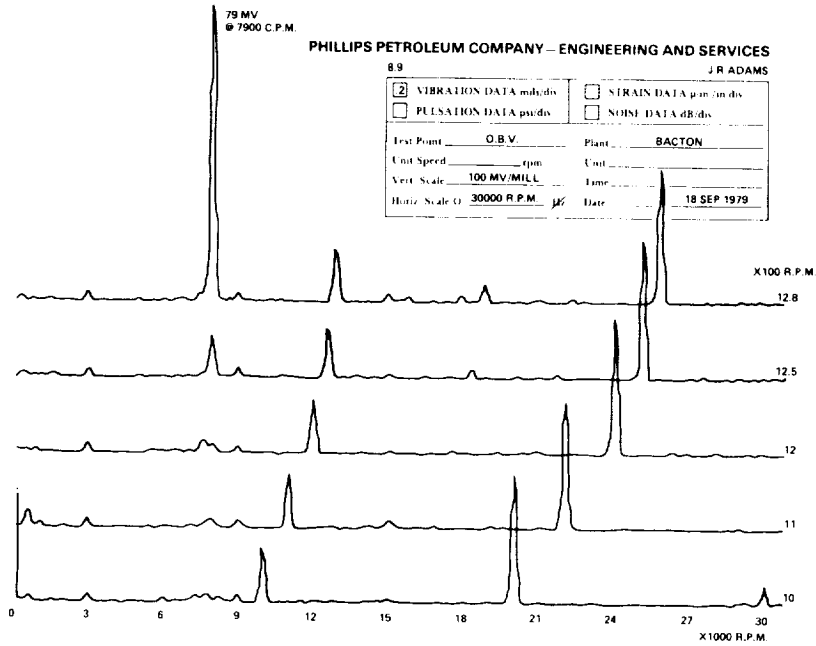
FIGURE 4

18 September 1979: The manufacturer fabricated a new bundle for unit 8 with two major changes. The shrink fit of impellers was reduced in areas by shortening the length of the fit. To do this it was necessary to key impellers to the shaft. The diaphragm wall was extended into the area between the backs of the two impellers and gas was introduced by two holes to induce a laminar flow along the back plates. Although there were several high-vibration tripouts upon startup, enough data were collected to indicate a change in instability frequency in that instability no longer tracked running speed but remained at one frequency regardless of running speed. The instability frequency appeared to be locking on the critical frequency of the shaft. Figure 4 is a plot of vibration for the outboard vertical probe made just before a tripout. Note that instability is not tracking running-speed frequency. Figure 5 is a plot for the inboard vertical bearing probe at tripout. Tripout amplitude was 8.2 mils at 8300 cycles per minute.
