## AN OVERVIEW OF FATIGUE FAILURES AT THE ROCKY FLATS WIND SYSTEM TEST CENTER

C. A. Waldon  
Rockwell International  
Wind Systems Program  
P.O. Box 464  
Golden, Colorado

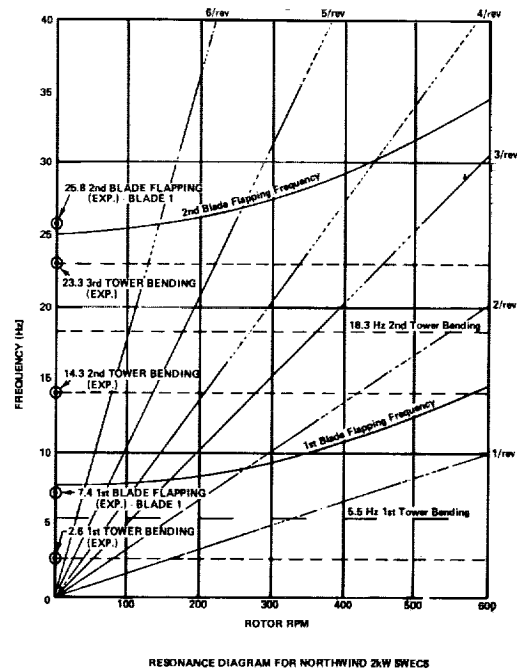
Several changes could be made to the system to rectify this problem, but the problem should have been originally noticed in a Fan Diagram and designed out as an undesirable operating point. A typical Fan Diagram is shown in Figure 8. It should be noted that if the diagram is generated by theoretical analysis, it must be substantiated

Figure 8 - Typical fan diagram.

for component compliance with predictions, which is sometimes beyond the manufacturer's capability. One possible design change is to modify the blade fundamental frequencies, in this case upward, as 420 rpm is near maximum for the machine. Another change might be to alter the rpm control and not allow the critical rpm to be reached. Both of these changes would have to be checked for interference frequencies with other components prior to implementation.
