Report To
JET PROPULSION LABORATORY
California Institute of Technology
Pasadena, California
JPL Contract No. 956493

EVALUATION OF DSS-14
PEDESTAL-REVIEW OF TOP SURFACE
REPAIR PROCEDURES

CONSTRUCTION TECHNOLOGY LABORATORIES
A Division of the Portland Cement Association
5420 Old Orchard Road
Skokie, Illinois 60077

May 1983

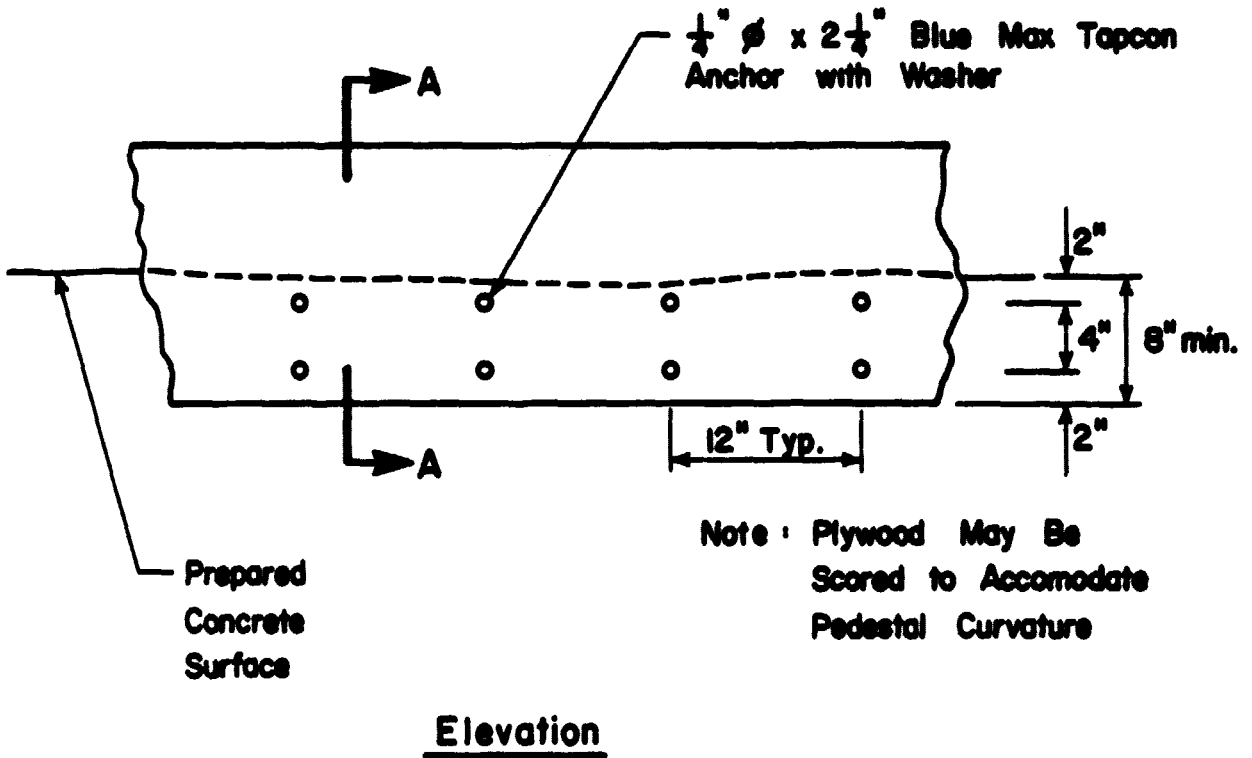
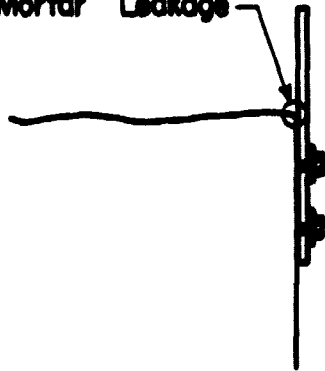
FIGURE 1. Pedestal Repair Formwork

Provide Sealant
Material Here to
Prevent Mortar Leakage

- 5.1 Formwork shall be constructed of 3/4-in. thick Duraply or JPL-approved equal as shown in Fig. 1.
- 5.2 Plywood shall be fastened to the pedestal wall using the Blue-Max Tapcon fastening system. JPL will furnish the Blue-Max Tapcon screws, washers and installation equipment.
- 5.3 Plywood form shall lap down onto sound concrete a minimum of 8 inches.
- 5.4 The inside face of the form at the horizontal concrete surface shall be sealed to prevent leakage of mortar.
