WORLDWIDE FLIGHT AND GROUND-BASED EXPOSURE OF COMPOSITE MATERIALS

H. Benson Dexter and Donald J. Baker  
NASA Langley Research Center  
Hampton, Virginia

ACEE Composite Structures Technology Conference  
Seattle, Washington  
August 13-16, 1984

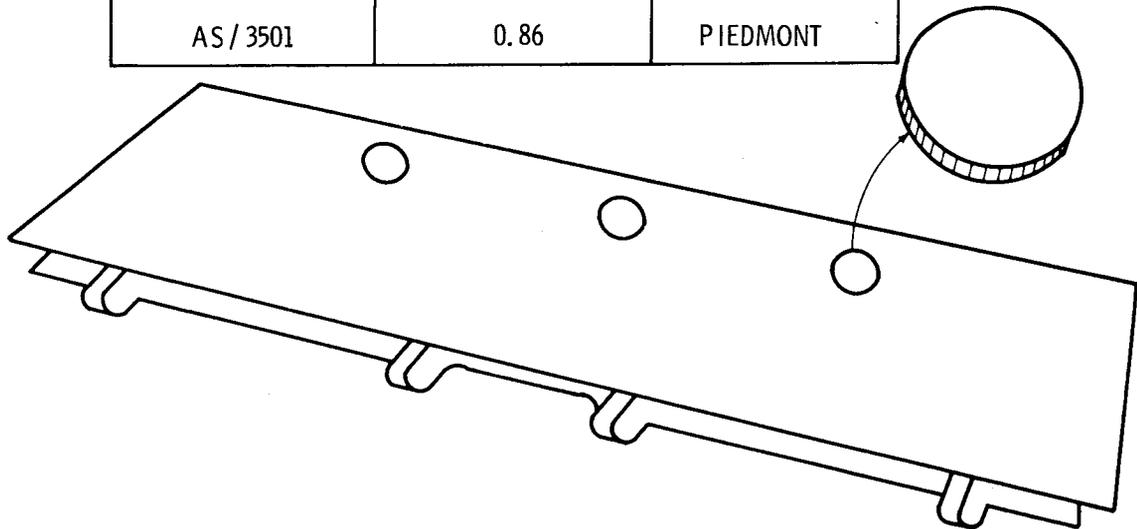
Figure 13

In addition to structural tests of the spoilers, tests have been conducted to determine absorbed moisture content of the graphite/epoxy skins. The moisture content is determined from plugs cut near the trailing edge as shown in figure 13. The plugs consist of aluminum honeycomb core, two graphite/epoxy facesheets, two layers of epoxy film adhesive, and two exterior coats of polyurethane paint. About 90 percent of the plug mass is in the composite faces, including the paint and adhesive. The moisture content is determined by drying the plugs and recording the mass change. The data shown in figure 13 for plugs removed from three spoilers after nine years of service indicate moisture levels in the graphite/epoxy skins ranging from 0.59 to 0.90 percent for T300/5209, T300/2544, and AS/3501 material systems. The moisture levels for the T300/5209 and AS/3501 systems are similar to moisture levels determined for unpainted material coupons exposed to worldwide outdoor environments. However, the moisture content of 0.90 percent for the T300/2544 plugs is only about one-half the moisture content of the unpainted material coupons. Severe ultraviolet radiation degradation to the T300/2544 unpainted material coupons may explain part of the difference in moisture absorption. Additional results for the material coupons are presented in a subsequent figure.

GRAPHITE/EPOXY	MOISTURE CONTENT PERCENT	AIRLINE
T300/5209	0.59	LUFTHANSA
T300/2544	0.90	PIEDMONT
AS/3501	0.86	PIEDMONT

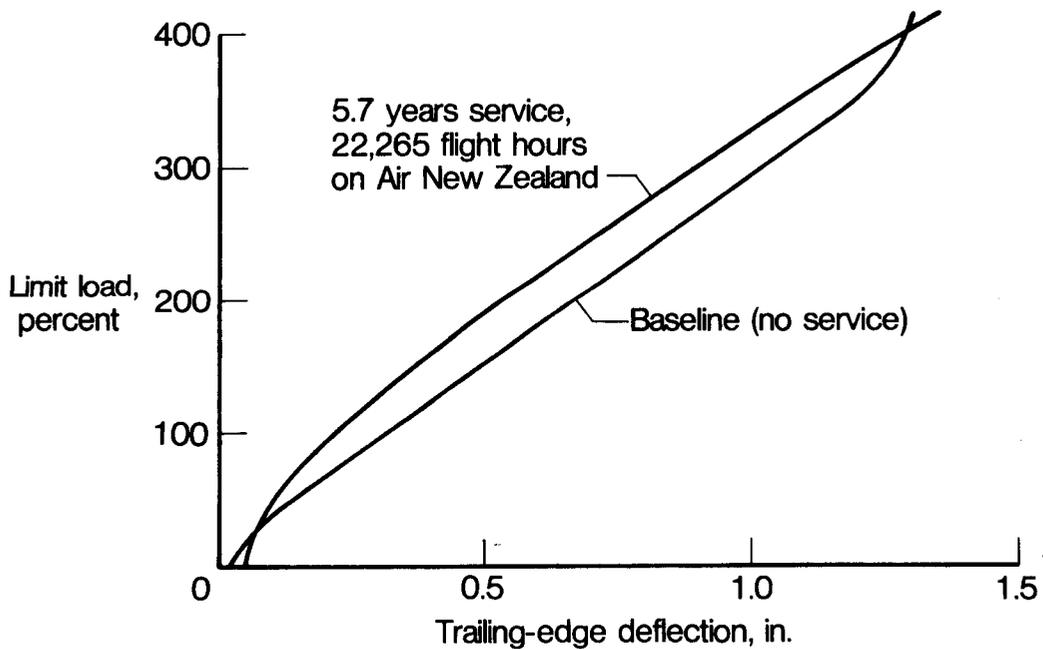
Figure 15

A DC-10 graphite/epoxy rudder was removed from service for residual strength testing after 5.7 years and 22,265 flight hours on Air New Zealand. The load deflection response shown in figure 15 indicates that the 5.7-year rudder had an initial stiffness higher than the baseline rudder but the overall response is similar for the two rudders. The baseline and the 5.7-year tests were stopped at approximately 400-percent limit load because of instability of the loading apparatus. Although the rudders are designed by stiffness considerations and only one residual strength test has been conducted, the overall response of the rudder indicates that no degradation has occurred as a result of 22,265 flight hours.

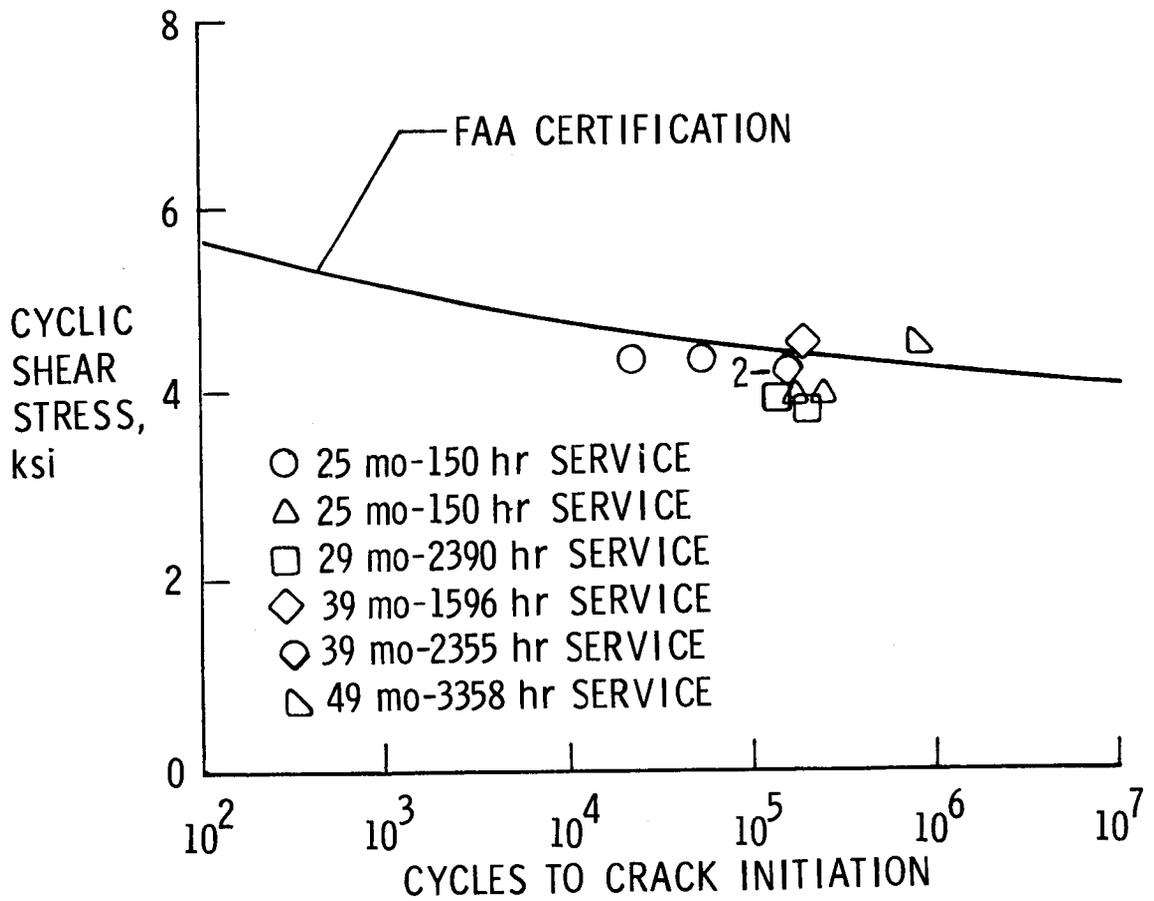
Figure 19

Full-scale fatigue tests have been conducted on six graphite/epoxy S-76 tail rotor spars removed from commercial service and the results are shown in figure 19. Two spars had 25 months and 150 hours of service on a Sikorsky flight test helicopter in West Palm Beach, FL, and four of the spars were removed from helicopters operating in the Lake Charles, LA, area with up to 49 months and 3358 hours of service. The test results are compared to the baseline room temperature dry strength of 10 spars tested for FAA certification. The results indicate that the minimum strength retention is 93 percent of the FAA certification curve shown in figure 19. These results compare well with strength retention factors projected from laboratory-conditioned specimens (ref. 10). Additional tests will be conducted on tail rotor spars with up to eight years of service.

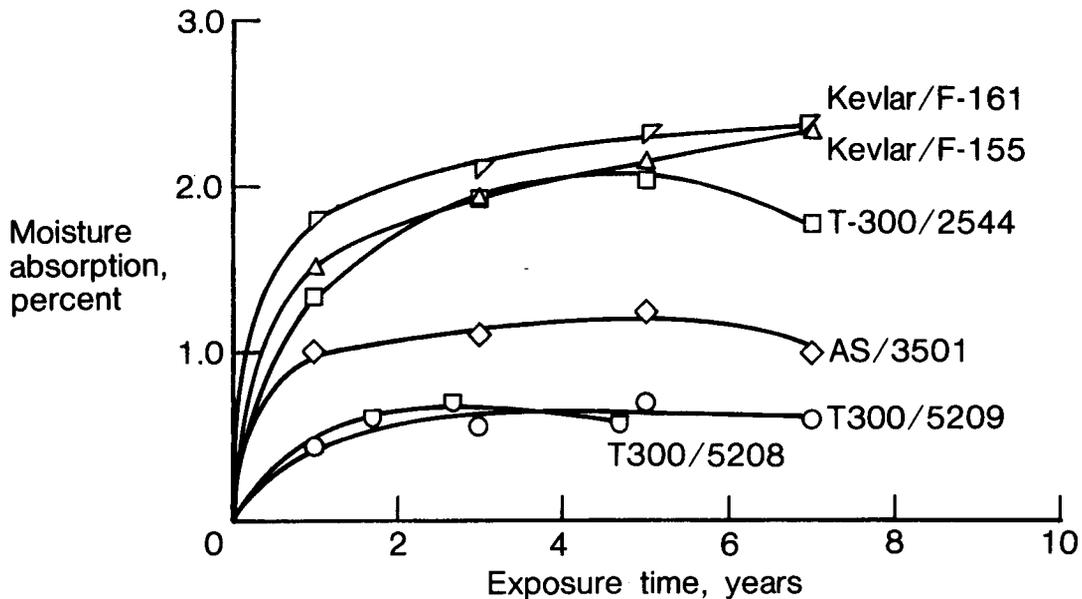
Figure 23

The moisture contents of four graphite/epoxy and two Kevlar/epoxy material systems after seven years of exposure at six exposure sites are shown in figure 23. The data shown were obtained from flexure coupons that were exposed on outdoor racks located at NASA Langley in Hampton, VA; San Diego, CA; Honolulu, HA; Wellington, New Zealand; São Paulo, Brazil; and Frankfurt, W. Germany. Each data point represents an average value for 18 specimens, three at each of the six exposure locations. The Kevlar/epoxy materials indicate moisture levels above 2.0 percent after seven years of exposure. The T300/2544 graphite/epoxy material indicated a decrease in moisture content from 2.0 percent after five years of exposure to 1.8 percent after seven years of exposure. The reduction may possibly be related to severe ultraviolet degradation of the 2544 epoxy matrix. The AS/3501 graphite/epoxy material appears to have stabilized at about 1.0 percent moisture, although a slight downward trend is noted after seven years of exposure. The T300/5209 and T300/5208 graphite/epoxy materials appear to have stabilized at approximately 0.6 percent moisture. In general, the specimens exposed at São Paulo, Brazil, had the highest moisture content. This result is somewhat expected since the average annual relative humidity is about 80 percent at São Paulo. The specimens exposed for 10 years are currently being dried in an oven to establish moisture content.

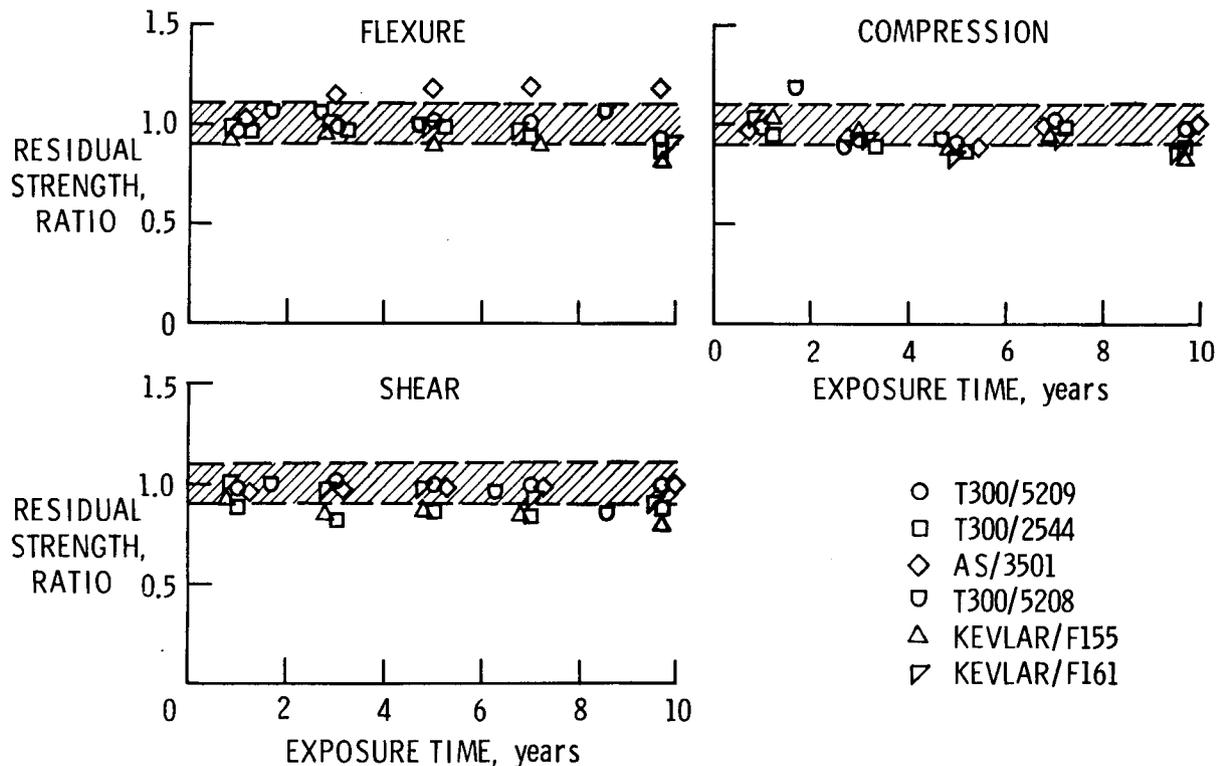
Figure 24

Residual strength data for unpainted graphite/epoxy and Kevlar/epoxy specimens exposed for 10 years at six exposure sites are shown in figure 24. The data points represent a comparison of the average strength value at six exposure sites with the average baseline strength value for that material system. The shaded area represents a plus-or-minus 10-percent scatter in the baseline strength values. Three-point flexure, IITRI compression, and short-beam shear tests were conducted on three replicate specimens after 1, 3, 5, 7, and 10 years of outdoor exposure. Since the T300/5208 material entered the exposure program at a later date, the exposure times are different than for the other five material systems. Also, the 10-year specimens from the Brazil exposure rack were not to be tested until the summer of 1984 because of a later deployment date. Results of the flexure tests indicate that the two Kevlar/epoxy materials and the T300/2544 graphite/epoxy material incurred the largest strength loss after 10 years of exposures. These three materials also had the highest moisture content, approximately 2.0 percent, and the T300/2544 material incurred the most severe surface degradation from ultraviolet radiation. The compression and shear tests indicate a similar trend in that the same three materials show the largest strength reduction after 10 years of exposure. Over the 10-year period the shear and compression specimens show a consistently slightly higher strength reduction than the flexure specimens. This trend indicates that the shear and compression specimens are more sensitive to matrix degradation and moisture than the flexure specimens.

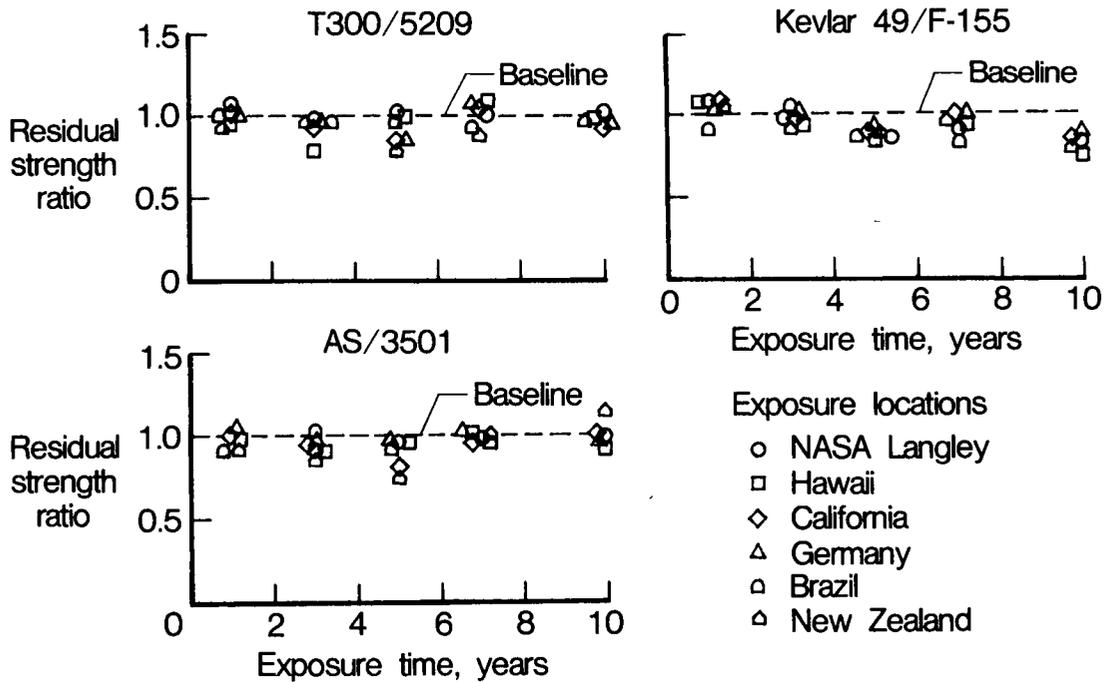
Figure 25

Compression strength data for three material systems, T300/5209 (250°F cure), Kevlar-49/F-155 (250°F cure), and AS/3501 (350°F cure), are shown in figure 25 to indicate the effect of exposure location. Note that the 10-year Brazil data are not yet available. Each data point is the average of three tests for a particular exposure time and exposure location. Average annual temperature and relative humidity data obtained from the U. S. Air Force indicate that Frankfurt, W. Germany, has the lowest average annual temperature of 49°F and Honolulu, Hawaii, has the highest temperature of 77°F of the six exposure locations. The relative humidity is similar for most of the exposure locations with a range from about 70 percent in Hawaii to about 80 percent in Brazil. The data shown in figure 25 do not indicate any definite trend for the most severe environment. The Kevlar-49/F-155 material shows a consistent compression strength reduction during the 10-year period. A maximum reduction of 27 percent is shown for the specimens exposed in Hawaii. The data for the T300/5209 and AS/3501 materials are somewhat more erratic with the maximum strength reduction occurring after five years of exposure at New Zealand.
