NASA Technical Memorandum TM 103814

Debris/Ice/TPS Assessment And Photographic Analysis For Shuttle Mission STS-41

DEBRIS/ICE/TPS ASSESSMENT
AND
PHOTOGRAPHIC ANALYSIS
OF
SHUTTLE MISSION STS-41

October 6, 1990

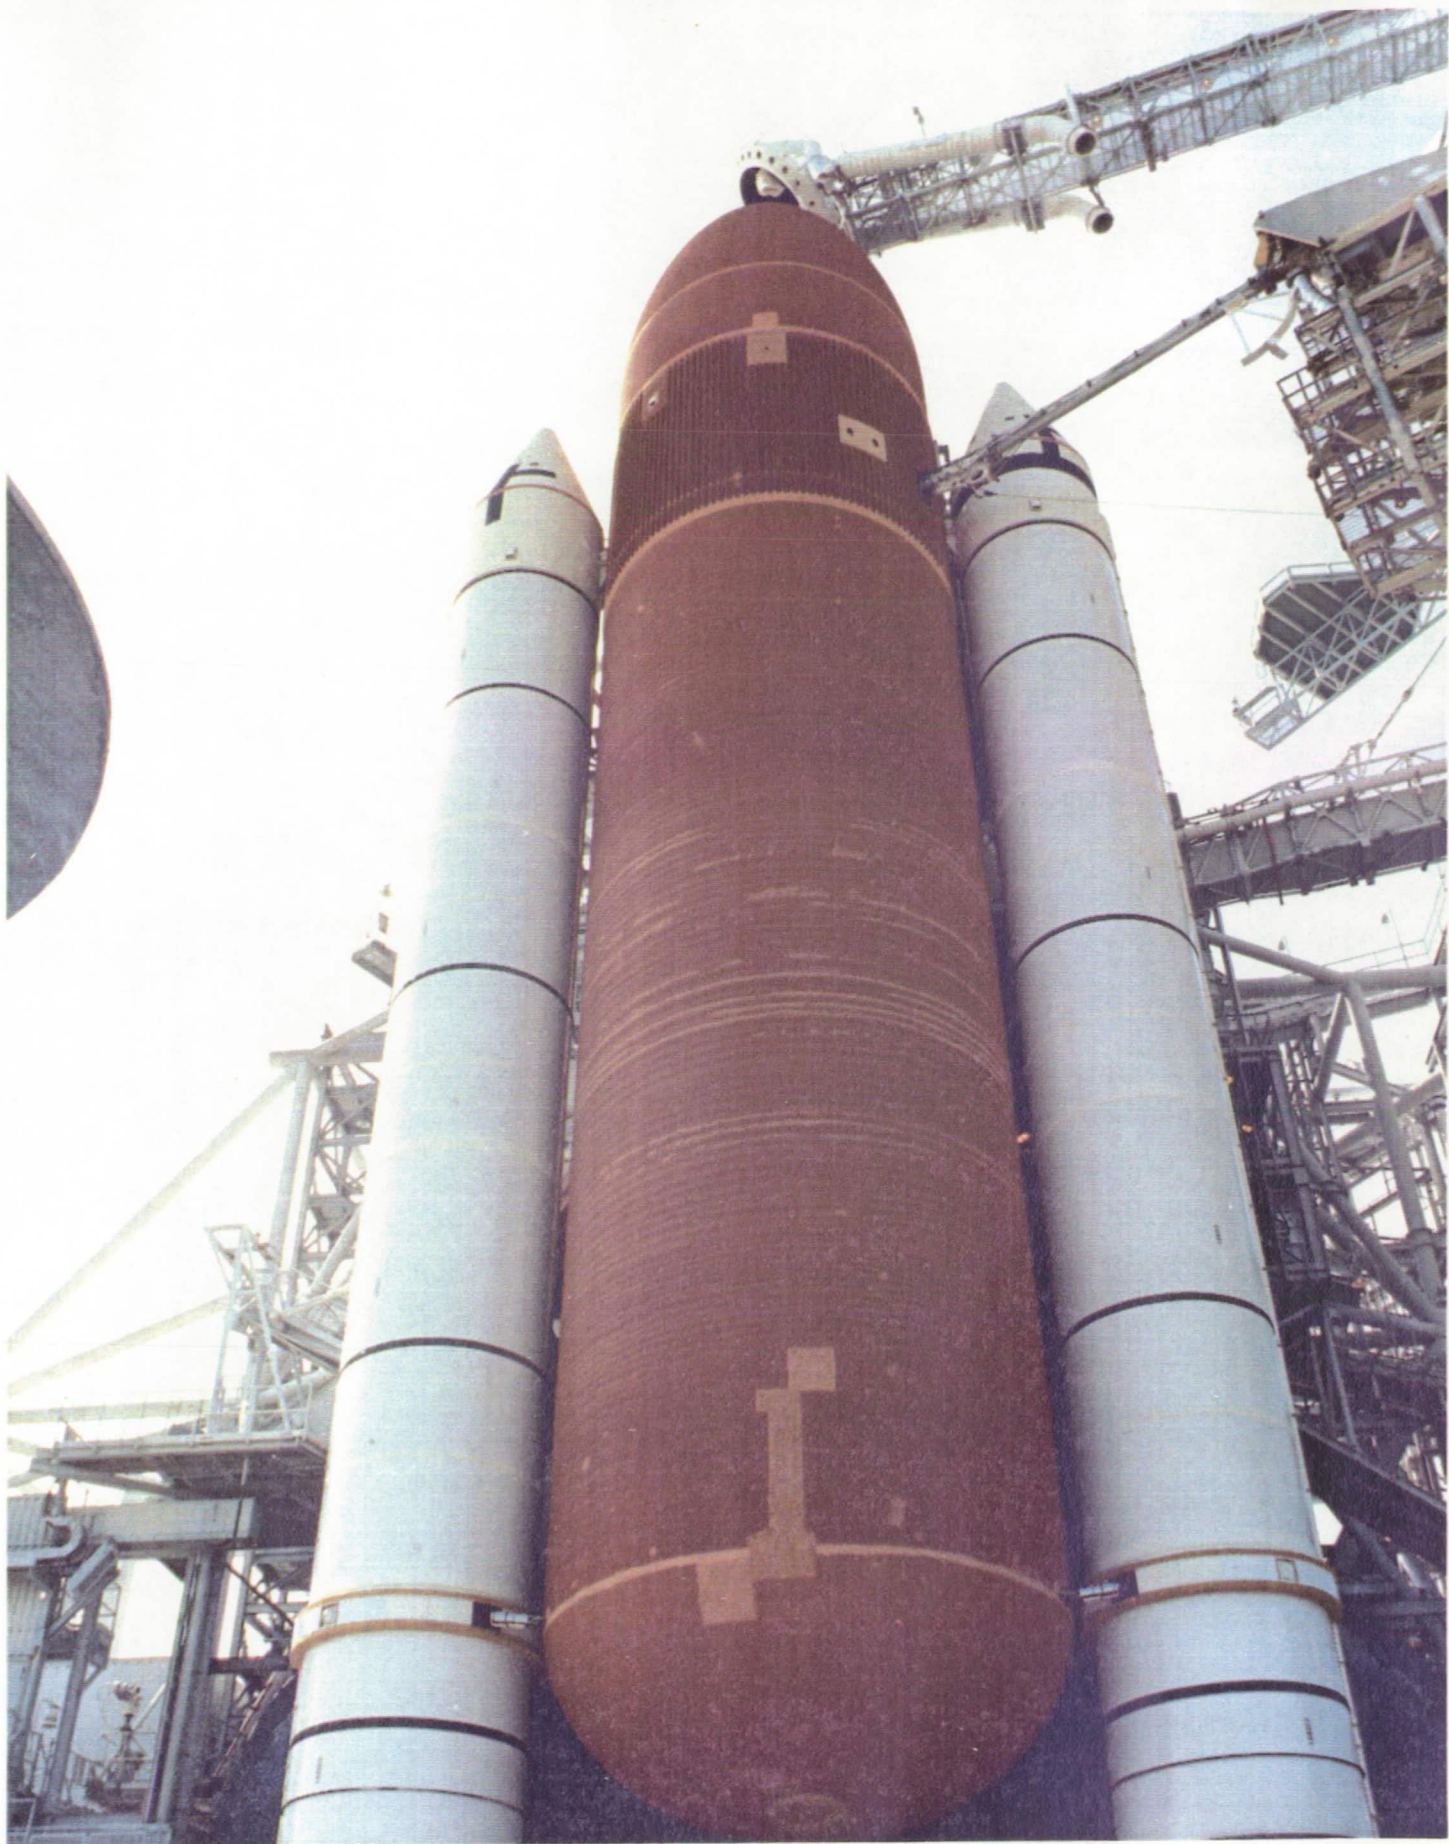
Overall view of ET-39 (LWT 32) and BIO40 -Z side

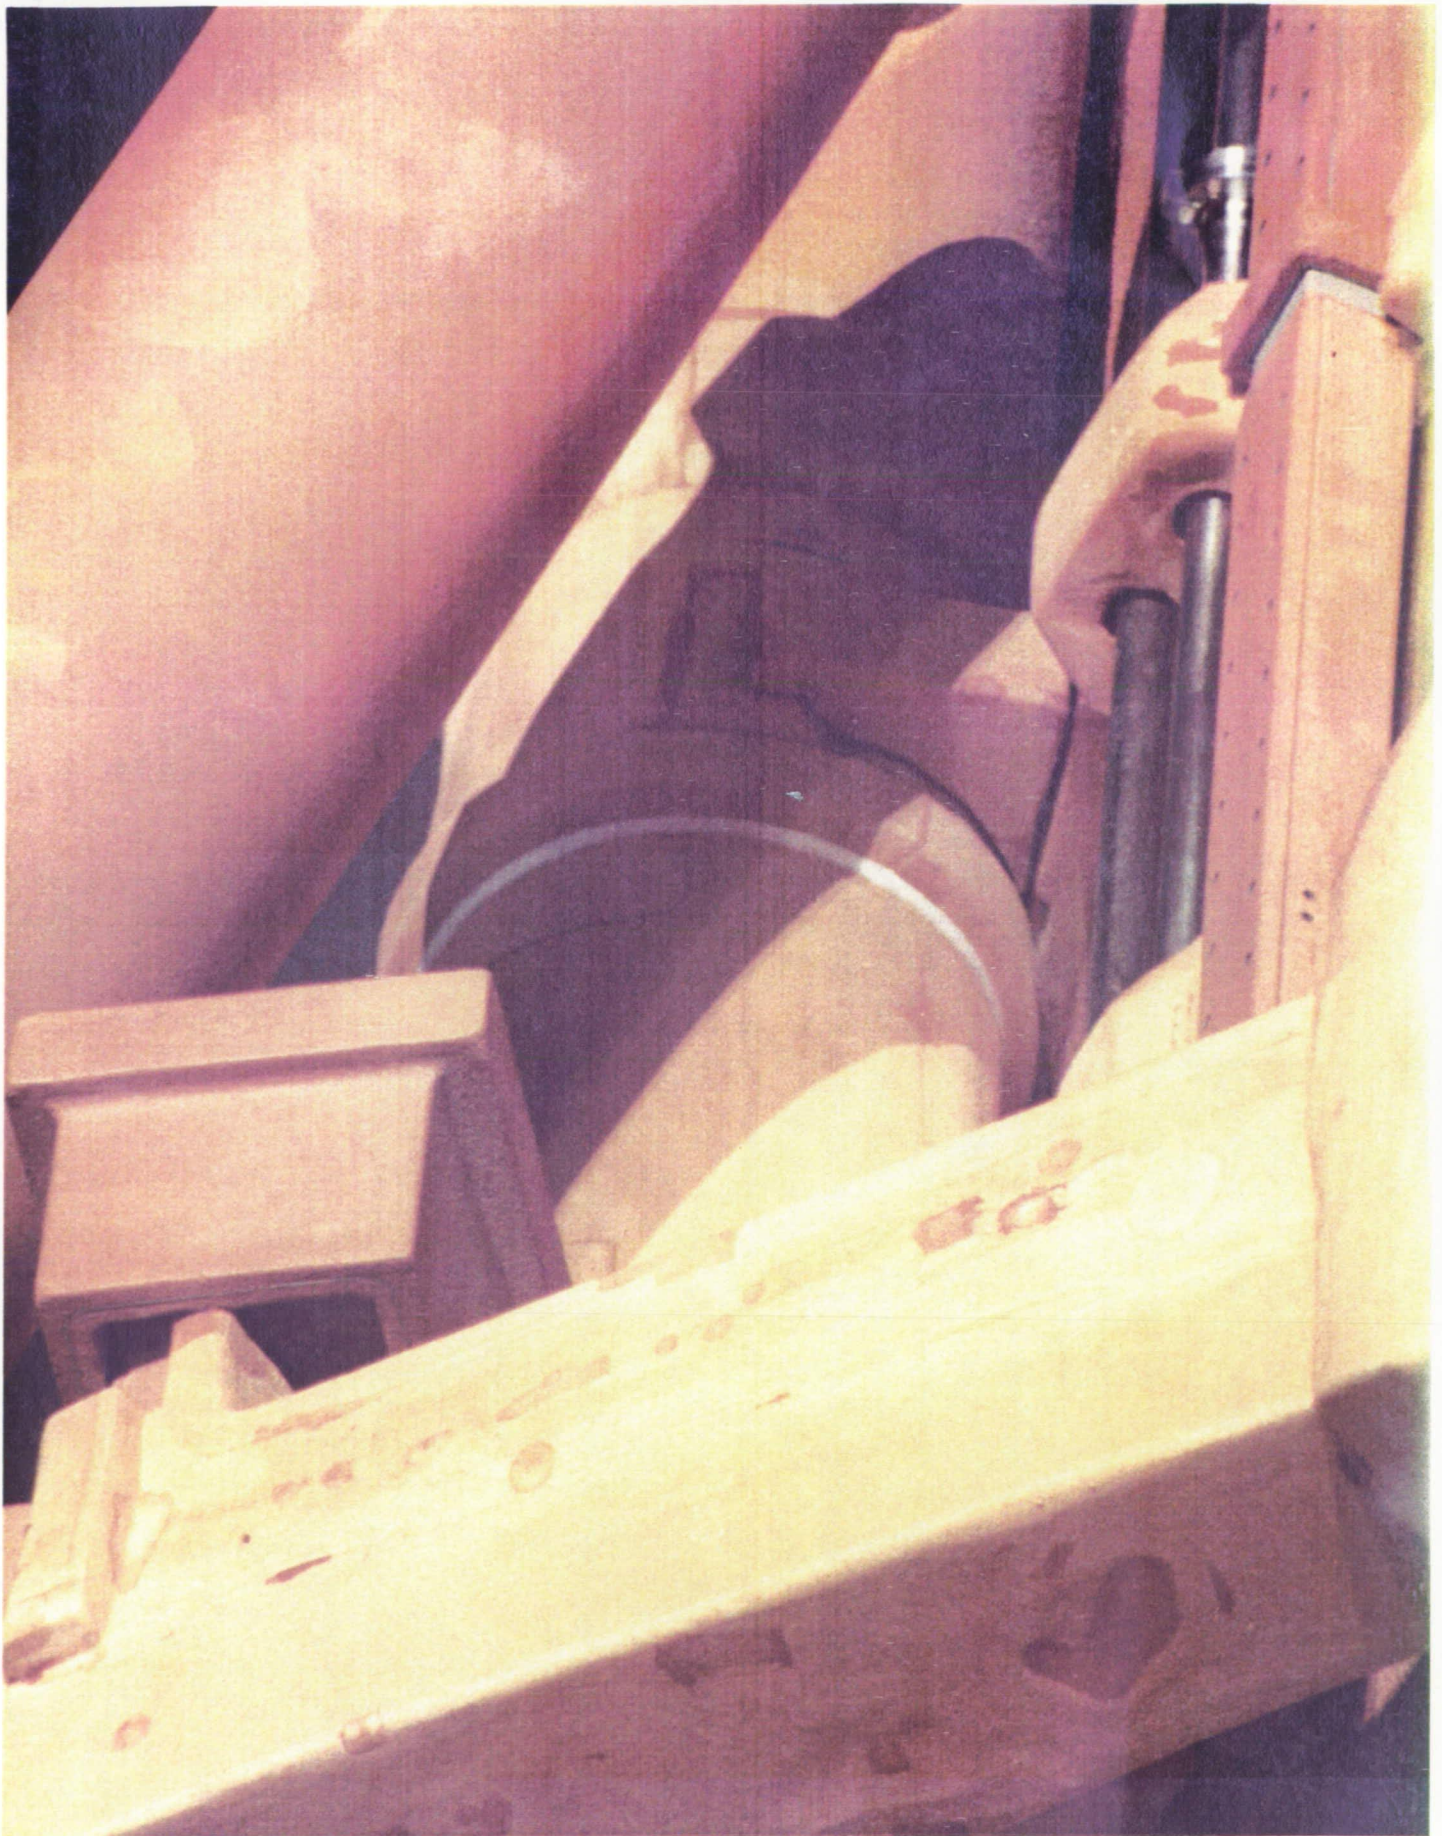
Typical ice/frost accumulation in the L02 feedline lower
bellows and support brackets

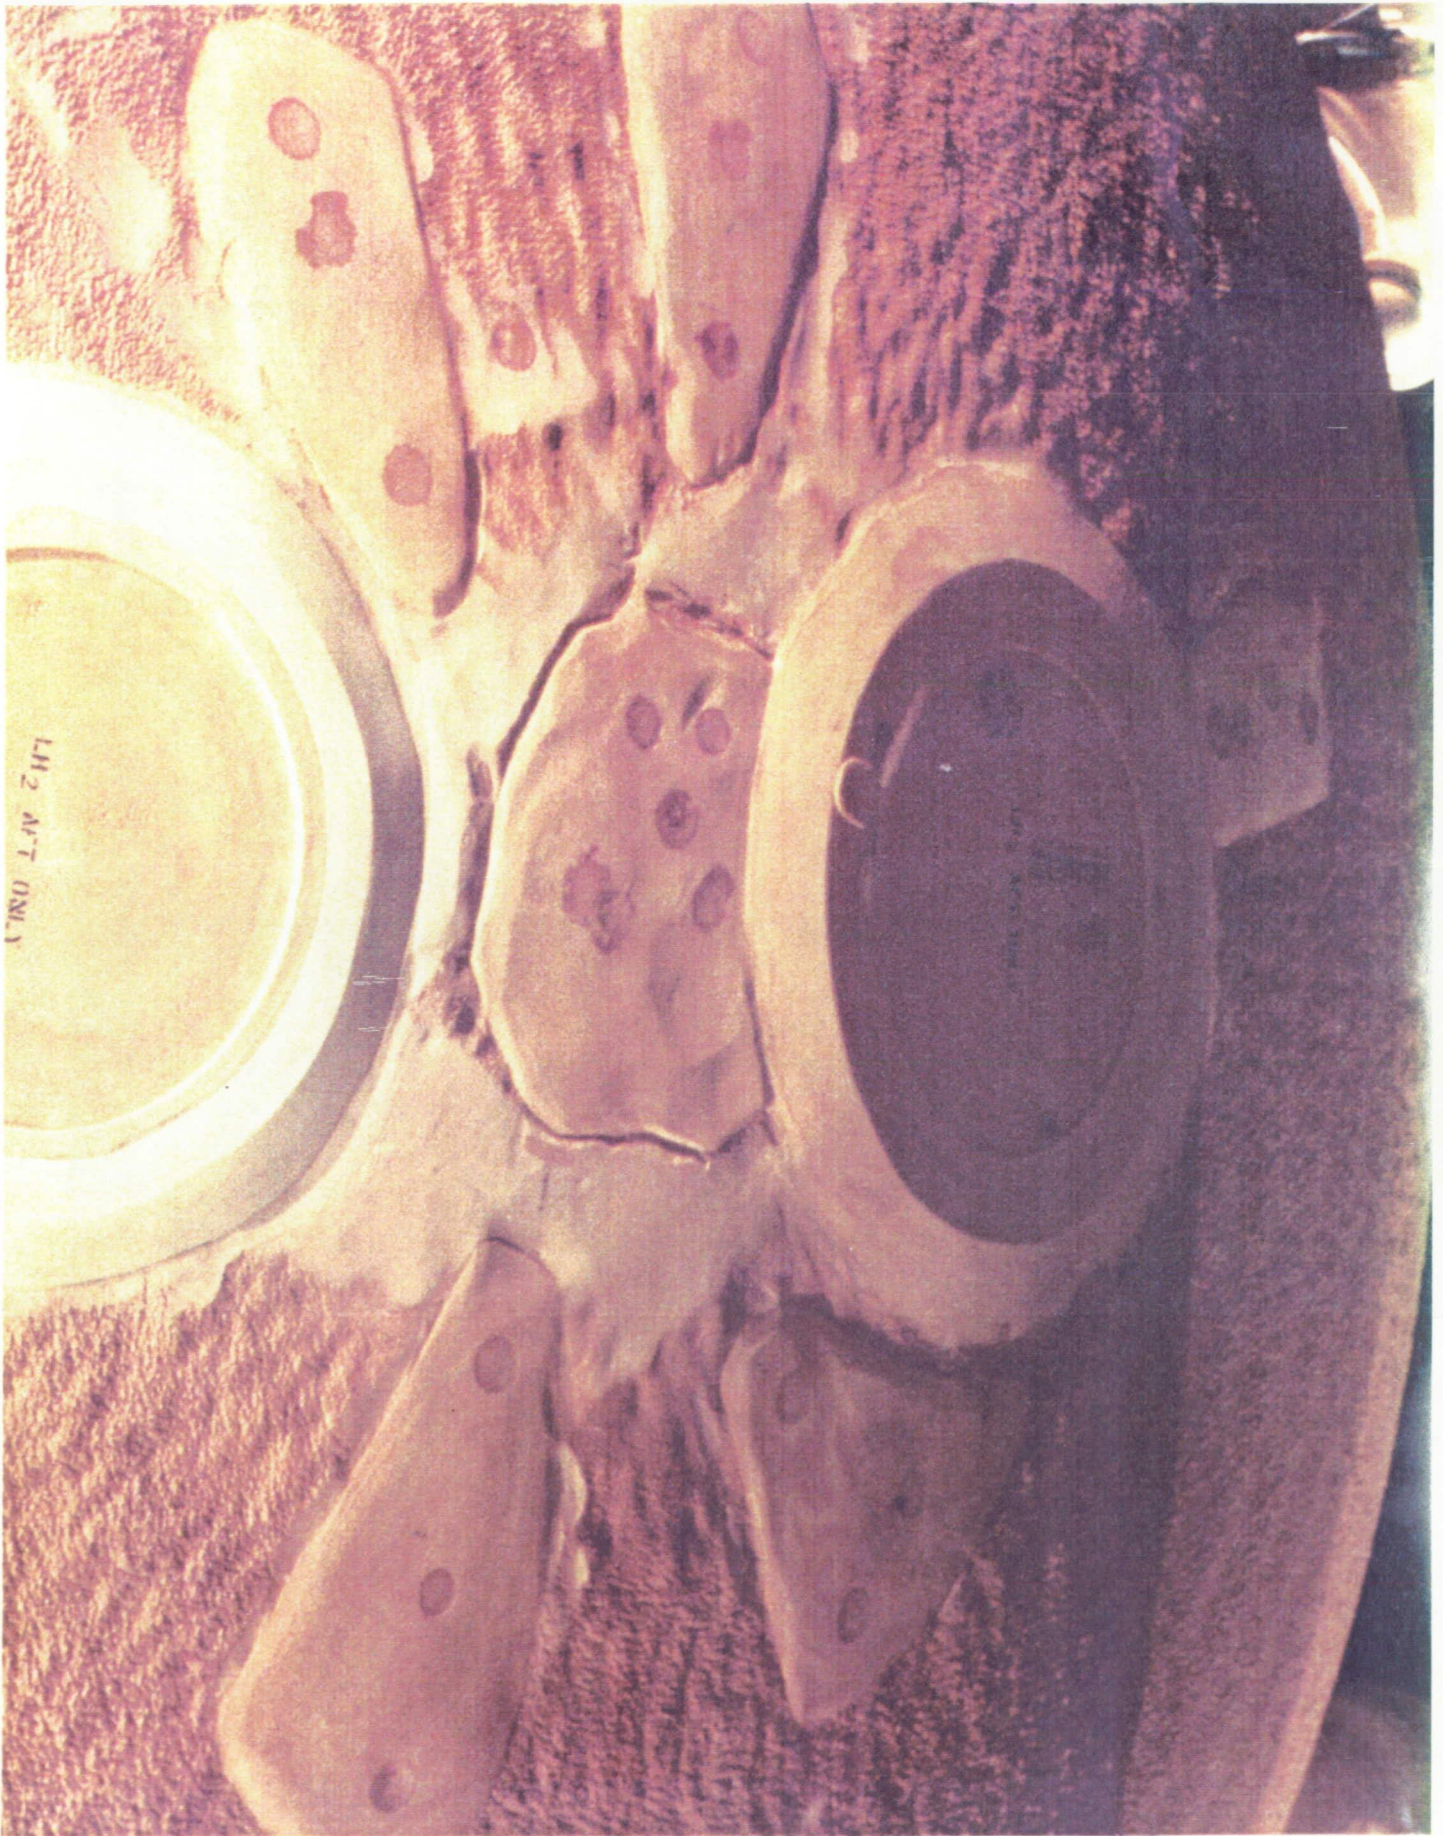
No run-off condensate was present on ET LH2 tank aft dome apex

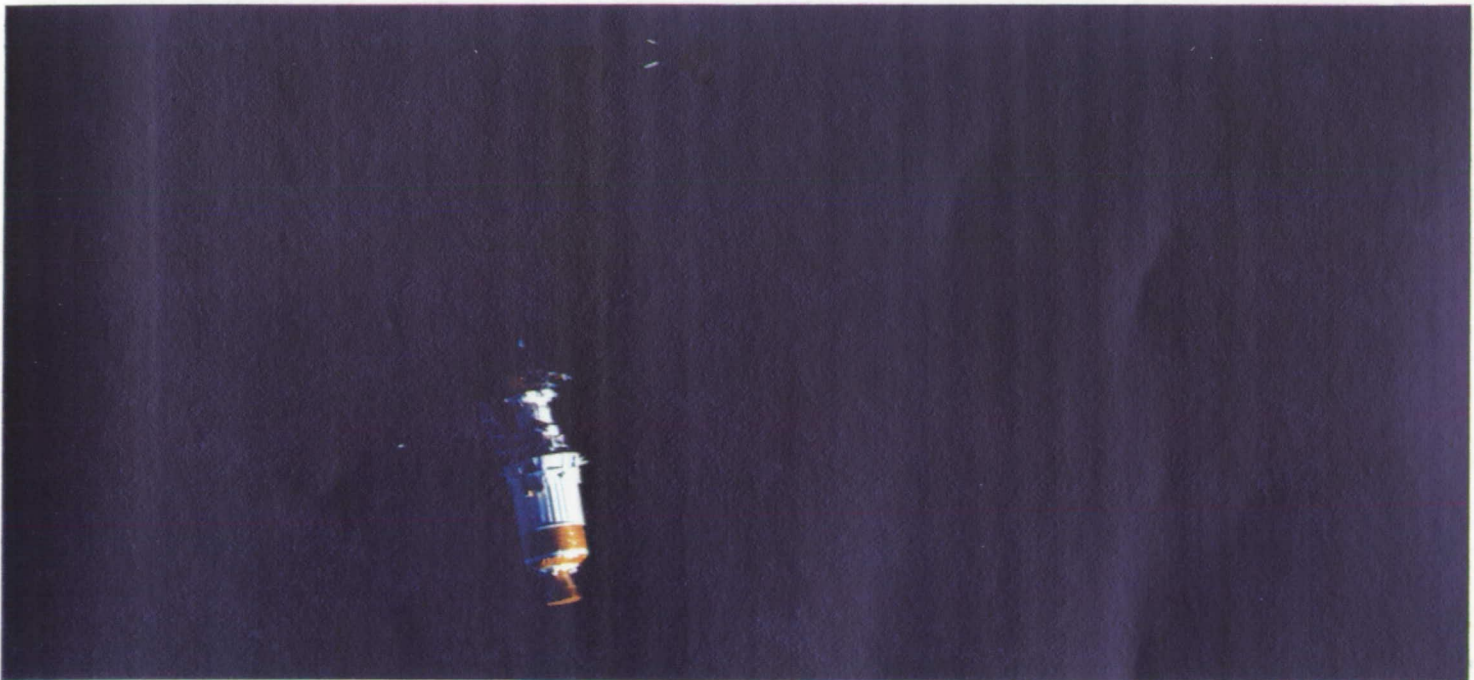
On-orbit photos of the External Tank after separation from the Orbiter revealed no significant anomalies. During the Ulysses/IUS deployment, three curved objects appeared near the aft end of the Orbiter and in the field-of-view with the payload. The objects were rectangular in plan form, but curved when viewed along the edge. The concave side of the objects were smooth while the opposite side was rough - similar to the frozen ice observed during ET separation. These objects are believed to be pieces of ice from the Orbiter MPS area.

Analysis of on-orbit photography revealed three debris objects,
which are all believed to be pieces of ice from the MPS area

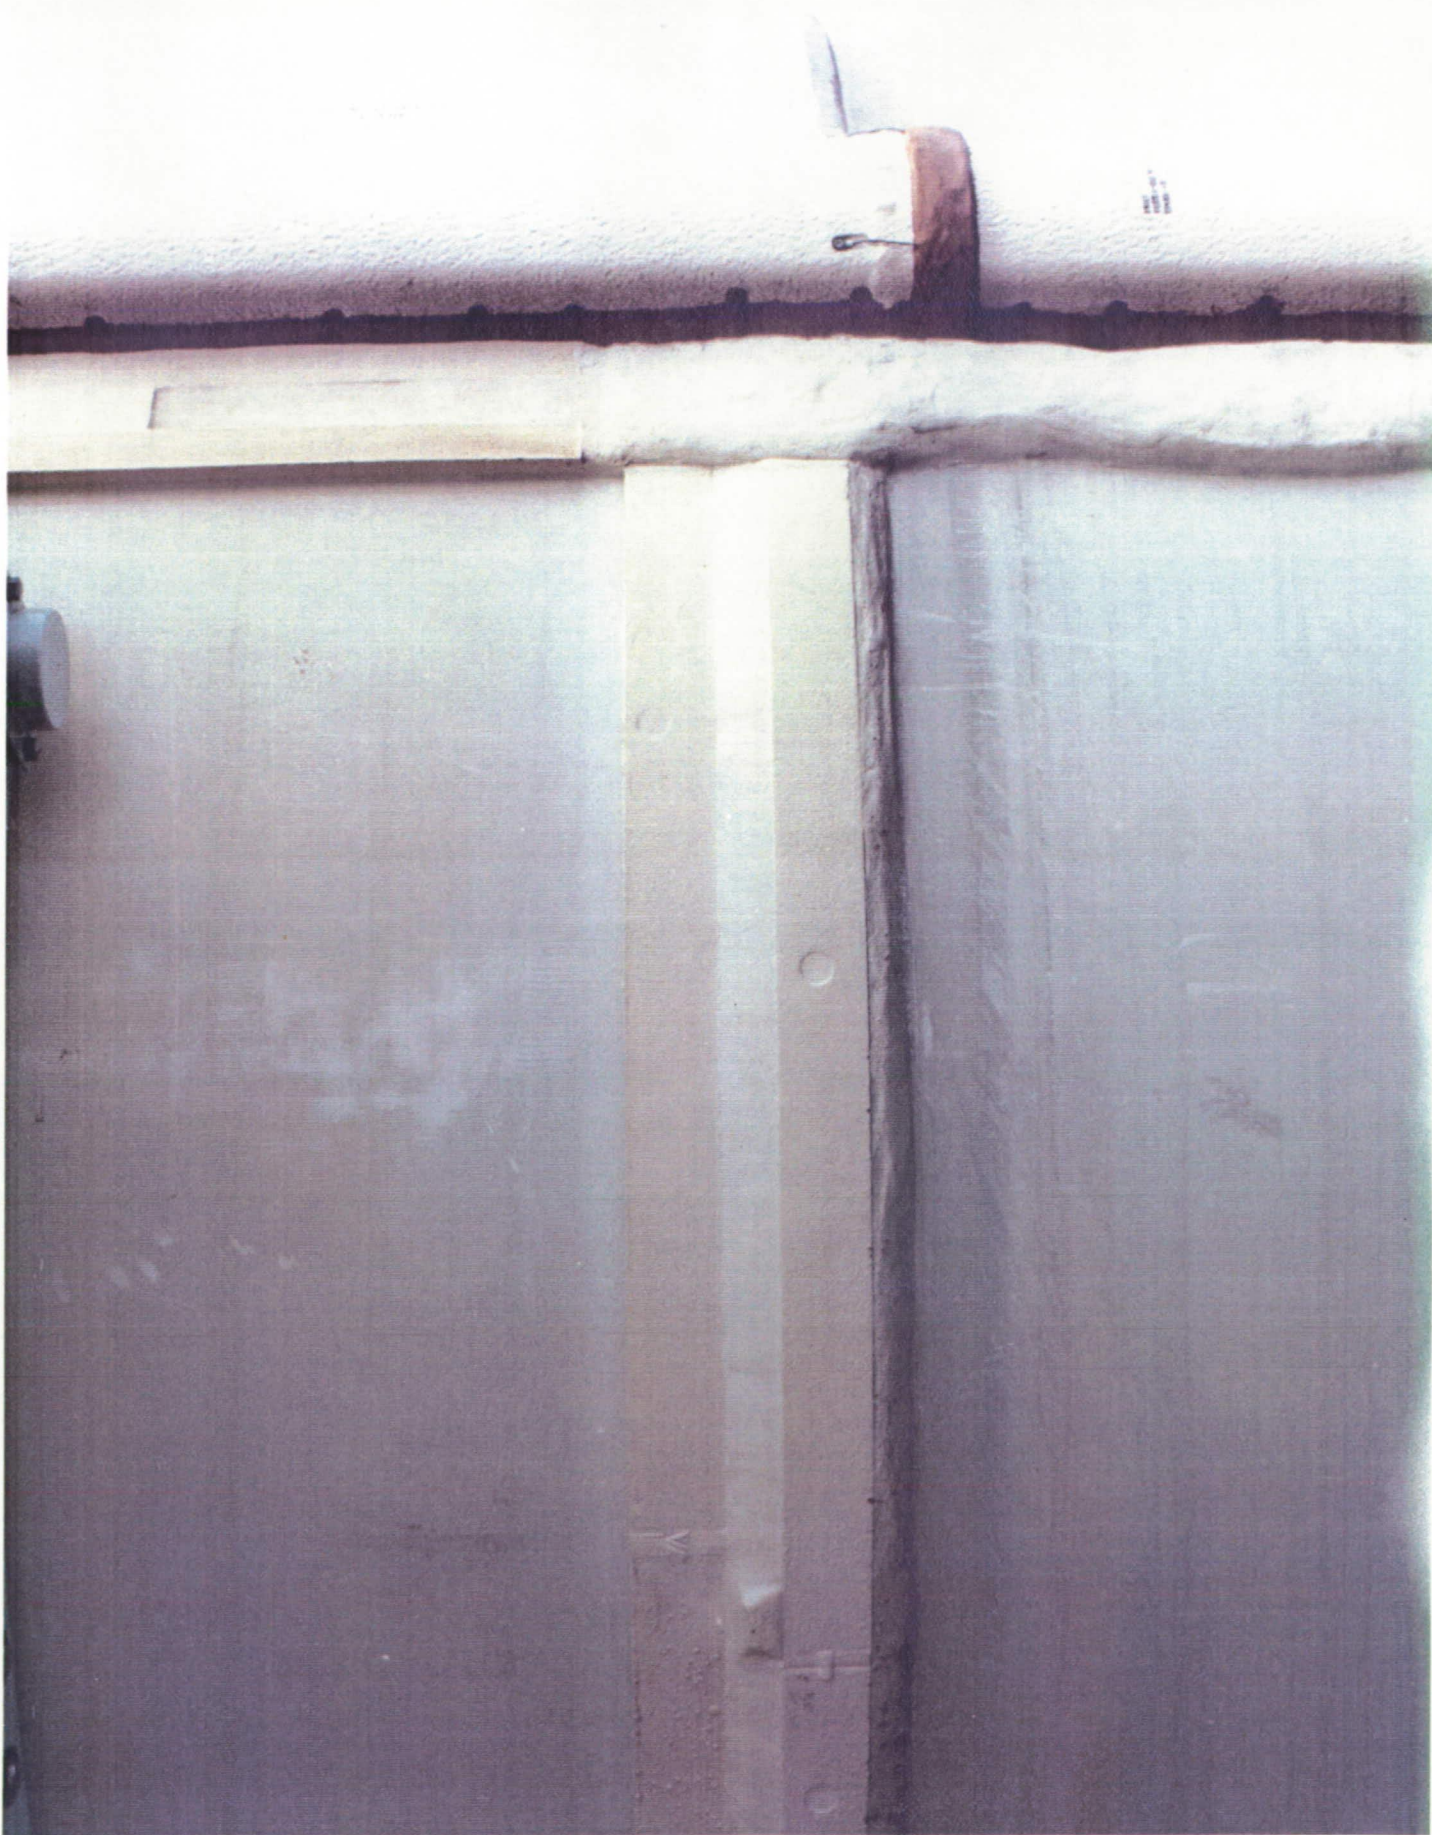
New Field Joint Protection System (FJPS) closeouts were in generally good condition
